Garisenda Tower in Bologna (Italy): health monitoring by different non-destructive testing techniques

Garisenda Tower in Bologna (Italy): Health monitoring by different nondestructive testing techniques

Angelo Di Tommaso[1,a], Gian Carlo Olivetti[2,b], Giuseppe Lacidogna[3,c*], Stefano Invernizzi[3,d], Oscar Borla[3,e], Alberto Carpinteri[3,f]

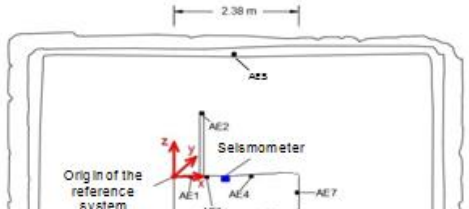
The experimental result analysis revealed several sources of AE activity, identified by a dedicated program of AE sources localization [11], implying the existence of an evolving cracking pattern. Figure 2 shows the plan of the tower cell at a height of two meters from the ground, with the AE sensors and the seismometer arrangement. In the same figure an axonometry with the representation of the AE sensors positions and the distribution of the AE sources localized along the walls in the South-East corner of cell are reported.

Figure 2: Plan of the tower with the origin of the Cartesian reference, for the arrangement of the AE sensors and the seismometer (up). Representation of the AE sensors positions in axonometry (down left). AE sources distribution along the South-East walls of the tower. The larger dots indicate overlapping acoustic sources. The points represented in blue were located from the 290th to the 450th day of monitoring in the masonry depth of the tower. The localization of other points from 450th day onwards is still in progress (down right).

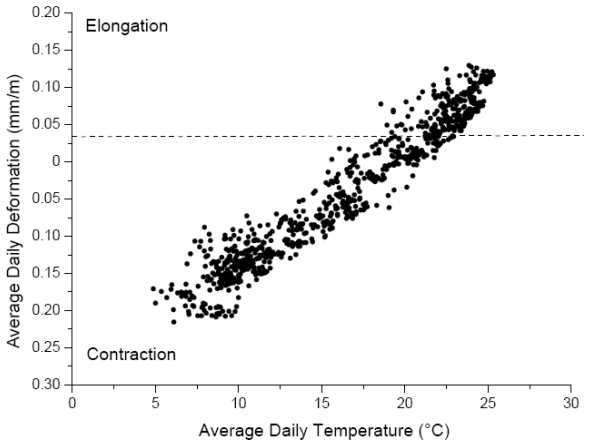
During the monitoring time FOS and temperature measurements revealed a fairly good correlation between wall deformations and tower internal temperature, with the largest contractions occurring at about 6.0 °C and the largest expansions occurring at 25.0 °C. See Figure 3 in which a graph showing the daily deformations, obtained by averaging the data recorded on the 6 optical strands, is reported as a function of the average daily temperature measured inside the tower cell.

Figure 3: Correlation between walls average vertical deformations measured by FOS and tower internal temperature.

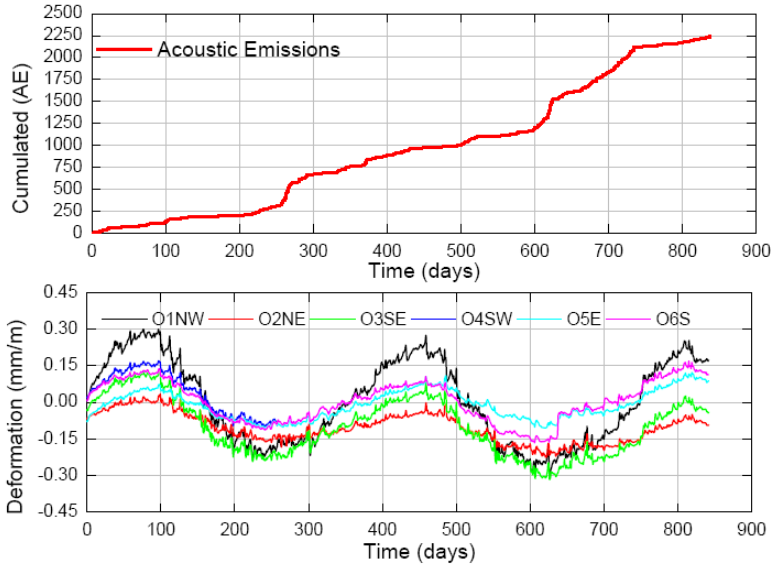
In addition, Figure 4 shows the growth of the AE signals cumulated function, obtained from all the transducers during the monitoring time, with the trend of the daily strains measured by means of the 6 optical strands. Observing the chart of the deformations trend, it can be seen that the minimum values of the contraction deformations are attributable to the optical strand O5E which is arranged in the South-East corner of the tower cell, while the maximum values of the expansion deformations are attributable to the optical strand O1NW arranged in the North-West corner. By relating the AE signals cumulative chart to that of the deformation trend, it can be seen that the maximum increases

of the AE signals are obtained in relation to the minimum values of the masonry walls contractions, i.e. around 240 days (January 25th, 2020) and 607 days (January 26th, 2021) from the start of monitoring.

Figure 4: Trend of the cumulate function of the AE signals recorded by the 8 sensors (up), and daily deformations measured by means of the 6 optical strands (down).

However, the continued growth of the cumulated function of AE signals during the monitoring period (Fig. 4), demonstrates that there are other effects besides those of thermal variations that produce damage to the tower. In many circumstances, the dead load, which could be very large in massive monumental buildings, is a major factor in the formation of the fracture patterns [12]. In this case, the inclination of the tower towards the side where the AE sensors have been applied can generate high stresses near the limit of the crack formation in the masonry. Therefore, the time-dependent creep behavior of the material under dead load and its interaction with fatigue due to thermal variations can be identified as the cause of damage.

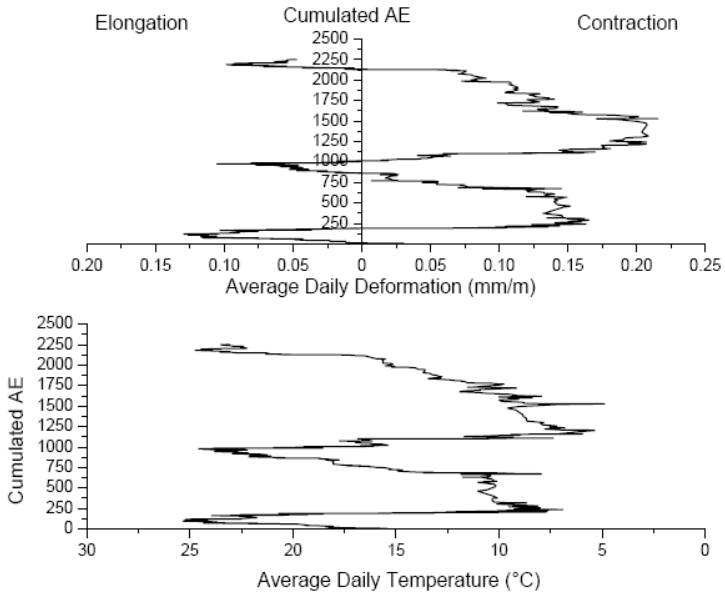
Figure 5: Correlation between cumulated AE activity vs FOS average daily deformations (up), and cumulated AE activity vs average daily temperature (down).

They reveal that the largest increases in AE signals is observed during wall contraction phases, in a strain interval near –0.15 mm/m or near –0.20 mm/m. This phenomenon is observed in a temperature range between 5.0 and 12.0 °C . This means that the tower at the cell level is damaged mainly in the winter season when the temperatures inside the cell are minimal and the masonry contracts after expanding in the hottest season, while in the other phases there is a trend characterized by a steady growth of AE signals but without apparent discontinuities or sudden jumps.

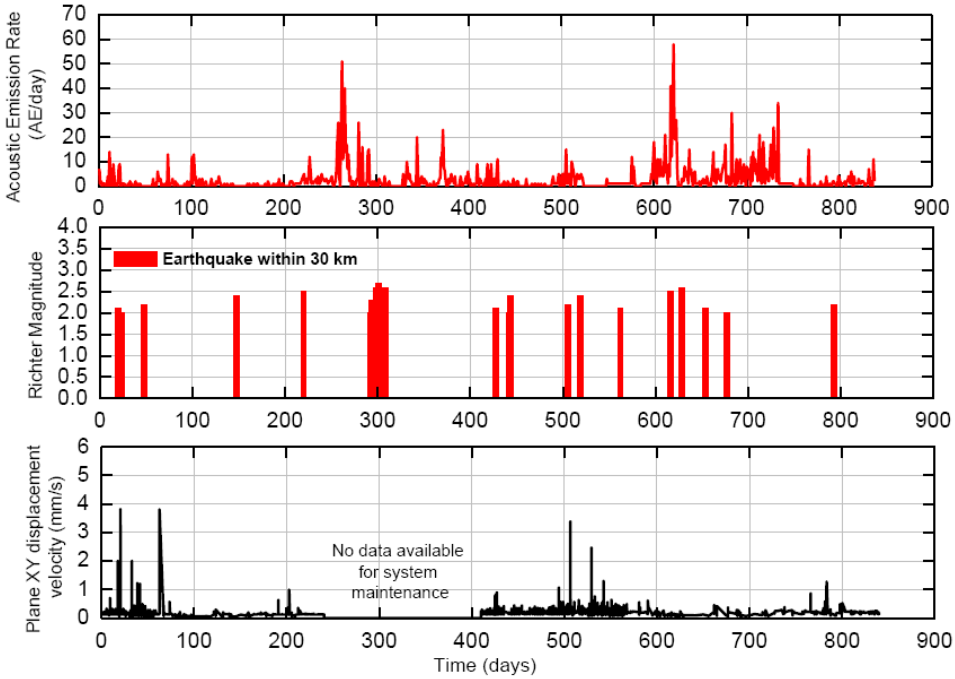
Figure 6: Rate trend of the AE signals during the entire monitoring period (up). Number of earthquakes, represented by their magnitude on the Richter scale, having their epicenters detected within a radius of 30 km from the city center of Bologna (middle). Speed of the transversal oscillations of the tower obtained by the seismometer (down).

As regards the other environmental actions on the tower, in the graphs of Figure 6 are compared the trend in the rate of the AE signals received by all the sensors during the entire monitoring period, the number of earthquakes, represented by their magnitude on the Richter scale, having their epicenters detected within a radius of 30 km from the city center of Bologna, as well as the speed of the transversal oscillations of the tower obtained by the seismometer. The earthquakes have been obtained from the web-site of the Italian National Institute of Geophysics and Volcanology (INGV)

The graph shows how there may be a correlation between the rate of the AE signals, which shows a significant increase in the initial days of monitoring, and the occurrence of two earthquakes with a magnitude close to 2.0 on the Richter scale. This correlation is also proven by the rather high values of the transverse displacement speed of the tower cell measured by the seismometer in the same period. On the other hand, around 250 days from the start of monitoring, although the rate of the AE signals presents a clear peak, no concomitant earthquakes appear. Unfortunately, in this case, the effects on the tower of the seismic action cannot be proven by the measurement of the displacement speed obtained by the seismometer, as the data in this period are not available due to system maintenance. The last peak of the AE signals occurs around 610 days from the monitoring start. Although in this case there are two concomitant earthquakes with a magnitude close to 2.5 on the Richter scale, but their effects on the tower are not proven by the increase in displacement speeds, which are almost null.

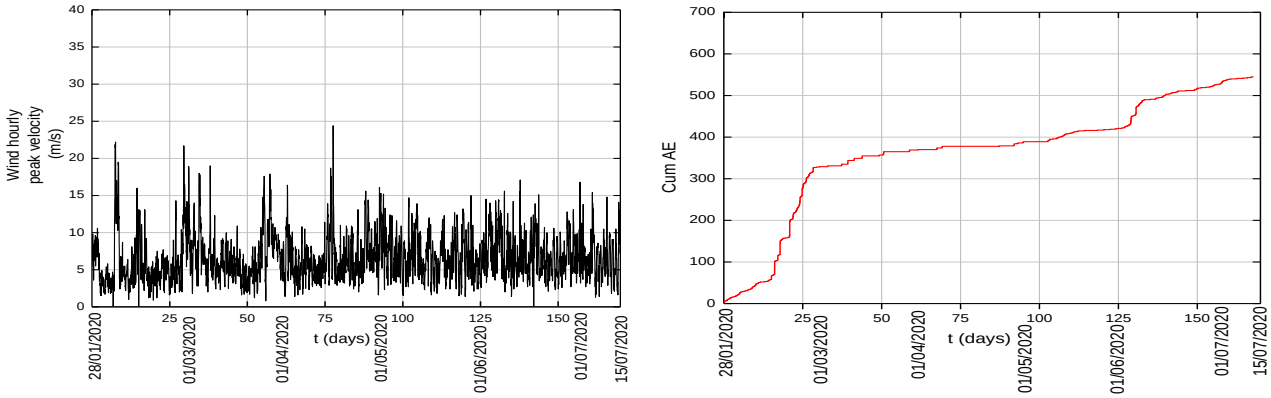
Concerning the actions of the wind on the tower, by way of example, in the graph of Figure 7 the hourly peak wind speed in m/s, recorded in the city of Bologna, is related to the cumulative function of the AE signals in the period from January 28th, 2020 to July,15th 2020, i.e., from 242 to 411 days from the start of monitoring. From the graph, it can be seen that wind and AE signals are not correlated, as the peaks in wind speeds do not correspond to simultaneous increases in the AE signals cumulated function.

Figure 7: Hourly peak wind speed in m/s, recorded in the city of Bologna (left), and cumulative function of the AE signals in the period of 242 to 411 days from the start of monitoring (right).
