Path of Knowledge for the Assessment of Structural Safety of the Pisan Tower of the Royal Palace of Palermo in Italy

Lidia La Mendola [1], Matteo Accardi [2], Fabrizio Agnello [3] and Alessia Monaco [4,*]

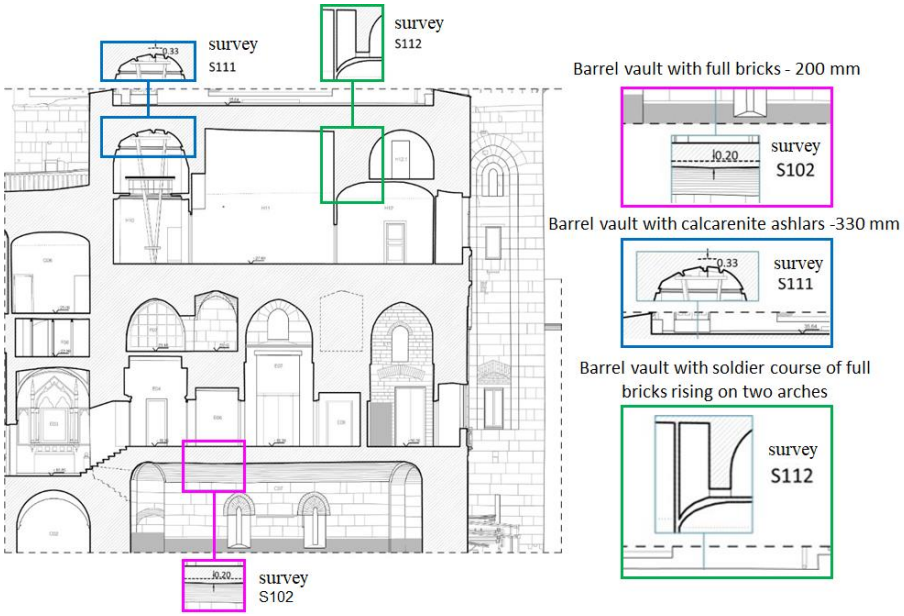
tower on the same level (sample S104), and in the Director's Office on level H (samples S109 and S110). The width of the barrel vault of the ambulacrum surrounding the Treasure Room (sample S102) and of the barrel vault above the Piazzi Library (sample S111) were surveyed. Despite the latter being currently covered by plaster, the constituting material was determined to be calcarenite ashlars. Finally, the real current structural configuration of the vault on the passageway between the Piazzi Library and the Observatory Director's Study was obtained, as it is hidden by partition walls and false ceilings. Horizontal sampling on a wall (sample S112) highlighted that the barrel vault had actually been realized with a soldier course of full bricks and that it rises on two arches: one of them is visible, while the other one is hidden by the abovementioned partition walls. Figure 13 shows the locations of samples S102, S111, and S112, which provided these results.

Figure 13. Results of endoscopic surveys S102, S111, and S112.

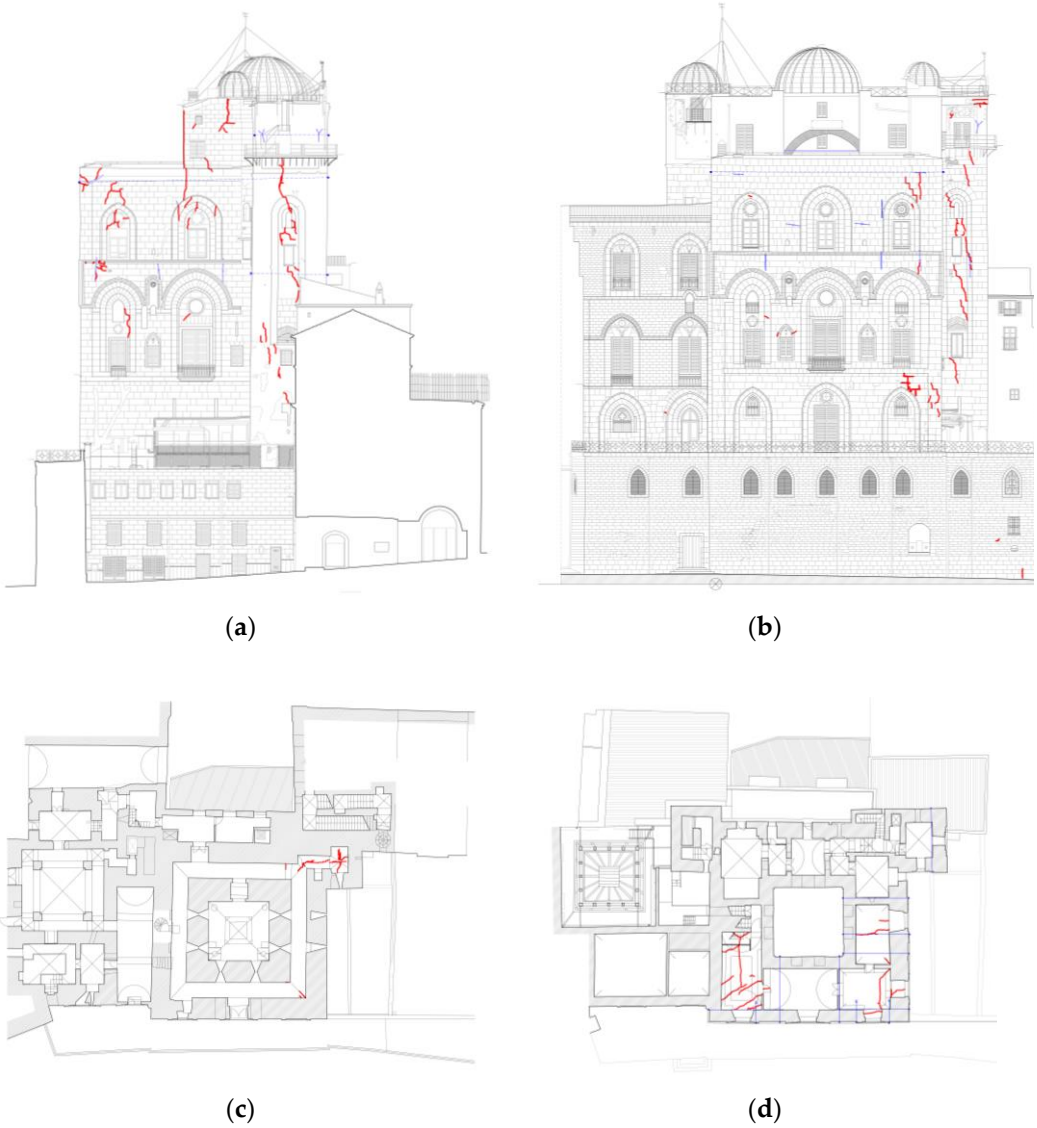
During the long life of the Royal Palace, many significant seismic events have occurred, and these have produced damage, which has been documented since 1693 [22] because of the various architectural modifications and the proximity of the Kemonia creek, which had a higher flow at that time. In particular, the Pisan Tower suffered significant damage during the 1968 earthquake, leading to the unavailability of some rooms on the level of the Observatory, with severe cracks in the vault of the Piazzi Library, which is currently still shored up for safety reasons. Comparison should be made of the current crack pattern—possibly worsened by the recent earthquake on 6 September 2002—with surveys of previous cracks; however, there was no available documentation for this purpose. Figure 14 shows some of the technical drawings by Officina per le Arti Opera, which illustrate the crack patterns.

Figure 14. Crack patterns (in red) and steel ties (in blue) (from the drawings of the Officina per le Arti Opera company): (**a**) on the north side; (**b**) on the east side; (**c**) on the floor plan at the height of 13.00 m; (**d**) on the floor plan at the height of 28.70 m.

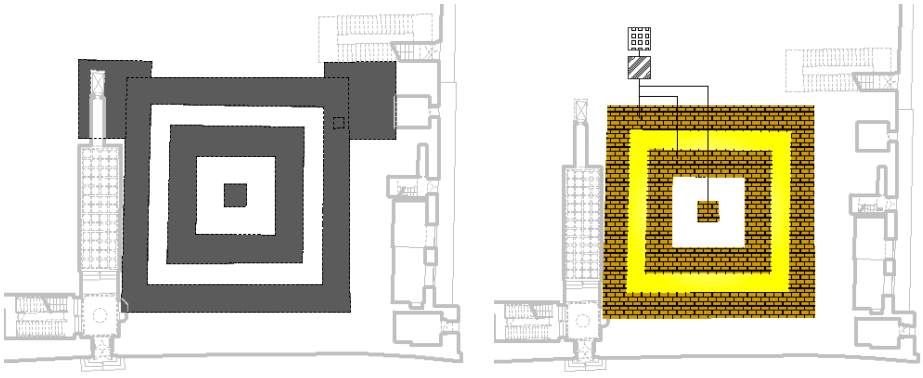
Figure 15. Identification of the structure of the Tower on level A (height 2.90 m); (**a**) hypothesized vertical load-bearing structure; (**b**) hypothesized materials.

The surveys performed and the information collected showed that the vertical load-bearing structure of the Tower consists, on level A, of two concentric quadrilaterals in the planimetry, with walls wider than 2 m, and two turrets at the vertices of the west side of the Tower, as represented in Figure 15a. These walls have been realized with a wall in large (70–100 cm) calcarenite ashlars, dry-placed and/or with low-width mortar joints. The wall was considered to show good workmanship and the ashlars have excellent mechanical properties, as shown by the high value of the compression strength of the extracted core samples. The material between the two squares of the Tower can be associated with an infill, mainly constituted by crushed ashlars, masonry with scarce mechanical properties, and incoherent materials (Figure 15b).

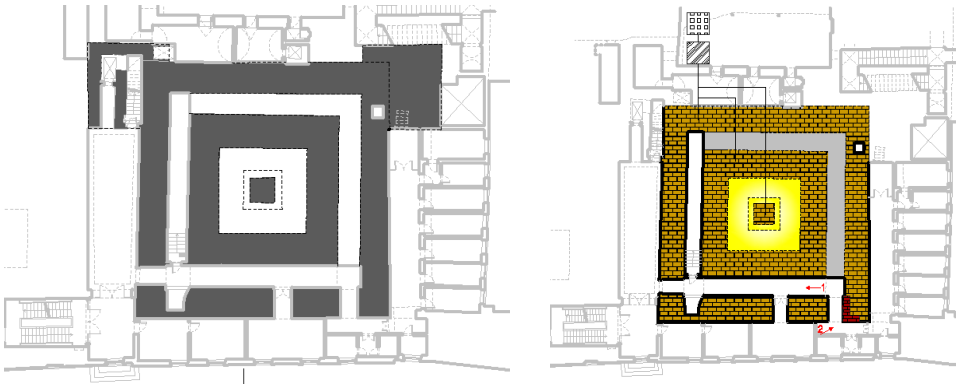
Figure 16. Identification of the structure of the Tower on level B (height 8.40 m): (**a**) hypothesized vertical load-bearing structure; (**b**) hypothesized materials.

The surveys performed and the information collected at level B repeated and confirmed the same structural layout as the lower level, consisting of two homothetic quadrilaterals with wall widths above 2 m, in calcarenite ashlars, dry-placed and/or with mortar (Figure 16a). Today, as in the Norman layout, the south turret is mainly used for vertical connections. The structural layout of the Tower has been presumably subjected to modifications during the complex and intricate evolution of the Norman Palace. At this level, the wall, which is partly visible, consists of calcarenite ashlars and variable-width lime mortar joints. The performed tests showed that the ashlars have good mechanical properties; however, these were lower than the values found at the lower level. The infill of the core between the two masonry squares is heterogeneous and incoherent, while in the internal core it is constituted by crushed ashlars with variable size and resistance (Figure 16b).

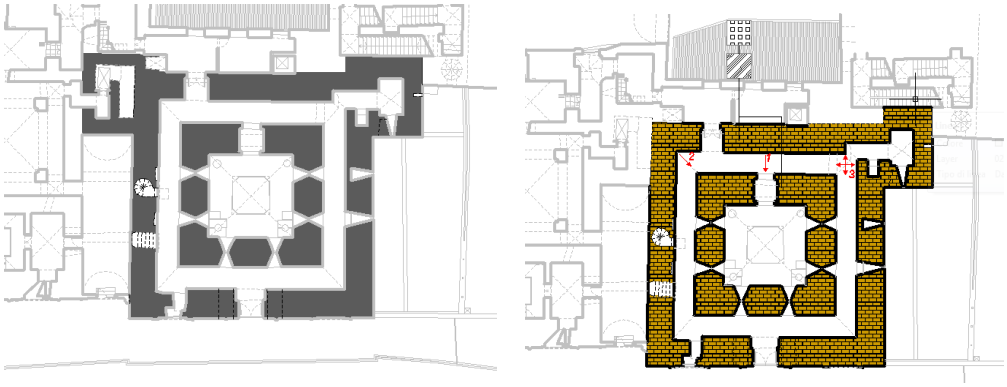
Figure 17. Identification of the structure of the Tower on level C (height 13.00 m): (**a**) hypothesized vertical load-bearing structure; (**b**) hypothesized materials.

Level C has a completely exposed structural layout, consisting of two concentric quadrilaterals, divided by an ambulacrum with a barrel vault covering and two side turrets (Figure 17a). The masonry walls are in large calcarenite ashlars and lime mortar. The mechanical parameters of the ashlars were only available for the exterior of the east wall, and the resistance values were aligned with those of the lower level. The values for the operating tension of the masonry wall of the external square were very high; this is probably incompatible with the resistance of the masonry (Figure 17b).

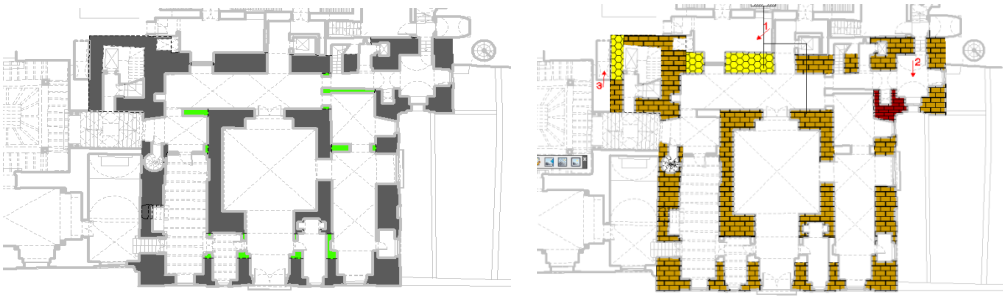
Figure 18. Identification of the structure of the Tower on levels D-E (height 19.60 m): (**a**) hypothesized vertical load-bearing structure; (**b**) hypothesized materials.

On levels D-E, the structural layout of the concentric quadrilaterals can be detected even if the walls are significantly set back from the lower level (Figure 18a). Moreover, the walls of the external square are intermitted by wide and numerous openings (doors, windows, rooms, and staircases). The President's Room has two different heights, while the other rooms are mainly double-height or have timber roofs. Superintendent Valenti, during the 1929 restoration intervention, performed several modifications to the structural layout. He demolished many mezzanine rooms, which had presumably been realized in the period of the Spanish Viceroyalty, and relocated some masonry walls to restore the Norman layout. The numerous performed interventions and the finishing with exposed faux masonry plaster were an obstacle to the precise definition of the wall typologies. Figure 18b shows a possible hypothesis, reconstructed solely on the basis of the historical documentation found.

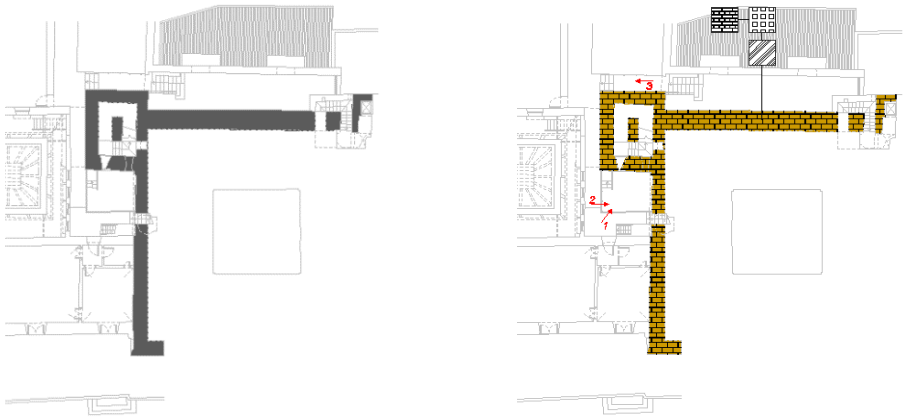
Figure 20. Identification of the structure of the Tower on level G (height 27.00 m): (**a**) hypothesized vertical load-bearing structure; (**b**) hypothesized materials.

Level G includes the rooms of the Astronomical Observatory adjacent to the south and west sides of the Tower. As has been mentioned, these were involved in the restoration intervention in the 1990s by Boscarino and Cottone. The intervention exposed the load-bearing structure on this level, allowing us to observe that it can be substantially associated with the original Norman construction (Figure 20a) and that it consists of large calcarenite ashlars and lime mortar (Figure 20b).

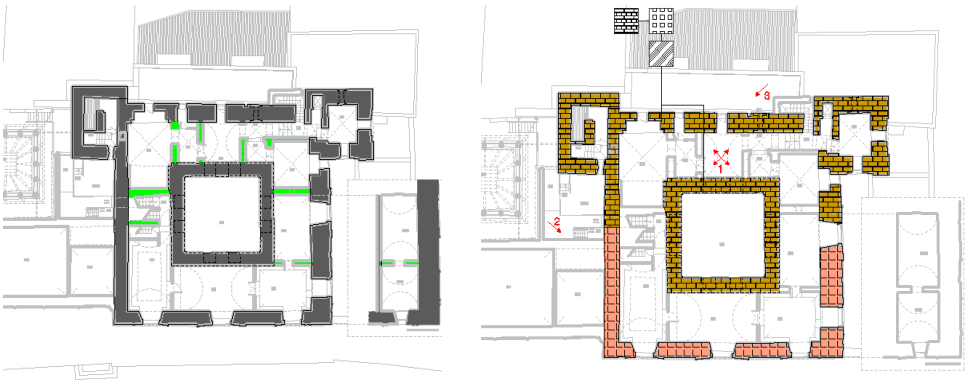
At the level of the Piazzi Library (level H), which hosts rooms of both the Astronomical Observatory and the ARS, the load-bearing structure provides the layout with concentric quadrilaterals (Figure 21a). The compactness and rigidity of the system are notably reduced by the narrow width of the walls, and by the numerous openings. As discussed in the previous paragraphs, the east side of the Tower probably represents an addition from the period of the Spanish Viceroyalty. Hence, techniques and materials differ significantly from the Norman construction (Figure 21b). This circumstance was also confirmed by the mechanical characteristics surveyed in the Spanish masonry, which was characterized by low values of compression strength as compared to those of the Norman masonry and to the suggested values for masonry walls in soft stone ashlars. These intrinsic flaws in the masonry, together with the presence of many transfer walls between the two squares in the load-bearing structure of the Tower, have certainly led to a relevant vulnerability. The effects of the 1968 earthquake and the constant and abundant infiltrations from the terrace of the upper level have produced several instability phenomena, including diffuse—and worrisome—cracks in both vertical and horizontal structural components. Following these damages, the rooms of the Observatory were shored up and made inaccessible. The cracks in the floor slabs are often extended in the walls, hence disrupting the wall structure and leading to additional vulnerability.

Figure 21. Identification of the structure of the Tower on level H (height 28.70 m): (**a**) hypothesized vertical load-bearing structure; (**b**) hypothesized materials.

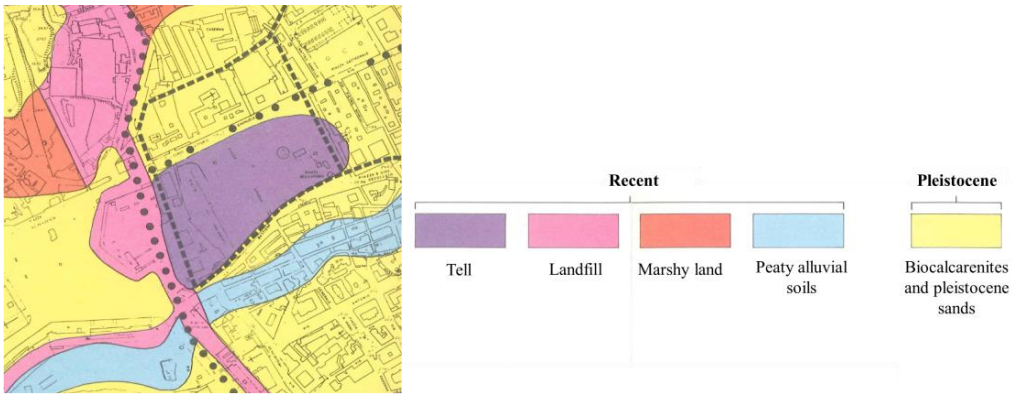
Figure 26. Geological map of the site [26].

The geological map of the site [26], shown in Figure 26, provides a detailed outline of the geological conditions of the area of the Palace, indicating a lithological sequence of landfills constituted by clastic sediment with various densification conditions (lime sands, gravels, and calcarenites) with superimpositions of remnants of ancient masonry structures—the so-called "*Tell*"—with a width between 1.5 and 9.0 m, placed on biocalcarenites with a sandy nodular texture with various solidification conditions, constituting the sandy–calcarenite complex.

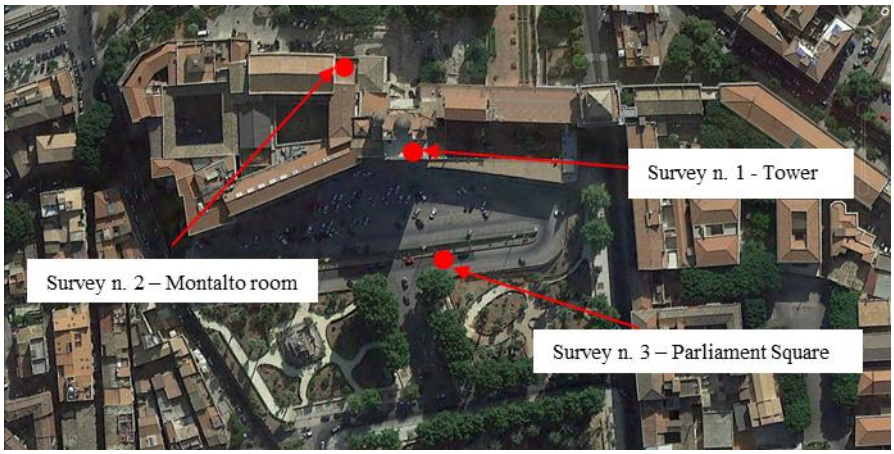
Figure 27. Planimetry with the location of the surveys.

The surveys were performed at the points shown on the planimetry in Figure 27; the first one was inside the Tower at the lowest height (n. 1), the second one was outside the Tower, but at a lower height corresponding to the Montalto Room (n. 2), and the third one was in Parliament Square (n. 3), just beyond the caretaker’s office at the entrance. Survey n. 1, named “Tower”, obtained a value of $V_{S,30}$ = 342 m/s and a width of 8 m for landfill on the sandy–calcarenite complex. Survey n. 2, named “Montalto room”, obtained a value of $V_{S,30}$ = 345 m/s and a width of 5 m for landfill on the sandy–calcarenite complex. Survey n. 3, named “Parliament Square”, obtained a value of $V_{S,30}$ = 352 m/s and a width of 5 m for landfill on the sandy–calcarenite complex.

In accordance with chapter 3 of *Guidelines*, which defines seismic action with reference to Section 3.2.2 of NTC2018, and hence according to the value of $V_{S,30}$ obtained in the three tests, the soil class to be assumed for the definition of the response spectra was Class C—coarse-grained, medium-dense soil deposits or fine-grained soils with a medium consistency, thicker than 30 m, characterized by a gradual improvement of mechanical properties along with the depth, and by values for $V_{S,30}$ between 180 m/s and 360 m/s (that is, 15 < $N_{SPT,30}$ < 50 in coarse-grained soils and 70 < $c_{u,30}$ < 250 kPa in fine-grained soils). Figure 28 shows the details of the interpretations of the experimental data obtained.

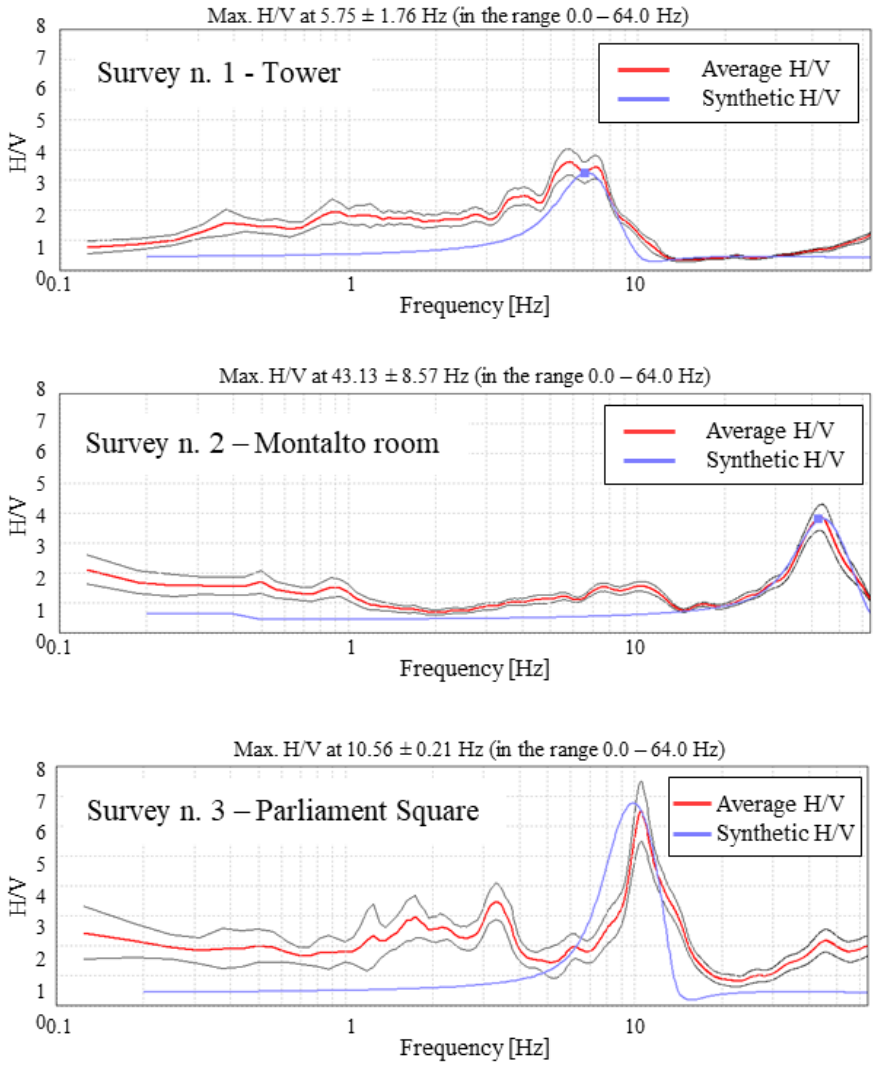
Depth [m]	Thickness [m]	V_s [m/s]	Poisson's Ratio
Survey n. 1—Tower			
8.00	8.00	209	0.40
inf.	inf.	445	0.35
Survey n. 2—Montalto room			
1.00	1.00	168	0.40
inf.	inf.	358	0.35
Survey n. 3—Parliament Square			
5.00	5.00	180	0.42
inf.	inf.	436	0.35

Figure 28. Results of single-station passive seismic tests.

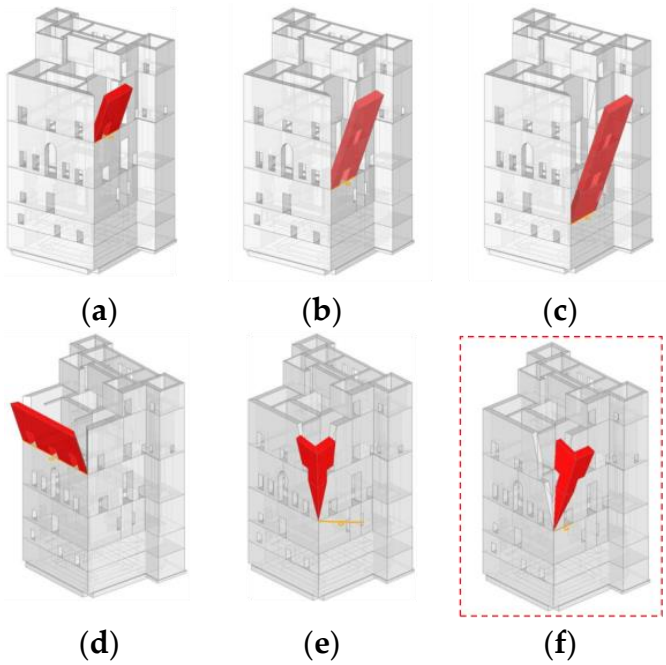
Figure 29. Axonometric views of the theoretical local collapse mechanisms: (**a**–**c**) rotation of the north wall at different levels; (**d**) rotation of the east wall; (**e**) rotation of the north-east corner area; (**f**) most probable simple overturning of the north wall (angle $\gamma = 0$) and a portion of masonry in the east wall.

The obtained results show that the most likely failure mechanism involves the simple overturning of the north wall (angle $\gamma = 0$) and a portion of masonry in the east wall.
