Path of Knowledge for the Assessment of Structural Safety of the Pisan Tower of the Royal Palace of Palermo in Italy

Lidia La Mendola [1], Matteo Accardi [2], Fabrizio Agnello [3] and Alessia Monaco [4,*]

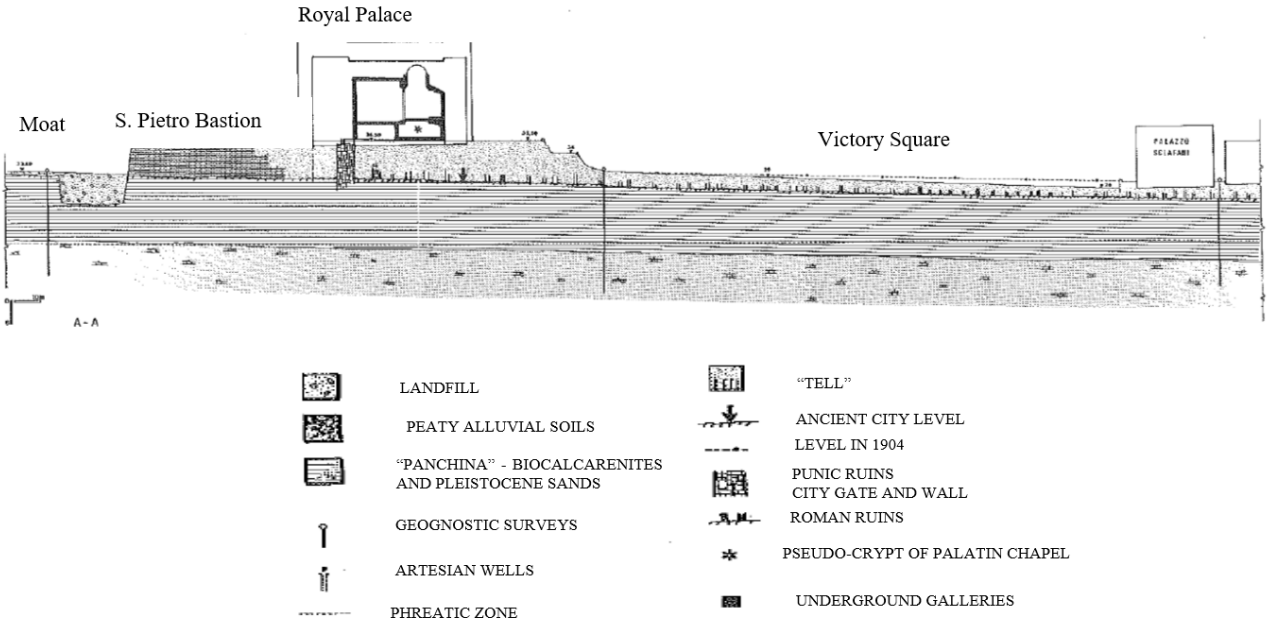
Figure 25. Typical geological cross-section [26].

Some studies from the literature [22] report that the area of the Norman Palace falls within the ancient urban core, called Panormus. The subsoil is constituted by a sandy-calcarenite complex, divided into two lithofacies: (1) lithofacies of solidified and soft biocalcarenites; (2) lithofacies of sands. This geological formation is covered by an ancient landfill (densified). Figure 25 shows a typical geological section [26].

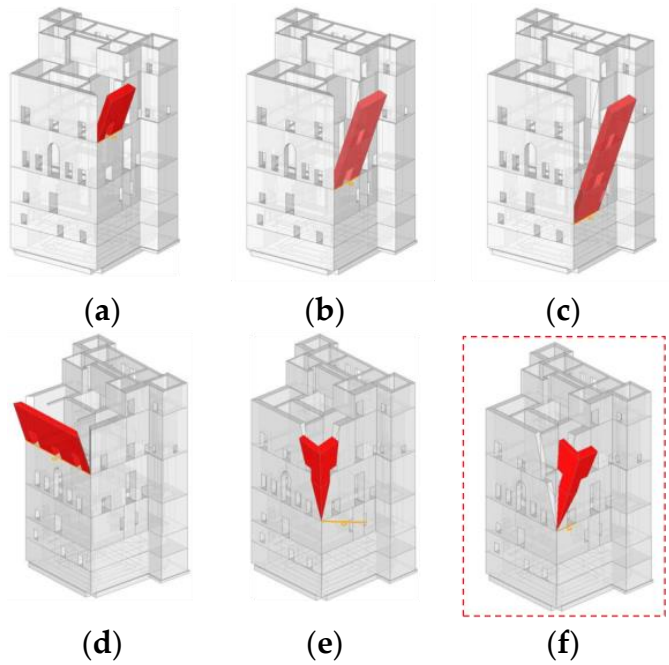
Figure 29. Axonometric views of the theoretical local collapse mechanisms: (**a**–**c**) rotation of the north wall at different levels; (**d**) rotation of the east wall; (**e**) rotation of the north-east corner area; (**f**) most probable simple overturning of the north wall (angle $\gamma = 0$) and a portion of masonry in the east wall.

The obtained results show that the most likely failure mechanism involves the simple overturning of the north wall (angle $\gamma = 0$) and a portion of masonry in the east wall.
