Path of Knowledge for the Assessment of Structural Safety of the Pisan Tower of the Royal Palace of Palermo in Italy

Lidia La Mendola [1], Matteo Accardi [2], Fabrizio Agnello [3] and Alessia Monaco [4,*]

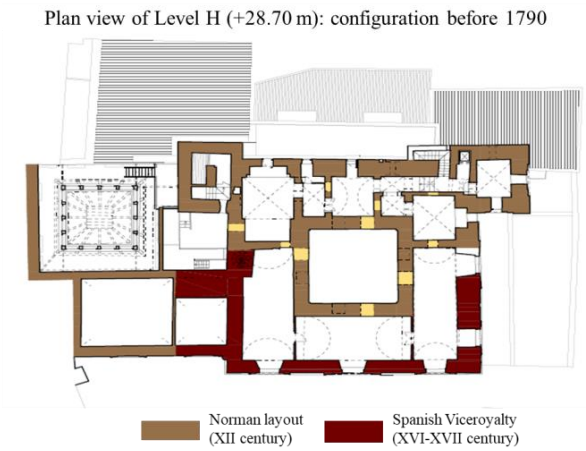
Figure 8. Conceptual reconstruction of the current floor of the Piazzi Library in the age of the Spanish Viceroyalty.

In particular, three vaulted spaces were realized to fill the height gap. They were placed on the finishing "parapet" of the flat roof of the current President's Room, through a masonry superelevation realized about four centuries after the previous one; this led to the current floor of the Piazzi Library (Figure 8). Two of the abovementioned vaulted spaces were placed perpendicular to the wall of the main prospect on the east side, while the third one serves as a connection between the others and is placed parallel to the line of the prospect. If the vault on the south side is still the original one, the three vaults were barrel vaults in calcarenite ashlars. The vaults were based on the shear walls of the Tower on one side and on the two arches on the other side, with a conveniently lower ridge height, to generate the additional vault of the perpendicular passageway (Figure 8). The latter was placed on the superelevated shear wall of the main prospect, and the parallel one in the pre-existing internal core of the Tower. Hence, this wall was not realized with the same crafts and clamps as the original one; even if it was well made, it was an addition to a structure from many centuries before.

This reconstruction was also inferred from the integrative surveys carried out in the framework of this study. It suggests that a considerable mass had been built over the pre-existing Norman structure; this mass was even greater due to the significant filling layer (a width of over 150 cm) detected through integrative endoscopic surveys. Consequently, the load excess could be one of the concurring causes that have contributed to the generation of cracks in the vaults of the underlying rooms, now part of the President's Room.
