2023 IMEKO TC-4 International Conference on
Metrology for Archaeology and Cultural Heritage
Rome, Italy, October 19-21, 2023

Preventive conservation plan for a group of bronze sculptures from the Gori Art Collection

Sara Croci[1], Leila Es Sebar[1], Caterina Gori[2], Leonardo Iannucci[1], Emma Angelini[1], Sabrina Grassini[1]

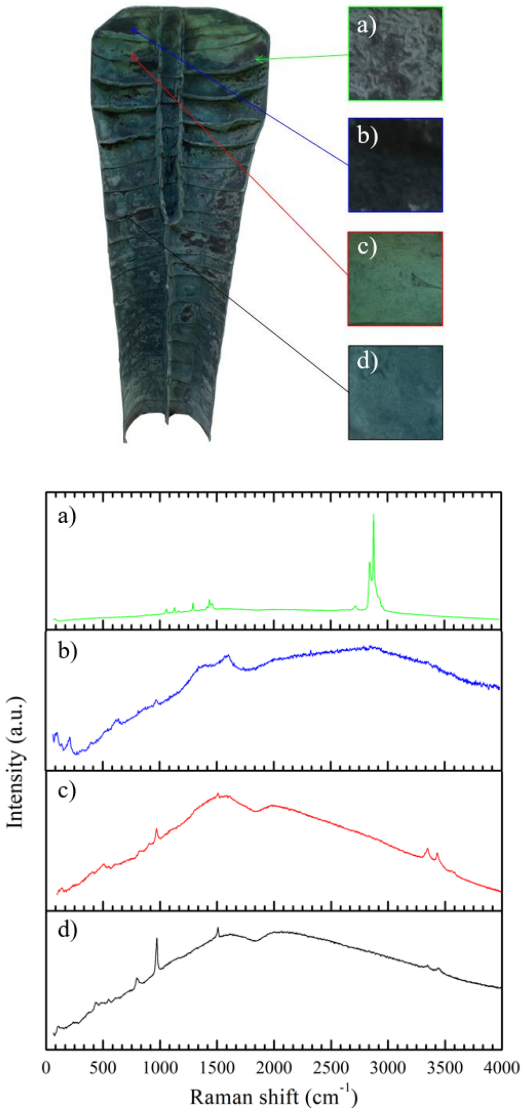
Fig. 2. Raman spectra recorded on different areas of one of the bronze elements of Katharsis: a) beeswax; b) cuprite, brochantite and amorphous carbon; c) brochantite and atacamite; d) brochantite and clinoatacamite.

process leading to the formation of cuprite, atacamite, and clinoatacamite in the areas of water stagnation. Raman analysis allowed to confirm the presence of beeswax used as a protective coating during the restoration performed in 2009. Some representative Raman spectra are shown in Fig. 2 for one of the elements of Katharsis and in Fig. 3 for the Cavaliere. Moreover, it is interesting to observed that in the case of Katharsis, all the 33 elements are characterised by corrosion patinas of similar chemical compositions.

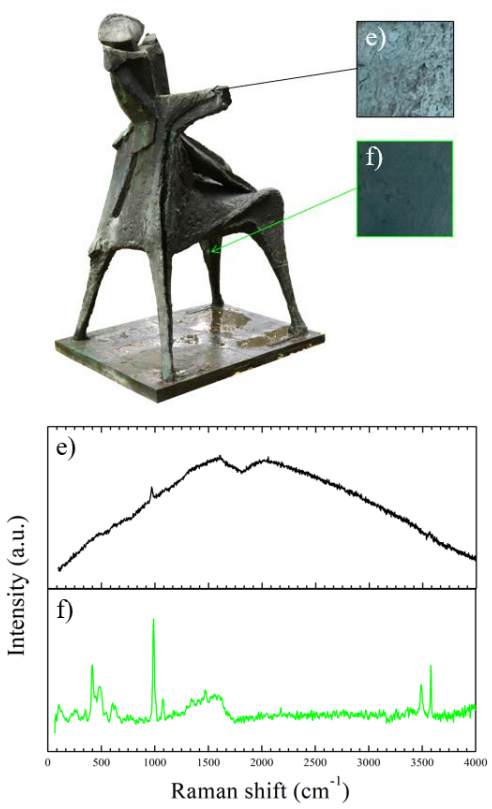
Both sculptures showed the presence of patinas typical of bronze alloys after long-lasting interaction with the atmosphere, whose Raman spectra are shown in Fig. 2 and Fig.3. In the case of the Cavaliere, the acquired spectra identified the darker green patinas as antlerite, and the lighter ones as brochantite. The same corrosion products were identified on the bronze sculpture of Katharsis in combination with an early stage of the bronze corrosion

Fig. 3. Raman spectra recorded on different areas of the Cavaliere: e) brochantite; f) antlerite.

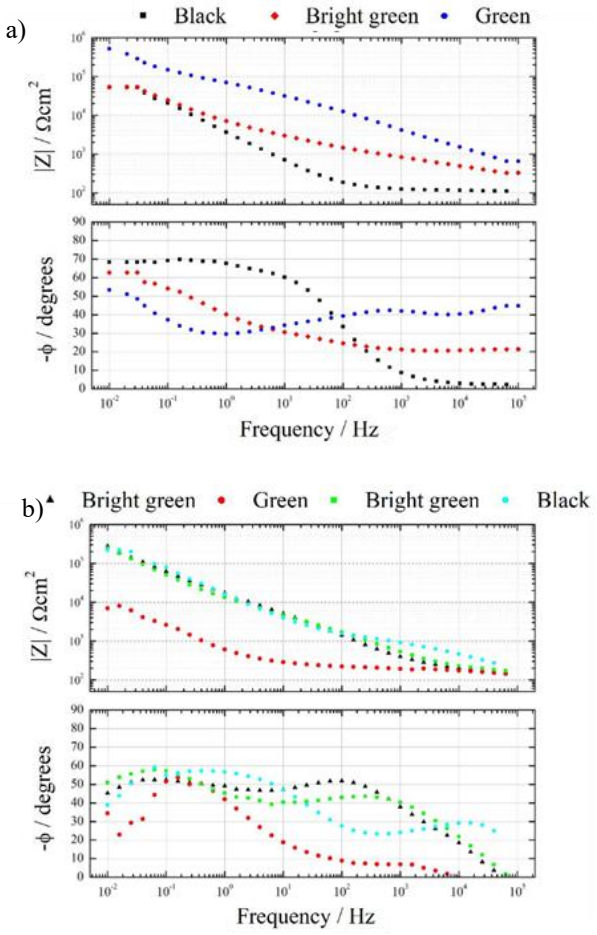
Fig. 4. EIS measurements as Bode plots, recorded on different areas of: a) one of the 33 elements of Katharsis; b) Cavaliere.

The patinas grown in sheltered areas of the artworks, whose chemical composition is identified by Raman spectra as antlerite, have a higher thickness and good protective effectiveness. On the contrary, the EIS measurements reveal that the patinas grown on areas exposed to the atmospheric corrosion, in which brochantite was identified, show higher porosity, lower thickness and poorer protective effectiveness.

Notwithstanding the different thickness, the patinas of both sculptures have an overall satisfactory protective effectiveness against further corrosion.
