A Preliminary Study for the Knowledge Process: Pier Luigi Nervi’s Taormina Stadium

Federico Vecchio[1*], Giuliana Di Mari[1], Alessandra Renzulli[1].
1 - Dipartimento di Ingegneria Strutturale, Edile e Geotecnica (DISEG), Politecnico di Torino, Italy.
* - federico.vecchio@polito.it

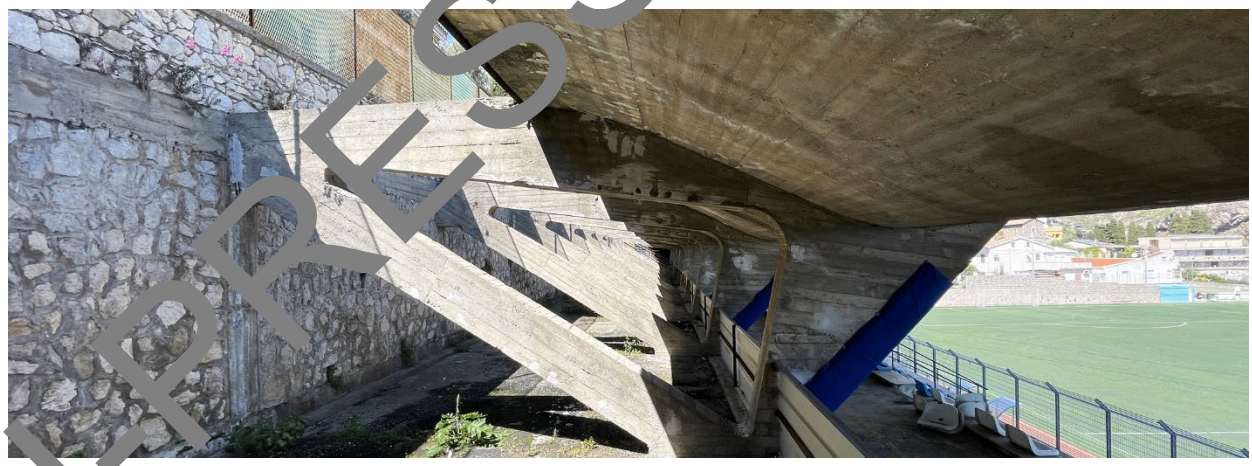
Figure 3 – The Nervi's skills emerges between fragility and degradation - © 2021, Authors

In the case of Taormina, there are further specific vulnerabilities (Fig. 3) characteristic of football stadiums, in addition to the criticalities typical of the Modern heritage. Several reasons lead to assimilating the stadium into a minor work [16]. The first is that, compared to the stadiums in Rome and Novara, it is smaller in size, designed to hold up to a maximum of 3900 spectators (Tab. 1). The second is that this stadium has been little studied and, at times, excluded from the scientific literature, being the subject of interest only of authors Antonino Marino and Laura Marino [14]. A third reason is the lack of interest in heritage protection from organizations and associations.

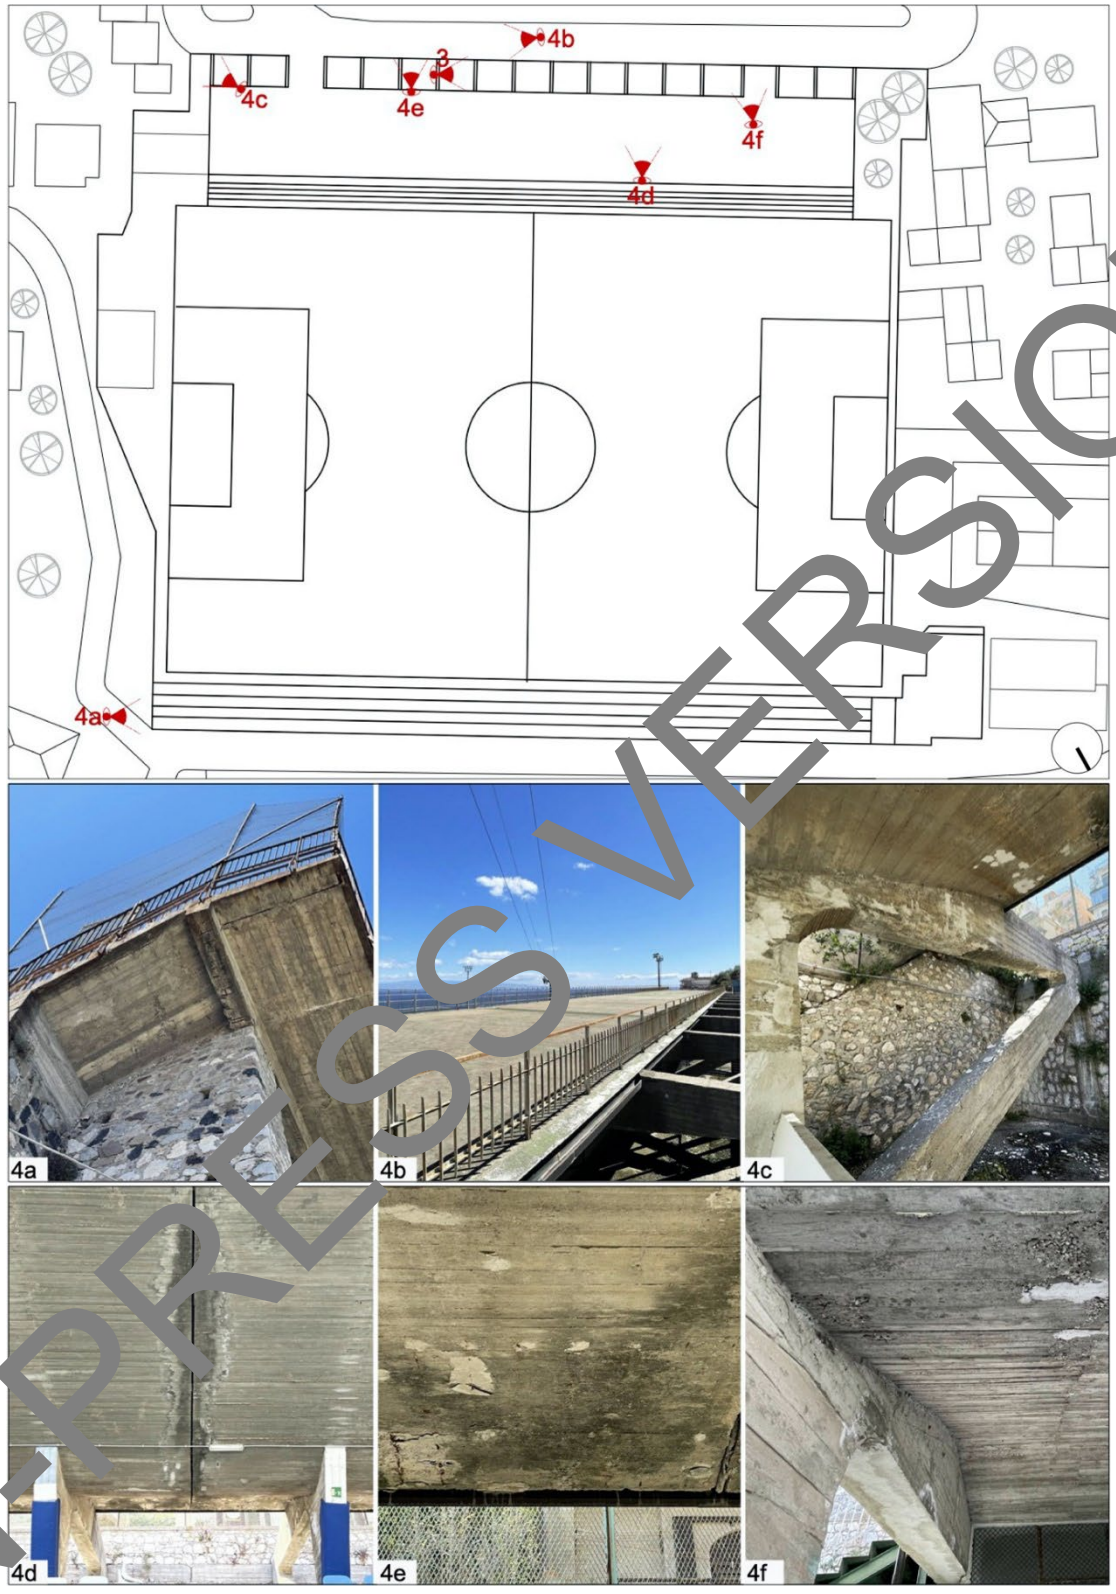
Figure 4 – Details of the degradation and location in the floor plan: (a) the north stand in structural decay, (b) the abandoned terrace, (c) aesthetic degradation from incorrect patching and vegetation, (d) degradation at the structural joint, (e) lack of concrete and spalling, (f) construction defects such as honeycombs - © 2021, Authors

In April 2021, an on-site inspection was conducted to study the actual state of the stadium, and it appeared to be in good condition from a structural point of view. However, it presented criticalities that prevented its use during the survey. The following description of the detected pathologies is referred to the Italian standard "UNI 11182:2006 Beni Culturali" (former "Normal 1/88 ICR-CNR").

The north stand is cantilevered and has reduced thickness (Fig. 4a), which shows damage due to pull-out phenomena that expose the reinforcement bars and have caused cracks and localized corrosion decay. In addition, it shows significant degradation due to increased exposure to weathering. The south grandstand presents problems that also impact the functional aspect: the terrace above the roof cannot be used for the heavily degraded flooring and the corroded metal parapets (Fig. 4b). Other problems are related to poor or inadequate maintenance, such as weed vegetation and inconsistent patching with cement mortars (Fig. 4c). Problems related to water exposure have caused efflorescence, discoloration, delamination, and cracking, particularly at the three structural joints of the south stand roof (Fig. 4d). In several places, material *lacunae* and small localized spalling phenomena are also evident where the ceiling reinforcement cover is thinner (Fig. 4e). Finally, sporadic honeycombs are evident (Fig. 4f). All of these elements contribute to an evolving cracking and degradation process that, over time, could alter the very stability of the structure. The sports facility generally does not meet regulatory requirements regarding fire prevention and removing architectural barriers.
