Small community water supplies in the Isiolo County, Kenya

2nd International Joint Conference on Water Distribution Systems Analysis & Computing and Control in the Water Industry
Valencia (Spain), 18-22 July 2022
doi: https://doi.org/10.4995/WDSA-CCWI2022.2022.14118

SMALL COMMUNITY WATER SUPPLIES IN THE ISIOLO COUNTY, KENYA

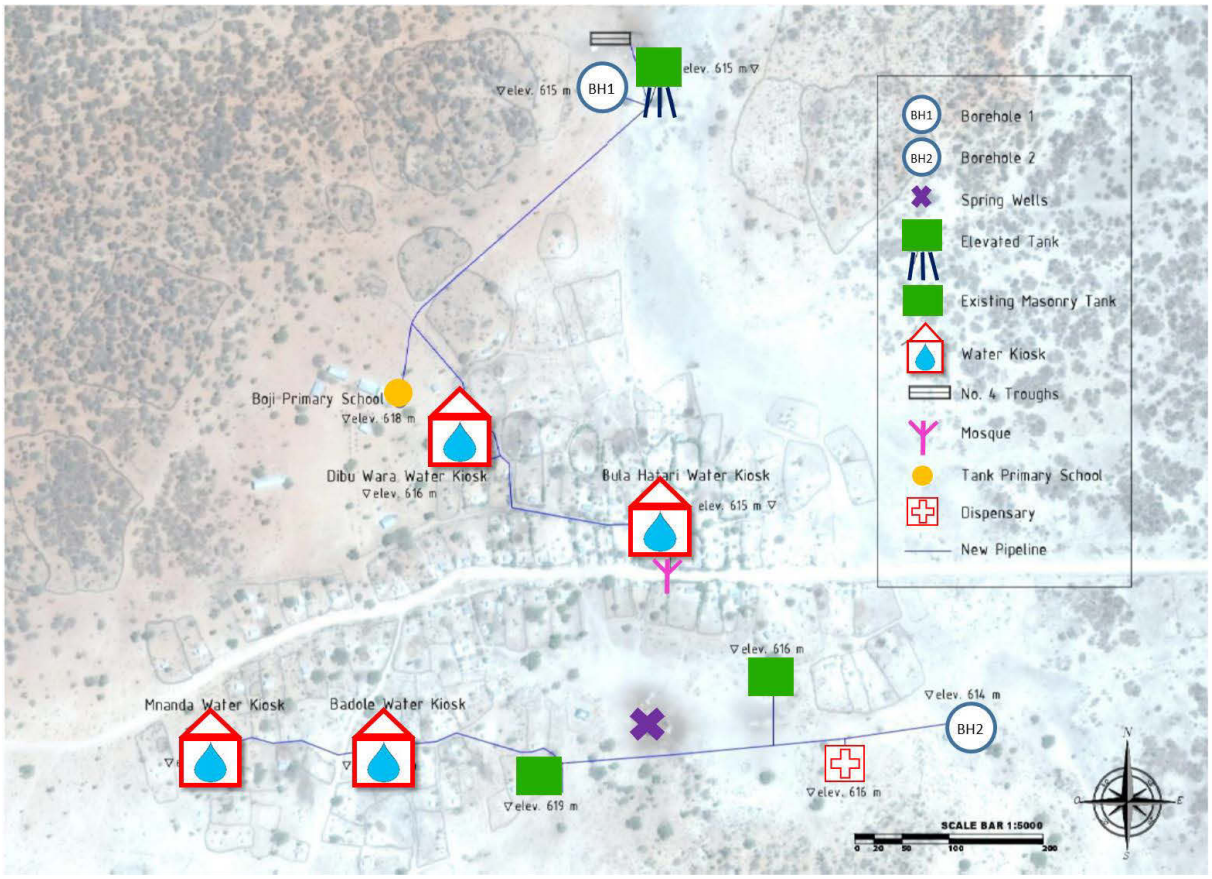
Figure 3: New water supply system at the Boji village.

The water supply protection and rehabilitation were completed within 18 months. The project achieved 100% of the targets set at the baseline which were measured through key indicators. This implies that the project improved the availability of safe water, through the rehabilitation of two boreholes and the construction of new pipelines and four water kiosks (Figure 3). This allowed to separate water for human use and livestock use, to provide water allocation also to schools, health dispensaries and mosques. Solar pumping systems, coupled with a diesel generator backup system, were installed to reduce water pumping operational costs.
