THE BUILDING MATERIALS OF THE LORENESE FORTS OF THE TUSCAN COAST

Silvia Rescic, Fabio Fratini, Manuela Mattone

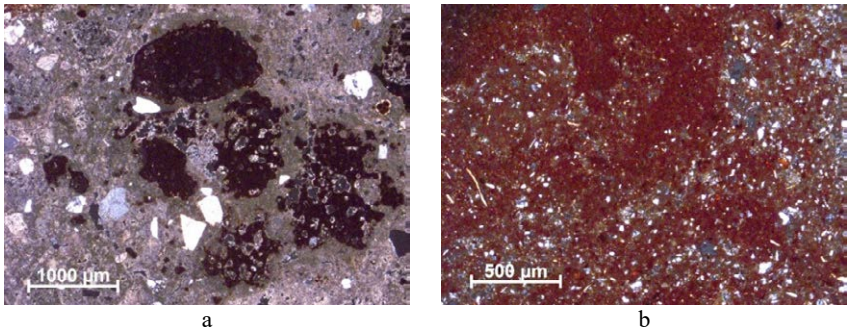
The bastion bedding mortars have an abundant to medium binder (binder/aggregate ratio from ~ 1/1 to ~ 1/3) consisting of aerial lime with a micritic appearance, hydraulicized with the addition of scarce pozzolan in both coarse and finely ground fragments. The aggregate is homogeneously distributed with unimodal grain size (200÷400 μm) and consists of subangular to subrounded granules of quartz, sparitic calcite, fragments of organogenic carbonate rocks, and feldspars. Lime putty lumps and under-burnt remnants of organogenic limestones are present. Macroporosity consists of irregularly shaped pores and shrinkage fractures (Fig. 7a).

The bricks of the bastion and tower are similar to each other. They were obtained by firing an almost pure clay. The framework is almost absent (rare quartz granules of size 200÷300 μm are present) (Fig. 7b). The groundmass is opaque, indicative of a firing temperature above 800 °C. Macroporosity is scarce and regular in shape.

Figure 7 – Images at the optical microscope in thin section, crossed polarized light: bedding mortar of the bastion with presence of pozzolan (a); brick with opaque groundmass and almost absence of framework (b).

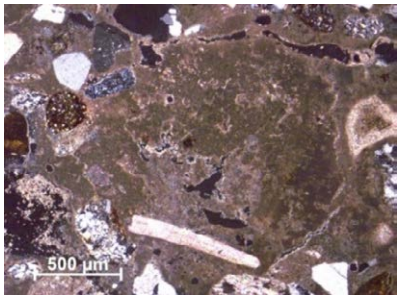
grain size (300÷400 μm) and consists of subrounded granules of sparitic calcite, organonogenic and micritic limestones, quartz, and arenaceous fragments (Fig. 8). Lumps of lime putty are present. Macroporosity is scarce and regular in shape.

Figure 8 – Images at the optical microscope in thin section, crossed polarized light of the bedding mortar with a lump of lime putty.

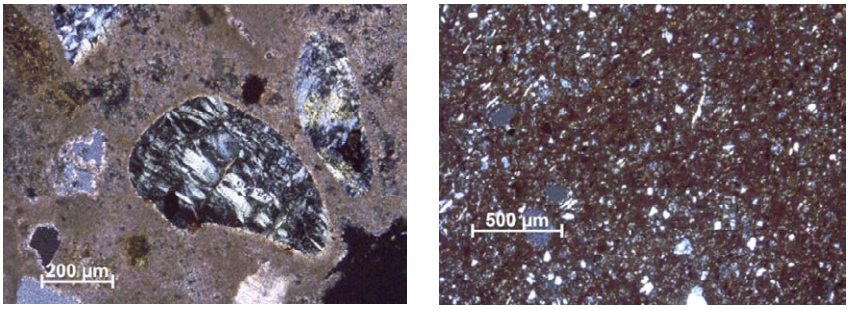
The bastion bedding mortars have a medium to abundant binder (binder/aggregate ratio ~ 1/2-1/3) of aerial lime of micritic appearance. The aggregate is homogeneously distributed with unimodal grain size (300÷500 μm), and consists of subangular to subrounded grains of quartz, serpentinites, sparitic calcite, and micritic carbonate rocks. Numerous lumps of lime putty and under-burnt remnants of organogenic limestones are present (Fig. 9a). Macroporosity is scarce and consists of irregularly shaped pores. The bricks of the rampart are similar to those of Forte San Rocco and were obtained by firing an almost pure clay. The framework is almost absent (rare quartz grains of size 200÷300 μm). The groundmass is opaque, indicating a firing temperature above 800 °C (Fig. 9b). Macroprosity is scarce and irregular in shape.

Figure 9 – Images at the optical microscope in thin section, crossed polarized light: bedding mortar with presence of serpentinite in the aggregate (a); brick with opaque groundmass and the almost absence of the framework (b).

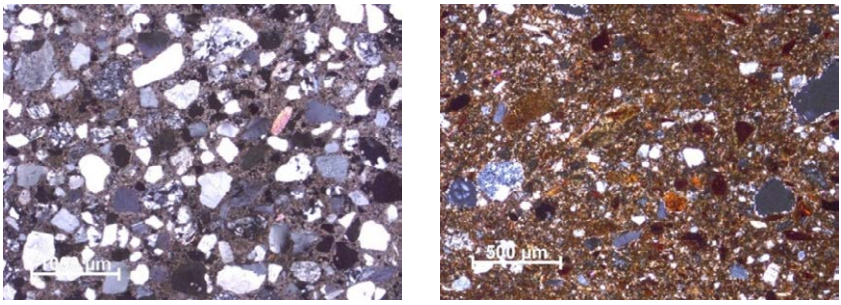
The bastion bedding mortars have a scarce binder (ratio binder/aggregate ~ 1/3-1/4) of aerial lime of micritic appearance. The aggregate is homogeneously distributed, with unimodal grain size (300÷500 μm) and consists of subangular-shaped grains of quartz, feldspars, quartzites, rare pyroxenes (Fig. 10a). Lumps are absent. Macroporosity is poor and consists in irregularly shaped pores.

The bastion bricks were obtained by firing a silty clay as indicated by a framework made of an abundant fraction of quartz and feldspars with a size of 20-40μm. The groundmass is weakly birefringent, suggesting a firing temperature below 700°C (Fig. 10b). Macroporosity is scarce and irregular in shape.

Figure 10 – Images at the optical microscope in thin section, crossed polarized light: bedding mortar with an abundant aggregate (a); brick with a weakly birefringent groundmass and abundant framework consisting of quartz and feldspars (b).
