Full-scale load test of a PRC bridge beam after 60 years of service life

SMAR 2024 – 7th International Conference on Smart Monitoring, Assessment and Rehabilitation of Civil Structures

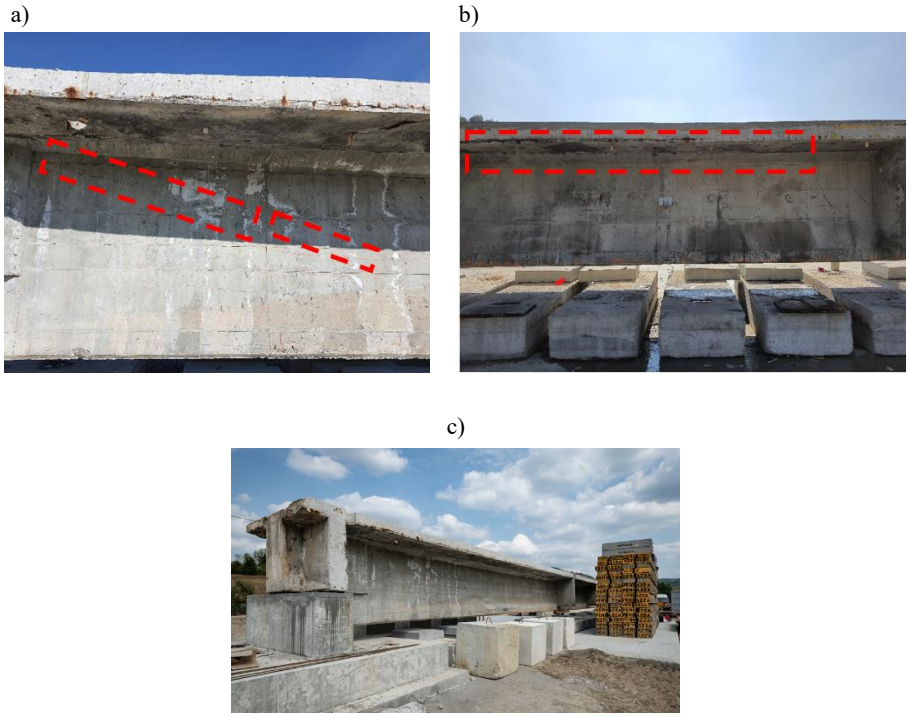
Fig. 2. Cracking along the longitudinal direction near the path of post-tensioning tendons close to the anchorages. (a). Longitudinal cracking of the slab (b). General view of the beam (c).

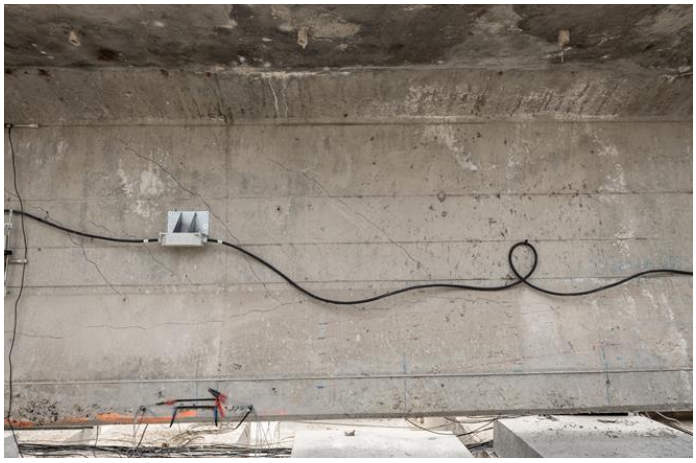
Fig.6. (b) provides a view of the deflection of the PRC beam under the maximum load. (c) shows the crack pattern of shear cracks close to the support.

The test concluded upon the beam exhibiting a mid-span deflection of approximately 46 cm, corresponding to a total load transmitted by the jacks of around 1800 kN. Across the beam axis, the neutral axis consistently extended beyond the upper slab thickness in every investigated section, leading to continuous compression of the slab. The observed crack pattern (Figure 6(b)) aligns with that of a structure fixed at both ends with simple supports and loaded by two concentrated forces straddling the midpoint. In the central zone with a constant moment (between the two jacks), cracks appeared nearly vertical due to minimal interference between bending and shear stress. However, as one moves toward the supports where shear stress intensifies, cracks tend to incline, with a minimum angle of around 30 degrees, influenced partially by the presence of prestressing force. The maximum midspan deflection measured approximately higher than 45 cm, as evident in Figure 6(a). Upon reaching this displacement level, the test was concluded.
