III Fabre Conference: Existing Bridges, Viaducts, and Tunnels: Research, Innovation, and Applications

Managing rockfall risk on the Italian road network with the new UX131 guideline

Maddalena Marchelli[a]*, Bernardino Chiaia[a], Valerio De Biagi[a], Daniele Peila[a]

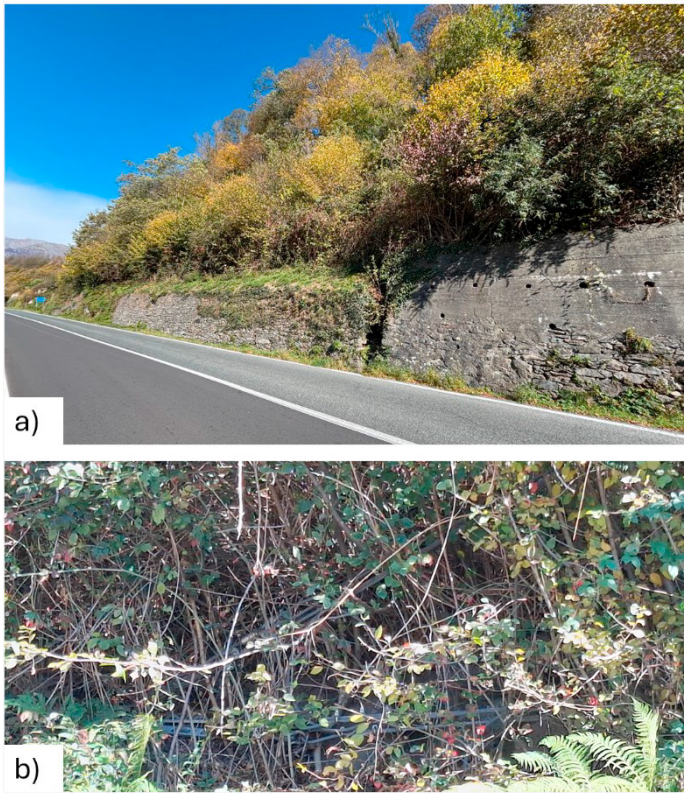
Barrier 2 spans 40 meters in length and 3 meters in height. It has a maximum energy absorption capacity of 500 kJ, and the installation is ETAG certified, though the barrier is heavily impacted by vegetation growth (Fig. 3a,b).

During the inspection, the following issues were identified. Heavy vegetation obstructed a full visual inspection, especially around the posts and connection points, and could interfere with the barrier's ability to function during a rockfall. Furthermore, vegetation promoted the swelling of the intercepting structure. Some upslope ropes were found to be slack or tensioned abnormally, which can lead to improper functioning during impact. Damage to the connection between ropes and posts was observed, with some connectors either severely corroded or completely detached. There was widespread corrosion on several components, including the ropes and anchors, particularly in areas where the metal was exposed to the elements. This corrosion threatens the structural integrity of the barrier.

Also in this case the Degree of Damage is high, but with a low Damage Diffusivity of 45%. Despite being certified, the score for Defect level is high. Similarly to Barrier 1, both hazard and exposure level result high as well, resulting in a high CdA.

Fig. 3 (a) Barrier 2, (b) rope anchor.

Both barriers were thus classified within the High Attention Class (CdA) due to severe damage and significant risks to their effectiveness. The application of the UX131 methodology provided a clear and structured process for assessing the barriers' current condition, identifying critical defects, and prioritizing the required maintenance actions. Barrier 1 required immediate attention to correct the installation issues, anchor grouting, and mesh repairs. Meanwhile, Barrier 2 needed urgent vegetation clearance, rope adjustments, and corrosion treatment to prevent failure during rockfall events.
