The Garisenda Tower in Bologna: Damage Assessment Results from Principal Component Analysis, Acoustic Emission, and Nonlinear Finite Element Analyses Involving Creep and Smeared Cracking

Giuseppe Lacidogna [1,*], Pedro Marin Montanari [1], Stefano Invernizzi [1] and Angelo Di Tommaso [2]

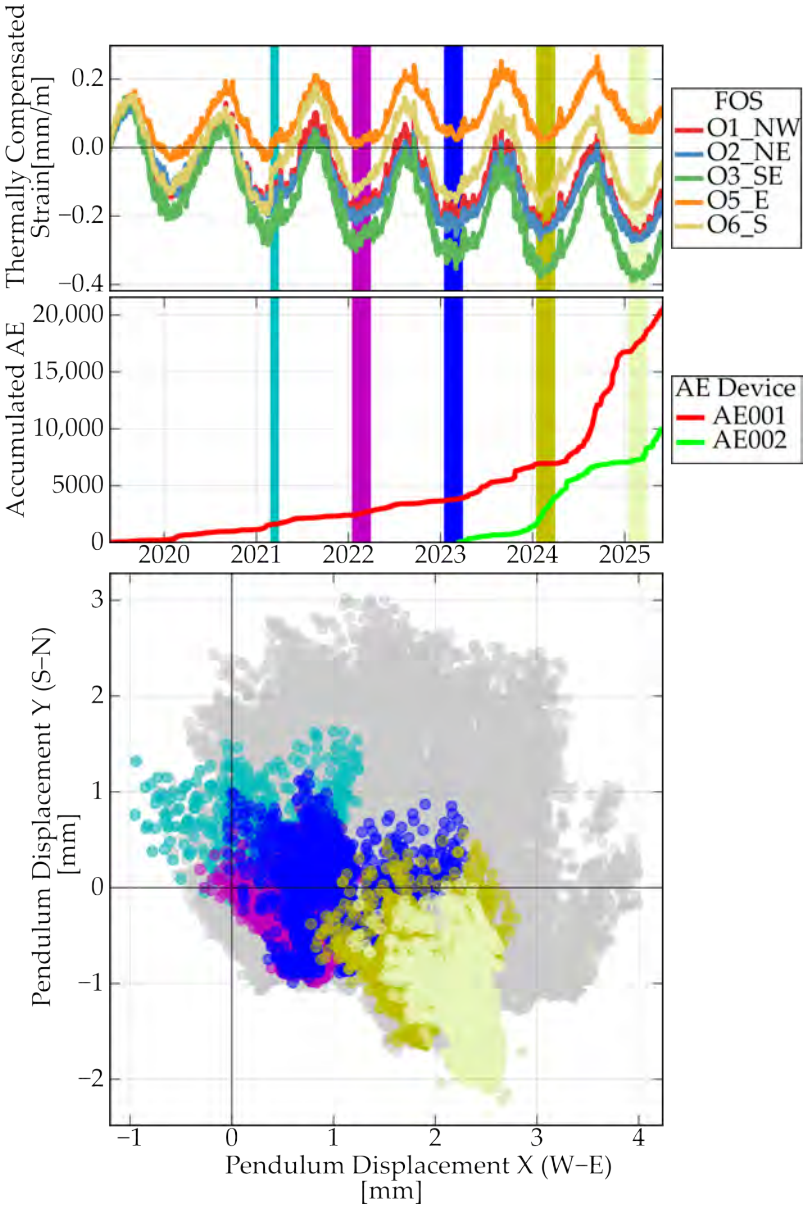
The periods were chosen to be roughly from mid-winter to mid-autumn, to highlight the behavior of the system in winter periods. As can be seen, the global behavior of the pendulum seems to be movement towards the south-east (SE) which is the direction of the leaning. This coincides with surges in AE rate and with global and local minima of FOS strains.

Figure 7. FOS strains (top graph), accumulated AE rate (center graph), and pendulum position (bottom graph) from 31 May 2019 to 6 September 2025.

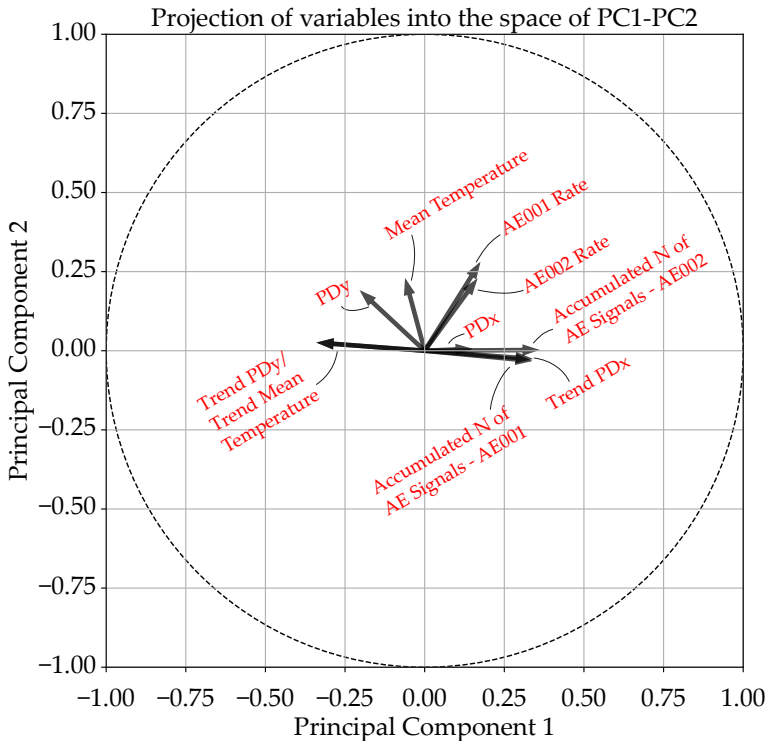
Figure 11. Circle of correlation: Projection of each original variable into the space of PC1-PC2.

- The variables PDx, Trend PDx, and both of the accumulated numbers of AE signals point strongly in the direction of PC1, but they point weakly in the direction of PC2. This could mean that they are correlated to damage caused by the pendulum movement in the S-E direction. This is the opposite behavior of the variables Trend PDy and trend mean temperature, which point strongly (and negatively) in the direction of PC1. An interpretation of this fact would be that, when temperatures and PDy increase, the damage related to the movement of the pendulum decreases.

- The AE rates point in the direction both of PC1 and PC2, which suggests that they are correlated to damage due to pendulum motion, specifically in the N-S direction. Interestingly, the AE rates seem to be more sensitive to the damage due to the pendulum movement in the N-S direction, as they point more in the direction of PC2 than in the direction of PC1. The variables PDy and mean temperature point in the direction of PC2, but point in the negative direction of PC1. This reflects that they are correlated to damage in the N-S direction (PC2), but anti-correlated to the damage considering the overall pendulum movement. An interpretation of this fact would be that, when temperatures and PDy increase, the overall effect of damage decreases, while increasing in the N-S direction, as if the damage shifted from W-E to N-S movement.

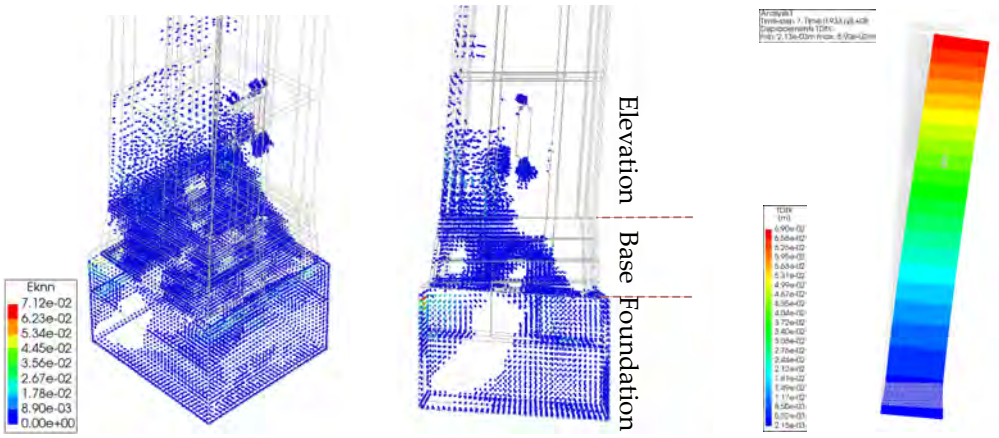
The numerical analysis converged up to an additional base rotation of approximately 2.6°. Beyond this value, convergence could not be achieved due to the development of diffuse cracking and strain localization, which can be interpreted as a physically meaningful indication of structural instability rather than a purely numerical issue. Figure 12a shows the diffused cracking pattern in the lower region of the tower, with the region under tension (closer to the entrance) being apparently the most affected.

If we consider a purely rigid body rotation, the displacement at the top would be around 48 m $\times$ tan(2.6°) = 2.18 m. In the numerical model, the total displacement at the top is around 3.39 m, which corresponds to 2.18 m of rigid rotation and thus 1.21 m of rotation due to deformable effects. It is noticeable that 3.39 m is is very close to the current lean of the tower of about 3.2 m. If we consider only the lean due to elastic effects, 1.21 m, the value is still not negligible. As such, this configuration is indicative of a kind of upper bound for failure due to tilting.

In relation to the viscoelastic creep model, the displacement in the east direction is shown in Figure 12b. Additional tilting clearly occurs in the presence of viscous deformation. A comparison between experimental and numerical results is presented in Figure 13.

Figure 12. Cracks in the tower after 2.5° of tilt, where it can be seen that cracking mostly occurs in the region under tension, closer to the entrance (**a**,**b**). Eastwards displacement of the tower after 3.5 years, as a result of viscoelastic creep (**c**).

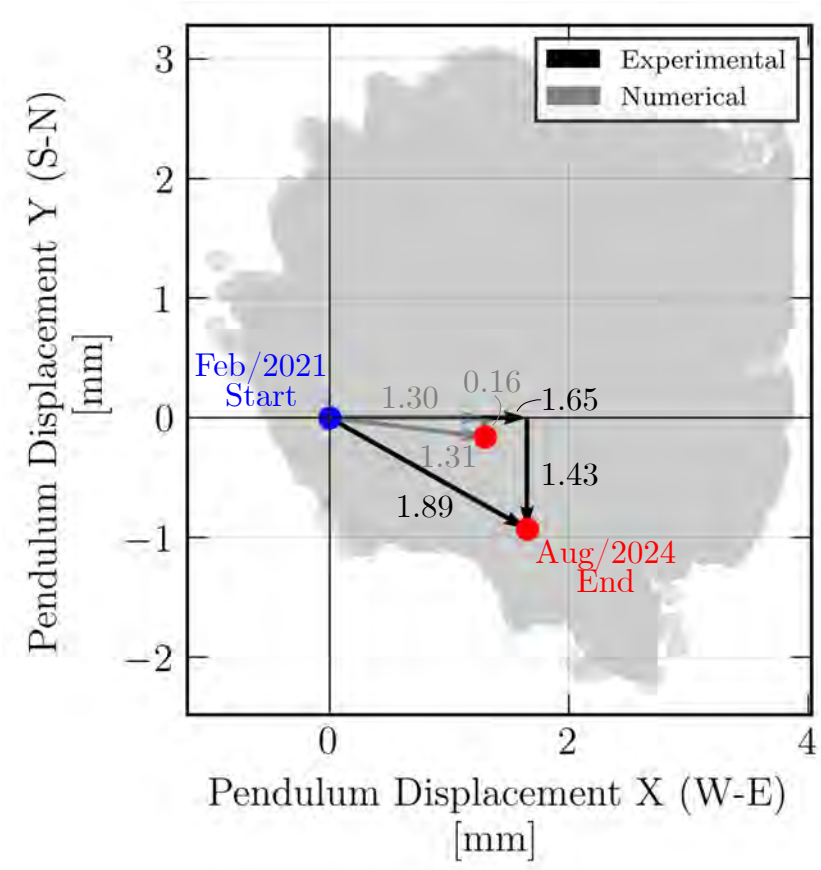
Figure 13. Experimental and numerical (due to creep) inelastic pendulum displacement after 3.5 years. The north–south displacements are not as well represented as the east–west displacements in the numerical model.

The creep model built in DIANA reflects well the long-term behavior observed experimentally in the tower, at least considering the displacement in the east direction. The behavior still has room for improvement in the north–south direction.
