Numerical Analysis of Cervo Cliff Stability Due to Basal Marine Erosion

ISRM Regional Symposium
Eurock 2026
Risk Management in Rock Engineering
Skopje, 15-19 September
ISBN ___-__-____-___-_

M.L. Napoli & M. Barbero
Politecnico di Torino, Torino, Italy
maria.napoli@polito.it

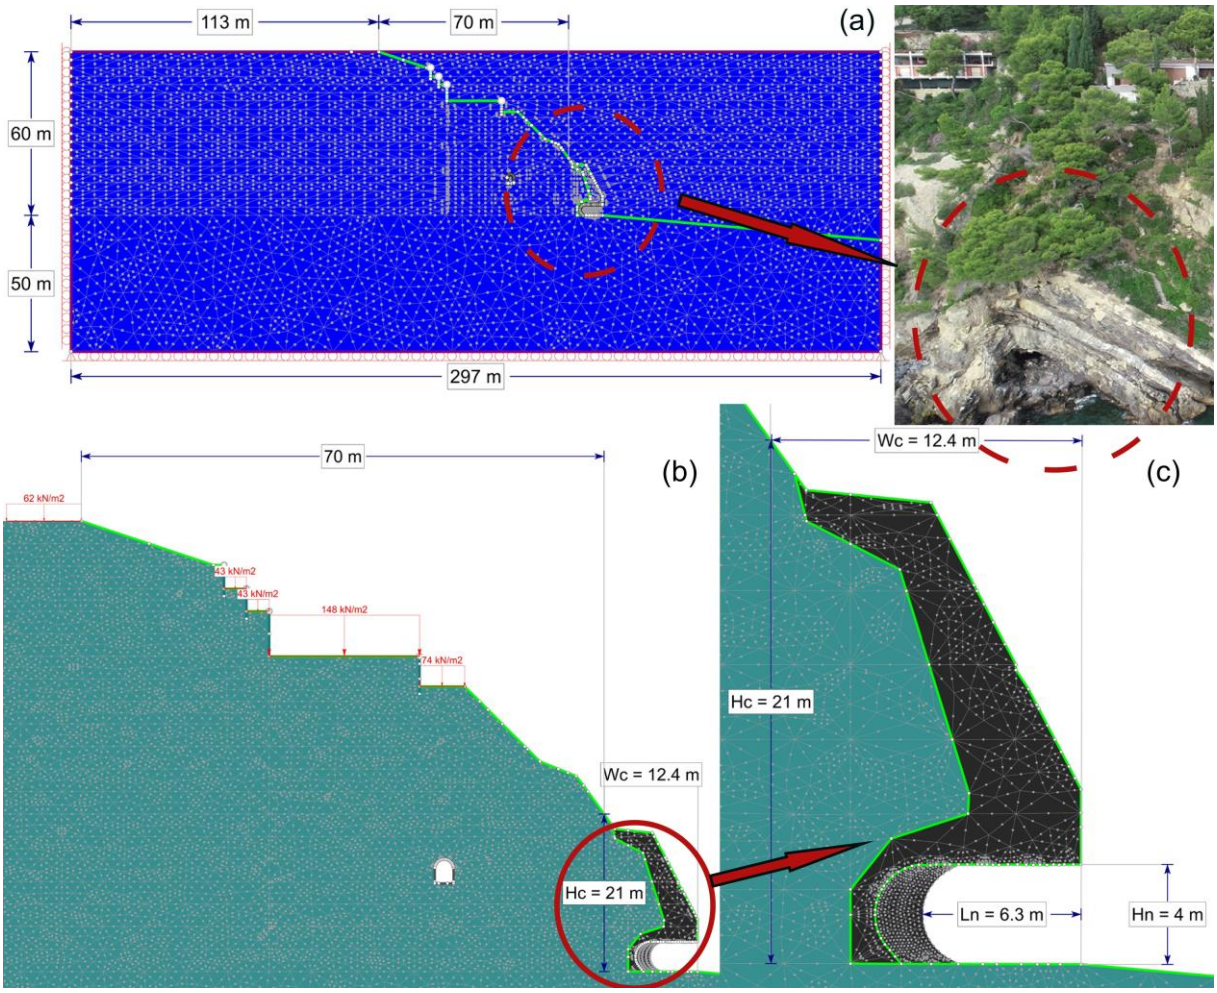
Figure 1. Numerical model setup: (a) overall geometry, dimensions, and boundary conditions, together with a field photograph of the cliff and basal notch; (b) applied external actions represented as equivalent uniformly distributed loads (building floors and road surfaces); (c) detail of the cliff-toe region showing the cliff geometry (Hc, Wc) and notch geometry (Hn, Ln), with local mesh refinement. The black layer represents the weathered rock layer.

The analysis was performed using the shear strength reduction (SSR) method to determine the strength reduction factor (SRF). The alteration of the external layer of the slope and the progressive notch retreat was simulated through a staged excavation scheme (Fig. 1c). The numerical model includes 32 stages, of which: 20 provide the creation of the slope profile by progressively removing the ground layers (Fig.1a), the following one is used for applying external loads and excavating the tunnel, and

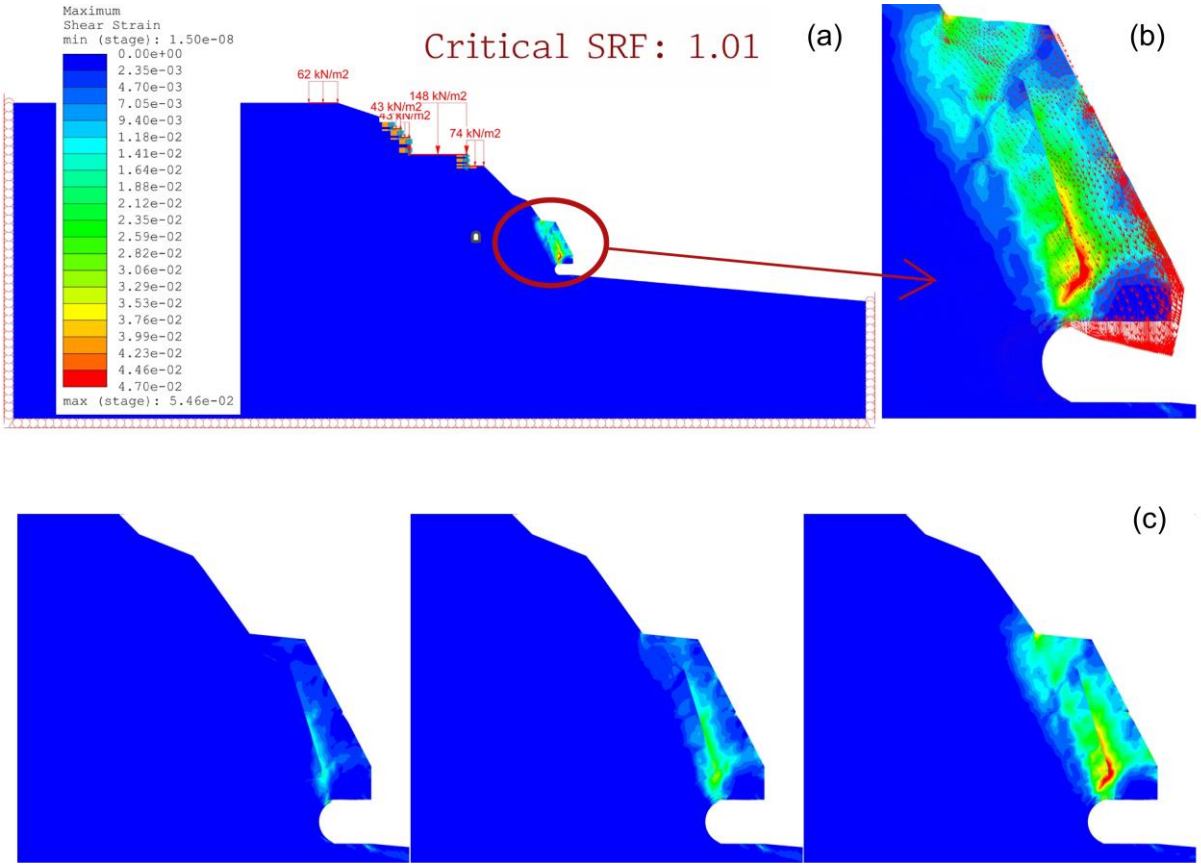
the final nine simulate the notch-retreat phases. The critical condition (SRF = 1.01) was reached after seven stages of notch retreat, corresponding to a final notch depth of 6.3 m. At this stage, progressive shear strain localization led to the collapse of the rock volume above the notch. The resulting failure mechanism, shown in Figure 2 in terms of maximum shear strain and total displacement, is consistent with field observations, confirming the representativeness of the model. These results are also consistent with the findings of Napoli et al. (2024a, b), who observed that when the ratio between the height of the cliff overhang (above the notch) and the notch depth is high, a shear failure mechanism is expected.

Figure 2. Maximum shear strain contours and critical SRF (a); maximum total displacements (b); evolution of the maximum shear strains with the progressive retreat of the notch (c).

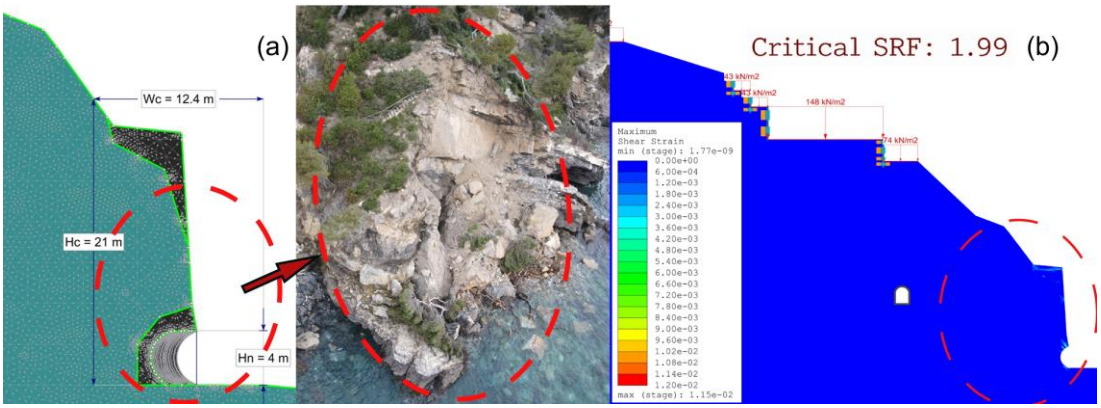
Two post-collapse scenarios were analysed to investigate the current stability condition of the rock cliff and its possible potential evolution driven by progressive rock-wall alteration and the deepening of the notch over time. The model geometry was updated to represent the post-collapse condition, modifying the cliff profile to account for the failure of the seaward portion (Fig. 3a). As shown in Fig. 3b, the cliff currently exhibits global and local stability with a factor of safety of 1.99, millimetric maximum displacements at the roof of the residual notch and negligible concentration of shear strains.

Figure 3. (a) Cliff geometry used for the current (post-collapse) scenario, together with a field photograph of the post-rockfall condition; (b) maximum shear strains.

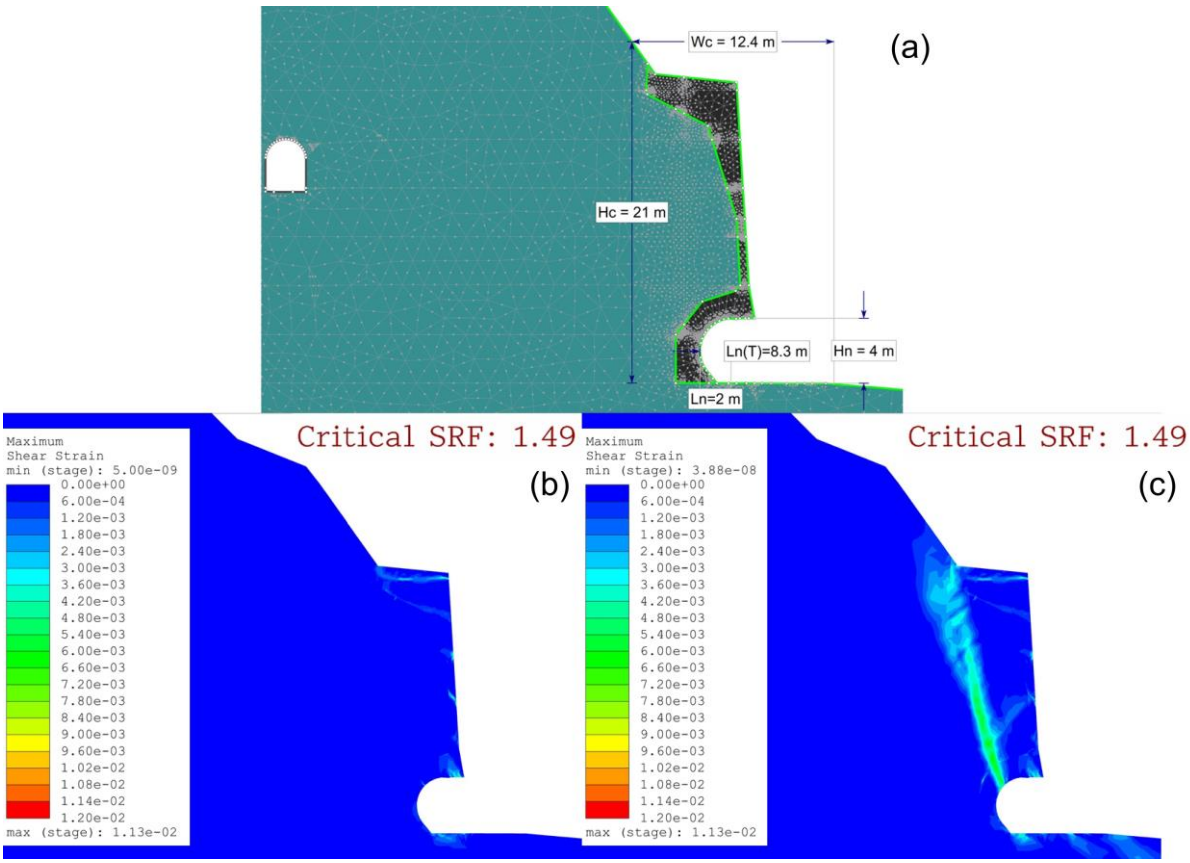
A predictive scenario was modelled to evaluate the impact of marine-induced weathering. The model incorporates a propagation of the weathered layer of approximately 0.5 m in the shallow part of the wall most exposed to marine actions, along with a progressive basal erosion of the rock for additional 2 meters. The deepening of the notch was simulated in 2 additional stages (Fig. 4 a). Under these conditions, the critical SRF was found to be 1.49, indicating a reduction of the global stability but a general still stable configuration (Fig. 4 b).

Figure 4. (a) Post-collapse cliff geometry used for the forecasting scenario; (b) maximum shear strains; (c) progressive increase of the maximum shear strain up to limit conditions.

Based on the maximum shear strain and total displacements obtained at limit conditions (SRF = 1.49), it can be stated that the damage induced by the marine environment is concentrated at the base of the cliff, close to the notch, and can spread progressively upslope (Fig. 4b, c). According to the slenderness of the cliff above the notch, shear failure is expected within the potential unstable rock volume. This effect seems not to affect the above structures, while remaining a hazard for the sea area below the cliff.
