Numerical Analysis of Cervo Cliff Stability Due to Basal Marine Erosion

ISRM Regional Symposium
Eurock 2026
Risk Management in Rock Engineering
Skopje, 15-19 September
ISBN ___-__-____-___-_

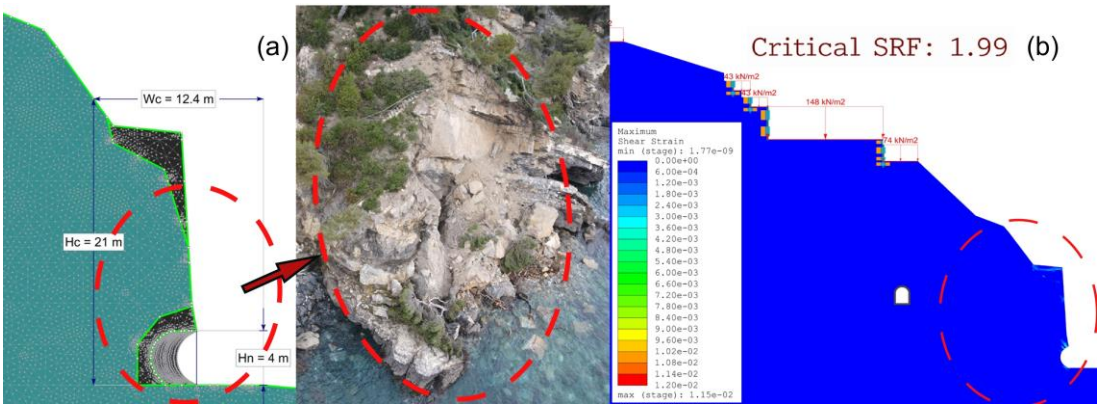
Two post-collapse scenarios were analysed to investigate the current stability condition of the rock cliff and its possible potential evolution driven by progressive rock-wall alteration and the deepening of the notch over time. The model geometry was updated to represent the post-collapse condition, modifying the cliff profile to account for the failure of the seaward portion (Fig. 3a). As shown in Fig. 3b, the cliff currently exhibits global and local stability with a factor of safety of 1.99, millimetric maximum displacements at the roof of the residual notch and negligible concentration of shear strains.

Figure 3. (a) Cliff geometry used for the current (post-collapse) scenario, together with a field photograph of the post-rockfall condition; (b) maximum shear strains.
