Casual or Causal? The Lightning-Triggered NaTech Accident at the Supertanker Base of Matanzas, Cuba

David J. Castro Rodriguez[a,*], Julio A. Dueñas Santana[b], Antonello A. Barresi[a], Micaela Demichela[a]

Keywords: major fire, lightning strike, NaTech, storage tank, technological scenarios.

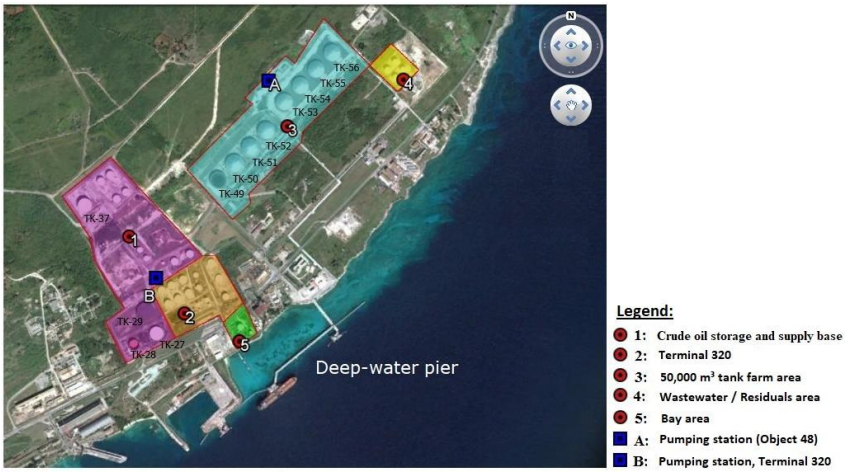
Figure 1: Matanzas Supertanker Base. Source: Modified from Cabrera-Estupiñán et al. (2016).

The initiating incident occurred on August 5 of 2022, approximately at 19:00, when lightning struck the geodesic dome roof of one of eight hydrocarbon tanks in the farm area igniting a fire (TK-52 in Figure 1). This tank contained approximately 26,000 m³ of fuel oil (approximately 50% of its capacity). By 5:00 a.m. on August 6, despite ongoing firefighting and cooling efforts, Tank 51 exploded, further escalating the incident. Several explosions occurred, including the boilover phenomenon—defined as the violent ejection of liquid hydrocarbons

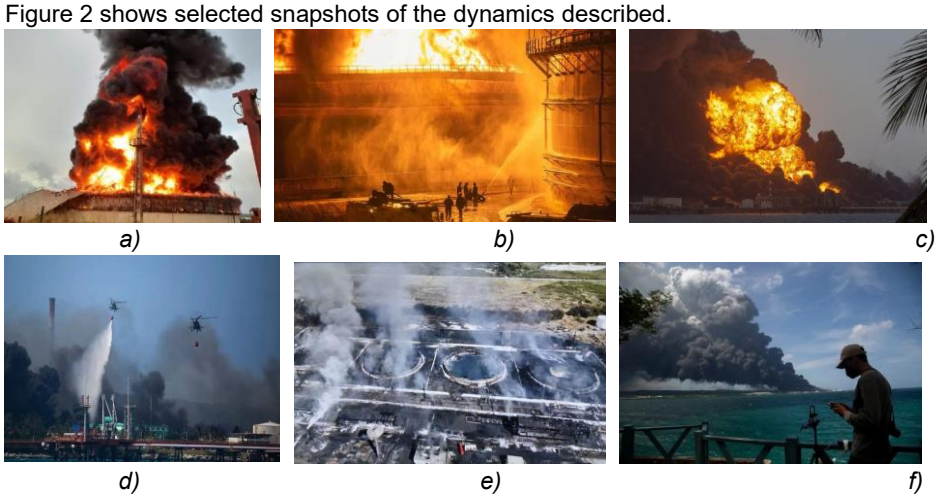
caused by the vaporization of water layers beneath the fuel during prolonged storage tank fires. These events led to tank rupture and structural failure. By August 8, a change in wind direction from the Northeast caused the fire to spread to tank 50 containing fuel oil. The flames subsequently reached tank 49 of crude oil, thereby substantially increasing the magnitude and consequences of the accident. The three additional affected tanks after the initiating event were all full, with a capacity of 50,000 m³. The resulting thermal radiation reached extreme intensities, severely impacting surrounding industrial areas. Thermal radiation intensities peaked at around 70 kW/m² within a radius of 500 meters after the initial fireball, considerably amplifying the severity of the incident. The firefighters, assisted by Mexican and Venezuelan reinforcements, also cooled tanks 53, 54, 55, and 56 and put out the fire after five days. The four tanks involved in the fire were destroyed and the inventory was totally lost. Consequently, a large amount of toxic black smoke persisted for approximately five days, substantially deteriorating regional air quality. Although the accident caused substantial operational and environmental impacts, its most severe effects were on the human and social dimension, which reached level 5 on the European industrial accident scale (where 6 represents the maximum severity). This led to 16 fatalities among firefighting personnel, 132 injuries, and the temporary evacuation of 4744 residents (BARPI, 2024). Figure 2 shows selected snapshots of the dynamics described.

Figure 2: Major fire at the Matanzas Supertanker Base: a) Fire in tank 52. Source: Portal Cubadebate. b) Firefighters cooling tank 51. Source: Gramma Newspaper. c) Third day of fire. Source: Portal Cubadebate. d) Aircraft fighting the fire. Source: Portal Cubadebate. e) Accident zone after five days. Source: The presidency of Cuba. f) Black smoke cloud above the Matanzas Supertanker Base. Source: Portal Cubadebate.

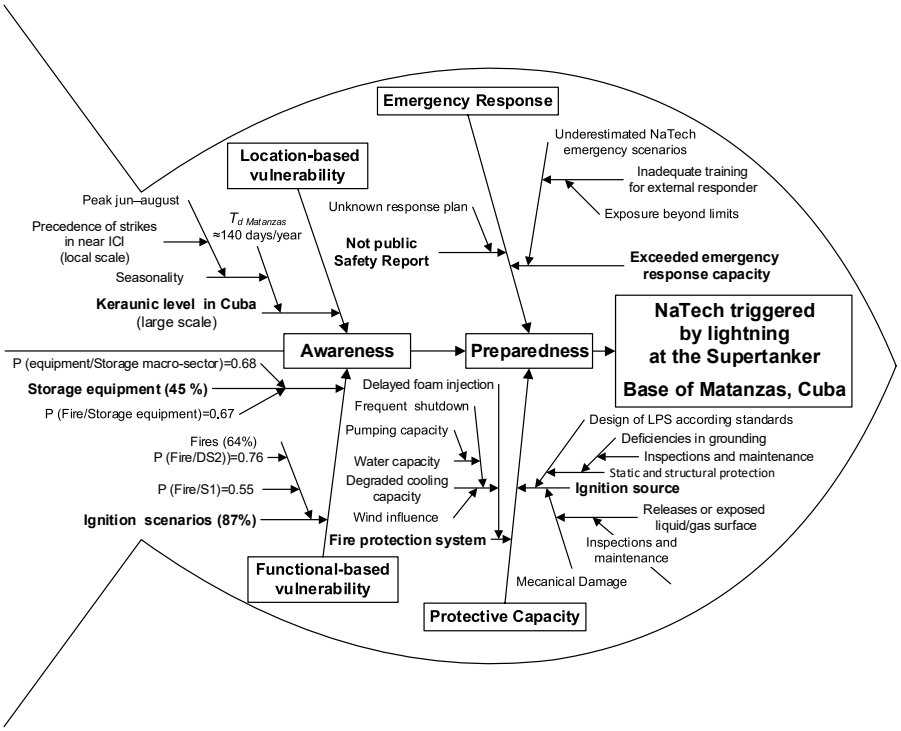
This section analyses the fishbone diagram in Figure 3 for the NaTech accident described in subsection 2.1, following the structured framework in 2.2. Subsection 3.1 addresses location-based vulnerabilities, 3.2 examines technological vulnerabilities, 3.3 evaluates protective capacity, and 3.4 discusses emergency response.

Figure 3: Fishbone Diagram of lightning-triggered NaTech accident at the Matanzas Supertanker Base.

From a causal perspective, several technical failure mechanisms can be considered: i) degradation or discontinuity of the grounding system; ii) insufficient equipotential bonding; iii) compromised dome sealing due to maintenance activities leading to vapor exposition; and iv) indirect lightning current propagation through instrumentation or sensor cabling. Overall, in the absence of evidence of a single-point failure, the event is better understood as the outcome of interacting factors. This systemic perspective coherently aligns with the causal pathways identified in the ignition-source branch of the fishbone diagram.

From a barrier failure perspective, the active fire protection system (FPS) functioned as a mitigation barrier intended to limit thermal escalation following ignition. Its safety function comprised two coupled mechanisms: (i) structural cooling to prevent tank failure and domino effects and (ii) foam-based extinguishment to suppress combustion. The fishbone structure identifies a progressive degradation pathway within this barrier. At the root level, insufficient water storage capacity and limited pumping capacity constrained the system hydraulic reliability. Because pumping demand exceeded water accumulation rates, the system operated in intermittent cycles, leading to frequent shutdowns. These interruptions reduced cooling continuity, resulting in degraded thermal control capacity. Consequently, foam injection was delayed or could not be sustained, particularly in tank 52. In barrier theory terms, this does not represent an instantaneous failure but a capacity exceedance mechanism. It was recognized by the authorities that the FPS at the Supertanker base of Matanzas was validated for a bounded fire scenario (approximately three hours), whereas the analyzed event evolved into a prolonged, high-intensity exposure lasting several days. Additionally, the event evolved under multi-hazard interaction due to a change in the direction of wind, which contributed to fire intensification and flame tilting, thereby amplifying the escalation potential. Accordingly, the escalation is best understood as progressive barrier degradation and saturation under extreme demand, rather than a single mechanical failure.
