Non- destructive characterization of carbon fiber composite/Cu joints for nuclear fusion applications

Non- destructive characterization of carbon fiber composite/Cu joints for nuclear fusion applications / Casalegno, Valentina; Salvo, Milena; Ferraris, Monica; Smeacetto, Federico; Merola, M; Bettuzzi, M.. - In: FUSION ENGINEERING AND DESIGN. - ISSN 0920-3796. - 83:(2008), pp. 702-712. [10.1016/j.fusengdes.2008.04.005]

Several non-destructive testing methods, lock-in thermography, ultrasonic inspection, microtomography and microradiography, were used to assess the manufacturing quality of joints between carbon fiber reinforced carbon composites and Cu/ CuCrZr.

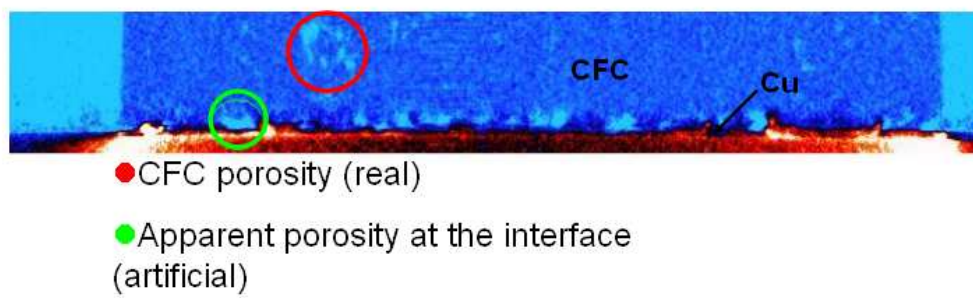
The effects of highly absorbing materials on tomographic reconstruction could lead to some “star-artifacts” (white rays radiating away from a spot, a typical star-like pattern also known as metal-artifact.) on the surface of the analyzed sample; they correspond to “lack of information” zones (figure 10). These spots could be explained as voids at CFC/Cu interface but actually they are reconstruction artifacts.

Figure 10 Artifacts at the CFC/Cu interface
