Seismic history of the church of San Pietro di Coppito in L'Aquila

Seismic History of the Church of San Pietro Di Coppito in L'Aquila

Renato Masiani, Department of Structural Engineering and Geotechnics, La Sapienza University of Rome, via Gramsci 53, Rome 00195, Italy

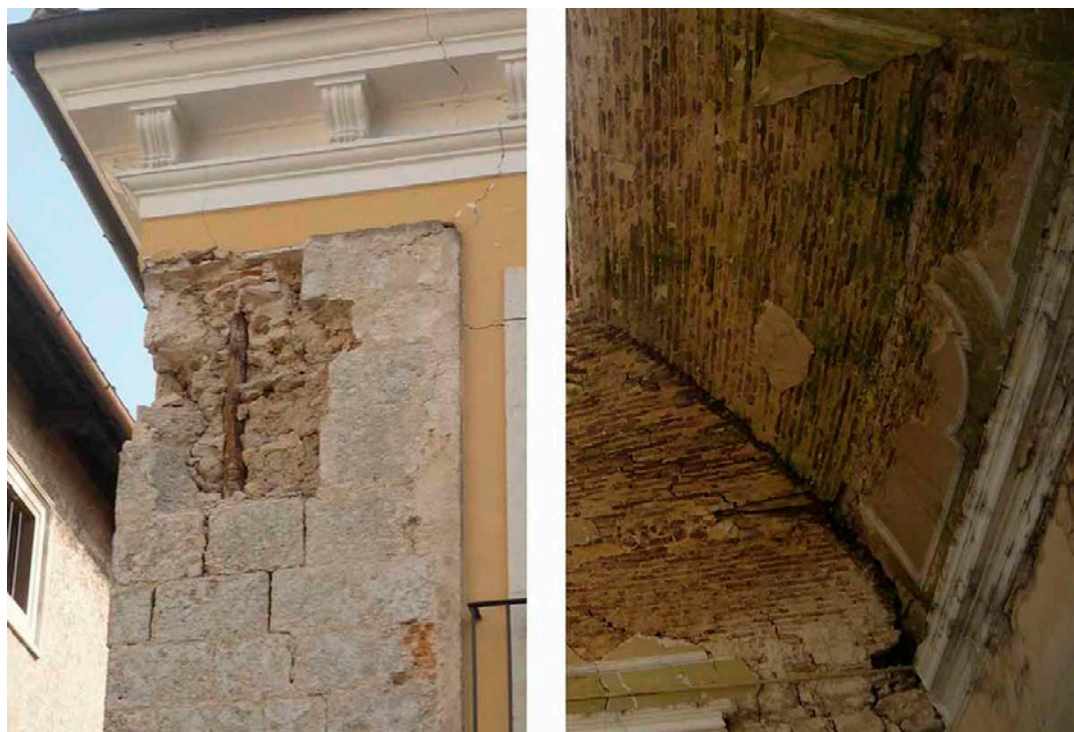
Fig. 2. L'Aquila: vertical wooden log, probably part of a more complex wooden frame (on the left). L'Aquila: wooden tie-rods in a cloister vault in Palazzo Ardinghelli (on the right).

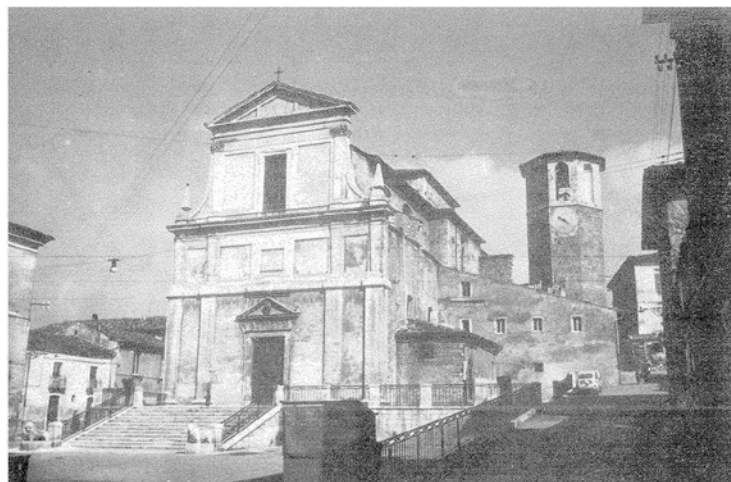
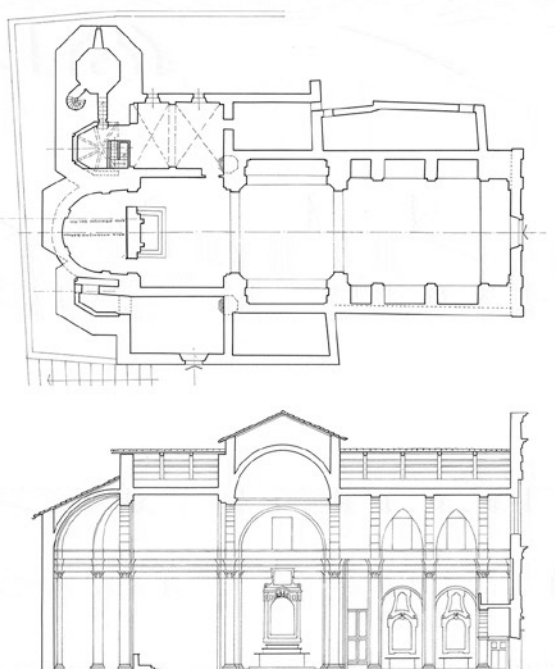
Fig. 5. Top: the façade and a view of the right side of the church of S. Pietro di Coppito before the 1969 restoration (Miarelli Mariani, 1979). The partition walls between the side chapels and the nave rise above the right side wall, effectively counterbalancing the higher walls of the nave. The two walls that delimit the transept rise to the same height as the wall of the nave, supporting the dome.

Bottom: plan and section of the church, before the 1969 restoration, as reconstructed by Gianfranco Spagnesi (Spagnesi and Properzi, 1972).

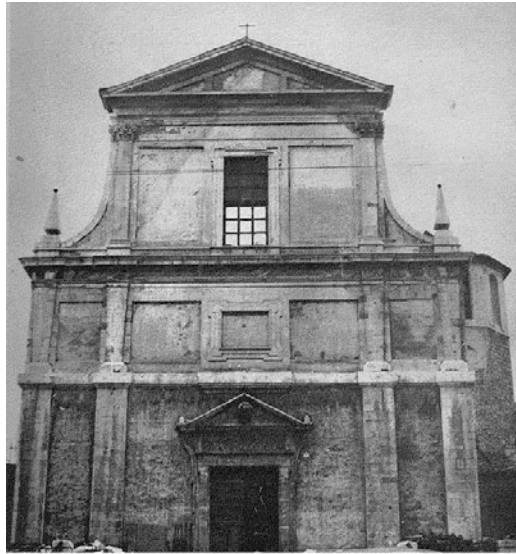
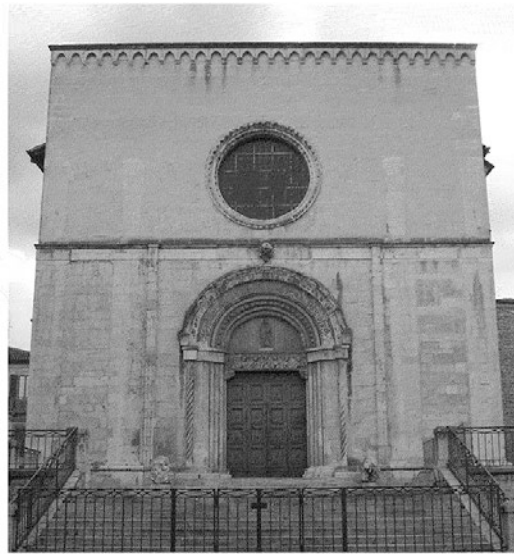
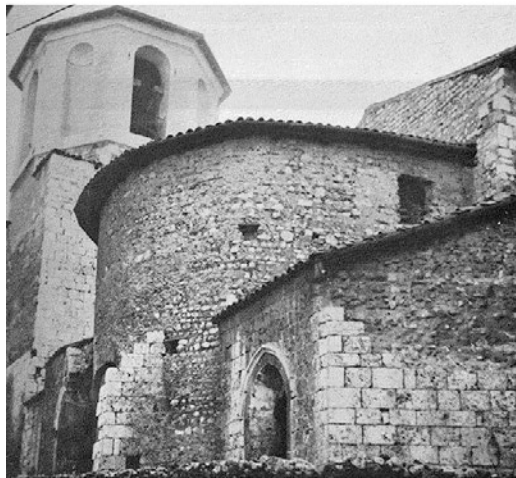
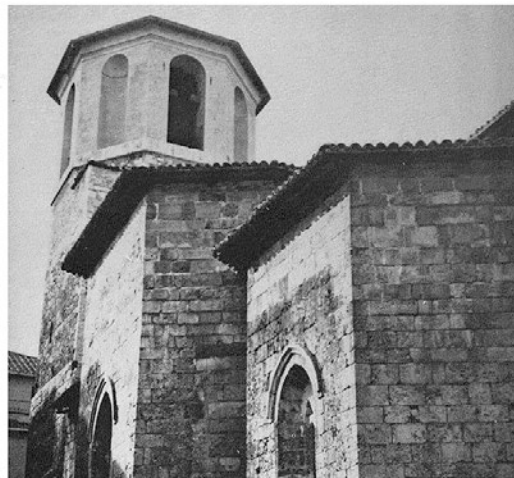
Apart from modifying the layout of the church, individual elements were also drastically changed, first and foremost the main façade, which was returned to its medieval square shape reducing its height (by demolishing the upper part of the nineteenth century façade), adding new parts (in order to obtain the squared outline) and thickening the wall (in order to realize a continuous vertical plane). If the two façades are compared side by side (before and after the 1969 restoration) we see that the discontinuities in the stone facing of the present façade correspond to the first order of pilasters in the nineteenth century façade (fig. 9). This can be clearly seen in the right corner pilaster, where there is a vertical dark patch in the upper part.

Fig. 6. Top: nineteenth century façade, before and after the 1969 restoration (in the stone facing of the present façade the pilasters of the first and second order of the nineteenth century façade can be easily identified).

Bottom: polygonal apses before and after the 1969 restoration.

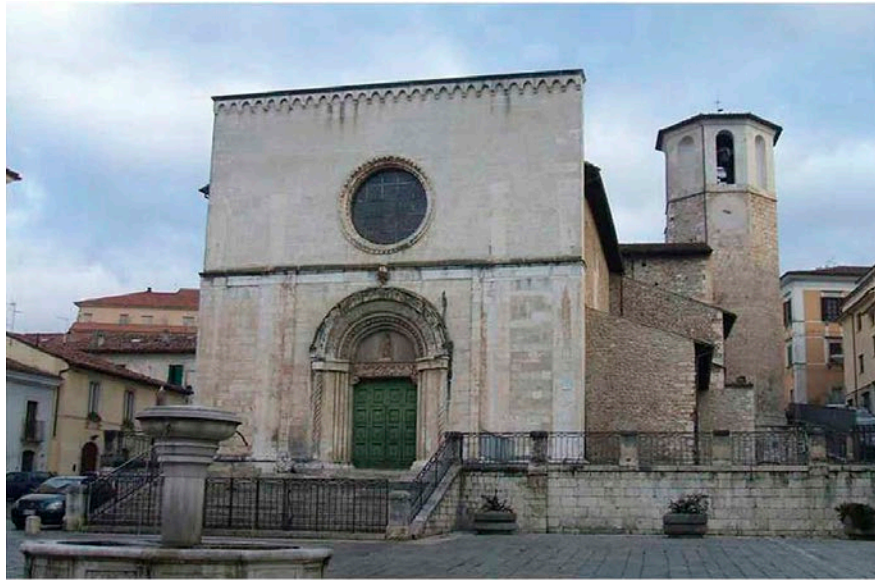
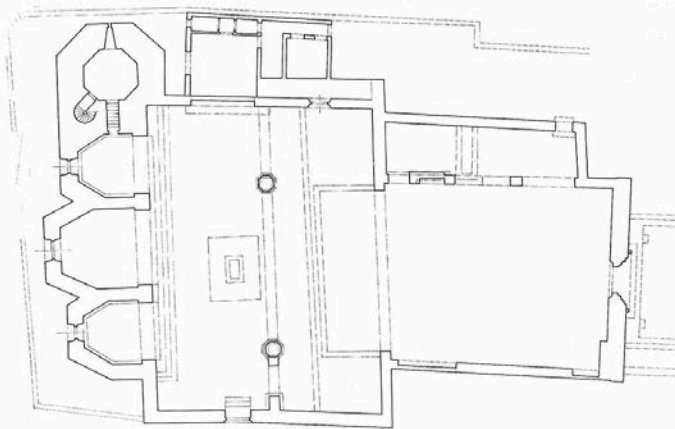
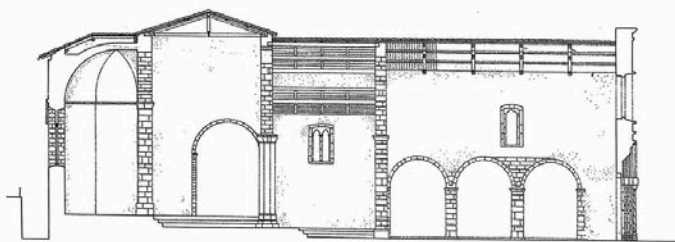
Fig. 7. Top: the façade and a view of the right side of the church of S. Pietro di Coppito before the 2009 earthquake.

Bottom: plan and section of the present church, in a drawing dating back to the 1969 restoration.

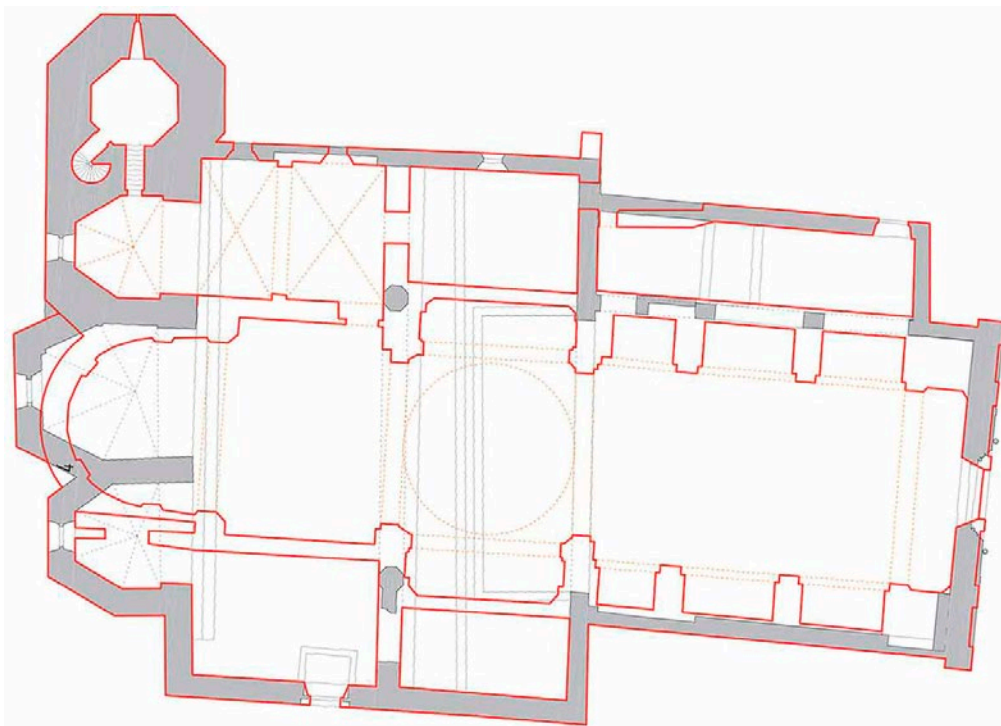
The intrinsically anti-seismic layout of the eighteenth-century church was, in fact, irreversibly destroyed by Moretti's restoration, which transformed the baroque church into a (hypothetically) medieval structure by: (i) removing the transverse walls of the chapels, (ii) opening the three arches in the right side wall of the nave; (iii) removing the longitudinal walls of the transept and the choir, and the transverse wall of the transept aligned with the two pillars (and taking apart the dome); (iv) restructuring the polygonal apses, perhaps by rebuilding the wall separating the central apse from the one on the left (fig. 8).

Fig. 8. The present plan of the church superimposed on the nineteenth century plan as reconstructed by Gianfranco Spagnesi.

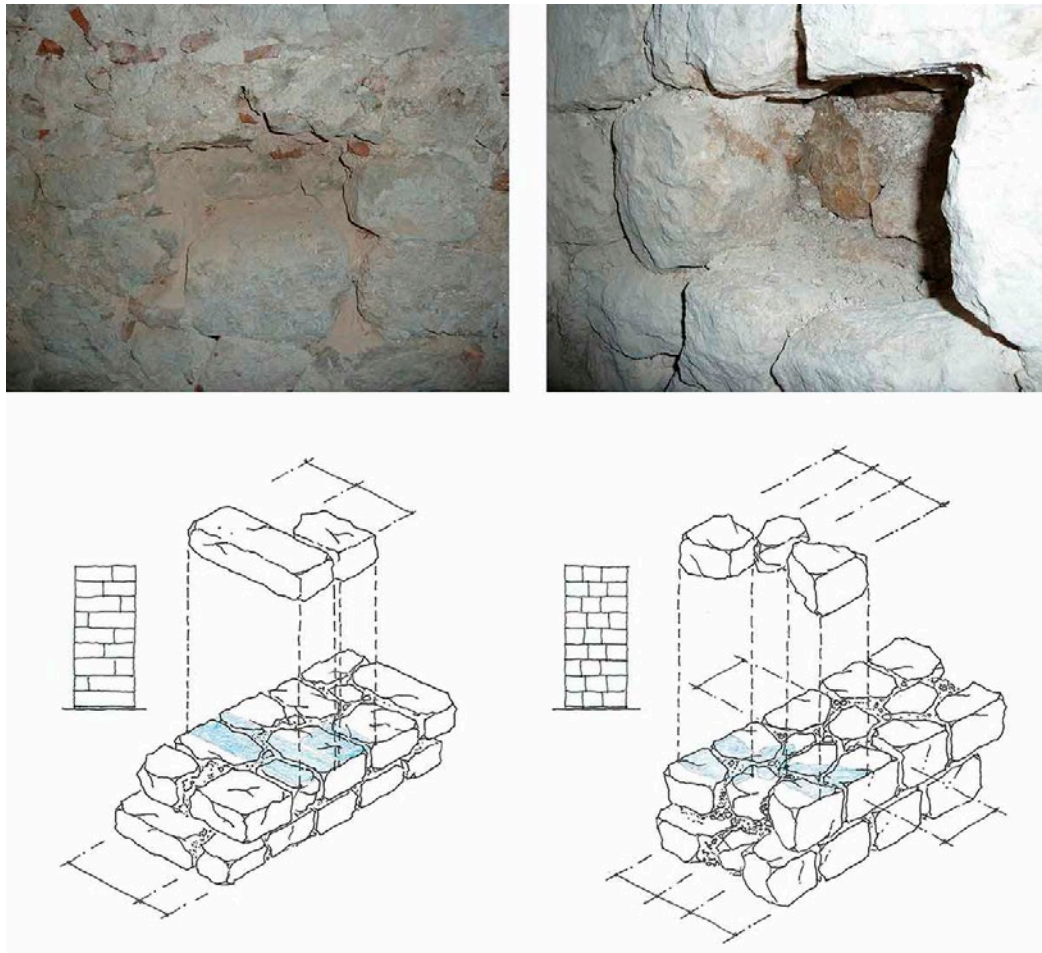
This can be seen first and foremost in the nave walls, both the façade and side walls whose masonry quality deserves to be looked at in detail (fig. 9, top). The walls are built using relatively small stones (up to 20 to 25 cm) in relation to the thickness of the walls themselves and, for this reason, they do not seem to be in line with the classical interpretative parameters of the rules of the art of masonry, as set out in late nineteenth century treatises (Curioni, 1875; Breymann, 1878), since it was evidently impossible to respect the fundamental requirement that imposes the use of large stones (headers) in the masonry to ensure transverse compactness of the walls (fig. 9, lower left). However, it would be wrong to say that this system simply does not respect the rules of masonry. It is more correct to say that the system respects a rule somewhat different from the classical one (and, undoubtedly, more complex and difficult because it makes use of poorer quality material) but whose mechanical intent is the same – and can be always

This rule, observed in the church and frequently recognized in other buildings of L'Aquila and of the minor historical centres in the surroundings, involves keeping to a rigorous arrangement of stones throughout the thickness of the wall (fig. 9, lower right), using stones of the same size for the two outer facings and for the inner core (thus not the type of masonry known as "*a sacco*"), and compensating for the lack of transverse block bonding, such as that provided by headers, with a distributed connection provided by stones of uniform size: these are arranged in regular courses – overlapping the stones of superimposed courses and tothing them out in the same course (where they are laid, alternately, with their main dimension parallel or orthogonal to the wall plane, i.e. as headers and stretchers) - and the gaps between them are filled with smaller stones and bricks wedged in.

Fig. 9. Top: direct survey of masonry works in the façade wall (on the left) and the left nave wall (on the right), by removing single stones from the outer facings.

Bottom: Comparison between the stone arrangement prescribed in classic nineteenth century treatises (on the left) and the stone arrangement surveyed in the church (on the right).

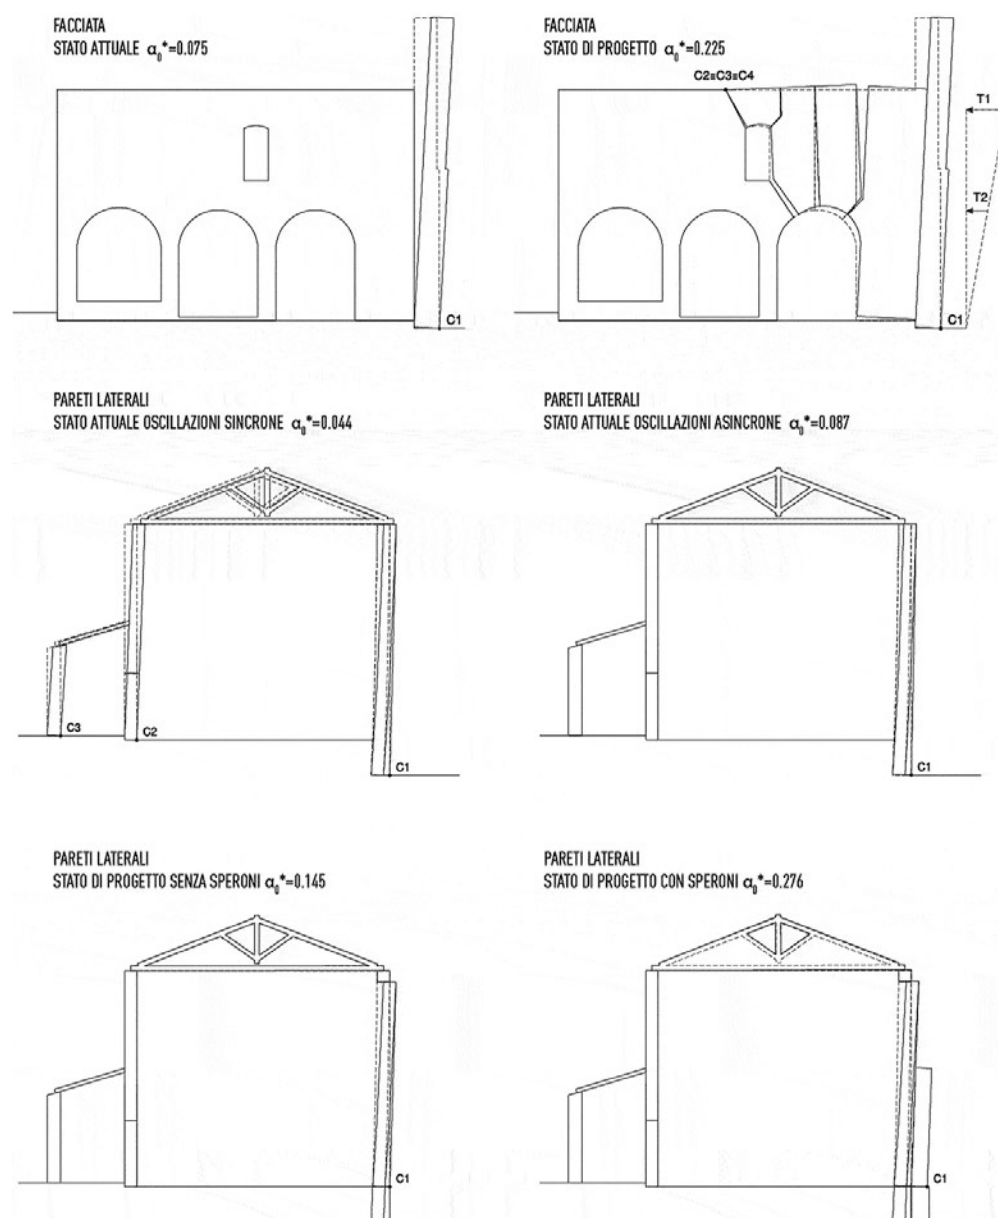
Although a detailed discussion of the different mechanisms analysed is beyond the purpose of this paper (some of them are illustrated, as an example, in figure 18), a particular aspect deserves nonetheless to be underlined. The project state is described, for both the façade and the nave side walls (the structural portions that have been considered in the analyses), by a succession of mechanisms which involve increasing resistant contributions – as provided for in an increasingly effective improvement strategy – and allow modelling the individual effectiveness of each intervention with the aim to take into account the possibility that some of them proves to be ineffectual, depriving the building of a stability factor that should therefore be excluded from the

Fig. 18. Collapse mechanisms for the façade (top) and the nave walls (bottom), at present and in the project.
