Seismic History of the Church of San Pietro Di Coppito in L'Aquila

Renato Masiani, Department of Structural Engineering and Geotechnics, La Sapienza University of Rome, via Gramsci 53, Rome 00195, Italy

Art of building, early earthquake engineering, masonry structures, L'Aquila earthquake, seismic improvement, static restoration.

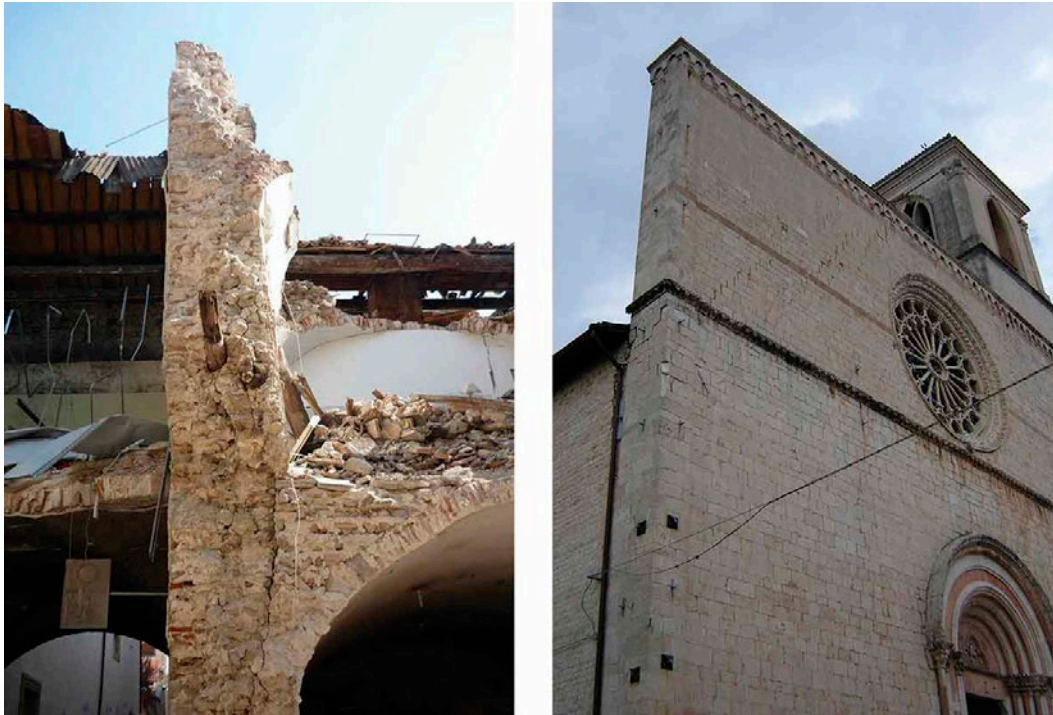
Fig. 1. L'Aquila: wooden log (*radiciamento*) in a shear wall (on the left). L'Aquila: the effectiveness of wooden logs inserted in the façade of the church of S. Silvestro preventing its global overturning (on the right).

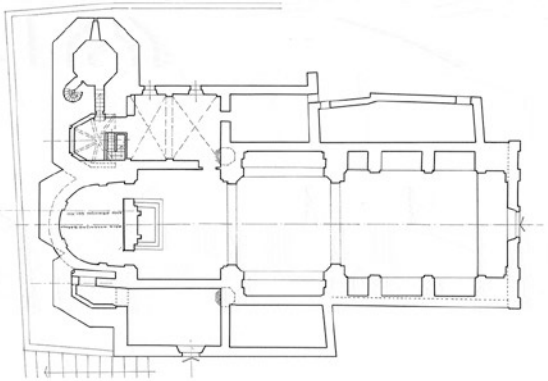
Fig. 5. Top: the façade and a view of the right side of the church of S. Pietro di Coppito before the 1969 restoration (Miarelli Mariani, 1979). The partition walls between the side chapels and the nave rise above the right side wall, effectively counterbalancing the higher walls of the nave. The two walls that delimit the transept rise to the same height as the wall of the nave, supporting the dome.

Bottom: plan and section of the church, before the 1969 restoration, as reconstructed by Gianfranco Spagnesi (Spagnesi and Properzi, 1972).

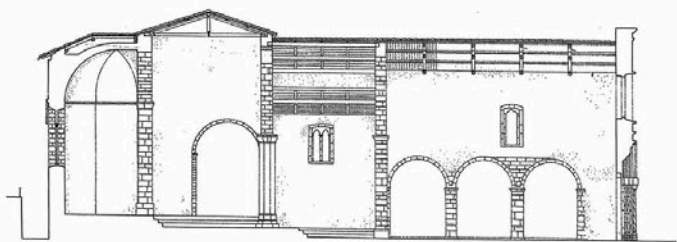
Fig. 7. Top: the façade and a view of the right side of the church of S. Pietro di Coppito before the 2009 earthquake.

Bottom: plan and section of the present church, in a drawing dating back to the 1969 restoration.
