Engineering Reconnaissance of the 24 August 2016 Central Italy Earthquake. Version 2

Geotechnical Extreme Events Reconnaissance Association

Report No. GEER-050B

22 November 2016

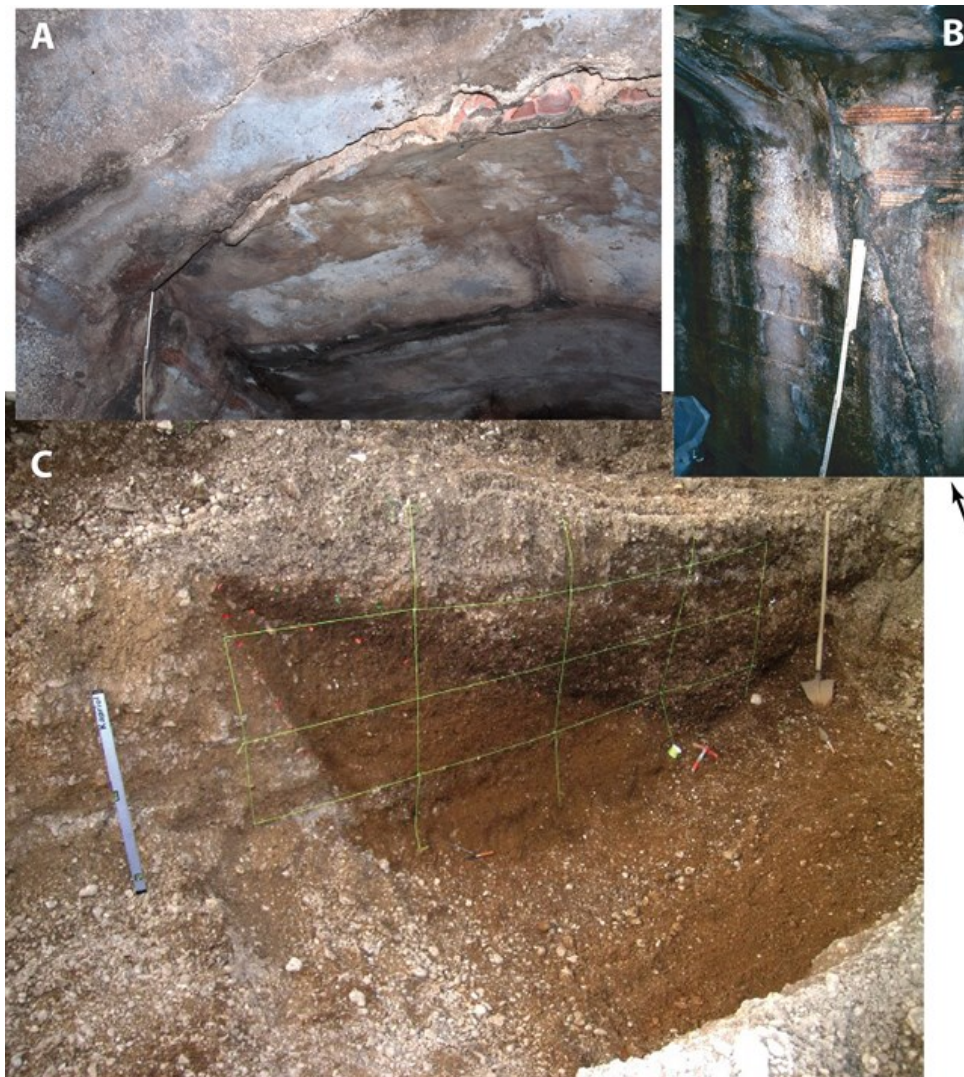
Recent displacements have also been related to minor fault sections within Norcia (Galli et al., 2005) (Figure 2.5). Paleoseismological investigations identified slip from the 1703 (14 January) earthquake and events between 6th-5th century BC and 3rd-1st BC (99 BC?). As a result, the recurrence interval for large **M** events can be estimated as 1,700-1,900 years (Galli et al., 2005).

Figure 2.5. Norcia fault: emergence of active fault splays in the settled area of Norcia: a, b) vault and walls of a cellar displaced by a fault which activated during the earthquake of 1979; c) panoramic view of the trenches excavated by Galli et al. (2005) in the suburbs of Norcia: the fault places Middle Pleistocene alluvial gravels in contact with colluvial units ranging in age from the Upper Pleistocene (i.e. the lowermost unit with the orange matrix in the hanging wall) to the 18th century AD.

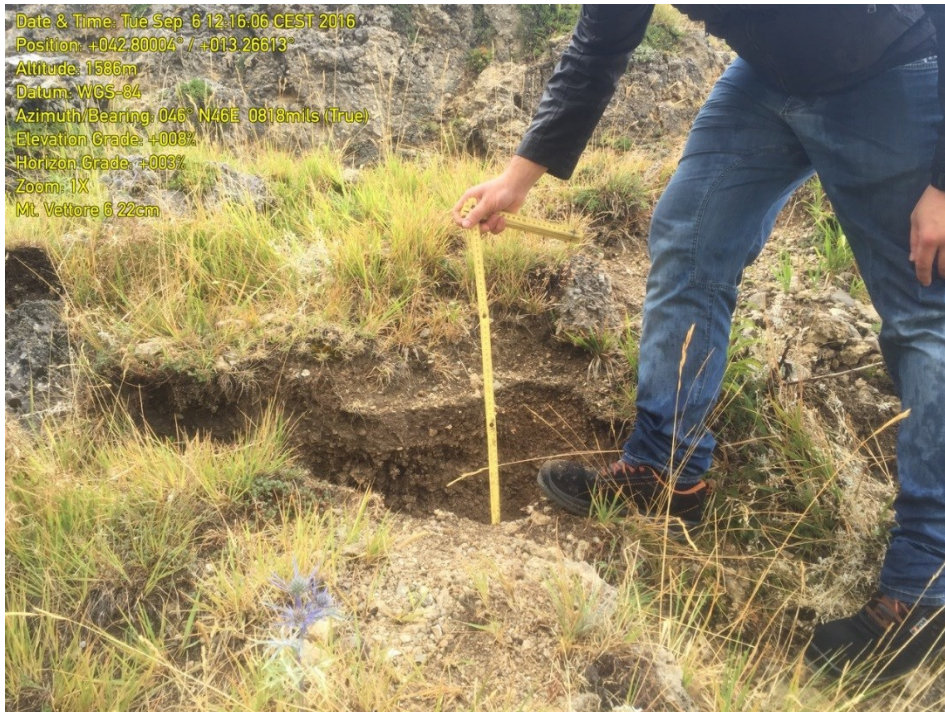
Figure 2.19h. Mt. Vettore fault Site 6 at a WGS84 ellipsoid elevation of 1527 m. The normal fault displacement at this site was 22 cm down toward the west (Latitude and Longitude are annotated on the image).

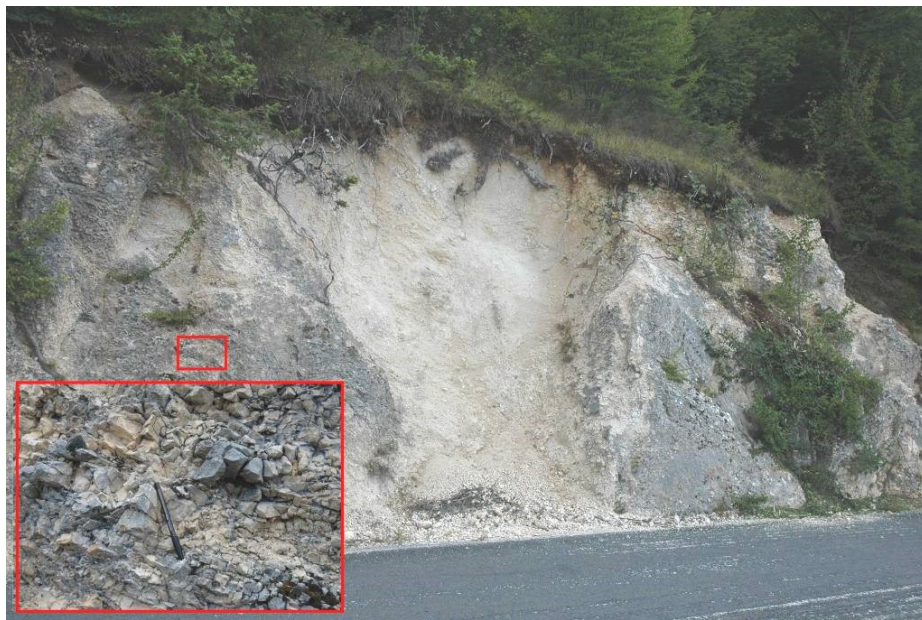
Figure 4.7. Failure in intensely fractured (i.e., sugar-cube) limestones (cataclasite).

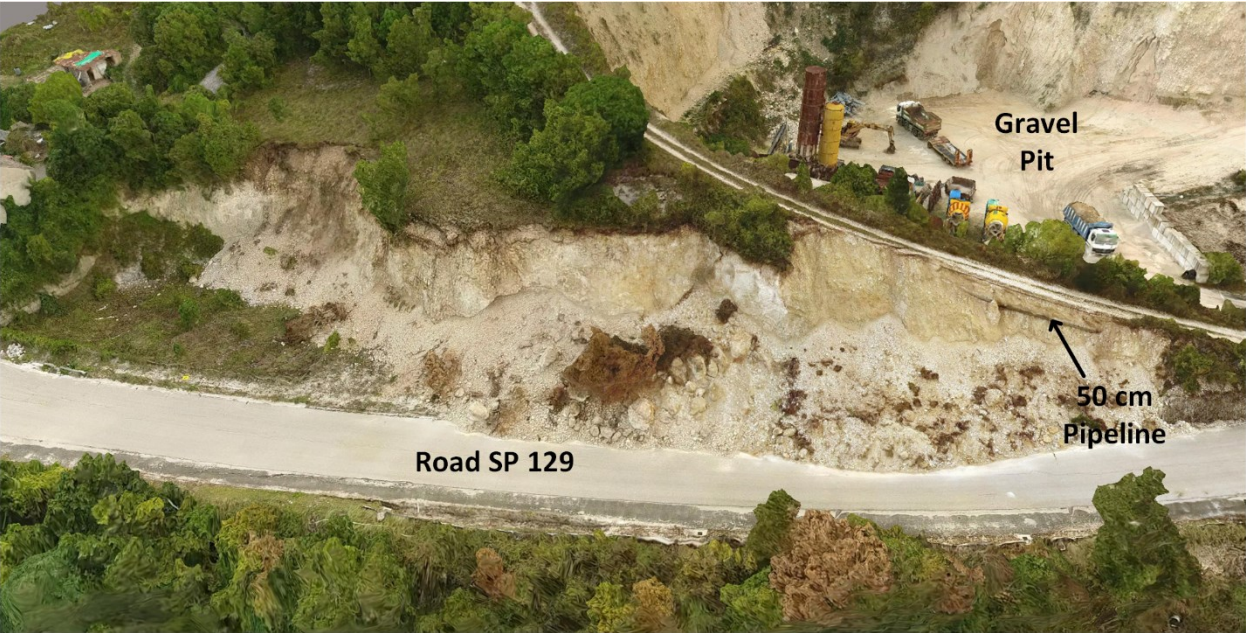
Figure 4.36. Model image of landslide near gravel pit and Road SP 129 that exposed a 50 cm-diameter pipeline (42.74950 N 13.26958 E).

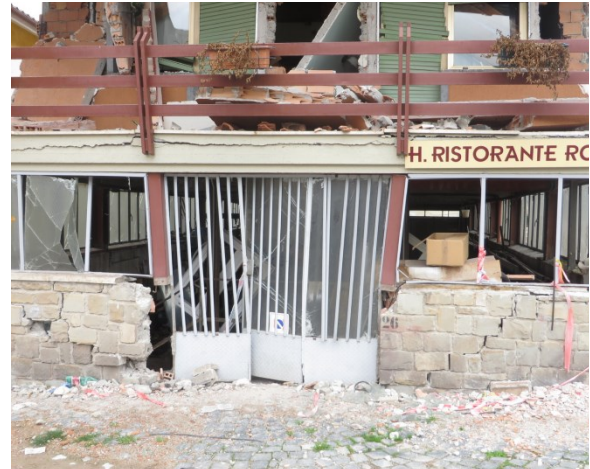
P34

Figure 5.15. Photos of a characteristic steel building with minor-to-moderate damage (DS2, P33-P34) next to Hotel Roma, a collapsed R/C building (P35, P36).

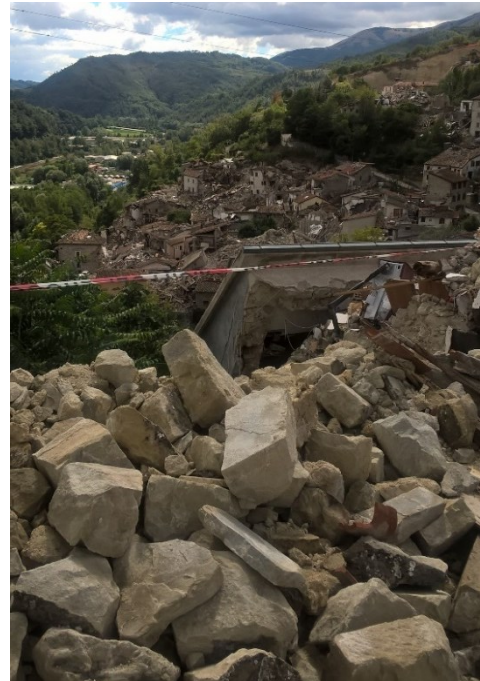
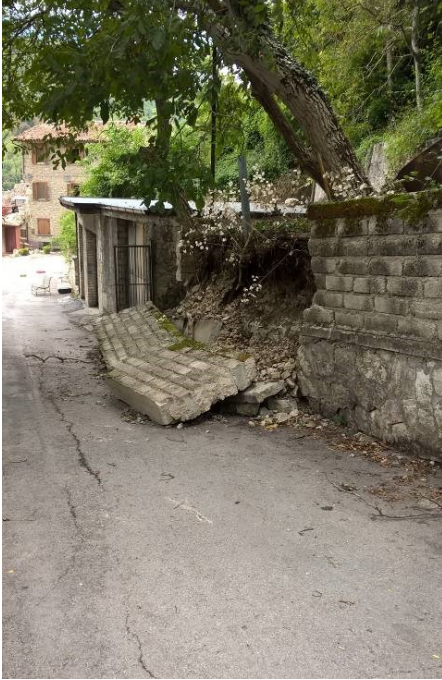
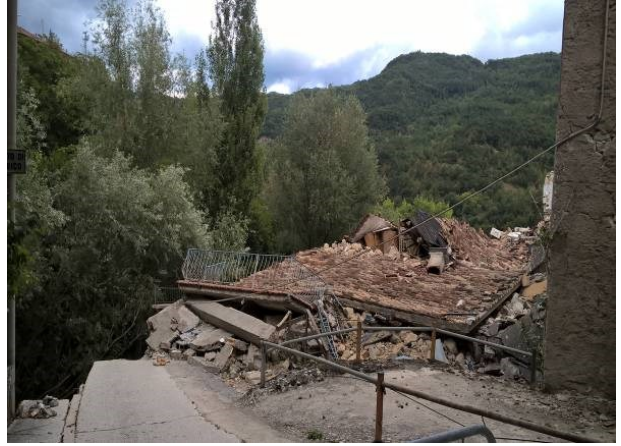
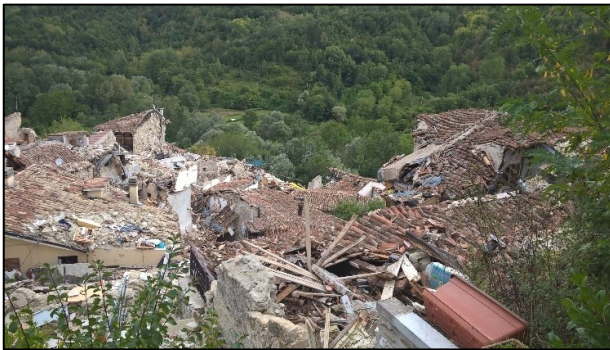
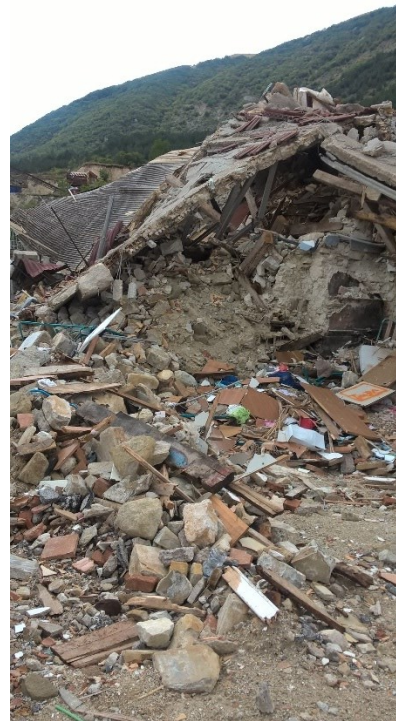
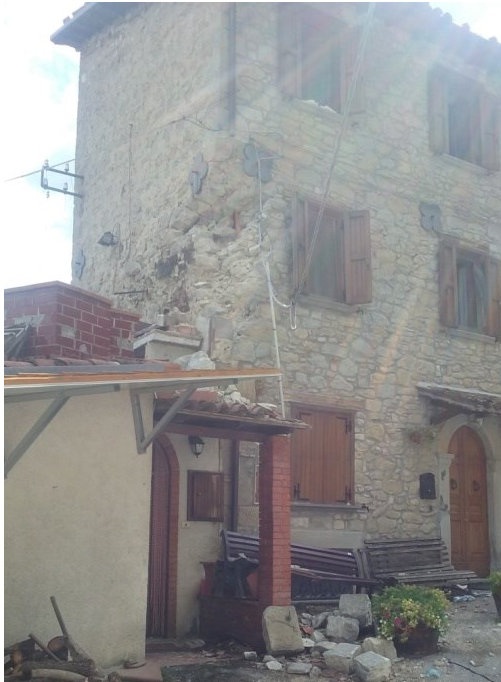
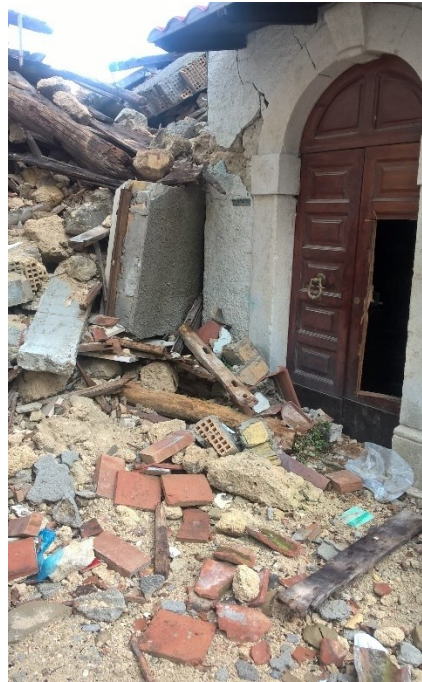
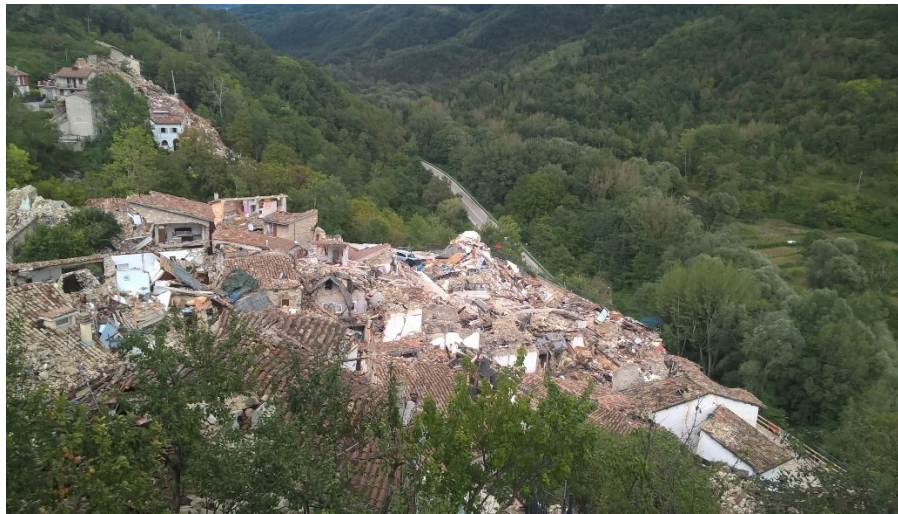
Figure 5.26. Representative pictures taken in Pescara del Tronto during the survey.

The village was extensively damaged by the mainshock, with the degree of damage greater than or equal to D3 in most places. A tentative damage zonation in this area is reported in Figure 5.27. On the road leading to the southern part of the hamlet (P01-P06) the level of damage seemed slightly lower; partial or full collapse (P02, P05 and P06) was observed together with smaller degrees of damage (P03, P04). It should be noted that the only concrete building in the village was subject to significant damage to beam-column nodes (D3 damage, see P1). The southern part of the hamlet was almost completely destroyed, ranging from partial to full collapse (P09-P13). These areas were not accessible to the GEER team, but the patterns can be

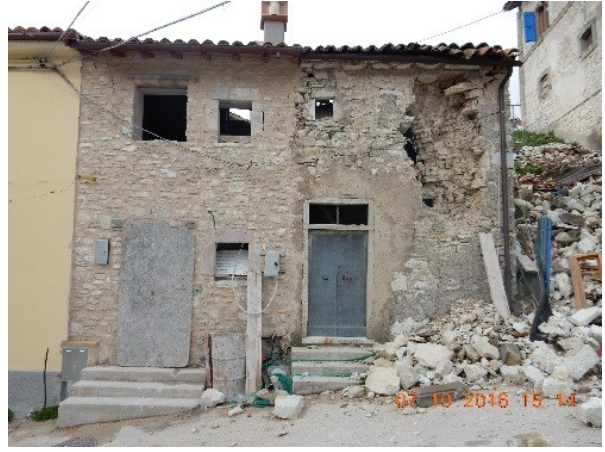
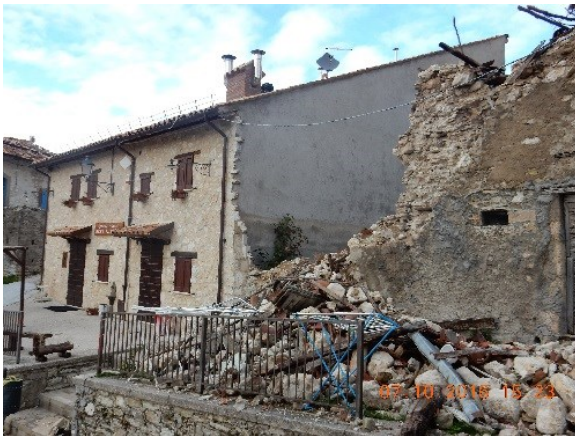
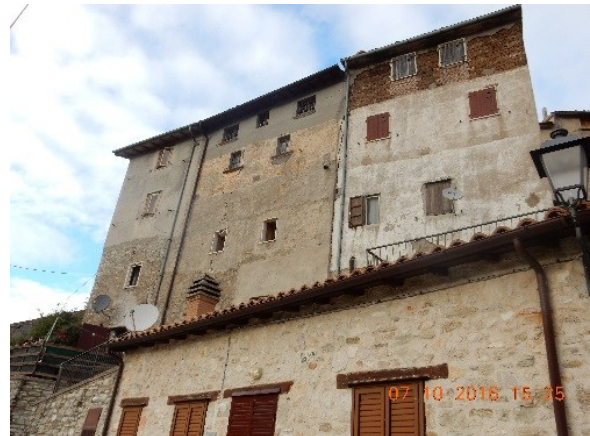
We documented the performance of five buildings according to the Italian inspection sheet, with the results in Table 5.9. The location of the surveyed buildings and the graphical representation of their damage state as well as representative photographs of damage are shown in Figure 5.40 and Figure 5.41.

Figure 5.41. Representative pictures taken in Castelluccio during the survey.

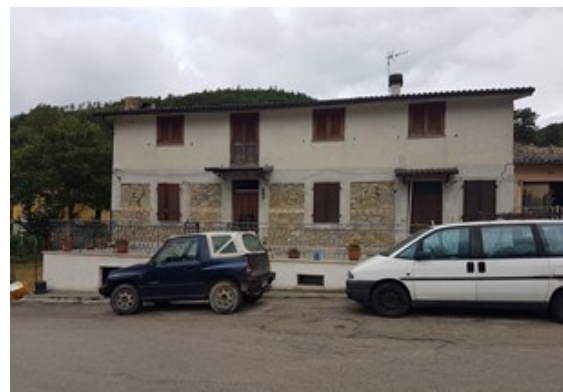
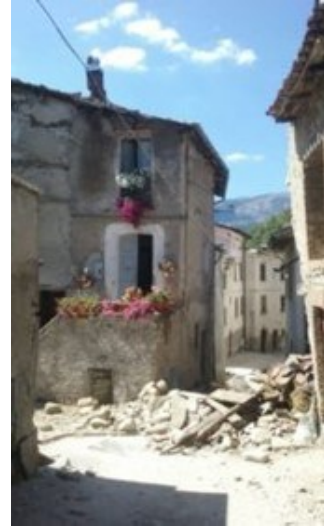
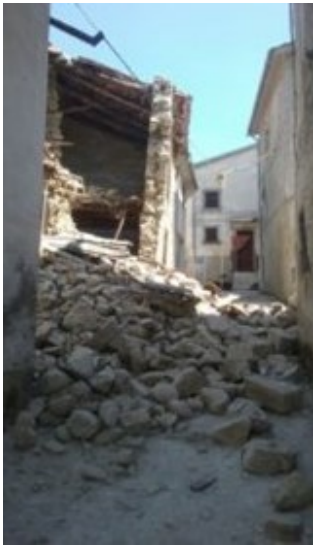
Figure 5.49. Representative pictures taken in Fonte del Campo during the survey.

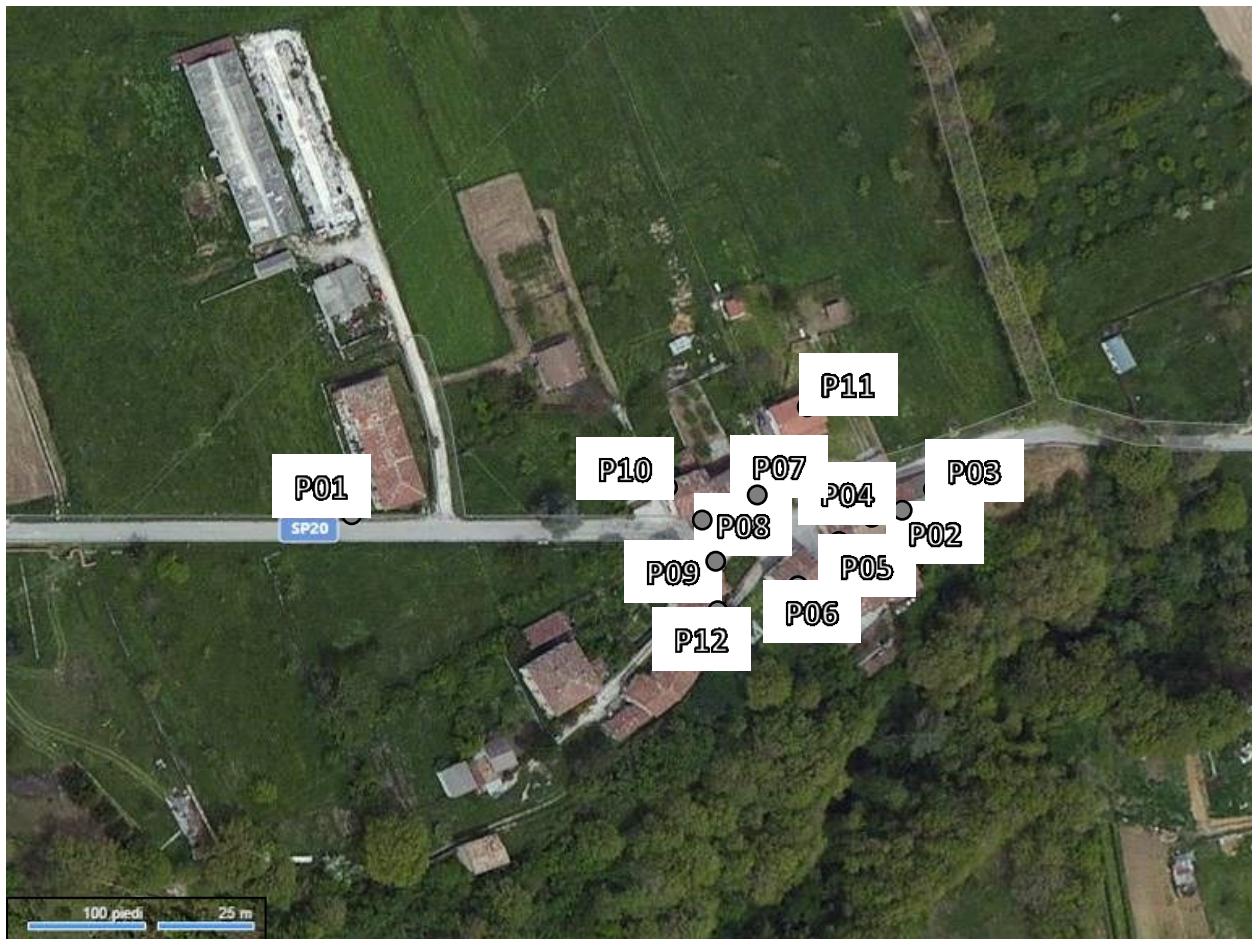
Cascello is located along the road northeast of Amatrice at approximate elevation 940 m ASL. This hamlet has 16 inhabitants, one of the smallest in the Amatrice municipality. Figure 5.55 and Table 5.13 summarize locations of the most significant damage cases in the area. Figure 5.56 shows the different mechanisms of damage detected during the field survey. Almost all the dwellings were two to three story, old buildings made of arenaceous masonry. Undamaged houses (e.g. P03, P04) were often found near partially collapsed buildings (P02, P05), indicating that local damage variability was mainly attributed to the vulnerability of the structures. The retrofitted structures often had tie rods, which proved more effective when installed at both second and third floors of the structures (e.g. P07, P12), otherwise they could not prevent partial collapse (e.g. P06) or extensive cracking (P08, P09) of the masonry walls. The building damage distribution, including several cases of partial collapse, seemed to be compatible with the macroseismic intensity IMCS=8 (Galli et al., 2016).

Figure 5.55. Location of representative pictures taken at Cascello (see Table 5.13 for details).

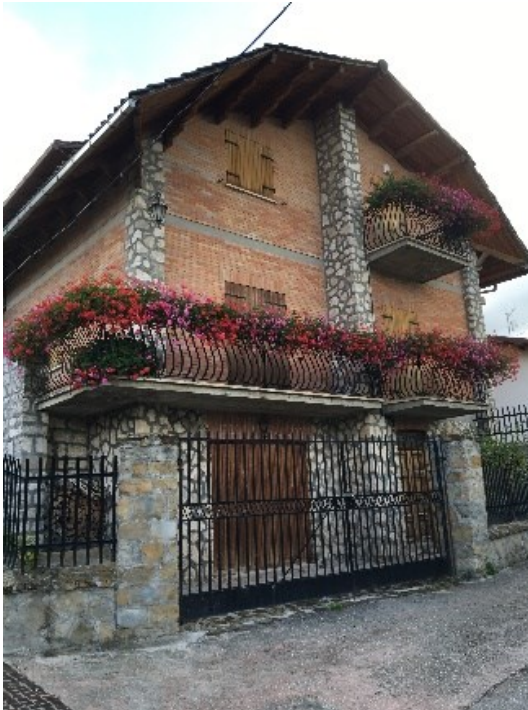
Picture	DATUM	longitude	latitude	Damage level	Note
P01	WGS- 84	13.324171	42.634639	D3	Old chapel, façade and absidal walls very deformed and x-cracked
P02	WGS- 84	13.324385	42.634543	D0	Almost undamaged new building in front of the chapel
P03	WGS- 84	13.324870	42.634559	D3	Intensely cracked building with a singular breach at the toe
P04	WGS- 84	13.325142	42.634781	D2 - D3	Small houses unevenly damaged
P05	WGS- 84	13.325969	42.634808	D3	Court house with dominating inter-openings cracks
P06	WGS- 84	13.325967	42.634803	D3-D4	Poor brickwork cracked (left) and breached (right)
P07	WGS- 84	13.325984	42.634731	D0	Undamaged restored building nearby
P08	WGS- 84	13.326309	42.634897	D0 – D1	Undamaged houses, one recently reinforced (see bottom picture, dated 2011) with tie rods with elliptical plates
P09	WGS- 84	13.326246	42.634884	D0	Recent low constructions uphill, almost undamaged
P10	WGS- 84	13.324369	42.634103	D3 - D4	Upper walls often breached

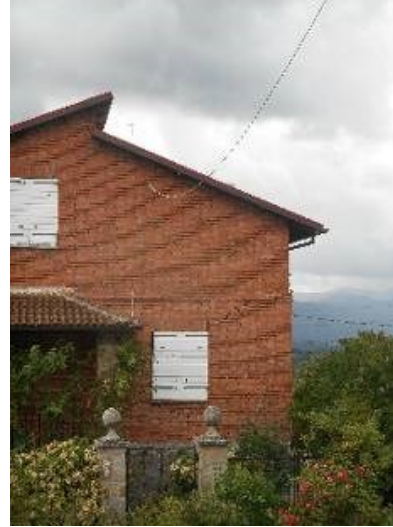
P11	WGS- 84	13.324422	42.633758	D3	Recent brickwork cracked and displaced
P12	WGS- 84	13.324433	42.633853	D3	Bulged and cracked poor masonry wall
P13	WGS- 84	13.324433	42.634000	D2	Partial damage even with tie rods

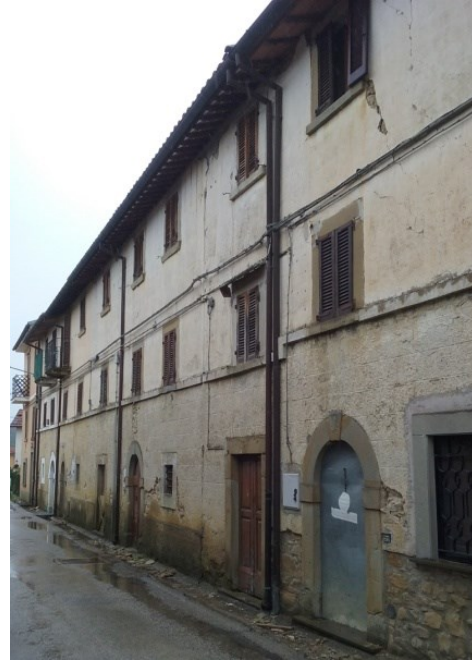
Photos of representative structures inspected in Mosicchio are shown in Figure 5.60, with further details provided in Table 5.15 (WGS-84 coordinates, damage level of buildings, other notes). The hamlet consists mainly of unreinforced masonry structures, 2-3 stories in height. The damage was quite low, on average classified as D2. Only one case of partial collapse (D4) was observed in a poorly constructed, unreinforced masonry building (see P4).

Picture	DATUM	Location		Damage Level	Notes
		Lat.	Long.		
P01	WGS-84	42.622807°	13.279402°	D0-D1	
P02	WGS-84	42.623130°	13.279552°	D1-D2	
P03	WGS-84	42.623654°	13.279299°	D2-D3	
P04	WGS-84	42.623777°	13.279313°	D4	<i>Partial collapse of the roof</i>

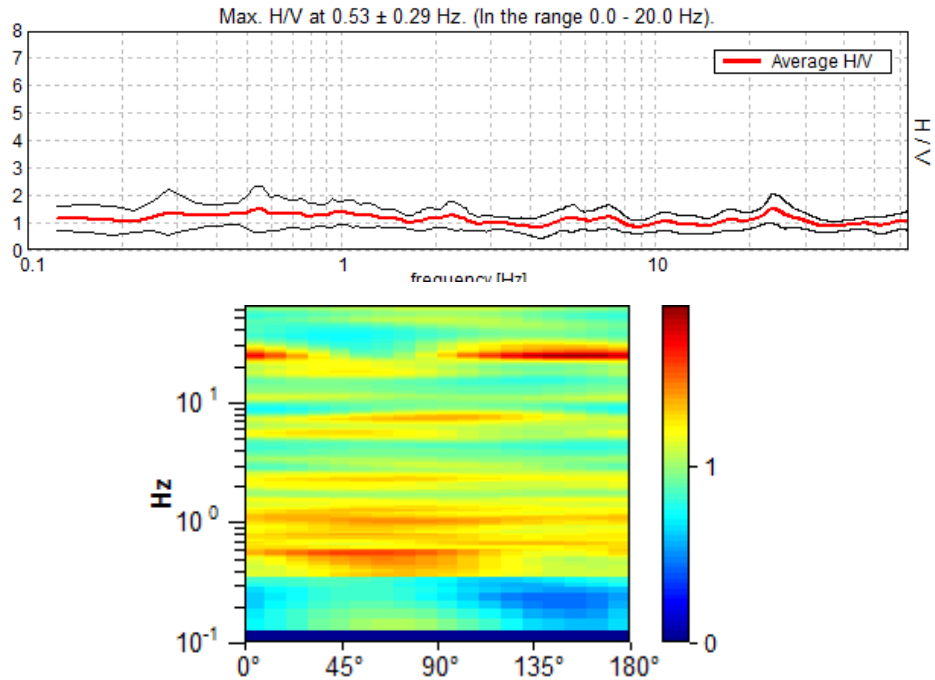
Figure 5.61. Noise measurements results in terms of H/V spectral ratio (on top) and H/V polar plots (on the bottom).

Noise measurements were obtained during the survey close to buildings shown in picture P01 (Figure 5.60). A portable Tromino tomograph was employed. The methodology used for these measurements is the same as that described in Section 5.3.3. Both H/V and polar H/V are reported in Figure 5.61. No significant H/V peaks can be observed in the measurements, roughly supporting that the village is located on seismic bedrock (Flysch) and often no significant amplification effects are expected. This apparent lack of site effect may have contributed to the low to moderate levels of damage.

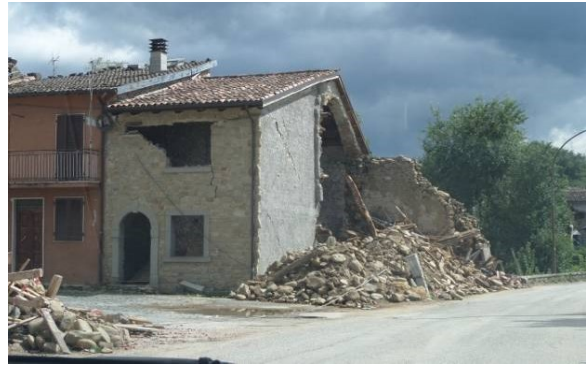
Only a small part of the village was accessible in the days of the reconnaissance, which was surveyed as shown in Figure 5.69 and Table 5.18. The few buildings inspected (Figure 5.70) in some cases were partially or totally collapsed (P02, P03, P07), but most frequently had diffuse cracking (P04, P05, P06). Sommati had an average damage level in the order of D3-D4 with a local IMCS = 9 (Galli et al. 2016).

Picture	DATUM	Location		Damage Level	Notes
		Lat.	Long.		
P01	WBG-84	42.642058	13.304934	D2	
P02	WBG-84	42.641640	13.305167	D4	
P03	WBG-84	42.641709	13.305461	D5	
P04	WBG-84	42.641251	13.306553	D1-D2	
P05	WBG-84	42.641172	13.306394	D3	
P06	WBG-84	42.641388	13.306857	D3	
P07	WBG-84	42.641438	13.307067	D3-D4

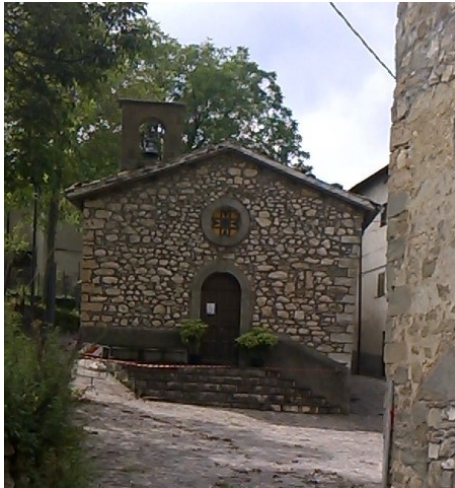
P13 (Astorara)

Astorara is a small hamlet located at elevation of 1008 m ASL, 3 km from Balzo. It is built on the Laga Flysch Formation, locally covered by eluvial colluvial deposits that in this area never exceed 2-10 m in thickness (from Seismic Microzonation Level 1-Regione Marche, Montegallo municipality, Regione Marche, 2015). The 1-2 story masonry buildings (P14) as well as the masonry monumental buildings behaved adequately, apparently suffering no damage. One such example, as evidenced in picture P13, is the *Santa Liberata* Church, dated presumably to the XVI-XVII century. The hamlet had an average damage level of D0-D1.

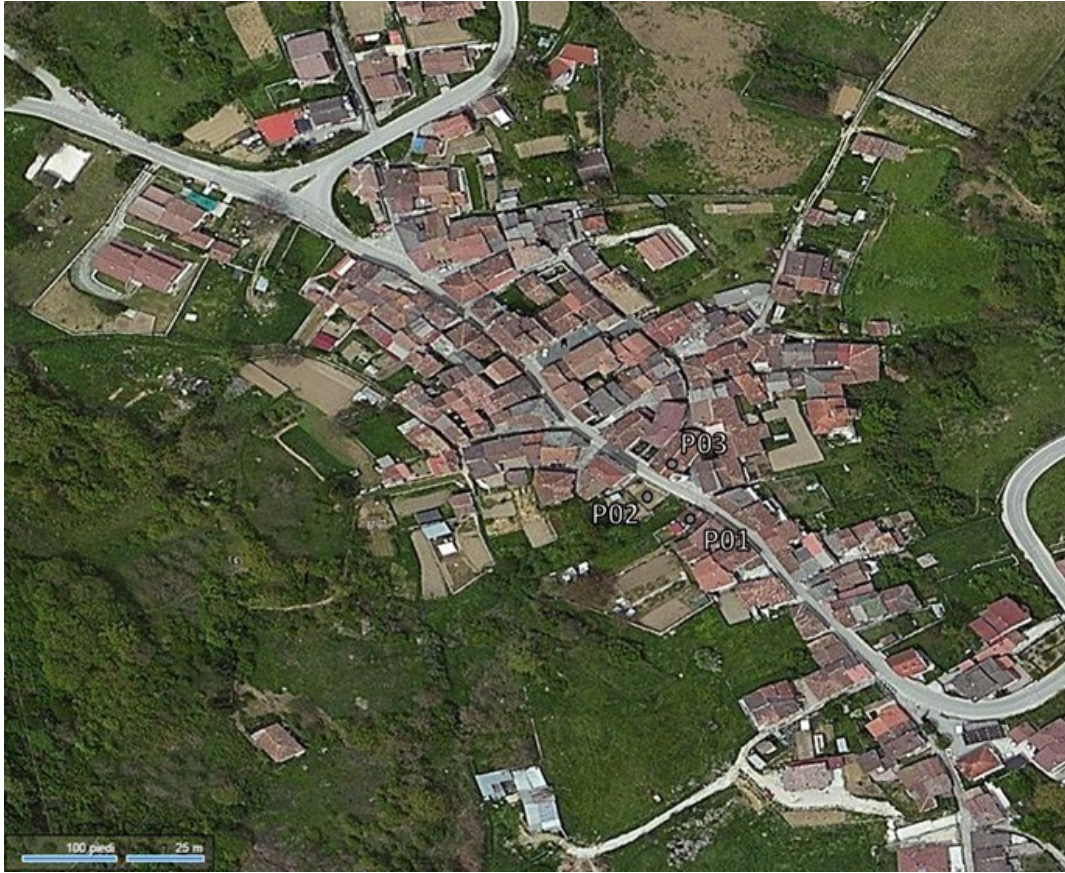
Figure 5.86. Location of representative picture taken in the village of Aringo (see Table 5.23 for details).

Picture	DATUM	longitude	latitude	Damage level
P01	WGS- 84	13.26763	42.55525	D0
P02	WGS- 84	13.26752	42.55489	D0
P03	WGS- 84	13.26760	42.55502	D0

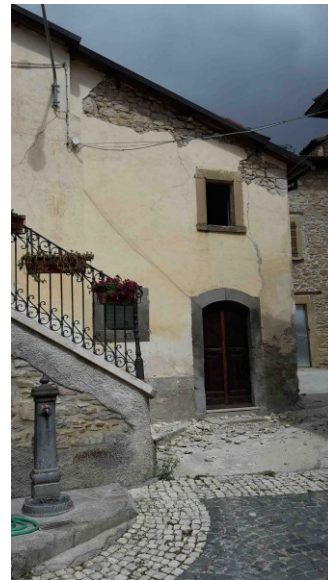
Figure 5.89. Representative pictures in Santa Lucia (Montereale) (see Table 5.24 for details).

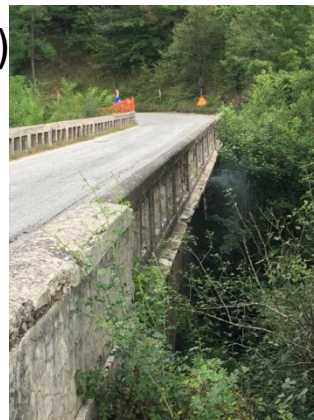
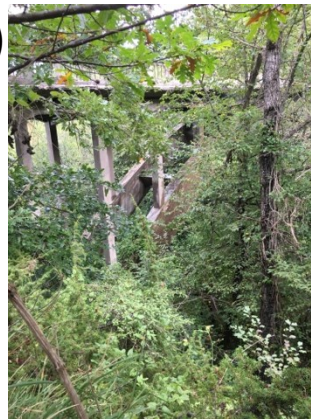
Figure 6.4. RC bridge along the SR577 Torrente Rionero (42.6172 deg, 13.3233 deg): overview of the bridge (a), rupture of the water pipeline on the bridge side (b) and view of the structure (c, d).

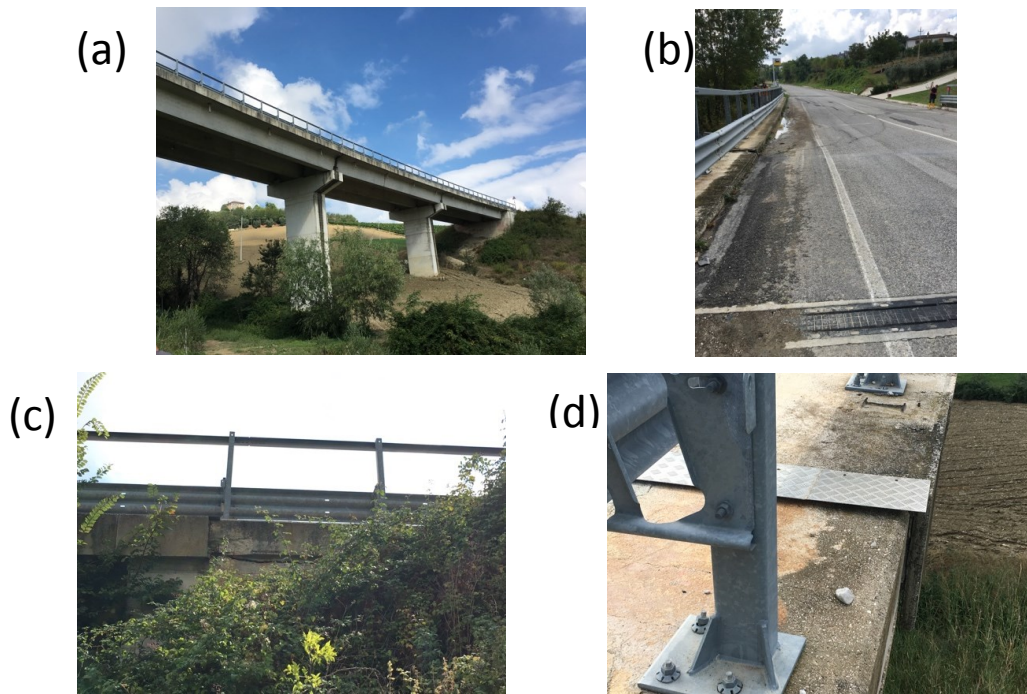
Figure 6.6 shows the RC bridge along the SP173 in Offida. This bridge presents significant settlements on the road close to the abutments (Figure 6.6b), that caused damage at the structural elements, as shown in Figure 6.6c. These settlements, which existed before the earthquake, have been amplified by seismic compression of backfill as a result of strong ground motion from the 24 August 2016 mainshock. Thus, it was suggested to limit the maximum load to be carried by the bridge, until specific geotechnical improvements to stabilize the area can be performed.

Figure 6.6. RC bridge along the SP173 in Offida (42.941687 deg, 13.702294 deg): overview of the bridge (a), settlement of the road (b) crack (c) and relative displacement of the abutment (d).

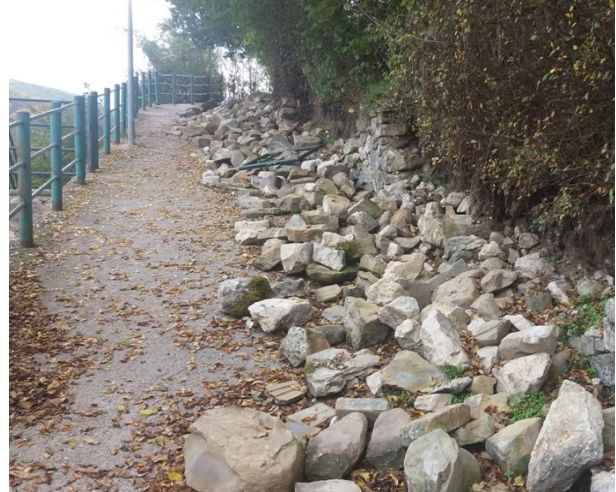
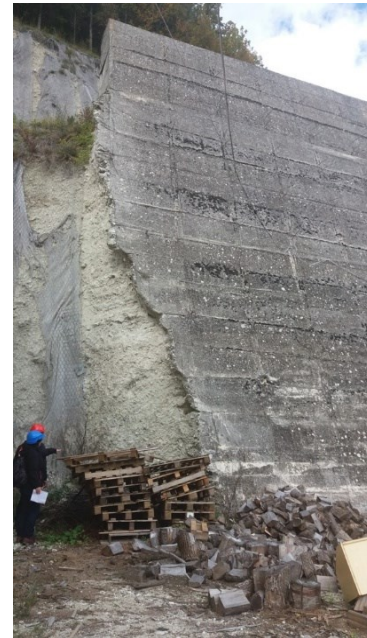
Figure 7.5 shows three cases of retaining walls damaged in Pescara del Tronto. In each case, the observed damage may be attributed in part to the poor quality of the retaining structures. Figures 7.5a-b show the collapse of two relatively low masonry walls. The wall in Figure 7.5a is made of concrete blocks connected by mortar, with no evidence of drainage measures having

been installed in the backfill. The wall in Figure 7.5b was erected with a typical dry-stone masonry technique (no mortar between stones) with no foundation. Figure 7.5c-d illustrate the damage to a fence drapery breached by calcarenite rock blocks falling from a slope as high as 8m. No significant damage was observed in the adjacent high concrete wall.

Figure 7.5. Retaining walls in Pescara del Tronto: (a) collapse of a concrete block masonry wall (42.751705N, 13.270562E), (b) collapse of a dry-stone masonry wall (42.751141N, 13.270889), (c) fence drapery breached by calcarenite rock blocks, (d) performance of the adjacent concrete wall (42.752331, 13.270207E).

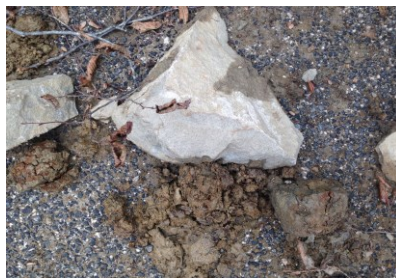
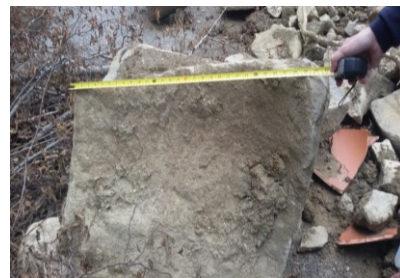
Figure 7.6a shows damage to a rockfall barrier along the SS260 road branch that connects Amatrice to the main road SS4 (Salaria). At the time of the reconnaissance, a protection embankment was placed at the toe of the slope (Figure 7.6b). The slope behind the barrier is covered with a hexagonal mesh, which along the failed slope is simply draped with no evidence of reinforcement (Figure 7.6c), while along the stable slope it appears connected to the arenaceous flysch formation by ropes and nails (Figure 7.6d).

Figure 7.6. Damage to a rockfall protection system along the SS260 road (42.648203N, 13.274285E) in Amatrice municipality: (a) collapsed zone; (b) failed (left) and stable (right) parts of the slope with protection embankment in the foreground; bottom view of the failed (c) vs. stable (d) slope and barrier; concrete wall supporting the barrier (e) and previous crack (f) denoting the absence of reinforcement; (g) arenaceous block with silty matrix and (h) maximum size of the rock blocks fallen.

The rockfall barrier is comprised of a fence with steel horizontal cables connected to vertical cantilever tubular piles anchored to a concrete beam placed upon a 1.4 m tall retaining wall (Figure 7.6e). The concrete wall appears to be unreinforced (Figure 7.6f).

Collapse of the system may be attributed to several factors, among which the lack of anchorage of the mesh panels to the slope and between adjacent panels too, inadequacy of the rockfall barrier with reference to the foundation of the tubular elements, the absence of any retaining cable on the top of the barrier, and the limited strength of both the fence and the horizontal cables. The rockfall barrier was not able to intercept arenaceous blocks up to approximately 30-40 cm in size (Figure 7.6f-g), sliding or falling from a maximum height of about 12 m.

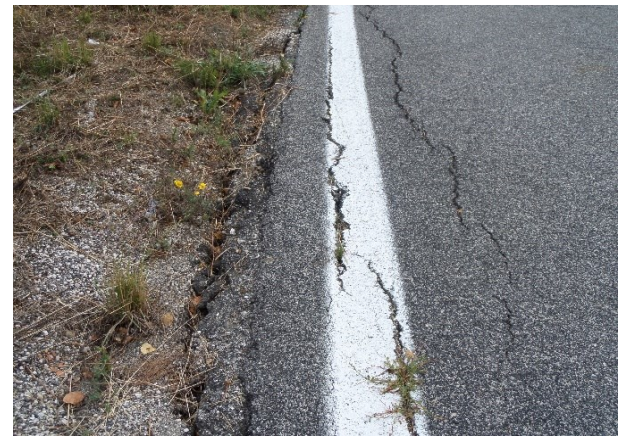
We observed longitudinal cracks (Figure 7.8a-b) at km 133 of main road SS4 (Salaria). Maximum crack widths in the asphalt surface are around 3 cm (Figure 7.8c) and cracking was also observed at the edge of the road pavement (Figure 7.8d). Adjacent to this section of road is a nearly vertical cut. Nearby areas with gentler slopes had no pavement cracking.

Figure 7.8. Embankment instability along the SS4 road at km 133 (42.650533N - 13.270442E): (a) longitudinal cracks along the whole rest area, (b) identification of the site location by road sign, (c) maximum horizontal opening of the longitudinal crack, (d) disconnection between the lateral slope and the road surface.

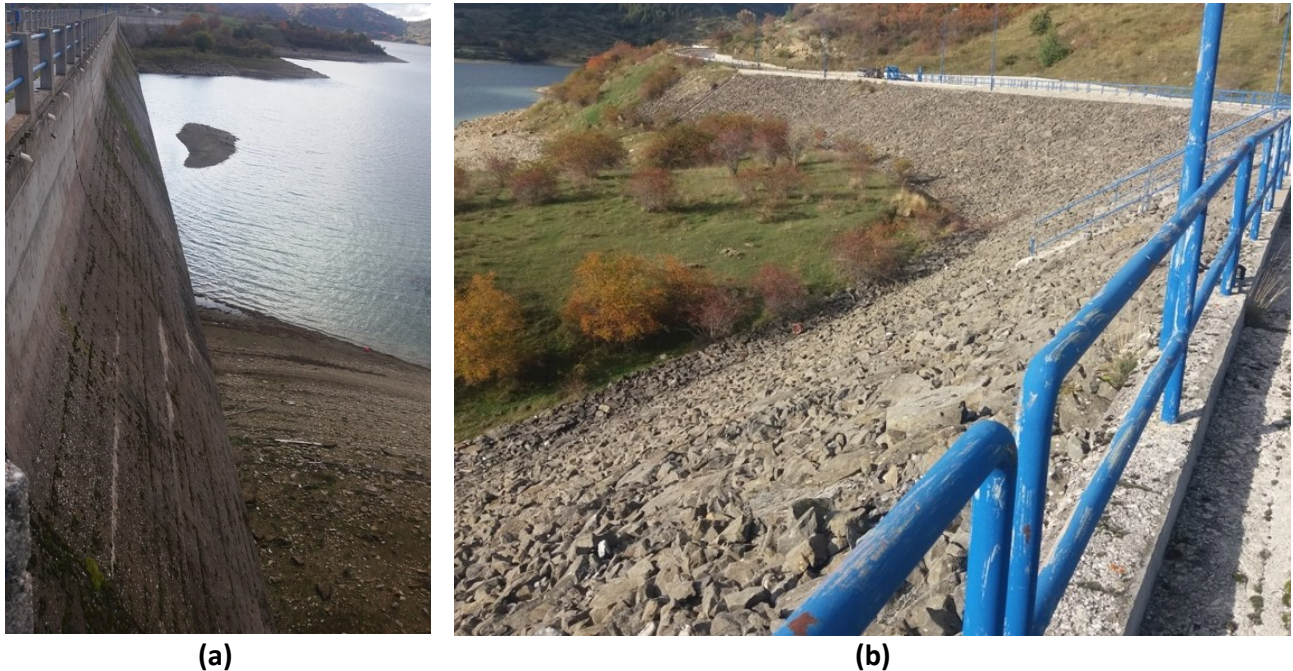
Sella Pedicate is a concrete gravity dam along most of its length but with a zoned embankment dam (with a clayey central core and a concrete foundation diaphragm) on the left abutment. The dam was built from 1965 to 1971; it is 20.75m tall and 750m long. Figure 7.18a shows the upstream face of the concrete dam, which is very steep (about 5 horizontal to 1 vertical), while the downstream face has a much milder inclination. The upstream face of the embankment dam is shown in Figure 7.18b, while the cross-section and the material properties are reported in Figure 7.16b and Figure 7.16c, respectively.

It is important to highlight that the SPD seismic station was located within the surveillance station of the dam since April 15, 2009 (after L'Aquila earthquake). During the August 24 earthquake, the SPD station recorded a peak ground acceleration of about 0.11 g. After the mainshock, no damage was observed to Sella Pedicate dam, which is located 23.7 km from the epicenter.

Figure 7.18. Photos taken on October 19, 2016 of the upstream face of Sella Pedicate concrete dam (a) and of one of its extremities (b), which is an embankment dam (42.514468°N, 13.370155°E).

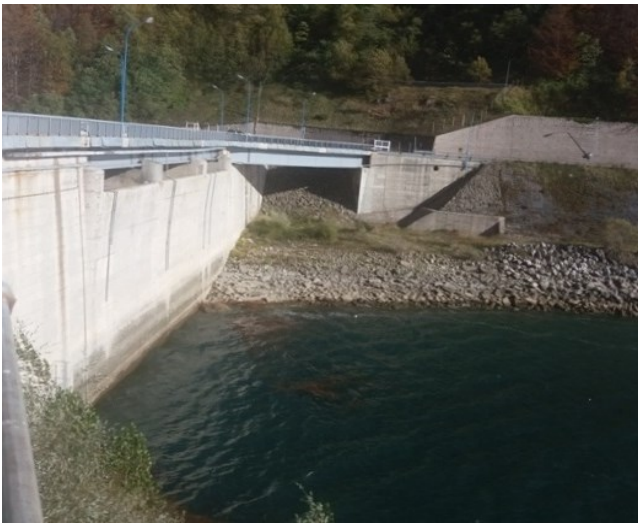
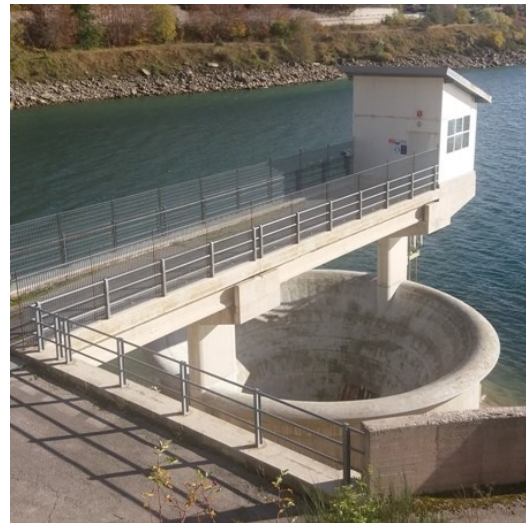
Rio Fucino is a concrete gravity dam with a triangular cross-section and a rectilinear longitudinal axis. The dam encloses the Campotosto basin at the eastern side (Figure 7.10). The maximum impounding level is equal to 39m and the length of crowning is equal to 154m. The body of the dam is subdivided into 12 ashlar through 11 joints located along vertical planes. The height of maximum storage is 1318.15m a.s.l.. A photo of the downstream face and a cross-section of the dam are shown in Figure 7.19a and Figure 7.19b, respectively. Pictures of the upstream face and bell-mouth spillway of the dam are shown in Figure 7.20a and Figure 7.20b,

The inspections carried out by ENEL staff after the August 24, 2016 earthquake revealed that no damage to Rio Fucino dam was observed.

Figure 7.20. Photo of upstream face (a) and of the bell-mouth spillway (b) of the Rio Fucino dam (October 19, 2016).
