Path of Knowledge for the Assessment of Structural Safety of the Pisan Tower of the Royal Palace of Palermo in Italy

Abstract: This paper presents the path of knowledge developed for assessing the structural safety of the Norman-age Pisan Tower, which is mostly incorporated into the Royal Palace in Palermo, Italy. Historical, geomatic, and mechanical investigations were conducted and the most relevant results are herein collected and presented. The research path was addressed to specific tasks: identification of the building, geometric surveys, recognition of the sequence of phases of building transformation, detection of the components of the load-bearing structure, structural diagnostic surveys, and investigation of the subsoil and foundations. The explicit vulnerabilities found were mostly confined to the Piazza library floor, while implicit vulnerabilities were identified in the presence of false walls and in high loads and fillings on the vaults of the last levels. The results of the analyses allowed the individuation of the confidence factors to use in structural analysis models aimed at the assessment of the seismic safety of the building.

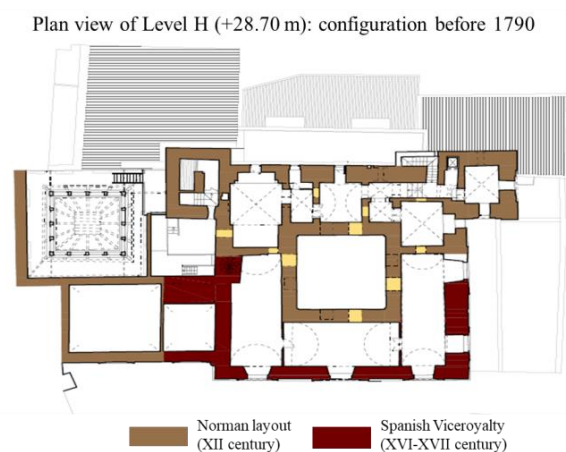
Figure 8. Conceptual reconstruction of the current floor of the Piazzzi Library in the age of the Spanish Viceroyalty.

In particular, three vaulted spaces were realized to fill the height gap. They were placed on the finishing “parapet” of the flat roof of the current President's Room, through a masonry superlevation realized about four centuries after the previous one; this led to the current floor of the Piazzzi Library (Figure 8). Two of the abovementioned vaulted spaces were placed perpendicular to the wall of the main prospect on the east side, while the third one serves as a connection between the others and is placed parallel to the line of the prospect. If the vault on the south side is still the original one, the three vaults were barrel vaults in calcarenite ashlars. The vaults were based on the shear walls of the Tower on one side and on the two arches on the other side, with a conveniently lower ridge height, to generate the additional vault of the perpendicular passageway (Figure 8). The latter was placed on the superelevated shear wall of the main prospect, and the parallel one in the pre-existing internal core of the Tower. Hence, this wall was not realized with the same crafts and clamps as the original one; even if it was well made, it was an addition to a structure from many centuries before.

This reconstruction was also inferred from the integrative surveys carried out in the framework of this study. It suggests that a considerable mass had been built over the pre-existing Norman structure; this mass was even greater due to the significant filling layer (a width of over 150 cm) detected through integrative endoscopic surveys. Consequently, the load excess could be one of the concurring causes that have contributed to the generation of cracks in the vaults of the underlying rooms, now part of the President's Room.

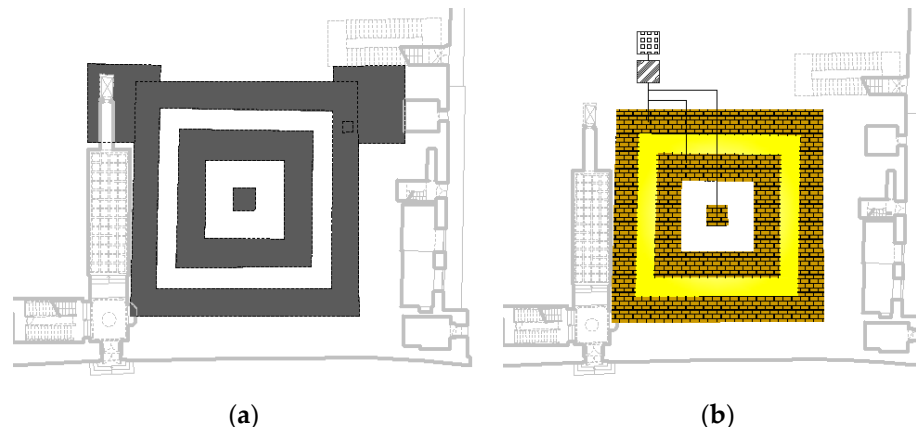
Figure 15. Identification of the structure of the Tower on level A (height 2.90 m); (a) hypothesized vertical load-bearing structure; (b) hypothesized materials.

The surveys performed and the information collected showed that the vertical load-bearing structure of the Tower consists, on level A, of two concentric quadrilaterals in the planimetry, with walls wider than 2 m, and two turrets at the vertices of the west side of the Tower, as represented in Figure 15a. These walls have been realized with a wall in large (70–100 cm) calcarenite ashlar, dry-placed and/or with low-width mortar joints. The wall was considered to show good workmanship and the ashlar have excellent mechanical properties, as shown by the high value of the compression strength of the extracted core samples. The material between the two squares of the Tower can be associated with an infill, mainly constituted by crushed ashlar, masonry with scarce mechanical properties, and incoherent materials (Figure 15b).

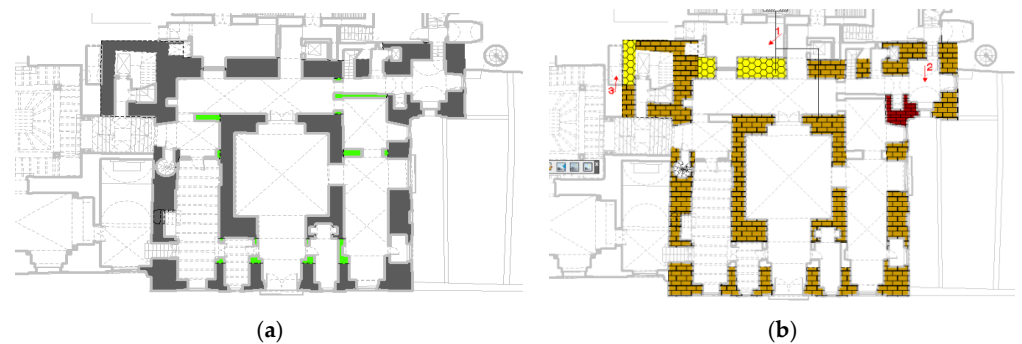
Figure 18. Identification of the structure of the Tower on levels D-E (height 19.60 m): (a) hypothesized vertical load-bearing structure; (b) hypothesized materials.

On levels D-E, the structural layout of the concentric quadrilaterals can be detected even if the walls are significantly set back from the lower level (Figure 18a). Moreover, the walls of the external square are intermitted by wide and numerous openings (doors, windows, rooms, and staircases). The President's Room has two different heights, while the other rooms are mainly double-height or have timber roofs. Superintendent Valenti, during the 1929 restoration intervention, performed several modifications to the structural layout. He demolished many mezzanine rooms, which had presumably been realized in the period of the Spanish Viceroyalty, and relocated some masonry walls to restore the Norman layout. The numerous performed interventions and the finishing with exposed faux masonry plaster were an obstacle to the precise definition of the wall typologies. Figure 18b shows a possible hypothesis, reconstructed solely on the basis of the historical documentation found.

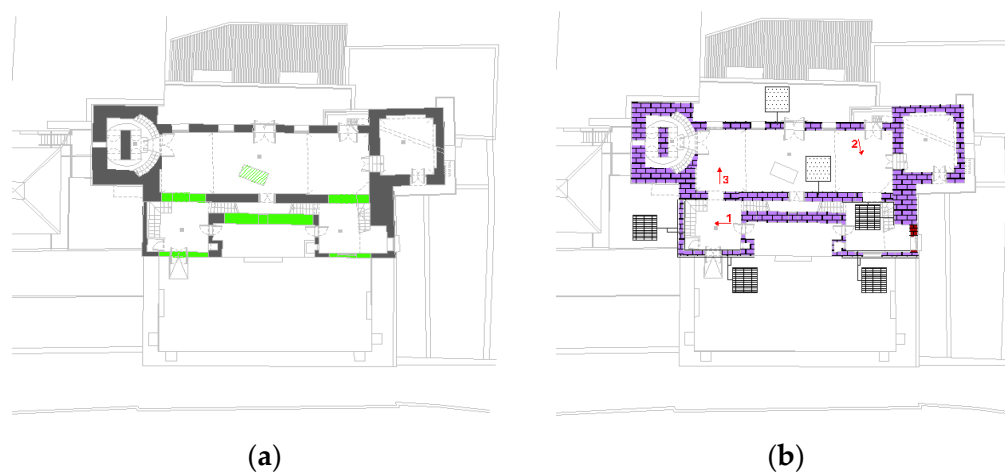
it was subjected to several integrations, modifications, adaptations, and an extended and complete restoration intervention by Boscarino and Cottone, who restored the layout of the original Observatory. At this level, the structural layout no longer has a rigid system with two concentric quadrilaterals; instead, a single hall connects the south and the north turrets (Figure 22a). Boscarino and Cottone's intervention included the demolition of the partition walls in the main room, and the substitution and/or the reconstruction of all the floors of this and the upper level, in addition to the construction of a new dome based on an octagonal steel drum. Since the original construction, the walls had been almost entirely in masonry, with calcarenite ashlar and mortar joints (Figure 22b). They were then subjected to repeated reinforcement interventions, using the techniques common at the times of the interventions, including local rebuilding with aerated bricks, reinforced plaster with an electro-welded mesh on the two sides, re-pointing of mortar joints, substitution and/or realization of new steel lintels, and construction of new steel tie-rods. These interventions improved the masonry resistance, but they did not cure the vulnerabilities of the vertical load-bearing structural components at this level, which are mainly related to the presence of some transfer walls. Among these, the wall on the east side—which provides a basement for the drum of the central dome—must certainly be investigated. At the walking level of the museum (36.18 m), Cottone and Boscarino's intervention removed the infill and realized new floors in I-beams and hollow flooring blocks detached from the vaults, which then lost their load-bearing structural role. Instead, the vault of the central room was reinforced so as to support the equatorial telescope. At the upper level, that is, the roof covering of the museum of the Observatory, the pre-existing timber roofs were substituted with new slabs, steel I-beams, and hollow flooring blocks.

Figure 22. Identification of the structure of the Tower on level L (height 37.70 m): (a) hypothesized vertical load-bearing structure; (b) hypothesized materials.

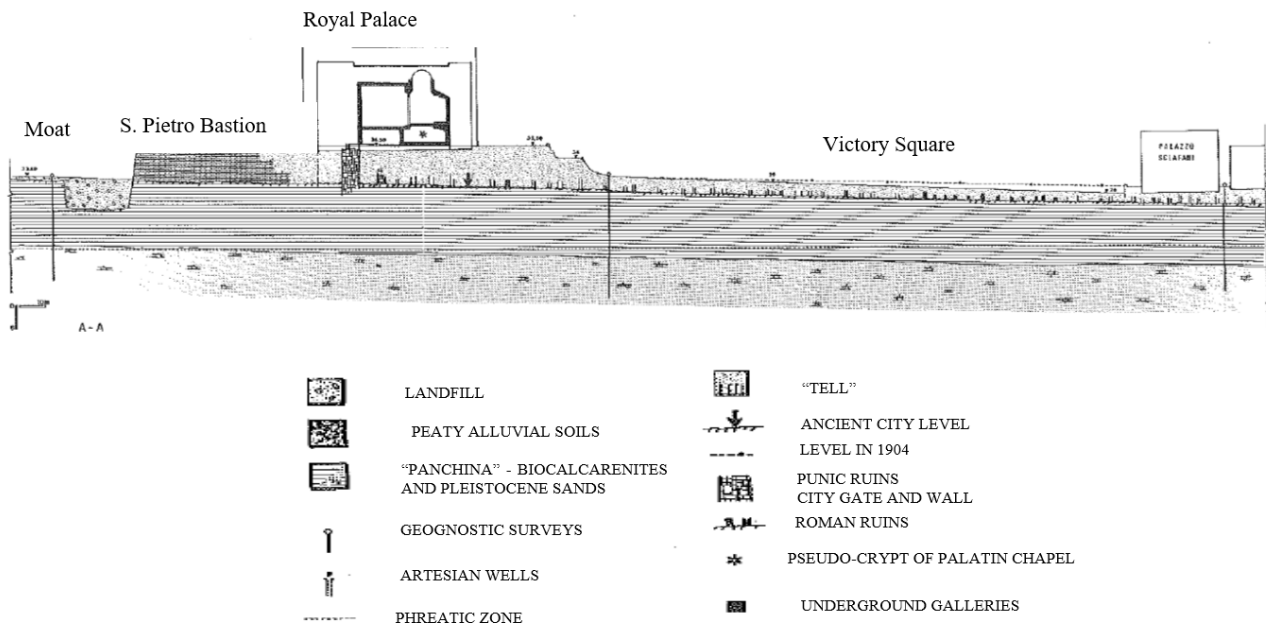
Some studies from the literature [22] report that the area of the Norman Palace falls within the ancient urban core, called Panormus. The subsoil is constituted by a sandy-calcareous complex, divided into two lithofacies: (1) lithofacies of solidified and soft biocalcareous; (2) lithofacies of sands. This geological formation is covered by an ancient landfill (densified). Figure 25 shows a typical geological section [26].

Figure 25. Typical geological cross-section [26].

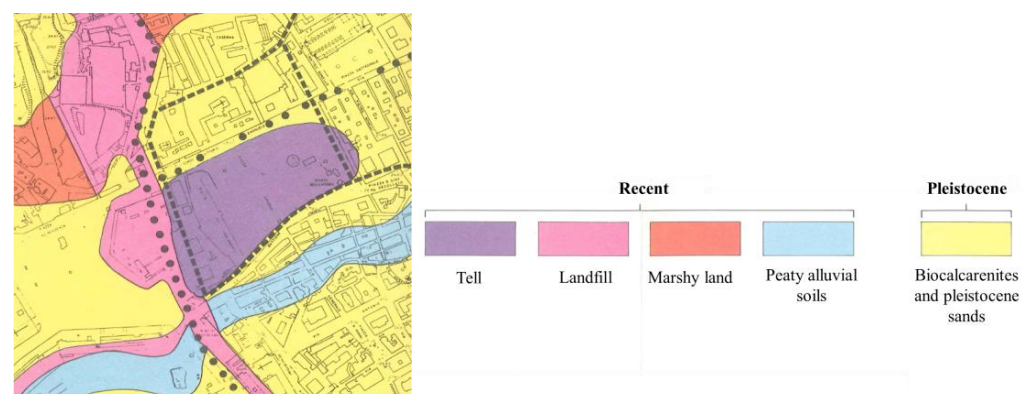
The geological map of the site [26], shown in Figure 26, provides a detailed outline of the geological conditions of the area of the Palace, indicating a lithological sequence of landfills constituted by clastic sediment with various densification conditions (lime sands, gravels, and calcarenites) with superimpositions of remnants of ancient masonry structures—the so-called “Tell”—with a width between 1.5 and 9.0 m, placed on biocalcarenes with a sandy nodular texture with various solidification conditions, constituting the sandy–calcarenite complex.

Figure 26. Geological map of the site [26].
