II Fabre Conference – Existing bridges, viaducts and tunnels: research, innovation and applications (FABRE24)

Preliminary Insights from Surveys of Bridges at High Scouring Risk in West Piedmont

Mauro Aimar^a, Marco Civera^{a*}, Sebastiano Foti^a, and Bernardino Chiaia^a

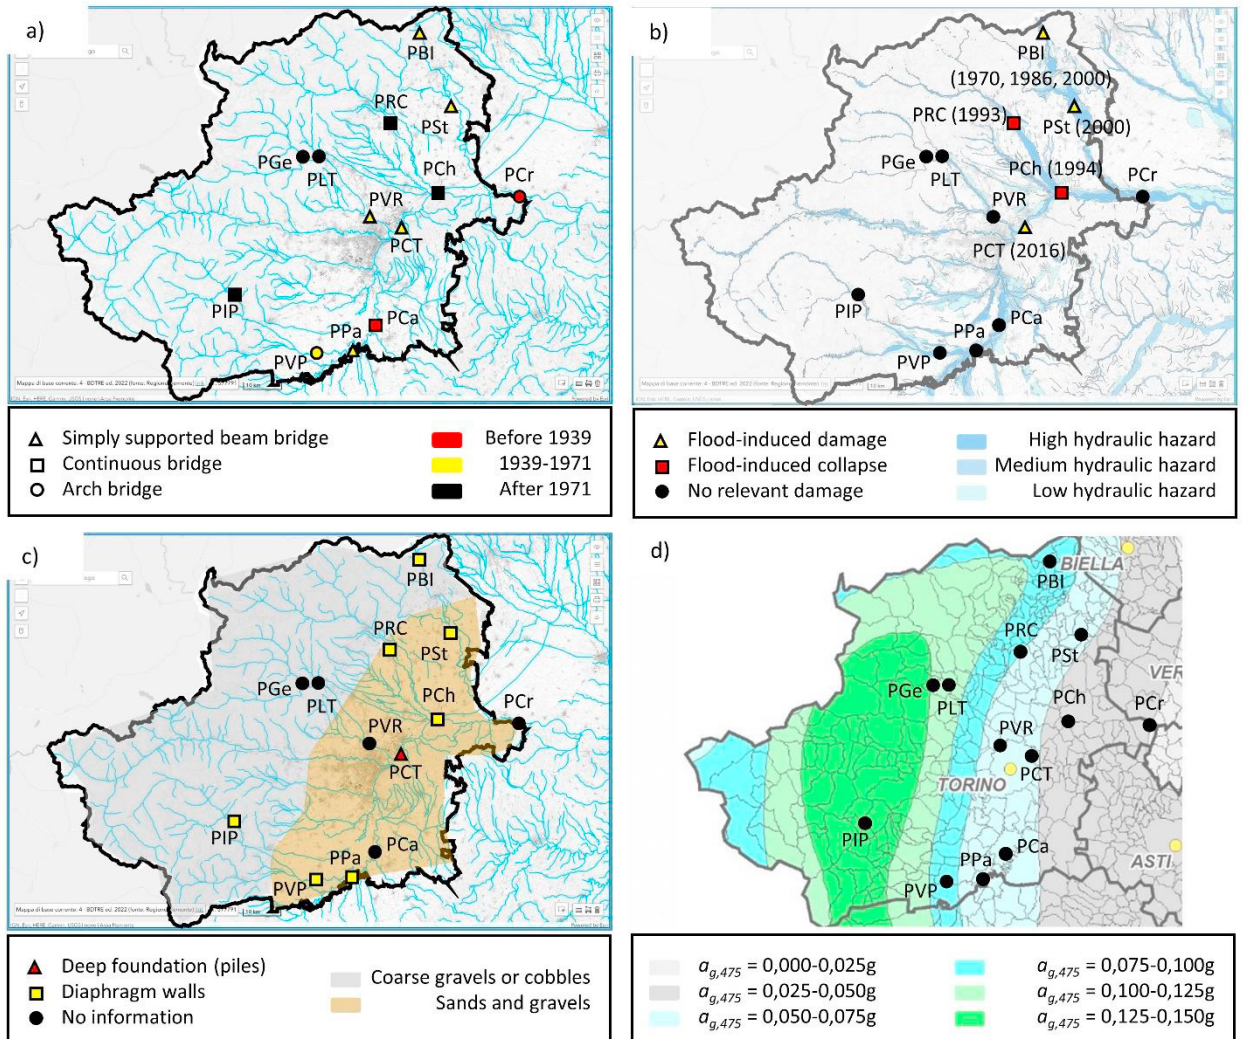
Figure 2. a) Location of the investigated bridges, labelled according to the structural scheme and the period of construction; b) Location of the investigated bridges in the hydraulic hazard map, classified according to the damage entity observed in past flood events and the event year; c) Location of the investigated bridges in the simplified map of the surface geology, labelled according to foundation type; d) Location of the investigated bridges in the seismic hazard map.

The selected case studies have been investigated in a past survey performed by the Metropolitan City of Turin in 2003, with the exception of the Inverso Pinasca and Lanzo Torinese bridges (PIP and PLT, respectively, in Fig. 2). Therefore, the inspection campaign tried to assess the evolution of bridge health from 2003 and 2003, both in terms of the superstructure and the foundation conditions. The evaluation of the structural components focused on the identification of degradation patterns (e.g., exposed rebars in reinforced concrete bridges and cracking in masonry structures) or peculiarities in the static scheme (e.g., variations of the span length or of the supporting conditions). Instead, the geotechnical survey mainly addressed the evidence of foundation scour (both general and local scour) and the presence of mitigation infrastructures in the riverbed, to mitigate the hydraulic risk. For simplicity, this study did not include the slope stability assessment.

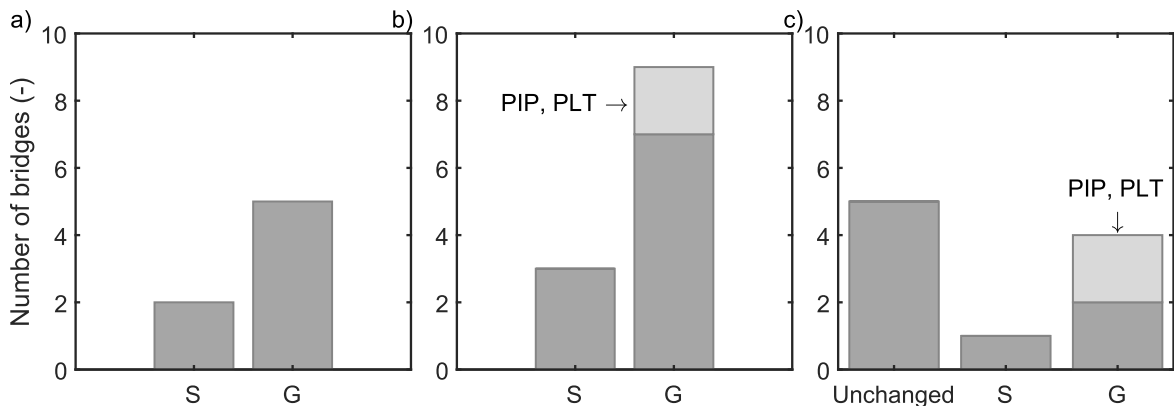
Fig. 3 summarizes the main results, showing the number of bridges characterized by peculiar structural and geotechnical conditions (labels “S” and “G”, respectively), that may require attention and further investigation. Specifically, Fig. 3a refers to the 2003 survey, whereas Fig. 3b results from the current inspection study (i.e., year 2023). To facilitate the comparison, Fig. 3c shows the number of considered bridges with unchanged conditions versus the number of those with peculiar structural and geotechnical conditions not originally identifies in the 2003 survey. The graphs also include the Lanzo Torinese and the Inverso Pinasca bridges (PLT and PIP, respectively), denoted through a different colour as not included in the 2003 study. In general, geotechnical-related issues are more frequently observed than structural problems. Indeed, notwithstanding the different age, the superstructure conditions are generally good or even excellent. Instead, foundations are often affected by flood-induced erosion. On the other hand, no relevant changes in the conditions were identified for most of the bridges from 2003 and 2023, despite the intense floods occurred in this time period. An increase in the foundation erosion was observed in the Crescentino and the Rivarolo Canavese bridges (PCR and PRC, respectively, in Fig. 2). Furthermore, the Castiglione Torinese bridge (PCT in Fig. 2) underwent a significant change in the structural conditions, which will be discussed in detail below.

Figure 3. a-b) Bar plots showing statistics for bridges with structural issues (label “S”) and geotechnical issues (label “G”) for years 2003 (a) and 2023 (b). c) bar plot showing the number of bridges with unchanged conditions and variations in structural and geotechnical conditions. Data related to the Lanzo Torinese and the Inverso Pinasca bridges (PLT and PIP) are colored differently because they were not included in the 2003 survey.
