Path of Knowledge for the Assessment of Structural Safety of the Pisan Tower of the Royal Palace of Palermo in Italy

# Path of Knowledge for the Assessment of Structural Safety of the Pisan Tower of the Royal Palace of Palermo in Italy

**Abstract:** This paper presents the path of knowledge developed for assessing the structural safety of the Norman-age Pisan Tower, which is mostly incorporated into the Royal Palace in Palermo, Italy. Historical, geomatic, and mechanical investigations were conducted and the most relevant results are herein collected and presented. The research path was addressed to specific tasks: identification of the building, geometric surveys, recognition of the sequence of phases of building transformation, detection of the components of the load-bearing structure, structural diagnostic surveys, and investigation of the subsoil and foundations. The explicit vulnerabilities found were mostly confined to the Piazzali library floor, while implicit vulnerabilities were identified in the presence of false walls and in high loads and fillings on the vaults of the last levels. The results of the analyses allowed the individuation of the confidence factors to use i

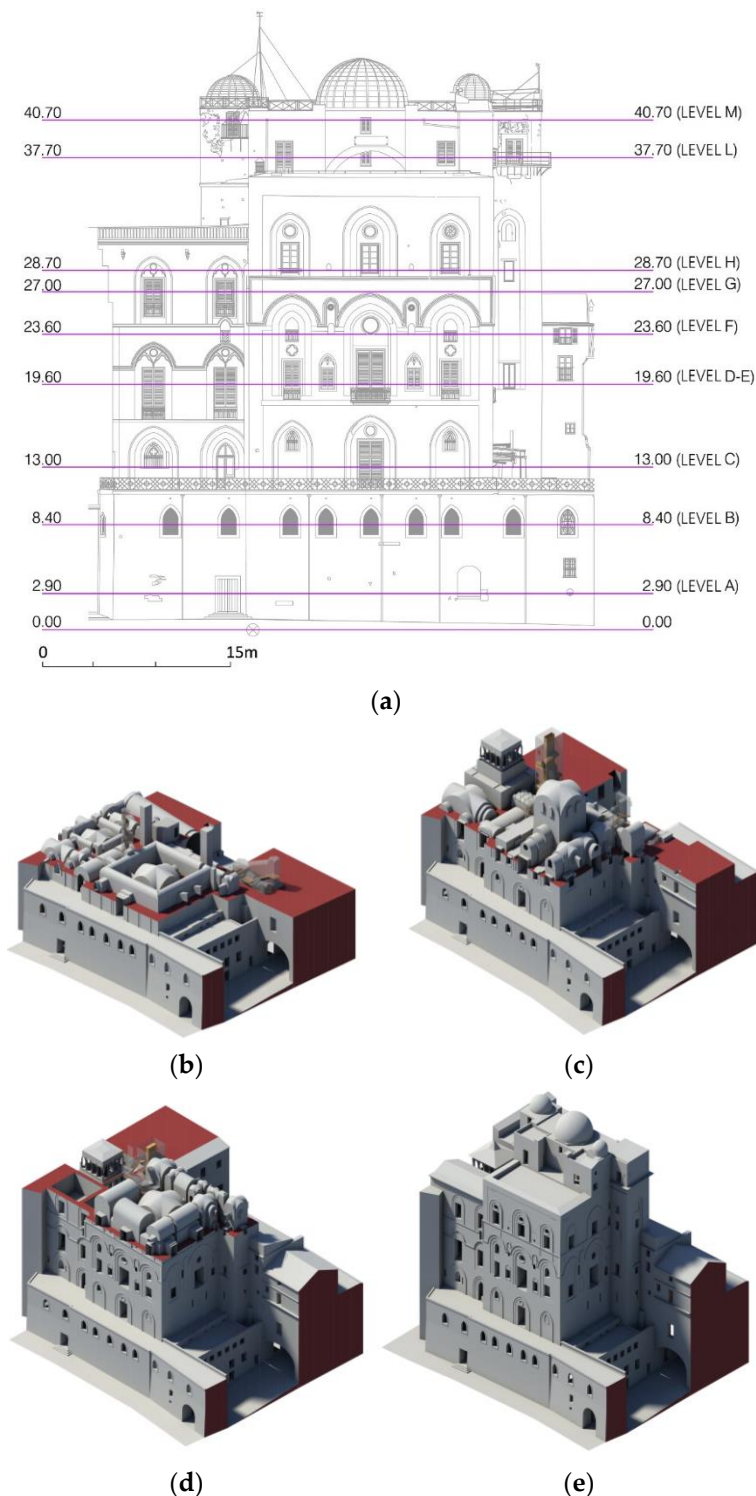
In addition to the available data and those obtained from direct observation of the current state and in-depth historical research, data related to the geometry and typology of the most damaged structural elements were acquired through endoscopic surveys; they were all located in the most damaged areas of the Tower.

**Figure 12.** Identification of the structural system (from the technical drawings of the Officina per le Arti Opera company): (a) denomination of the various levels of the Pisan Tower; (b) axonometric sectional view at level C; (c) axonometric sectional view at levels D-E; (d) axonometric sectional view at level H; (e) axonometric general view of the Tower.

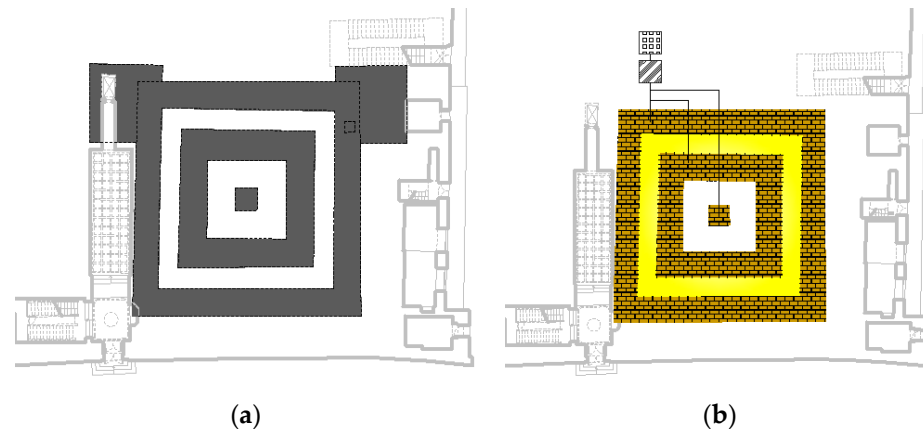
The surveys performed and the information collected showed that the vertical load-bearing structure of the Tower consists, on level A, of two concentric quadrilaterals in the planimetry, with walls wider than 2 m, and two turrets at the vertices of the west side of the Tower, as represented in Figure 15a. These walls have been realized with a wall in large (70–100 cm) calcarenite ashlar, dry-placed and/or with low-width mortar joints. The wall was considered to show good workmanship and the ashlar have excellent mechanical properties, as shown by the high value of the compression strength of the extracted core samples. The material between the two squares of the Tower can be associated with an infill, mainly constituted by crushed ashlar, masonry with scarce mechanical properties, and incoherent materials (Figure 15b).

**Figure 15.** Identification of the structure of the Tower on level A (height 2.90 m); (a) hypothesized vertical load-bearing structure; (b) hypothesized materials.

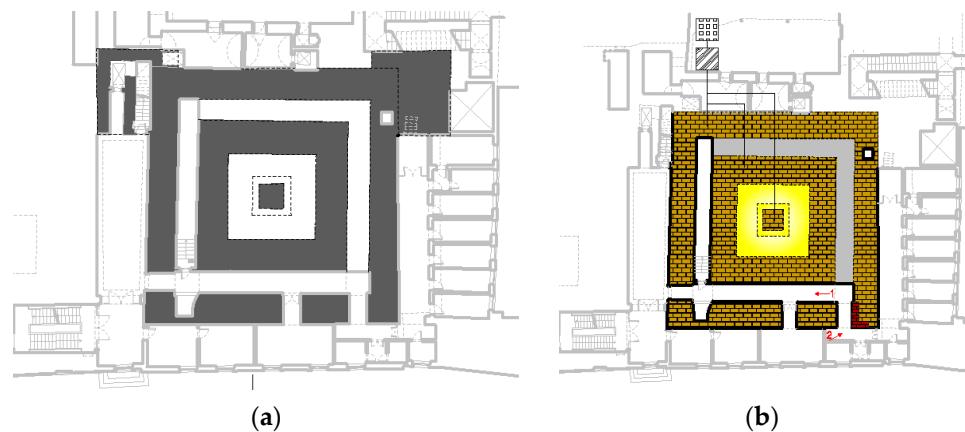
The surveys performed and the information collected at level B repeated and confirmed the same structural layout as the lower level, consisting of two homothetic quadrilaterals with wall widths above 2 m, in calcarenite ashlar, dry-placed and/or with mortar (Figure 16a). Today, as in the Norman layout, the south turret is mainly used for vertical connections. The structural layout of the Tower has been presumably subjected to modifications during the complex and intricate evolution of the Norman Palace. At this level, the wall, which is partly visible, consists of calcarenite ashlar and variable-width lime mortar joints. The performed tests showed that the ashlar have good mechanical properties; however, these were lower than the values found at the lower level. The infill of the core between the two masonry squares is heterogeneous and incoherent, while in the internal core it is constituted by crushed ashlar with variable size and resistance (Figure 16b).

**Figure 16.** Identification of the structure of the Tower on level B (height 8.40 m): (a) hypothesized vertical load-bearing structure; (b) hypothesized materials.

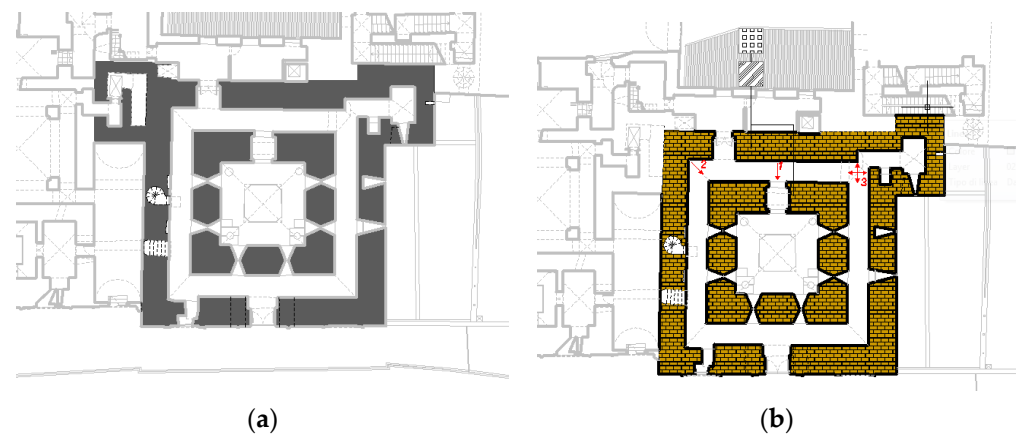
Level C has a completely exposed structural layout, consisting of two concentric quadrilaterals, divided by an ambulatory with a barrel vault covering and two side turrets (Figure 17a). The masonry walls are in large calcarenite ashlar and lime mortar. The mechanical parameters of the ashlars were only available for the exterior of the east wall, and the resistance values were aligned with those of the lower level. The values for the operating tension of the masonry wall of the external square were very high; this is probably incompatible with the resistance of the masonry (Figure 17b).

**Figure 17.** Identification of the structure of the Tower on level C (height 13.00 m): (a) hypothesized vertical load-bearing structure; (b) hypothesized materials.

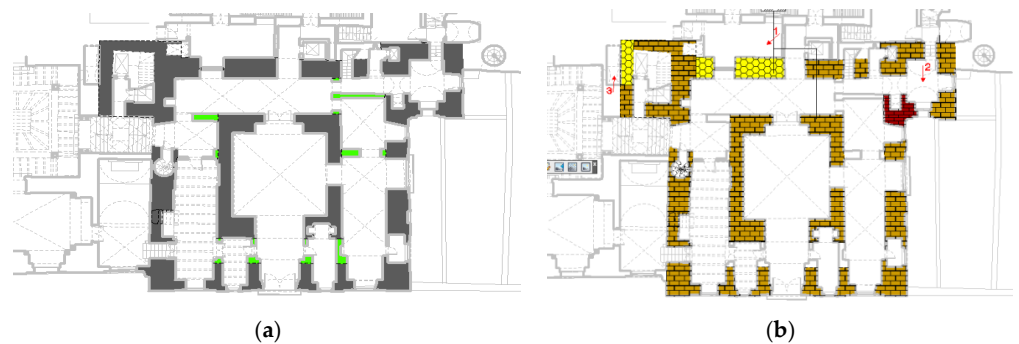
On levels D-E, the structural layout of the concentric quadrilaterals can be detected even if the walls are significantly set back from the lower level (Figure 18a). Moreover, the walls of the external square are intermitted by wide and numerous openings (doors, windows, rooms, and staircases). The President's Room has two different heights, while the other rooms are mainly double-height or have timber roofs. Superintendent Valenti, during the 1929 restoration intervention, performed several modifications to the structural layout. He demolished many mezzanine rooms, which had presumably been realized in the period of the Spanish Viceroyalty, and relocated some masonry walls to restore the Norman layout. The numerous performed interventions and the finishing with exposed faux masonry plaster were an obstacle to the precise definition of the wall typologies. Figure 18b shows a possible hypothesis, reconstructed solely on the basis of the historical documentation found.

**Figure 18.** Identification of the structure of the Tower on levels D-E (height 19.60 m): (a) hypothesized vertical load-bearing structure; (b) hypothesized materials.

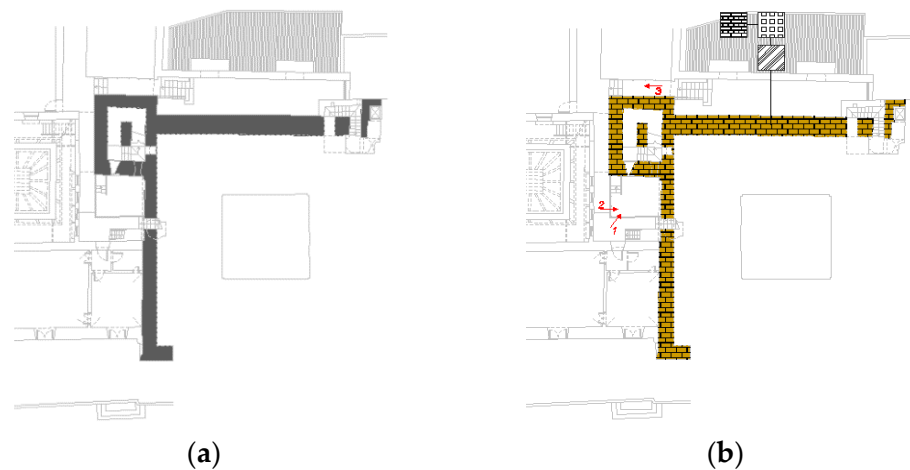
**Figure 20.** Identification of the structure of the Tower on level G (height 27.00 m): (a) hypothesized vertical load-bearing structure; (b) hypothesized materials.

Level G includes the rooms of the Astronomical Observatory adjacent to the south and west sides of the Tower. As has been mentioned, these were involved in the restoration intervention in the 1990s by Boscarino and Cottone. The intervention exposed the load-bearing structure on this level, allowing us to observe that it can be substantially associated with the original Norman construction (Figure 20a) and that it consists of large calcarenite ashlars and lime mortar (Figure 20b).

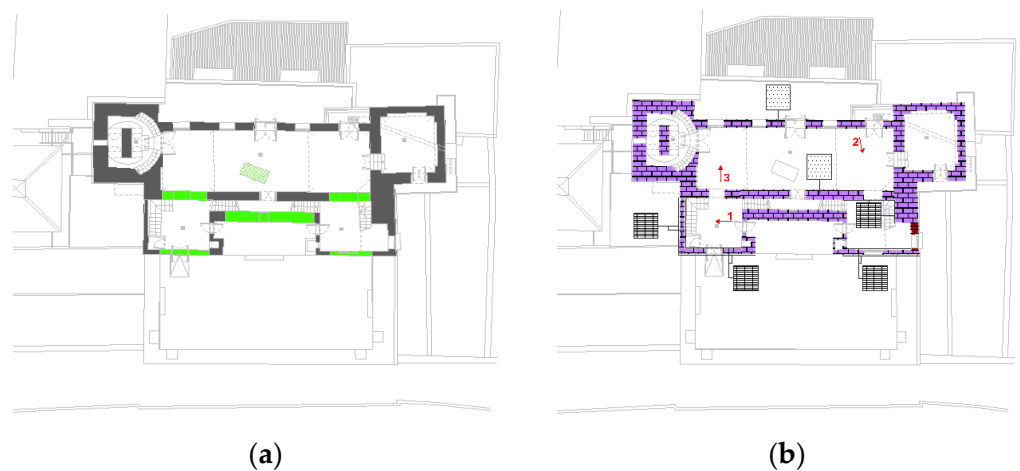
**Figure 22.** Identification of the structure of the Tower on level L (height 37.70 m): (a) hypothesized vertical load-bearing structure; (b) hypothesized materials.

it was subjected to several integrations, modifications, adaptations, and an extended and complete restoration intervention by Boscarino and Cottone, who restored the layout of the original Observatory. At this level, the structural layout no longer has a rigid system with two concentric quadrilaterals; instead, a single hall connects the south and the north turrets (Figure 22a). Boscarino and Cottone's intervention included the demolition of the partition walls in the main room, and the substitution and/or the reconstruction of all the floors of this and the upper level, in addition to the construction of a new dome based on an octagonal steel drum. Since the original construction, the walls had been almost entirely in masonry, with calcarenite ashlar and mortar joints (Figure 22b). They were then subjected to repeated reinforcement interventions, using the techniques common at the times of the interventions, including local rebuilding with aerated bricks, reinforced plaster with an electro-welded mesh on the two sides, re-pointing of mortar joints, substitution and/or realization of new steel lintels, and construction of new steel tie-rods. These interventions improved the masonry resistance, but they did not cure the vulnerabilities of the vertical load-bearing structural components at this level, which are mainly related to the presence of some transfer walls. Among these, the wall on the east side—which provides a basement for the drum of the central dome—must certainly be investigated. At the walking level of the museum (36.18 m), Cottone and Boscarino's intervention removed the infill and realized new floors in I-beams and hollow flooring blocks detached from the vaults, which then lost their load-bearing structural role. Instead, the vault of the central room was reinforced so as to support the equatorial telescope. At the upper level, that is, the roof covering of the museum of the Observatory, the pre-existing timber roofs were substituted with new slabs, steel I-beams, and hollow flooring blocks.

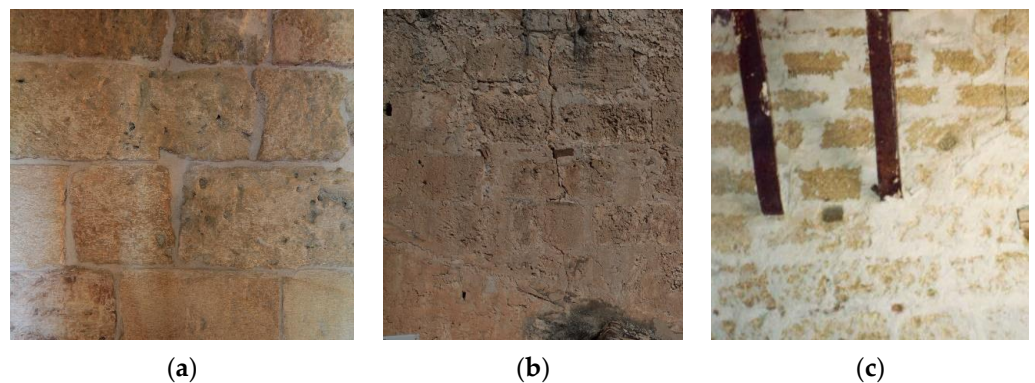
**Figure 23.** Masonry typologies: (a) Norman era; (b) Spanish era; (c) 19th century.

- Masonry in soft stone ashlar (tuff, calcarenite, etc.) of the Norman period (Figure 23a);
- Masonry in soft stone ashlar (tuff, calcarenite, etc.) of the period of the Spanish Viceroyalty (Figure 23b);
- Masonry in soft stone ashlar (tuff, calcarenite, etc.)—19th century—Astronomical Observatory (Figure 23c).

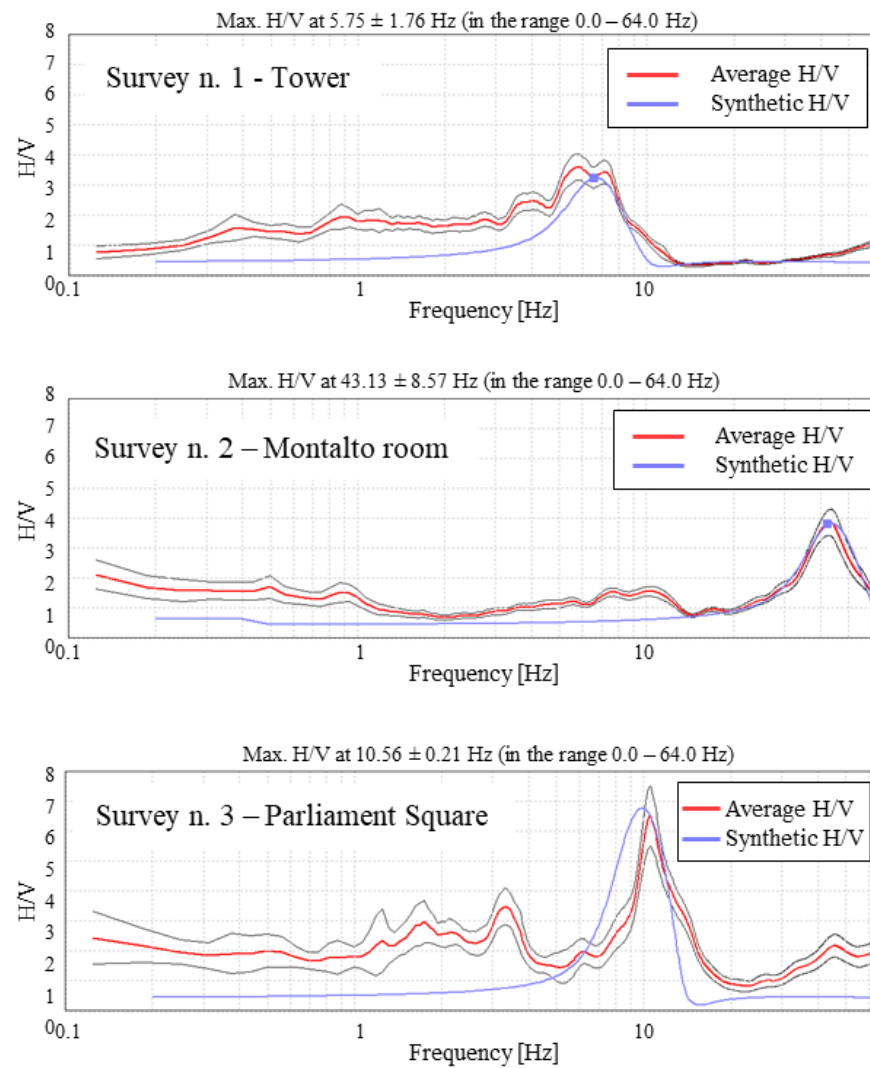
**Figure 28.** Results of single-station passive seismic tests.

In accordance with chapter 3 of *Guidelines*, which defines seismic action with reference to Section 3.2.2 of NTC2018, and hence according to the value of  $V_{S,30}$  obtained in the three tests, the soil class to be assumed for the definition of the response spectra was Class C—coarse-grained, medium-dense soil deposits or fine-grained soils with a medium consistency, thicker than 30 m, characterized by a gradual improvement of mechanical properties along with the depth, and by values for  $V_{S,30}$  between 180 m/s and 360 m/s (that is,  $15 < N_{SPT,30} < 50$  in coarse-grained soils and  $70 < c_{u,30} < 250 \text{ kPa}$  in fine-grained soils). Figure 28 shows the details of the interpretations of the experimental data obtained.
