Path of Knowledge for the Assessment of Structural Safety of the Pisan Tower of the Royal Palace of Palermo in Italy

# Path of Knowledge for the Assessment of Structural Safety of the Pisan Tower of the Royal Palace of Palermo in Italy

**Abstract:** This paper presents the path of knowledge developed for assessing the structural safety of the Norman-age Pisan Tower, which is mostly incorporated into the Royal Palace in Palermo, Italy. Historical, geomatic, and mechanical investigations were conducted and the most relevant results are herein collected and presented. The research path was addressed to specific tasks: identification of the building, geometric surveys, recognition of the sequence of phases of building transformation, detection of the components of the load-bearing structure, structural diagnostic surveys, and investigation of the subsoil and foundations. The explicit vulnerabilities found were mostly confined to the Piazza library floor, while implicit vulnerabilities were identified in the presence of false walls and in high loads and fillings on the vaults of the last levels. The results of the analyses allowed the individuation of the confidence factors to use in

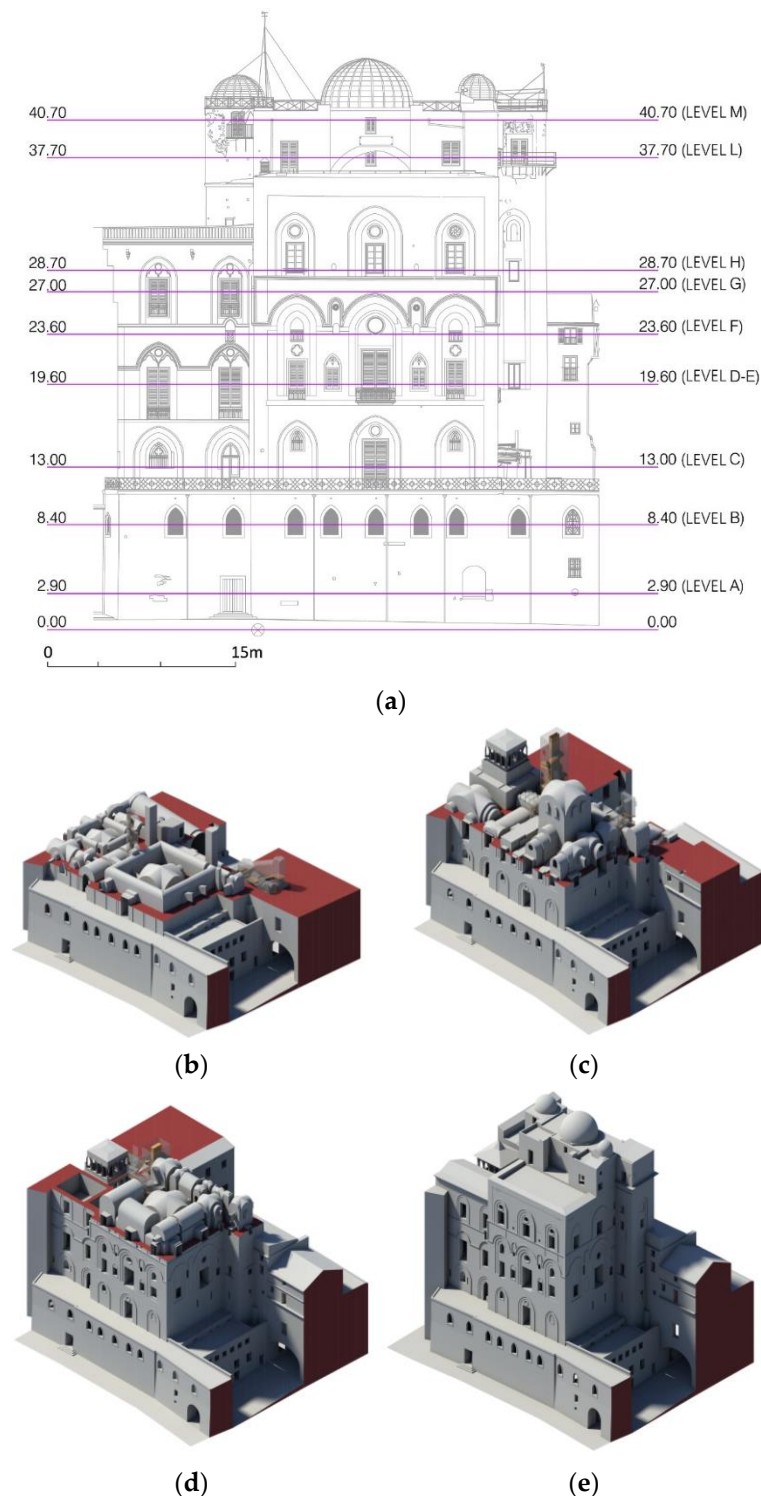
The building was surveyed by levels, whose heights are indicated in Figure 12a. Figure 12b–e also show the main axonometric sectional views of the Tower obtained from the 3D geometric model in order to clarify the structural complexity of the system. For each level, the reported surveys were performed on the vertical structural component intersected by the section plane, and the horizontal structures that serve as roof coverings for the respective levels. The floors of the Tower, which correspond to the section representations, are denoted with letters from A to M (Figure 12), while all the rooms are indicated with progressive numbers following the letter.

**Figure 12.** Identification of the structural system (from the technical drawings of the Officina per le Arti Opera company): (a) denomination of the various levels of the Pisan Tower; (b) axonometric sectional view at level C; (c) axonometric sectional view at levels D-E; (d) axonometric sectional view at level H; (e) axonometric general view of the Tower.

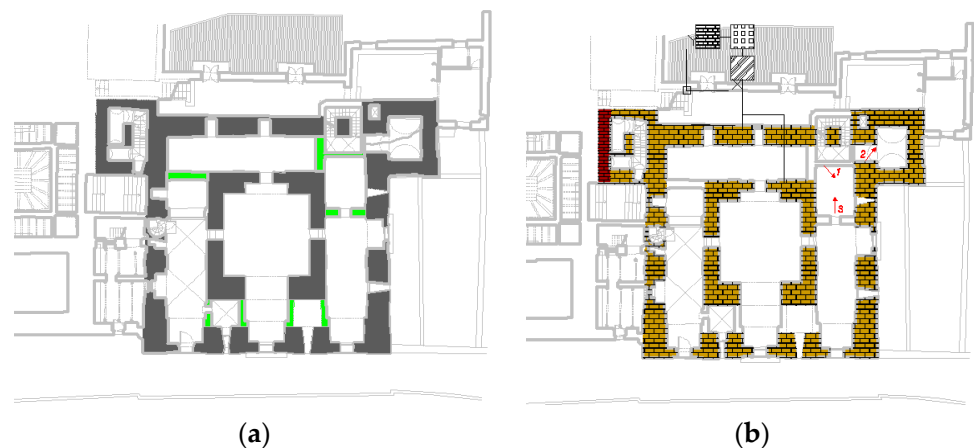
At level F, the two mezzanine rooms used as offices were examined. The structural layout and related considerations (Figure 19a) were the same as for the lower level (19.60 m). During the 1929 restoration intervention, Superintendent Valenti performed several modifications to the structural layout. He demolished many mezzanine floors on this level and only left the ones that are currently being examined. Several extensive reinforcement interventions were performed on the vertical load-bearing structure through local rebuilding and, sometimes, demolition and reconstruction. The masonry walls used in these interventions were both in aerated bricks and calcarenite blocks (Figure 19b); however, the large number of interventions and the use of an exposed faux masonry plaster finishing complicate the precise definition of the wall typologies.

**Figure 19.** Identification of the structure of the Tower on level F (height 23.60 m): (a) hypothesized vertical load-bearing structure; (b) hypothesized materials.

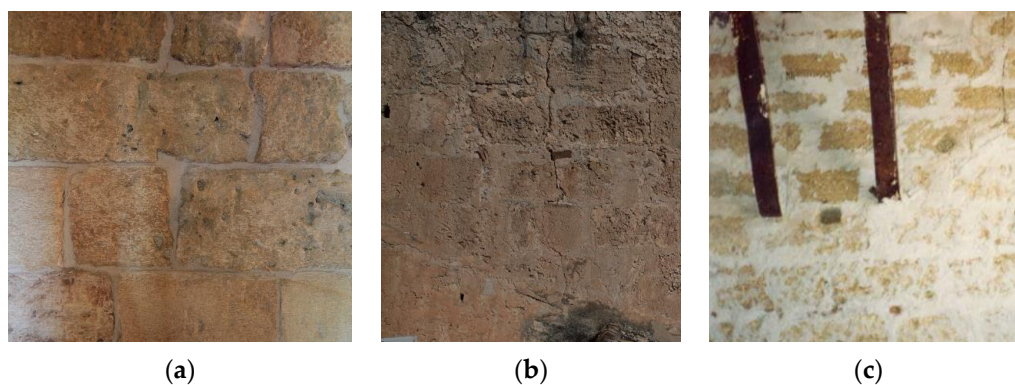
- Masonry in soft stone ashlar (tuff, calcarenite, etc.) of the Norman period (Figure 23a);
- Masonry in soft stone ashlar (tuff, calcarenite, etc.) of the period of the Spanish Viceroyalty (Figure 23b);
- Masonry in soft stone ashlar (tuff, calcarenite, etc.)—19th century—Astronomical Observatory (Figure 23c).

**Figure 23.** Masonry typologies: (a) Norman era; (b) Spanish era; (c) 19th century.
