II Fabre Conference – Existing bridges, viaducts and tunnels: research, innovation and applications (FABRE24)

Preliminary Insights from Surveys of Bridges at High Scouring Risk in West Piedmont

Mauro Aimar^a, Marco Civera^{a*}, Sebastiano Foti^a, and Bernardino Chiaia^a

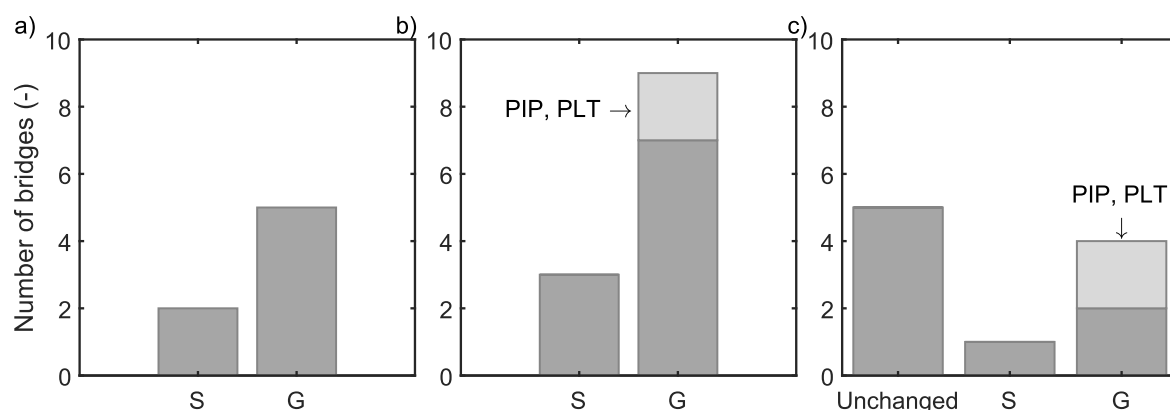
Fig. 3 summarizes the main results, showing the number of bridges characterized by peculiar structural and geotechnical conditions (labels “S” and “G”, respectively), that may require attention and further investigation. Specifically, Fig. 3a refers to the 2003 survey, whereas Fig. 3b results from the current inspection study (i.e., year 2023). To facilitate the comparison, Fig. 3c shows the number of considered bridges with unchanged conditions versus the number of those with peculiar structural and geotechnical conditions not originally identifies in the 2003 survey. The graphs also include the Lanzo Torinese and the Inverso Pinasca bridges (PLT and PIP, respectively), denoted through a different colour as not included in the 2003 study. In general, geotechnical-related issues are more frequently observed than structural problems. Indeed, notwithstanding the different age, the superstructure conditions are generally good or even excellent. Instead, foundations are often affected by flood-induced erosion. On the other hand, no relevant changes in the conditions were identified for most of the bridges from 2003 and 2023, despite the intense floods occurred in this time period. An increase in the foundation erosion was observed in the Crescentino and the Rivarolo Canavese bridges (PCR and PRC, respectively, in Fig. 2). Furthermore, the Castiglione Torinese bridge (PCT in Fig. 2) underwent a significant change in the structural conditions, which will be discussed in detail below.

Figure 3. a-b) Bar plots showing statistics for bridges with structural issues (label “S”) and geotechnical issues (label “G”) for years 2003 (a) and 2023 (b). c) bar plot showing the number of bridges with unchanged conditions and variations in structural and geotechnical conditions. Data related to the Lanzo Torinese and the Inverso Pinasca bridges (PLT and PIP) are colored differently because they were not included in the 2003 survey.
