## Considerations over the Italian road bridge infrastructure safety after the Polcevera viaduct collapse: past errors and future perspectives

Fabio Bazzucchi, Luciana Restuccia, Giuseppe Andrea Ferro

**ABSTRACT.** In the last four years, Italy experienced the collapse of five road bridge: Petrulla viaduct (2014), Annone (2016) and Ancona (2017) overpasses, Fossano viaduct (2017) and Polcevera (2018) bridge.

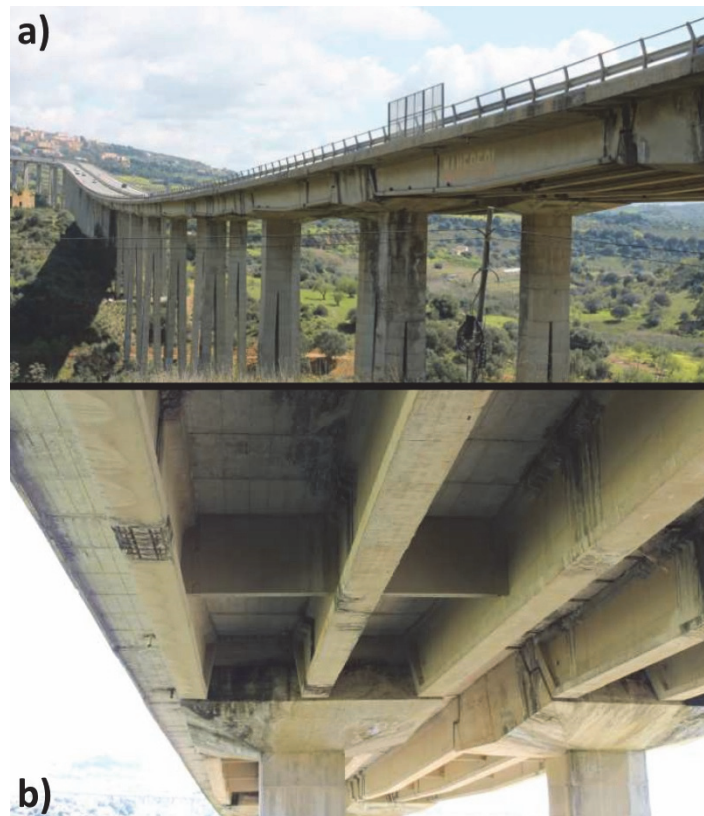
Figure 13: Overall view of the Akragas viaduct (a); deck detail (b) [23].

Throughout the same years, the Akragas Viaduct (S.S. 115-AG, Agrigento, 1970) was erected in Sicily. The design, by Morandi, considered a total length of 1400 m skewed viaduct with 31 spans, each 44 m long (Fig. 13(a)). The deck, 10 m wide, was realized by a grillage of 3 unbonded prestressed I-beams, 5 transverse beams, and a precasted pavement (Fig. 13(b)) [23]. Support for each beam consisted in a couple of reinforced concrete A columns, with a maximum height of 60 m. To date, these latter elements represent the key vulnerability of the structure. Each column was erected through a concrete concave precast box that works both as scaffolding (in the pouring phase) and as shear resisting element (Fig. 14(a)). It is reasonable to think that visible damage is due to the concave shape of the external box. When shear forces required confinement, the bars pushed against the box bulged the internal part as visible in Fig. 14(b). Together with the static problems, the retrofitting intervention has the aim of improving the seismic behavior by providing sufficient shear strength and ductility: a new element and the recovering of a confined state for the concrete of the core.

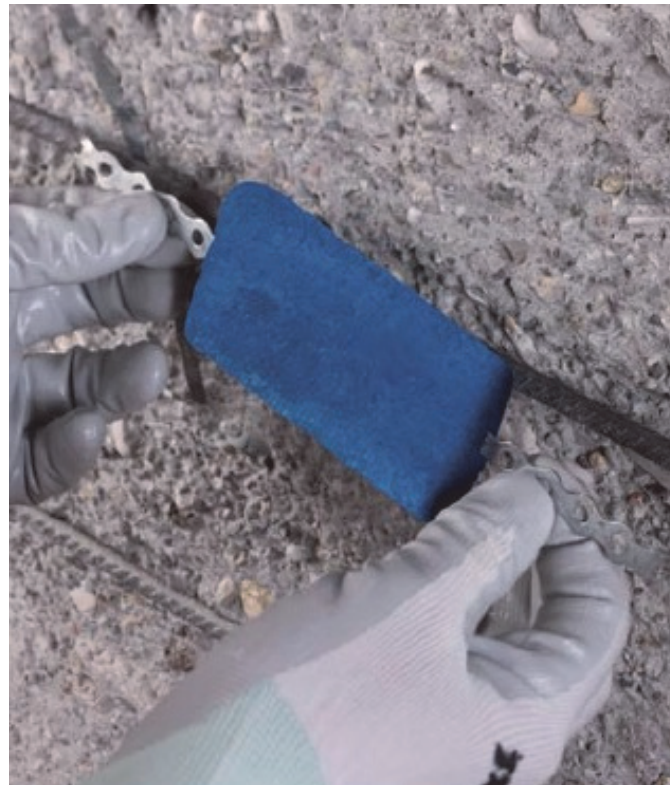
Figure 16: galvanic protection: sacrificial anode [Copyright: Mapei].

Considering now the case of La Reale Viaduct (Fig. 7(a)). Durability problems are overcome by the peculiar shape of the deck and its modular assemblage. To avoid a fragile collapse, the structure must improve its robustness. Since the analyses of the safety of the infrastructure are still under exploitation, different levels of intervention are suggested towards the observed damage pattern. For the spans that will evidence lack of cable protective grout, epoxy injection would be necessary to stop di advancement of corrosion. This operation could result particularly difficult to do because of the inaccessible boxed section. A frequent problem in bridge concrete walls is concrete spalling and exposure of reinforcement. This situation is particularly dangerous when the exposed reinforcement realizes the primary load carrying system, i.e. dapped-end corbels (Fig. 5(a), Fig. 5(b)). Under this circumstances, health of the steel is essential to exclude a sudden collapse due to shear failures. Considering the numbers of the existing artifacts, sometimes just blocking the advance of corrosion represents a good strategy to keep reasonable safety factors while retrofitting is pending. This strategy cab be implemented by the use of sacrificial anodes (galvanic protection) directly connected to exposed reinforcements (Fig. 16) [24]. These anodes, usually realized in zinc-based compounds, guarantee local protection to the

steel by the higher electronegative power of the sacrificial anode. The monitoring of these devices can be executed by simple electronic tester that measures electricity rates in the anodes. When the exposed reinforcement is large and interconnected (i.e. a wire mesh), an alternative solution is the cathode protection. In this case, an electric current is supplied to the steel by an external generator, shielding the reinforcement from corrosion.

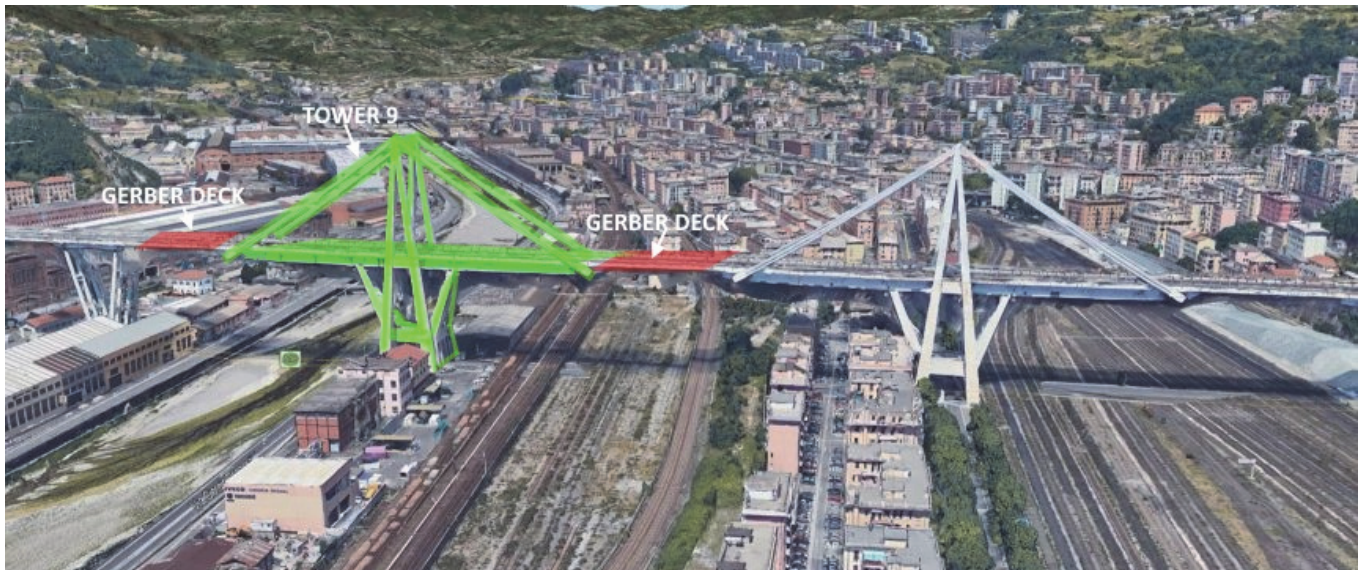
Figure 17: Involved structure in the collapse: tower and Gerber decks.

One of the shocking aspects of the Polcevera Viaduct collapse was its catastrophic nature. Even if the causes are currently under investigation, it is clear that the failure of one component has been followed by the entire structure, composed by the tower (green, Fig. 17) and two simply supported Gerber decks (red, Fig. 17). As anticipated, the equilibrium of the system rests upon the balance between the symmetry axes of the tower (Fig. 18a). A lack of balance in one of the two directions of the equatorial planes induces a flexural moment in the deck plane that can lose in-plane stability and could break due to unbalanced compressive forces (blue, Fig. 18(a)). Under these circumstances, the in-plane twisting could cause the slip of the Gerber decks, that without a vertical support become free to fall. At the same time, a disequilibrium in the plane of the bridge direction induces torsion and bending moment to the double framed A tower (red, Fig. 18a). This structure could not have the ductility capacity to resist at such asymmetric stress, because of the limited rotational capacity at the base (wider) and the lack of redundancy for force redistribution. Moreover, unbalanced forces in the plane of the stays causes deck uplifting on one side and subside to the other. This mechanism, could be again

- the low number of stays elements that causes zero redundancy in deck support;
- the low rotation capacity of the A framed lateral tower and its limited redistribution;
- the statically determined scheme for the entire viaduct, which causes higher displacements (and cracking as a consequence) and domino effect collapse;
- the low ductility at member scale;
- the intrinsic sudden loss of strength of prestressing technology.

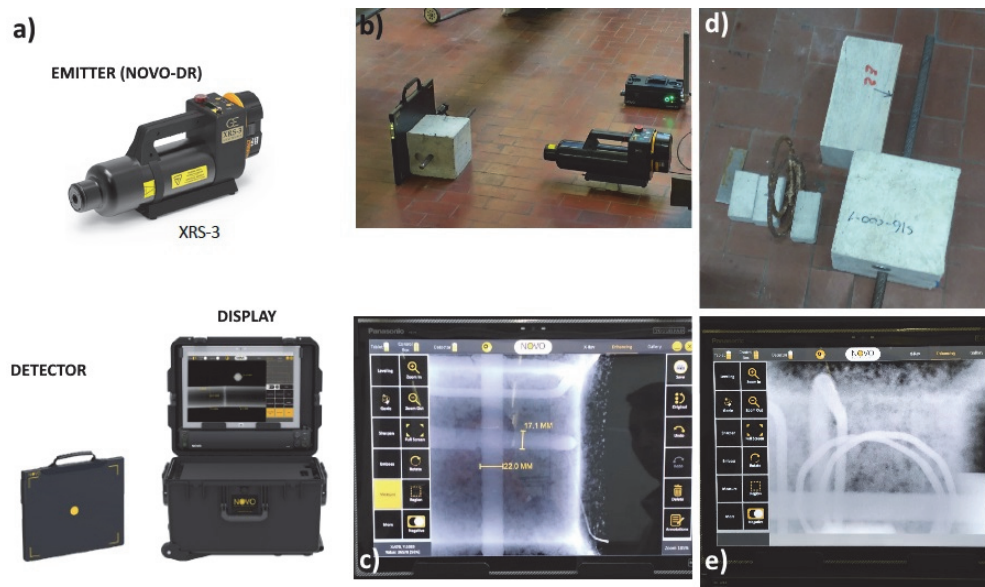
Figure 20: X-Ray device (a) [Copyright: <https://www.novo-dr.com/>]; scanned image (b) of specimen (c); scanned image (d) of specimen (e).

The system is usually composed by an emitter, a real time display and a shield detached detector (Fig. 20(a)). This technology enables to generate immediate and high-quality X-ray images while keeping radiation levels to the minimum. Fig. 20(b) shows the results of an X-Ray test conducted in Politecnico di Torino laboratory Fig. 20(c). The system exhibited a significant power of penetration, completely scanning the 150x150x150 mm concrete cube. Furthermore, the system was able to detect additional reinforcement positioned beyond the cube, then has a great potential also for the inaccessible portion of a structure (Fig. 20(d), Fig. 20(e)). The all system weight less than 200 kg (the heavier component is the detector, 150 kg in its largest dimension) and can be easily carried by a robotic-arm installed on a vehicle (Fig. 21). Inspection of I-beams could be carried by a scraped scanning. Of course, this method represents a screening procedure but could be extremely reliable and effective for a preliminary census or fast track assessment.
