Considerations over the Italian road bridge infrastructure safety after the Polcevera viaduct collapse:
past errors and future perspectives

Considerations over the Italian road bridge infrastructure safety after the Polcevera viaduct collapse: past errors and future perspectives

Fabio Bazzucchi, Luciana Restuccia, Giuseppe Andrea Ferro

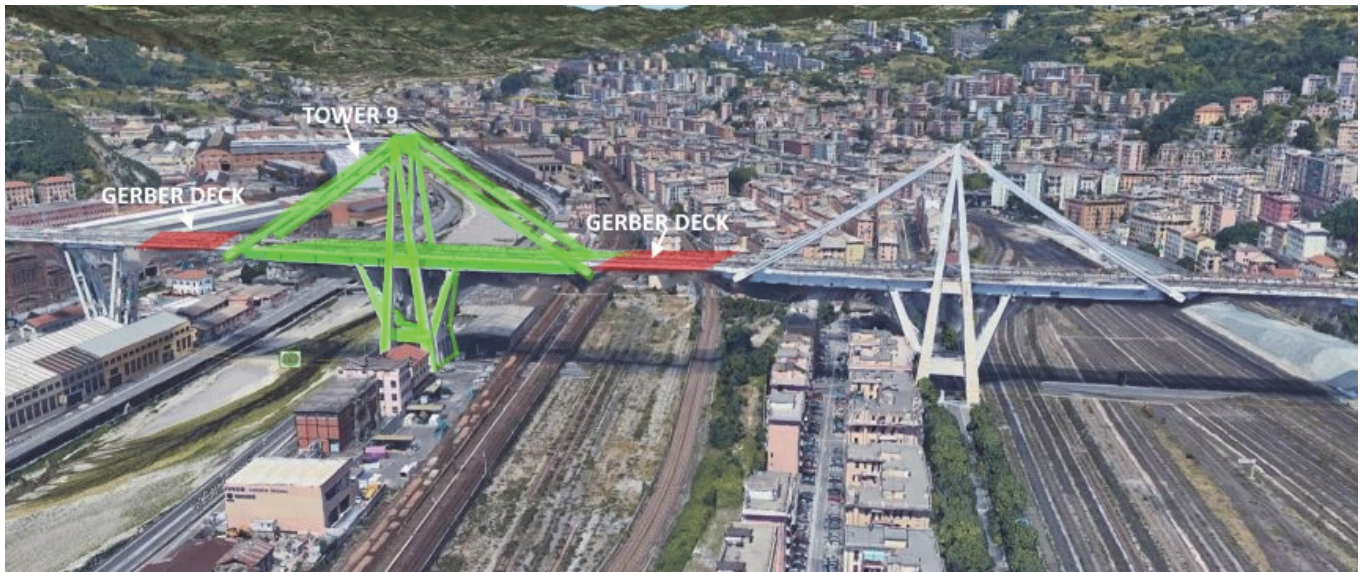
Figure 17: Involved structure in the collapse: tower and Gerber decks.

One of the shocking aspects of the Polcevera Viaduct collapse was its catastrophic nature. Even if the causes are currently under investigation, it is clear that the failure of one component has been followed by the entire structure, composed by the tower (green, Fig. 17) and two simply supported Gerber decks (red, Fig. 17). As anticipated, the equilibrium of the system rests upon the balance between the symmetry axes of the tower (Fig. 18a). A lack of balance in one of the two directions of the equatorial planes induces a flexural moment in the deck plane that can lose in-plane stability and could break due to unbalanced compressive forces (blue, Fig. 18(a)). Under these circumstances, the in-plane twisting could cause the slip of the Gerber decks, that without a vertical support become free to fall. At the same time, a disequilibrium in the plane of the bridge direction induces torsion and bending moment to the double framed A tower (red, Fig. 18a). This structure could not have the ductility capacity to resist at such asymmetric stress, because of the limited rotational capacity at the base (wider) and the lack of redundancy for force redistribution. Moreover, unbalanced forces in the plane of the stays causes deck uplifting on one side and subside to the other. This mechanism, could be again

responsible for the support loss of the Gerber deck and the rupture of the deck due to bending in its plane (yellow, Fig. 18a). An asymmetric fall of the deck causes and inevitable impact with the intermediate deck support that would find themselves dragged into the collapse. Finally, the observation of the Tower 9 ruins allows an additional comment: many of the parts of the tower broke with planar surfaces, evidencing low or nonexistent process zone and plastic hinge creation. These planar surfaces represent probably the casting phases of the vertical structure. This would imply that (i) no sufficient rebars content was present in that zones, or (i) the boxed section had not sufficient plasticity reserve (red, Fig. 18b). In the end, at this level of knowledge, the lack of structural robustness can be addressed to these factors:

- the low number of stays elements that causes zero redundancy in deck support;
- the low rotation capacity of the A framed lateral tower and its limited redistribution;
- the statically determined scheme for the entire viaduct, which causes higher displacements (and cracking as a consequence) and domino effect collapse;
- the low ductility at member scale;
- the intrinsic sudden loss of strength of prestressing technology.

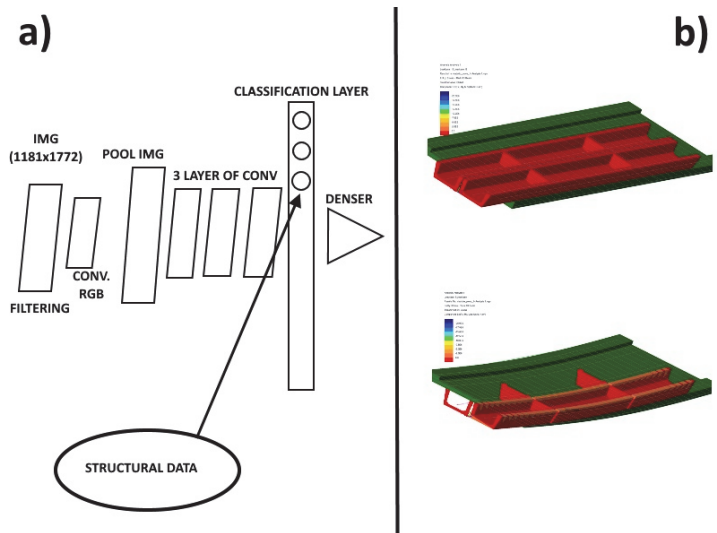
Figure 23: DCNN scheme (a); FEM tuned model (b).

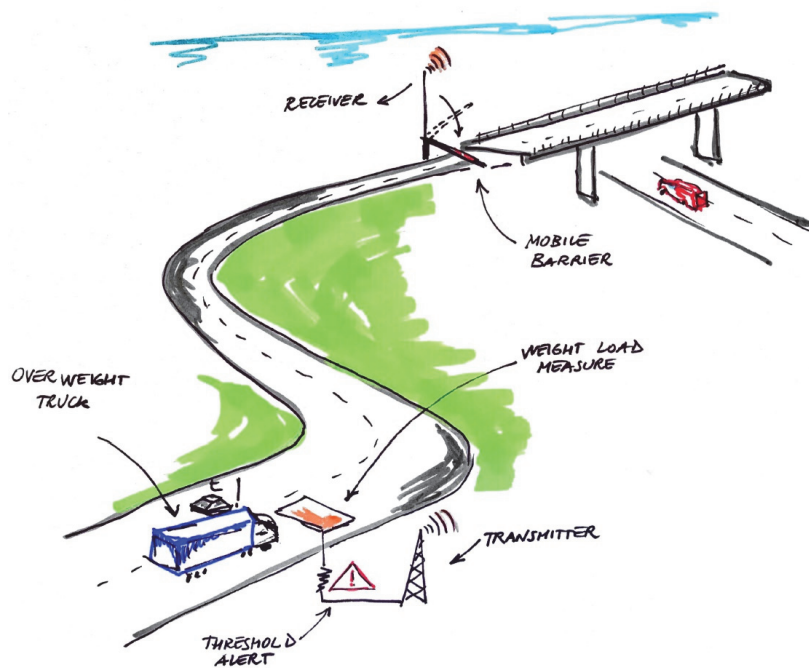
Figure 26: Weight detection systems.

Collapses as the one of the Annone overpass have demonstrated that a check on the actual traffic loads is essential to assess the safety factor of an existing artifact. In fact, the category of the bridge relies on the possible applied maximum load. In order to do so, a weight-detection system, based on embedded actuators (piezo-actuators or fiber optic coils) in the asphalt, could be applied in a preventive distance before the bridge to cross. The device, like a Velox detector, check the admissible vehicular weight and allow the bridge crossing (Fig. 26) [44]. Otherwise, the truck would be halted by an automated barrier. The system should be tuned for heavy loads, remaining blind for car vehicles or small vans. The entire road infrastructural framework will benefit from the installment of this control system by the following cornerstones:
