Seismic history of the church of San Pietro di Coppito in L'Aquila

## Seismic History of the Church of San Pietro Di Coppito in L'Aquila

Renato Masiani, Department of Structural Engineering and Geotechnics, La Sapienza University of Rome, via Gramsci 53, Rome 00195, Italy

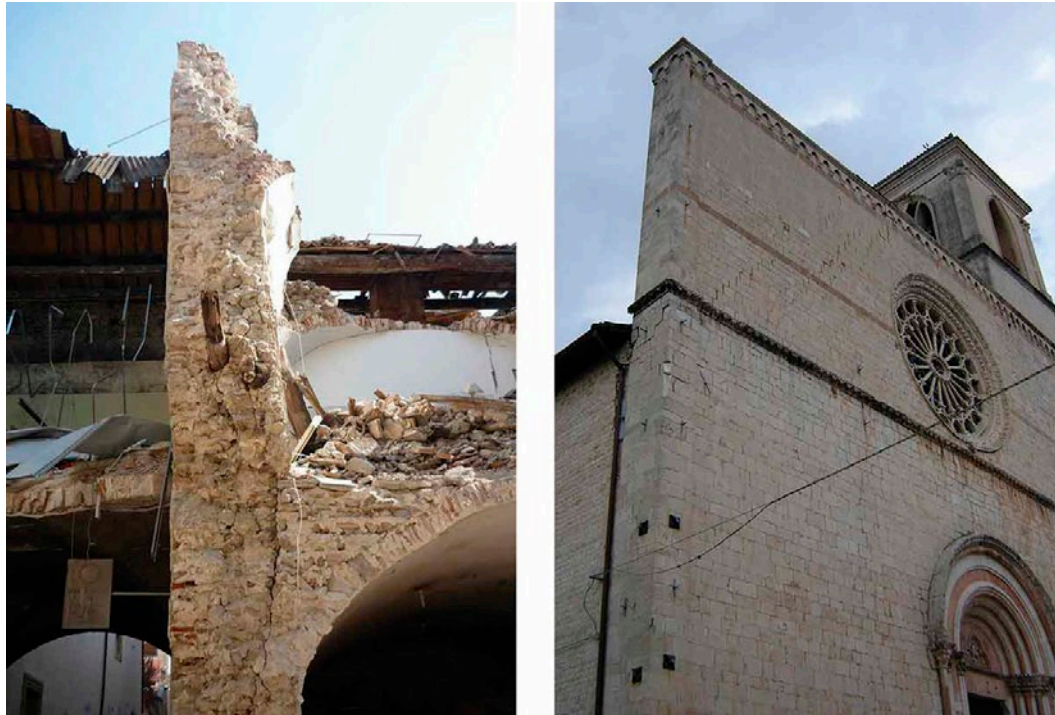
**Fig. 1.** L'Aquila: wooden log (*radiciamento*) in a shear wall (on the left). L'Aquila: the effectiveness of wooden logs inserted in the façade of the church of S. Silvestro preventing its global overturning (on the right).

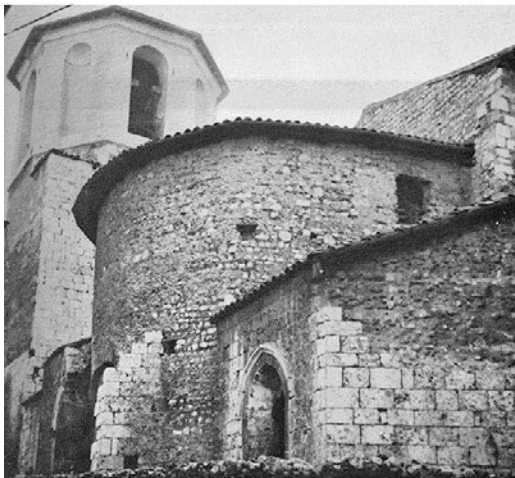
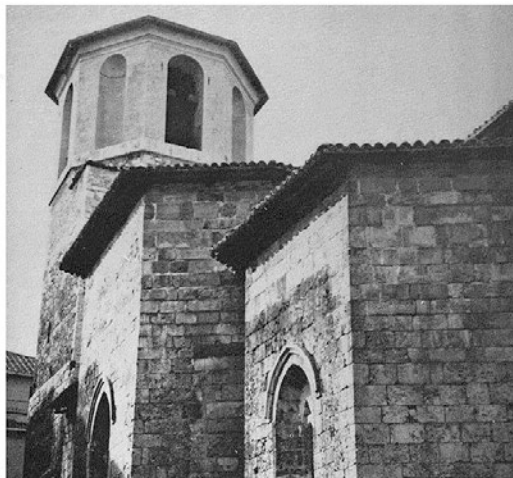
Apart from modifying the layout of the church, individual elements were also drastically changed, first and foremost the main façade, which was returned to its medieval square shape reducing its height (by demolishing the upper part of the nineteenth century façade), adding new parts (in order to obtain the squared outline) and thickening the wall (in order to realize a continuous vertical plane). If the two façades are compared side by side (before and after the 1969 restoration) we see that the discontinuities in the stone facing of the present façade correspond to the first order of pilasters in the nineteenth century façade (fig. 9). This can be clearly seen in the right corner pilaster, where there is a vertical dark patch in the upper part.

**Fig. 6.** Top: nineteenth century façade, before and after the 1969 restoration (in the stone facing of the present façade the pilasters of the first and second order of the nineteenth century façade can be easily identified).

Bottom: polygonal apses before and after the 1969 restoration.

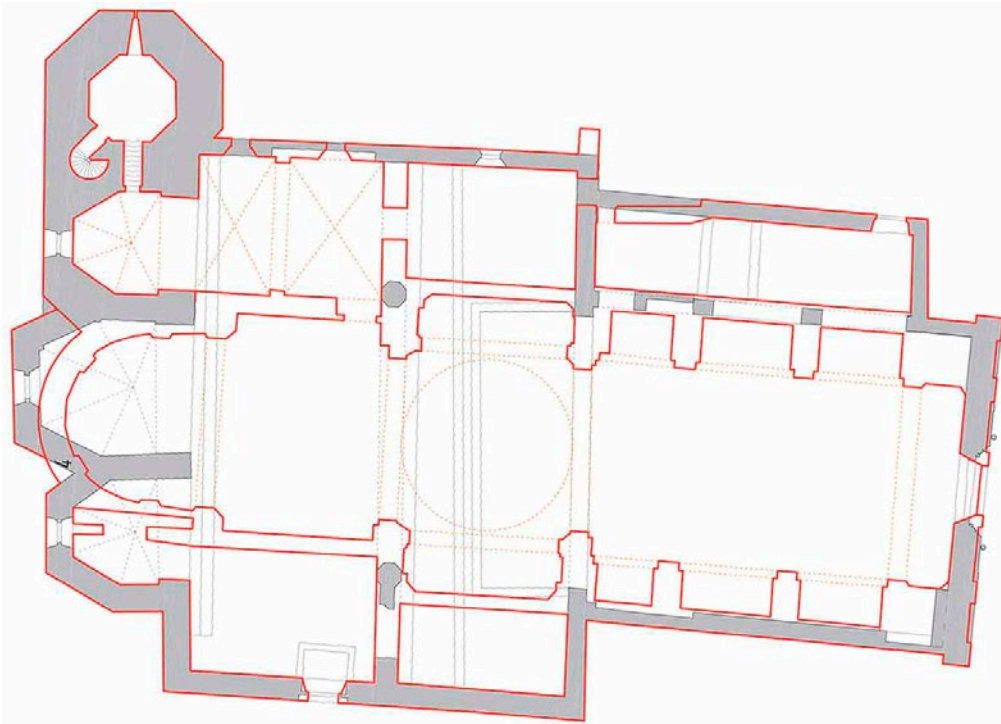
The intrinsically anti-seismic layout of the eighteenth-century church was, in fact, irreversibly destroyed by Moretti's restoration, which transformed the baroque church into a (hypothetically) medieval structure by: (i) removing the transverse walls of the chapels, (ii) opening the three arches in the right side wall of the nave; (iii) removing the longitudinal walls of the transept and the choir, and the transverse wall of the transept aligned with the two pillars (and taking apart the dome); (iv) restructuring the polygonal apses, perhaps by rebuilding the wall separating the central apse from the one on the left (fig. 8).

**Fig. 8.** The present plan of the church superimposed on the nineteenth century plan as reconstructed by Gianfranco Spagnesi.

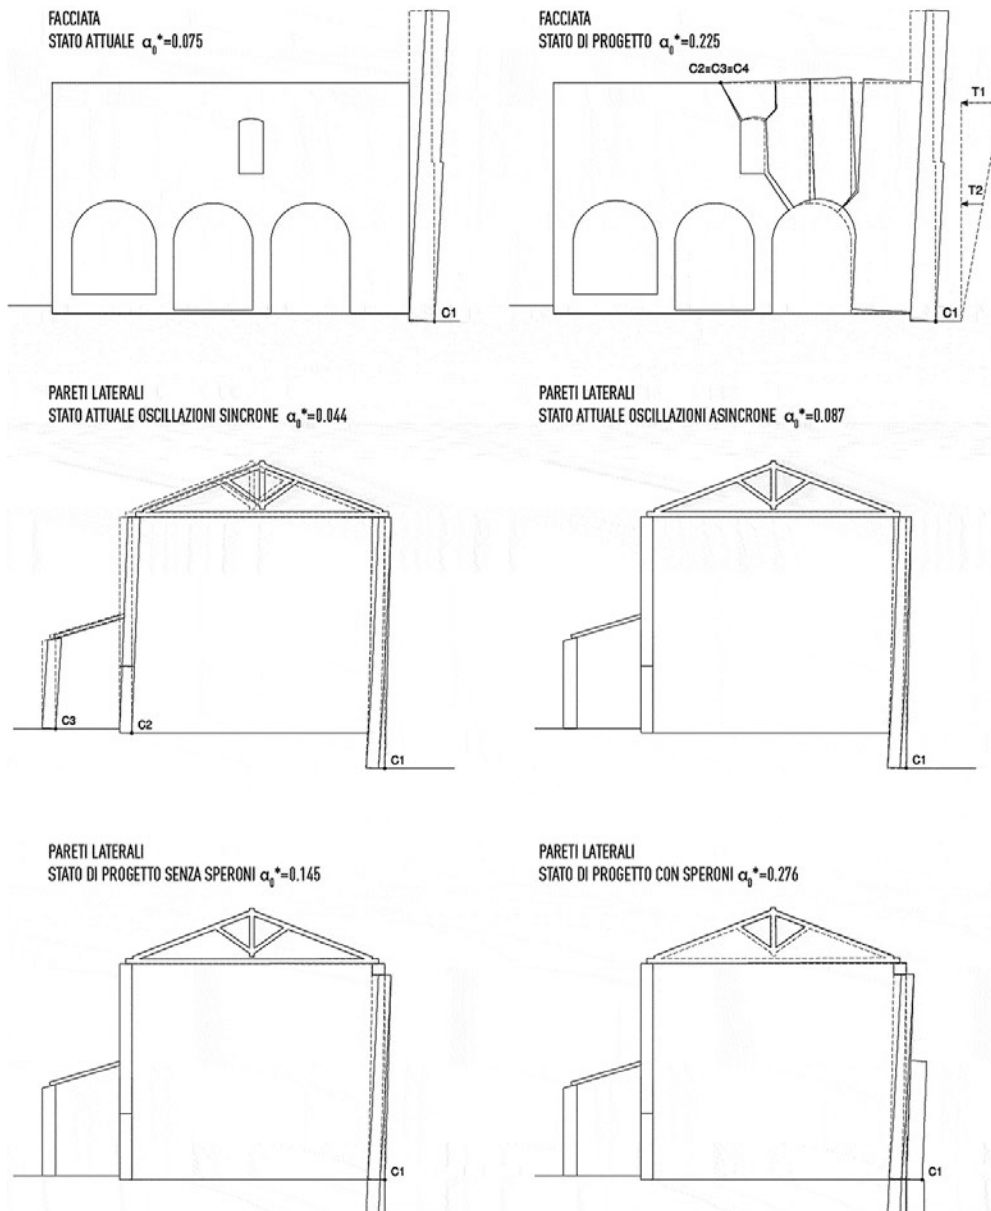
Although a detailed discussion of the different mechanisms analysed is beyond the purpose of this paper (some of them are illustrated, as an example, in figure 18), a particular aspect deserves nonetheless to be underlined. The project state is described, for both the façade and the nave side walls (the structural portions that have been considered in the analyses), by a succession of mechanisms which involve increasing resistant contributions – as provided for in an increasingly effective improvement strategy – and allow modelling the individual effectiveness of each intervention with the aim to take into account the possibility that some of them proves to be ineffectual, depriving the building of a stability factor that should therefore be excluded from the

**Fig. 18.** Collapse mechanisms for the façade (top) and the nave walls (bottom), at present and in the project.
