REINFORCEMENT OF THE 18TH CENTURY BUTTRESSES OF MANIACE CASTLE:
DESIGN AND EXECUTION

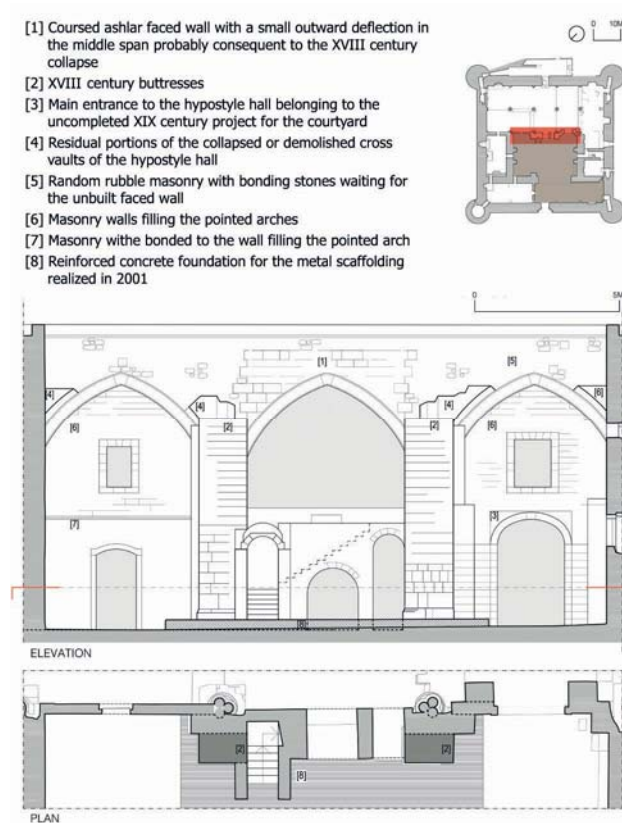
Figure 6 Plan and elevation of the façade overlooking the inner courtyard of the Castle with the two buttresses built in the XVIII century to counteract the thrust of the surviving vaults of the hypostyle hall springing from the trilobate columns.

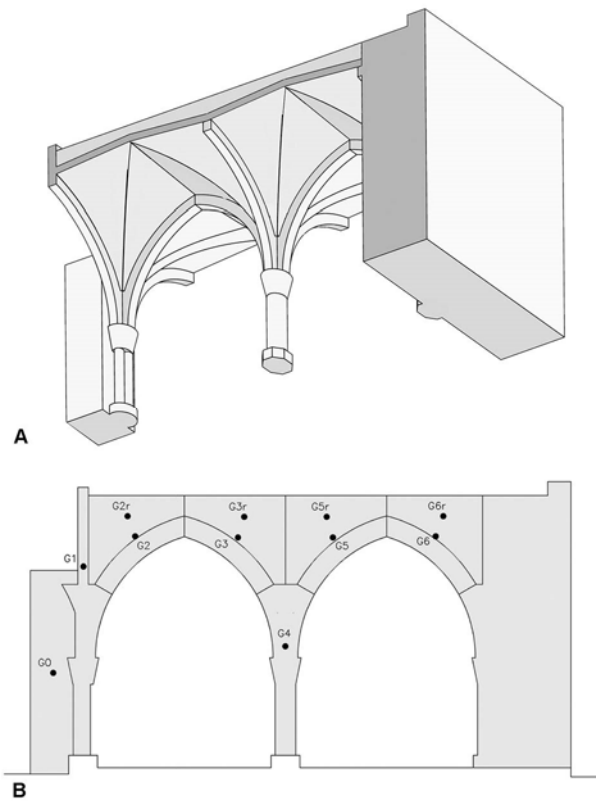
Figure 13 Structural section comprising vaults, trilobate columns and buttresses (A), and corresponding 2-D model with rigid body discretization and mass centres' position (B).

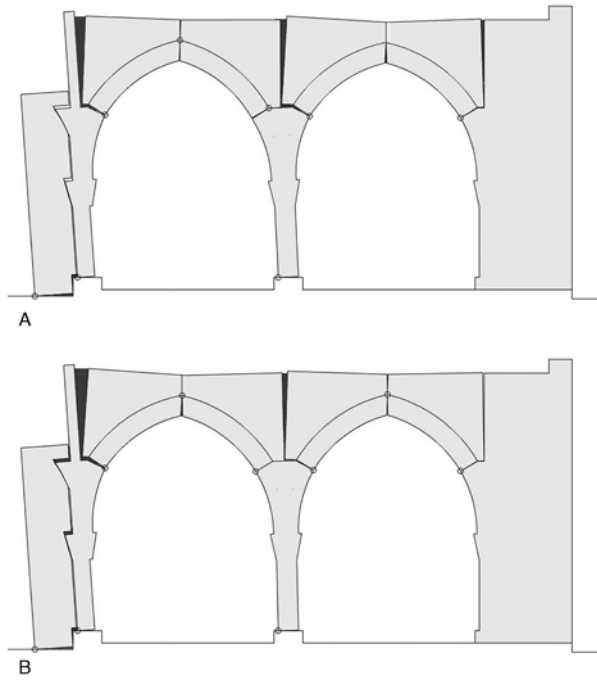
Figure 14 Critical kinematic mechanism detected in the analysis (A). The mechanism involves an intrados crack opening at the haunch of the left vault – unlike the classical flexural mechanism (B), which is nonetheless kinematically consistent – because it entails a larger outward rotation for the inner column and, consequently, a lower ultimate load factor.

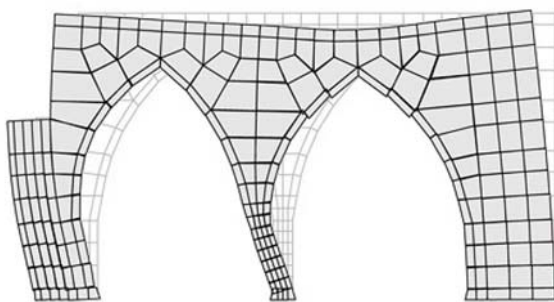
Figure 15 Collapse deformed shape obtained by FE analyses (Casolo and Sanjust 2009)

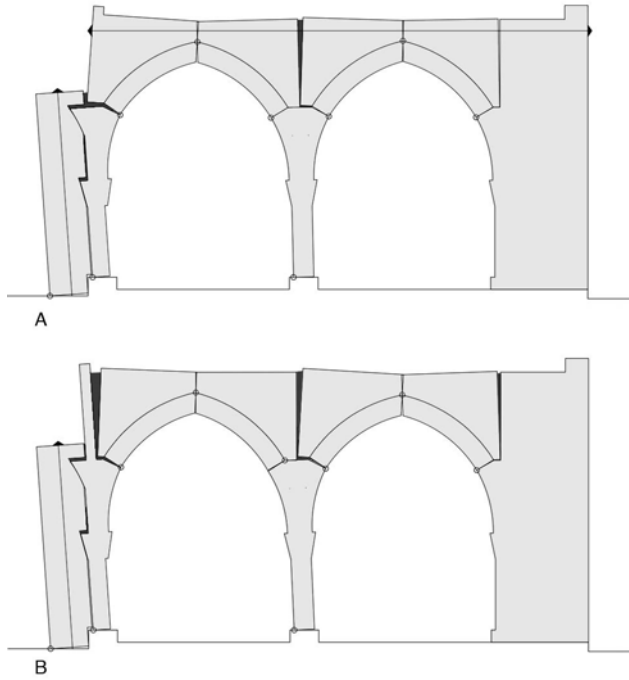
Figure 20 Kinematic analysis of the design solution: with both vertical tendons and horizontal tie-rods (A) and with vertical tendons only (B).

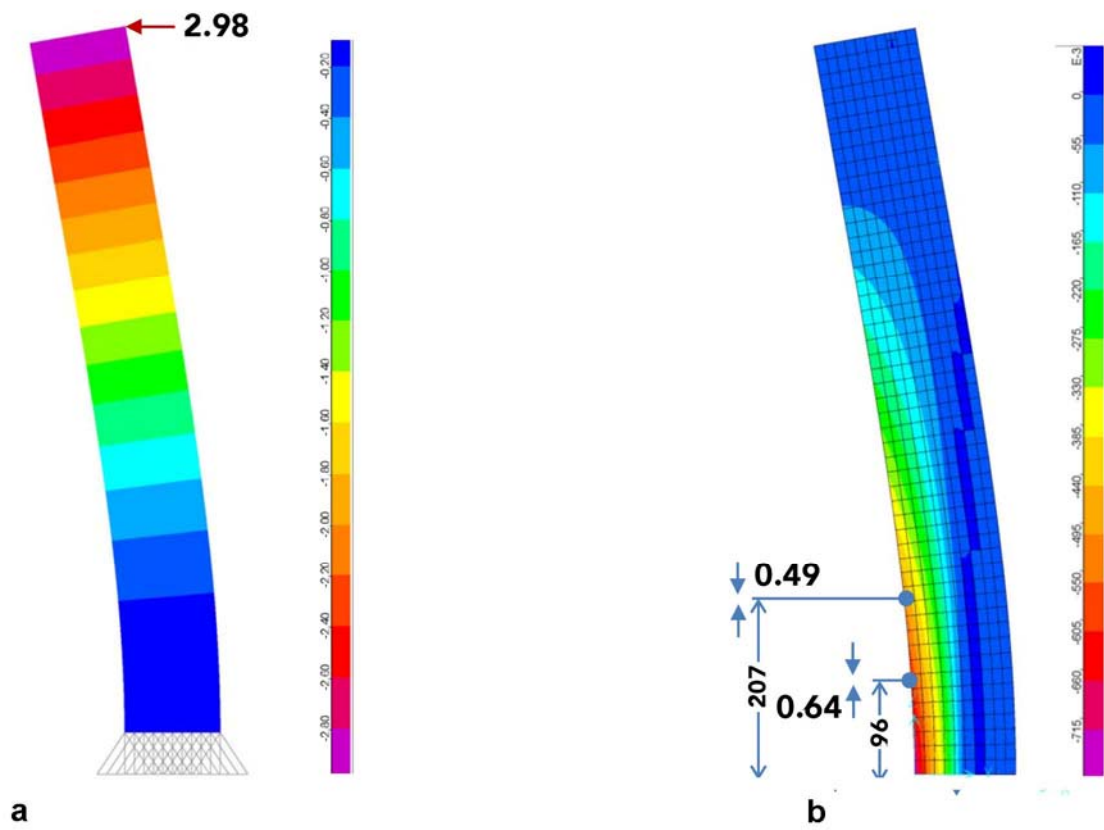
Figure 22 2-D non-linear analysis of the buttresses in the present configuration: displacement [mm] (a) and vertical stress [MPa] (b).

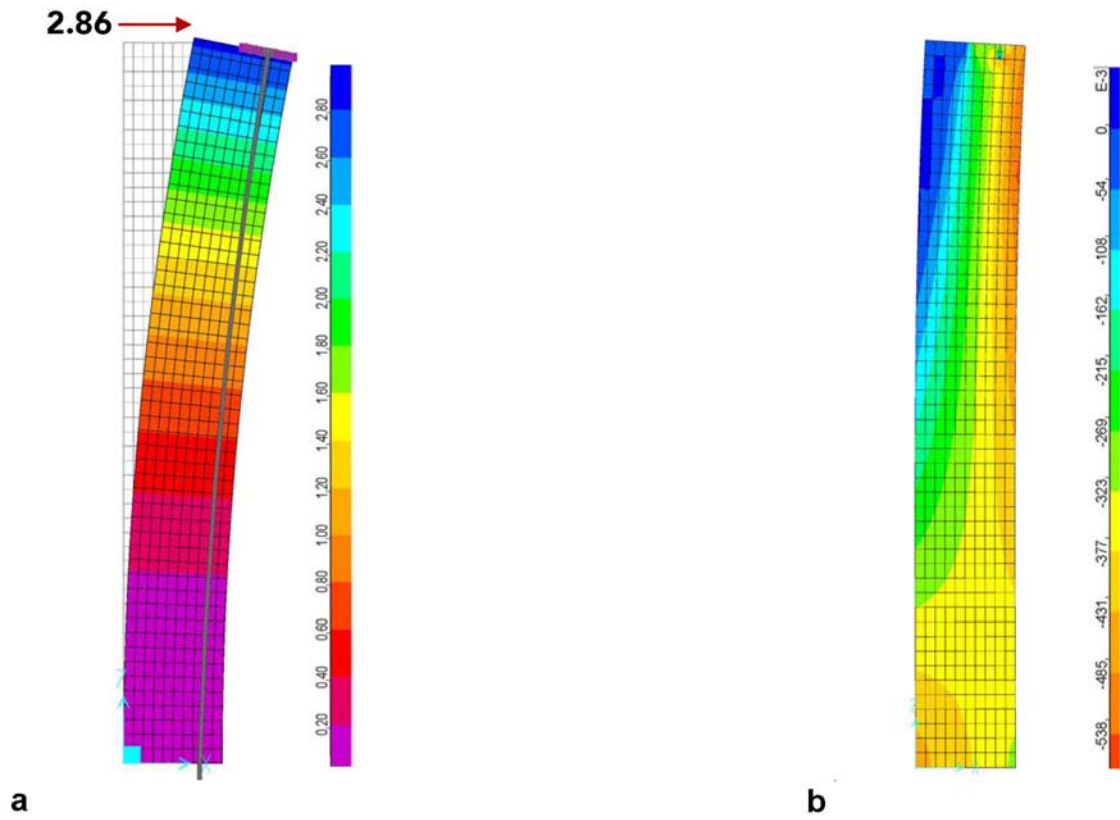
Figure 23 2-D non-linear analysis of the buttresses in the design configuration: displacement [mm] (a) and vertical stress [MPa] (b) for static loads.

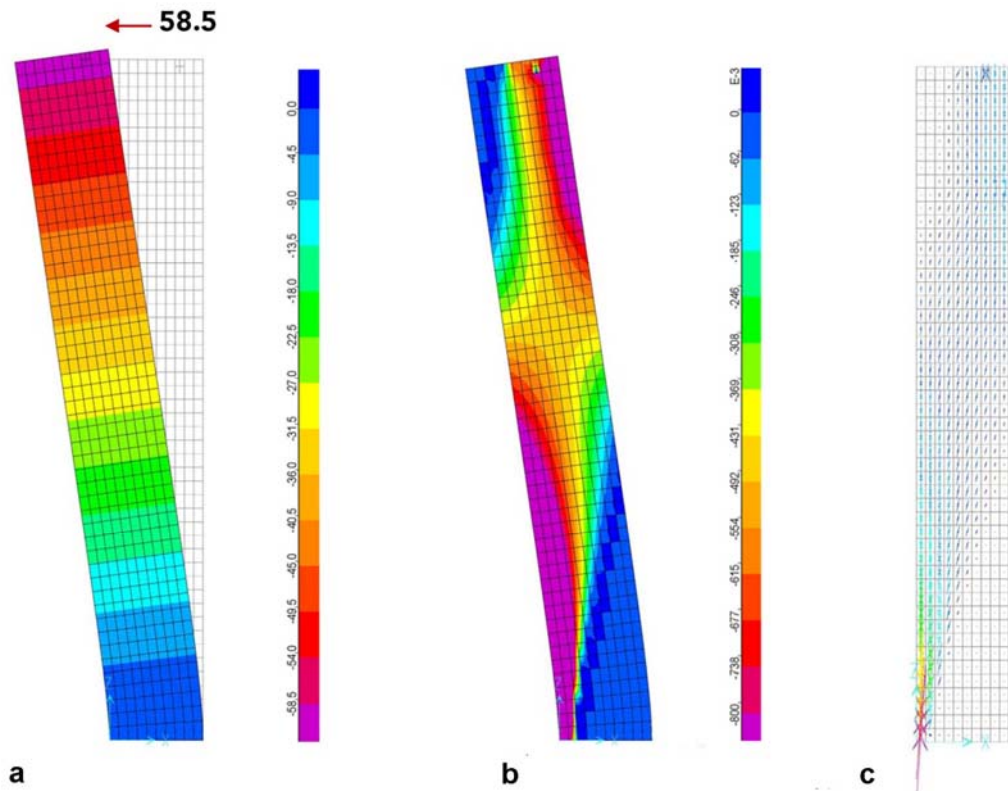
Figure 24 2-D non-linear analysis of the buttresses in the design configuration: displacement [mm] (a) and vertical stress [MPa] (b) under seismic action.
