Non- destructive characterization of carbon fiber composite/Cu joints for nuclear fusion applications

This is the author post-print version of an article published on *FUSION ENGINEERING AND DESIGN*, Vol. 83, pp. 702-712, 2008 (ISSN 0920-3796).

Abstract

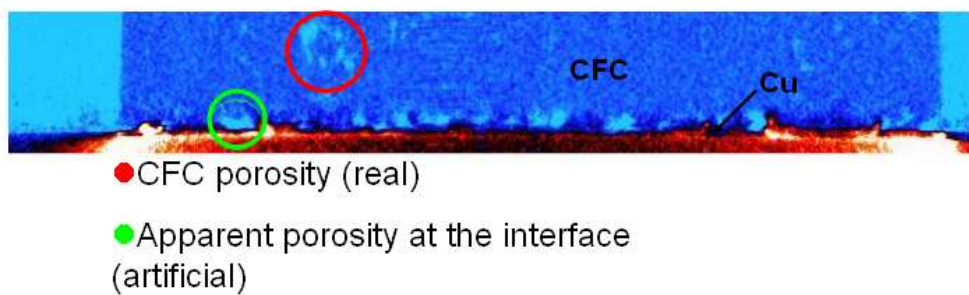
X-ray micro-radiography along the 19 mm side of the examined area (figure 11) shows the interface between CFC and copper; the structure suggests that molten Cu penetrates into CFC substrate in a “finger-like” pattern.

Figure 11 X-ray micro-radiography along the 19 mm side of the tested sample K
