Non- destructive characterization of carbon fiber composite/Cu joints for nuclear fusion applications

Non- destructive characterization of carbon fiber composite/Cu joints for nuclear fusion applications / Casalegno, V., Salvo, M., Ferraris, M., Smeacetto, F., Merola, M., Bettuzzi, M.. - In: FUSION ENGINEERING AND DESIGN. - ISSN 0920-3796. - 83:(2008), pp. 702-712. [10.1016/j.fusengdes.2008.04.005]

Abstract

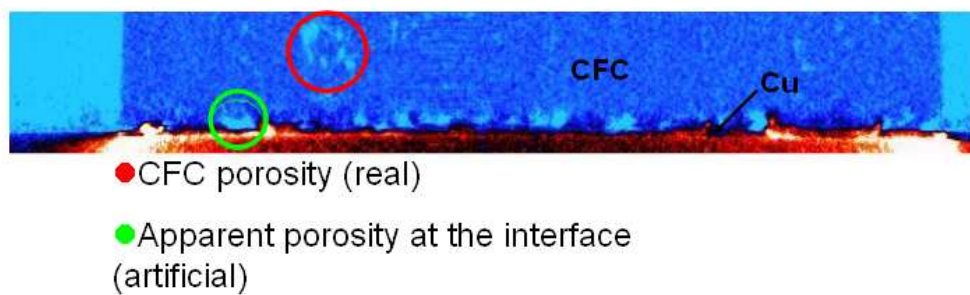
X-ray micro-radiography along the 19 mm side of the examined area (figure 11) shows the interface between CFC and copper; the structure suggests that molten Cu penetrates into CFC substrate in a “finger-like” pattern.

Figure 11 X-ray micro-radiography along the 19 mm side of the tested sample K
