Seismic history of the church of San Pietro di Coppito in L'Aquila

## Seismic History of the Church of San Pietro Di Coppito in L'Aquila

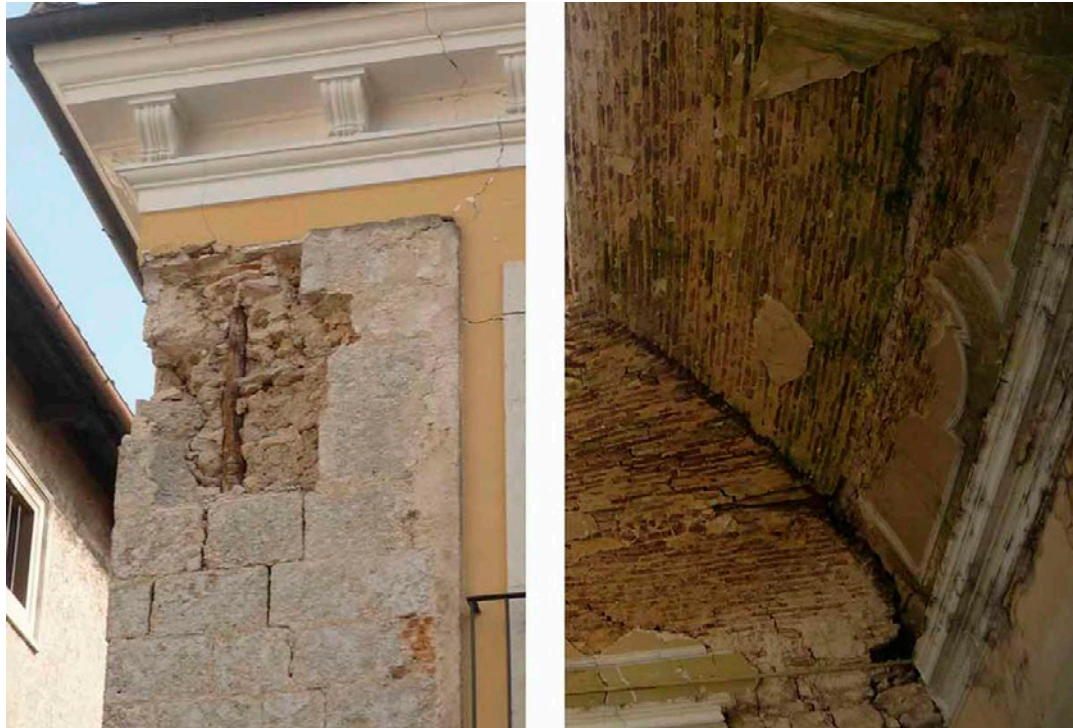
**Fig. 2.** L'Aquila: vertical wooden log, probably part of a more complex wooden frame (on the left). L'Aquila: wooden tie-rods in a cloister vault in Palazzo Ardinghelli (on the right).

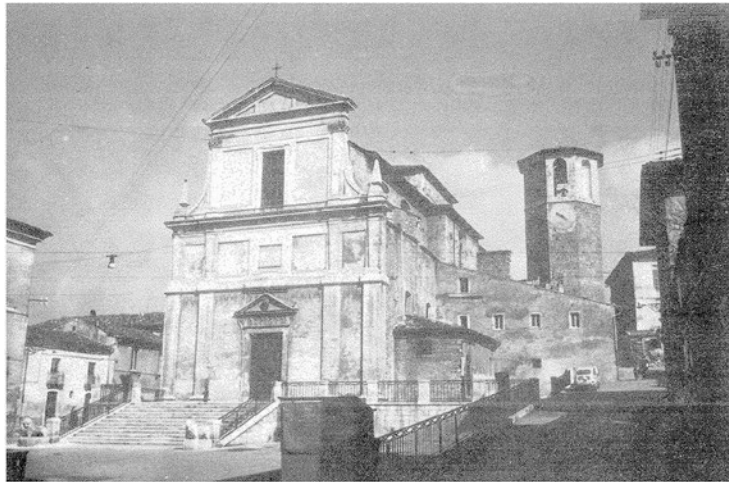
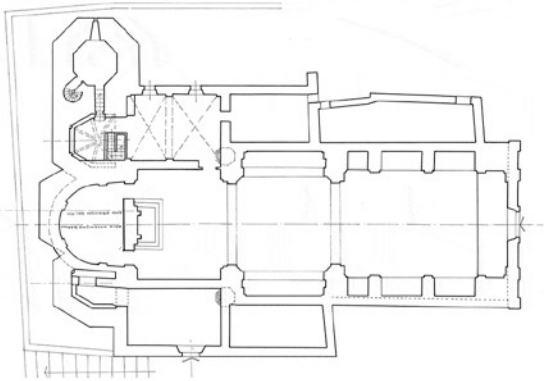
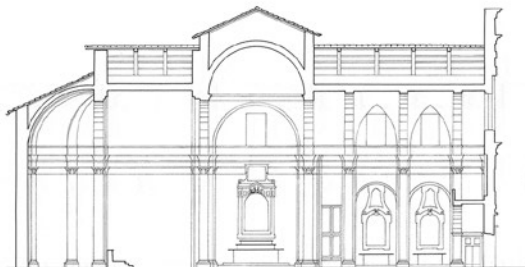
During the nineteenth century, starting in 1862, the church underwent further transformations (Signorini 1868) with the construction of the dome and the completion of the façade (fig. 5) on which, other interventions are also documented, up to the beginning of the twentieth century (Moretti, 1973).

**Fig. 5.** Top: the façade and a view of the right side of the church of S. Pietro di Coppito before the 1969 restoration (Miarelli Mariani, 1979). The partition walls between the side chapels and the nave rise above the right side wall, effectively counterbalancing the higher walls of the nave. The two walls that delimit the transept rise to the same height as the wall of the nave, supporting the dome.

Bottom: plan and section of the church, before the 1969 restoration, as reconstructed by Gianfranco Spagnesi (Spagnesi and Properzi, 1972).

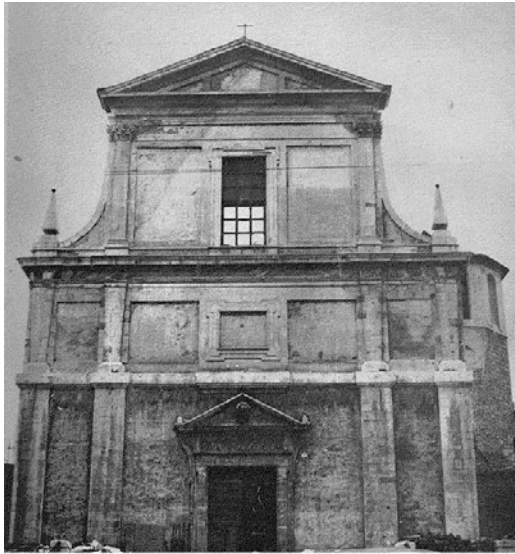
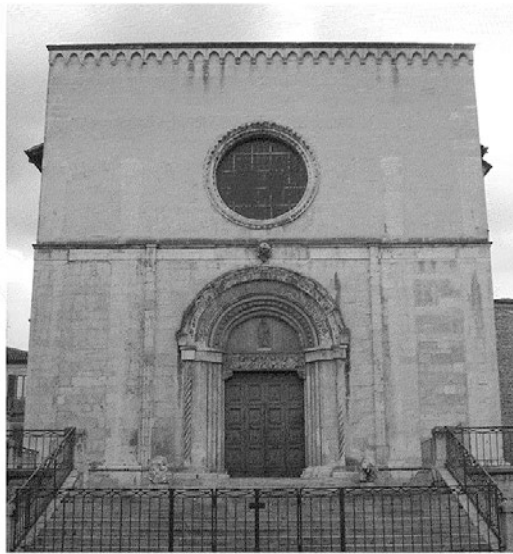
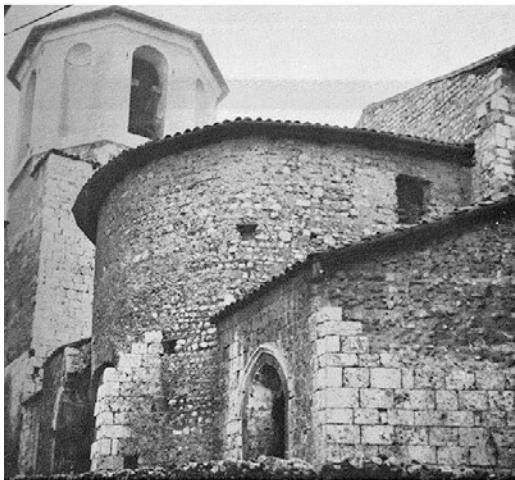
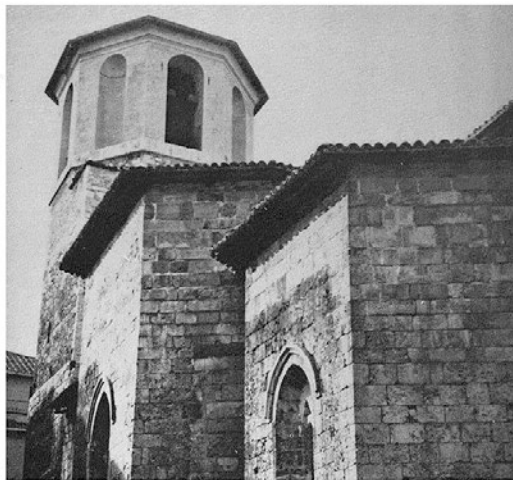
Between 1969 and 1972 the church underwent major transformations at the hands of Mario Moretti (Moretti, 1973), who demolished the eighteenth-century church and redesigned it in the *Abruzzo medieval style* (figs. 6, 7).

Apart from modifying the layout of the church, individual elements were also drastically changed, first and foremost the main façade, which was returned to its medieval square shape reducing its height (by demolishing the upper part of the nineteenth century façade), adding new parts (in order to obtain the squared outline) and thickening the wall (in order to realize a continuous vertical plane). If the two façades are compared side by side (before and after the 1969 restoration) we see that the discontinuities in the stone facing of the present façade correspond to the first order of pilasters in the nineteenth century façade (fig. 9). This can be clearly seen in the right corner pilaster, where there is a vertical dark patch in the upper part.

**Fig. 6.** Top: nineteenth century façade, before and after the 1969 restoration (in the stone facing of the present façade the pilasters of the first and second order of the nineteenth century façade can be easily identified).

Bottom: polygonal apses before and after the 1969 restoration.

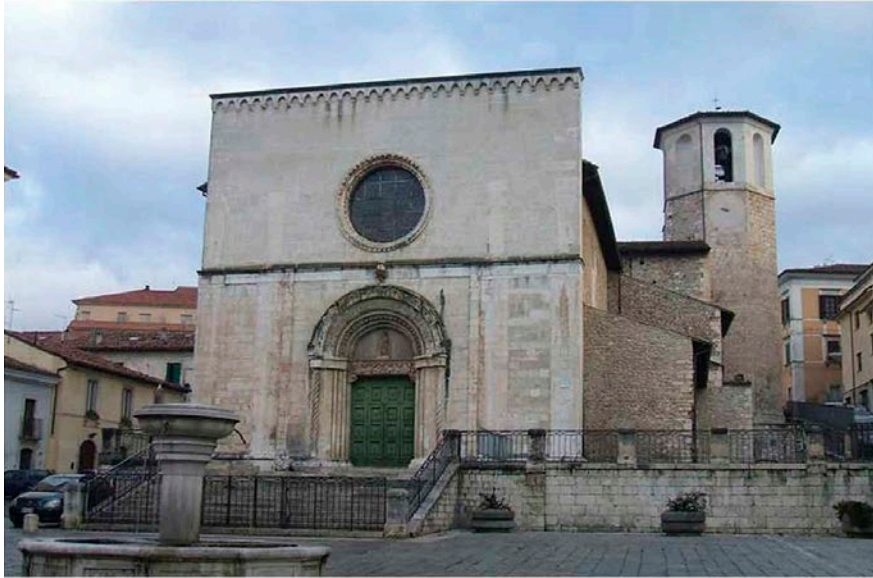
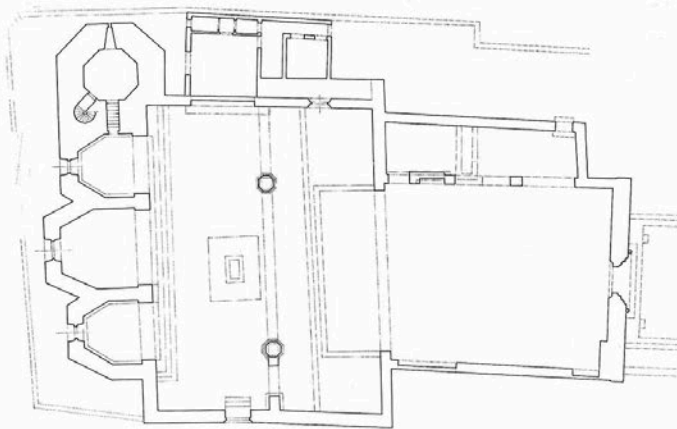
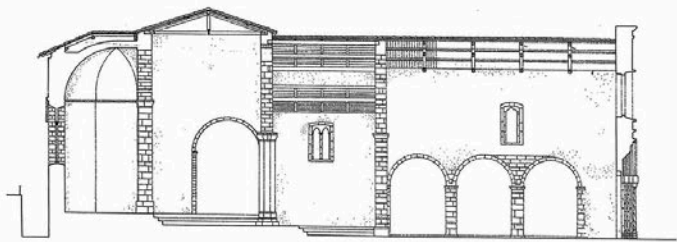
**Fig. 7.** Top: the façade and a view of the right side of the church of S. Pietro di Coppito before the 2009 earthquake.

Bottom: plan and section of the present church, in a drawing dating back to the 1969 restoration.

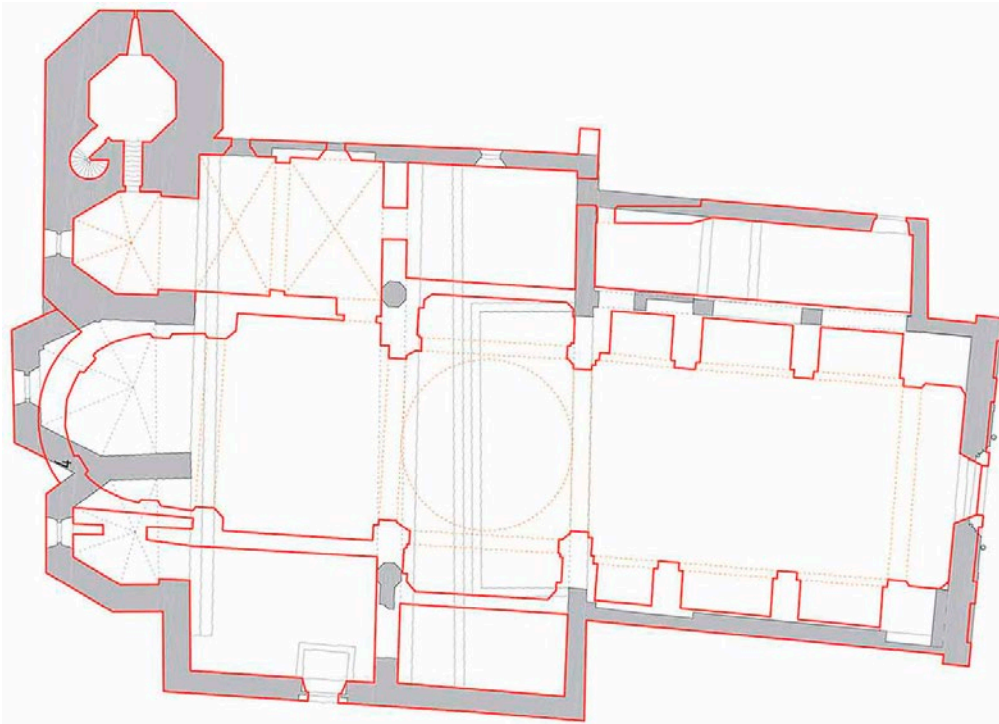
The intrinsically anti-seismic layout of the eighteenth-century church was, in fact, irreversibly destroyed by Moretti's restoration, which transformed the baroque church into a (hypothetically) medieval structure by: (i) removing the transverse walls of the chapels, (ii) opening the three arches in the right side wall of the nave; (iii) removing the longitudinal walls of the transept and the choir, and the transverse wall of the transept aligned with the two pillars (and taking apart the dome); (iv) restructuring the polygonal apses, perhaps by rebuilding the wall separating the central apse from the one on the left (fig. 8).

**Fig. 8.** The present plan of the church superimposed on the nineteenth century plan as reconstructed by Gianfranco Spagnesi.

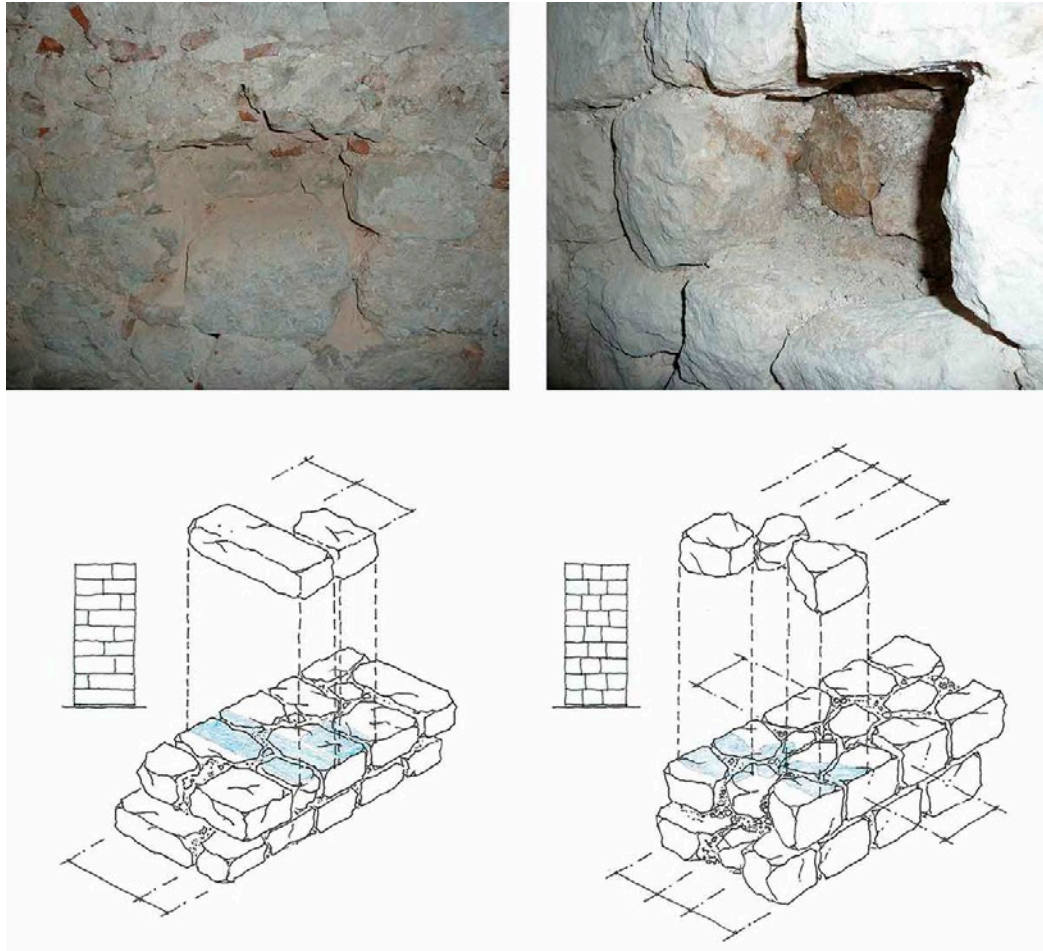
This can be seen first and foremost in the nave walls, both the façade and side walls whose masonry quality deserves to be looked at in detail (fig. 9, top). The walls are built using relatively small stones (up to 20 to 25 cm) in relation to the thickness of the walls themselves and, for this reason, they do not seem to be in line with the classical interpretative parameters of the rules of the art of masonry, as set out in late nineteenth century treatises (Curioni, 1875; Breymann, 1878), since it was evidently impossible to respect the fundamental requirement that imposes the use of large stones (headers) in the masonry to ensure transverse compactness of the walls (fig. 9, lower left). However, it would be wrong to say that this system simply does not respect the rules of masonry. It is more correct to say that the system respects a rule somewhat different from the classical one (and, undoubtedly, more complex and difficult because it makes use of poorer quality material) but whose mechanical intent is the same – and can be always

This rule, observed in the church and frequently recognized in other buildings of L'Aquila and of the minor historical centres in the surroundings, involves keeping to a rigorous arrangement of stones throughout the thickness of the wall (fig. 9, lower right), using stones of the same size for the two outer facings and for the inner core (thus not the type of masonry known as "*a sacco*"), and compensating for the lack of transverse block bonding, such as that provided by headers, with a distributed connection provided by stones of uniform size: these are arranged in regular courses – overlapping the stones of superimposed courses and tothing them out in the same course (where they are laid, alternately, with their main dimension parallel or orthogonal to the wall plane, i.e. as headers and stretchers) - and the gaps between them are filled with smaller stones and bricks wedged in.

**Fig. 9.** Top: direct survey of masonry works in the façade wall (on the left) and the left nave wall (on the right), by removing single stones from the outer facings.

Bottom: Comparison between the stone arrangement prescribed in classic nineteenth century treatises (on the left) and the stone arrangement surveyed in the church (on the right).

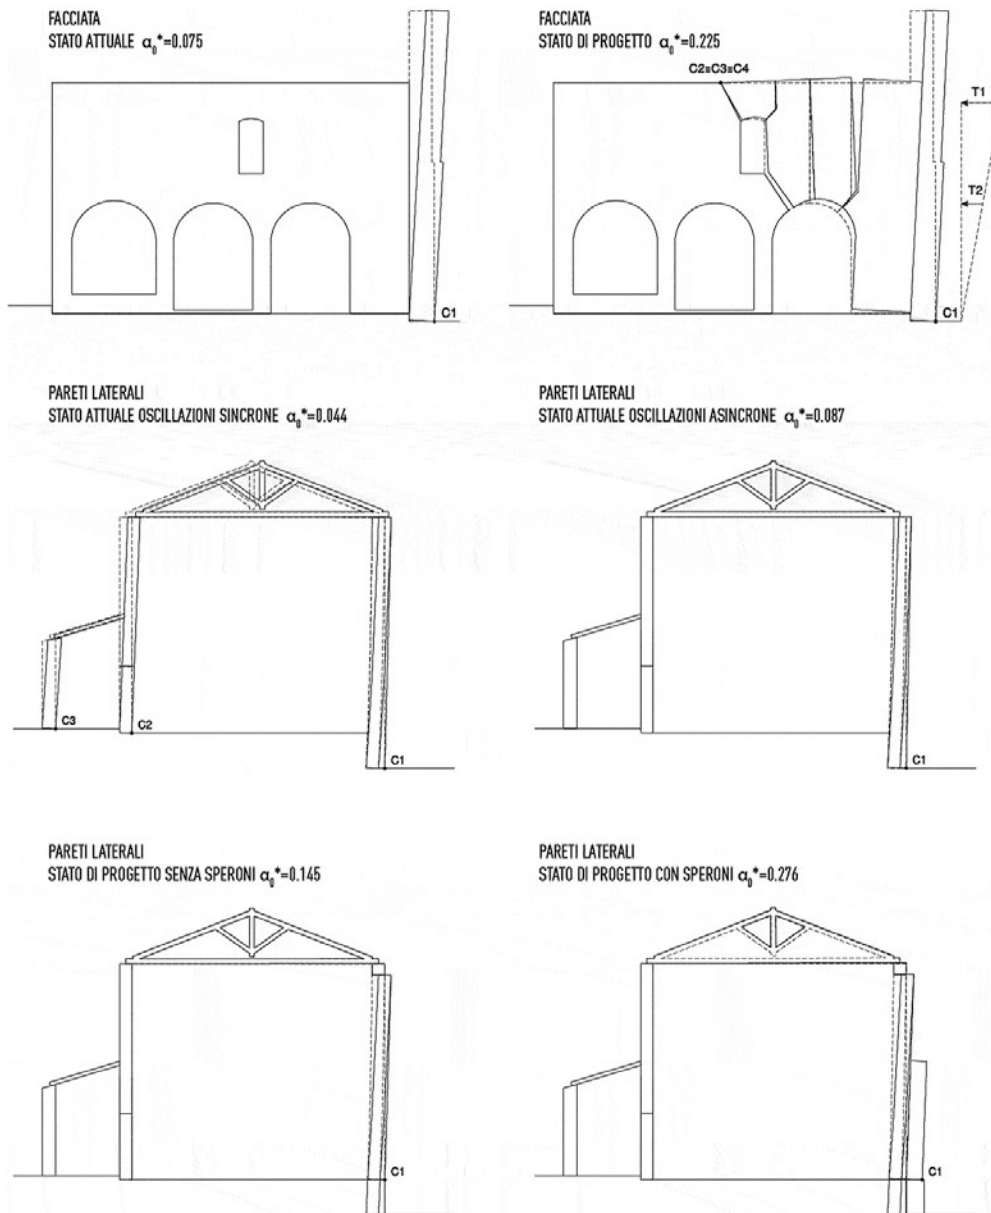
Although a detailed discussion of the different mechanisms analysed is beyond the purpose of this paper (some of them are illustrated, as an example, in figure 18), a particular aspect deserves nonetheless to be underlined. The project state is described, for both the façade and the nave side walls (the structural portions that have been considered in the analyses), by a succession of mechanisms which involve increasing resistant contributions – as provided for in an increasingly effective improvement strategy – and allow modelling the individual effectiveness of each intervention with the aim to take into account the possibility that some of them proves to be ineffectual, depriving the building of a stability factor that should therefore be excluded from the

**Fig. 18.** Collapse mechanisms for the façade (top) and the nave walls (bottom), at present and in the project.
