# Engineering Reconnaissance Following the October 2016 Central Italy Earthquakes *Version 2*

GEER Team Leaders: Jonathan P. Stewart and Giuseppe Lanzo

Geotechnical Extreme Events Reconnaissance Association  
Report No. GEER-050D  
8 May 2017

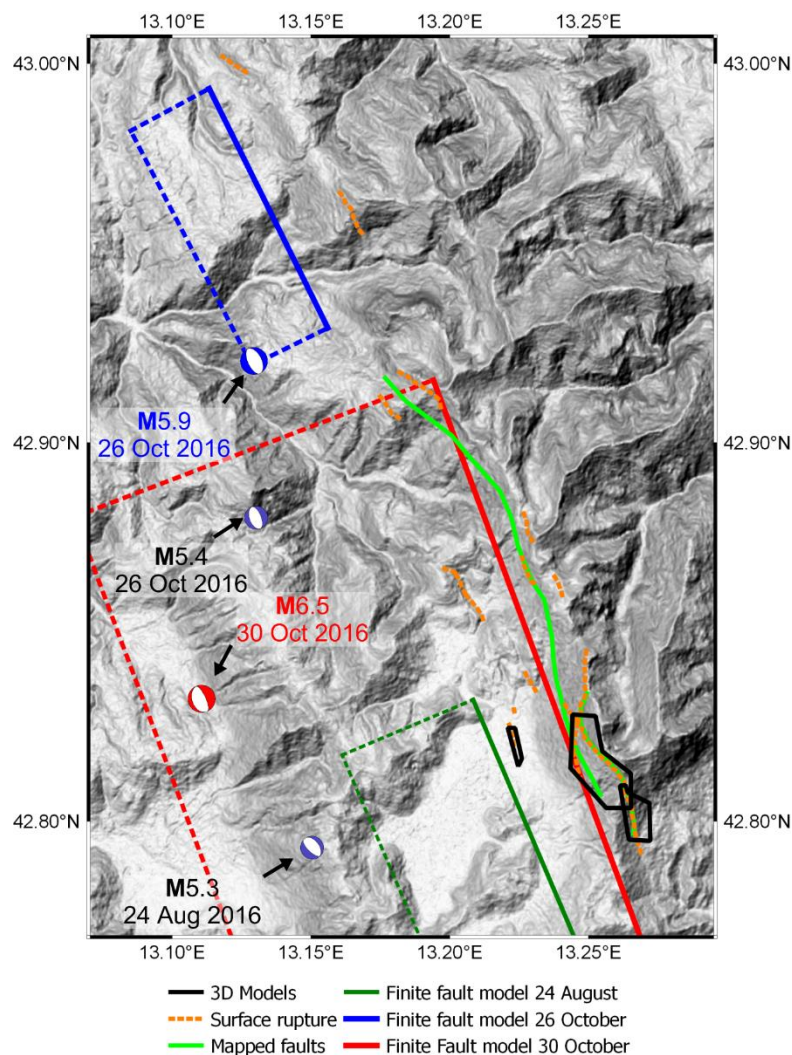
**Figure 2.4.** Detailed map of surface fault rupture, pre-event mapping of Mt. Vettore-Mt. Bove (green) fault system, and locations of 3D models.

As shown on Figure 2.4, the locations of the observed surface ruptures coincide with a segment of the Mt. Vettore fault as mapped by Falcucci et al. (2016). This segment of the fault did not rupture in the 24 August event. No information about the last known rupture of this fault segment is available. It has likely ruptured during past events on the Mt. Vettore fault as identified by Galadini and Gali (2003) through paleoseismological studies.

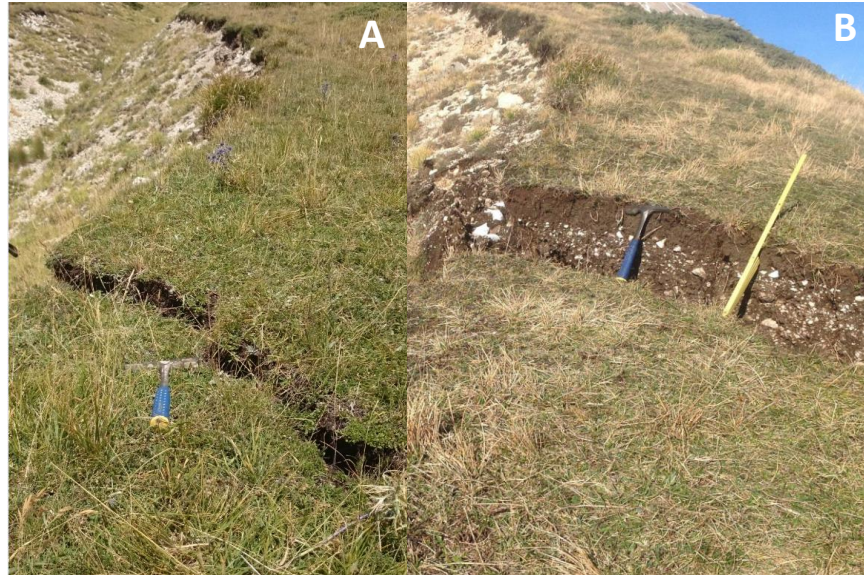
An important point to make here is that surface rupture observations at any point in time represent the cumulative slip from all prior events. Hence, the only way to evaluate slip from any particular event is through the differencing of multi-epoch displacement measurements. Detailed, by hand, mapping was conducted following the 24 August event (GEER 2016) for the southern portion of the Mt Vettore fault, shown in Figure 2.4. Because such areas did not experience slip in the 26 October event, but were observed to have additional displacements in our December 2016 reconnaissance, such differentials can be attributed to the 30 October event. As an example, Figure 2.5 shows a location near the south end of the fault rupture close to road SP477 where multi-epoch photographs and measurements are available, showing the much larger slip in these areas from the second (30 October) event. Figure 2.6 compares cumulative displacements (total displacement measured in December reconnaissance) with the September-to-December differential, which is attributed to the 30 October event. These results were measured along the southern portion of the Mt. Vettore fault rupture.

**Figure 2.5.** Comparative fault offset of 10cm. (a) Vertical offset from the August event, and (b) 30cm Vertical offset from the October 2016 events on the south face of Mt. Vettore near road SP477. Horizontal offsets were 0cm and 2cm. Lat = 42.79795, Long = 13.26607.

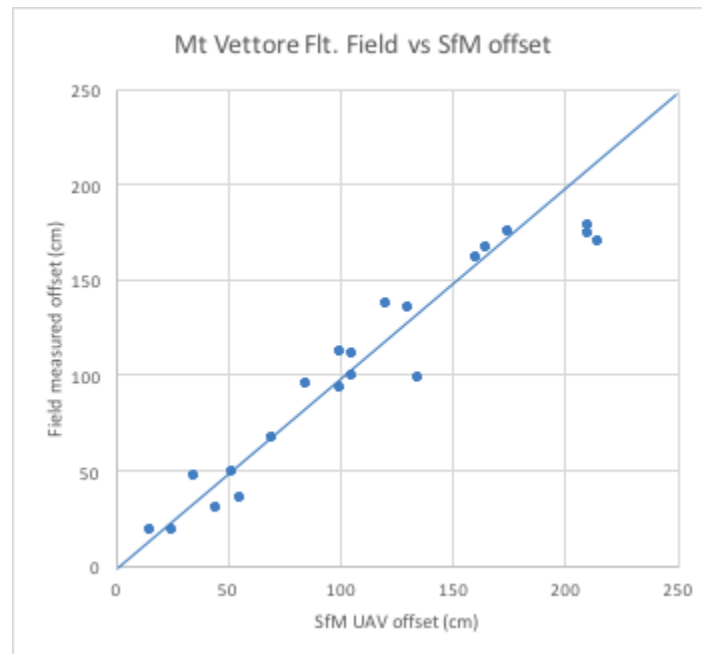
In Figure 2.7 we compare displacements along the primary (highest elevation) segment of the Mt. Vettore fault as measured by hand and from the 3D terrain model. These displacements were made along the portions of Mt. Vettore that are on the west face of the ridge and on the branch descending the ridge towards SP477. Figure 2.7 shows cumulative displacements across

all events, which for this portion of the fault arise from the 24 August and 30 October events. The 3D model in these areas is based on UAV point cloud data, and the displacements were measured from the model using the program Dronedeploy. The comparison is considered quite good, with no clear evidence of bias. Further comparisons in other areas will be undertaken in future work.

**Figure 2.7.** Surface fault rupture displacements from August-October event sequence as evaluated from hand measurements in the field and UAV-based 3D model.

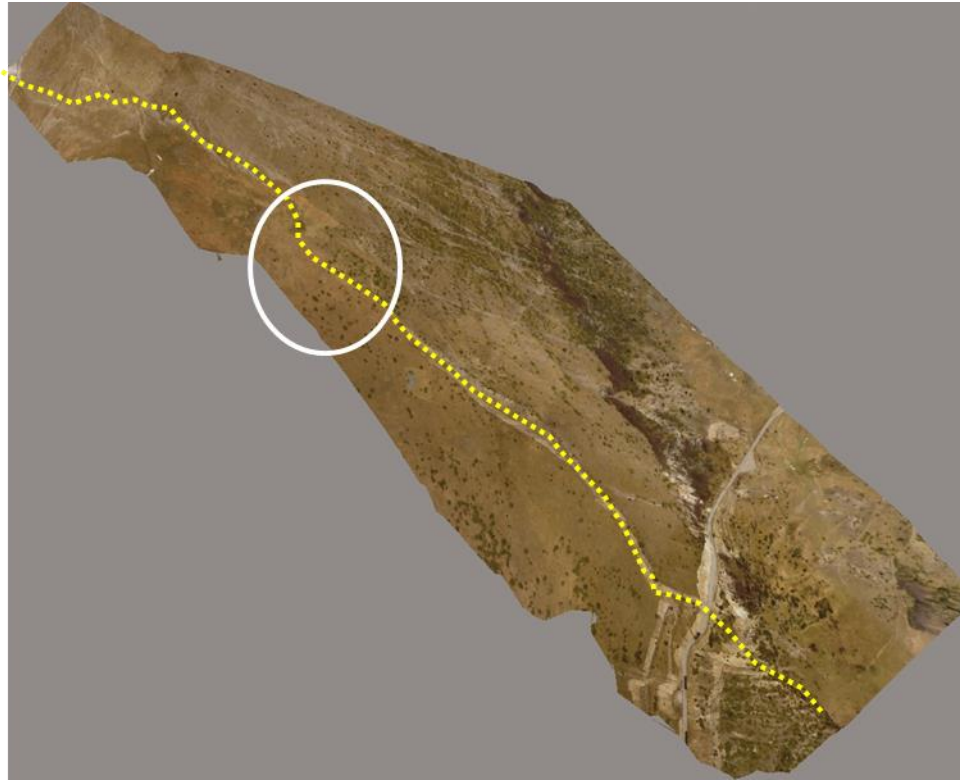
The 3D point cloud model, generated using both UAV SfM and LiDAR point cloud modeling, for the south face of Mt. Vettore is shown in Figure 2.9. Due to the large area and low color contrast of fault scarps compared to the native ground surface, lines have been added to this image to show approximate surface fault rupture traces. Figure 2.9 shows that the fault rupture alignment climbs the slope from south to north. In general, larger fault offsets were measured to the north. The southern terminus of observed fault rupture is down slope of road SP477 which is at bottom of Figure 2.9. Most of the mapping effort was performed north of SP477, as the fault dip offsets observed south of SP477 were minimal.

An interesting observation from both 3D point cloud and conventional mapping is that there is a zone of apparently thick and soft (ductile) soil sediment overburden on the slope where the distinct single fault rupture surface is defrayed into several smaller scarps. This area is shown in Figure 2.9. Above and below this area, the fault trace is singular and well defined. Within the

area, the fault splinters into 4 to 6 distinct, short, small displacement traces roughly parallel to one another.

**Figure 2.9.** 3D digital terrain model from merged SfM and LiDAR data of the Mt Vettore fault on the southern flank of the Mt Vettore Massif. Approximate main fault trace indicated in yellow. Looking from the west to the east. The upper left of the image is the top of the slope. Area of soft sediments where the fault trace breaks into several (4 – 6) small scarps is indicated in white.

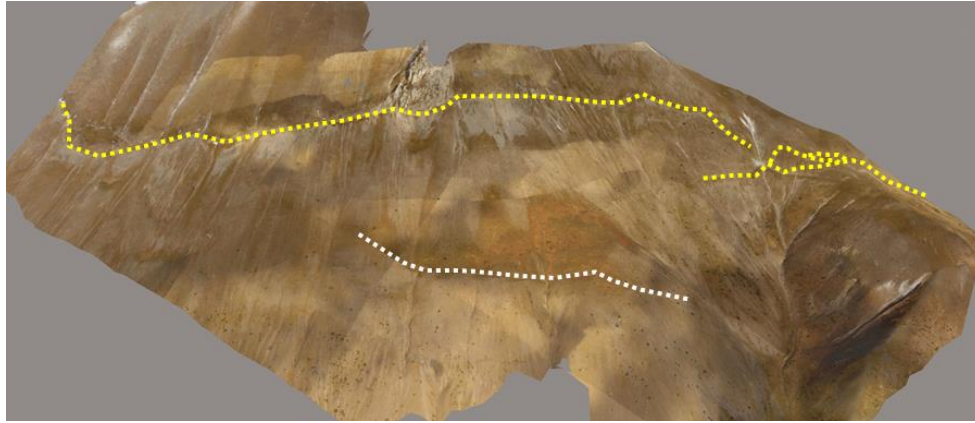
Similarly to Figure 2.9, the image in Figure 2.10 depicts a 3D model of the west face of the Mt. Vettore Massif that was generated from combined UAV images and LiDAR scans. Figure 2.10 shows an area that is located north of the area depicted in Figure 2.9, and covers the northern extent of the fault mapping. Figure 2.10 shows an approximate fault trace location for the main trace and the aforementioned western trace. We performed field mapping on both the main trace and the western trace, though mapping activities were more extensive on the main trace.

Rupture displacements increase as the fault extends to the north. Also, the rupture becomes more centralized to a single surface as the fault moves north between Figures 2.9 and 2.10. On the south (right) of Figure 2.10, the fault has several distinct rupture scarps that we have interpreted as fault scarps. Several other scarps were measured, mapped, and are shown in the 3D model. These other scarps are interpreted as minor slope instability scarps and are discussed in Chapter 4 (Section 4.2.10).

**Figure 2.10.** 3D digital terrain model from merged SfM and LiDAR data of the Mt Vettore fault on the western flank of the Mt Vettore Massif. Approximate main fault trace(s) indicated in yellow, a second visible trace of the “Western Trace” shown in white (See Figure 2.11 for more details). Looking from the west. The left of the image is to the north. The slope moves from top to bottom of the image.

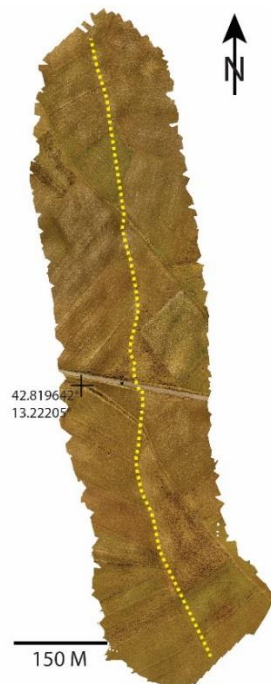
The final 3D point cloud model is from LiDAR imaging of the Piano Grande fault at the western foot of the Mt. Vettore Massif (location shown by the orange rectangle on left side of Figure 2.8). The Piano Grande fault has been interpreted as a secondary rupture surface. This fault was not observed after the August 2016 event. Figure 2.11 presents an image of this 3D model.

**Figure 2.11.** 3D digital terrain model from merged SfM and LiDAR data of the Piano Grande fault on the western toe of the Mt Vettore Massif. Approximate fault trace(s) indicated in yellow. Looking from the west. The left of the image is to the north. Mt. Vettore on the top of the image

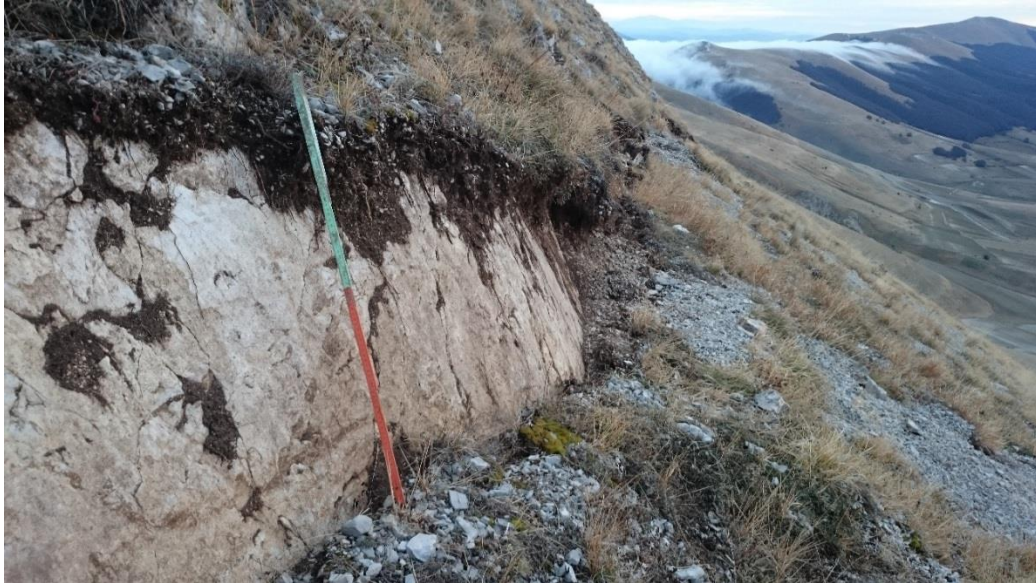
**Figure 2.12.** Fault offset measurements showing relative offset of August 2016 (0 cm) and October 2016 (70 cm) events on the lower or “western” fault trace in Figure 2.10 (shown in white). Lat = 42.812901, Long = 13.24626.

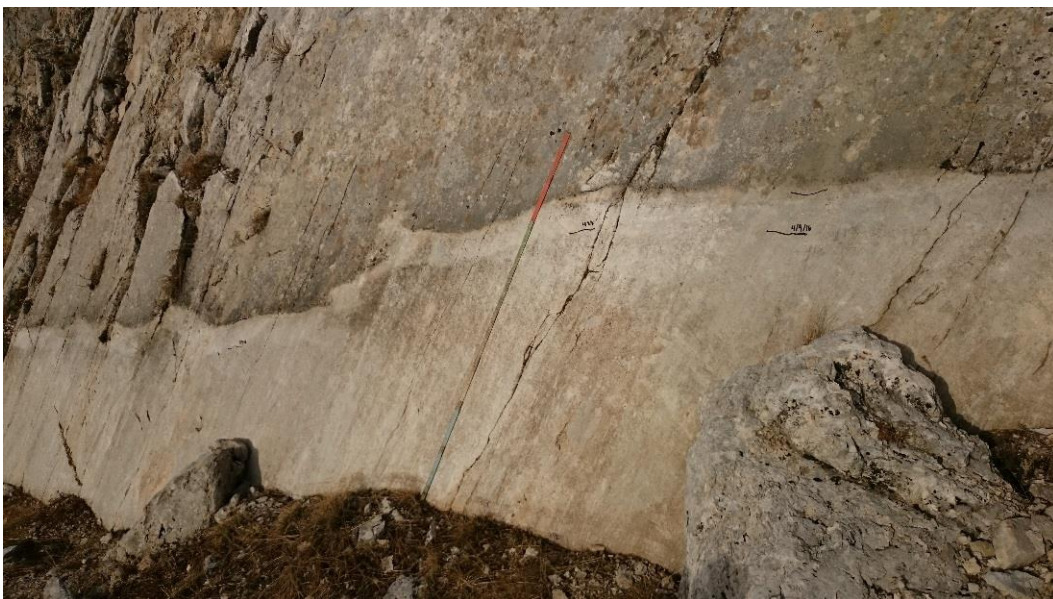
**Figure 2.13.** Fault slip measurements showing multi-epoch offsets from August 2016 (upper white band, 16 cm) and October 2016 (130 cm) events. Lat = 42.81724, Long = 13.25449.

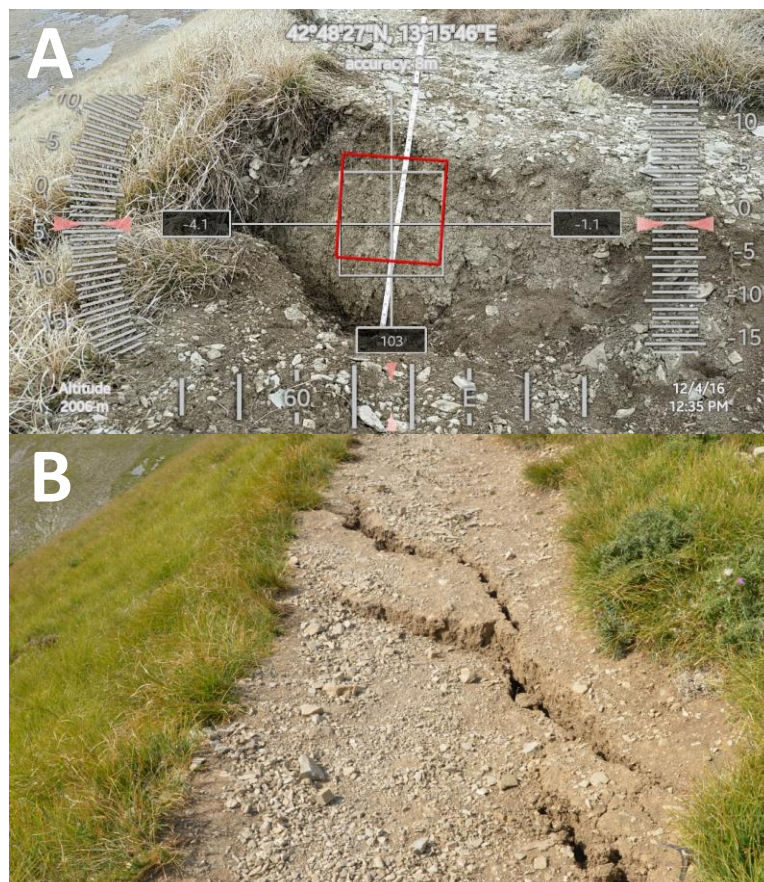
**Figure 2.15.** Fault offset measurement across the footpath on the west face of Mt. Vettore. Offset measured as 80 cm following October events (a). This offset was 30 cm following August events (b). Lat = 42.807379, Long = 13.262966.

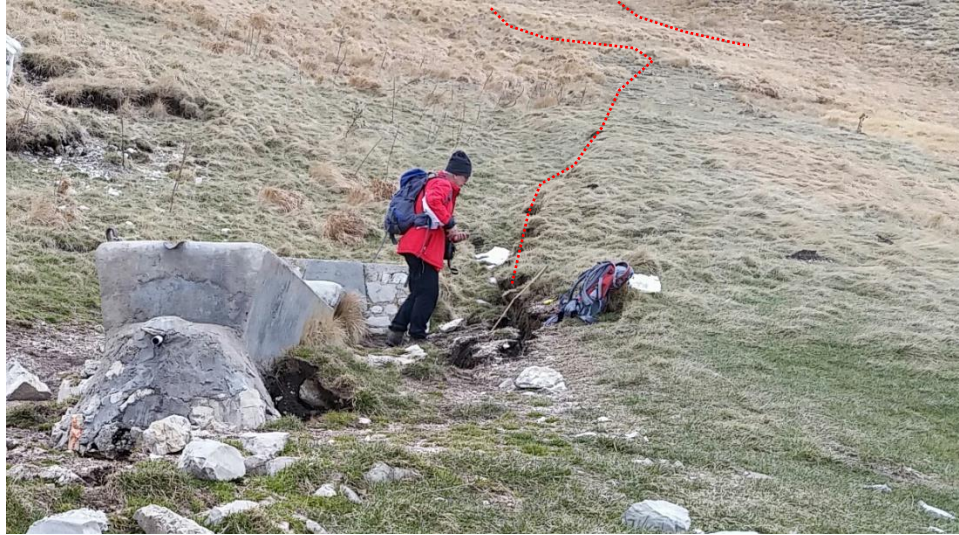
**Figure 2.16.** Fault trace on the south face of Mt. Vettore, where the fault has ruptured along the path of buried polyethylene pipe supplying the pictured spring. Rupture partially hidden by long grass. Offset measured at 45 to 65cm. August offset data nearby is 0 to 15cm. Trace(s) above the spring indicated in red. Lat = 42.80474, Long = 13.26441.

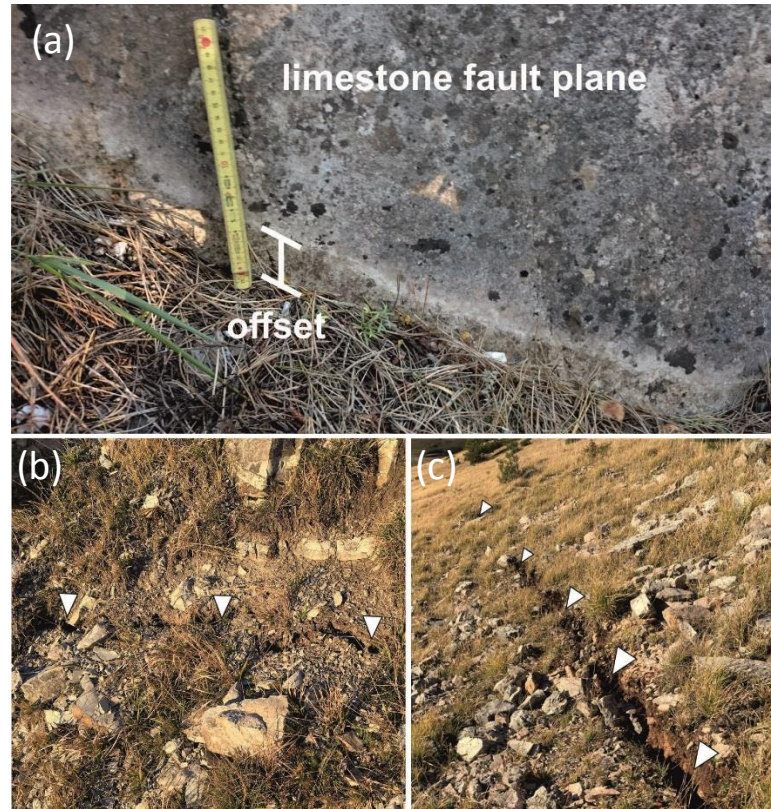
The Mt. Vettore fault crosses variable surficial geologies, with differences in fault rupture manifestation for each surface material type. Figure 2.21 presents three different images of the fault rupture. The fault occasionally followed a well-defined limestone fault plane. This was especially true in the “gulley” on the south face of Mt. Vettore and along much of the west face of the Massif for both the main and western splays of the fault. Measurements are relatively straightforward in these areas. In areas where a near-surface limestone fault plane was not present (i.e. thick soil sediment cover), the fault rupture often appears as shown in Figures 2.21a and 2.21b, with lateral gapping developing and the fault trace occasionally splitting into two or more traces. Displacements across these individual traces often sum to be as much as the displacement in adjacent areas with shallow or exposed limestone. For example, between latitudes 42.806 and 42.808, the fault trace splits into several traces, converges, and then diverges again before becoming a single distinct surface north of Latitude 42.808. In the locations of a single trace, the measured offset is 92 cm. In the nearby locations with 2 or 3 traces, the individual traces measure 30 to 40 cm, but the sum is very close to 90 cm.

**Figure 2.21.** Fault offset measurements along the south and west faces of the Mt. Vettore Massif showing differences in fault rupture offset through soil versus along the rock fault plane (where visible on the slope).

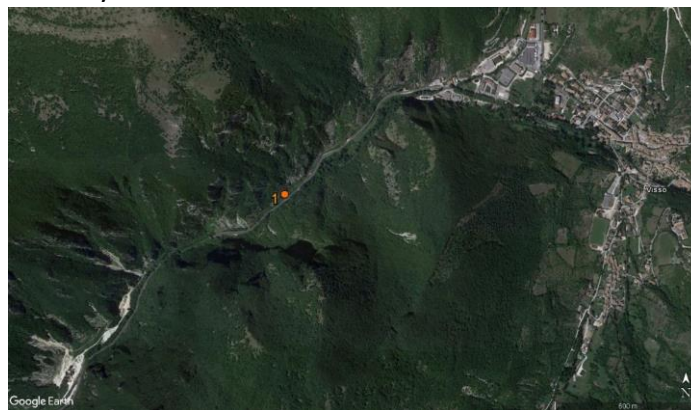
**Figure 4.4. Location of the Nera landslide.**

A large rockfall above the Nera River, a tributary of the Tiber River, occurred just downstream and 1 kilometer west of the town of Visso (Figure 4.4 and Table 4.1). No reports of slope instability at this location were made following the 24 Aug 2017 event nor the 26 October 2017 event. The landslide was witnessed by a passing car during the 30 October 2017 event (Visso resident), who had just passed through the Strade Provinciale 209 tunnel west of the site and saw the slide debris pass over the roadway in his rear-view mirror.

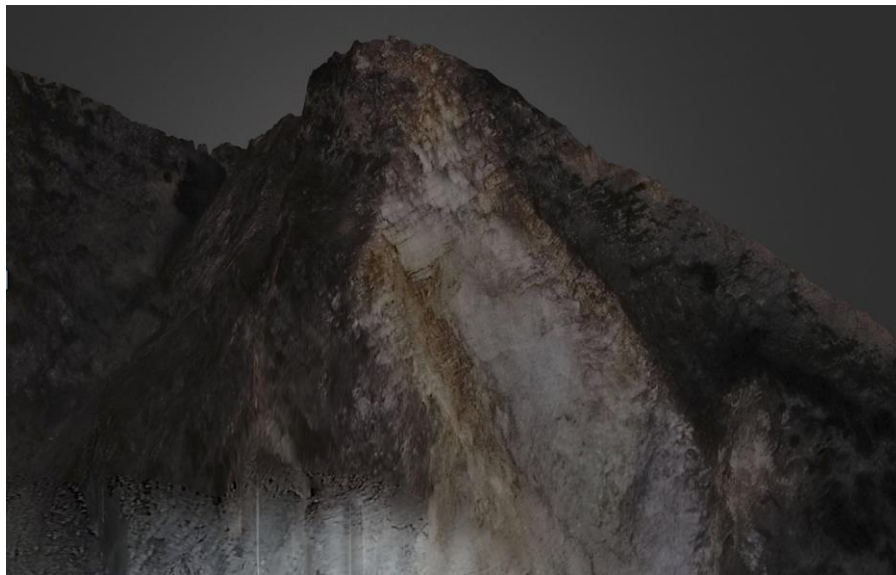
The upper detachment zone can be seen in the SFM imagery of Figure 4.6-4.7. In these images, the bedding is seen with an apparent dip towards the east of 20°-30°, and the wedge is apparently a double joint set orthogonal to the bedding. The failure occurred along the joint sets. Further analysis of the SFM data may resolve the strike and dip of the bedding and the joint sets that resulted in the detachment.

**Figure 4.6.** Headscarp of Nera rockfall.

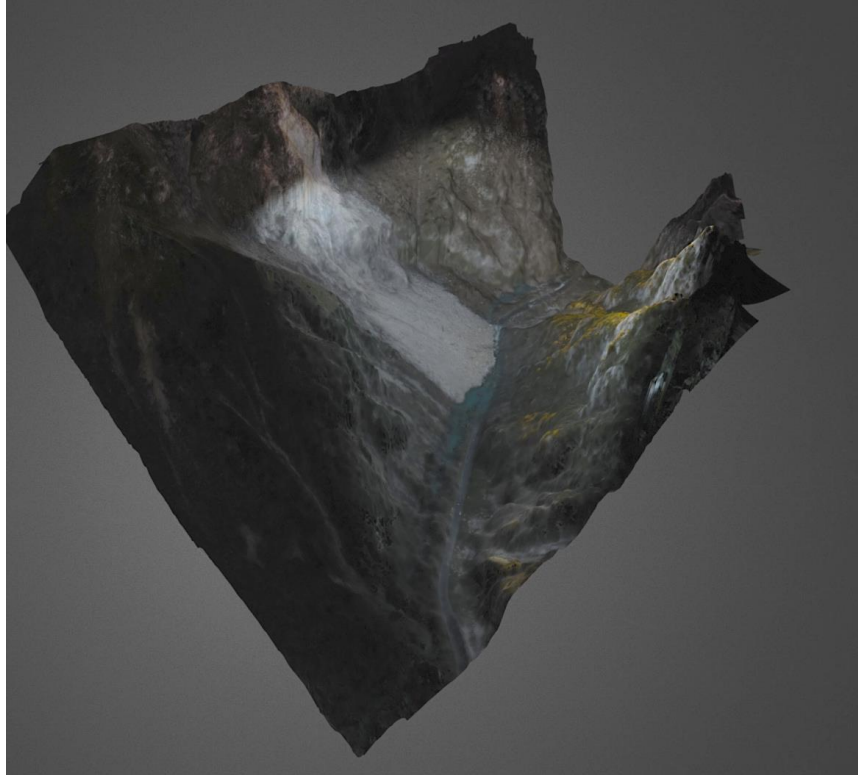
**Figure 4.7.** 3D Structure-from Motion (SfM) model of the Nera river valley at the rockfall. The Nera rock avalanche is seen here from the east (Visso) side of the rockfall. The light color on the midslope is from the setting sunlight on the SfM UAV imagery. Elevation difference from the crest of the headscarp to the river is 330m.

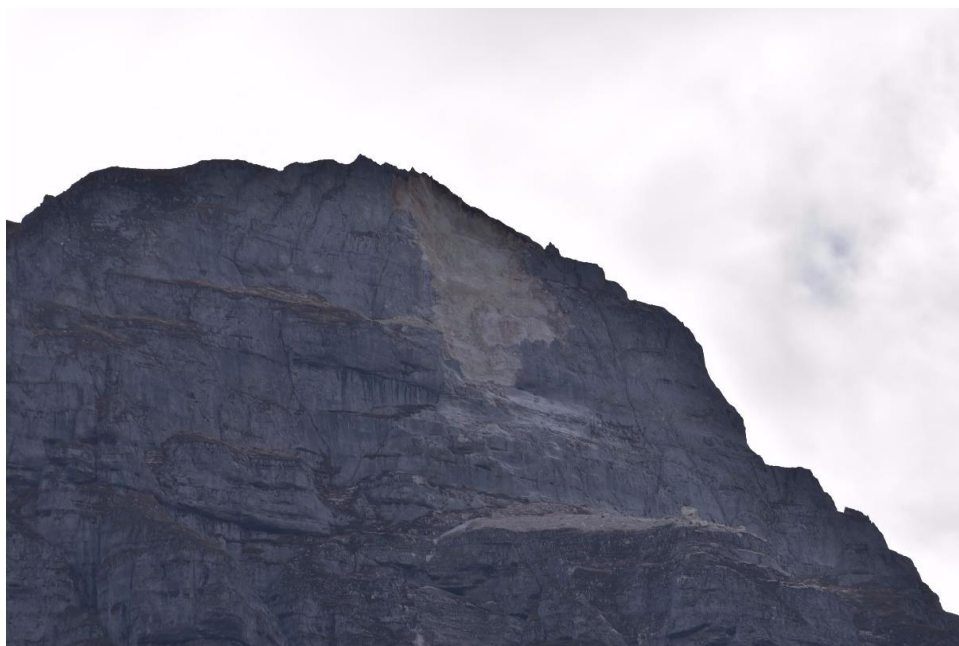
**Figure 4.10.** Photograph (300 mm) of the upper rockfall near the summit of Monte Bove.

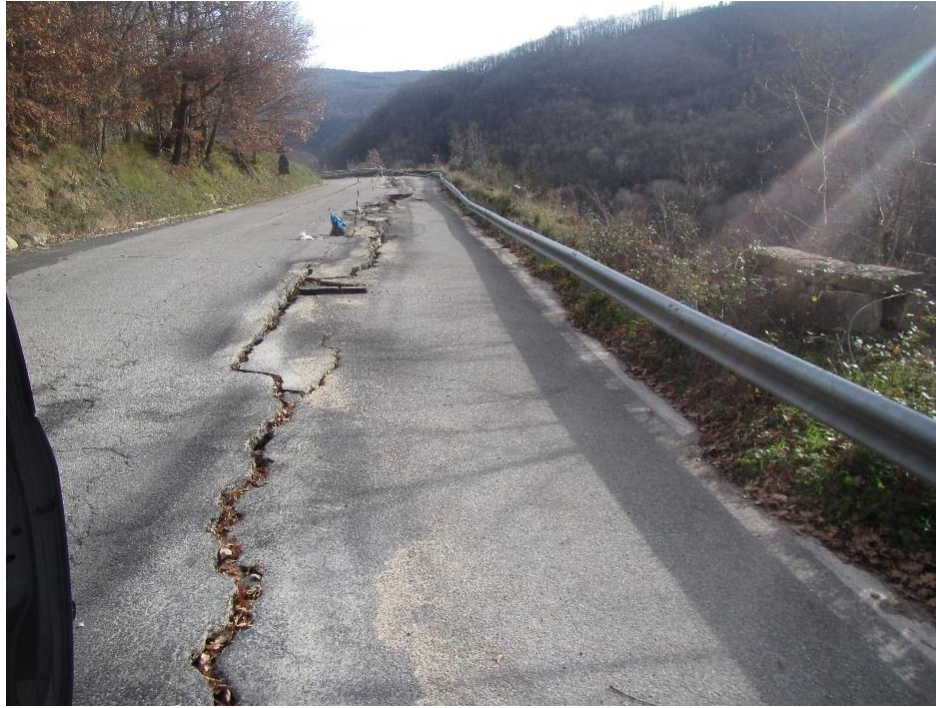
Moderate to severe damage was observed in most of the roads located adjacent to slopes and/or above retaining walls throughout Pescara del Tronto. An example of the typical damage that was observed is presented in Figures 4.16 and 4.17. Most of the damaged observed in the roads appears to be due to horizontal deformations in the fill material placed on the slopes (Figure 4.16) or behind the retaining walls (Figure 4.17). Observed damage typically consisted of long cracks in the pavement running parallel with the face of the slope or retaining wall, often with variable amounts of vertical offsets due to rotation of the retaining wall and/or settlement of the underlying fill.

**Figure 4.17.** Road damage induced by slight rotation of the underlying retaining wall and/or settlement of the retaining wall backfill.

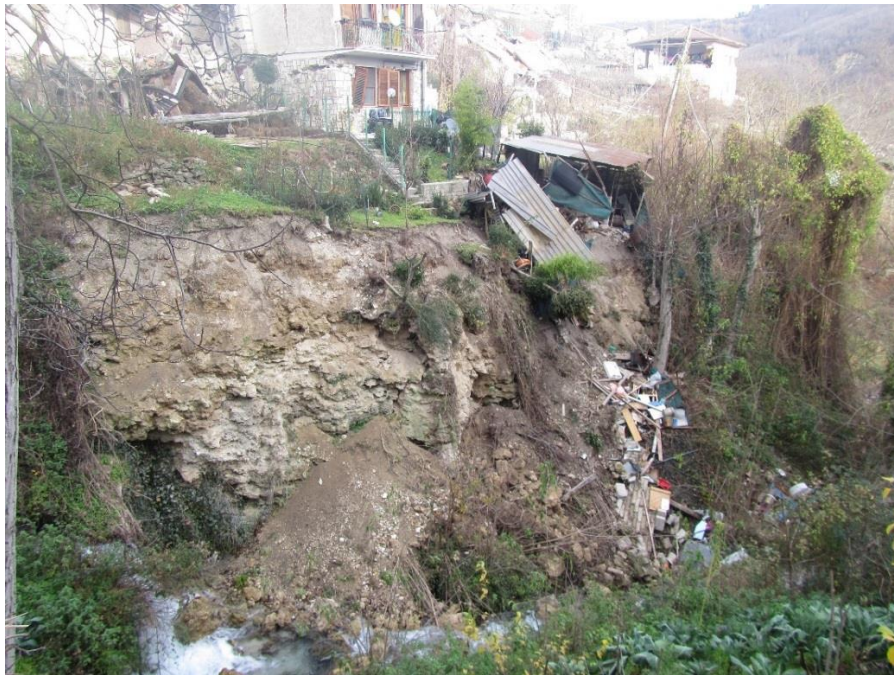
Within the village of Pescara del Tronto, there exists a natural creek that flows down a gulley located in the middle of the village. The presence of the gulley gives Pescara del Tronto the appearance of an inverted horseshoe shape or upside-down “U” when observed from the air (see Figure 4.12). During the December reconnaissance mission, GEER team members observed that portions of the gulley wall had failed in localized landslides, causing any overlying structures to fall into the gulley (Figure 4.20). The exposed scarps revealed talus comprised of heavily weathered limestone.

**Figure 4.20.** Failure of steepened talus gully wall material and crest area above (Location 3e).

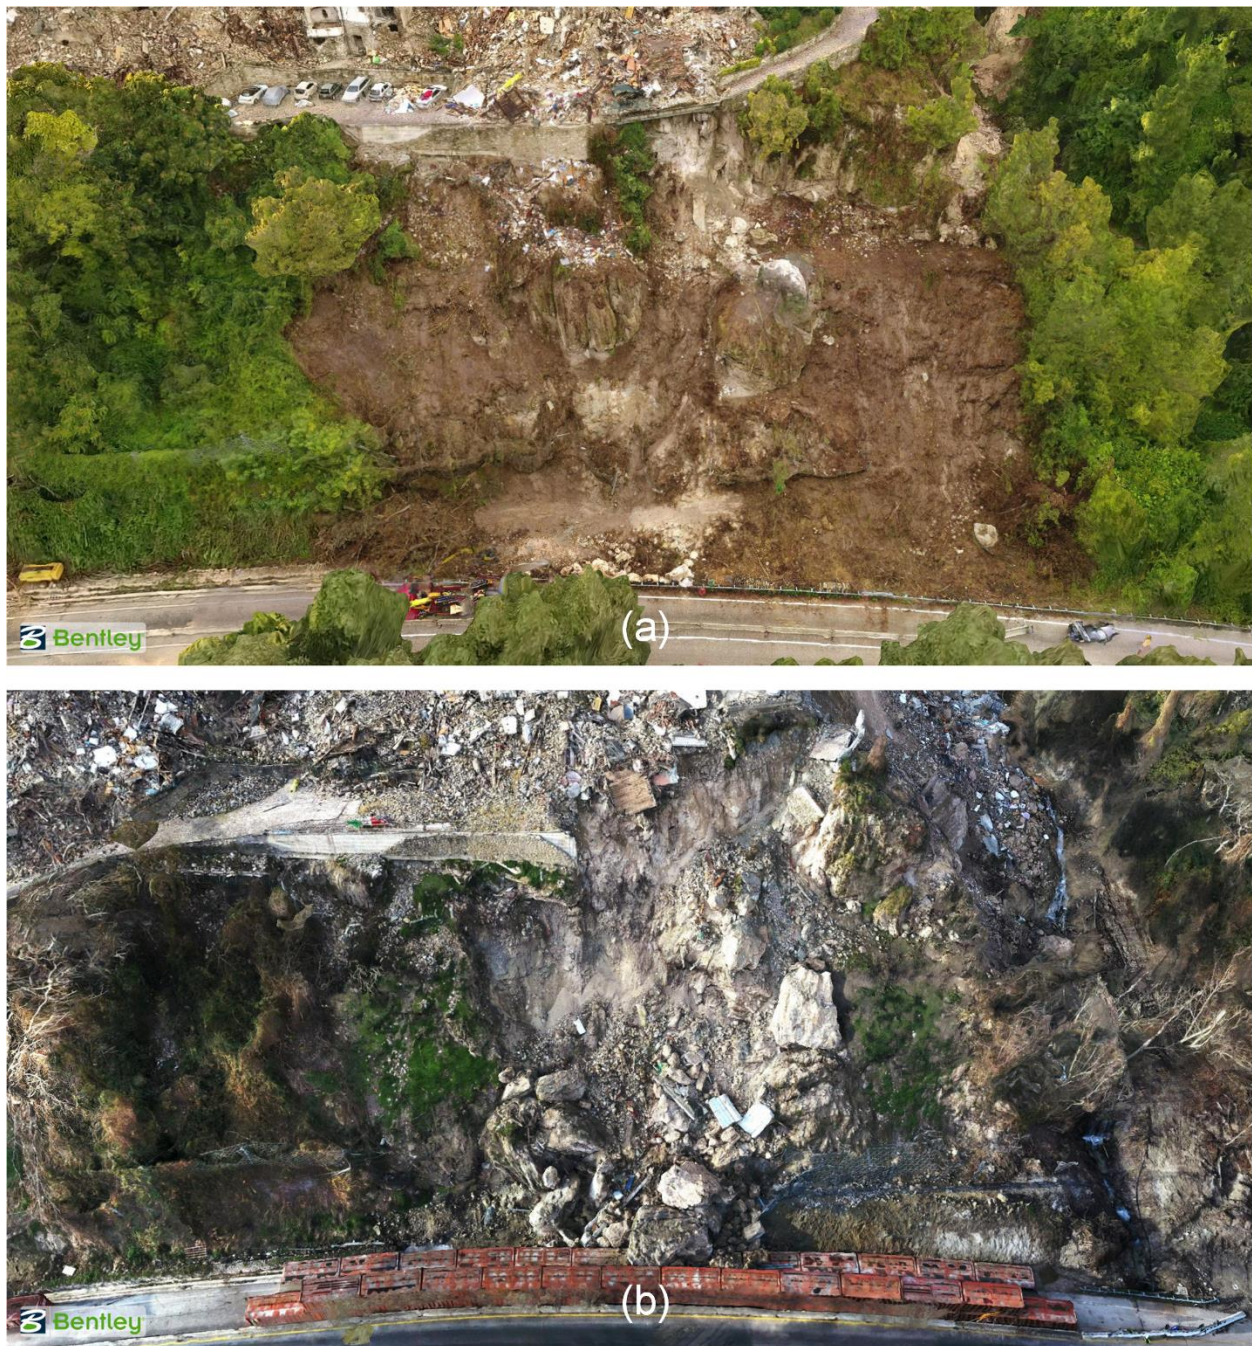
Area 1: Landslide above Strada Statale No. 4: As mentioned above, significant movement occurred on the landslide below Pescara del Tronto, directly above Strada Statale No. 4. This significant movement is apparent when comparing the landslide from September (Figure 4.22a) with the landslide from December (Figure 4.22b). Large portions of the road and supporting retaining wall that were standing in September collapsed with the landslide in December. It appears that the majority of the very large limestone boulders visible in December were dislodged from beneath the road.

**Figure 4.22.** 3D model comparison of the landslide below Pescara del Tronto between September 2016 (a) and December 2016 (b).

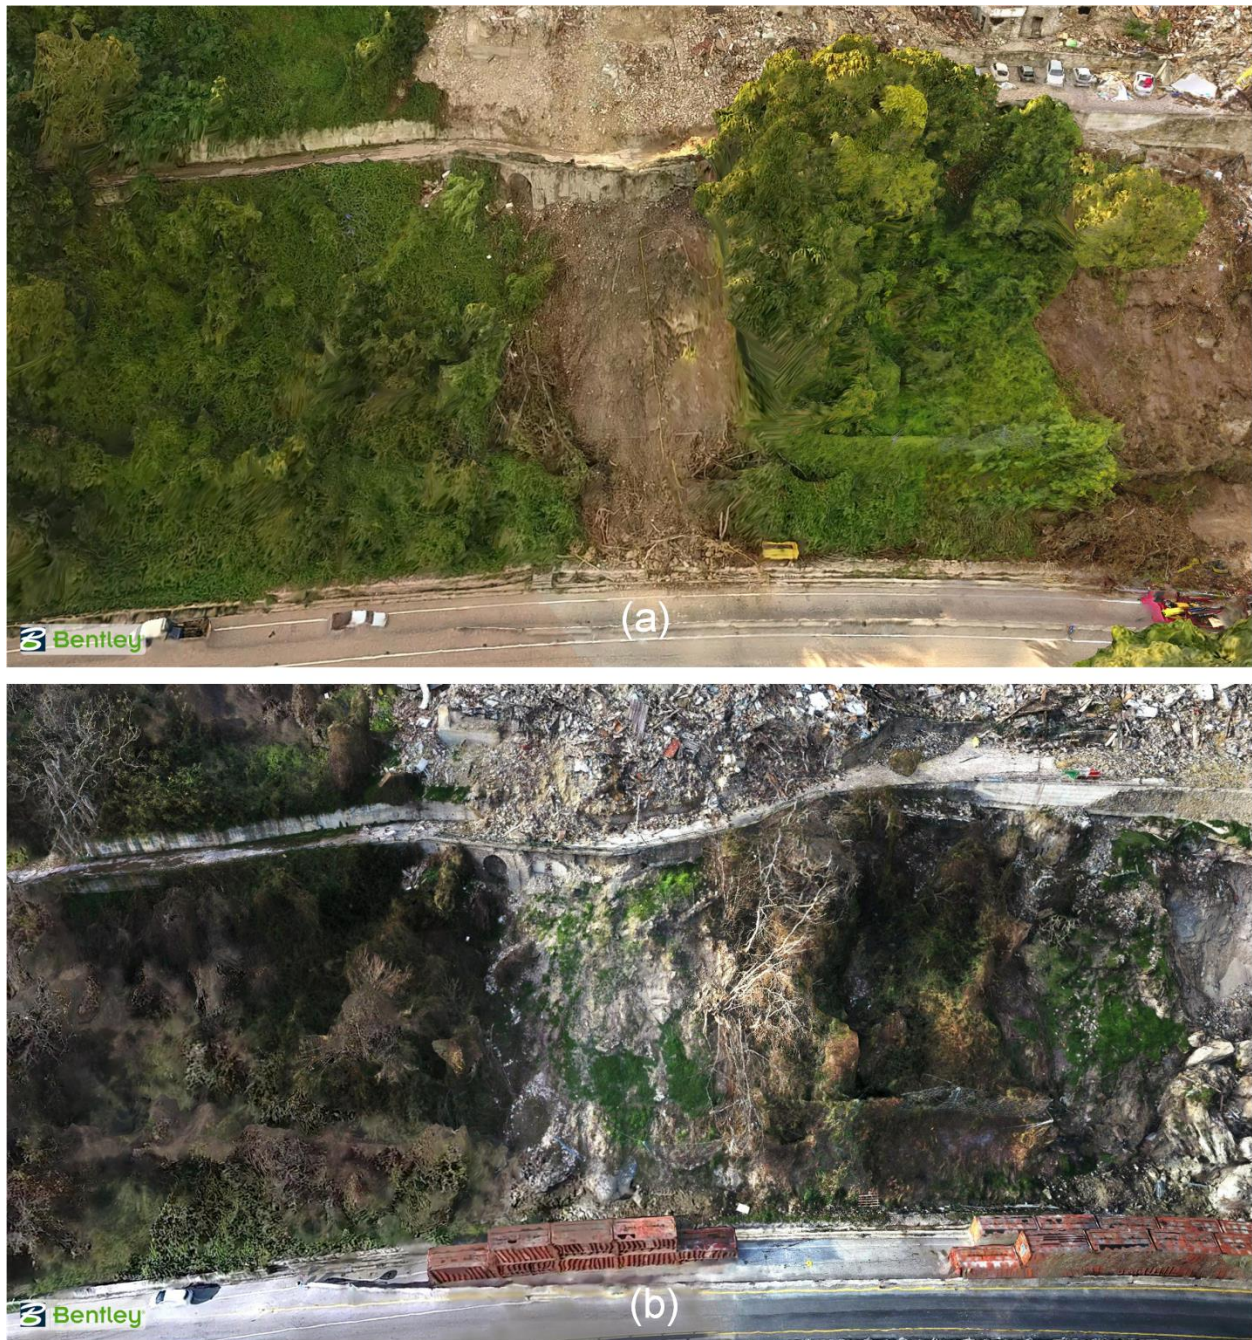
Area 2: Smaller landslide above Strada Statale No. 4: The smaller landslide just to the south of the landslide described as Area 1 was not observed to change significantly between September (Figure 4.23a) and December (Figure 4.23b). In this section, even the retaining wall supporting the road appeared to maintain its stability. However, significantly more structural debris from collapsed residences was observed at this location in December.

**Figure 4.23.** 3D model comparison of the smaller landslide below Pescara del Tronto between September 2016 (a) and December 2016 (b).

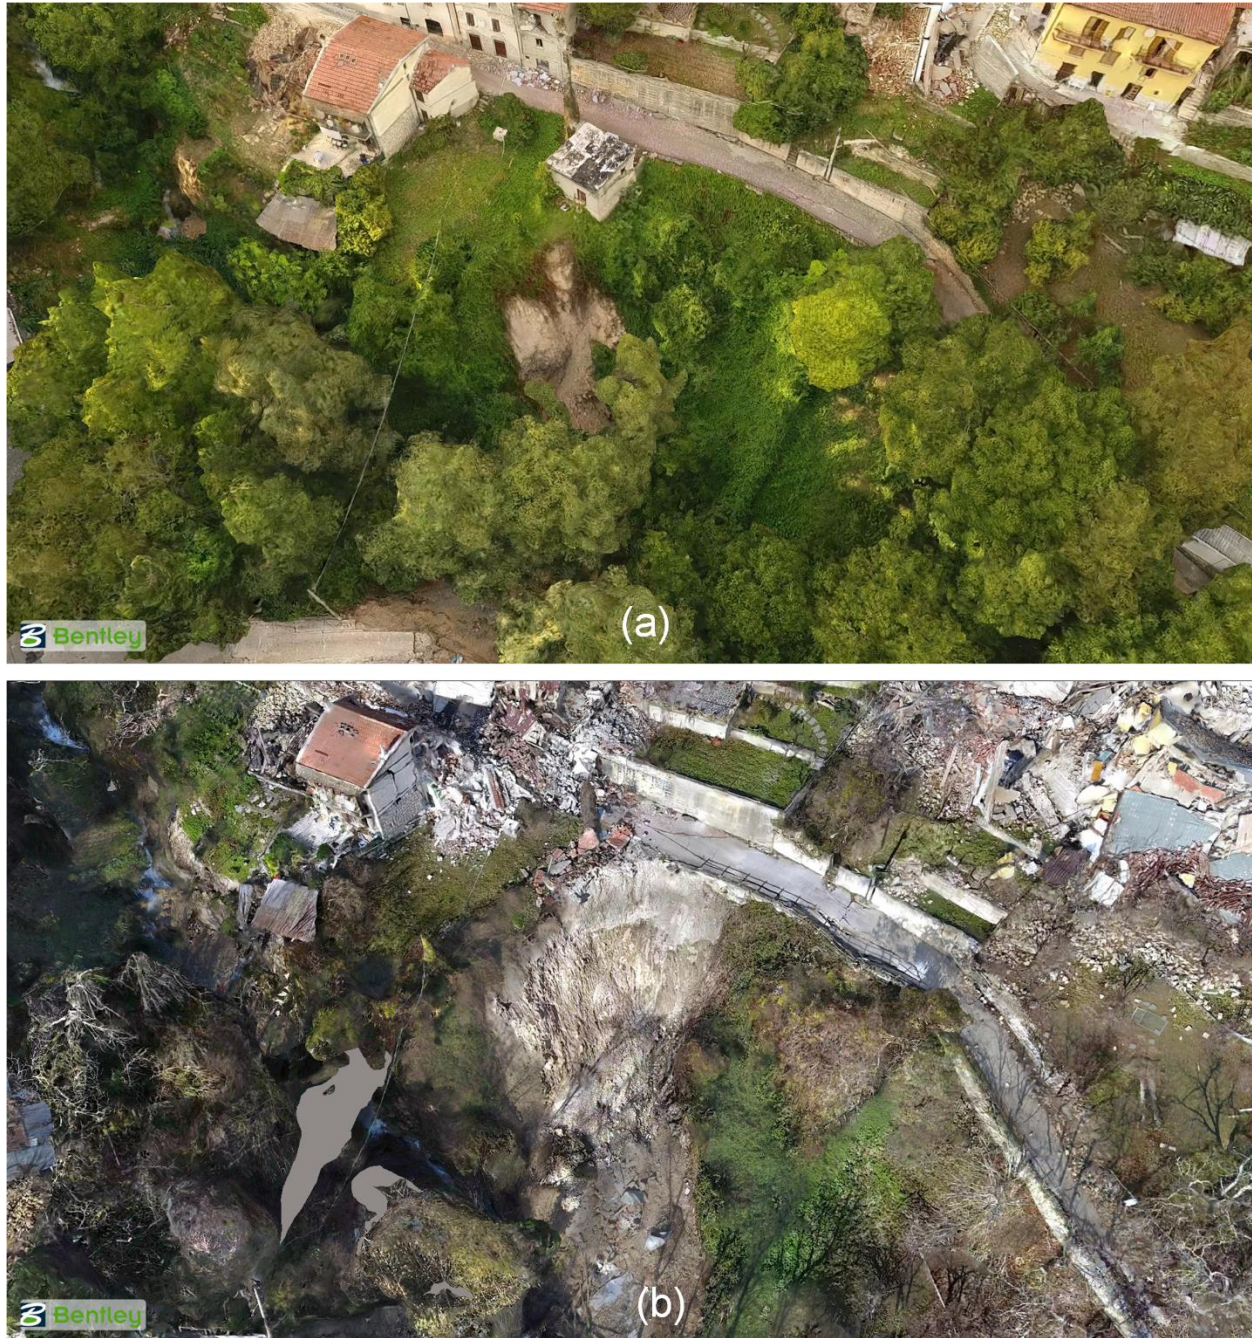
Area 5: Landslide near the Head of the Gulley: Following the 24 August event, a minor sloughing of the gulley wall was observed from the UAV imaging (Figure 4.26a). However, similar UAV imaging performed in December after the October earthquake events revealed that a section of the slope nearly 9 m thick and 20 m wide failed and slid into the gulley (Figure 4.26b). The remaining scarp is nearly 12 m in height and stands with at an angle of 52 degrees, remarkably similar to the same scarp angle that remains behind the failed lower retaining wall (i.e., Areas 3 and 4). A small residential structure that was observed to rest on top of the slope in September had plummeted into the gulley by December.

**Figure 4.26.** 3D model comparison of the landslide near the head of the gulley in Pescara del Tronto between September 2016 (a) and December 2016 (b).

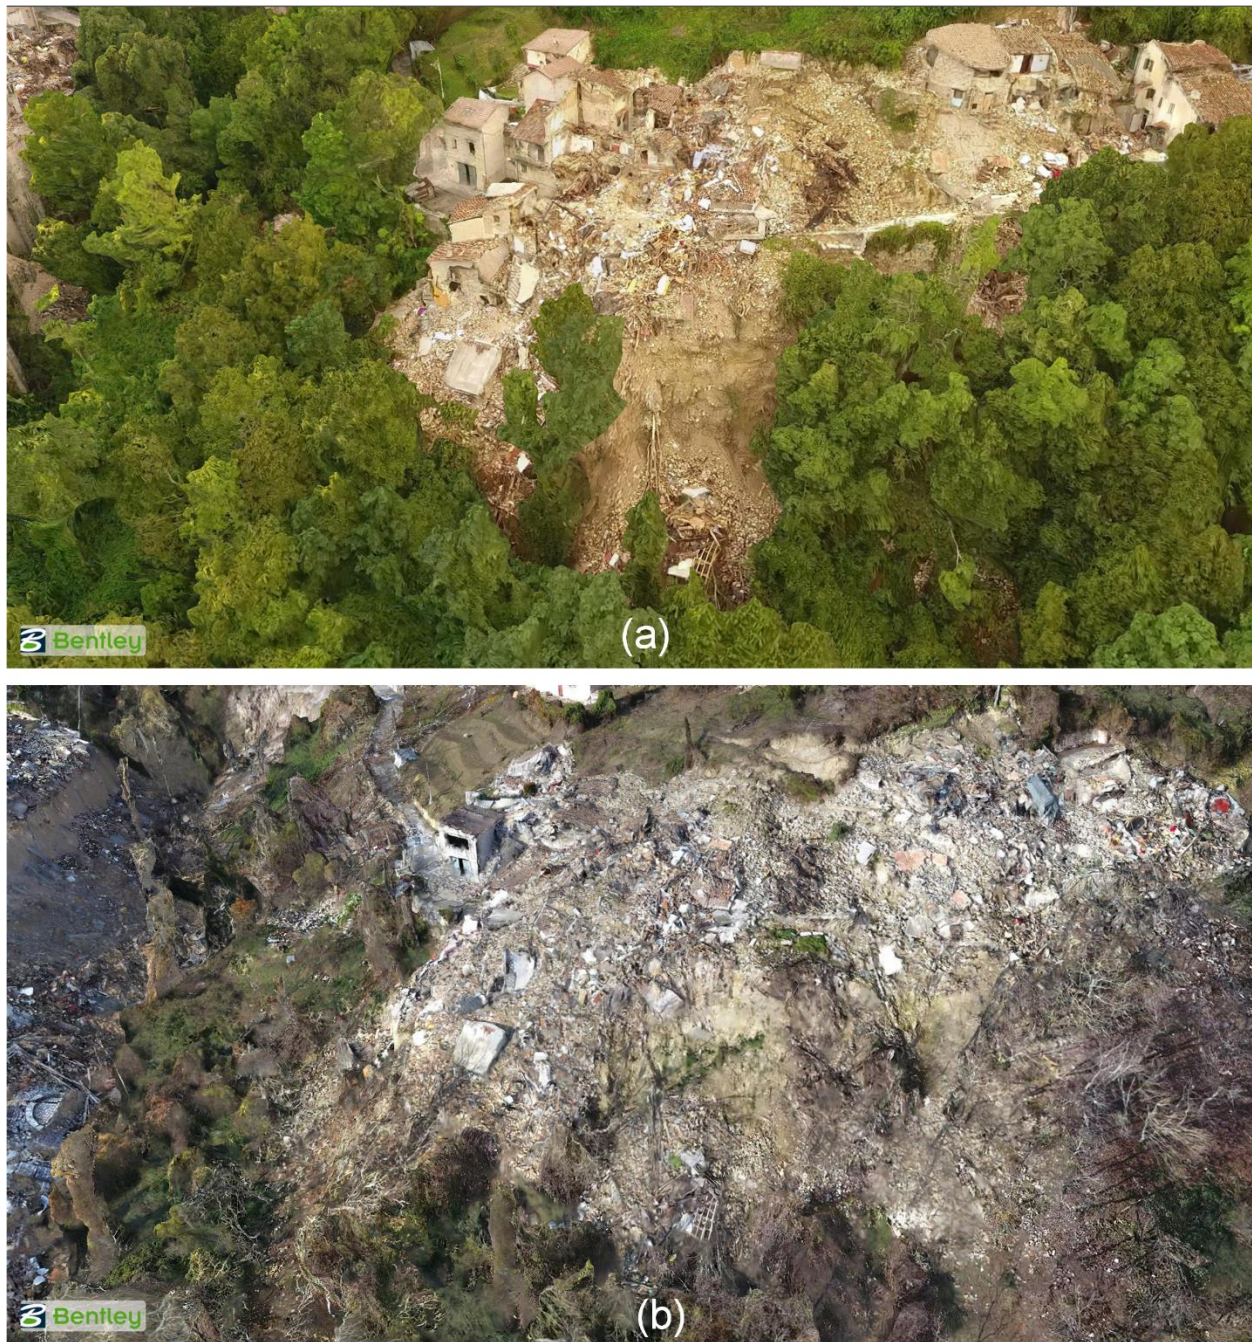
Area 6: Landslide on the Northern Slope of the Village: A shallow landslide was observed on the northern slope of the city following the 24 August event (Figure 4.27a). This landslide was observed to have exposed some tree roots and undermined a few residential structures. Investigation of the same slope in December following the October events revealed that the depth of the landslide remained relatively unchanged, but the width of the landslide appears to have expanded from 17 m in September to more than 36 m in December (Figure 4.27b). However, it is difficult to discern from the UAV images and 3D model whether the flattened trees along the slope are due to an expansion of the shallow landslide or due to structural debris from above the slope.

**Figure 4.27.** 3D model comparison of the landslide beneath the northern slope of Pescara del Tronto between September 2016 (a) and December 2016 (b).

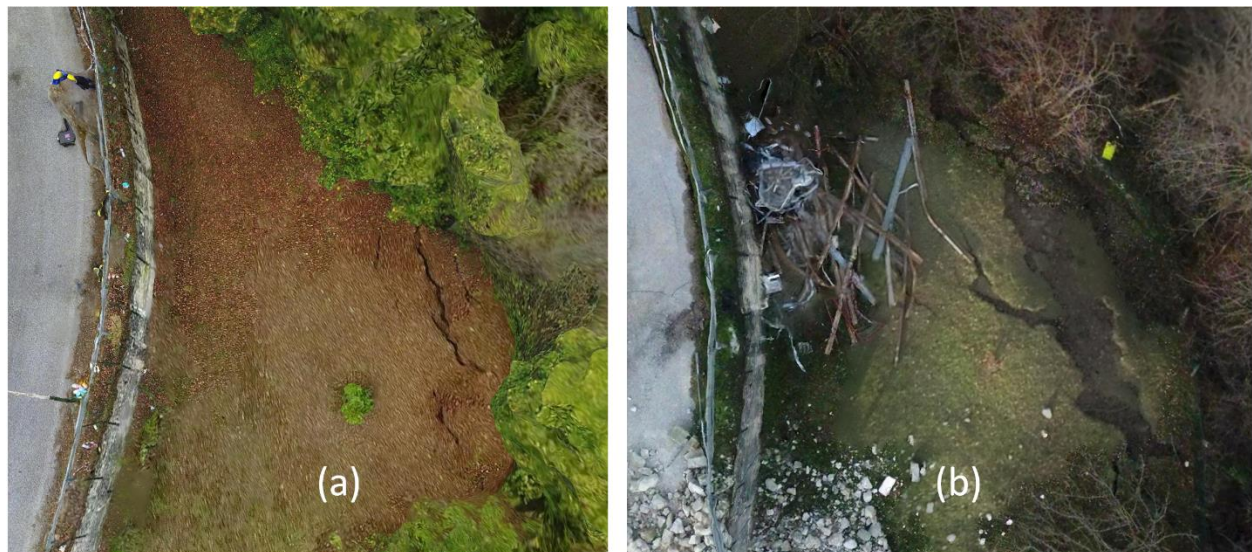
During the September 2016 reconnaissance, the GEER team observed a series of shallow cracks approximately 5–14 cm in width in the soil below the southeastern slope of the village (42.69406 N 13.25019 E). These cracks were believed to have been caused by shallow landslide displacements in the soft silty-sand located near the surface of the fillslope.

Much more deformation was observed by the GEER team in December 2016. Figure 4.35 presents 3D model images of the headscarp cracks in both September (Figure 4.35a) and December (Figure 4.35b). In general, the GEER team observed that the cracks developed in the 24 August event opened further from 5-14 cm to 0.8-1.9 m. The depth of the crack was measured from the 3D model as approximately 55 cm. However, beyond the widening of the cracks from the shallow landslide, no other significant damage was observed at this point.

**Figure 4.35.** 3D model screenshots showing cracking from a shallow landslide (a) during the September GEER reconnaissance, and (b) during the December GEER reconnaissance.

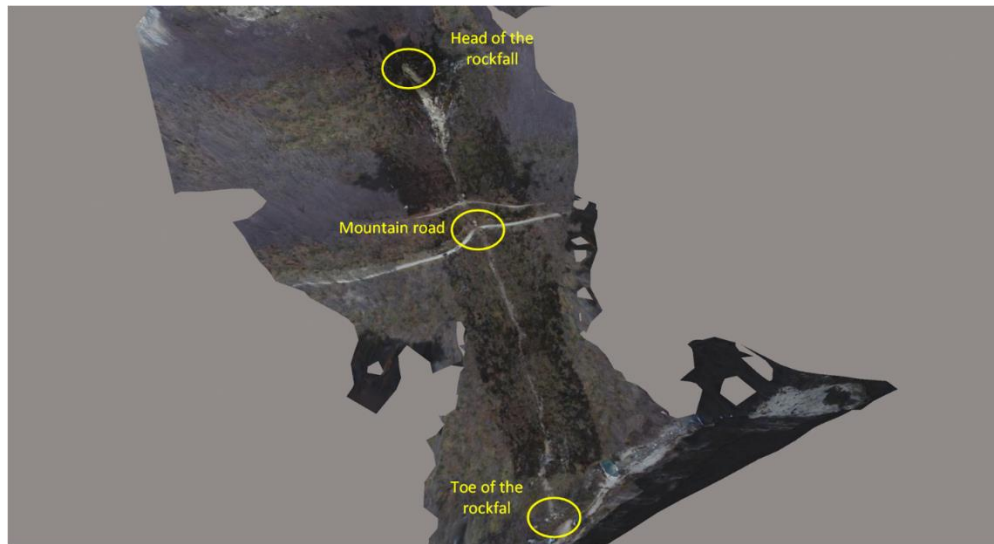
The second site encountered (Point 5b) was a rockfall nearly 419 m in length along the mountain road in the Valle di Panico. A 3D model of the entire rockfall is presented in Figure 4.40. The total change in elevation from the source of the boulder to the final resting place on the bottom of the valley is approximately 235 m. The sideslope of the valley was measured to rest at an angle of 34 degrees from the horizontal (1.5H:1V). Numerous boulder fragments ranging in diameter from gravel-size to over 3 m were observed and photographed along the entire rockfall length. The largest boulder fragment was observed to rest adjacent to the mountain road, and is pictured in Figure 4.41. The source boulder appeared to be approximately 11.2 m in length and to have broken free from a formation of heavily weathered and fractured limestone located 91 m above the mountain road (Figure 4.42). Much of the limestone boulder exploded into gravel-sized fragments in the first 90 m of the rockfall. The remaining parts of the boulder broke in larger fragments while tumbling to the bottom of the valley. At the bottom of the valley, over ten large boulder fragments ranging in diameter from 0.8-2.9 m were observed to rest at the valley floor just 13 m from what appeared to be a small pump or power house (Figure 4.43). Amazingly, none of the boulders appeared to damage this small structure.

**Figure 4.40.** 3D model of the Valle di Panico rockfall.
