# Engineering Reconnaissance Following the October 2016 Central Italy Earthquakes *Version 2*

GEER Team Leaders: Jonathan P. Stewart and Giuseppe Lanzo

Geotechnical Extreme Events Reconnaissance Association  
Report No. GEER-050D  
8 May 2017

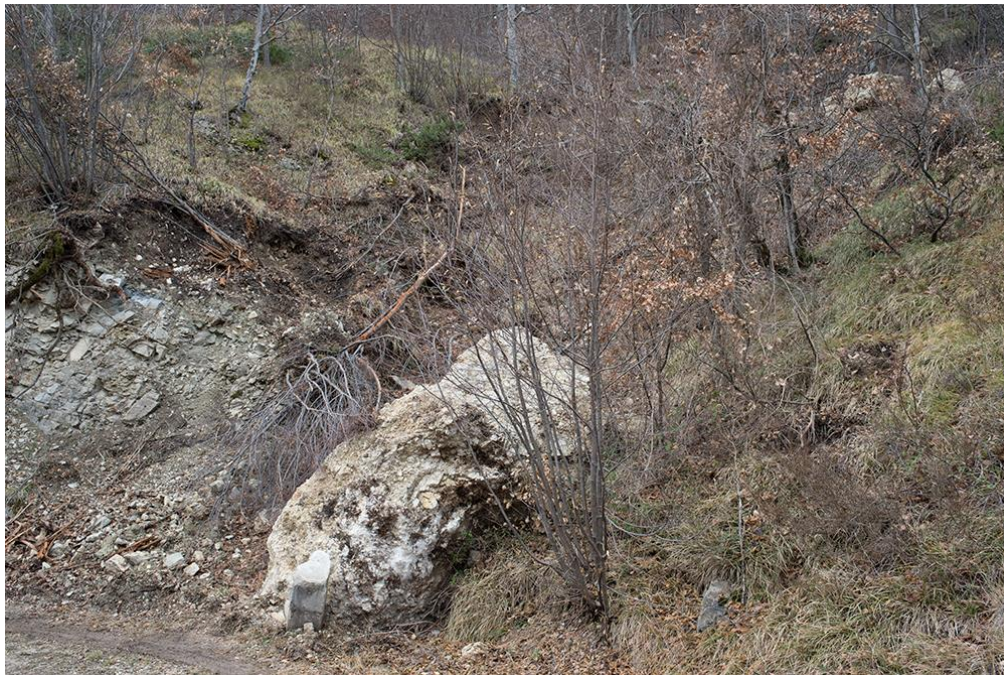
**Figure 4.41.** Photograph of the largest observed boulder fragment in the Valle di Panico rockfall. The boulder measured approximately 3.0 meters in diameter.

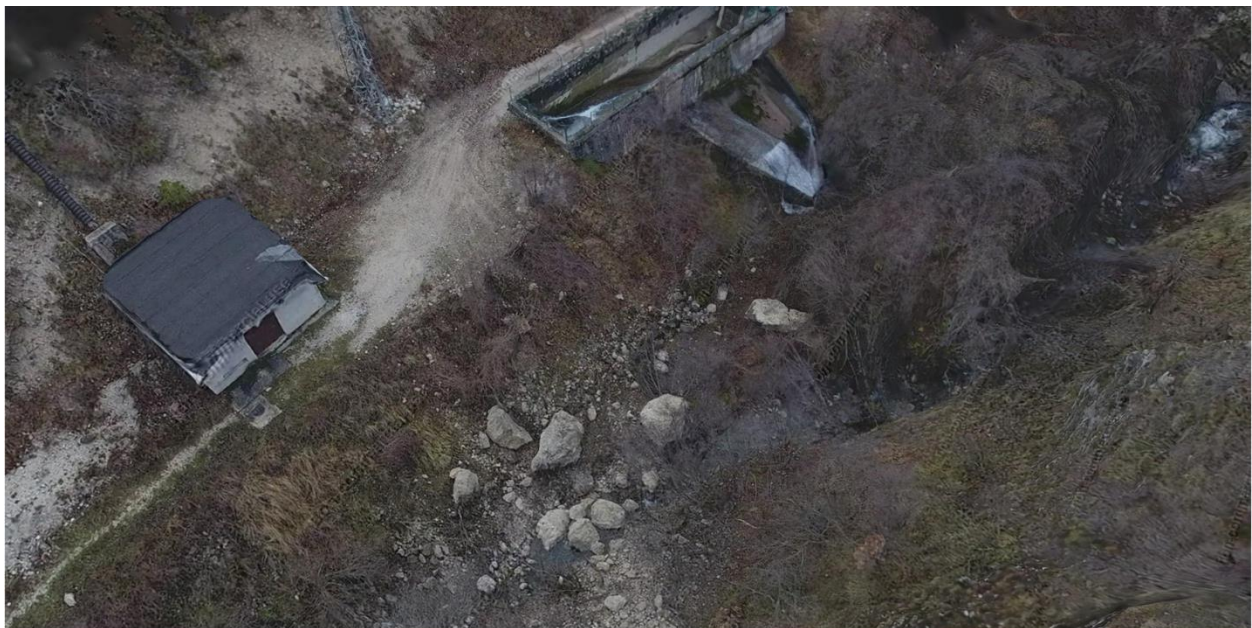
The second site encountered (Point 5b) was a rockfall nearly 419 m in length along the mountain road in the Valle di Panico. A 3D model of the entire rockfall is presented in Figure 4.40. The total change in elevation from the source of the boulder to the final resting place on the bottom of the valley is approximately 235 m. The sideslope of the valley was measured to rest at an angle of 34 degrees from the horizontal (1.5H:1V). Numerous boulder fragments ranging in diameter from gravel-size to over 3 m were observed and photographed along the entire rockfall length. The largest boulder fragment was observed to rest adjacent to the mountain road, and is pictured in Figure 4.41. The source boulder appeared to be approximately 11.2 m in length and to have broken free from a formation of heavily weathered and fractured limestone located 91 m above the mountain road (Figure 4.42). Much of the limestone boulder exploded into gravel-sized fragments in the first 90 m of the rockfall. The remaining parts of the boulder broke in larger fragments while tumbling to the bottom of the valley. At the bottom of the valley, over ten large boulder fragments ranging in diameter from 0.8-2.9 m were observed to rest at the valley floor just 13 m from what appeared to be a small pump or power house (Figure 4.43). Amazingly, none of the boulders appeared to damage this small structure.

**Figure 4.43.** 3D model of the boulders and small power or pump house at the toe of the Valle di Panico rockfall.

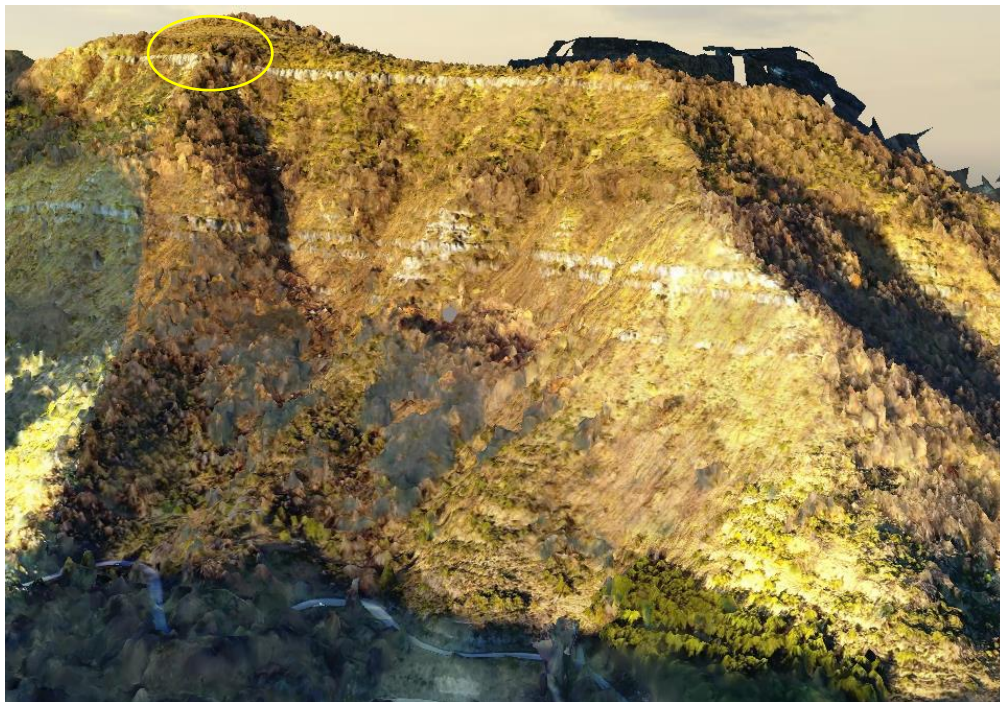
The rock source itself is an 8 m-thick massive arenaceous limestone exposure that sits at the top of the slope like a rim. The primary source area of the rockfall was measured using 3D point cloud models to be 8 m tall (the entire thickness of the exposure) and 10.5 m wide, and at least 3 m deep. Several other, smaller, source areas on the rim-rock exposure were identified and on

**Figure 4.45.** 3D SfM model of rockfall site near Cervaro village (Crognaleto). Primary rockfall source circled in yellow.

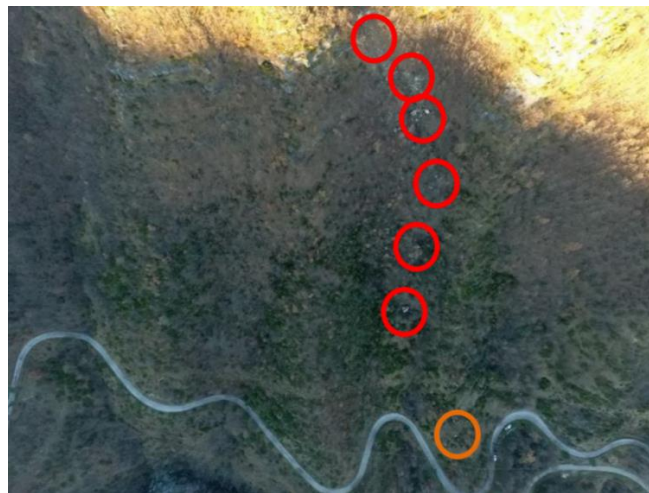
Below the primary rock source, the large rock mass(es) followed the path of a drainage feature to the bottom of the slope just above the Via Trieste where the final large boulder came to rest. Figure 4.47 shows an overhead photo from the UAV with large boulder fragments identified. It may have been that the source rock was already fractured prior to the earthquake into 1 to 4 m blocks that dislodged. It may also be that the rock dislodged in one or two large masses that broke apart on the runout down the slope towards the road. The final boulder is 4 m and is shown in Figure 4.48, with a 1.7 m tall GEER team member next to the boulder for size perspective.

**Figure 4.47.** UAV aerial image of rockfall path from source at top of slope to the road at bottom of slope. Red circles show boulder fragments larger than 1.5m. Last boulder fragment from rockfall near road at base of slope is circled in orange.

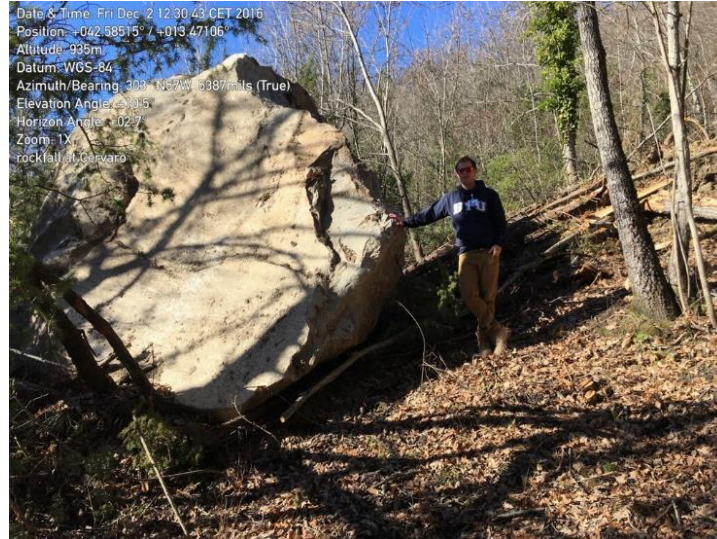
**Figure 4.48.** Last boulder fragment (4 meter) from rockfall near road at base of slope. Also pictured are freshly toppled trees from the boulder's roll to its final position.

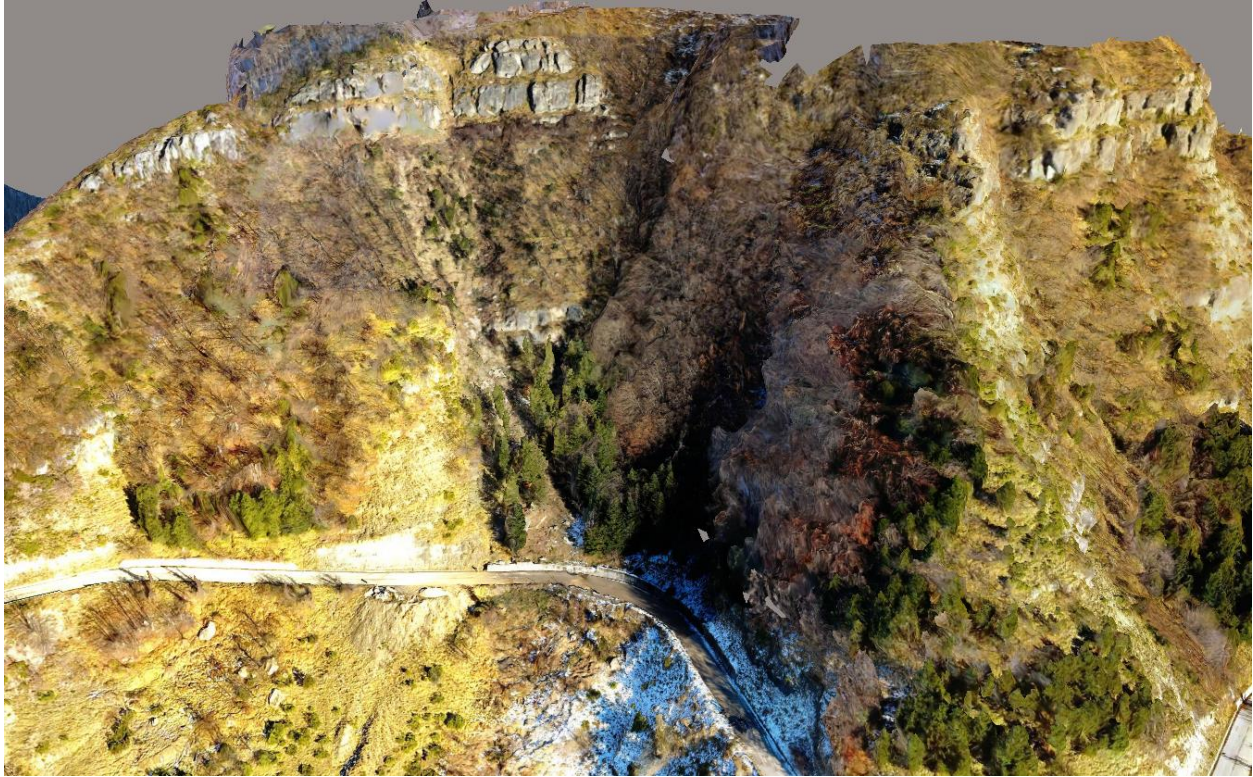
**Figure 4.50.** 3D SfM model from UAV imagery of the rockfall site near Crognaleto village.

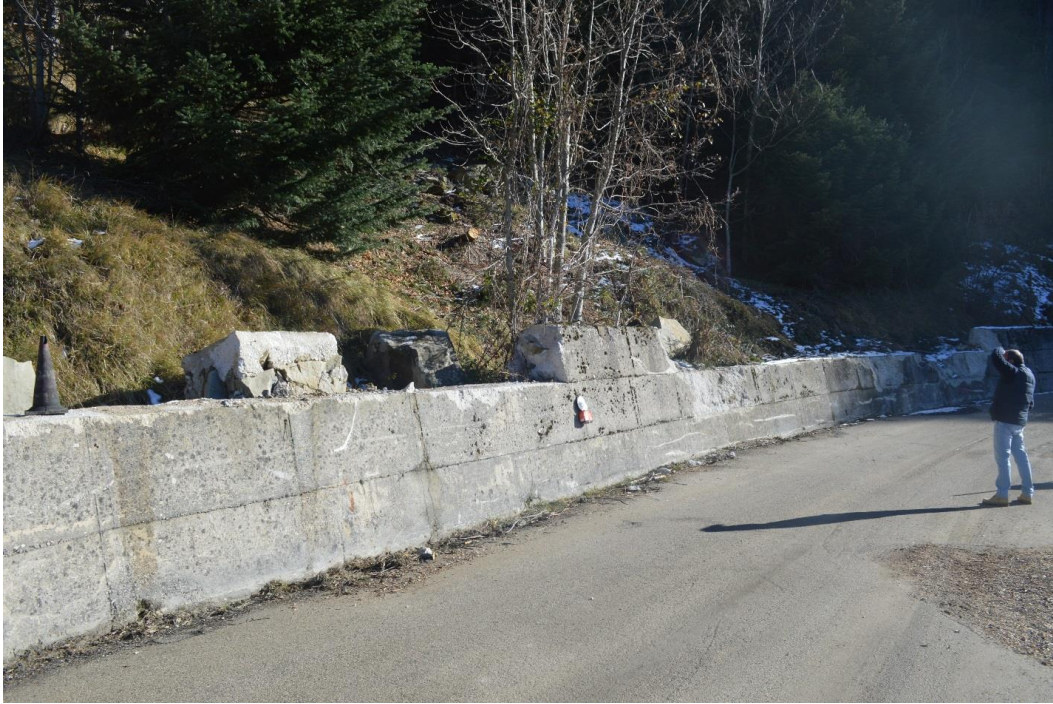
The local highway officials also cleared 9 pre-cast concrete retaining wall blocks off of the road after the earthquake. These large pre-cast concrete retaining wall blocks can be seen in Figure 4.52. Each block is 75cmx100cmx200cm and has some small amount of internal steel reinforcement. Two small steel bars connect the blocks in the wall as shear pins. Concrete blocks not damaged appeared to be in good condition, with minor surface weathering but no cracking. The wall is formed by stacking the blocks with shear pins in place and a thin mortar. The retaining wall runs along SP45a for several hundred meters with no damage from strong ground shaking or dynamic lateral earth pressures. Only at the location of the rockfall and boulder run-out does that wall have any damage. At the location of the boulder runout, it is clear that the boulders impacted the back of the retaining wall, dislodged or shattered the top blocks, and then fell onto or over the road. Figure 4.53 is a photo taken from SP45a looking up the runout chute towards the top of the slope over the damaged wall. A number of boulders are seen in this photo, two of which are the remains of a larger boulder blasted by local officials due to an unsafe resting position. Other, older rockfall boulders can be seen in Figure 4.53 covered in vegetation. This

**Figure 4.52.** Damaged segmented concrete block retaining wall at roadway. Blocks that fell on road have been removed by local officials prior to visit from GEER team.

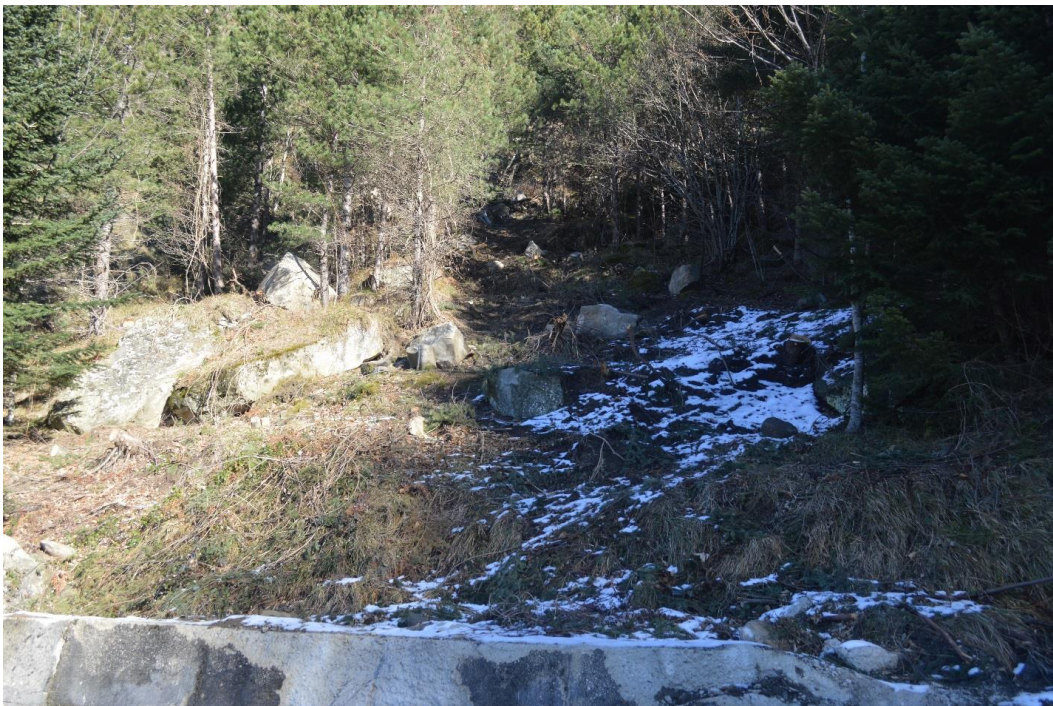
shows that the area has regular rockfall, and that strong ground shaking from the October 30, 2016 earthquake has merely accelerated the rate of rockfall at the site.

**Figure 4.53.** View upslope of damaged retaining wall, boulder fragments and runout chute from road at rockfall site near Crognaleto village.

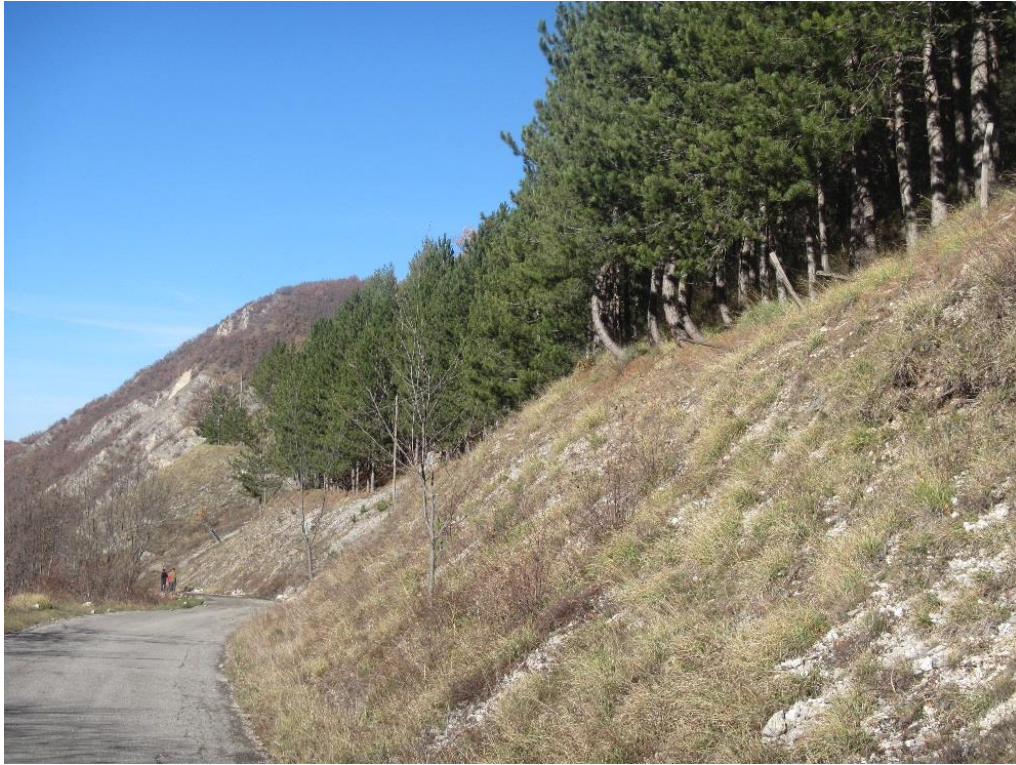
**Figure 4.55.** Pescia rockfall. Possible soil slope creep shown by tree trunks. (site 9a).

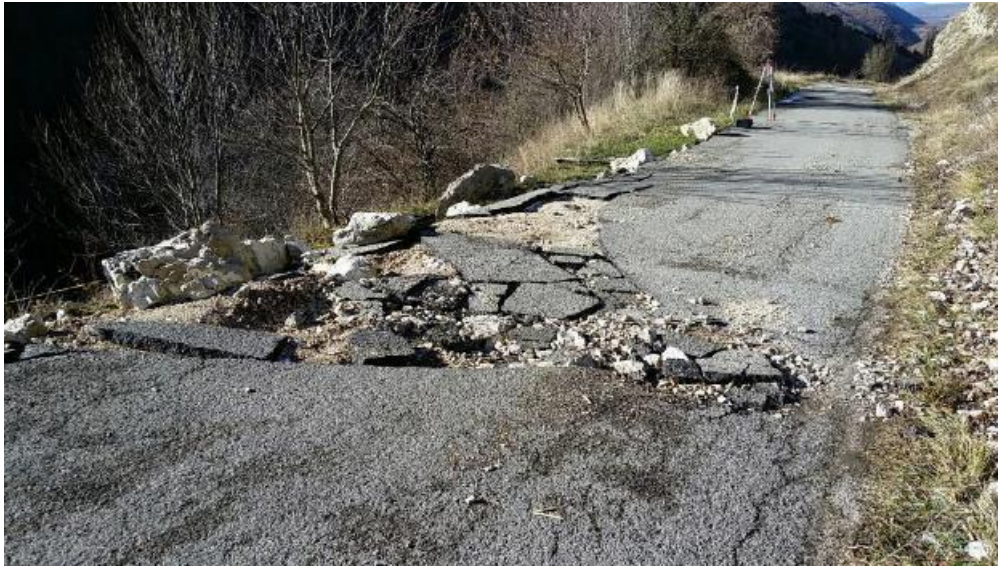
Damage to the pavements occurred between Sites 9a and 9b from boulder impacts. Figure 4.58 shows one such example. This photo was taken directly up-slope of the large 2.5 m boulders

shown in Figure 4.56. Still visible in Figure 4.58 is a smaller 1 m limestone boulder and several smaller 150-250cm boulders. The pavement was heavily damaged from multiple boulder impacts at this and several other locations.

**Figure 4.58.** Damage to road from 1-2.5 m boulder impacts from rockfall between sites 9a and 9b.

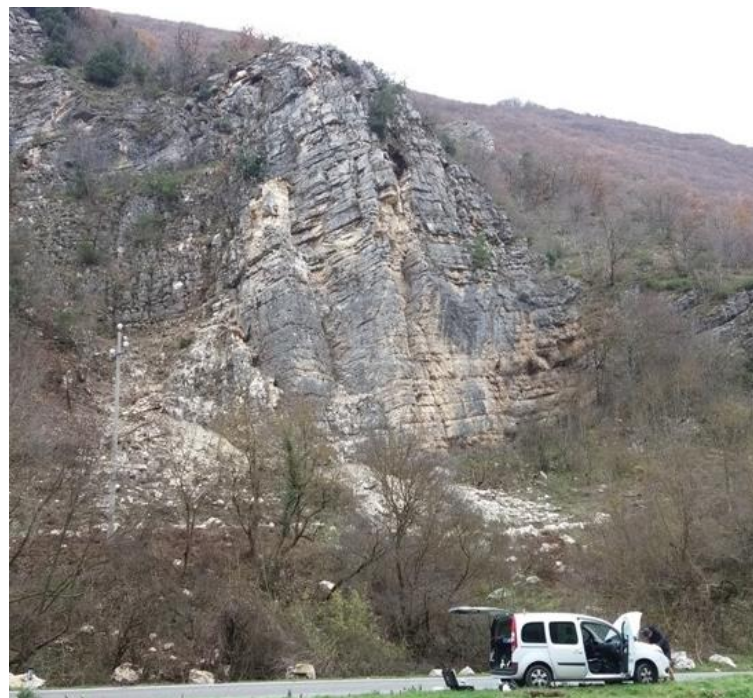
At km 3, a 23-m-high rock column consisting of regular sub-horizontal layers of *Maiolica* limestone experienced toppling of the prism cap (9 m high) and falls of blocks from the column walls and the cap itself (Fig. 4.61). The prism is isolated by very persistent joints belonging to two nearly-orthogonal sets, at about 45° with respect to the direction of the valley and its cap was intensely fractured and split in two parts by an opened joint before the 2016 seismic sequence.

**Figure 4.61.** Frontal view of the rock monolith at km 3 of SP134 motorway.

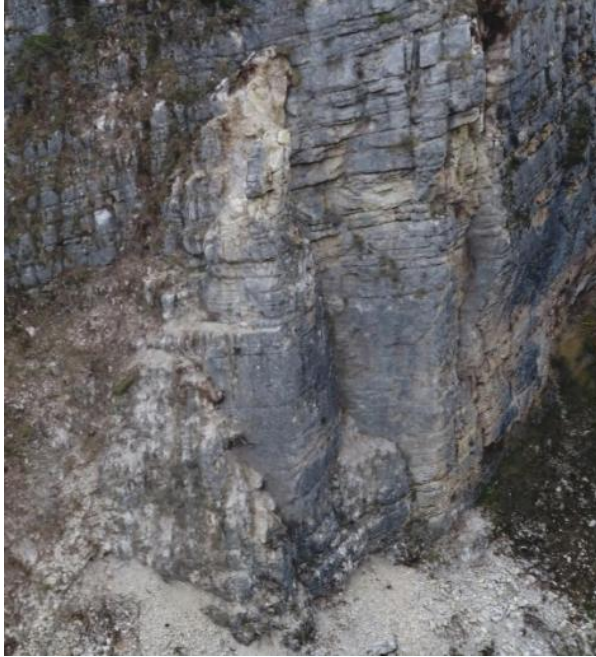
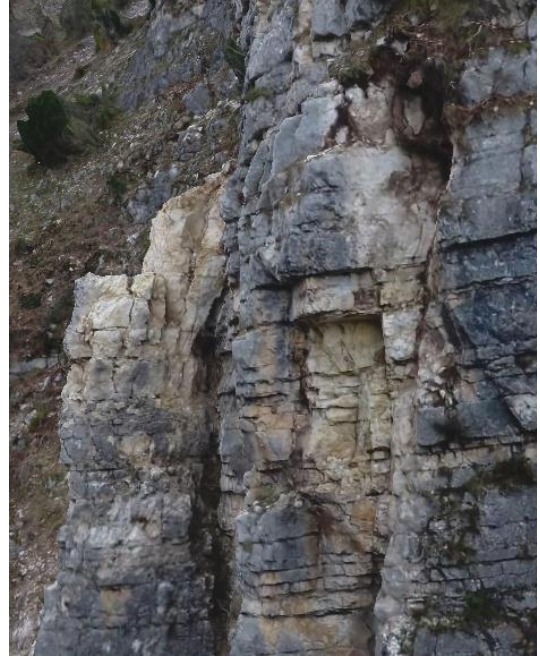
UAV surveys (Figure 4.62) suggest that one half of the cap collapsed and the other was damaged as a consequence of the shaking. Similarly, a 4-m-high hanging wedge (center-left of Figure 4.62b) and a 5-m-high wedge high (upper-left in Figure 4.62b) failed along a bedding joints and slid along two vertical joints, respectively.

Drone surveys and pictures at high-zoom also indicate that fracturing of the rock mass is not homogeneous. The rock mass above the bedding joint at delimiting the cap bottom is more fractured. Similarly, the rock forming the cap and the cliff at its left is more fractured than the rock mass at the right of the cap.

**Figure 4.62.** Lateral view from the drone of the rock column at km 3 of SP134 (right valley flank) (a). The left part of the column cap collapsed producing two small avalanches towards the column front and along the column free side. Scars left from two wedges on the adjacent cliff (b). Leftward tilting of the column cap is also visible in figure 4.61.

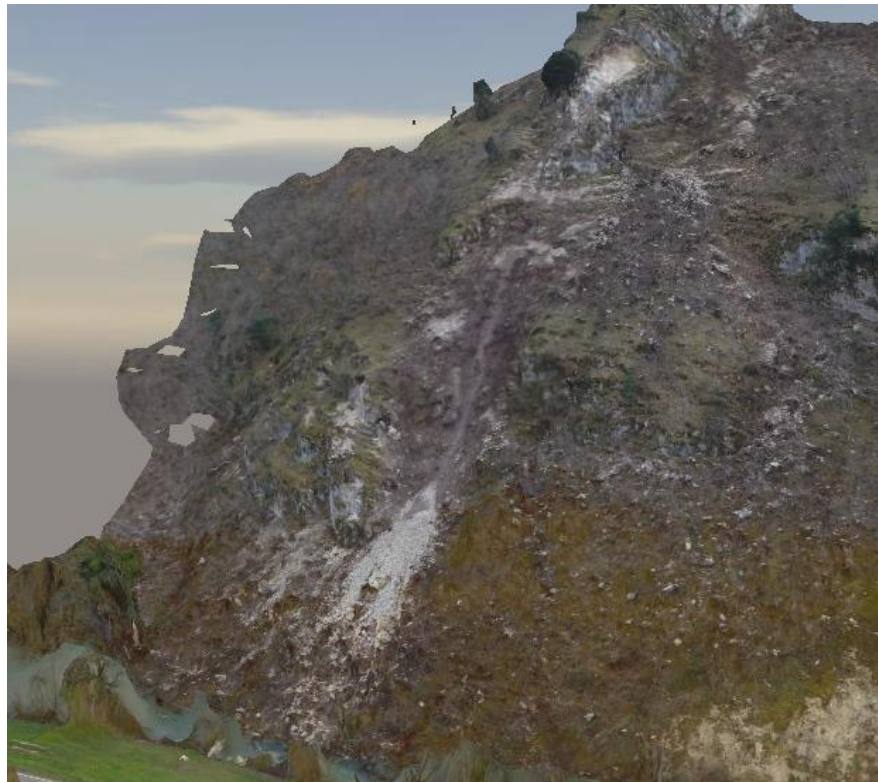
On the opposite valley flank a rock slide occurred at a height of about 100 m above the valley bottom and evolved into a small rock avalanche that fell into the Nera River (some blocks reached the opposite riverside). UAV drone surveys were instrumental in understanding landslide geometry, rock mass quality and failure mechanism. The oblique view in Figure 4.63a shows that the failed mass suffered intense fragmentation and eroded the slope with significant entraining of debris overlying the bedrock. Figure 4.63b indicates that sliding involved an intensely fractured wedge of Maiolica limestone delimited by two persistent joints.

**Figure 4.63.** General oblique view of the rock slide and subsequent rock avalanche on the left flank of the Nera valley (km 3 of SP134 motorway) (a); detail of the detachment area (b). Images taken from the 3D model generated by BYU on the basis of drone surveys.

The left joint (observing the slide from the opposite flank) was a sub-vertical, persistent, relatively smooth and striated fault plane, whilst the right joint seems a relatively planar joint dipping at low angle toward the valley. It is not clear if the mechanism was planar or three-dimensional. The wedge is sector-shaped with a height of 19 m and maximum transversal dimensions of 8m and 4 m respectively.

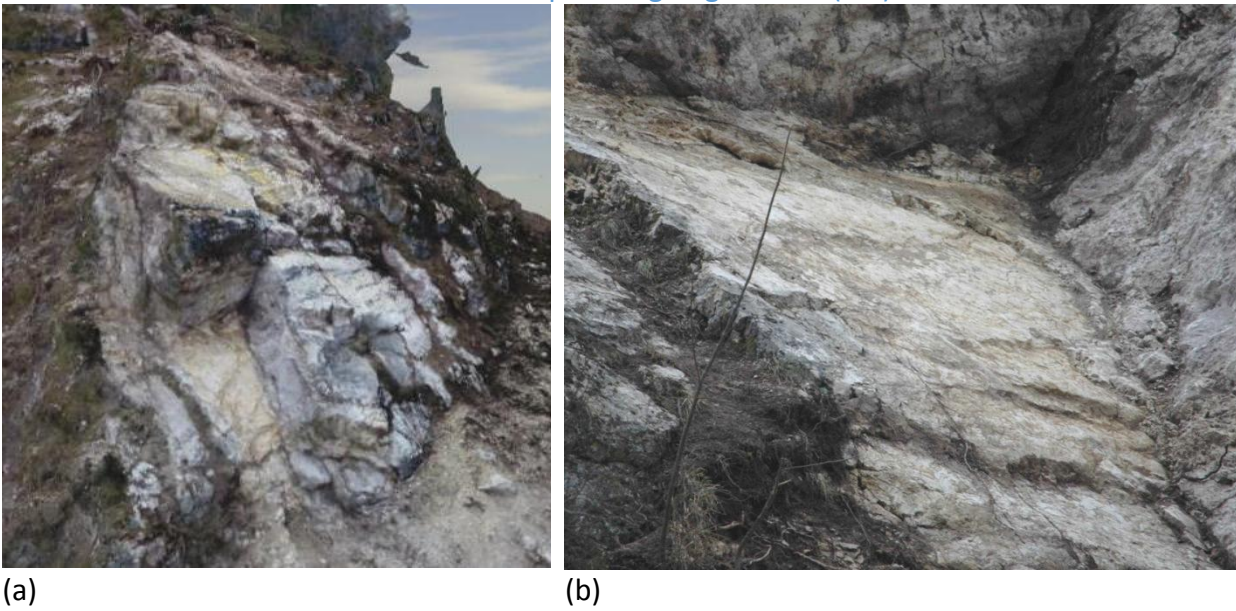
A major failure occurred on the northeast flank of the valley at km 4 of SP 134 within the Maiolica limestone formation (Figure 4.64a). The subsequent rock avalanche invaded the motorway and the valley bottom below for a stretch of about 70 m with large blocks (Figure 4.64b and Figure 4.64c). The main slide scar, located on a rock spur, suggests that the slide was planar and occurred along a surface composed of a number of bedding joints dipping parallel to the slope. Bedding dip progressively increases from top to bottom of the slide scar (about 15°). The sliding surface is stepped both longitudinally and transversally (Figure 4.65a) due to well-spaced joints of two sets roughly striking parallel and normal to the slope. On the left side (viewing from the opposite, southwest, valley flank) the slide had no confinement. Bedding joints are relatively planar and smooth with apparent signs of weathering and oxidation (Figure 4.65b). Weathering seems to affect also the sub-vertical joints. The rock mass appears to be loosened and the rock material intensely fractured.

**Figure 4.65.** Close-range drone image of the detachment area (a) and detail of a bedding joint forming the sliding surface taken from the slide foot (b).

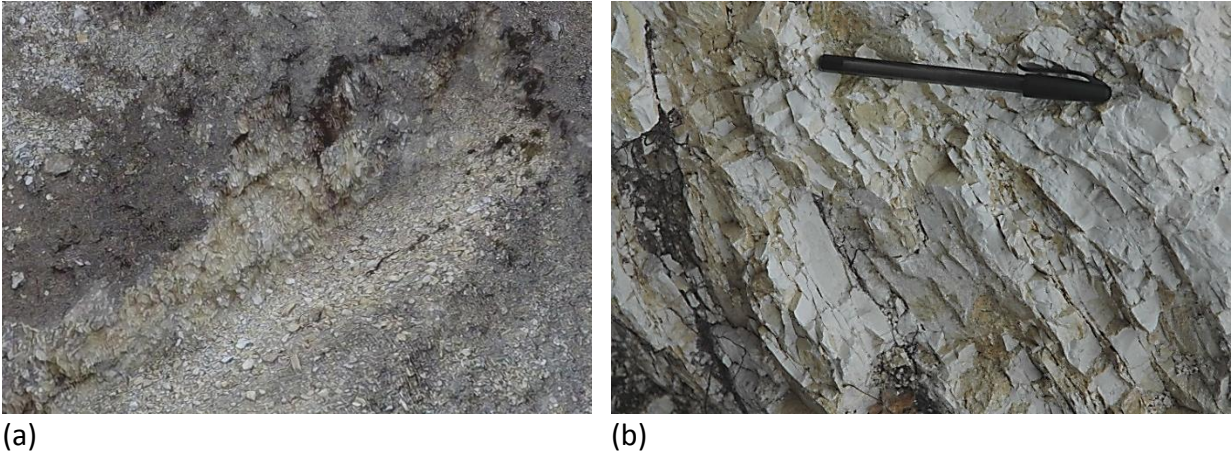
The height of the main slide scar is estimated from the 3D model as 20m. A layer of pervasively fractured rock below the main scar (Figure 4.66a), visible on close-range drone images, and the general ravinement of the lower half of the slope, suggest that the slide mass might extend downward and movement could be more complex. Apparent loosening of the rock mass, the pervasive fracturing of the rock at small scale (Figure 4.66b) indicate that the zone is tectonically disturbed and the slope underlying the slid rock spur was involved in the failure.

**Figure 4.66.** Drone image of a layer of cataclasized limestone located under the main slide scar(a) and detail of a pervasively fractured limestone block fallen from the slope (b).

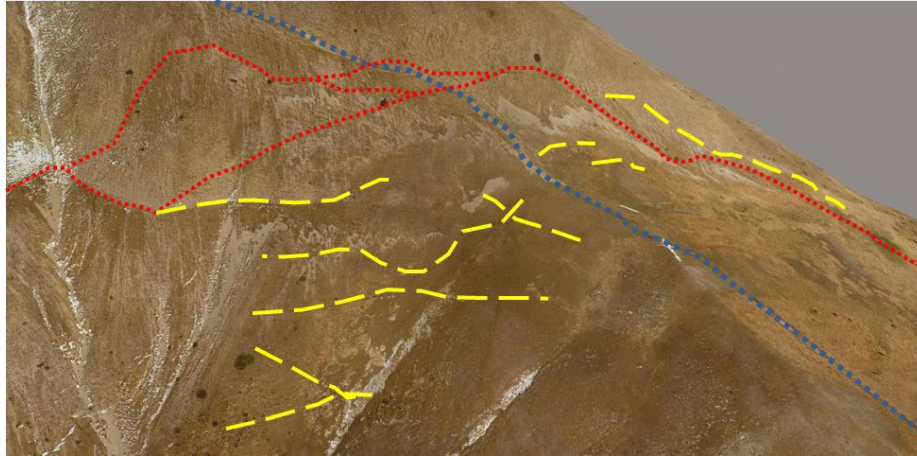
**Figure 4.68.** Excerpt from 3D SfM model from UAV data of the side of Mt. Vettore. The blue dashed line indicates the footpath. Red dashed line indicates scarps interpreted as the fault rupture trace(s). The yellow lines indicate scarps interpreted as minor slope instabilities. Looking from the west to the west face of Mt. Vettore. On the right of the image the slope descends on the south face towards road SR477.

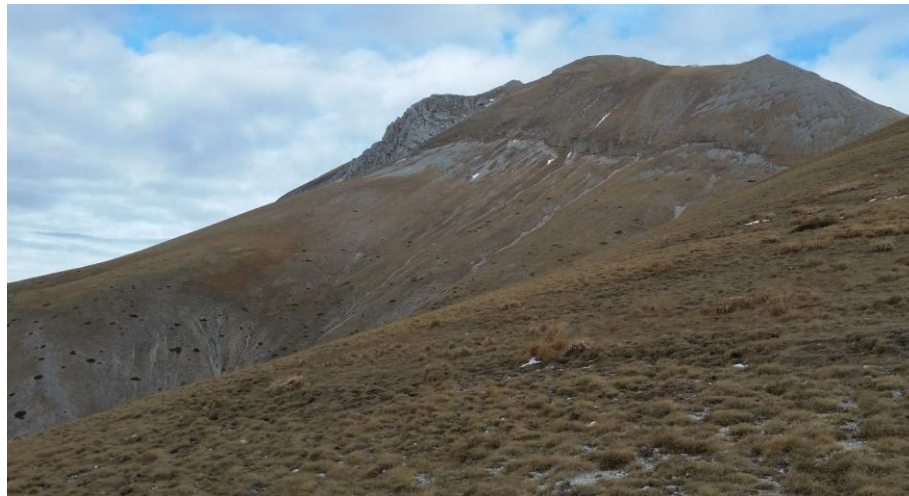
Figure 4.69 shows an image of the west flank of Mt. Vettore from the footpath. The fault can be seen as the linear feature that runs along the slope towards the large rock outcropping of Cima del Lago at the top left of the Massif in the image. Also seen are thick talus slopes below the fault. One of the key features that enables the distinction between faulting versus slope instability or talus compaction as the cause of the linear feature is the large fault offsets recorded at Cima del Lago. At Cima del Lago, limestone bedrock rises steeply to exposure at the surface. Below the limestone exposure is thick sediments without thick talus. At this location very few fissures, cracks, or scarps were identified aside from the fault trace. The only scarp lower on the slope at this location is the western trace of the Mt. Vettore fault, approximately half way down the face of the Massif to the Piano Grande plain below. No indications of slope instability, landsliding, or talus compaction were observed at Cima del Lago.

**Figure 4.69.** View of the east slope of Mt. Vettore showing talus slopes and fault rupture trace. Fault rupture displacements and strong ground shaking have caused densification and sliding of talus.

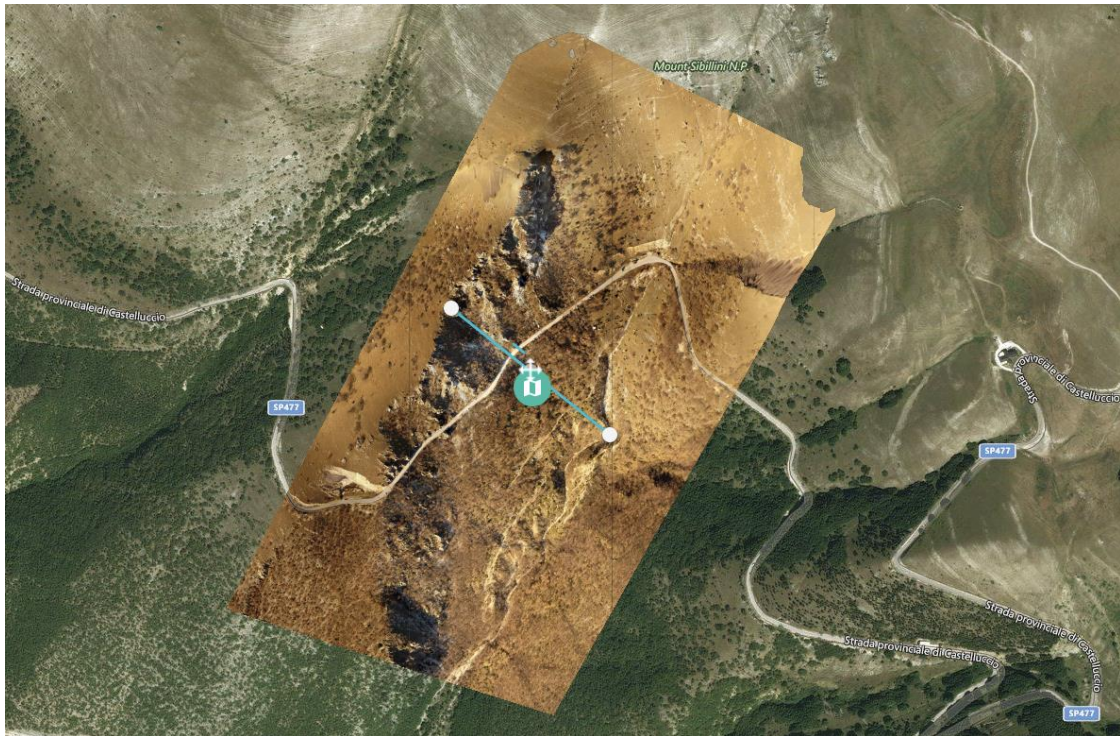
**Figure 4.72.** Overlay of the UAV orthomosaic on top of the Google Earth image of SP477, the Castelluccio-Norcia highway. Isolated boulders descended from the outcrop NE trending ridge on the left down to a ravine on the right side of the ortho mosaic, a maximum distance of approximately 375 m as indicated by the blue line. No other area along this highway had intense rockfall.

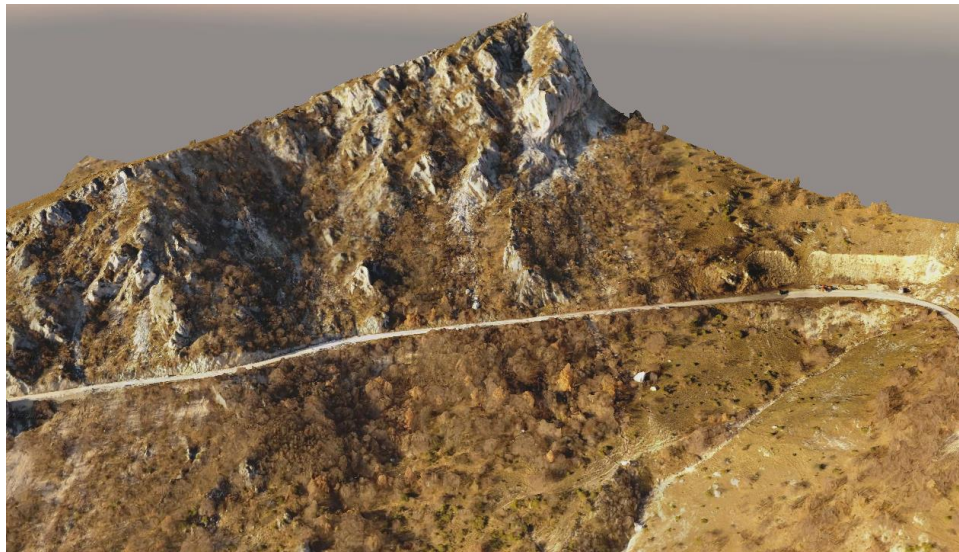
**Figure 4.73.** The most active area along Route SP 477 is below a large south facing ridge of limestone. The white areas near the top of the ridge are zones where fresh rock is exposed following collapse of blocks. This ortho mosaic is part of a three-dimensional model produced using a UAV phantom 4.

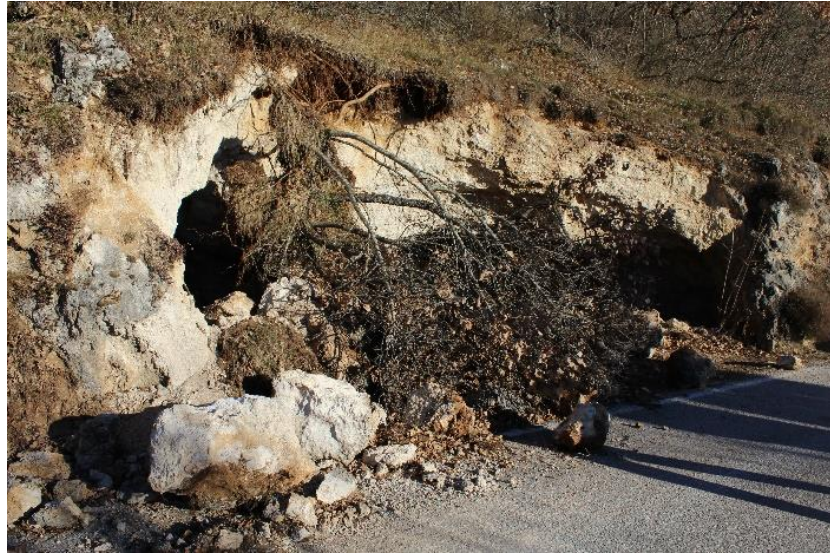
**Figure 4.75.** Rockfalls with boulders on the road.

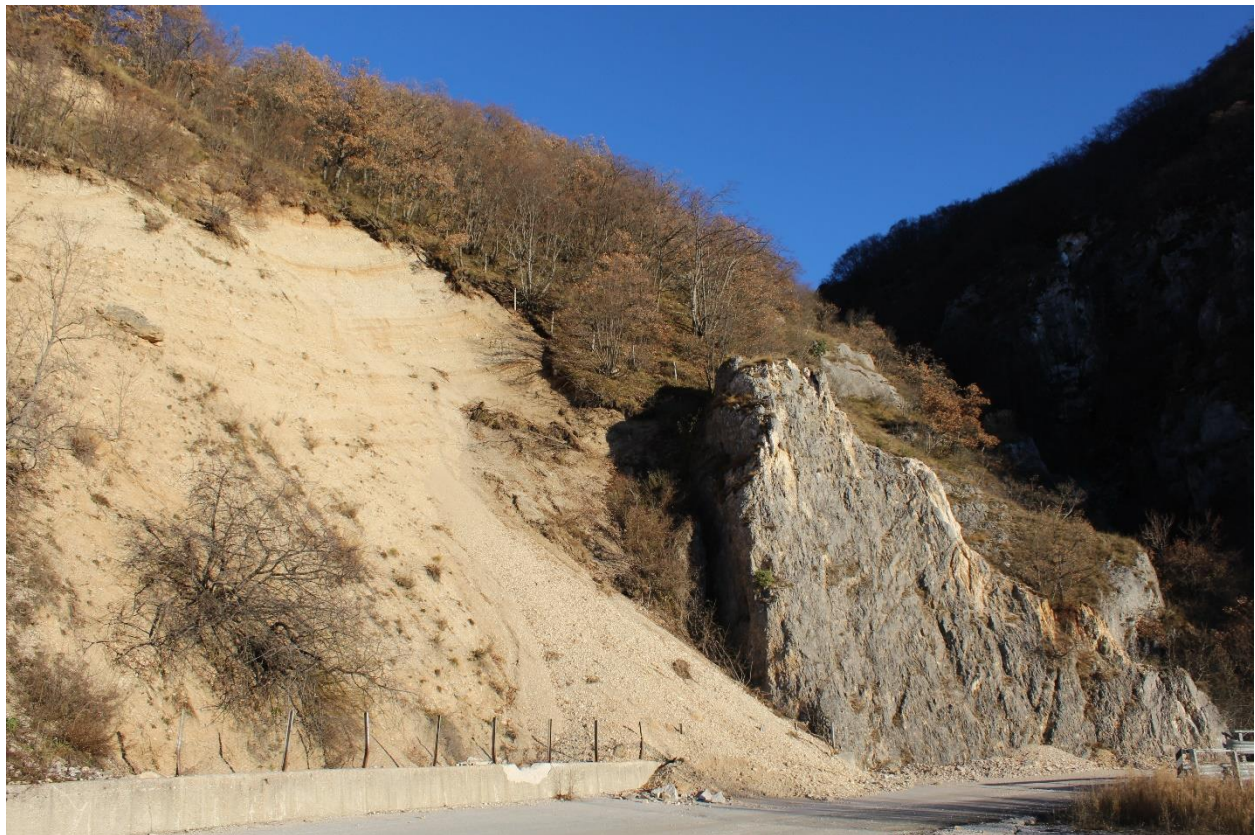
**Figure 4.76.** Debris avalanche along the scarp of a previous landslide.

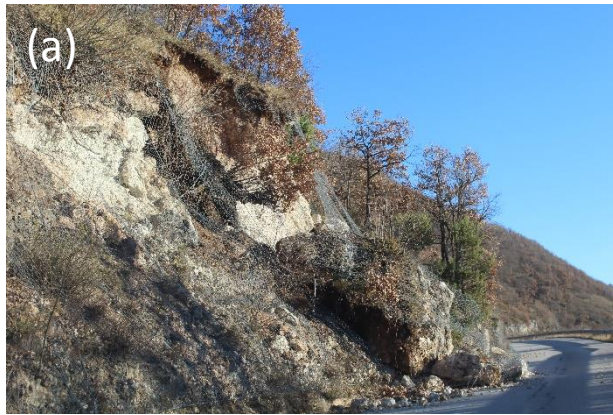
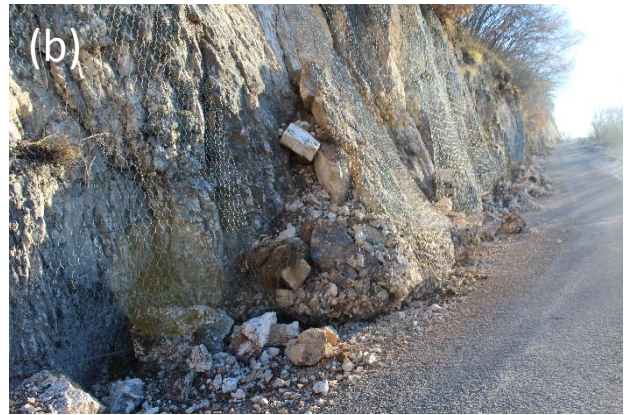
**Figure 4.77.** Debris and boulders captured by the rockfall protection nets.

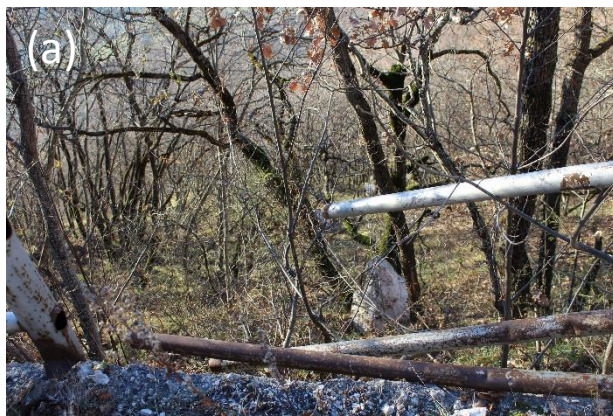
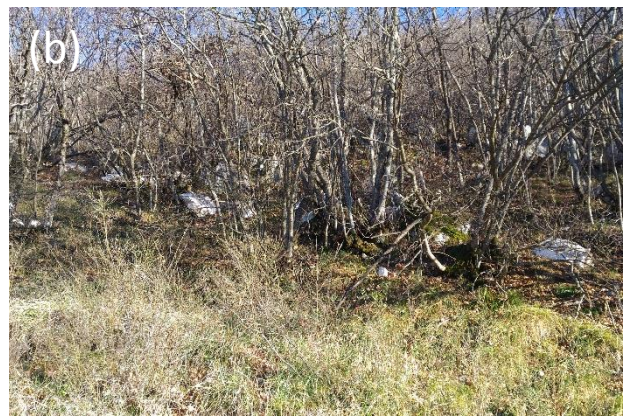
**Figure 4.78.** Boulders supported by the vegetation.

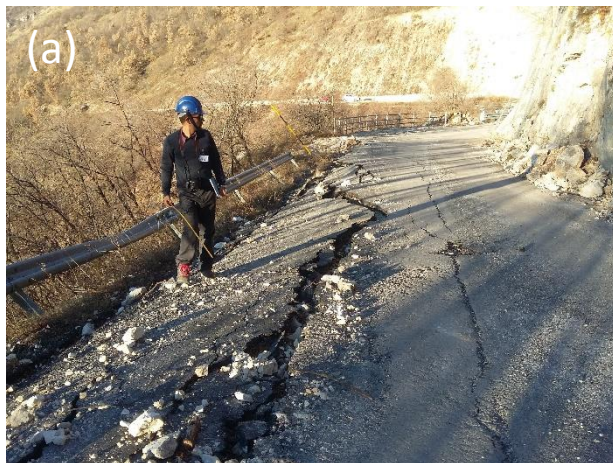
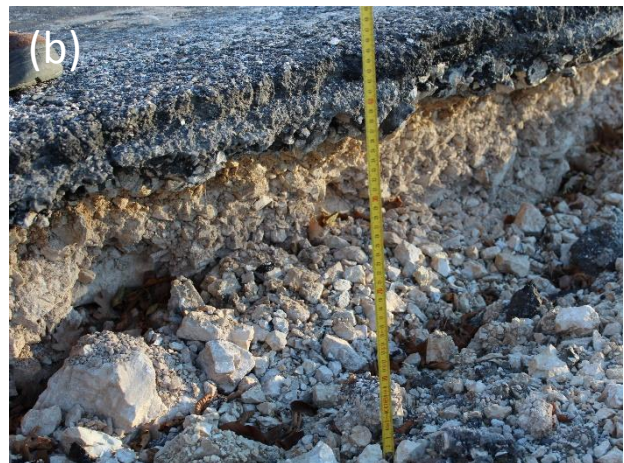
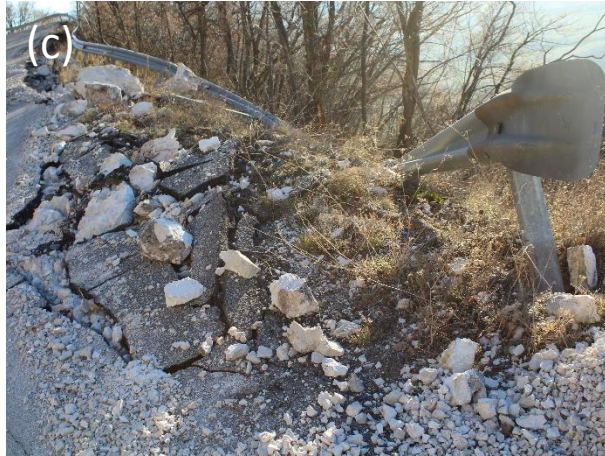
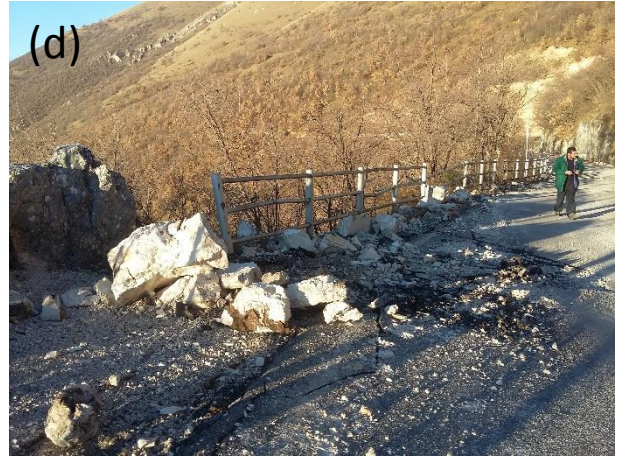
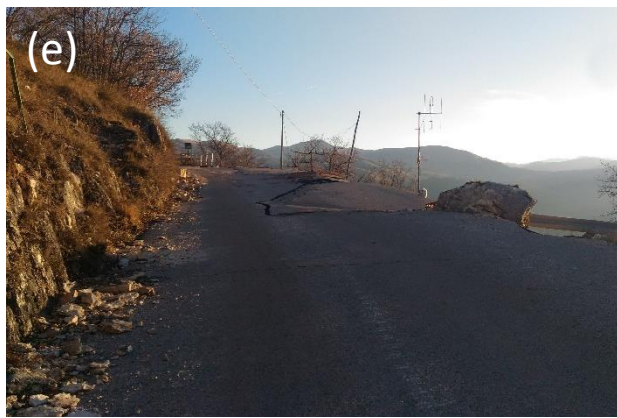
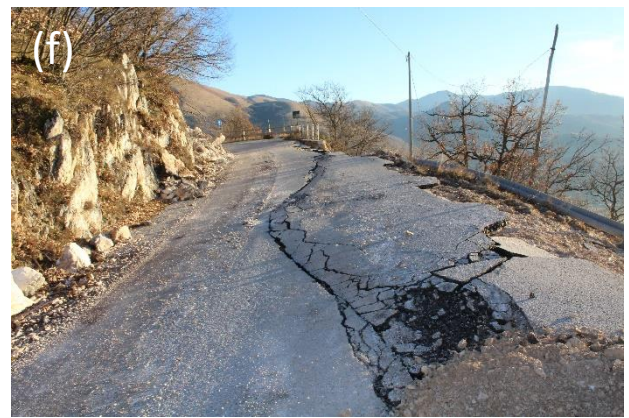
**Figure 4.79.** Fracture along the road, large vertical offset due to fracture and ultimate movement, damaged edge barriers and debris and boulders on the road surface.

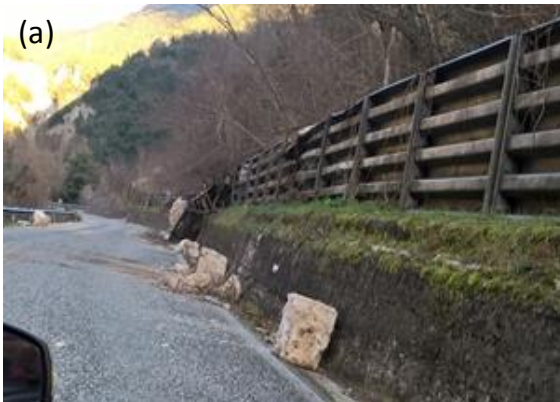
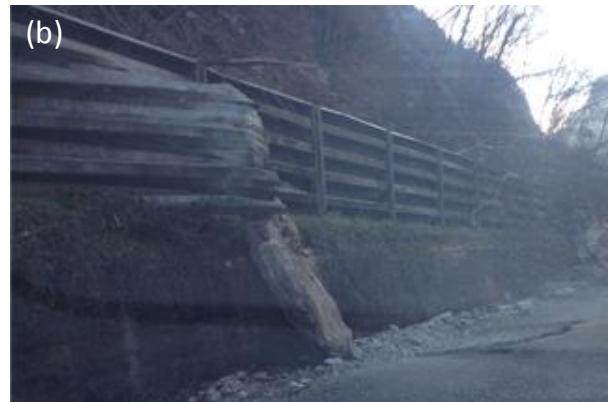
Figure 4.82 shows some of the rockfalls in the calcareous formations located on the left bank of the Nera river that we have identified after the 30 October 2016 earthquake. Many blocks, having a volume ranging from a dozen of cubic centimeters to a few of cubic meters, have been found on the shoulder or across the road. At the time of our reconnaissance, slide debris remained on the road and the highway was still closed.

**Figure 4.82.** Rockfalls along the SP209 between Triponzi and Visso.

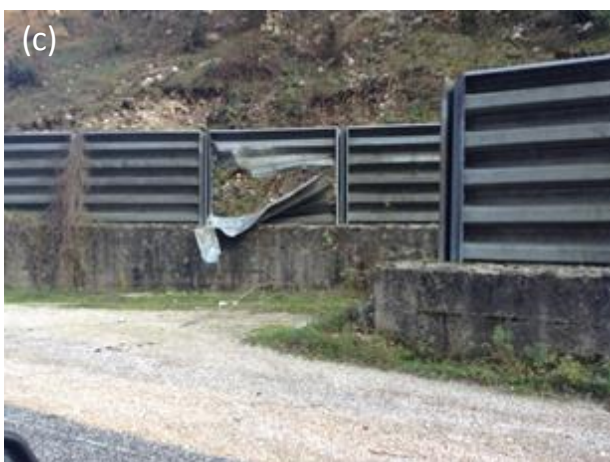
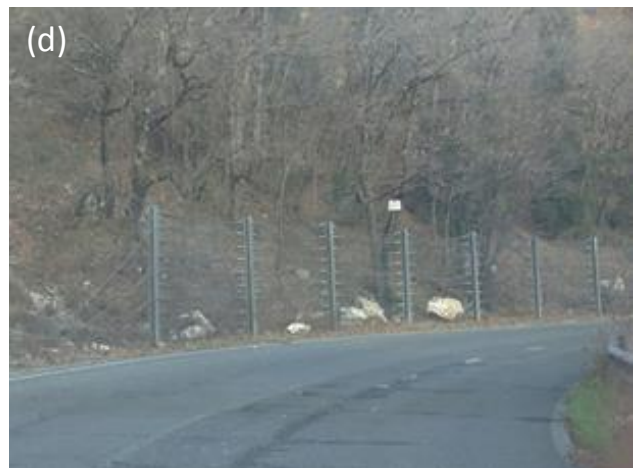
The area has been subjected to slump failures in the past. As a result, slope protections (i.e. rockfall nets, dynamic rockfall barriers or catch fences) are present along the road. Figure 4.83 shows many cases in which rock-nets have been passed over or damaged by boulders and rock-blocks. The slope located on the right bank of the Nera river has been interested by various slope instability events. They consisted of gravel debris. These features (Figure 4.84) are similar to those observed for the Nera landslide (Section 4.2.1) but very limited spatially and in volume.

**Figure 4.83.** Slope protection damaged by boulders and rock-blocks.

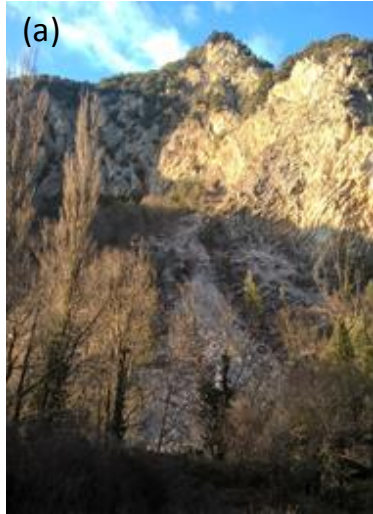
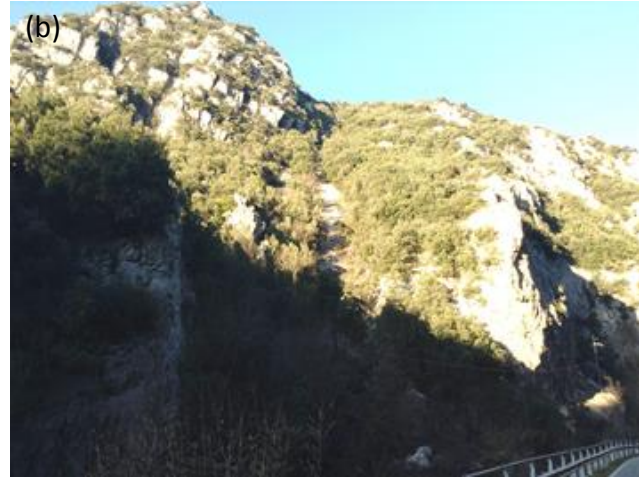
**Figure 4.84.** Debris occurred on the right bank of the Nera river along SP209 (lat 42.9157N, lon 13.0456E).
