# Engineering Reconnaissance Following the October 2016 Central Italy Earthquakes *Version 2*

GEER Team Leaders: Jonathan P. Stewart and Giuseppe Lanzo

Geotechnical Extreme Events Reconnaissance Association  
Report No. GEER-050D  
8 May 2017

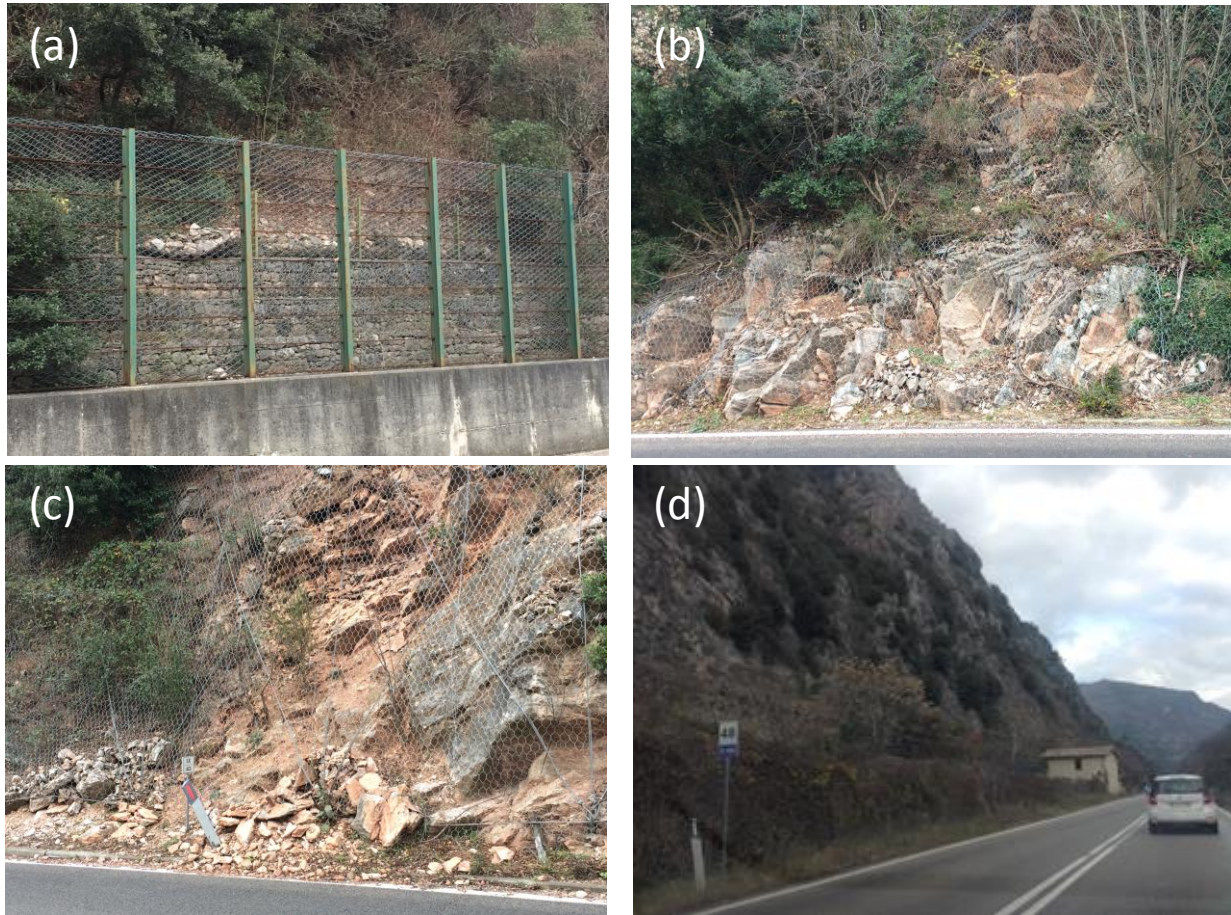
We observed several rock failures along the highway SS685 (also known as Tre Valli Umbre) between the villages of Piedipaterno and Borgo Cerreto (Figure 4.85). These features, shown in Figure 4.86, are mainly isolated rock falls having a volume ranging from a dozen of cubic centimeters to a few of cubic meters. The geology of the site is characterized by the presence of calcareous rock formations known as red flakes (*scaglia rossa*), and screes constituted by broken rock fragments variously sized. The IFFI landslide inventory (Figure 4.1b) classifies this area as subjected to widespread rock falls and slumps. We did not observe damages on the slope protections (i.e. rockfall nets, dynamic rockfall barriers or catch fences) present along the road.

**Figure 4.86.** Rockfalls between Piedipaterno and Cerreto along highway SS685.

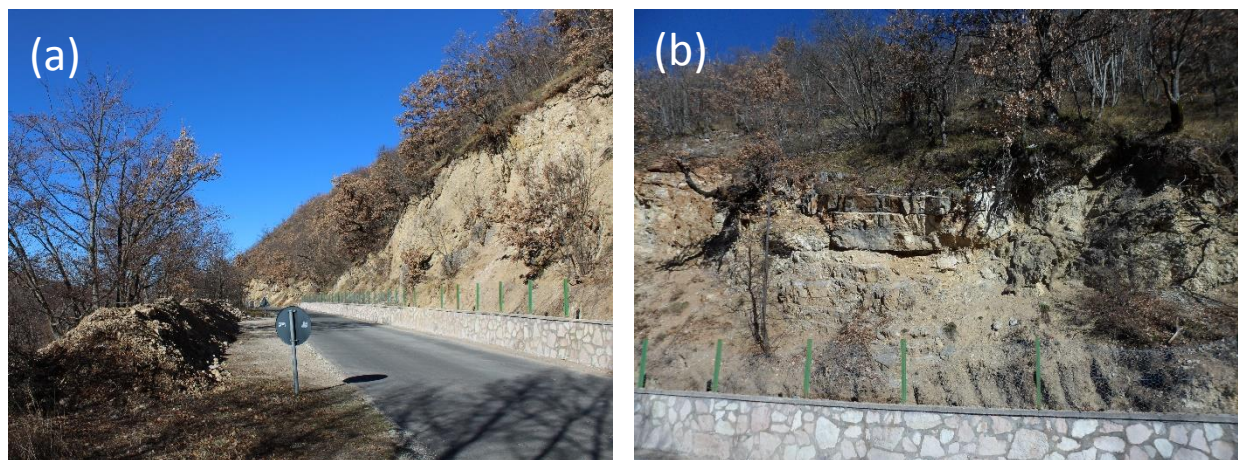
Along the SP746 road between Cittareale and Norcia a localized landslide was observed (Figure 4.87). The landslide was located in the vicinity of the *Calcareous Breccia* failure site as reported by earlier GEER report (see GEER 2016). The landslide occurred in the carbonate sequence named Corniola as from the geological map of the Umbria region (<http://www.regione.umbria.it/paesaggio-urbanistica/cartografia-geologica-per-google-earth>). From a general inspection of the area, no damage to the road was observed however the debris from the road was already cleared during our visit (Figure 4.88) so that a minimum level of damage can be assigned. The overall mass movement was confined to ~50-70 m. Along the mass movement site, a retaining structure was present that appears to have limited damage. The wall itself was undamaged (Figure 4.89). Other nearby locations presented some rock falls although such rock falls were confined to rockfall protection nets and no road obstructions were observed (Figure 4.89). In case of absence of rockfall protection nets, debris including boulders were observed beside the pavement (Figure 4.89).

**Figure 4.88.** Landslide between Cittareale and Norcia along the SP746: (a) General view of the area; (b) Zoom on the crown and main body of the scarp.

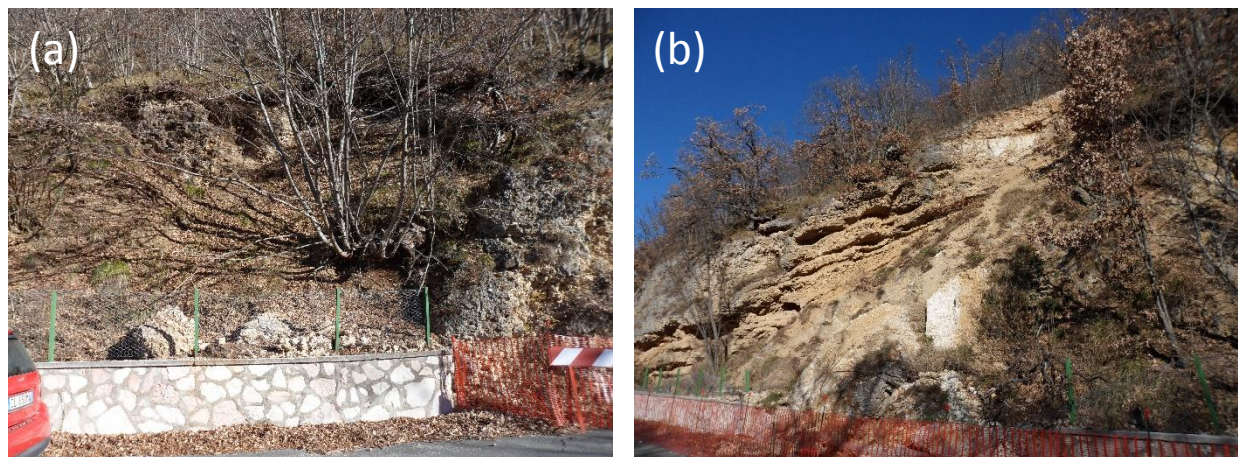
**Figure 4.89.** Failure in calcareous breccia between Cittareale and Norcia along the SP746: from (a) to (e) view of the all facade; (f) rockfall on the road.

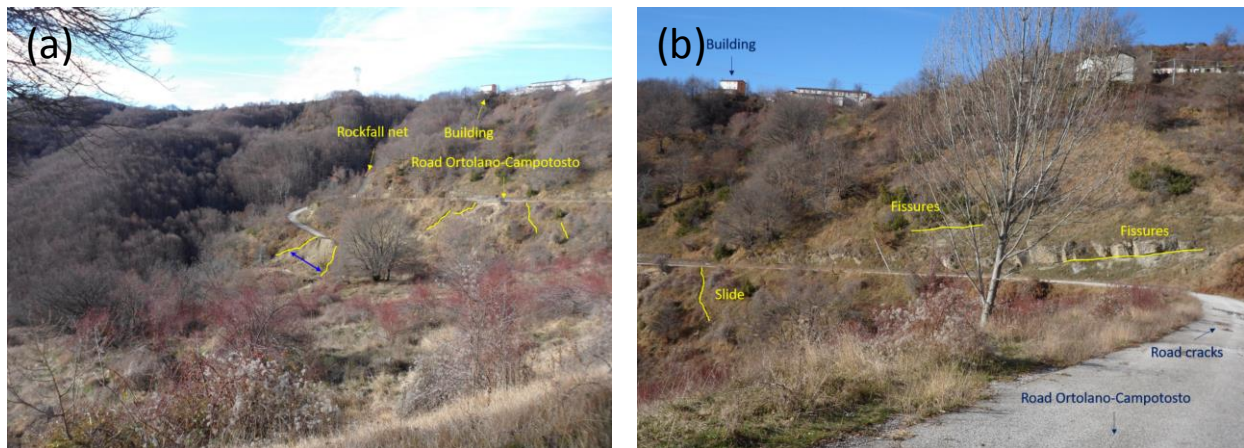
We observed a shallow landslide along the road of Ortolano-Campotosto (Figure 4.90). Figure 4.91 shows the extension of this feature. Along the whole longitudinal extension of the landslide, there is a cut and fill road. The landslide has a spatial extension, along the road of 100 m, with observed maximum vertical offsets of 3-5 m. According to the official geologic map of Italy (sheet 139, 1:100,000 scale; [http://193.206.192.231/carta\\_geologica\\_italia/tavoletta.php?foglio=139](http://193.206.192.231/carta_geologica_italia/tavoletta.php?foglio=139), last accessed April 29, 0217) and the ISPRA geologic map (sheet 349, 1:50,000 scale; [http://www.isprambiente.gov.it/Media/carg/349\\_GRANSASSO/Foglio.html](http://www.isprambiente.gov.it/Media/carg/349_GRANSASSO/Foglio.html), last accessed April 29, 0217), the formation in this area comprises highly fractured sandstones and marly-clayey strata. The sandstone stratum, is buried by a weathered soil cover, which was affected by the observed landslide feature.

**Figure 4.91.** (a) Overview of the whole longitudinal extent of the landslide area; (b) close up view of the landslide-related features from the road Ortolano-Campotosto.

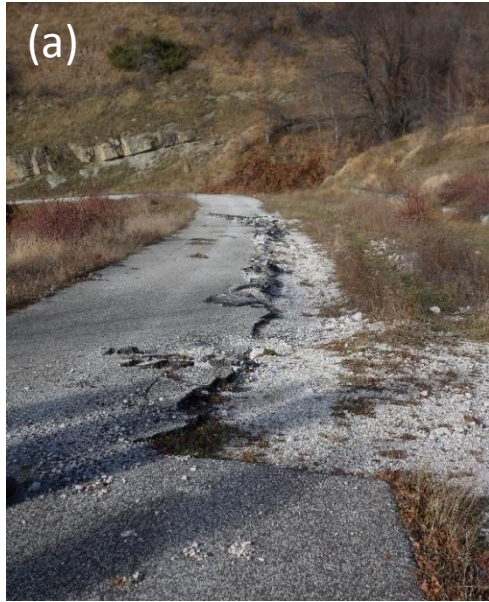
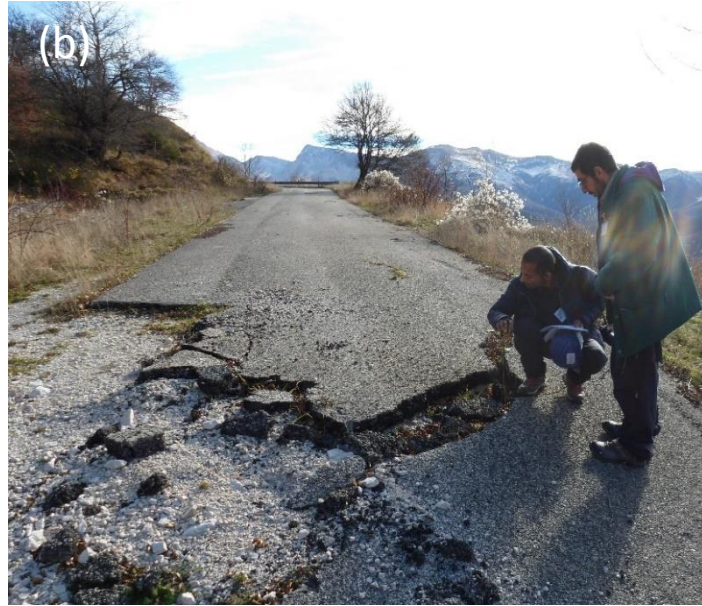
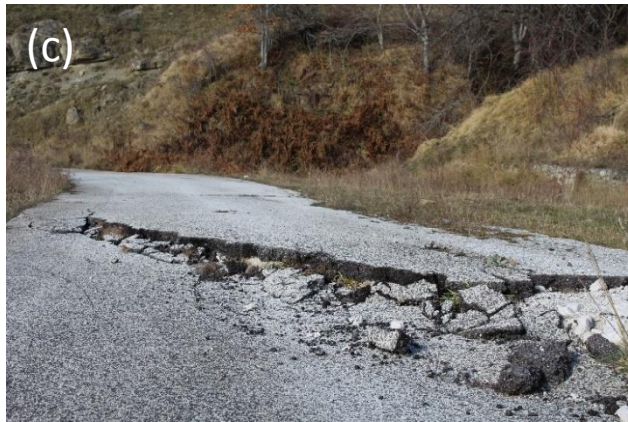
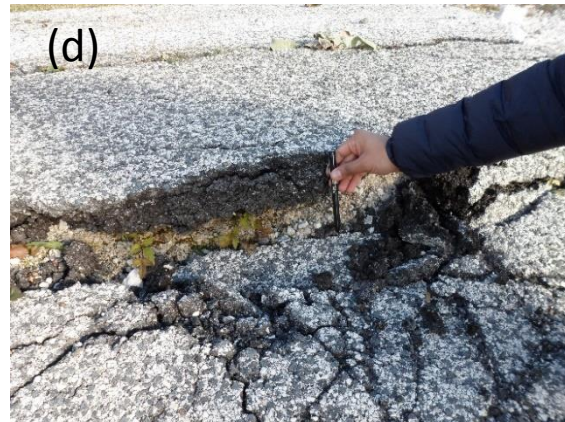
On the exposed surface of the landslide we observed silty clay with traces of sand, gravel, and cobbles. Figures 4.92-4.96 show several cracks on the road, fissures and minor scarps on the cut slope, and minor slide features on the fill slope. We did not observe major damages on the slope protections (i.e. rockfall nets) present along the road (Figure 4.97)

**Figure 4.92.** Cracks along the road.

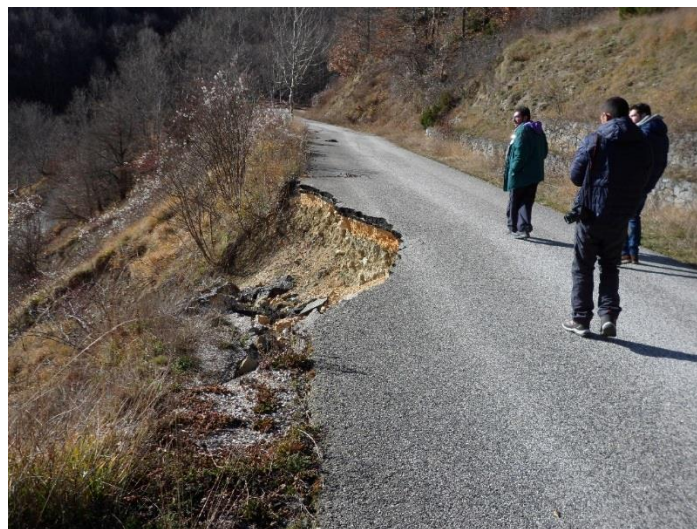
**Figure 4.93.** A slide observed on the fill slope.

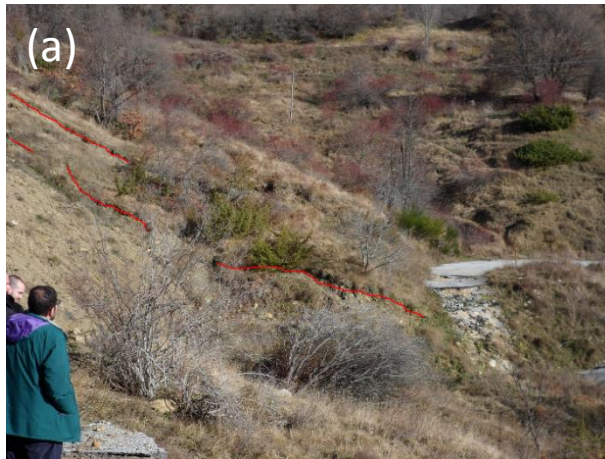
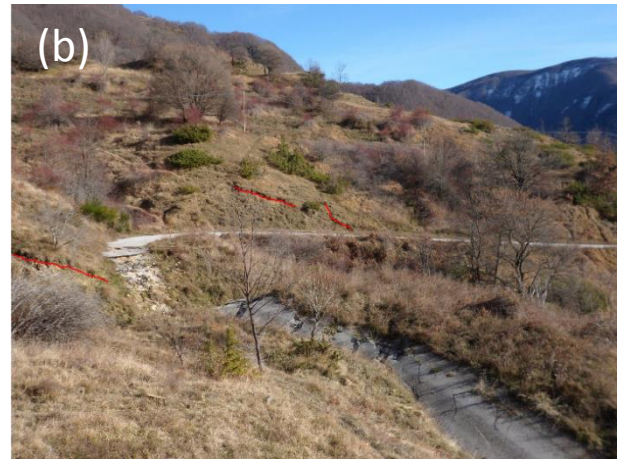
**Figure 4.94.** Fractures on the cut slope.

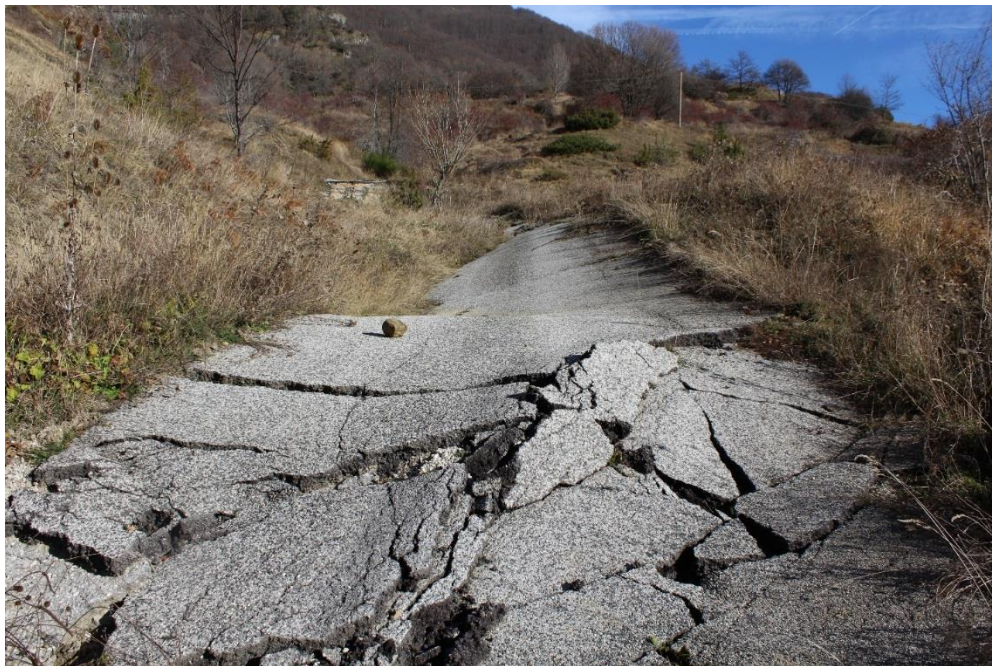
**Figure 4.95.** Damages along the road.

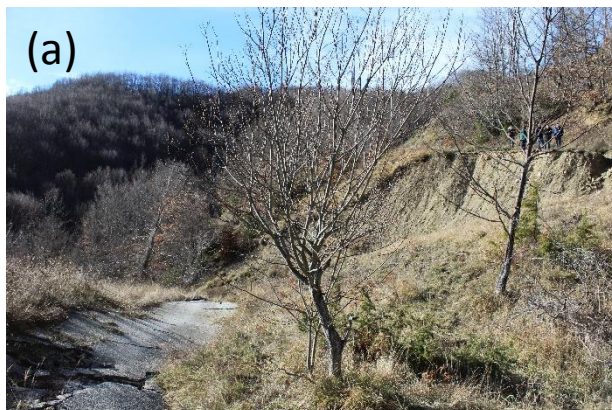
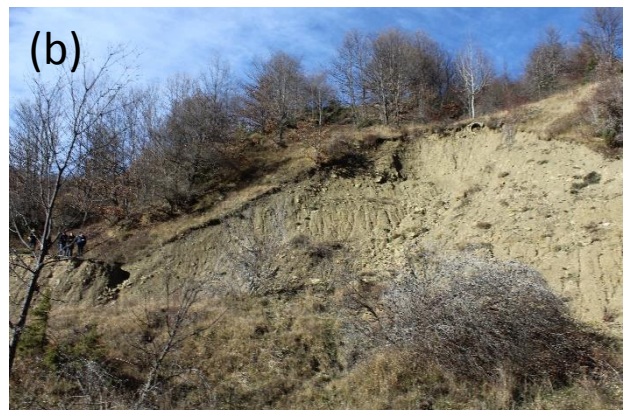
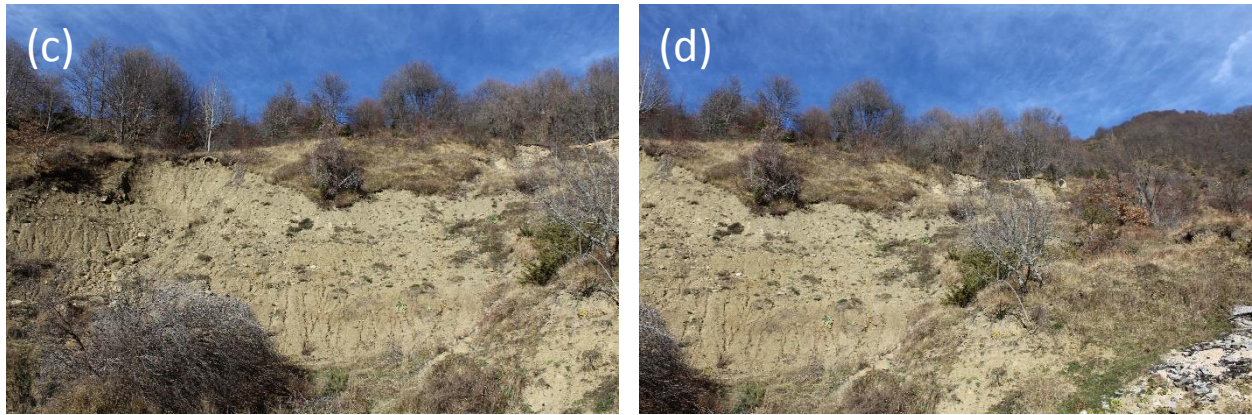
**Figure 4.96.** Minor scarps observed on the cut slope side of the road.

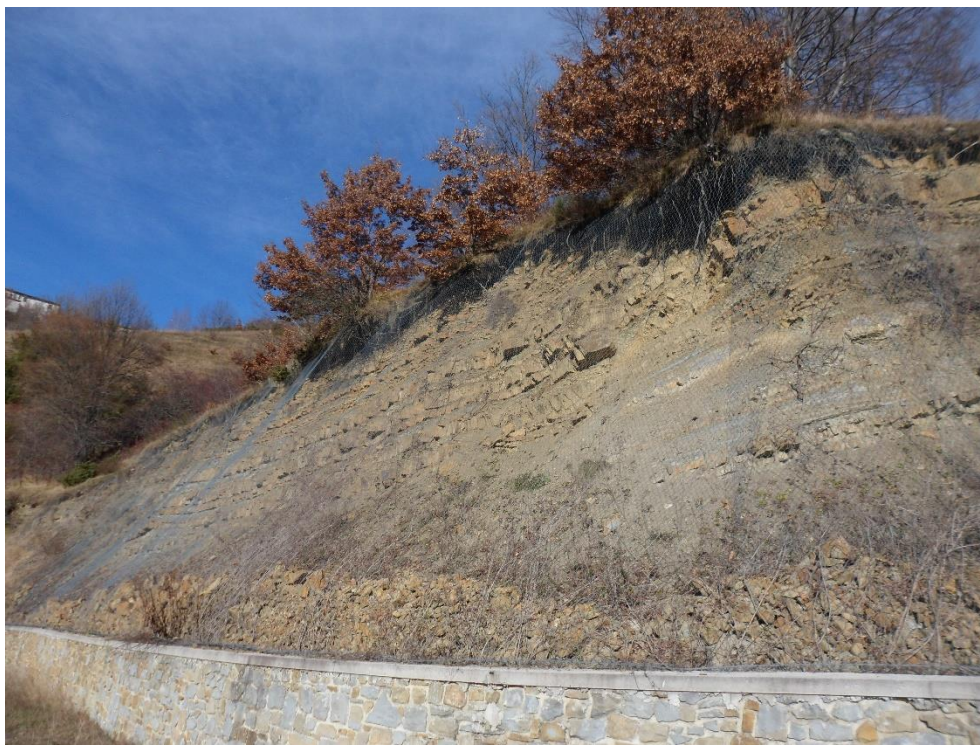
**Figure 4.97.** Rock-net protection with captured debris.

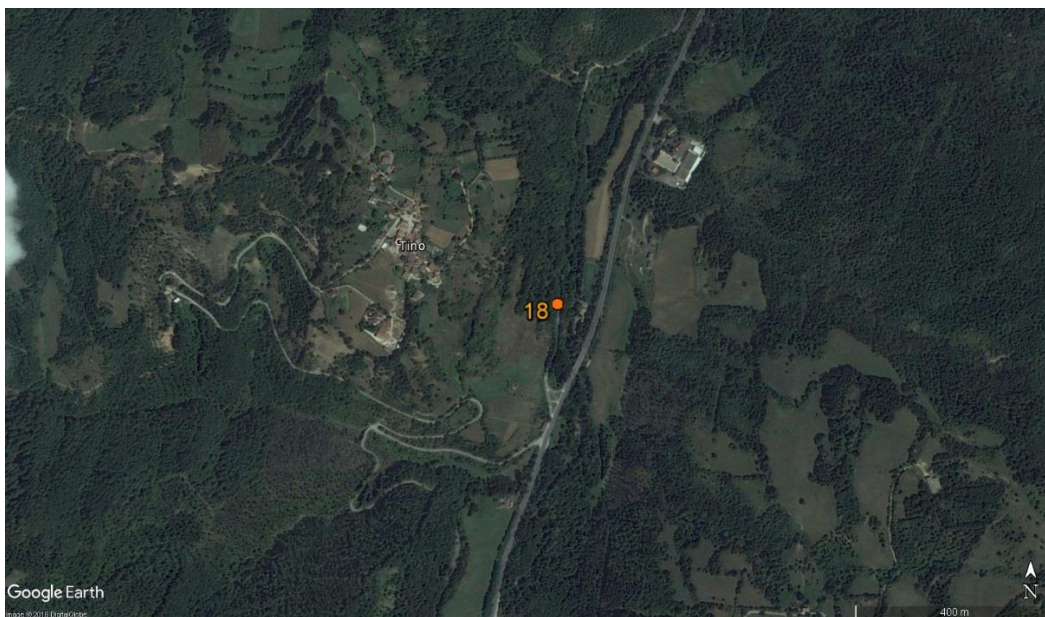
While attempting to reach the landslides at Pescia, the GEER team tried to use a small road parallel to SS4 that winds through the foothills of Mt. Vettore. Soon after turning off of SS4, we found the road unpassable due to a landslide that followed the August 2016 and the 26 October 26 events. It is possible, however that this landslide was triggered by a Magnitude 5.0 aftershock

**Figure 4.100.** Location of the Landslide below the village of Tino on small road parallel to highway SS4.

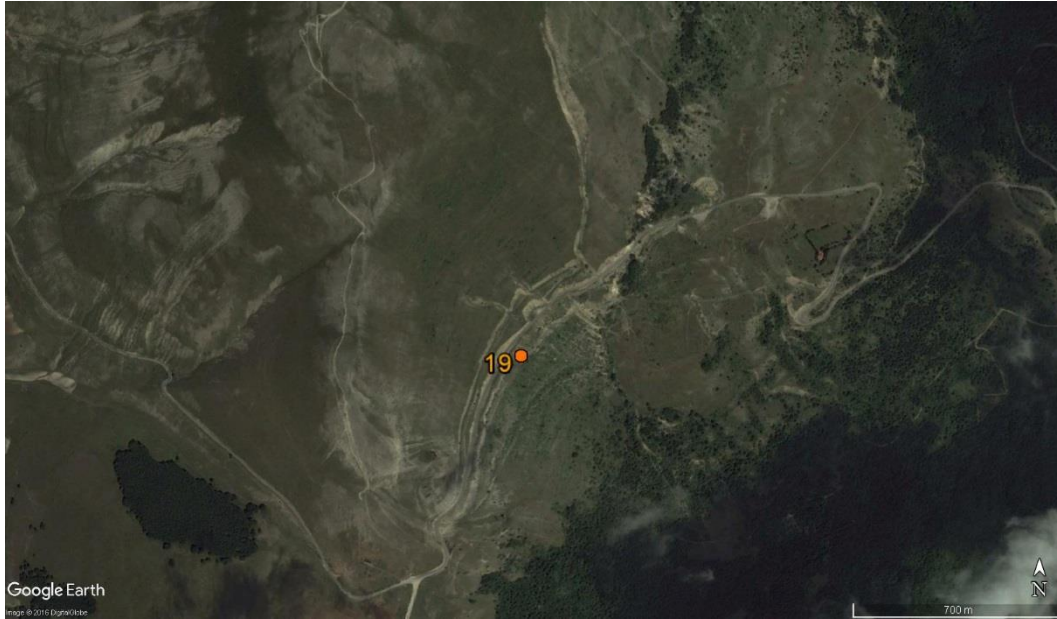
The fill embankment for Road SP477 running across the south face of Mt. Vettore was damaged in the 30 October event, occurring at the same location as the Mt. Vettore fault surface rupture (Figures 4.103 and 4.104). No reports of slope instability at this location were made following the 24 August event nor the 26 October event. Road embankment damage was parallel to the roadway, in the direction of the slope.

**Figure 4.103.** Location embankment fill damage area next to fault trace zone along SP477 road, Mt Vettore.

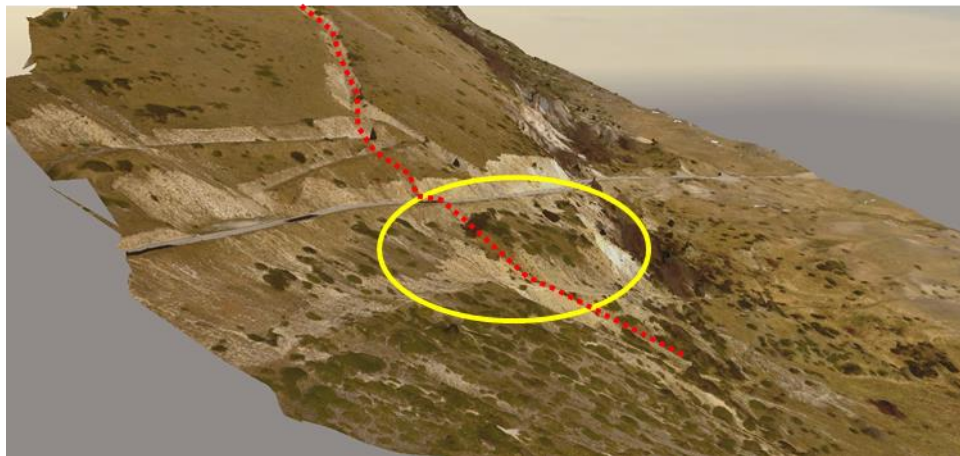
**Figure 4.104.** 3D SfM model of embankment fill damage area next to fault trace zone along SP477 road, Mt Vettore. Fill that has experienced 15 to 20cm lateral displacement circled in yellow. Observed fault rupture trace shown in red.

We visited the fault rupture and observed the embankment slope damage after documenting surface fault rupture offset. At the location of the SP477 road, strike displacements on the Mt. Vettore fault (in the direction of the embankment displacement down slope) were observed to be zero. Therefore, the GEER team concluded that the roadway embankment damage was from slope displacements rather than lateral fault rupture. Lateral displacement of the slope was estimated at 15cm to 20cm. Cracking parallel to the road along the top of the embankment is seen in Figures 4.105 and 4.106. The total height of the embankment slope was measured at 25-35 m from 3D SfM model (Chapter 2) for the south face of Mt. Vettore. The embankment fill

slope is approximately 20° to 30°, while the slope of Mt. Vettore near the embankment fill is 15° to 20°. Slopes were also measured from 3D SfM model for the location. Embankment material appeared to be a compacted mixture of low plasticity clay soil, granular native limestone aggregates and chert fragments from roadway construction.

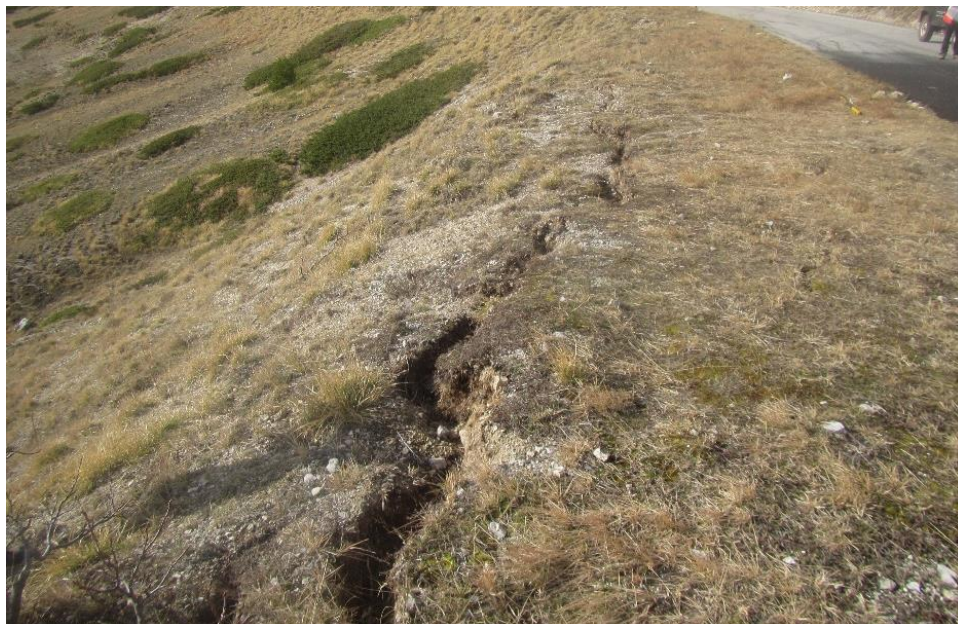
**Figure 4.106.** Road embankment damage along SP477 road, Mt Vettore (Location 19, viewing west).

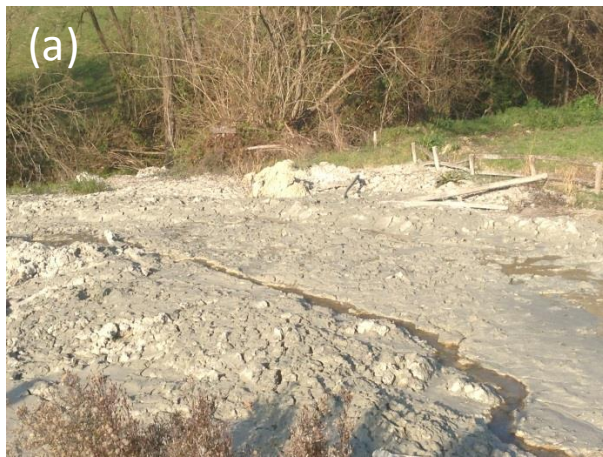
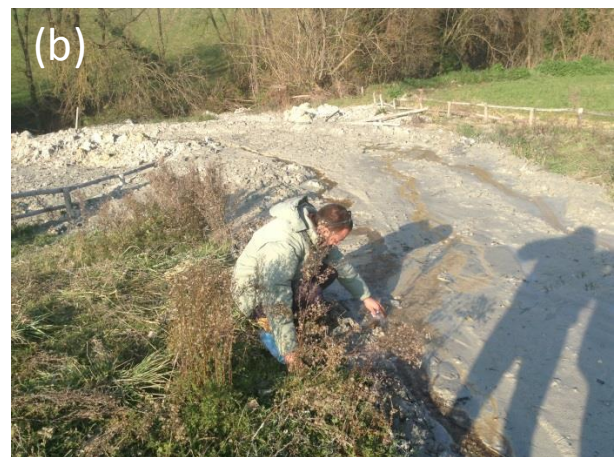
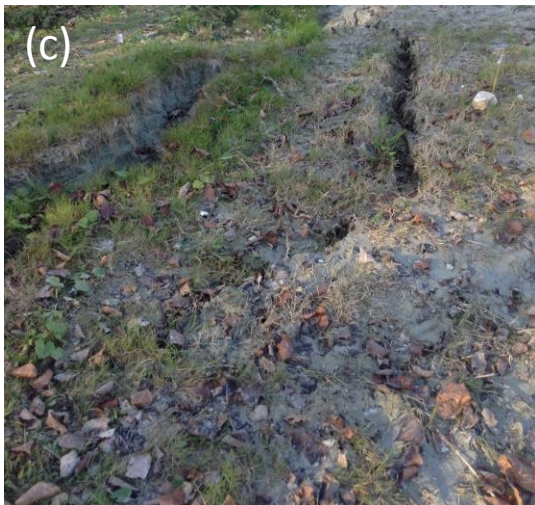
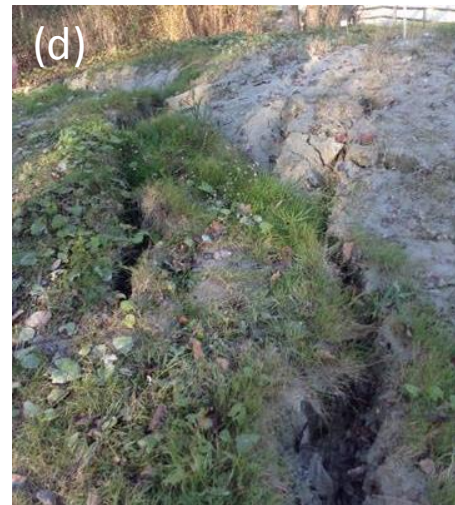
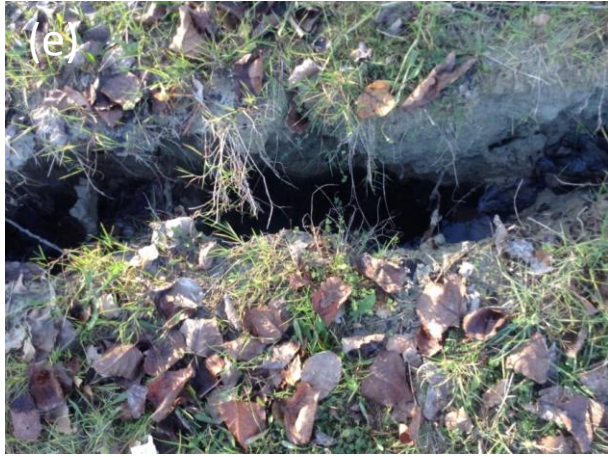
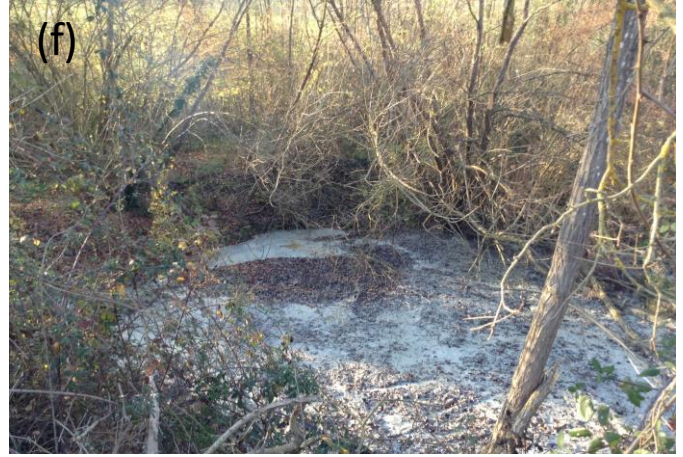
We inspected two mud volcanoes that erupted within one day from the **M6.5** 30 October earthquake event (Figure 5.3): (1) Santa Maria in Paganico (Figures 5.4a-b) and (2) Valle Corvone (Figures 5.4c-d-e-f). In both cases, we observed fresh deposits of ejected material. Both eruptions, are located within 45 km from the epicenter. . During our reconnaissance activities, both mud volcanoes showed a reduced activity, with a small emission of water. We inspected the sites about one month after the INGV reconnaissance mission. We did not detect any new activity or variations in the soil surface conditions in the inspected area as shown in Figure 5.5. As shown in Figure 5.4c-d-e-f, the material erupted by the mud volcano located in Valle Corvone covered a wide area involving both the river and the pavement of the road. This mud volcano is characterized by radial fractures 140 cm long, 38 cm wide and 80 cm deep. This eruption partially blocked the Ete river's course (Figure 5.4f).

**Figure 5.4.** (a) overview of the mud volcano in Santa Maria in Paganico; (b) sampling activities in in Santa Maria in Paganico; (c) crack originated by the mud volcano in Valle Corvone, (d) mud volcano in Valle Corvone, (e) details of a crack in Valle Corvone, (f) close-up view of the material ejected in the Ete Vivo river (Valle Corvone).

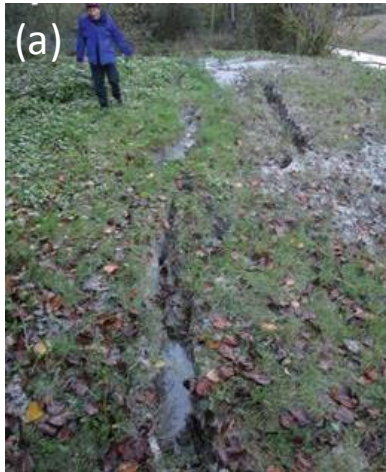
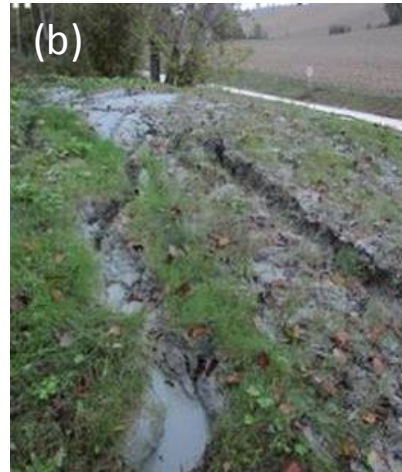
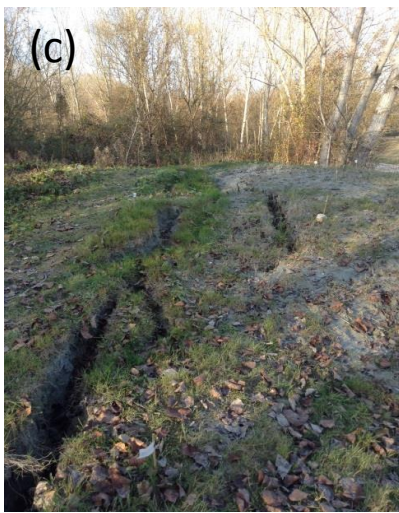
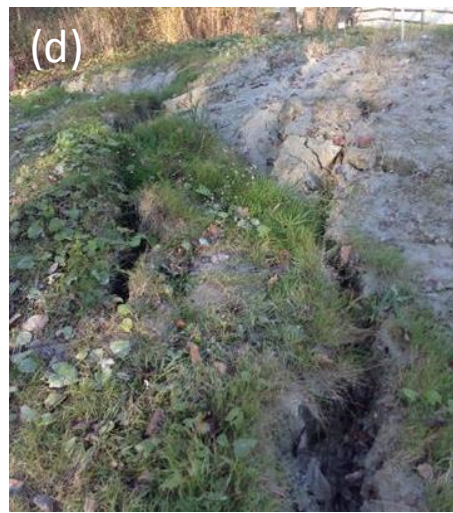
**Figure 5.5.** (a) and (b) photos of the mud volcano in Valle Corvone taken by INGV in November 2016 (INGV, 2016); (c) and (d) photos of the mud volcano in Valle Corvone taken from a common perspective by GEER in December 2016.

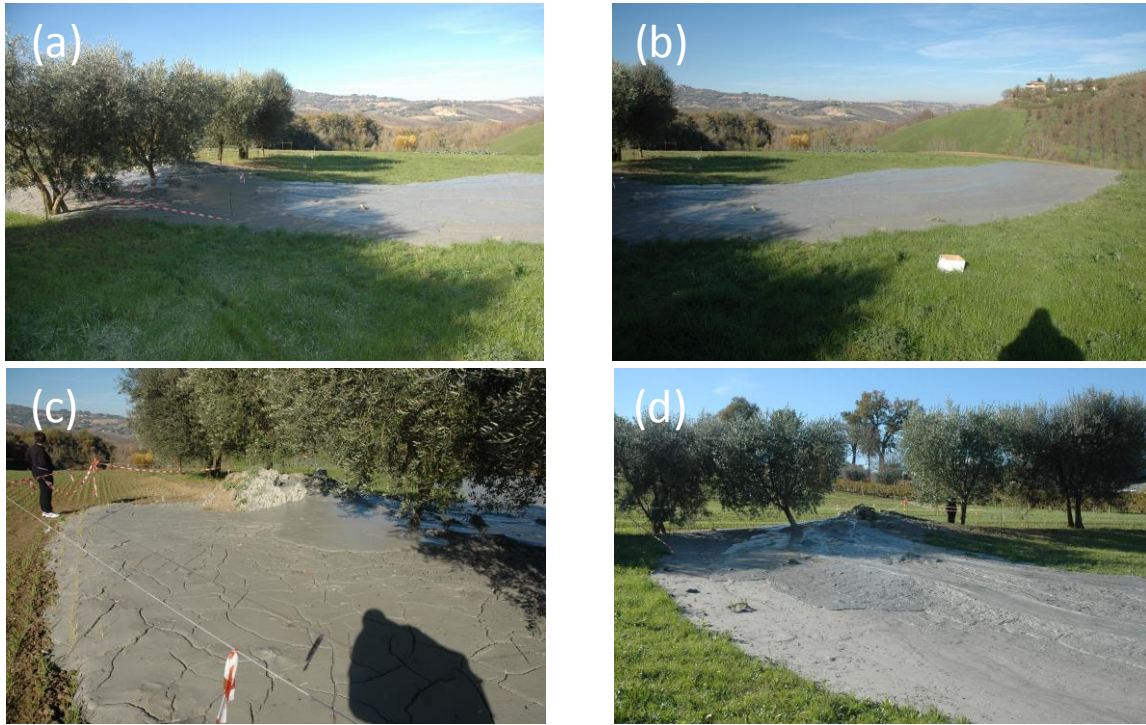
We inspected the newly formed volcano that erupted within one day from the **M6.5** 30 October earthquake event. Figure 5.8 shows the location of this eruption. Figure 5.9 shows photos taken during our reconnaissance. During our reconnaissance activities, the eruption showed a reduced activity, with a small emission of water. We inspected the site about one month after the INGV reconnaissance mission. We observed a substantial increase in the erupted material compared to the INGV reconnaissance (Figure 5.9).

**Figure 5.9.** Overview of the mud new volcano in Santa Vittoria in Matenano.

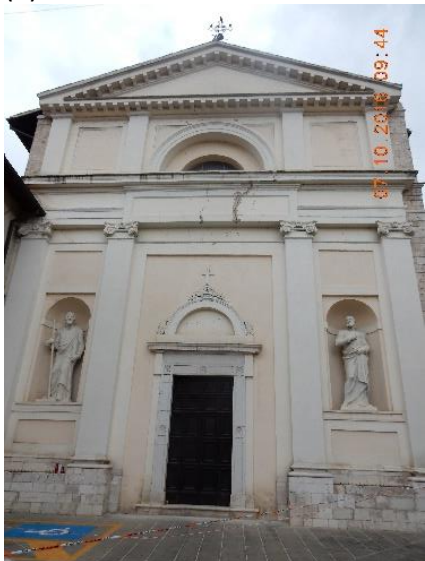
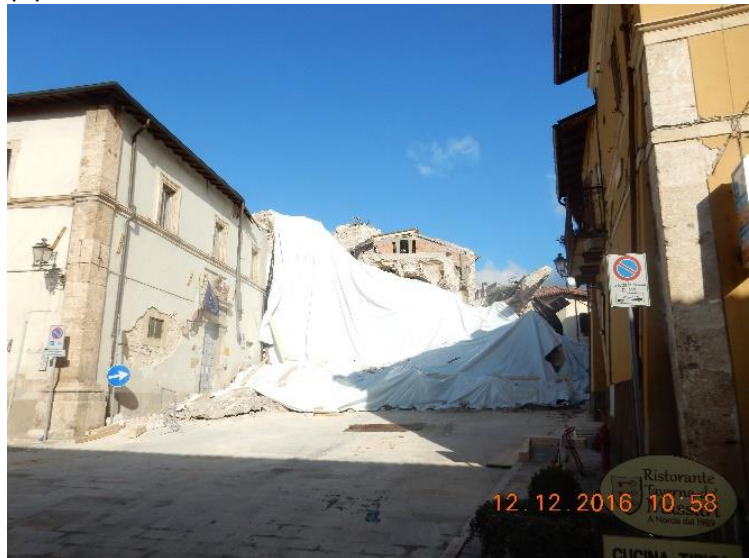
Figure 6.4. Building M1.

Apart from the wider assessment, a side-by-side comparison of significant structures with multi-epoch surveys is made. Figure 6.3 depicts the locations of the buildings presented. Figure 6.4 illustrates one of the churches that were slightly damaged by the first seismic event, but completely collapsed subsequently. Many historical churches in Norcia experienced the same kind of damage evolution. Figure 6.5 shows one exceptional case of a typical residential masonry building where the evolution of damage was rather moderate (damage state shifting from DS2 to DS3). Conversely, Figure 6.6 shows a residential building with irregular masonry construction. This group of buildings experienced an abrupt damage evolution, with an out-of-plane mechanism and increased in-plane damage. Finally, Figure 6.7 depicts the out-of-plane failure of an historical monastery leading to partial loss of support of the roof. Notably, the wall failure was concentrated at a level higher to that of the seismic retrofit, thus highlighting that local interventions should not be only localized on the ground level but also take into consideration the reduced axial load and weak diaphragm action of the masonry walls at higher levels.

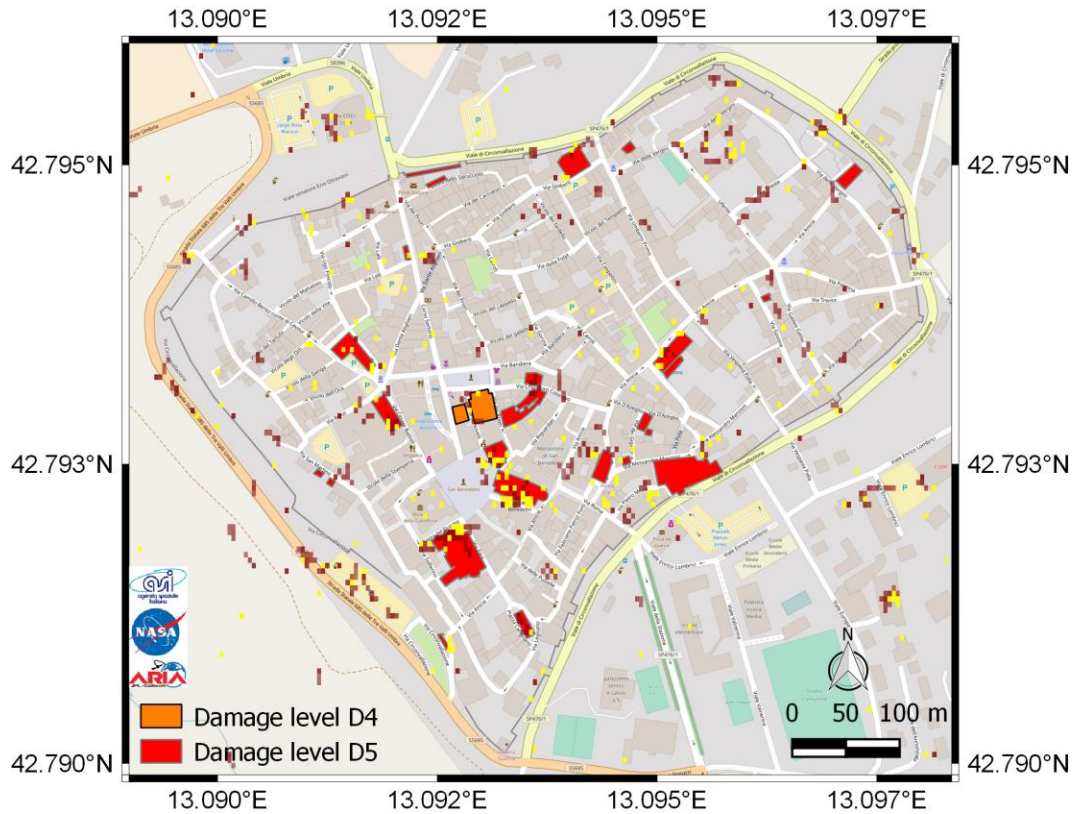
After the 30 October **M**6.5 earthquake, a detailed DPM for the city center of Norcia was released ([aria-share.jpl.nasa.gov/events/20161030-Italy\\_EQ/DPM/](http://aria-share.jpl.nasa.gov/events/20161030-Italy_EQ/DPM/), last accessed 26 February, 2017). This DPM has a relatively limited spatial extent, but high resolution. Figure 6.15 shows the DPM produced after the 30 October event, superimposed on the map of the city center of Norcia, along with all structures that have been classified, through on-site visual inspection, as completely collapsed (for which a damage level D5 has been assigned), and selected D4 structures.

**Figure 6.15.** Damage proxy map of Norcia, along with all structures with assigned damage level D5, and selected structures with assigned damage level D4.

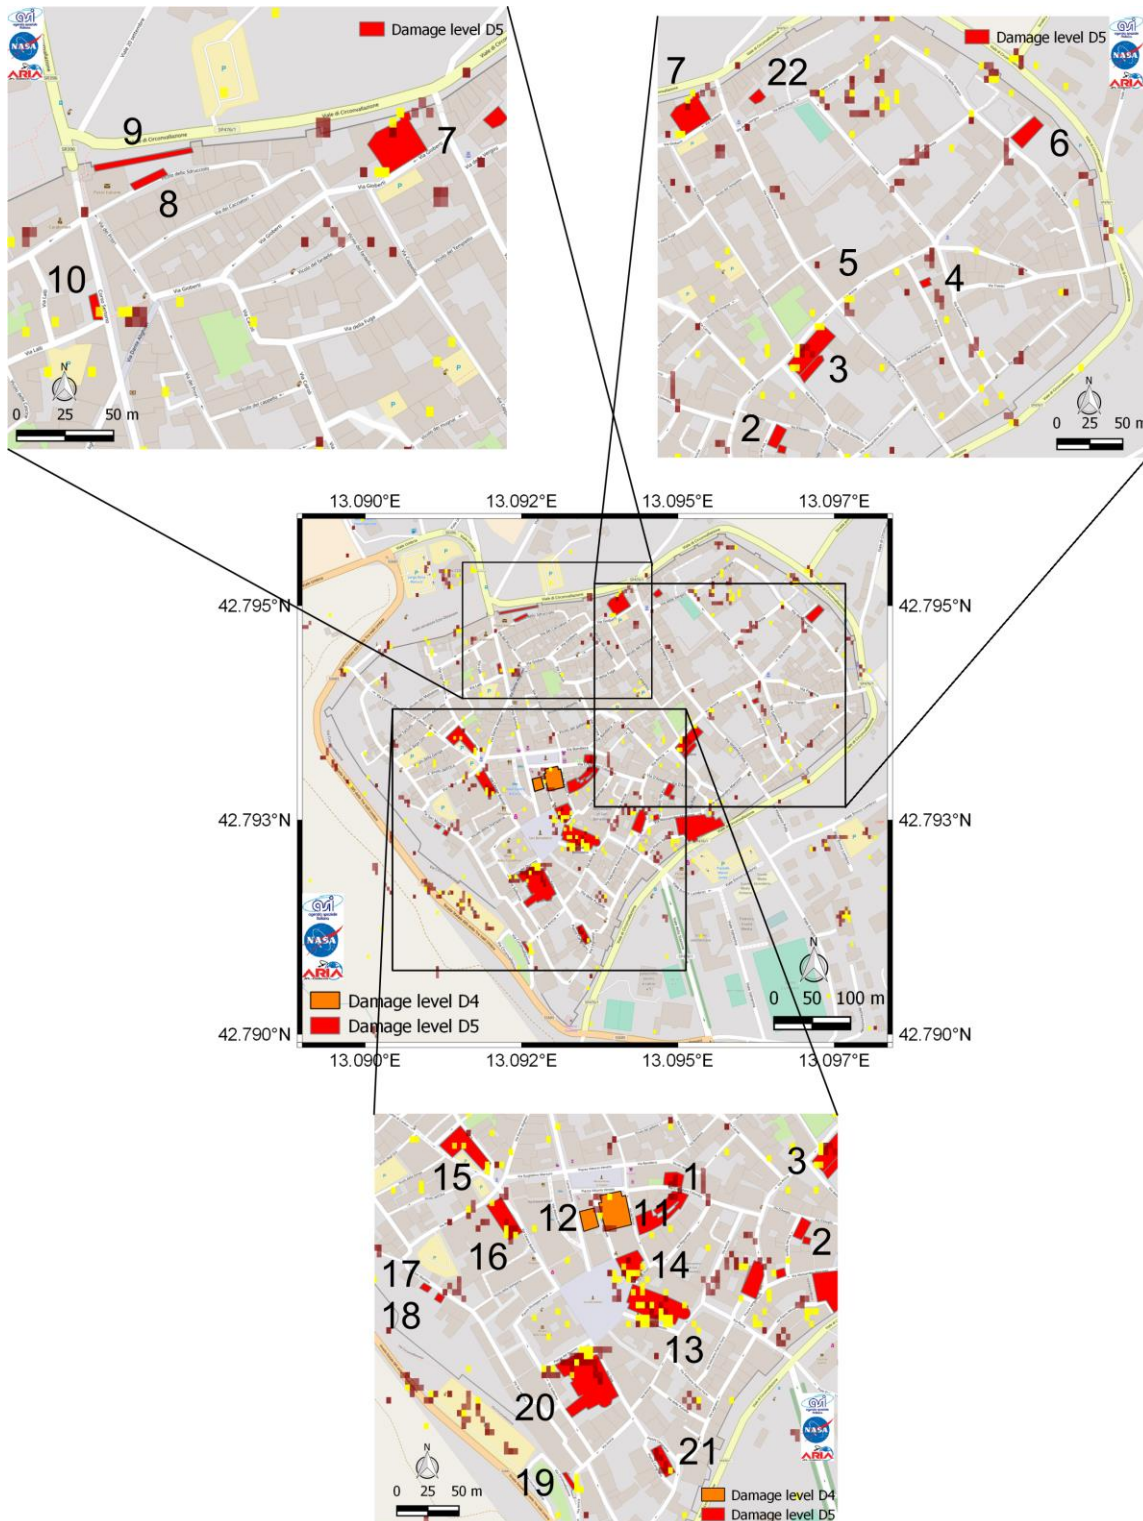
We analyze 22 structures assigned damage levels D5 and D4; within this group is the full inventory of D5 structures as identified in our field inspections. Figure 6.16 shows the spatial distribution of these structures, along with their identification numbers.

In order to provide a sense for the damage in Norcia at these sites, Figure 6.17 shows representative pictures taken during the on-site inspection performed following the 30 October **M**6.5 earthquake event. By comparing the locations of these mapped structures and damage zones per the ARIA imaging, we find good agreement. For all structures with assigned damage level D5, the DPM shows a concentration of red and dark red zones, representing areas in which substantial deformations occurred.

**Figure 6.16.** Zoom-in of the damage proxy map of Norcia, along with the identification numbers of all structures with assigned damage level D5 from field inspections and available high-quality on-site information and photos.

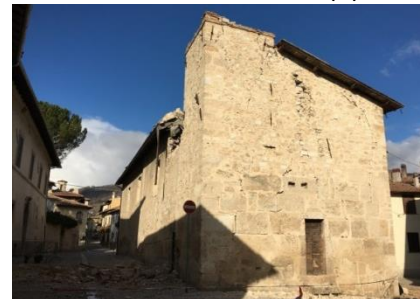
N. 21 Collapsed church (1)

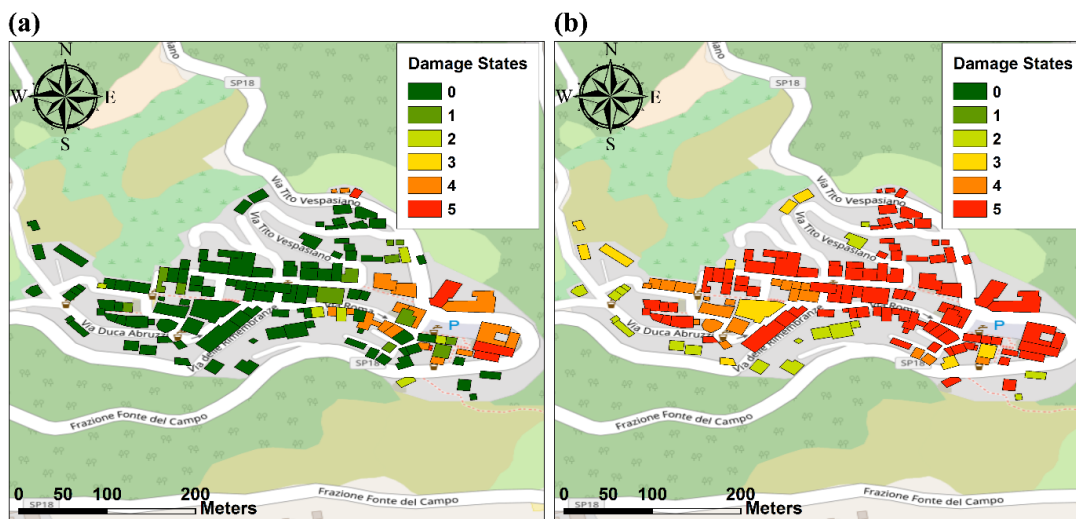
The seismic sequence in October caused total devastation of the village. As shown in Figure 6.18, the vast majority of the buildings that were damaged during the August earthquake, eventually collapsed. The evolution of damage after multiple seismic events is also evident as also depicted in Figure 6.19, where a drastic shift from low (DS0/DS1) to high (DS4/DS5) damage states is clearly observed.

**Figure 6.18.** Evolution of damage after (a) the first seismic event and (b) the sequence of events.

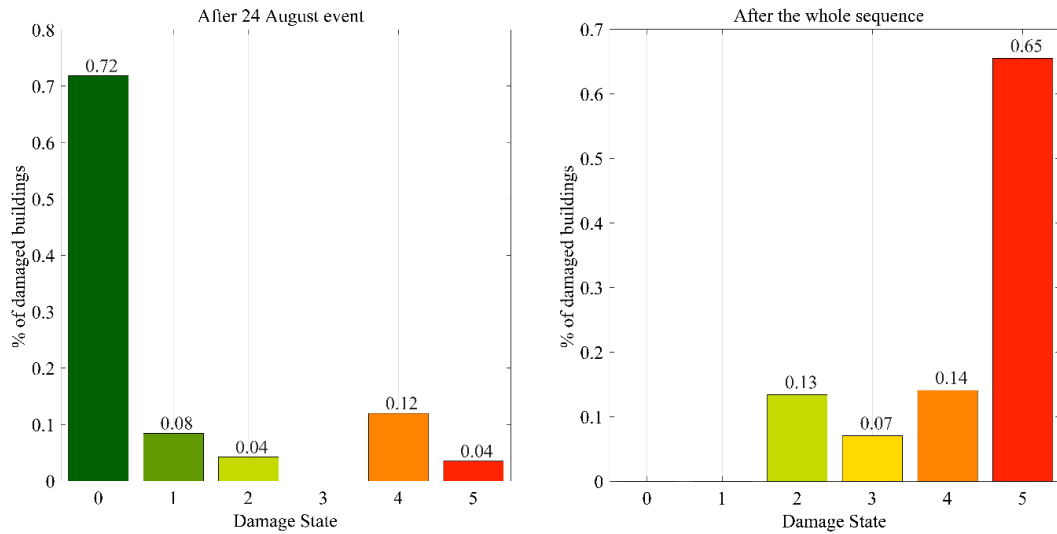
**Figure 6.19.** Percentage of damaged structures (a) after the first event and (b) after the whole sequence.

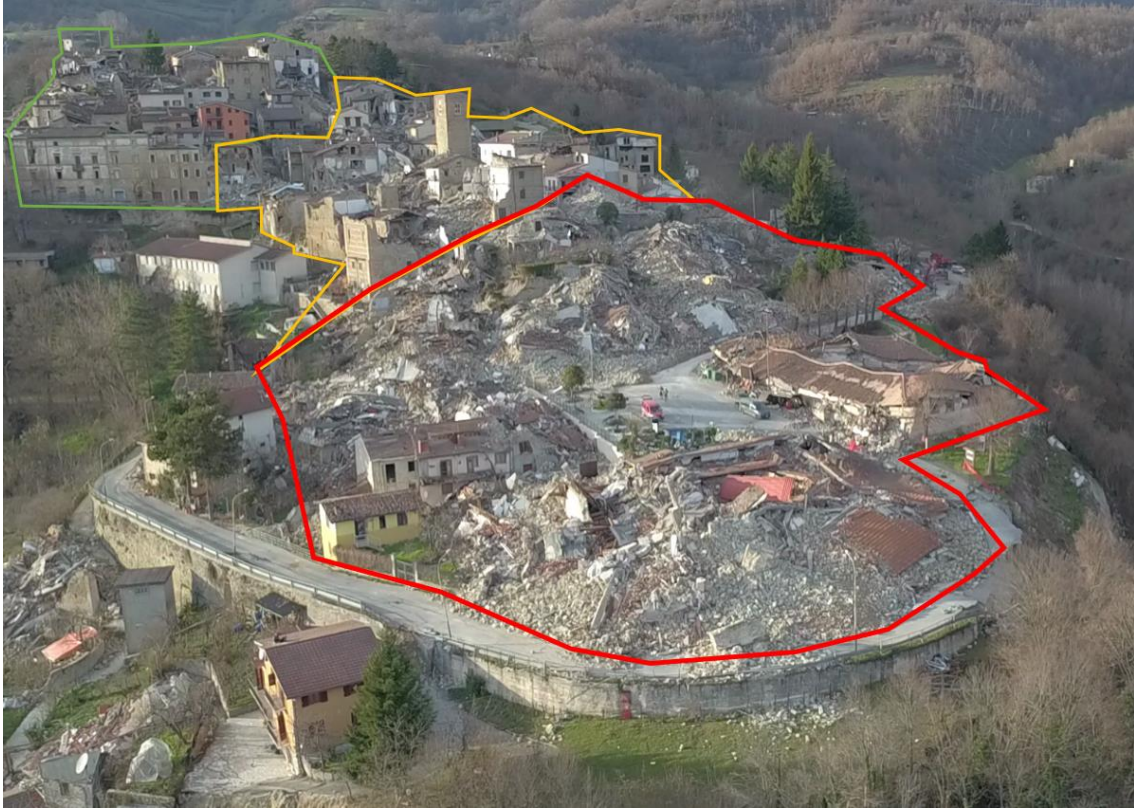
Figure 6.21. Aerial view, east-west direction (V3).

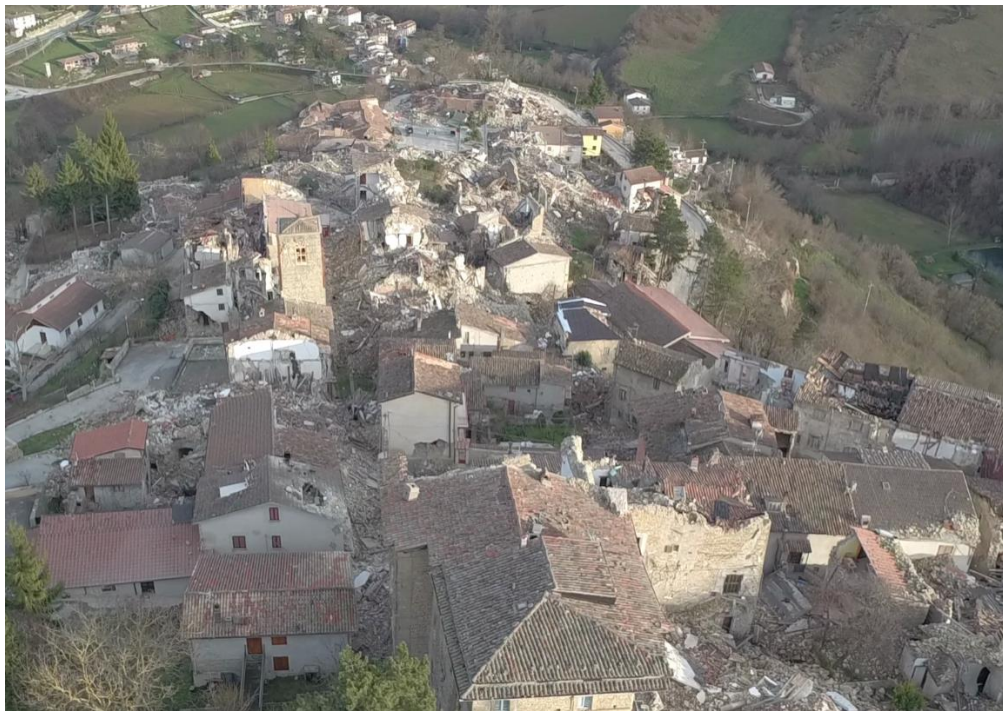
Figure 6.22. Aerial view, west-east direction (V4).
