# Engineering Reconnaissance Following the October 2016 Central Italy Earthquakes *Version 2*

GEER Team Leaders: Jonathan P. Stewart and Giuseppe Lanzo

Geotechnical Extreme Events Reconnaissance Association  
Report No. GEER-050D  
8 May 2017

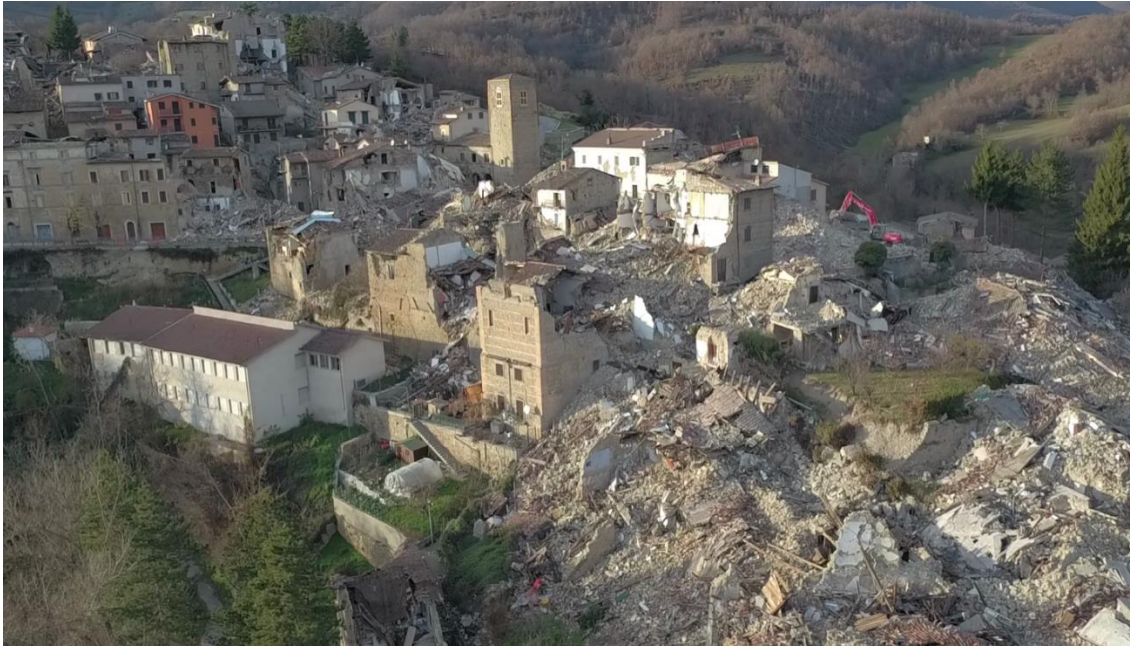
**Figure 6.23.** Aerial view, south-north direction (V5).

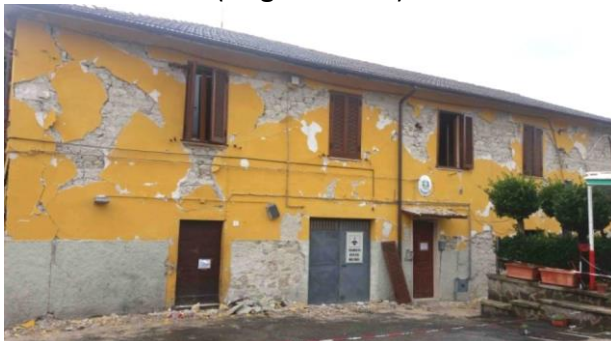
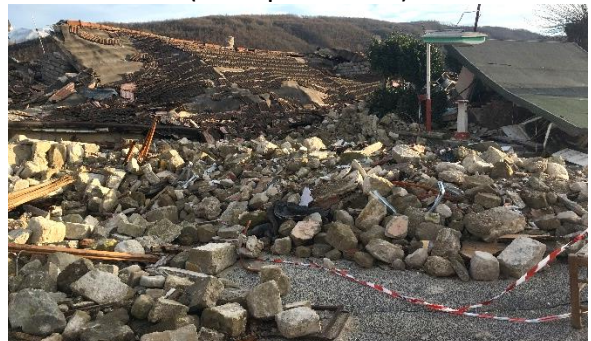
**P03 (Police station, square side)**

Accumoli was one of the most damaged villages after the 24 August main shock (GEER 2016). During the September reconnaissance, significant additional damage was observed, with widespread partial collapses throughout the village. The eastern part of the village, around the main square (Piazza San Francesco), was the most heavily damaged area, with partial collapses

of the police station and the small church. Moreover, the retaining wall along the eastern side of the village experienced significant relative movements, most likely associated to the instability of the slope below.

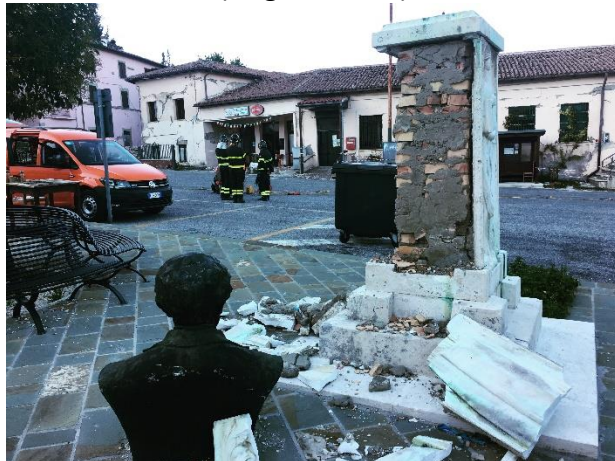
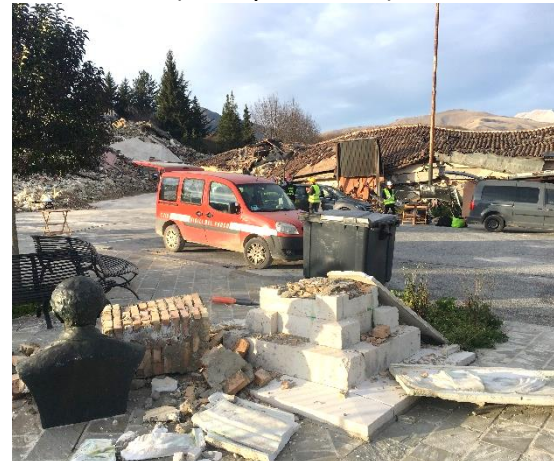
**P04 (Western view from square)**

Picture	DATUM	Description	Position		September Damage Level	December Damage Level
			Lat.	Long.		
V1	WGS-84	Pedestrian route crossing the village	42.694972°	13.248886°	D3	D5
V2	WGS-84	Piazza San Francesco entrance	42.694601°	13.248556°	D3	D5
V3	-	Air view east-west direction	-	-	D1-2	D5
V4	-	Air view west-east direction	-	-	D1-2	D4
V5	-	Air view south-north direction	-	-	D1-2	D3/4
P01*	WGS-84	Church	42.694073°	13.249509°	D4	D5
P02*	WGS-84	Town hall	42.694304°	13.249263°	D3	D5
P03*	WGS-84	Police Station (view from the square)	42.694325°	13.249507°	D3	D5
P04*	WGS-84	Western (view from the square)	42.694215°	13.248842°	D2	D5
P05*	WGS-84	Northern view from the square (bar)	42.694428°	13.249379°	D3	D5
P06*	WGS-84	Small square in front of the church	42.694073°	13.249509°	D2	D5
P07	WGS-84	Panoramic view of the square	42.694215°	13.248842°	D2	D5

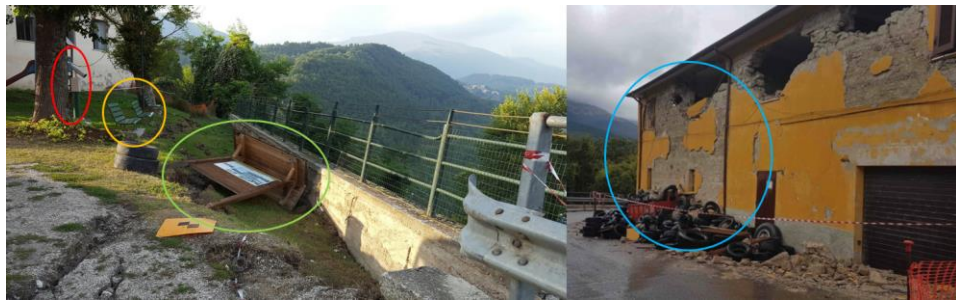
The accumulation of damage across seismic events is also evident by comparing the panoramic view of the village after the September and December field missions (Figure 6.26 and Figure 6.27). More precisely, it is seen that the retaining wall completely overturned, causing disruption of the adjacent road. It is noted that it was not possible to take the pictures from the same position, hence, colored circles are used to indicate the corresponding spots.

**Figure 6.26.** Representative pictures of landslide in eastern part of village (September 2016).

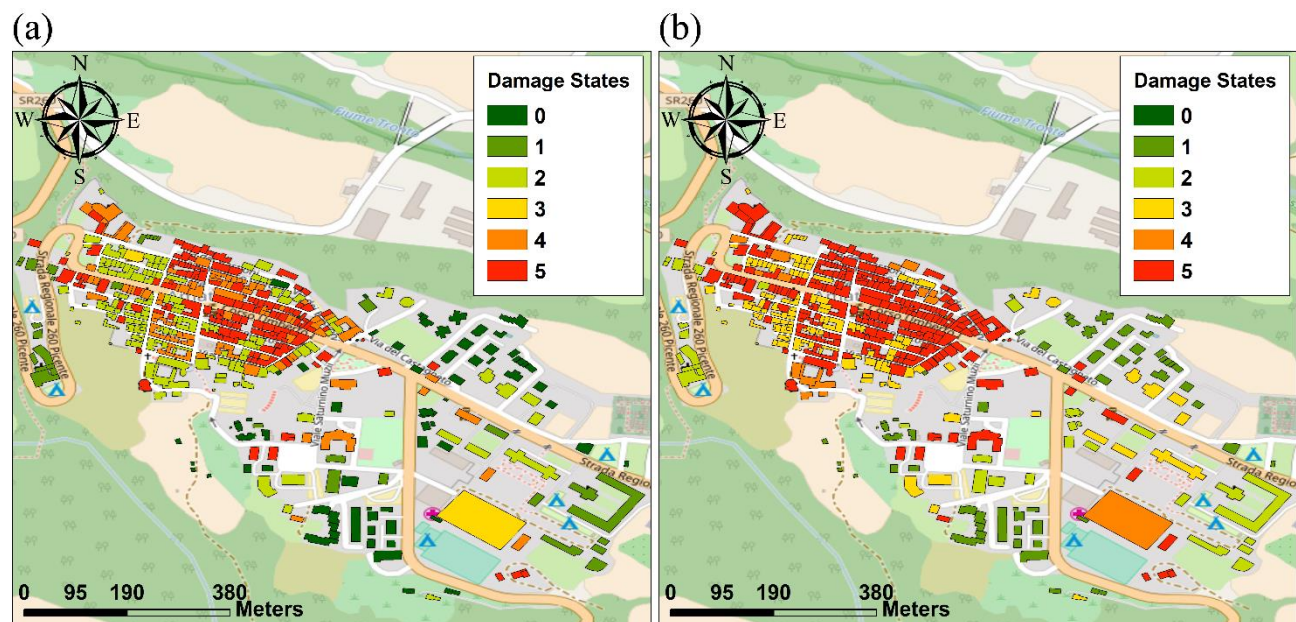
Amatrice's buildings were severely affected by August event sequence (Section 5.3.2 of GEER 2016). Many buildings that remained standing after the August events had only a small residual capacity, and then collapsed during September and October events. Figure 6.28 shows the multi-epoch damage evolution. This is also reflected in the histograms of red zone damage statistics in Figure 6.29, which show that the percentage of D5 structures increased from 23% to 42%. We distinguish performance of different structural systems qualitatively for a number of characteristic buildings, the locations of which are shown in Figure 6.30.

**Figure 6.28.** Evolution of damage after (a) the first seismic event and (b) the sequence of events.

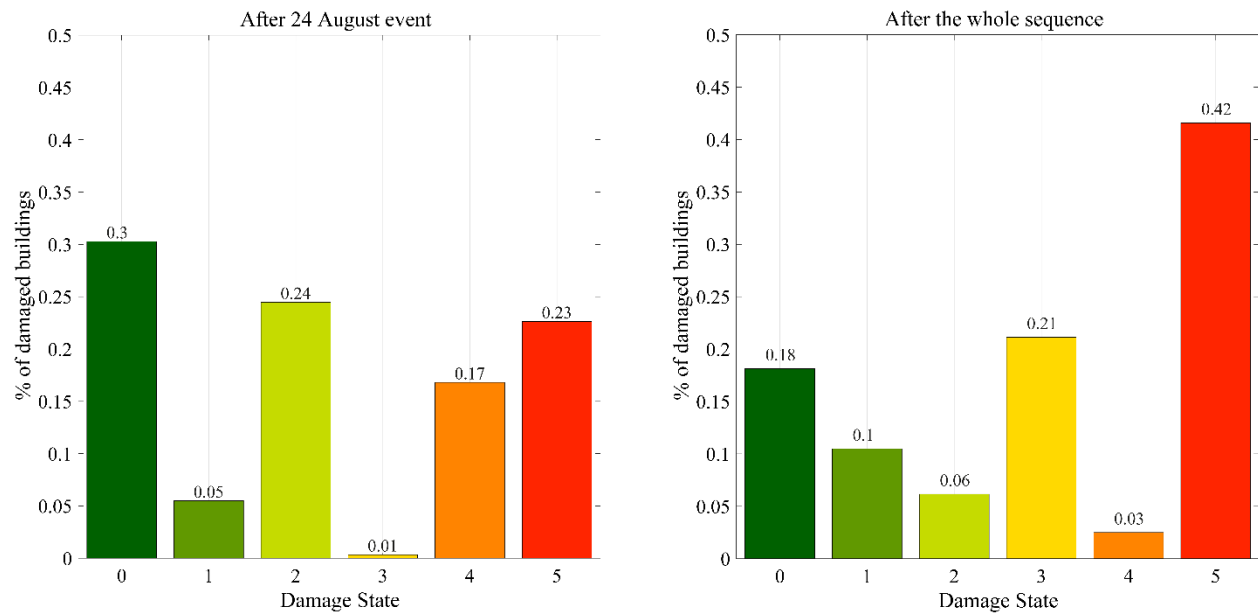
**Figure 6.29.** Percentage of damaged structures (a) in the aftermath of first event and (b) after the whole sequence.

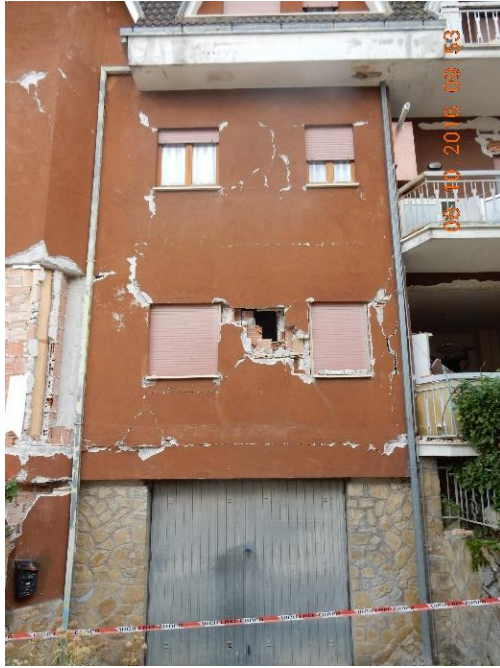
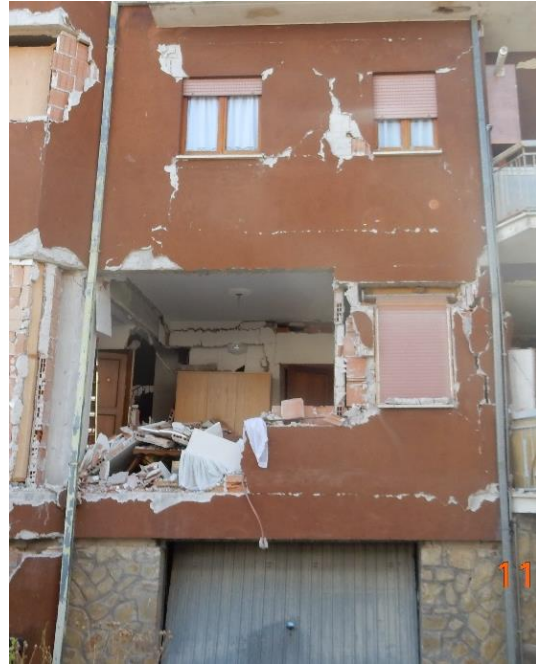
Figure 6.38. Building RC2.

Figure 6.37 illustrates building RC1 in the aftermath of the first event (a,c) and after the October sequence (b,d). It evident that the infill panel has failed out-of-plane after the seismic sequence (but not after the first main shock), whereas the shear failure at the top of the right column has been clearly pronounced. Figure 6.38 depicts building RC2, a dual shear wall – moment resisting frame built with the older Italian seismic code (The Italian National Annex DM 1996, Norme Tecniche per le Costruzioni, 1996; NTC96). Similar out of plane failure of the,

initially diagonally cracked, infill panel is again observed as a result of shaking from multiple events. A detail of beam-column joint damage is illustrated in Figure 6.39 for building RC3. We observe cyclic degradation of column top, spalling of concrete, and minor longitudinal rebar buckling in the absence of adequate transverse reinforcement. Finally, building RC4 in Figure 6.40 experienced only minor damage after the August event but suffered out-of-plane failure of the majority of its infill panels subsequently, thus exposing the structure to a potential soft story mechanism. Performance of this type was characteristic of the area.

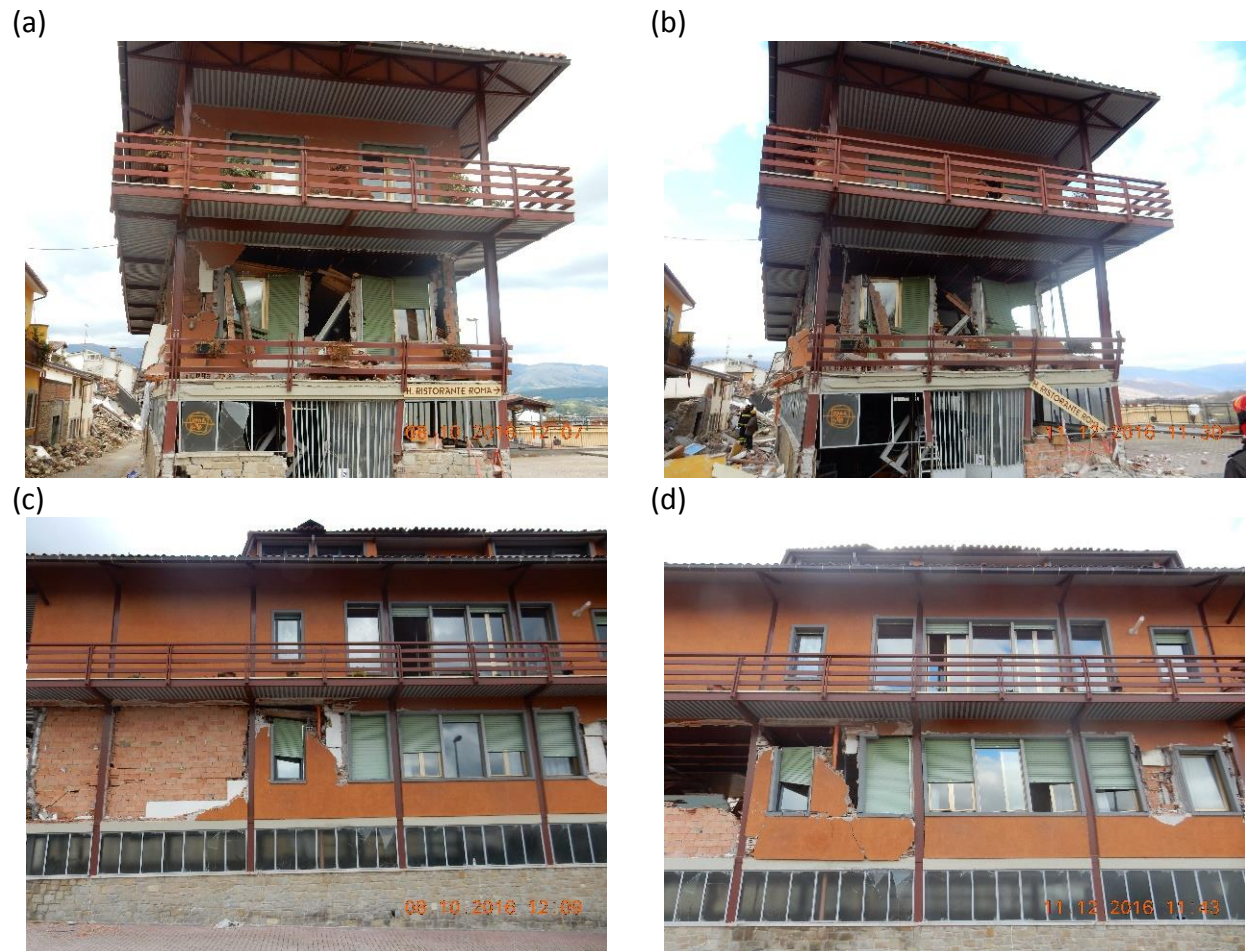
Figure 6.41. Building S1.

There is only one high-rise steel structure within the Amatrice red zone (Figure 6.41) built in the early 90's with the Italian seismic code of the time (The Italian National Annex DM 1996, Norme Tecniche per le Costruzioni, 1996; NTC96). It consists of a basement, a ground floor and two upper stories, alongside a shorter story on top that serves as a penthouse. Given the intensity of ground motion, its overall performance is deemed relatively satisfactory. Contrarily, Hotel Roma, one of Amatrice's most iconic structures, located a few meters from the steel building, collapsed completely. After the first event, damage was only concentrated to non-structural elements, with small local flange instability at the top of two front columns of the ground floor. At the end of the October event sequence, the building presented permanent deformation along the longer direction, as shown in Figure 6.41. Such permanent deformation is localized at the second level of the building with a visible inter-story drift. Preliminary finite element analyses of the building suggest that the fundamental mode period of the structure is approximately 0.75sec. The mode shape indicates an almost uncoupled translation along the long side, mainly due to the orientation of the steel columns whose strong axis is aligned with the short side of the building.

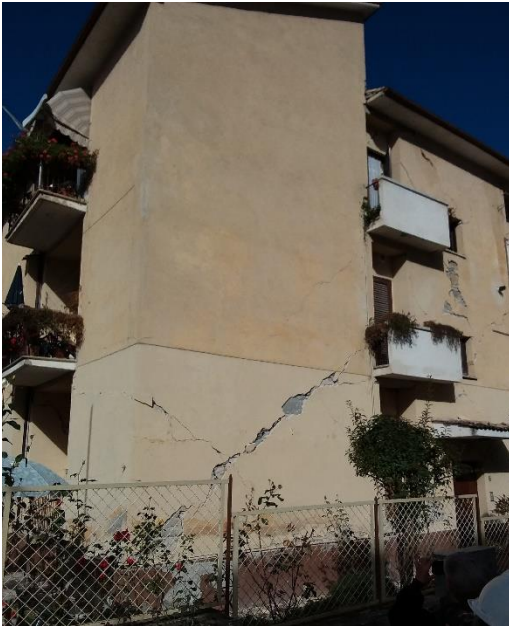
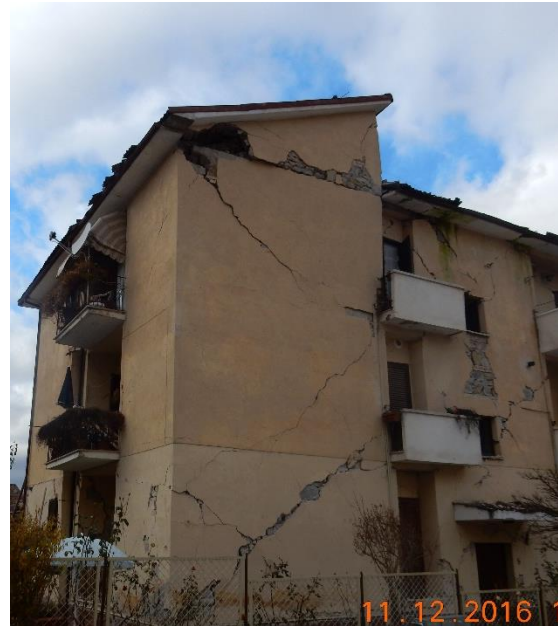
Figure 6.42. Building M1.

Figure 6.42 shows multi-epoch damage to a masonry building. Damage at the base of the structure is essentially unchanged, but new damage features are observed in the top story. Figure 6.43 shows the local police (“Carabinieri”) station. It is evident that diagonal cracks were extended in both sides of the building after multiple seismic events. Notably, the local retrofit by means of steel ties at the corners of the upper story mitigated further damage and possible collapse.

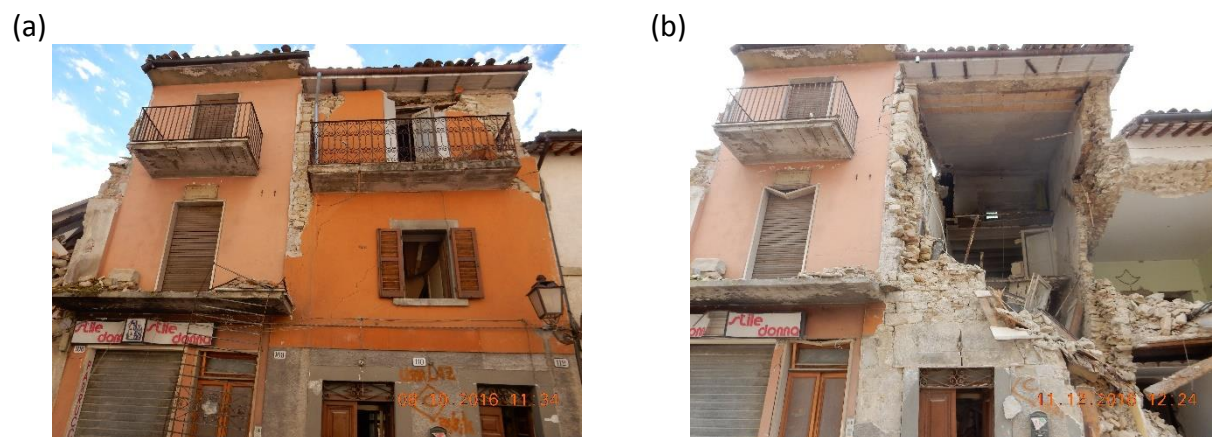
Figure 6.44. Building M3.

Figure 6.44 and Figure 6.45 present two buildings within the Amatrice red-zone, where initial damage of the outer masonry due to the first event evolved to partial collapse after the event sequence. This is also an interesting case in that such partial collapse is not always visible by satellite, thus highlighting the importance of careful on-site ground inspection. The soft-story of another masonry building is illustrated in Figure 6.45. Such a mechanism is presumably due to the higher stiffness of the upper part with respect to the ground floor, and due to the previous shear failures observed at the ground level in the aftermath of the first event. It is also a characteristic case where the evolution of damage in masonry structures under multiple seismic events, as well as the increase of the corresponding damage indeed, is strongly nonlinear. Figure 6.46 shows the complete collapse of a building that was heavily damaged from the first event.

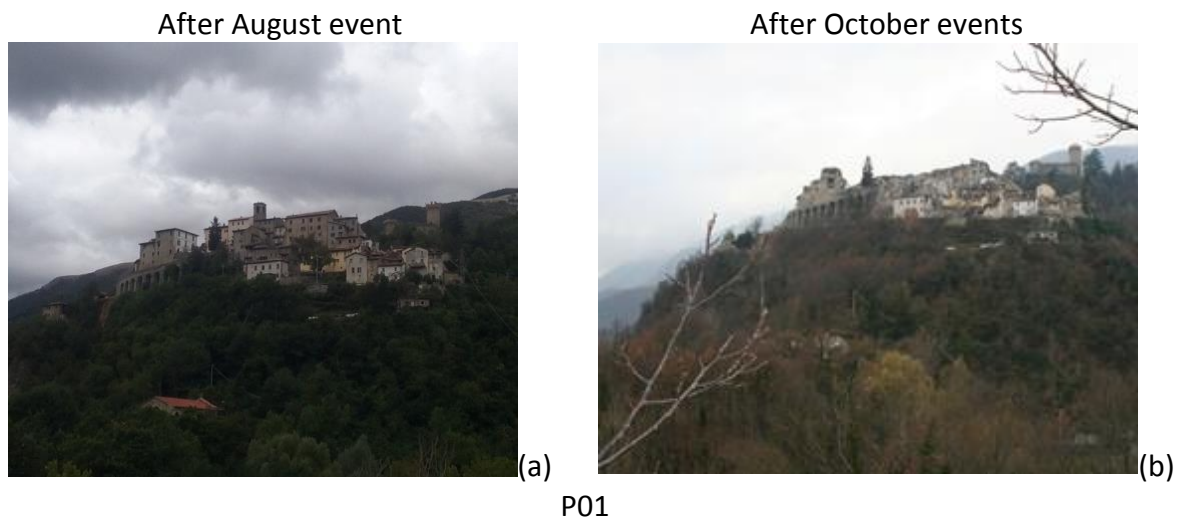
The photographs in Figure 6.48 show Arquata del Tronto after the August and October events, from which a substantial damage increase is evident following the 26 and 30 October earthquakes. Conversely, Borgo did not suffer appreciable cumulated damage, as shown in Figure 6.49 and Figure 6.50. Figure 6.51 shows the collapse of a structure onto the access road for Arquata village. At the time of our November reconnaissance, the village was not accessible and much of the village center was destroyed. The damage level assigned to Arquata del Tronto

**Figure 6.48.** Overview of Arquata del Tronto (a) after the 24 August earthquake, and (b) after the October events.

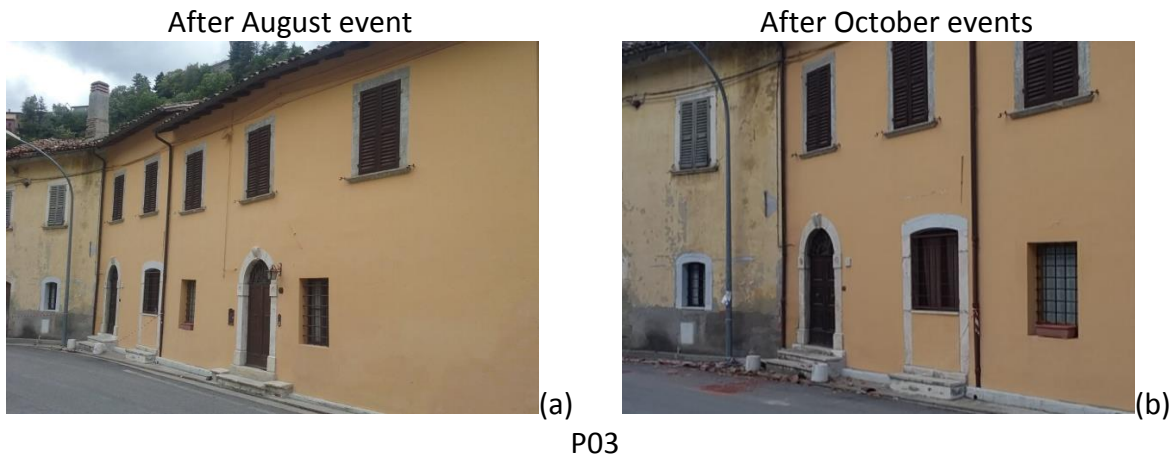
**Figure 6.49.** A reinforced masonry building in Borgo (a) after the 24 August earthquake, and (b) after the October events.

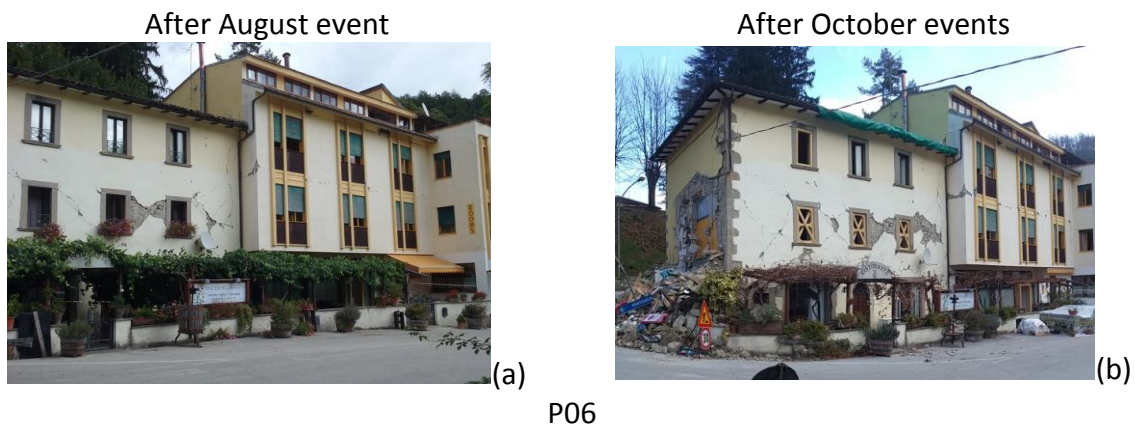
**Figure 6.50.** A building in Borgo (a) after the 24 August earthquake, and (b) after the October events.

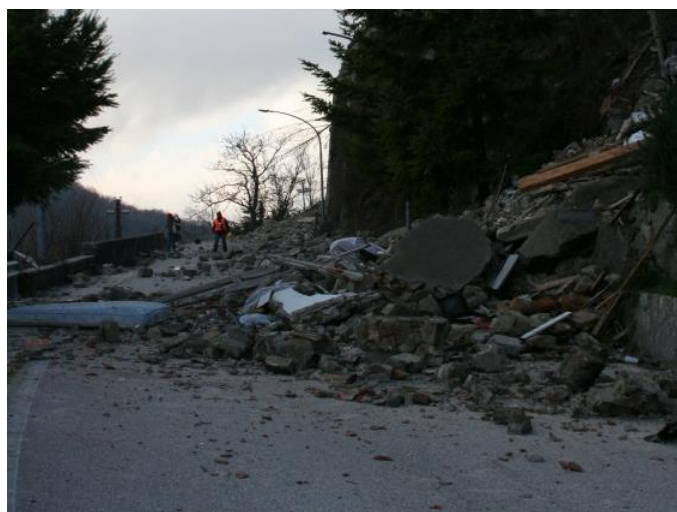
**Figure 6.51.** Access road to Arquata del Tronto after the October events.

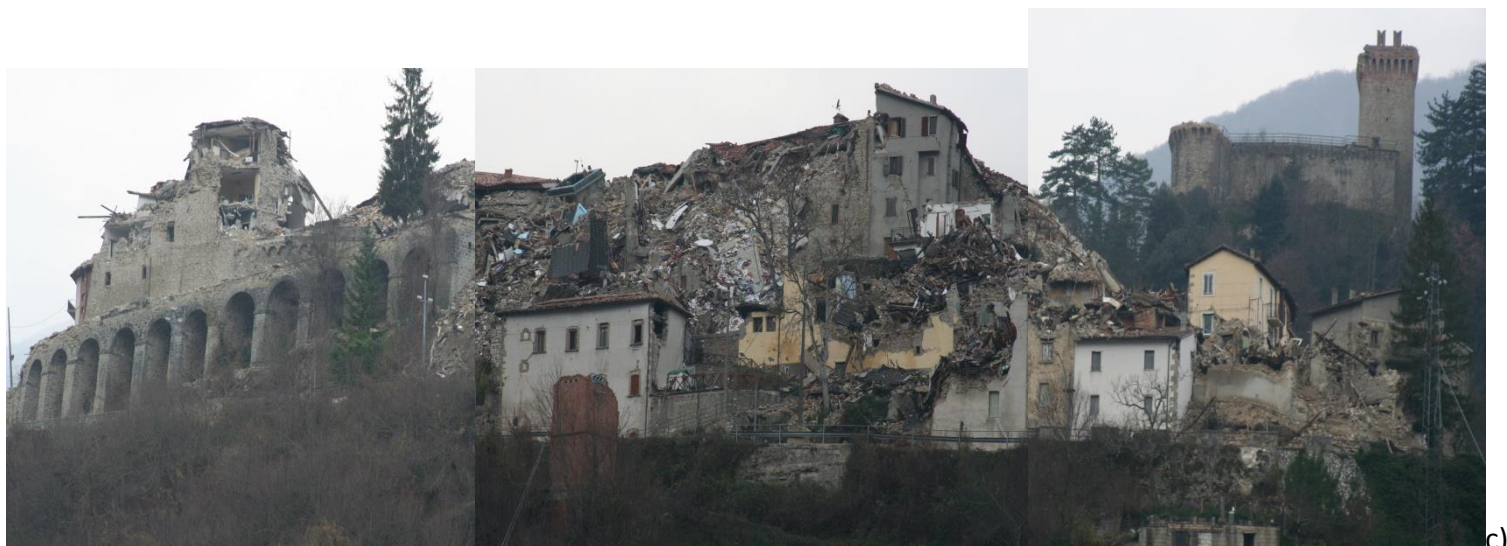
(D5) is documented in Figure 6.52. Table 6.3 shows the locations and damage levels for all selected representative structures.

**Figure 6.52.** Overview of the damage level in Arquata del Tronto after October events.

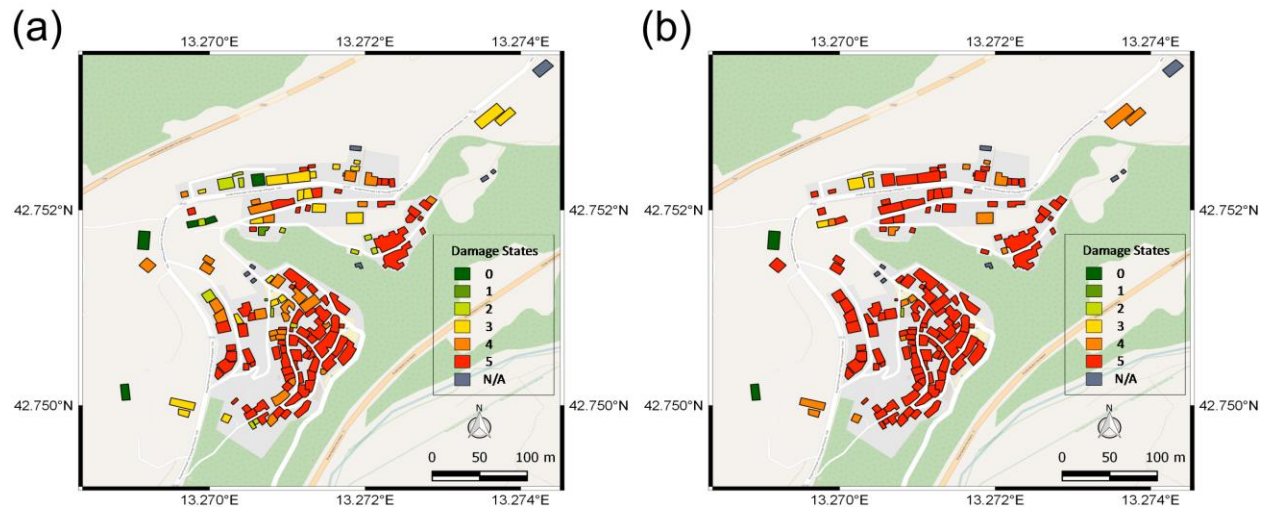
Pescara del Tronto was devastated by the 24 August earthquake (GEER 2016), with nearly half of the structures having collapsed. Figure 6.53 and Figure 6.54 show the evolution of damage from the August (Figure 6.53a and Figure 6.54a) to the October events (Figure 6.53b

and Figure 6.54b). Damage levels in Pescara del Tronto increased as a result of the October events, with approximately 70% of the structures having damage levels D4 or D5 (was 65% following August events).

**Figure 6.53.** Mapped damage levels in Pescara del Tronto: (a) after the 24 August, and (b) the October events.

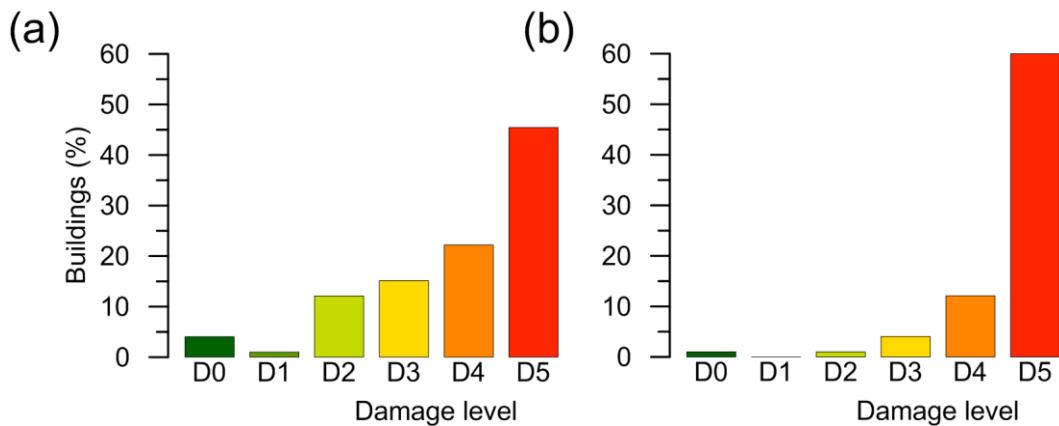
**Figure 6.54.** Histogram of damage levels in Pescara del Tronto: (a) after the 24 August, and (b) the October events.

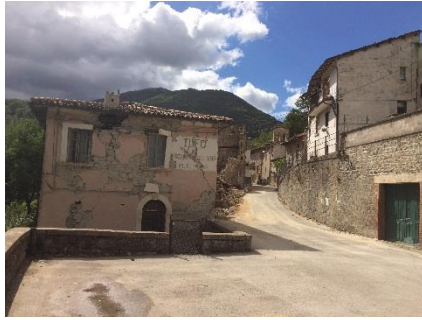
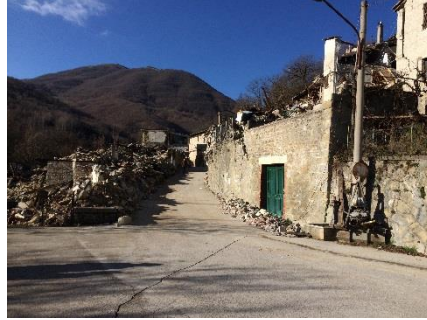
Picture	DATUM	Description	Location		September Damage Level	December Damage Level
			Lat.	Long.		
P1	WGS-84	Entrance of the historical center (M2-M3)	42.7353°	13.2532°	D3	D5
P2	WGS-84	Masonry buildings (M4)	42.7354°	13.2528°	D1	D5
P3	WGS-84	Reinforced concrete building (RC1)	42.7351°	13.2519°	D0	D2
P4	WGS-84	Santissima Maria Annunziata Church (M1)	42.7351°	13.2522°	D0	D3
P5	WGS-84	Santissima Maria Annunziata Church (M1)	42.7351°	13.2522°	D0	D3
P6	WGS-84	Santissima Maria Annunziata Church (M1)	42.7351°	13.2522°	D0	D3

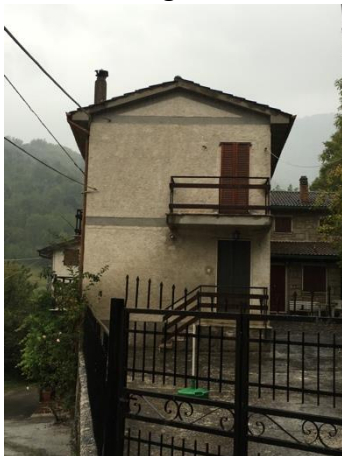
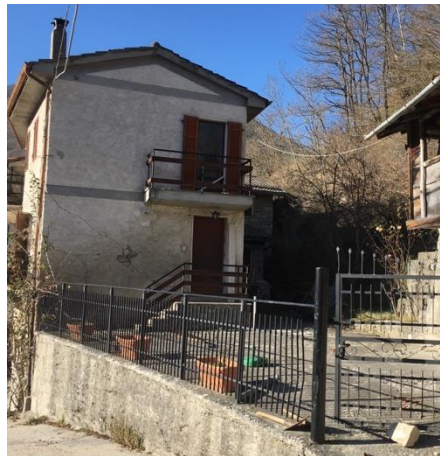
P3

Figure 6.61 shows locations of selected buildings for which we show photos taken after the August and October events. Figure 6.62 shows these pictures, which were taken from a common perspective. Table 6.5 summarizes locations and damage levels for each of the representative structures. Structures M2, M3, and M4 (P1 and P2 in Figure 6.62) are unreinforced masonry buildings. They had damage levels ranging from D1-D3 after the August events and D5 (complete collapse) following the October events. We documented the performance of one reinforced concrete structure (RC1). It had no apparent damage from the August events and damage level D2 after the October events (P3 in Figure 6.62).

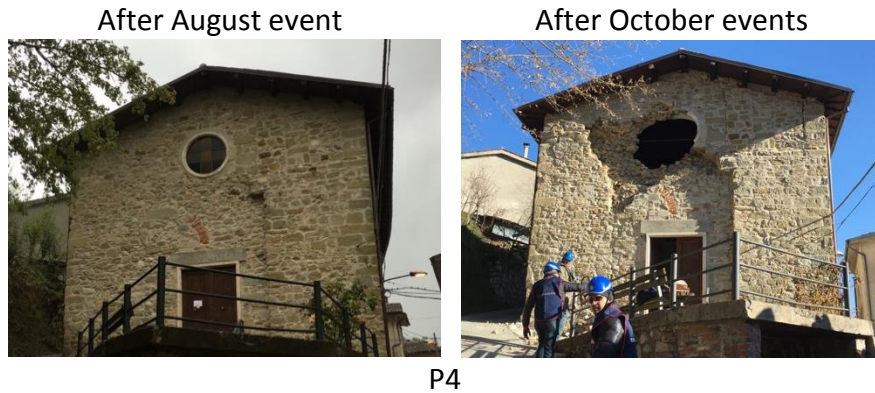
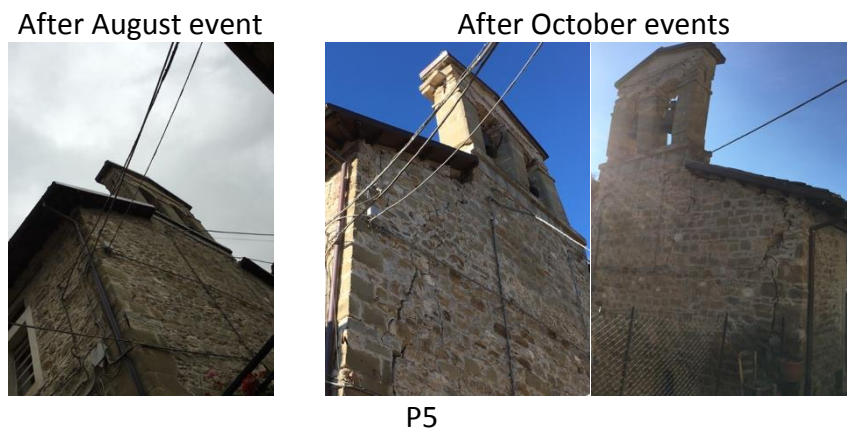
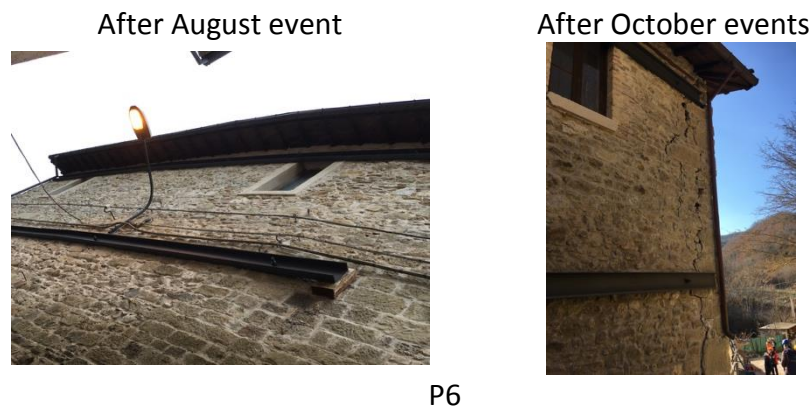
An important monument in Tufo is the *Santissima Maria Annunziata Church*. It is a church built in the XVII century that appears to have been recently retrofitted. The church had no apparent damage (D0) from the August events (P4, P5, and P6 in Figure 6.62) and damage level D3 (partial collapse of façade around the rose window; P4 in Figure 6.62) following the October events. Figure 6.62 also shows multiple layers of untied bricks and significant new cracks at corners (P5 and P6), possibly from lack of lateral reinforcement at the corner.

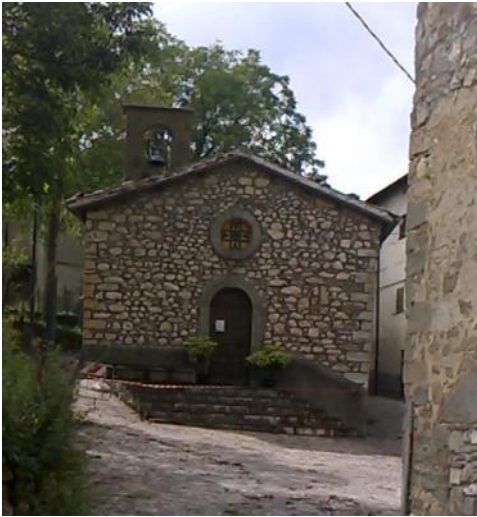
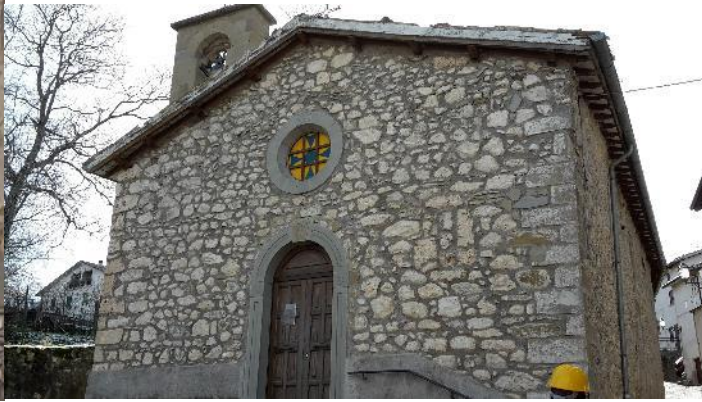
P01 (Astorara)

Hamlet	Structures	Damage description
Astorara	P01*-P02-P03	At the entrance, there are recent buildings with evidence of recent structural retrofitting (D0 level). Many older structures at the back of the village show a D4/5 damage level. At the highest portion of the village a full collapse occurred.
Balzo	P04	General D2/D3 damage level. The village is completely abandoned, while in September after the August main shock it was still populated and with shops and restaurants still in operation.
Castro	P05-P06	Church with a full collapsed apse and the rest of the hamlet with diffused D4/5 damage level. A recent house on the main road with no damage (D0) and still inhabited.
Colle	P07-P08-P09	Similar to Astorara with various levels of structures vulnerability. Recently restored buildings with D0; old masonry buildings with partial or full collapses (D4/D5).
Collefratte	P10-P11*-P12	Very damaged hamlets D3/D3 and a full collapse D5.

Picture	Hamlet	DATUM	Position		September damage Level	December damage Level
			Lat.	Long.		
P01*	Astorara	WGS-84	42.837436°	13.31119°	D0-D1	D0-D1
P02	Astorara	WGS-84	42.837222°	13.31055°	-	D0-D1
P03	Astorara	WGS-84	42.837222°	13.31055°	-	D4-D5
P04	Balzo	WGS-84	42.8425°	13.33222°	-	D2-D3
P05	Castro	WGS-84	42.84583°	13.32527°	-	D4-D5
P06	Castro	WGS-84	42.84722°	13.32638°	-	D4-D5
P07	Colle	WGS-84	42.84416°	13.30583°	-	D4-D5
P08	Colle	WGS-84	42.84416°	13.30583°	-	D4-D5
P09	Colle	WGS-84	42.84416°	13.30583°	-	D4-D5
P10	Collefratte	WGS-84	42.83952°	13.31907°	-	D5
P11*	Collefratte	WGS-84	42.83934°	13.31907°	D3	D3
P12	Collefratte	WGS-84	42.83952°	13.31907°	-	D3-D4

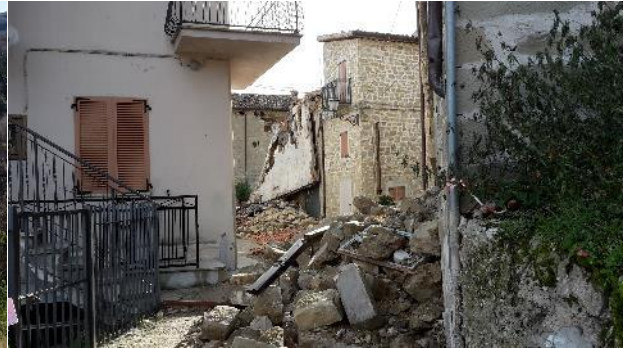
P06 (Castro)

Table 6.6 summarizes observed damage patterns for each hamlet. Most of these hamlets were visited (Astorara, Collefratte, Colleluce, Colle, Piano and Pistrino), although Balzo and Castro were assessed from afar due to limited access. In particular, the main access road to Castro was blocked by debris (see Picture P06 below).

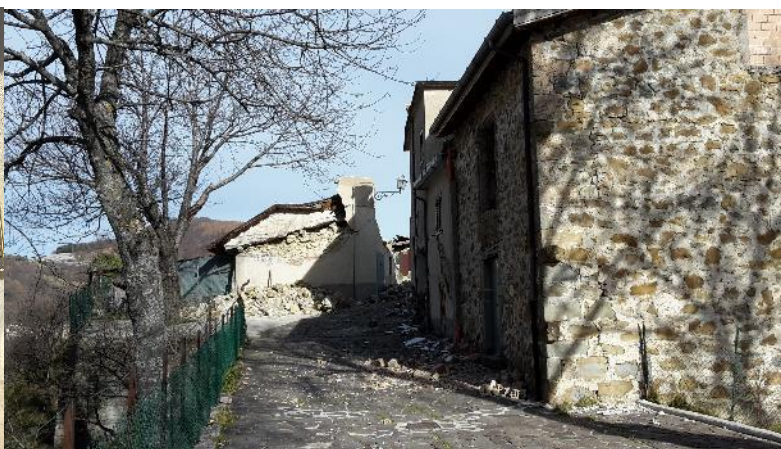
P13 (Colleluce)

Colleluce	P13	Totally D4/5.
Piano	P14*	Generally D0/D1.
Pistrino	P15*-P16*-P17*	The initial part of the village (Pistrino di Sopra) was seriously damaged (D3/D4), whereas the other part (Pitrino di sotto, 1 km from Piano) showed minor problems (D0/D2) except for a collapsed small stones wall.

Picture	Hamlet	DATUM	Position		September damage Level	December damage Level
			Lat.	Long.		
P13	Colleluce	WGS-84	42.83805°	13.30722°	-	D4-D5
P14*	Piano	WGS-84	42.854116°	13.339129°	D0	D0
P15*	Pistrino	WGS-84	42.855579°	13.332649°	D0-D1	D0-D1
P16*	Pistrino	WGS-84	42.855579°	13.332642°	D0-D1	D0-D1
P17*	Pistrino	WGS-84	42.855579°	13.332649°	D0-D1	D0-D1

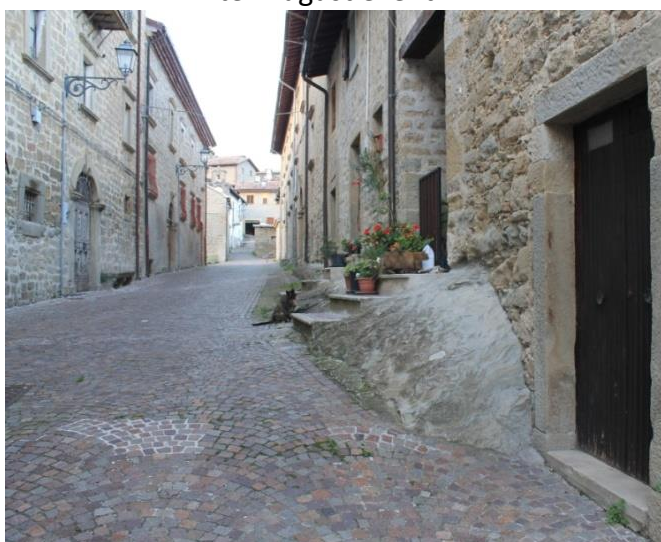
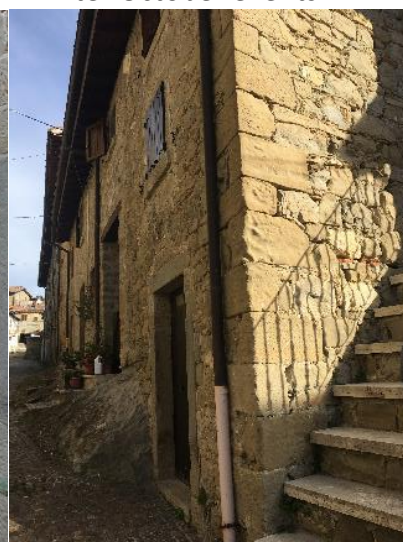
P14 (Piano)

Damage levels were variable across Montegalloy, which is likely a result of variable ground motion levels (mostly as a result of different site effects) and variable construction types and quality. In general, we encountered significant increased damage levels (approximately one class, e.g., D2 to D3) following the October events. A notable exception is Piano, which showed no evidence of damage following either event sequence, despite some examples of apparently poor construction (P14 in Figure 6.63).

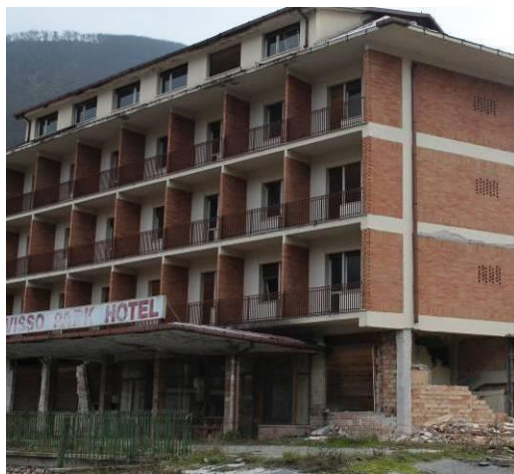
P01

The pictures are presented in Figure 6.66. The historical center consists mainly of unreinforced masonry structures (some of which have been recently retrofitted), 2-3 stories in height. Outside of the historical center, modern reinforced concrete structures were encountered (see P01-P02).

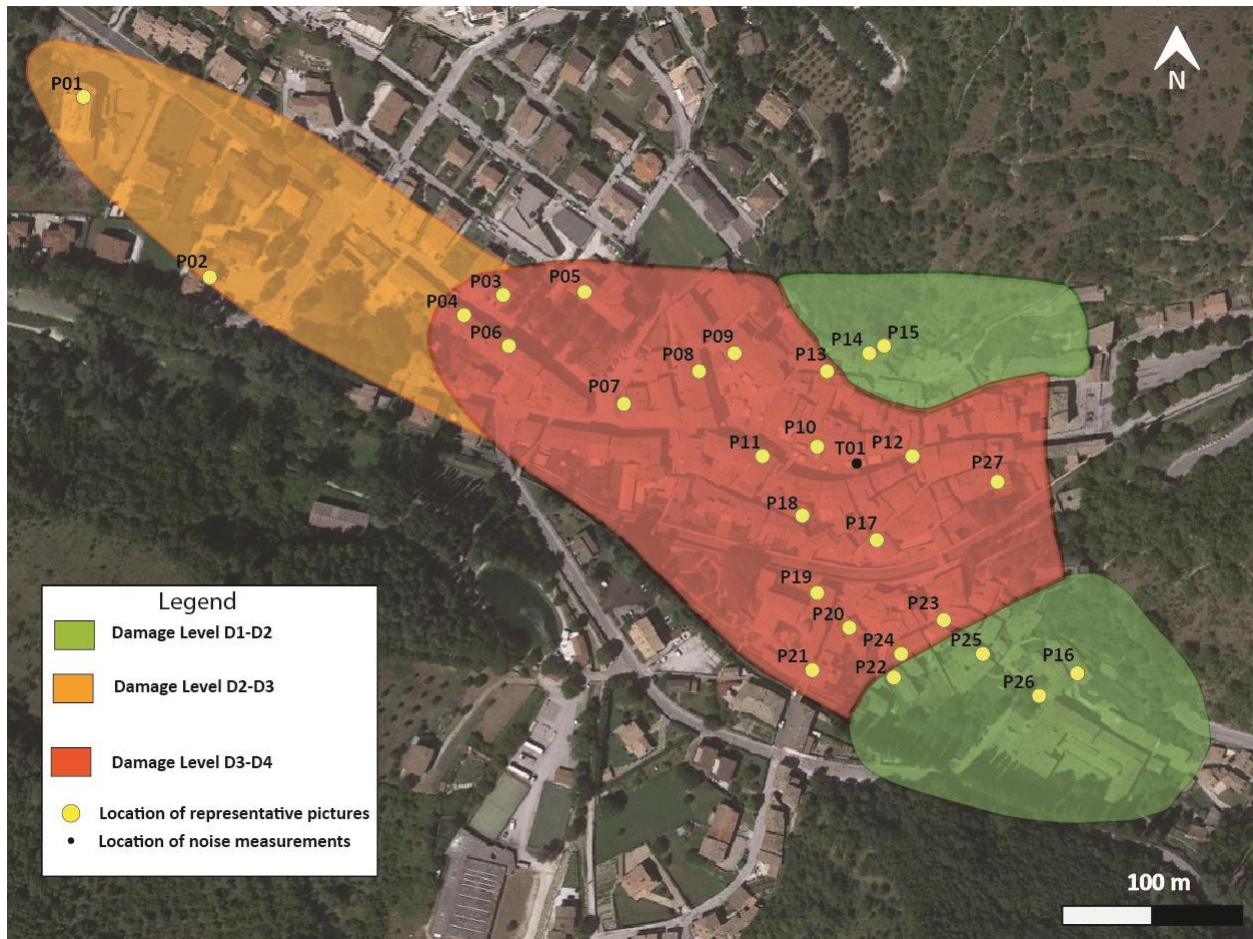
The village was significantly damaged by the October events. However, the degree of damage to buildings is spatially variable. A tentative damage zonation map is reported in Figure 6.67. Damage levels as high as D3-D4 are concentrated in the historical center, especially the portion founded on the quaternary continental deposits (alluvial deposits, eluvio-colluvial deposits, and widespread slope deposits). Minor damage (D1-D2) was encountered in the portion founded on the SCC rock (Scaglia Cinerea Formation). In the NW portion (outside the historical center), we encountered D2-D3 on average. This part of the village is located on quaternary deposits. However, the relatively minor vulnerability of buildings was probably responsible for the minor damage observed in this part of the historical center.

**Figure 6.67.** Damage zonation within the villages of Visso village.

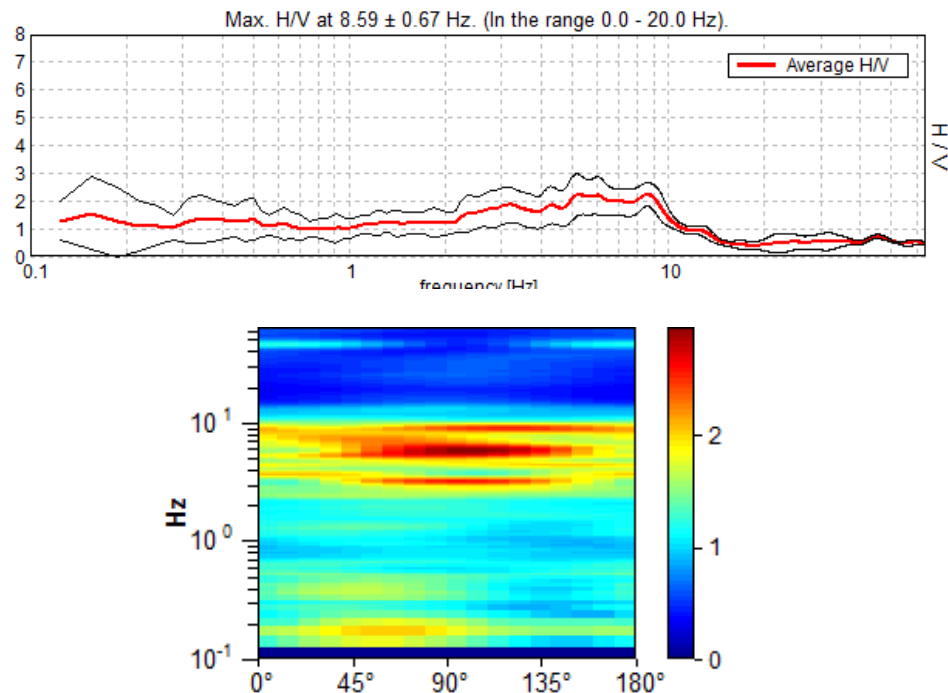
are reported in Figure 6.68. We observe no large H/V peaks at T1, suggesting the lack of a site condition producing a strong resonant site response.

**Figure 6.68.** Noise measurement T01 results in terms of H/V spectral ratio (up) and H/V polar plots (bottom).

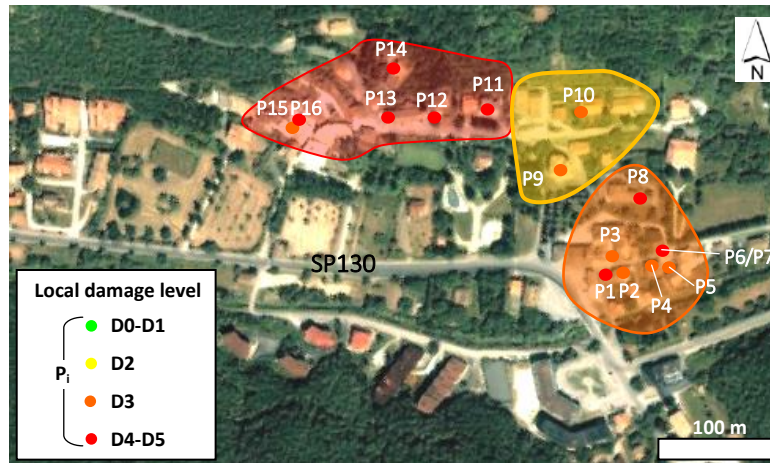
Figure 6.69 shows locations of representative structures inspected in Ussita and maps damage zones within the village. Damage levels were generally between D3 and D4. Figure 6.70 shows pictures of selected structures in the area of Ussita that experienced the higher level of damage.

**Figure 6.69.** Locations of representative structures inspected in Ussita, and damage zonation within the village.

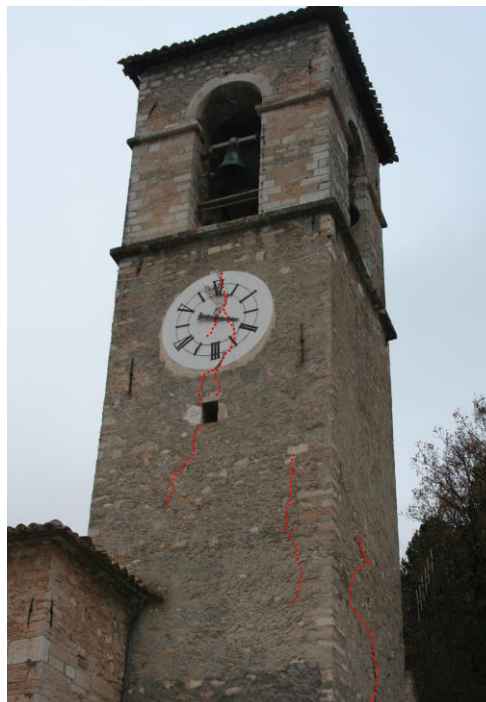
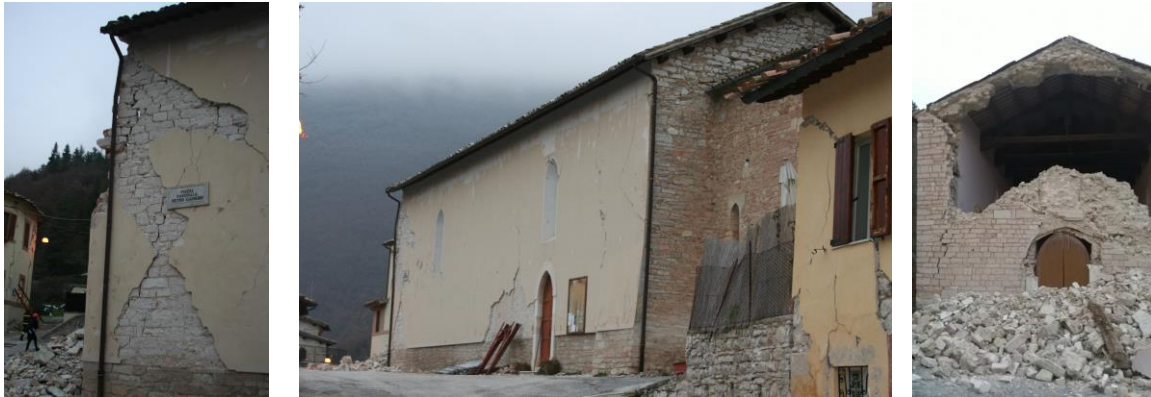
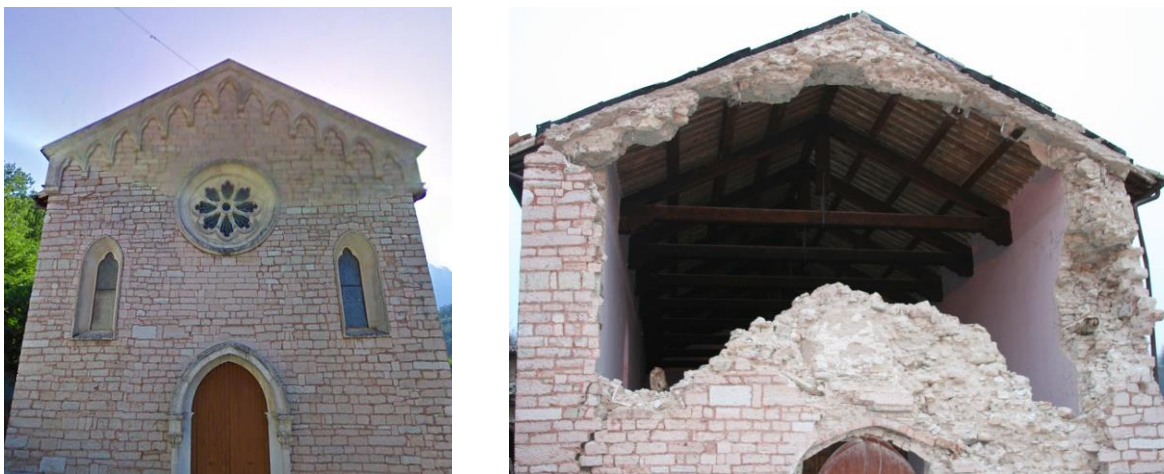
**Figure 6.70.** Representative pictures taken in Ussita (P13)
