# Engineering Reconnaissance Following the October 2016 Central Italy Earthquakes *Version 2*

GEER Team Leaders: Jonathan P. Stewart and Giuseppe Lanzo

Geotechnical Extreme Events Reconnaissance Association  
Report No. GEER-050D  
8 May 2017

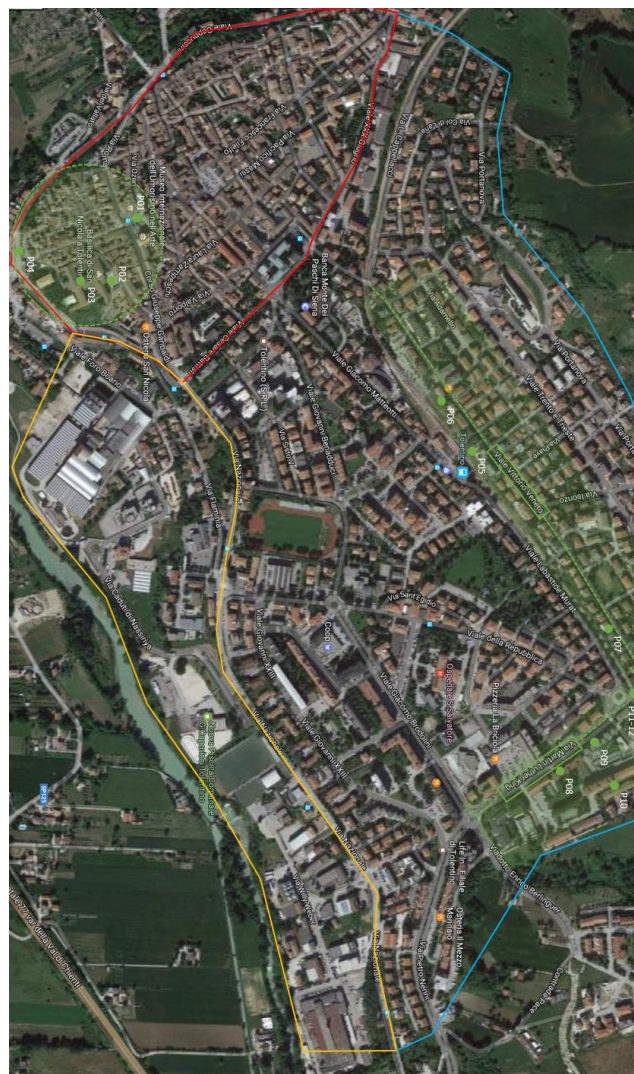
Very interesting is the Viale Vittorio Veneto-Viale Martin Luther King-Via Kennedy area. In this neighborhood, an evident site effect was observed, since diffused building damages are observed much more prominently than in the other parts of the town. In particular, the buildings along the eastern side of Martin Luther King road are recent reinforced concrete frames 5-to-8 floors above ground from the 1980s. Most of these buildings were seriously damaged and abandoned at the time of the reconnaissance. On the other side of the road, smaller buildings (most of them 3 floors above ground) suffered much less damage and were apparently in use at the time of the reconnaissance.

Figure 6.73. Tolentino reconnaissance map: in green the most damaged zones.

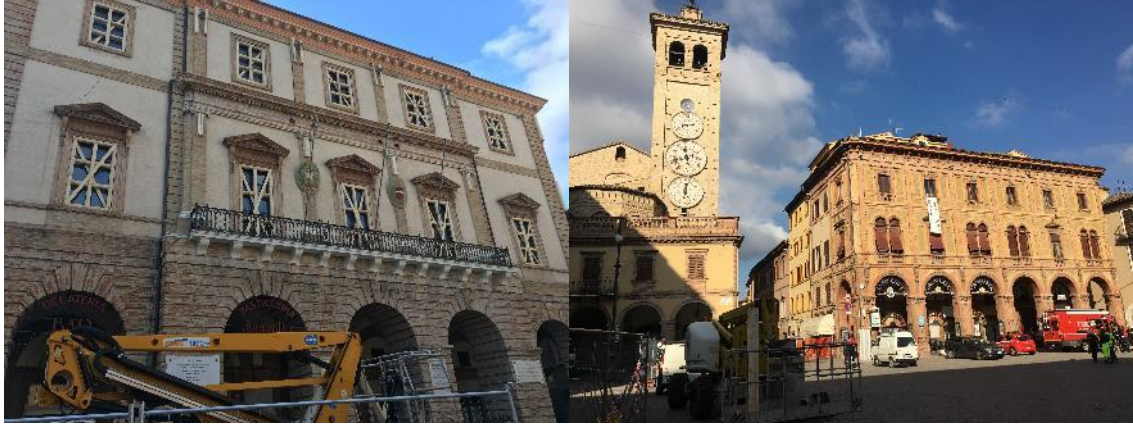
P01 (Piazza della Libertà)

Table 6.9 lists the locations of representative structures photographed and documented in the GEER reconnaissance. Figure 6.74 shows these structures. The town-center was partially damaged, especially Piazza della Libertà (main square of the town), where most of the buildings were strengthened with structural supports.

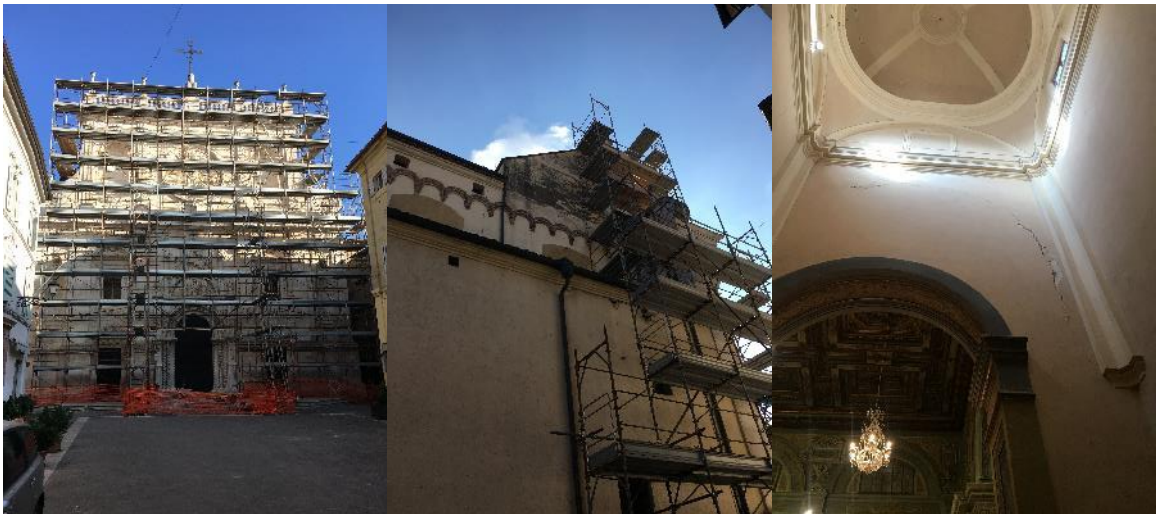
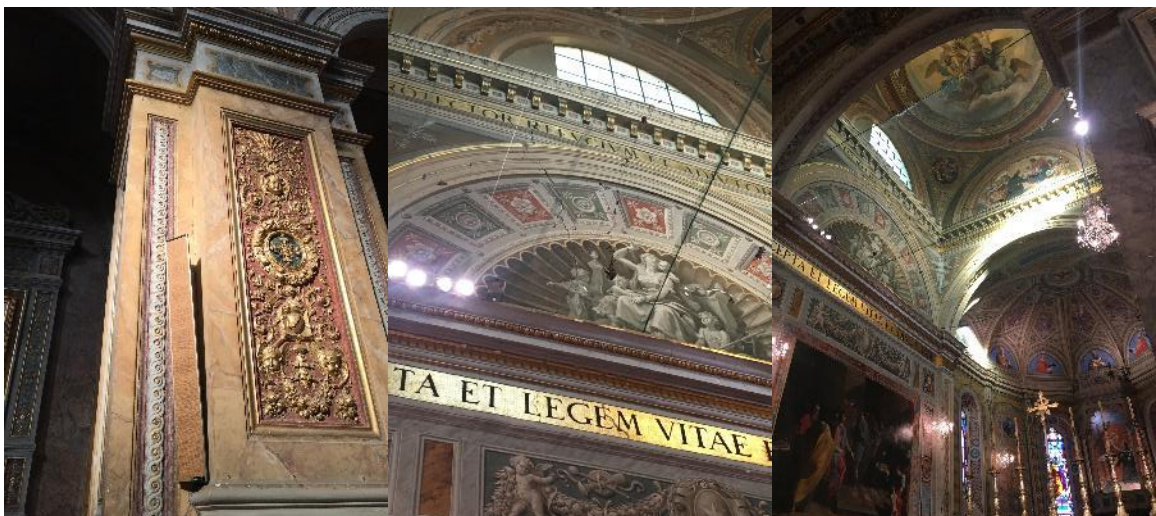
P02a-b-c Basilica di San Nicola (Saint Nicholas Church)

The San Nicola church is out of service and not accessible to the public as a result of diffused damage to the façade and the unstable wood decorated roof. The adjacent convent is a complex and heterogeneous building made by different and subsequent enlargements. For this reason, there are different states of damage inside the huge complex, depending on the structural type (masonry or reinforced concrete).

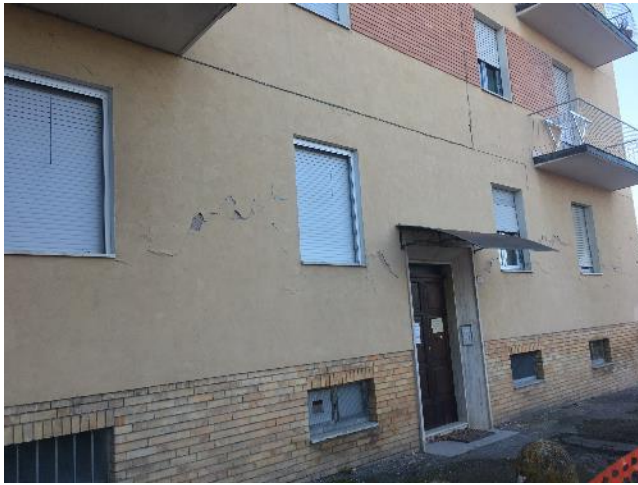
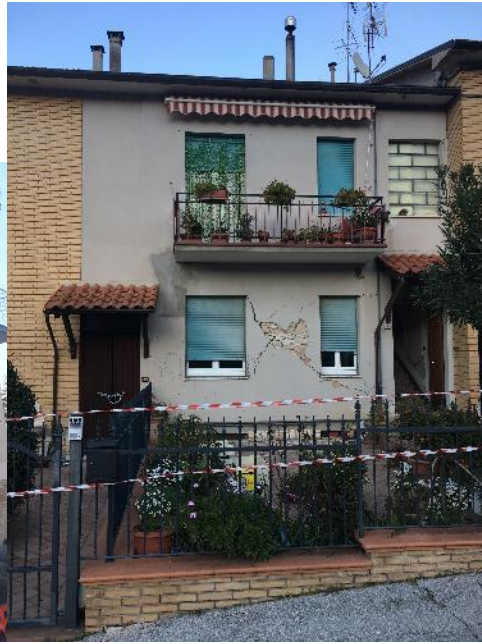
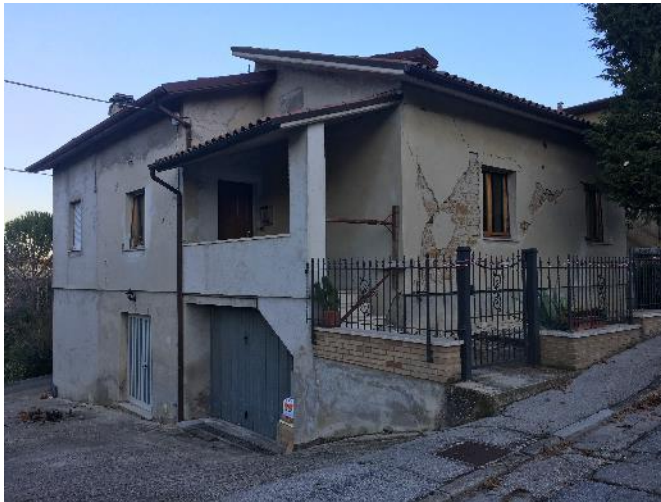
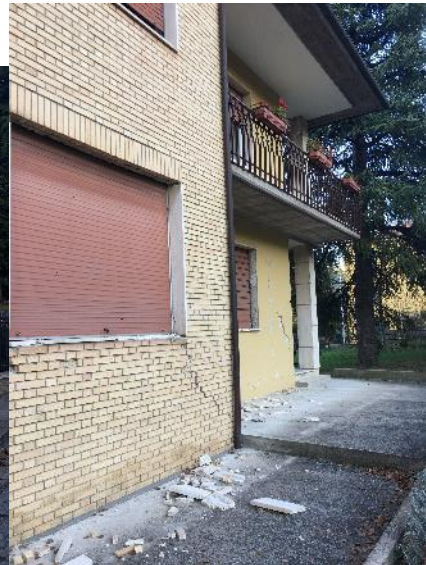
Major attention during the reconnaissance was paid to Via Mazzini and Via Rossini neighborhoods, since evident site effects were detected. The first is located on a rise and is parallel to another very damaged road (Via Monti Sibillini). The latter is very close to the Potenza River and the structures were likely built up on the ancient riverbed. Close to Via Rossini there is Villa Collio, a restaurant-villa that was severely damaged. Furthermore, a quick inspection of two towers located on the village hill was carried out (Torre Smeducci and the old Cathedral Tower), as there are plans for the installations of a permanent monitoring system by Politecnico di Torino and Nagoya City University.

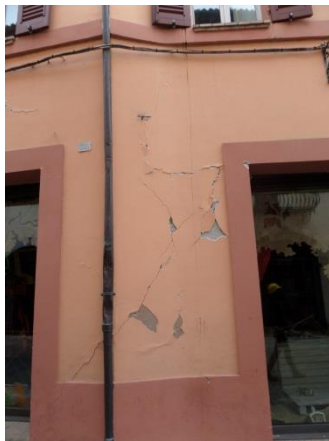
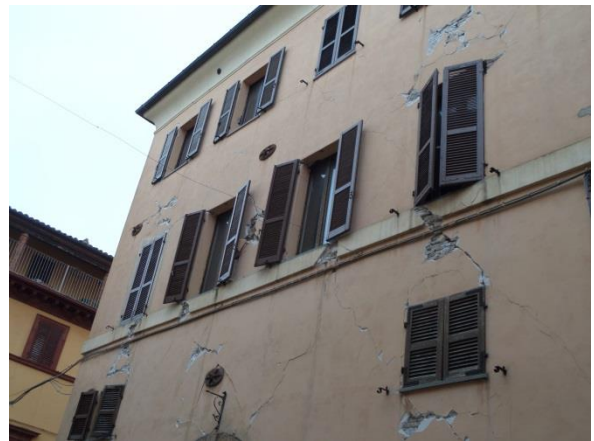
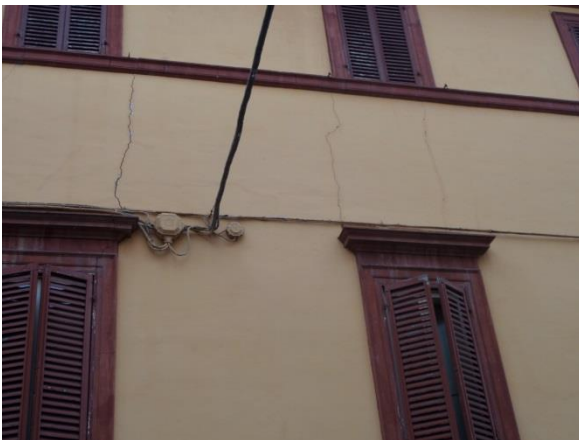
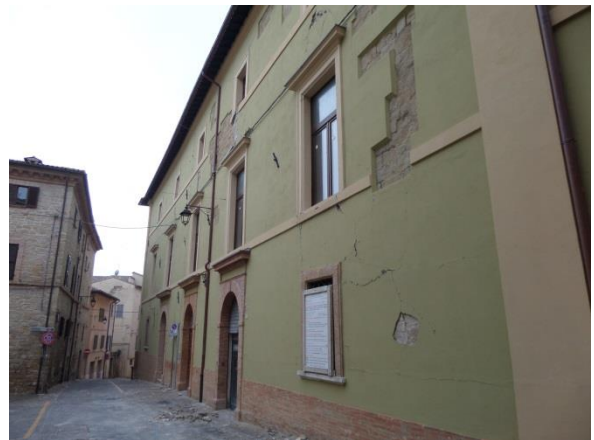
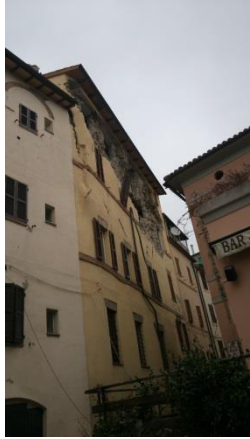
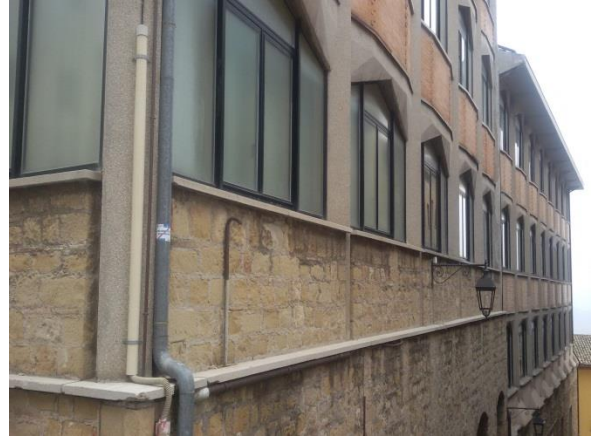
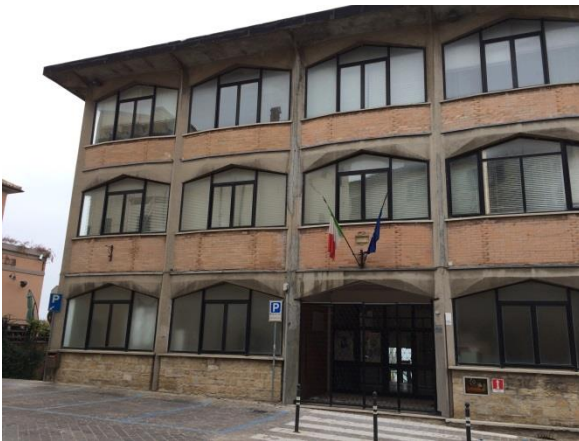
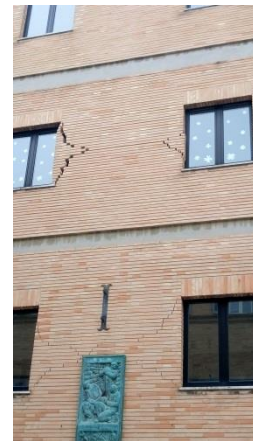
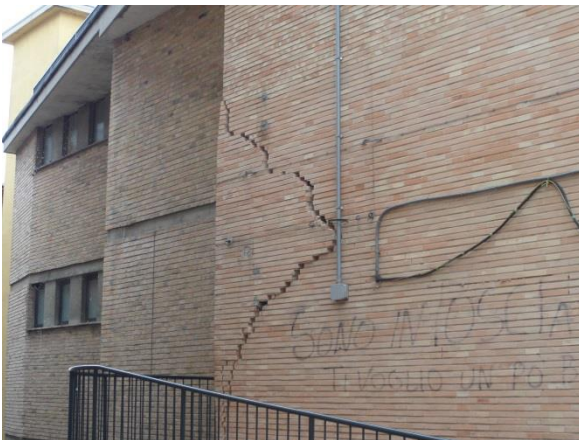
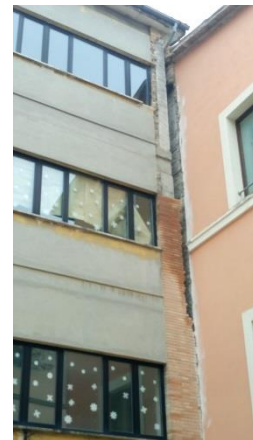
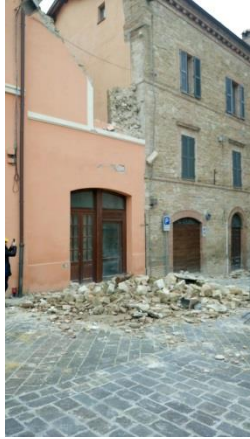
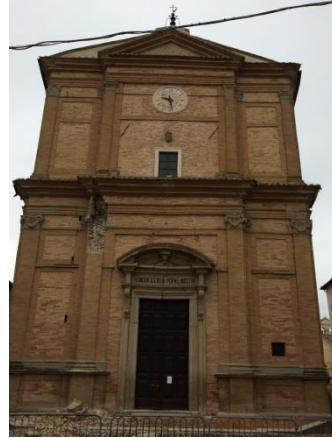
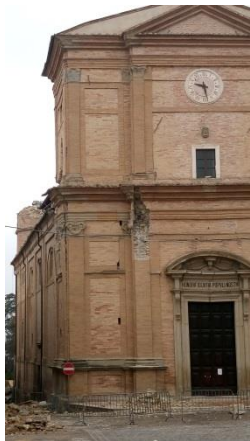
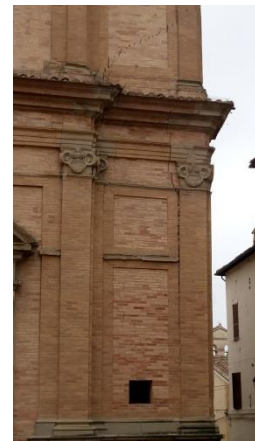
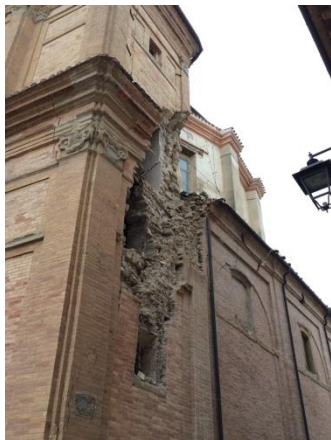
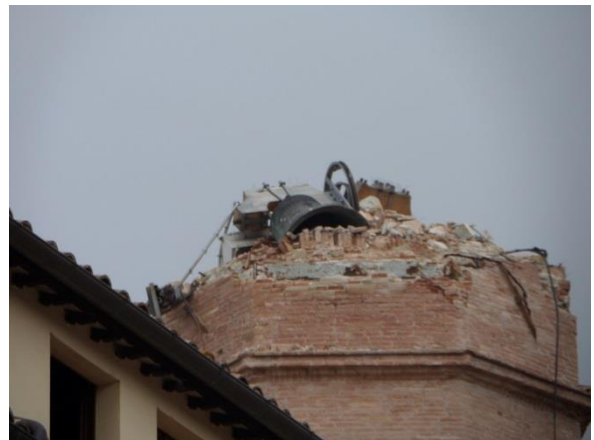
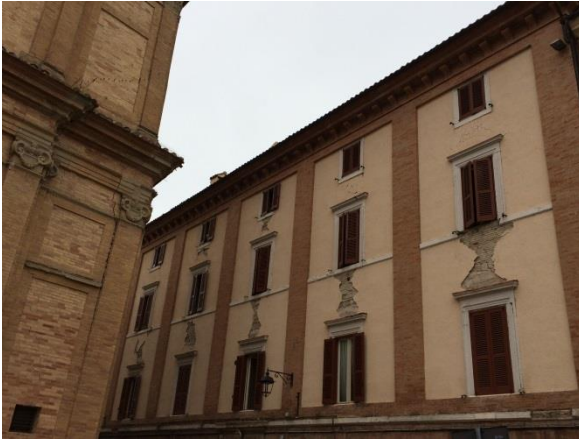
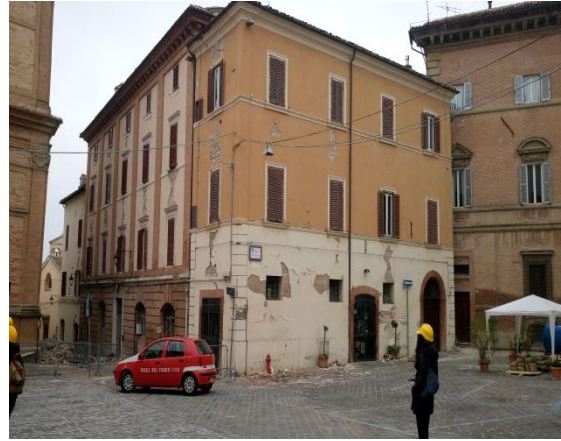
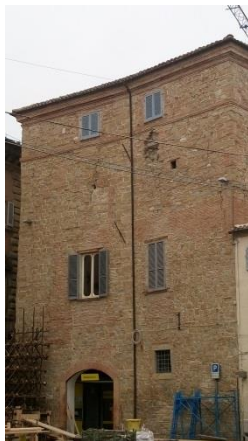
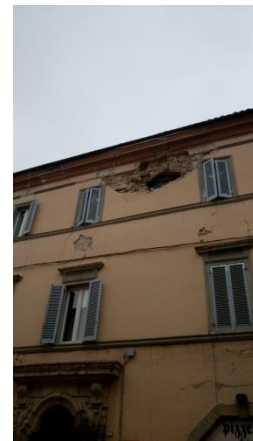
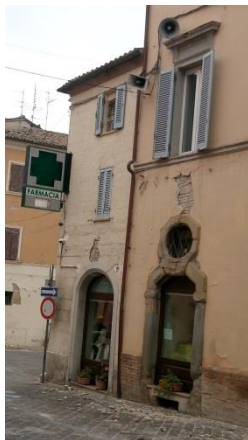
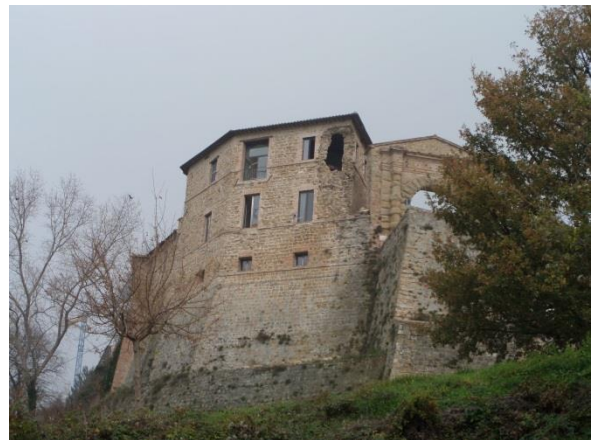
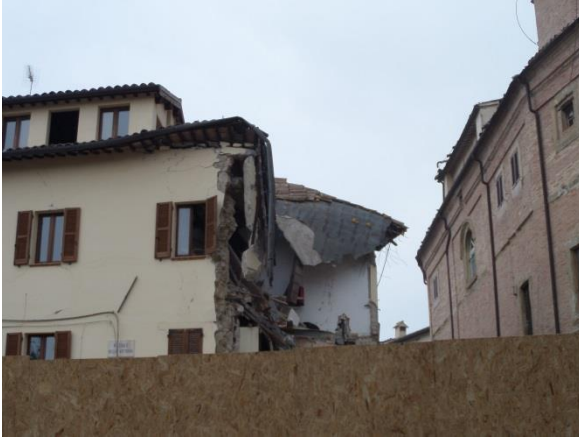
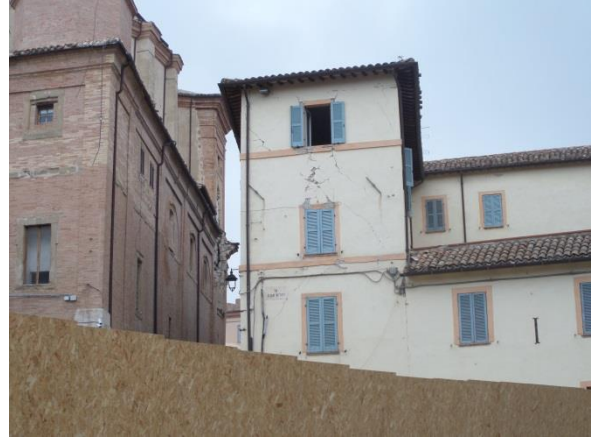
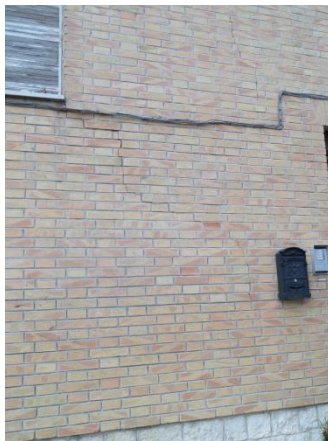
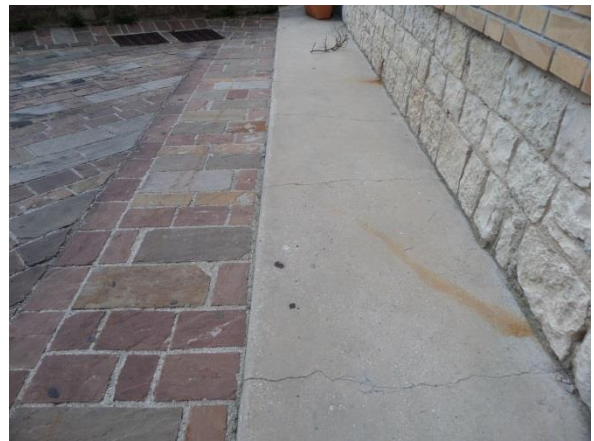
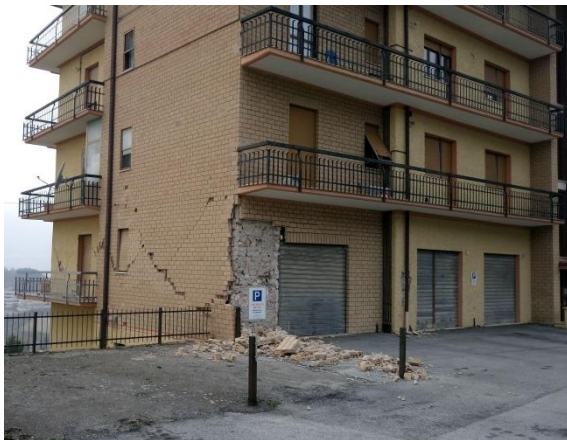
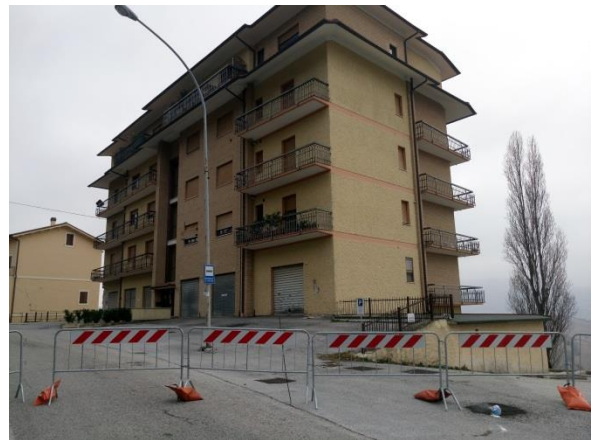
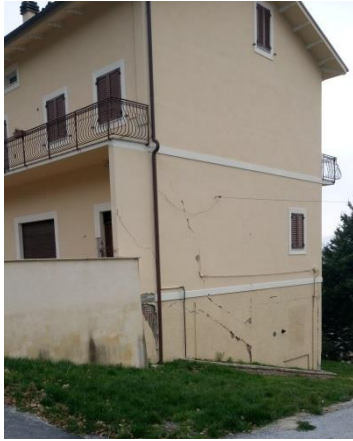
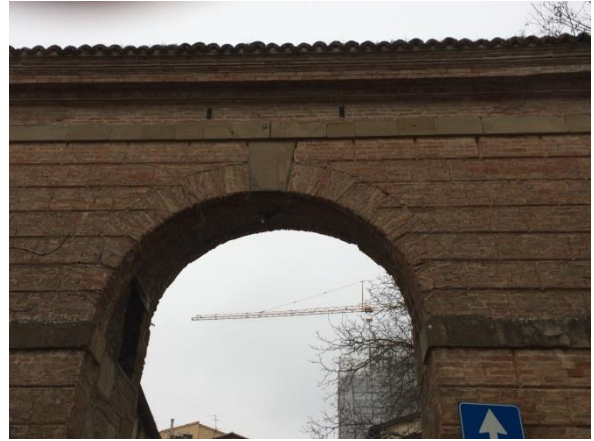
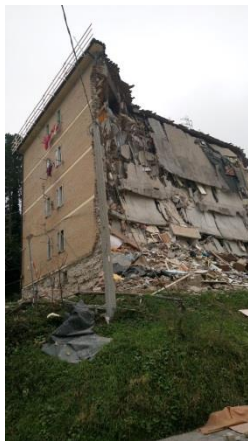
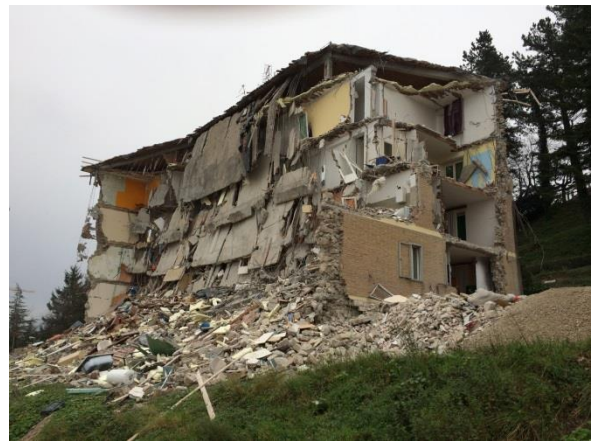
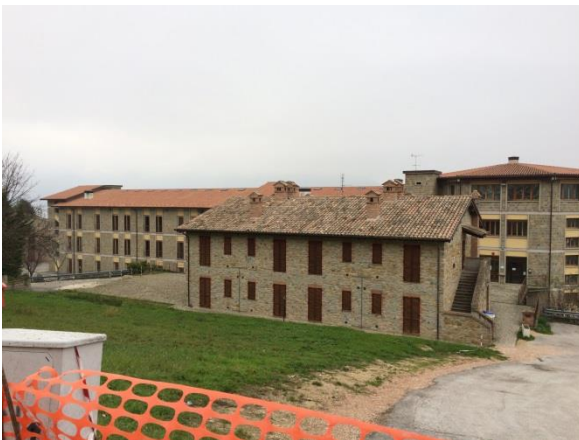
Figure 6.83 and Table 6.11 show locations of representative buildings inspected in the historic center of Camerino, including the red zone. Figure 6.84 shows photographs of these representative structures, which include both masonry and reinforced concrete dwellings two to four stories in height. The average damage level in the inspected zone was D2.

**Figure 6.84.** Representative pictures taken in Camerino (see Table 6.11 for details).

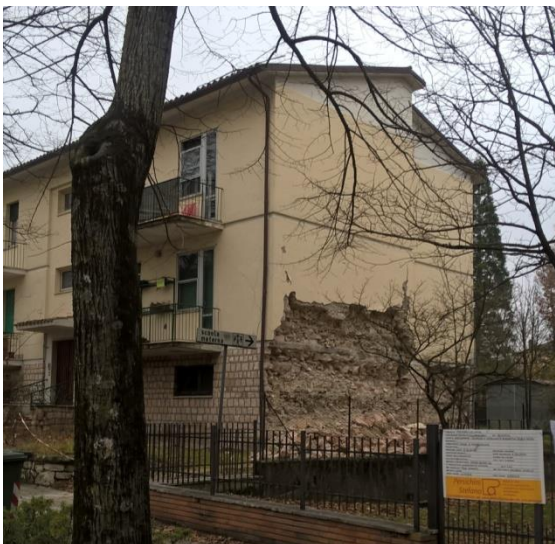
**P01**

**Figure 6.87.** Representative pictures in Pievebovigliana during the survey (see Table 6.12).

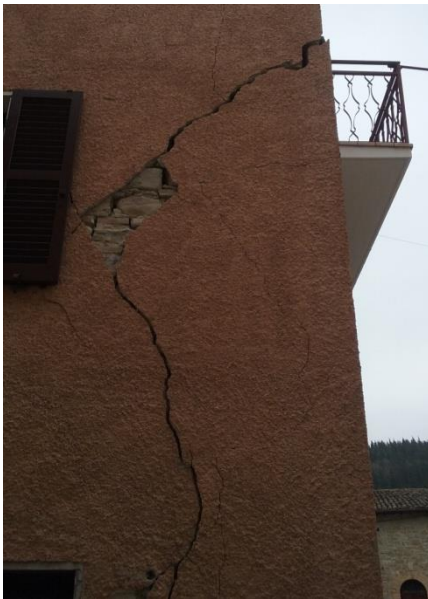
**P04a**

Pievebovigliana				
Picture	Datum	Location		Damage Level
		Lat	Long	
P01	WGS-84	43.062787°	13.083464°	D3
P02	WGS-84	43.061945°	13.084577°	D3
P03	WGS-84	43.063389°	13.084261°	D3
P04	WGS-84	43.063783°	13.083991°	D3
P05	WGS-84	43.063783°	13.083991°	D3
P06	WGS-84	43.063899°	13.082638°	D2
P07	WGS-84	43.064250°	13.084019°	D3-D4
P08	WGS-84	43.064200°	13.084639°	D2-D3
P09	WGS-84	43.060806°	13.084796°	D2
P10	WGS-84	43.060468°	13.084825°	D3-D4
P11	WGS-84	43.060045°	13.085259°	D1-D2
P12	WGS-84	43.061275°	13.084864°	D1-D2
P13	WGS-84	43.059584°	13.085267°	D3-D4
P14	WGS-84	43.060023°	13.085500°	D2-D3
P15	WGS-84	43.059860°	13.085446°	D3
P16	WGS-84	43.063751°	13.084271°	D3
P17	WGS-84	43.061613°	13.084808°	D1
P18a-P18b	WGS-84	43.063833°	13.082469°	D2-D3
P19	WGS-84	43.061650°	13.084506°	D2
P20	WGS-84	43.060083°	13.084933°	D1
P21	WGS-84	43.060303°	13.085108°	D1
P22	WGS-84	43.059975°	13.085269°	D3

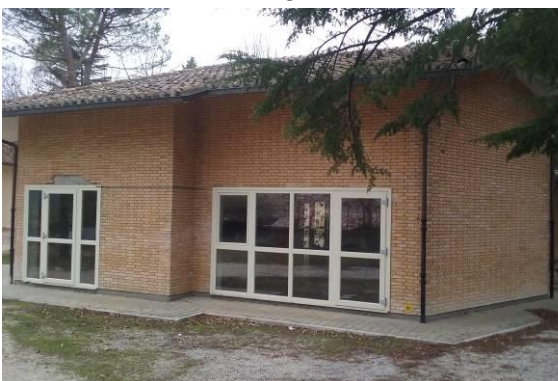
**P17**

Locations of representative photos taken in Pievebovigliana by the GEER team are reported in Figure 6.86. The pictures are presented in Figure 6.87. The historical center consists mainly of un-reinforced old masonry structures, 2-3 stories in height. Some of these structures have retrofitted. Outside of the historical center, isolated modern masonry and reinforced concrete structures were found (see P17-P18). Table 6.12 shows details and damage levels for the inspected structures.

Pievebovigliana was significantly damaged by the October events. However, the degree of damage to buildings is quite variable across the village. A preliminary damage zonation is reported in Figure 6.88. Damage levels as high as D3-D4 are concentrated in the southern portion (area of Castello or S. Maria Assunta church) built on a slight ridge oriented NNW-SSE that is comprised of Scaglia-Cinerea bedrock. Topographic site effects may have impacted structural performance in this area. The northern and central portions of the village generally have damage levels D2 to D2-D3. These areas are mainly located on alluvial terraced deposits. Minor damage was observed along the western portion of the village; the northern part of this area, located on alluvium, has relatively modern buildings (see P17) while the southern area is on bedrock at the toe of the Scaglia-Cinerea ridge.

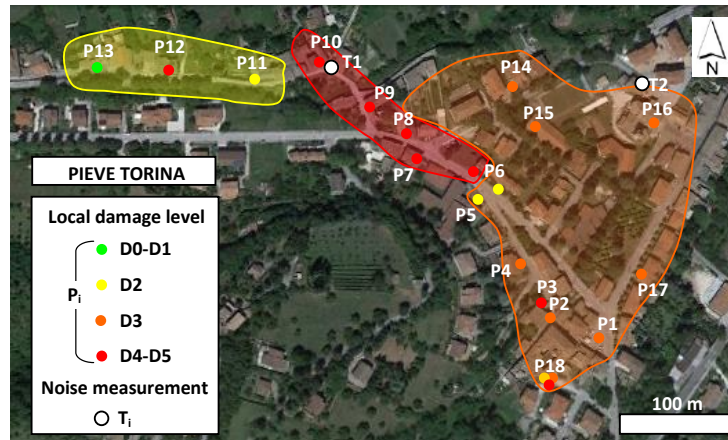
**Figure 6.90.** Locations of representative structures inspected in Pieve Torina, and damage zonation within the village.

- D1-D2 - With the exception of complete collapse of pre-existing ruins, the area seems to be characterized by limited damages to non structural elements.
- D3 - Heterogeneous area, in terms of structural typology and damage extent; overall, major damage to non structural elements and limited to significant damage to load bearing elements (with local collapse in some points) can be identified.
- D4-D5 - Strip characterized by structures interested by huge damage to load bearing elements and local collapse.

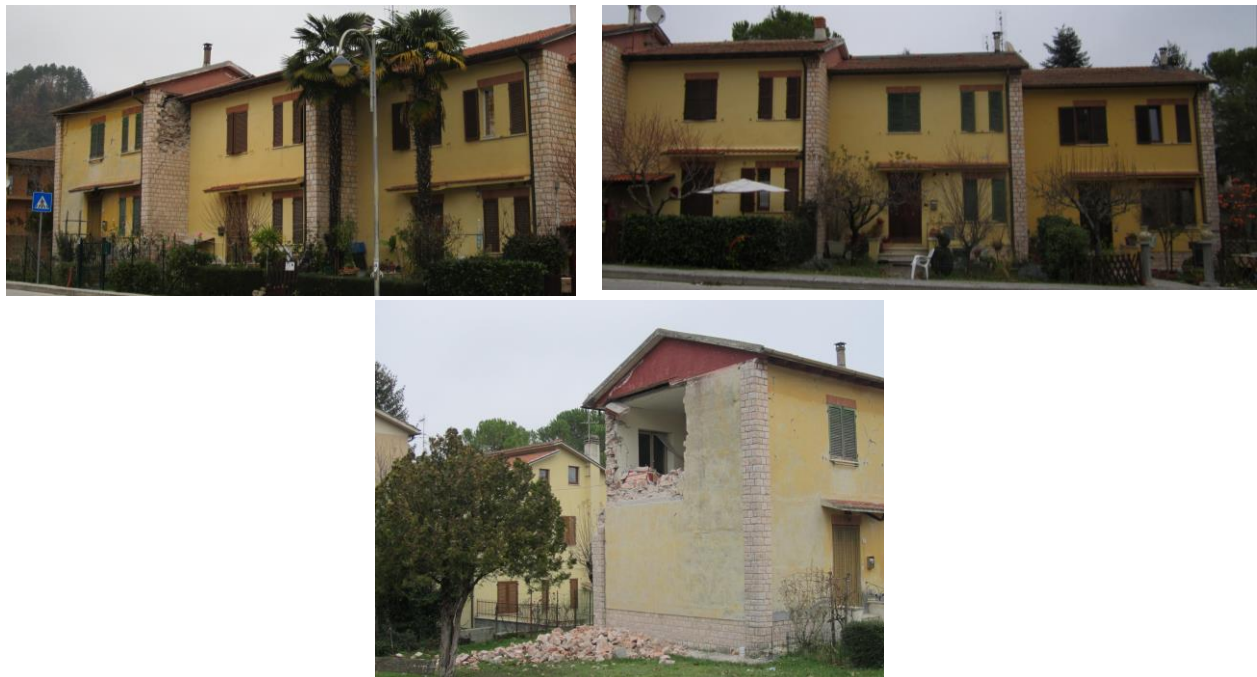
**Figure 6.91.** Representative pictures taken in Pieve Torina.

Pieve Torina is crossed by the Sant'Angelo creek. Most of the buildings are masonry structures. Figure 6.90 shows the locations of representative structures inspected and a preliminary damage zonation. Figure 6.91 shows details of a building complex, and a damaged structure located in the center of the village. Two microtremor noise measurements (T01-T02 in Figure 6.90) were carried out during the survey in the most damaged zone of the town. Figure 6.92 shows noise measurements results in terms of H/V spectral ratio and H/V polar plots. Both measurements show a peak at about 10 Hz. This value is compatible with the high level of damage observed for one-two stories buildings (usually characterized by similar values of fundamental frequency), indicating possible double resonance phenomena.

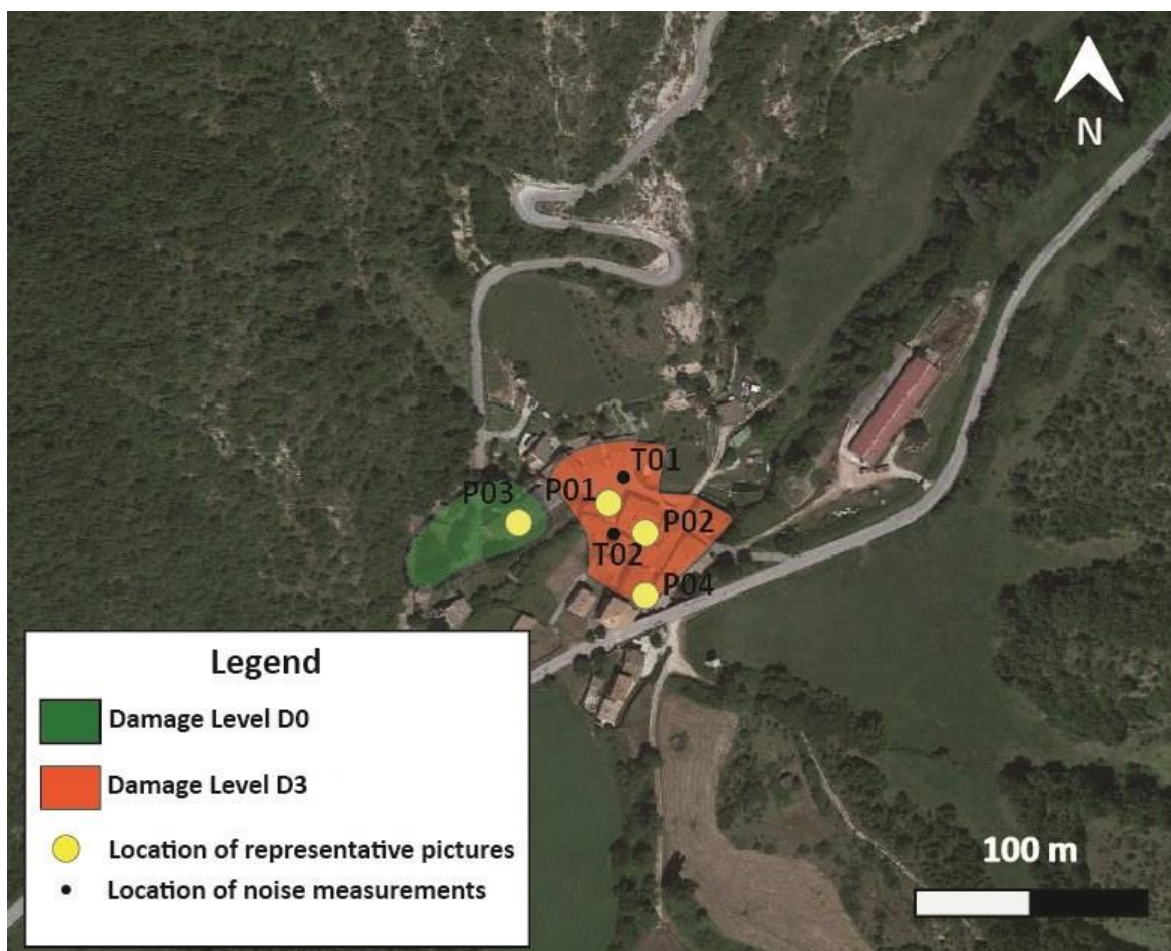
**Figure 6.94.** Locations of representative structures inspected in Fiume (Pieve Torina) and damage zonation (see Table 6.13 for details).

Fiume was significantly damaged by the October events. However, the degree of damage to buildings is strongly variable across the village (Figure 6.94). In particular, the eastern portion, founded on colluvial and alluvial deposits resting on bedrock, experienced high levels of damage (D3, see pictures P01-P02) whereas the western portion located on travertine rock had negligible damage (see P03).

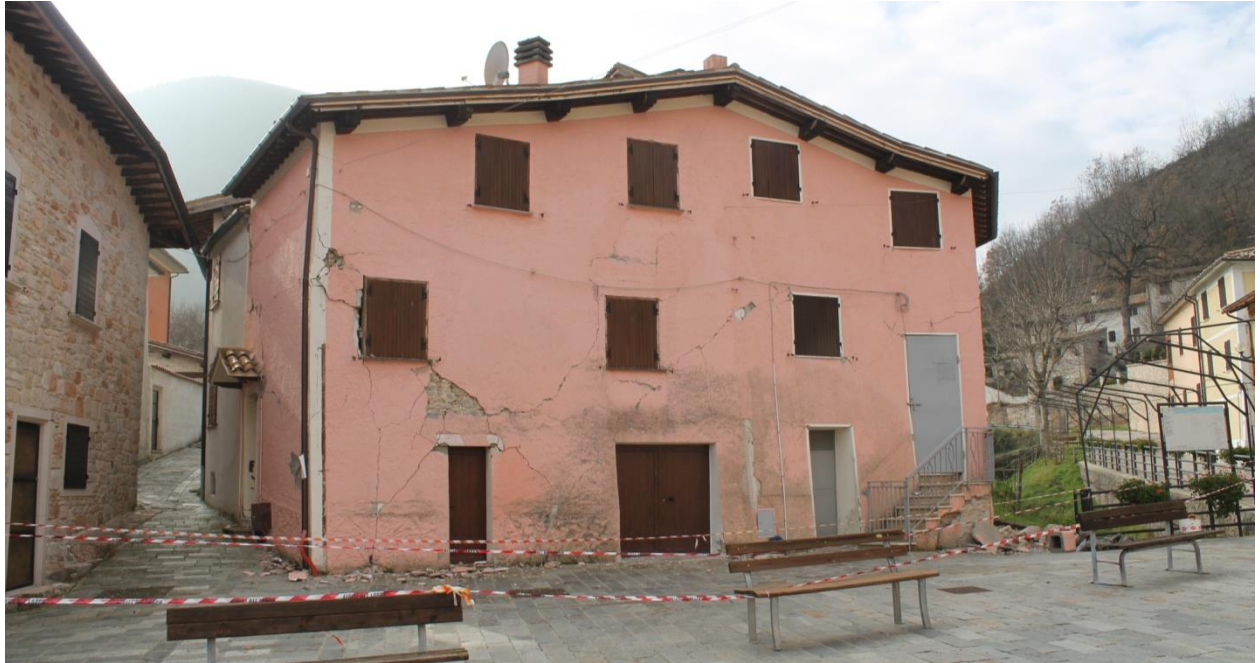
***P01a***

Fiume (Pieve Torina)				
Picture	Datum	Location		Damage Level
		Lat	Long	
P01a,b	WGS-84	43.042201°	13.001130°	D3
P02	WGS-84	43.042146°	13.001298°	D3
P03	WGS-84	43.042172°	13.000544°	D0/D1
P04	WGS-84	43.041870°	13.001228°	D3

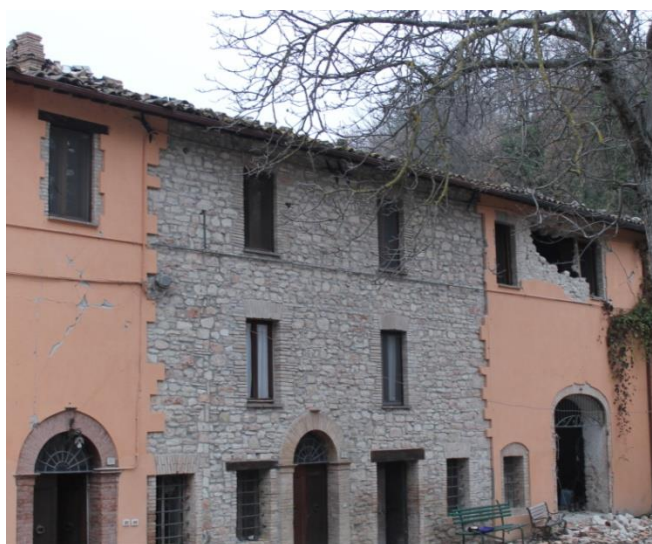
**P01**

the upper part (Casavecchia Alta) where several partial and full collapses took place (see P03-P04) with respect to Piè Casavecchia (P01-P02).

Casavecchia Alta / Piè Casavecchia				
Picture	Datum	Location		Damage Level
		Lat	Long	
P01	WGS-84	42.996714°	13.060456°	D3-D4
P02	WGS-84	42.997693°	13.064266°	D2-D3
P03	WGS-84	42.998803°	13.062181°	D4-D5
P04	WGS-84	42.998500°	13.061722°	D4-D5

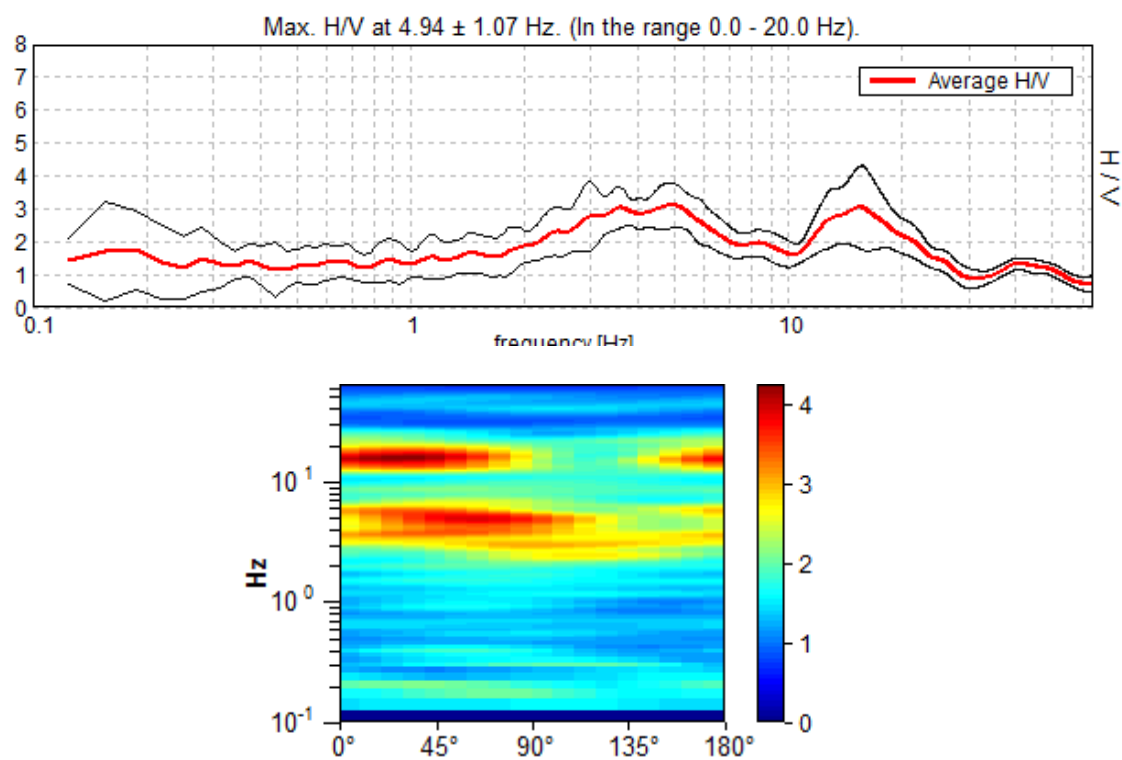
A noise measurements (T01 in Figure 6.98) was carried out during the survey in the upper part. The same instrument and data acquisition procedures described for Visso survey were employed. Average horizontal-to-vertical (H/V) spectral ratios and polar H/V plot are reported in Figure 6.100. A broad band H/V peak appears at 2-6 Hz polarized in the direction of about 60°, i.e. perpendicular to the axis of the ridge, thus indicating possible topographic site effects (Pagliaroli et al., 2015).

**Figure 6.100.** Noise measurement T01 results in terms of H/V spectral ratio (up) and H/V polar plots (bottom).

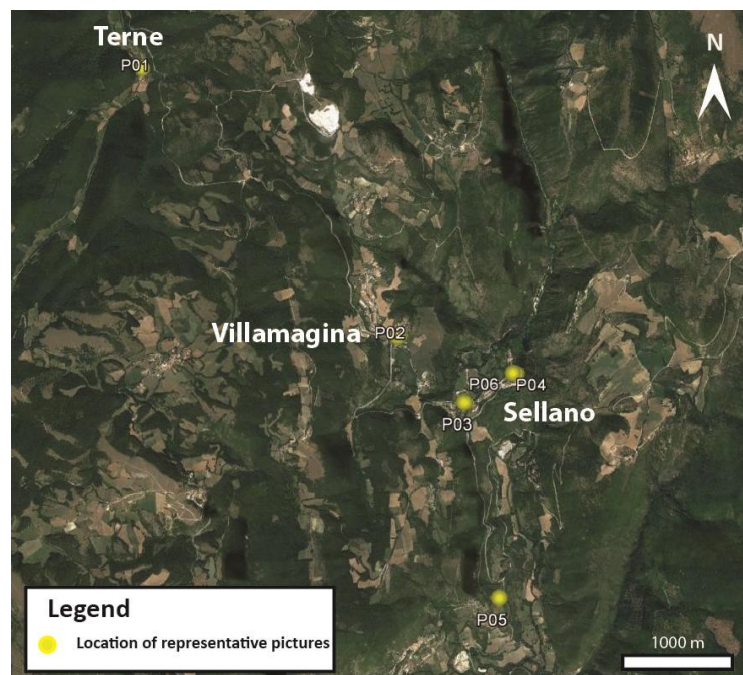
**Figure 6.101.** Locations of representative structures inspected in Sellano and surrounding hamlets (see Table 6.15 for details).

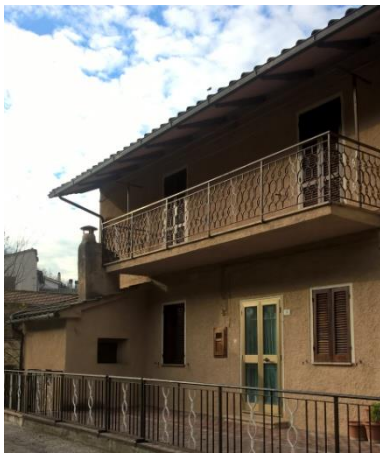
**P01**

No or negligible damage was observed in the hamlets of Terne and Villamagina (on average D0-D1). Slightly higher damage (D1-D2) was reported in the upper part of Sellano (area of Santa Maria Assunta and Municipio, see P04 and P06).

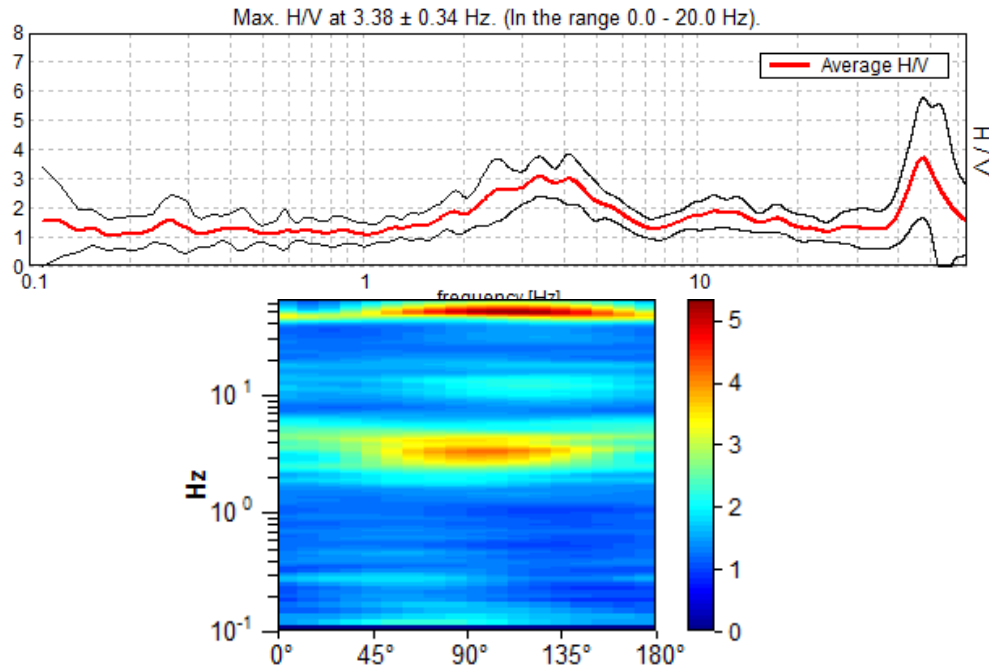
A noise measurement was carried out during the survey in the upper part of Sellano (close to P06 in the Municipio square), about 30 m from a slope. The same instrument and data acquisition procedures described for Visso survey were employed. Average horizontal-to-vertical (H/V) spectral ratios and polar H/V plots are reported in Figure 6.103. A broad band peak can be identified at about 3-5 Hz that is clearly polarized in the direction of about  $90^\circ$ , which is roughly orthogonal to the strike of the adjacent slope.

**Figure 6.103.** Noise measurement results in terms of H/V spectral ratio (top) and H/V polar plots (bottom) (Sellano, Municipio square, 42.888828°- 12.926805°).

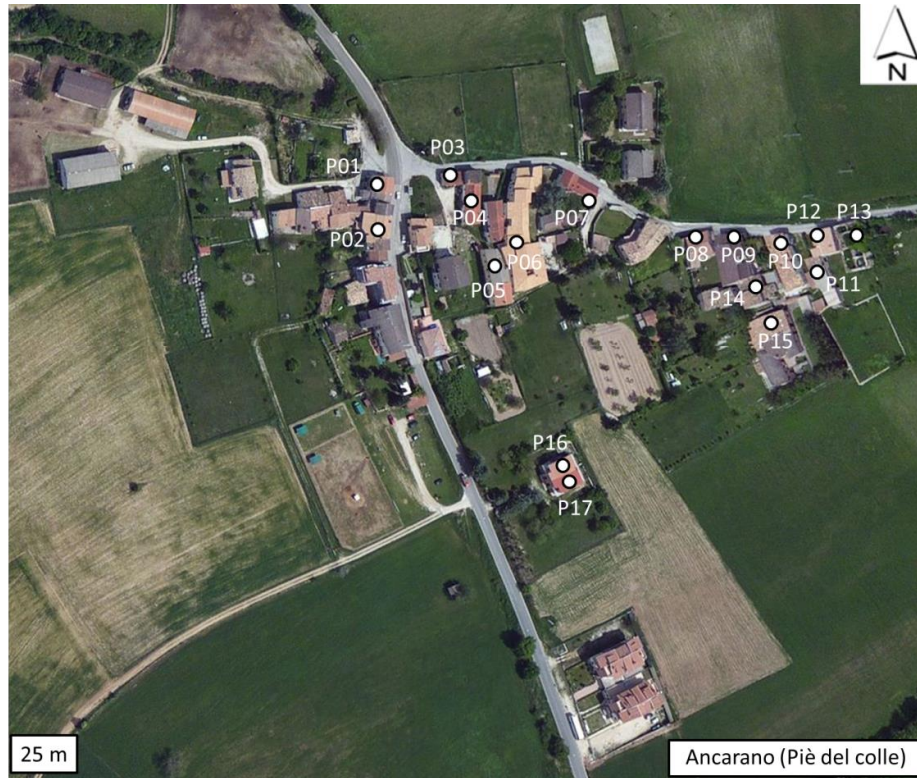
**Figure 6.104.** Locations of the representative structures inspected in Ancarano piè del colle (see Table 6.16 for details).
