# Engineering Reconnaissance Following the October 2016 Central Italy Earthquakes *Version 2*

GEER Team Leaders: Jonathan P. Stewart and Giuseppe Lanzo

Geotechnical Extreme Events Reconnaissance Association  
Report No. GEER-050D  
8 May 2017

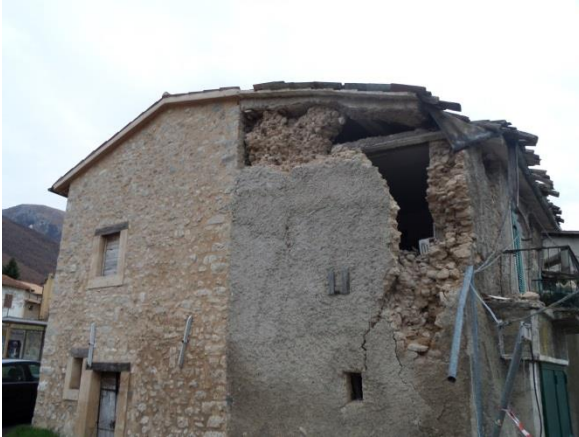
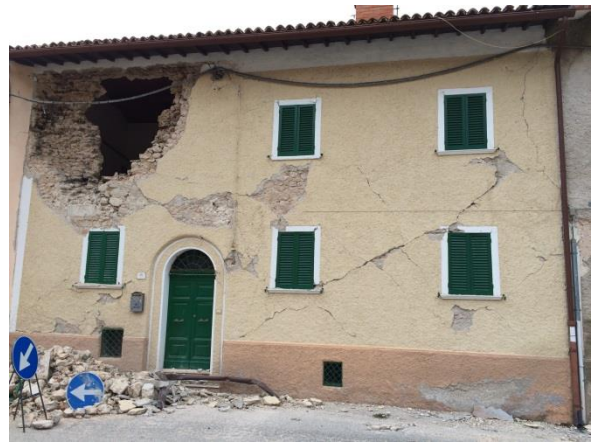
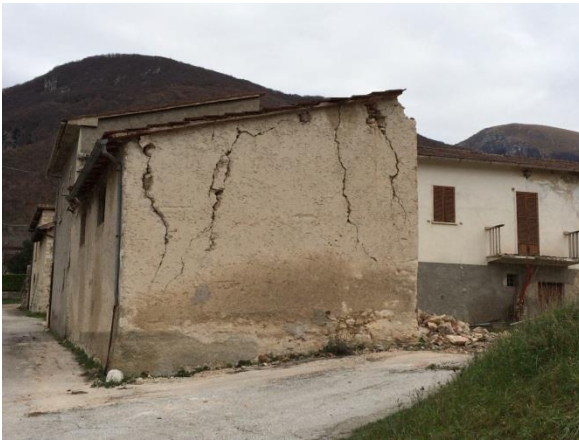
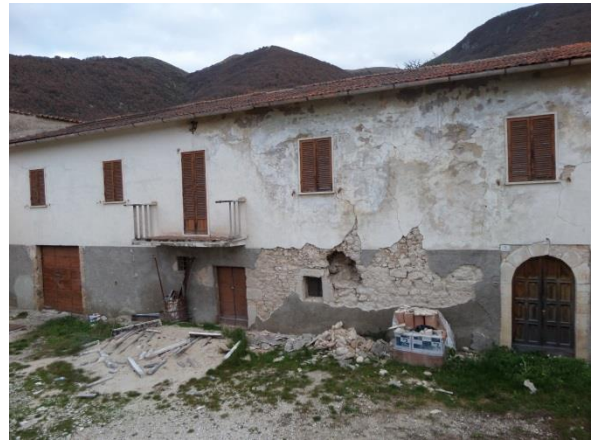
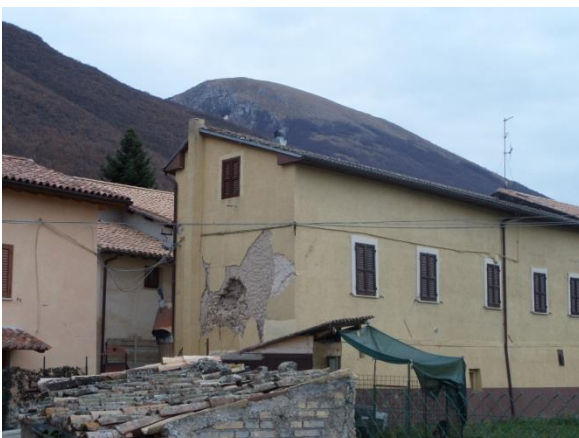
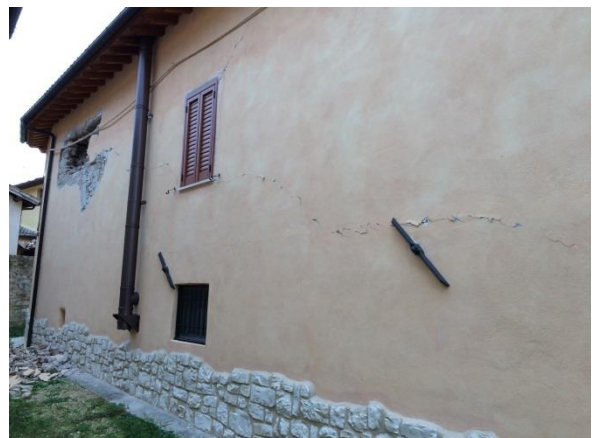
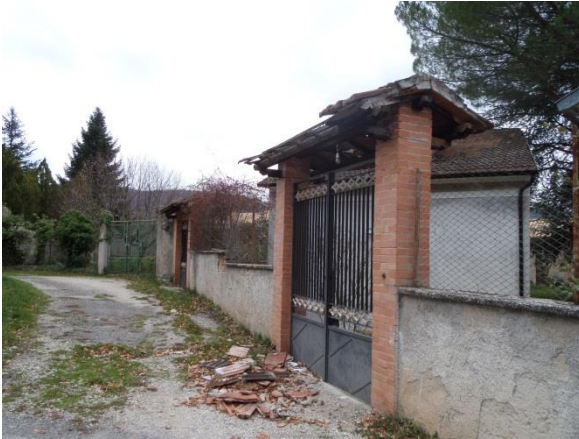
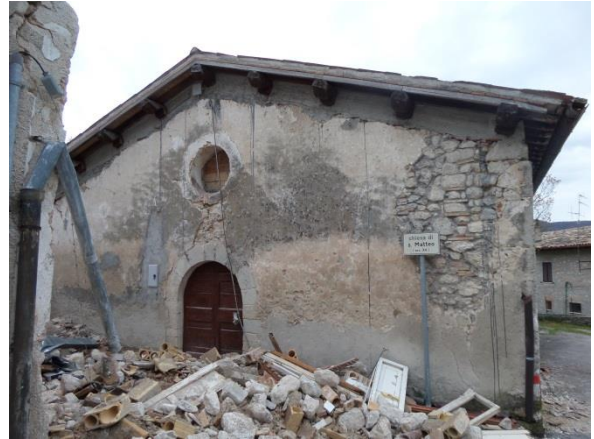
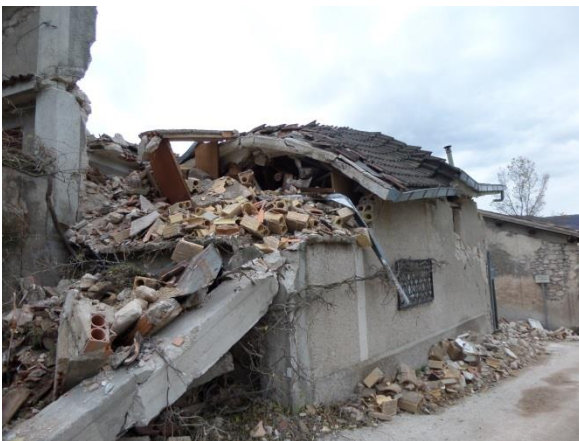
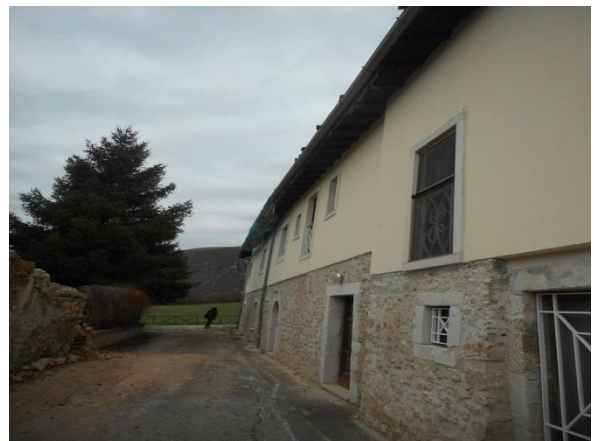
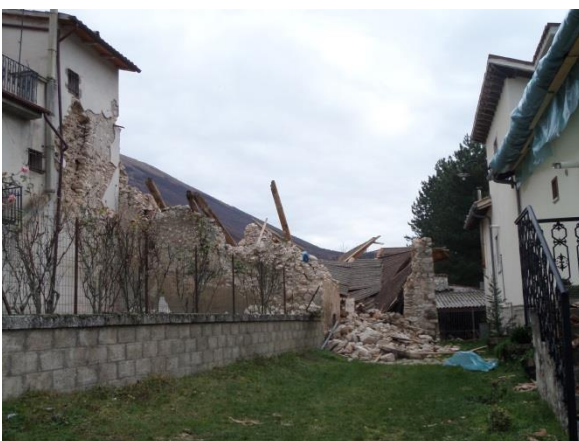
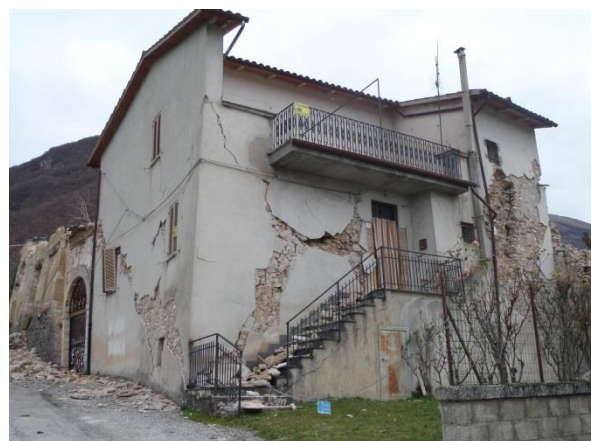
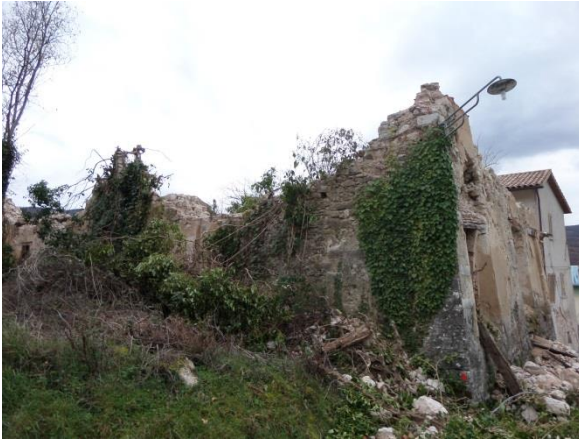
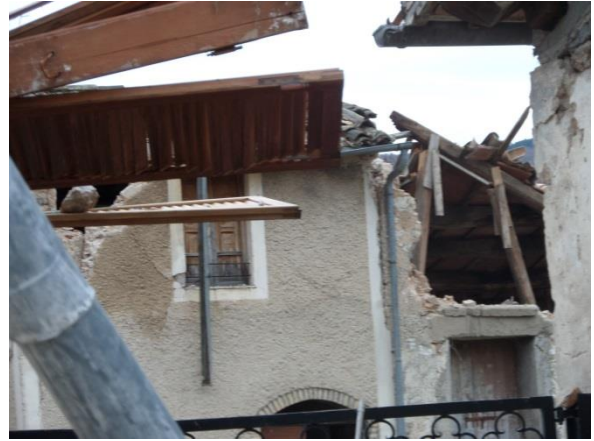
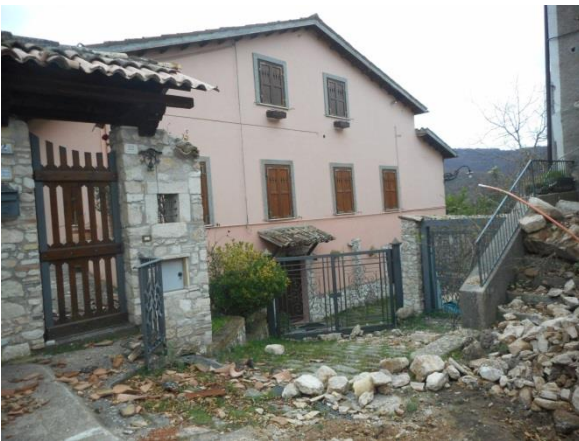
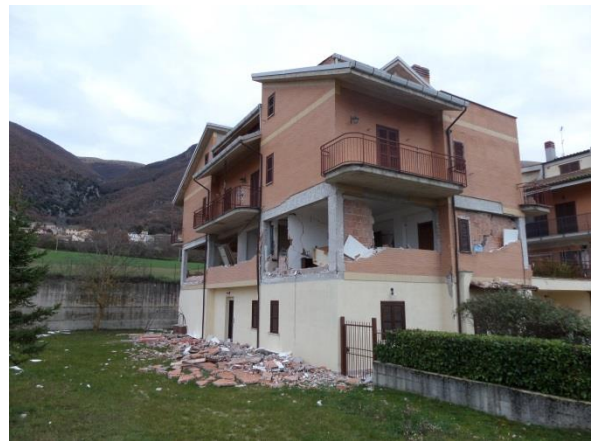
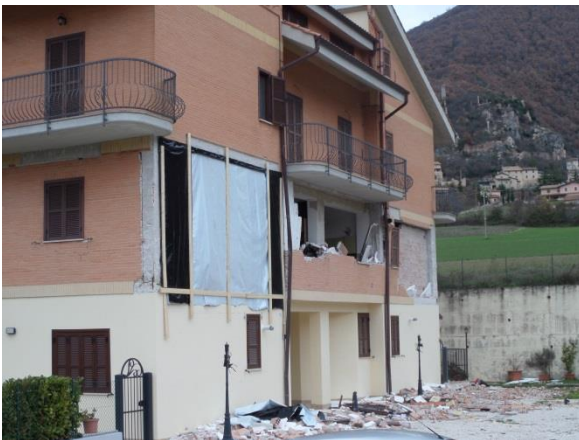
Figure 6.104 and Table 6.16 show locations and details of representative buildings inspected in Pié del Colle. Figure 6.105 shows representative structures, which include unreinforced masonry and reinforced concrete buildings. Damage was observed to both types of structures, although among reinforced concrete structures the principal damage was collapse of interior tiles from frames. Typical damage levels were between D2 and D3.

Picture	DATUM	Location		Damage Level	Notes
		Lat.	Long.		
P01	WGS-84	42.844373	13.101296	D2	
P02	WGS-84	42.844211	13.101267	D2	
P03	WGS-84	42.844400	13.101682	D1	
P04	WGS-84	42.844270	13.101787	D1	
P05	WGS-84	42.844039	13.101900	D1	
P06	WGS-84	42.844130	13.102034	D1	
P07	WGS-84	42.844310	13.102489	D1	
P08	WGS-84	42.844148	13.103076	D1	
P09	WGS-84	42.844152	13.103284	D4	
P10	WGS-84	42.844152	13.103527	D0	
P11	WGS-84	42.844028	13.103713	D5	
P12	WGS-84	42.844166	13.103785	D2	
P13	WGS-84	42.844177	13.103916	D5	
P14	WGS-84	42.843939	13.103436	D3	
P15	WGS-84	42.843826	13.103548	D0	
P16	WGS-84	42.843215	13.102244	D2	
P17	WGS-84	42.843167	13.102265	D2

**Figure 6.105.** Representative pictures taken at Ancarano pié del Colle (see Table 6.16 for details).

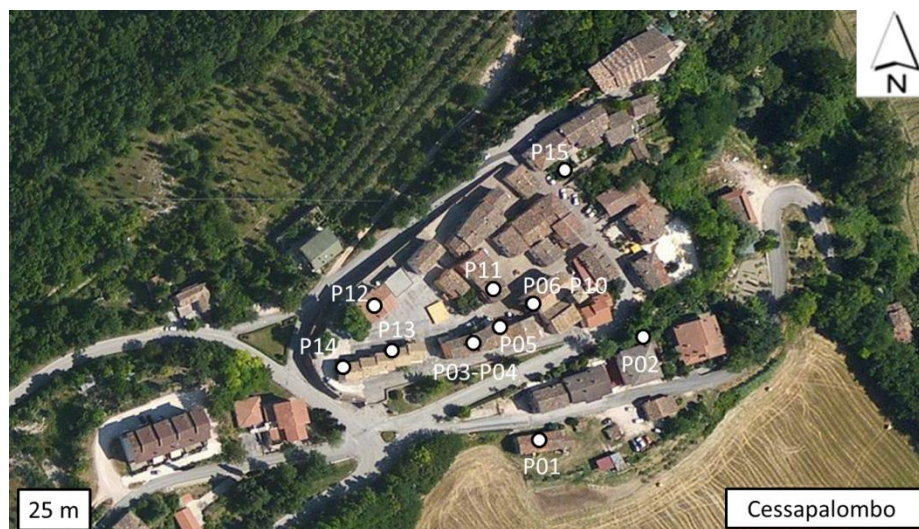
**Figure 6.108.** Locations of the representative structures inspected in Cessapalombo (see Table 6.17 for details).

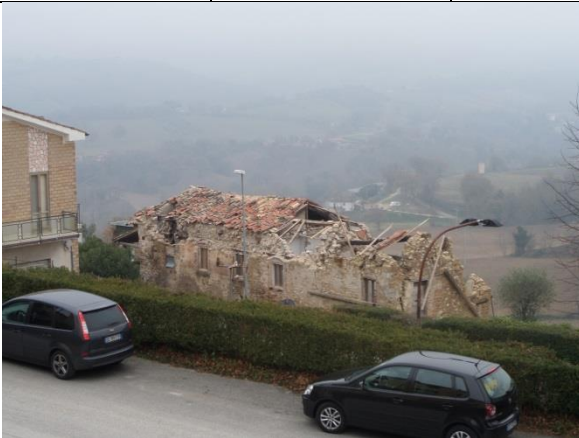
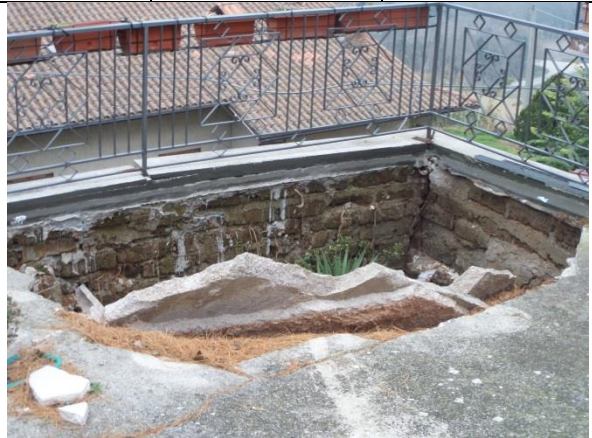
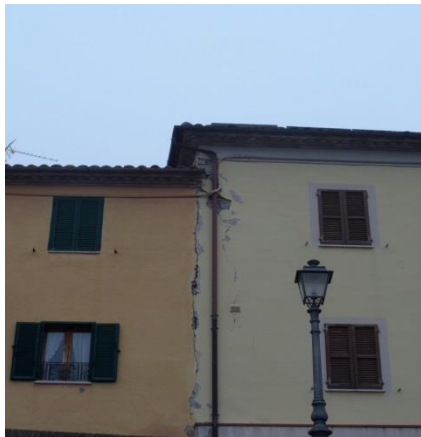
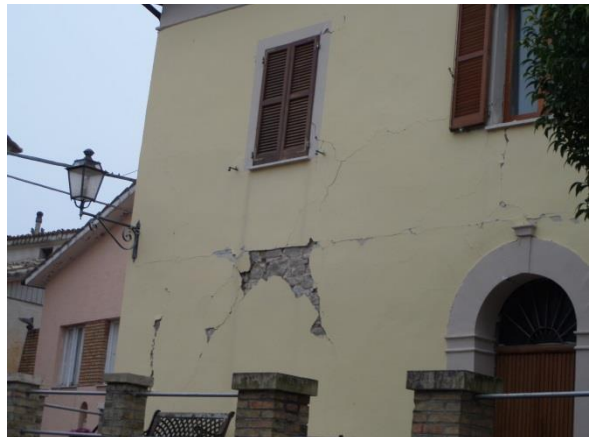
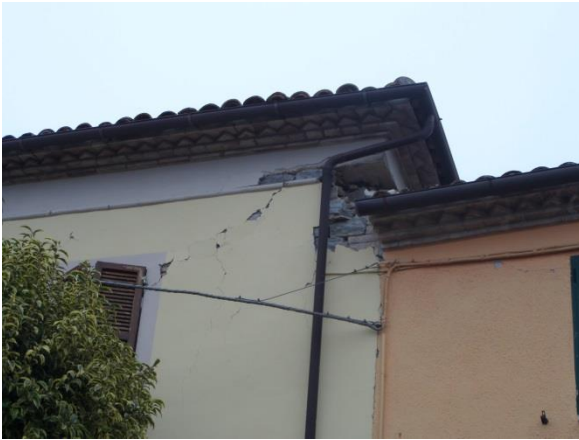
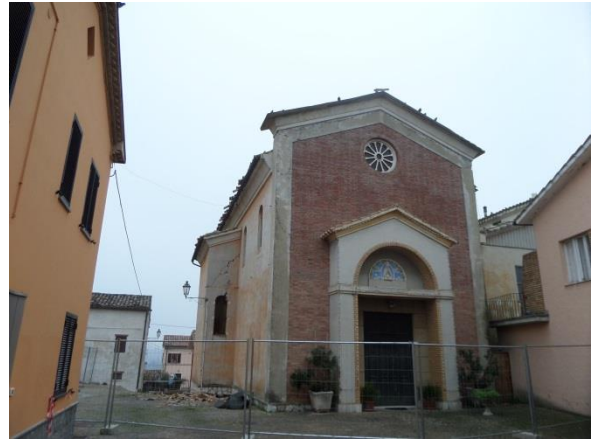
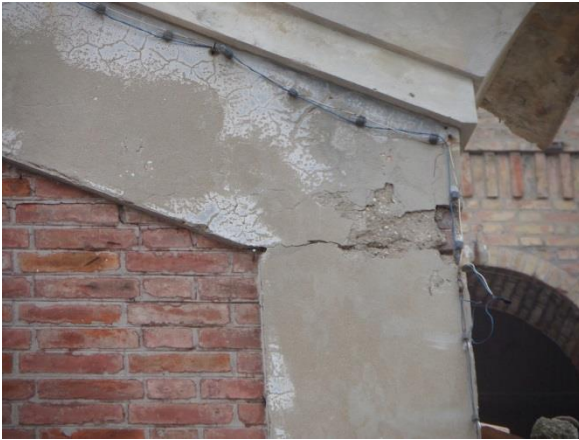
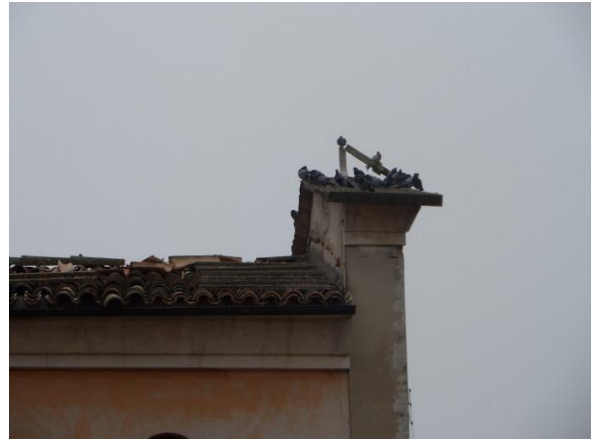
Table 6.17 summarizes locations and details of the representative inspected buildings, while Figure 6.108 shows locations of these buildings. Figure 6.109 shows pictures of representative structures in the village. The average damage level in the main village is approximately D1 to D2.

Picture	DATUM	Location		Damage Level	Notes
		Lat.	Long.		
P01	WGS-84	43.108198	13.258378	D5	
P02	WGS-84	43.108592	13.258880	D2	
P03	WGS-84	43.108566	13.257992	D1	
P04	WGS-84				
P05	WGS-84				
P06	WGS-84				
P07	WGS-84				
P08	WGS-84	43.108739	13.258286	D1	
P09	WGS-84				
P10	WGS-84				
P11	WGS-84				
P12	WGS-84	43.108713	13.257500	D0	
P13	WGS-84	43.108522	13.257597	D3-D4	
P14	WGS-84	43.108463	13.257340	D1	
P15	WGS-84	43.109235	13.258417	D2

**Figure 6.109.** Representative pictures taken at Cessapalombo (see Table 6.17 for details).

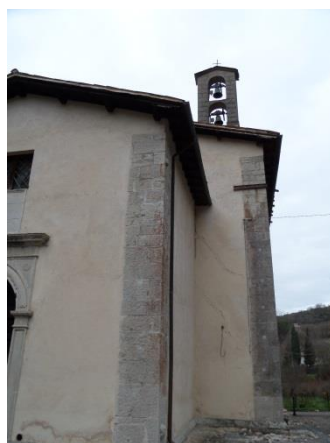
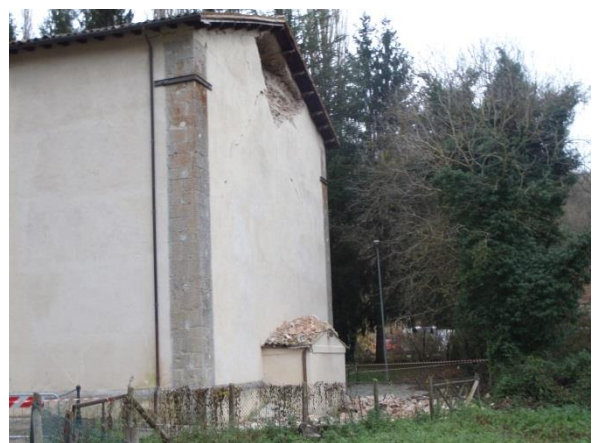
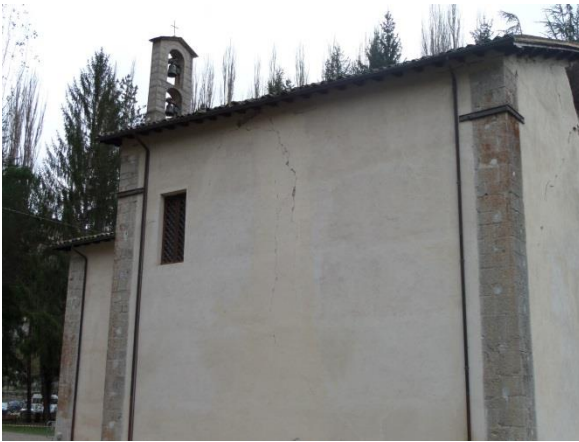
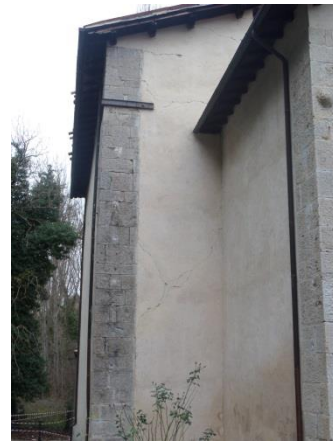
**Figure 6.111.** Representative pictures of church in Preci (Lat = 42.881418, Lon = 13.036290).

Guado. Ground motion levels are reported in Table 6.1. The main village was lightly damaged. Figure 6.110 shows the location of representative pictures taken in Preci, while Figure 6.111 shows a church with damage level D1.

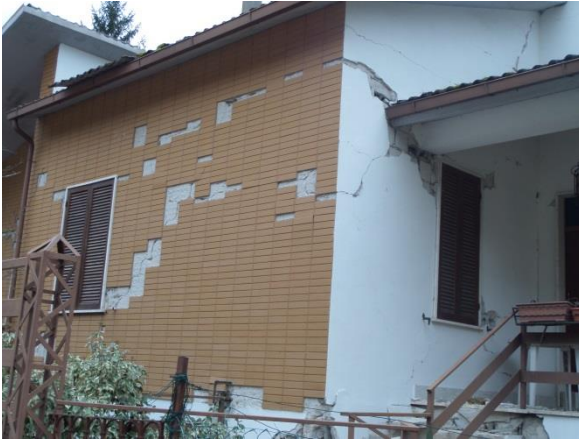
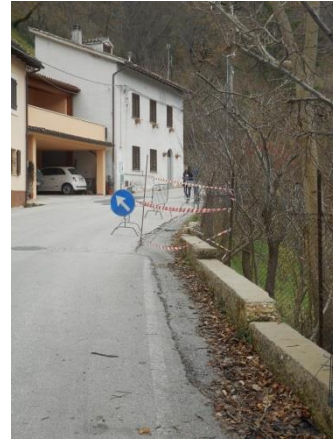
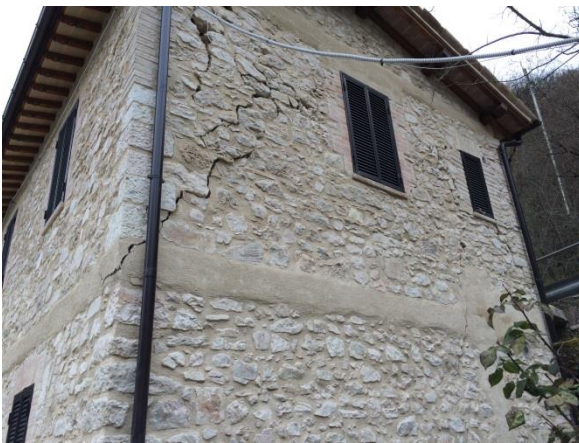
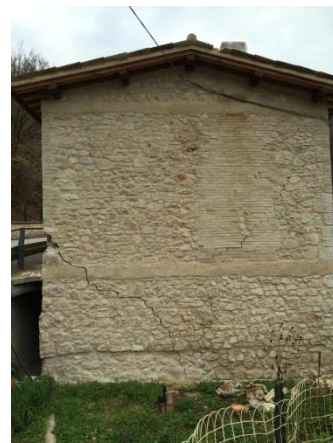
**Figure 6.113.** Representative pictures taken at Piedivalle.

The hamlet of Piedivalle (42.866786, 13.060767) belongs to the municipality of Preci and is about 2.5 km from the Preci center. Its elevation is 611 m a.s.l. and it has 35 inhabitants. Estimated ground motions are given in Table 6.1. We inspected three structures at the location shown in Figure 6.112. The building photographs are shown in Figure 6.113. The masonry structures have damage level D1.

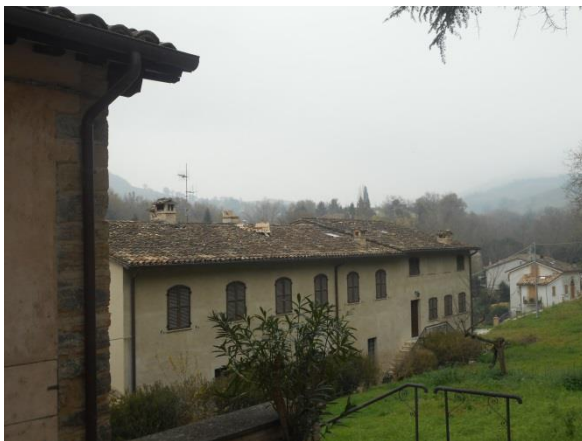
**P01**

Picture	DATUM	Location		Damage Level	Notes
		Lat.	Long.		
P01	WGS-84	43.136801	13.226607	D1	
P02	WGS-84	43.137202	13.225963	D0	
P03	WGS-84	43.137617	13.226234	D1	
P04	WGS-84	43.137827	13.225873	D1	
P05	WGS-84	43.138038	13.226472	D2	
P06	WGS-84	43.138212	13.226377	D0	
P07	WGS-84	43.138370	13.226287	D0	
P08	WGS-84	43.138488	13.226146	D0	
P09	WGS-84	43.127572	13.220054	D3	
P10	WGS-84	43.127735	13.219258	D3	
P11	WGS-84

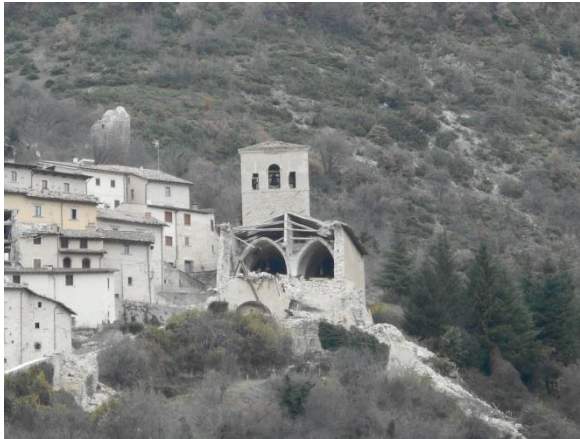
**P01**

Picture	DATUM	Location		Damage Level	Notes
		Lat.	Long.		
P01	WGS-84	42.853422	13.101411	D4	
P02	WGS-84	42.853480	13.100616	D2-D5	
P03	WGS-84	42.853819	13.100276	D2-D5

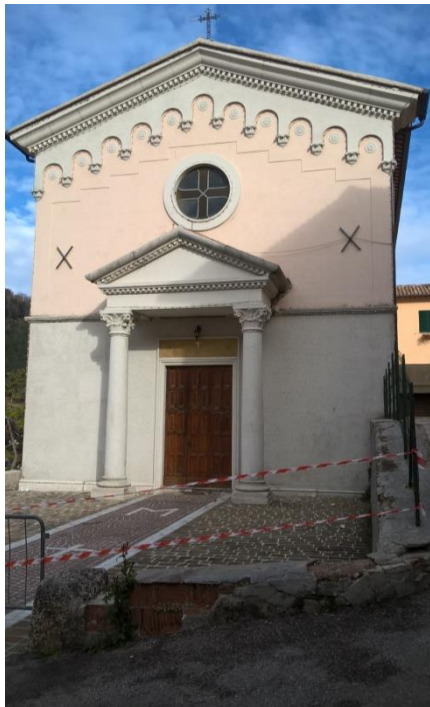
**P01**

Colfiorito				
Picture	Datum	Location		Damage Level
		Lat	Long	
P01	WGS-84	43.026700°	12.890759°	D1
P02	WGS-84	43.028375°	12.891436°	D0
P03	WGS-84	43.026766°	12.890206°	D0

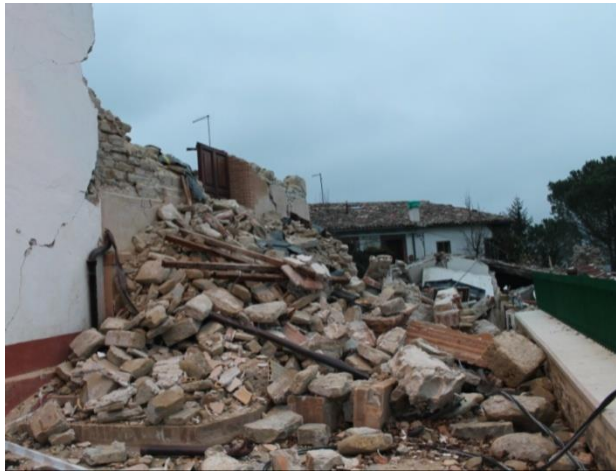
**P01**

The village consists essentially of un-reinforced masonry structures, 2-3 stories in height. Some structures are retrofitted. The damage at the top of the ridge was quite high (D3-D4 on average) with several partial collapses (see P01- P03-P04).

San Lorenzo in Colpolina				
Picture	Datum	Location		Damage Level
		Lat	Long	
P01	WGS-84	43.086690°	13.124509°	D5
P02	WGS-84	43.086511°	13.124582°	D3-D4
P03	WGS-84	43.086319°	13.124638°	D4
P04	WGS-84	43.087064°	13.124486°	D4

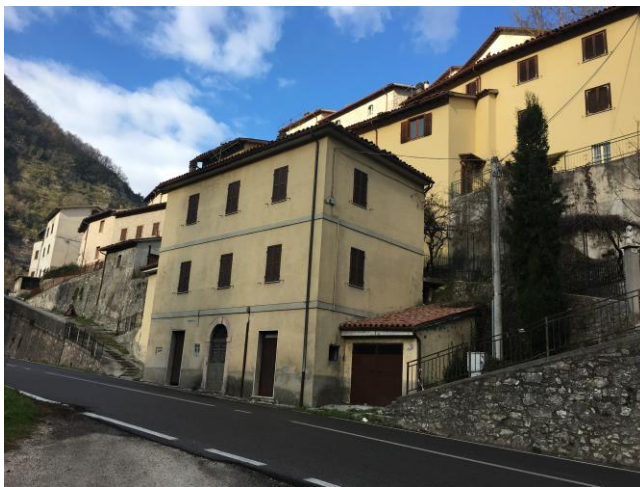
Serravalle is a hamlet part of the municipality of Norcia, in the province of Perugia, Umbria region. Serravalle is located about 6 kilometers from Norcia and it has a population of 25 people. Ground motion levels are reported in Table 6.1 The hamlet was not damaged by the earthquake and the generalized damage level was D0 (Figure 6.123, Table 6.22).

Serravalle				
Picture	Datum	Location		Damage Level
		Lat	Long	
P01	WGS-84	42.785802	13.022287	D0
P02	WGS-84	42.785816	13.022504	D0
P03	WGS-84	42.785852	13.022981	Do

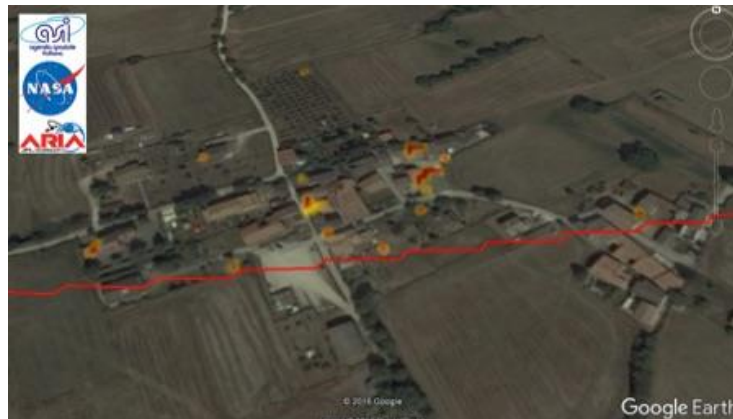
The small village of Popoli is located 4.67 km far from Norcia. Before the 24 August 2016 earthquake, 47 people lived there. There were 51 buildings, 43 of which for residential use. The majority of the structures are one or two-story masonry buildings, constructed before 1919. In the last 30 years, only seven buildings were built. Others structural types are also present (wooden and steel structures). Before the 24 August event, 32 buildings were assessed in excellent conditions, 7 in good conditions and 4 in poor conditions due to aging effects and lack of maintenance ([http://italia.indettaglio.it/ita/umbria/perugia\\_norcia\\_popoli.html](http://italia.indettaglio.it/ita/umbria/perugia_norcia_popoli.html), last accessed 21 April, 2017). The village is located in a valley floor consisted of alluvial deposits, susceptible to seismic amplification phenomena. Ground motion levels are reported in Table 6.23 Figure 6.124 shows the damage proxy map after the 30 October earthquake. Red zones mark zones seriously damaged (damage level D5). Figure 6.125 shows buildings with different

**Figure 6.124.** Damage proxy map of Popoli ([http://aria-share.jpl.nasa.gov/events/20161030-Italy\\_EQ/DPM/](http://aria-share.jpl.nasa.gov/events/20161030-Italy_EQ/DPM/), last accessed 21 April, 2017).

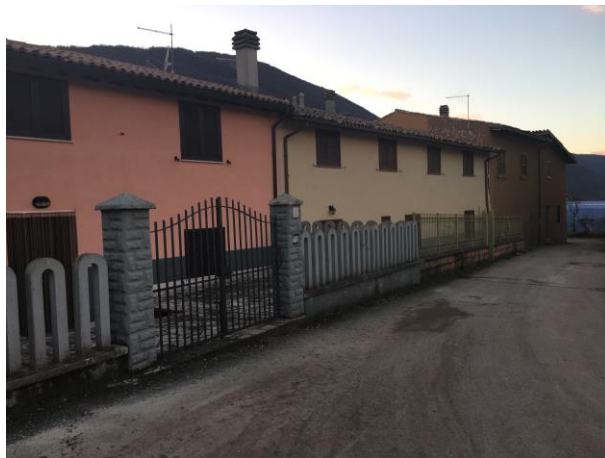
Picture	DATUM	Location		Damage Level
		Lat.	Long.	
P01	WGS-84	42.751381	13.106139	D1
P02	WGS-84	42.751381	13.106139	D1
P03	WGS-84	42.751800	13.105000	D3
P04	WGS-84	42.751700	13.105700	D2/D3
P05	WGS-84	42.751572	13.106256	D4/D5
P06	WGS-84	42.751300	13.106075	D0

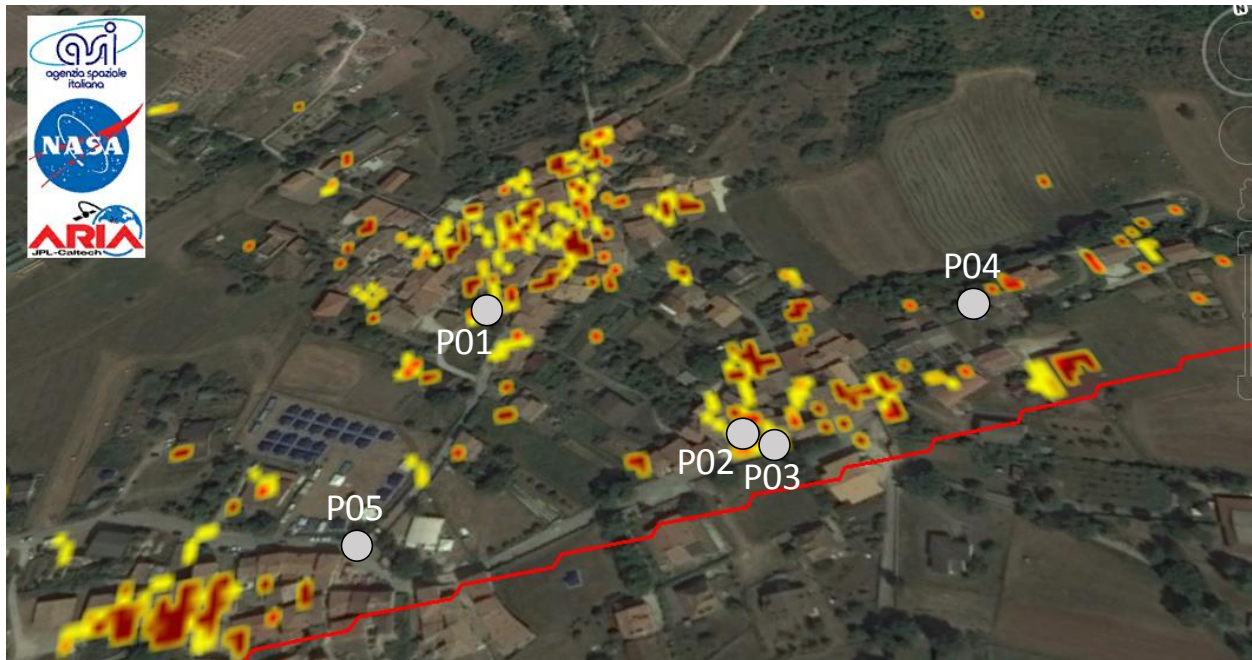
**Figure 6.126.** Damage proxy map of San Pellegrino ([http://aria-share.jpl.nasa.gov/events/20161030-Italy\\_EQ/DPM/](http://aria-share.jpl.nasa.gov/events/20161030-Italy_EQ/DPM/)) along with the identification numbers of the structures with assigned damage level D5.

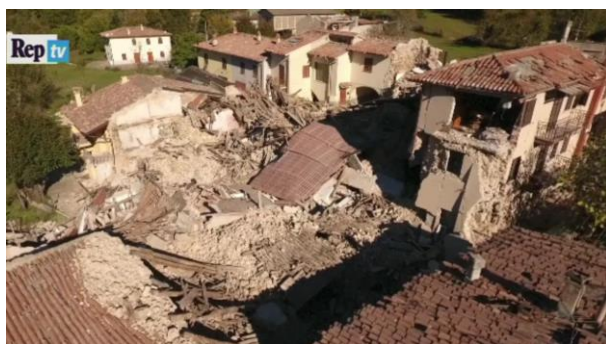
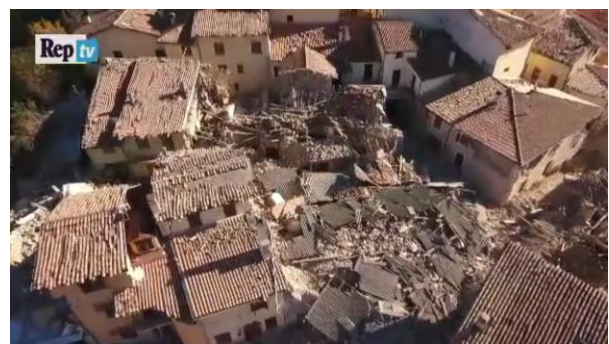
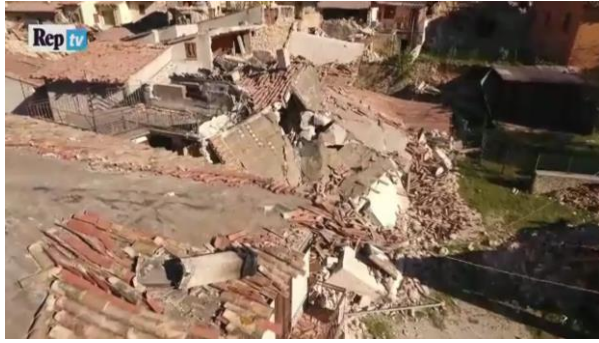
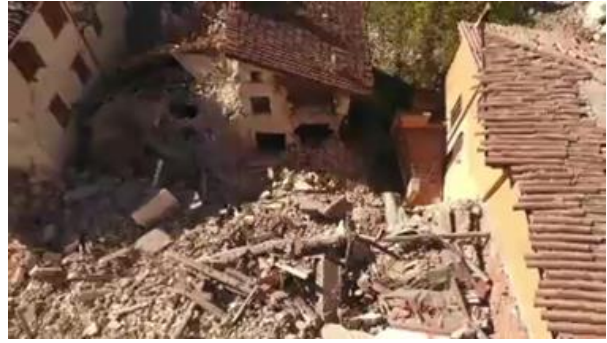
During our reconnaissance following the 30 October event, we observed extensive damages in almost all the masonry structures (classified as D3-D5) located mainly in the historical center of the town, which was in part not accessible. Some pictures of the damaged buildings in the historical center are shown in Figure 6.127 (source Repubblica.it, last accessed 21 April, 2017). In the new part of the town damages were concentrated on non-structural components of some of the reinforced concrete buildings recently constructed (classified as D2). Figure 6.128 shows multi-epoch pictures (before August and after 30 October, 2017) of selected locations. Table 6.24 summarizes the overall damage level observed in these locations.

**Figure 6.127.** Damaged constructions in the oldest part of San Pellegrino  
(<http://video.repubblica.it/dossier/terremoto-30-ottobre/terremoto-centro-italia-la-distruzione-a-san-pellegrino-di-norcia-dal-drone/257495/257761>).

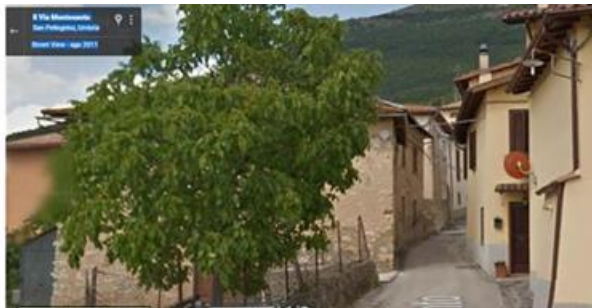
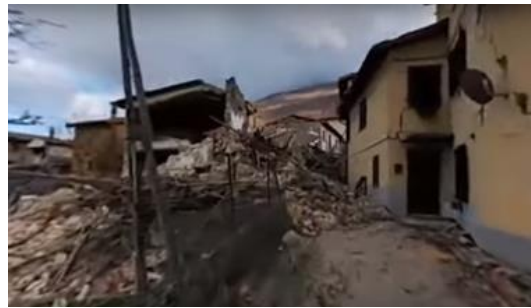
P01. Montesanto street

**Figure 6.128.** Pictures of the structures with assigned damage level D5 in San Pellegrino, before and after the October earthquake, along with their identification numbers.

<i>Picture</i>	<i>Damage Level</i>
<i>P01</i>	<i>D4</i>
<i>P02</i>	<i>D4</i>
<i>P03</i>	<i>D5</i>
<i>P04</i>	<i>D3/D4</i>
<i>P05</i>	<i>D4/D5</i>

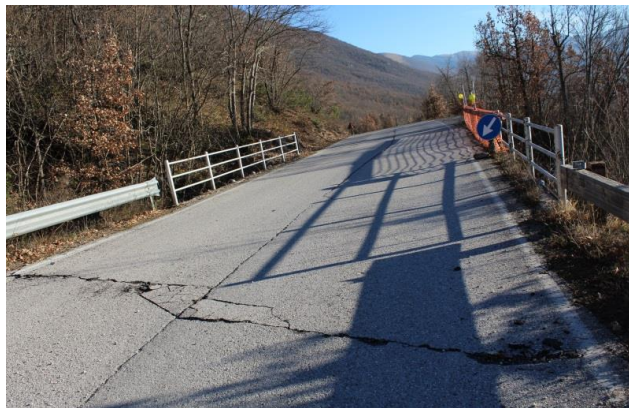
(a)

Figure 7.2 shows damage observed on the single arch masonry bridge along road SP477. The bridge did not appear seriously damaged, but several cracks were observed, especially in the road carriage. Transversal and longitudinal cracks along the road surface were documented (Figure 7.2a), with a measured maximum opening in the longitudinal direction of about 6 cm. From the visual inspection, the transversal cracks close to the road-bridge connection appear more recent when compared to those in the longitudinal direction. Longitudinal cracks also formed in road fill adjacent to the bridge (Figure 7.2b). Minor additional cracking was observed within the bridge arch (Figures 7.2c and 7.2d). Figure 7.2e (from Google earth) shows a photo of the bridge in December 2011, when no roadway cracks are evident. Because this bridge was not inspected in the reconnaissance performed following the August 2016 sequence, we cannot identify which events produced the observed effects.

**Figure 7.2.** Bridge along SP477 (42.782073 deg, 13.142383 deg): road surface cracks (a); longitudinal cracks along the road side (b); cracks between the bridge arch and the main structure (c-d); view of the bridge on December 2011 (e).

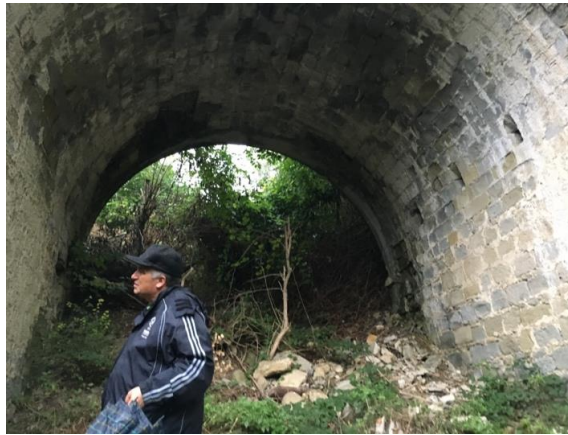
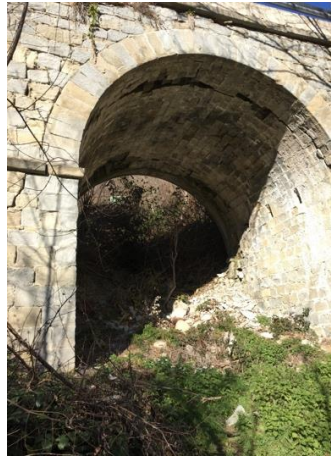
Figure 7.3 shows comparative pictures (taken after the 24 August and the October events) of the 1-span masonry bridge along the Trisungo route (along road SP129). The bridge presents additional cracks following the October events in the interior part of the arch (Figure 7.3b). The

**Figure 7.3.** Roman-era bridge along the Trisungo route (1 span bridge - Tufo area – Arquata del Tronto - N42.735981, E13.254862): view of the arch (a, b) and the road cracks (c, d) after the 24 August event (photo on September 7 2016 (a, c)) and after the 30 October event (photo on December 13 2016 (b, d)).

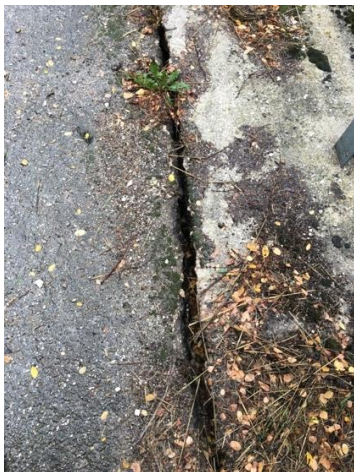
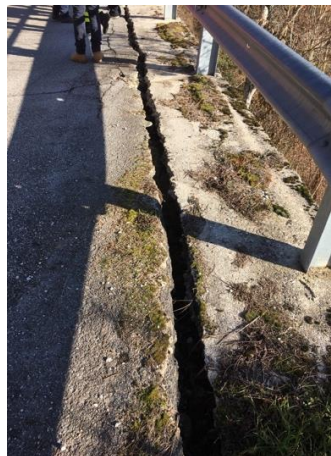
width of the crack in the longitudinal direction (Figure 7.3d) has increased with respect to that observed in the first reconnaissance (Figure 7.3c). However, there was no additional spalling of masonry elements as had been observed following the first event.

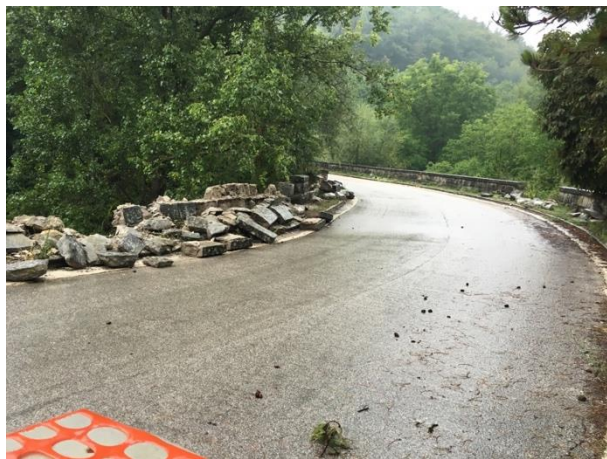
(a)

Figure 7.4 shows the response of the second arch along the Trisungo route (3 spans bridge) after the different events (24 August and October 2016). The incremental damage was significant: part of central arch, already damaged after the first event (Figures 7.4a and 7.4c), collapsed as a result of the October earthquakes (Figures 7.4b and 7.4d).

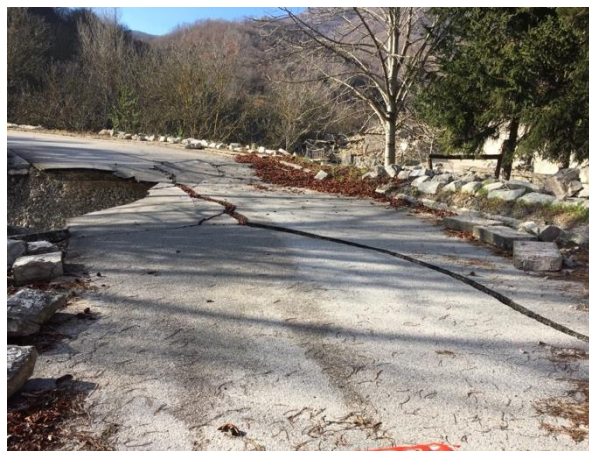
(b)

**Figure 7.4.** Roman-era bridge along the Trisungo route (3 spans bridge - Tufo area – Arquata del Tronto - N42.73538, E13.25365): (c) after the 24 August event (photo on September 7 2016) and (d) after the 30 October event (photo on December 13 2016).

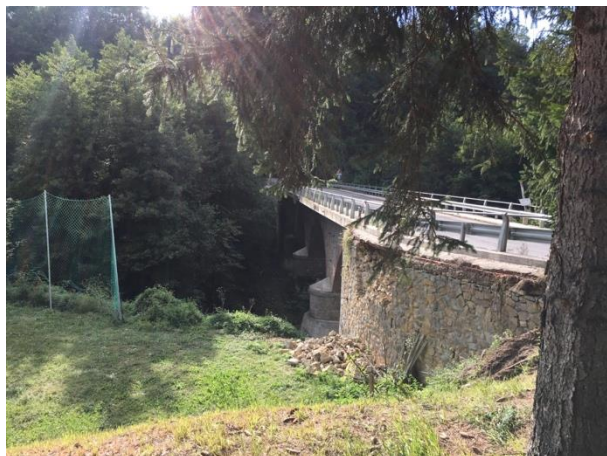
**Figure 7.5.** Ponte a Tre Occhi (42.620668 deg, 13.290176deg): (a) after the 24 August event (photo on September 7 2016) and (b,c,d) after the 30 October event (photo on December 13 2016), repairing works (c) and bridge masonry collapse (d).

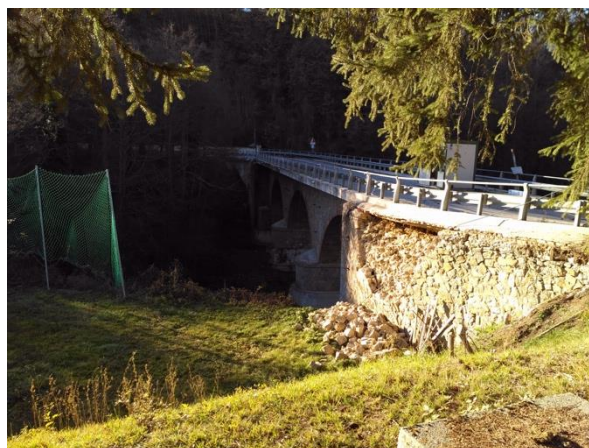
(b)

The Ponte a Tre Occhi (Three eyes) near Amatrice (Figure 7.5) also experienced additional damage, consisting mainly of spalling of outer-layer masonry elements located along abutment areas (not involving the three arches) (Figure 7.5b). At the time of the reconnaissance (December 2, 2016) repairs had been carried out on one of the two abutments (Figure 7.5c), while the bridge masonry and structure appeared to have not yet been repaired (Figure 7.5d).

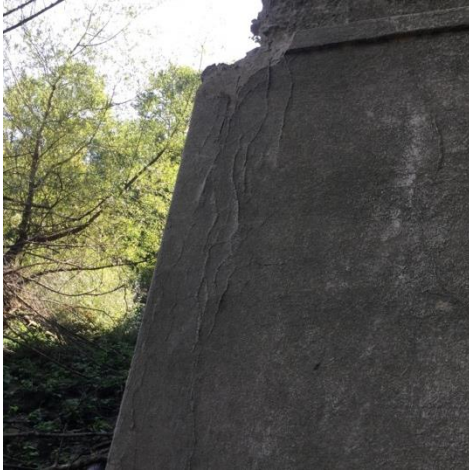
The Ponte a Cinque Occhi (Five eyes) along the internal road connecting SS4 (from the Casale Nibbi exit) to SR260 along Scandarello lake suffered additional damage during the October strong motions. The damage was concentrated in the arches and the piers as shown in Figures 7.6a and 7.6b. The bridge was retrofitted, as a rapid intervention, in early December 2016 with fiber-reinforced mortar and steel mesh (see Figures 7.6c and 7.6d). The latter intervention was aimed at restoring the structural capacity to the piers and the abutments. Construction was also carried out on the carriage way (bridge deck) and drainage ducts were installed.

**Figure 7.6.** Ponte a Cinque Occhi (42.623178 deg, 13.250428deg): increased sub-vertical cracks to the piers after the 30 October event at the top (a) and bottom (b) of the piers (photo on November 20 2016) and structural retrofitting of the bridge (c and d) (photo on December 15 2016).
