Engineering Reconnaissance Following the October 2016 Central Italy Earthquakes *Version 2*

GEER Team Leaders: Jonathan P. Stewart and Giuseppe Lanzo

Geotechnical Extreme Events Reconnaissance Association
Report No. GEER-050D
8 May 2017

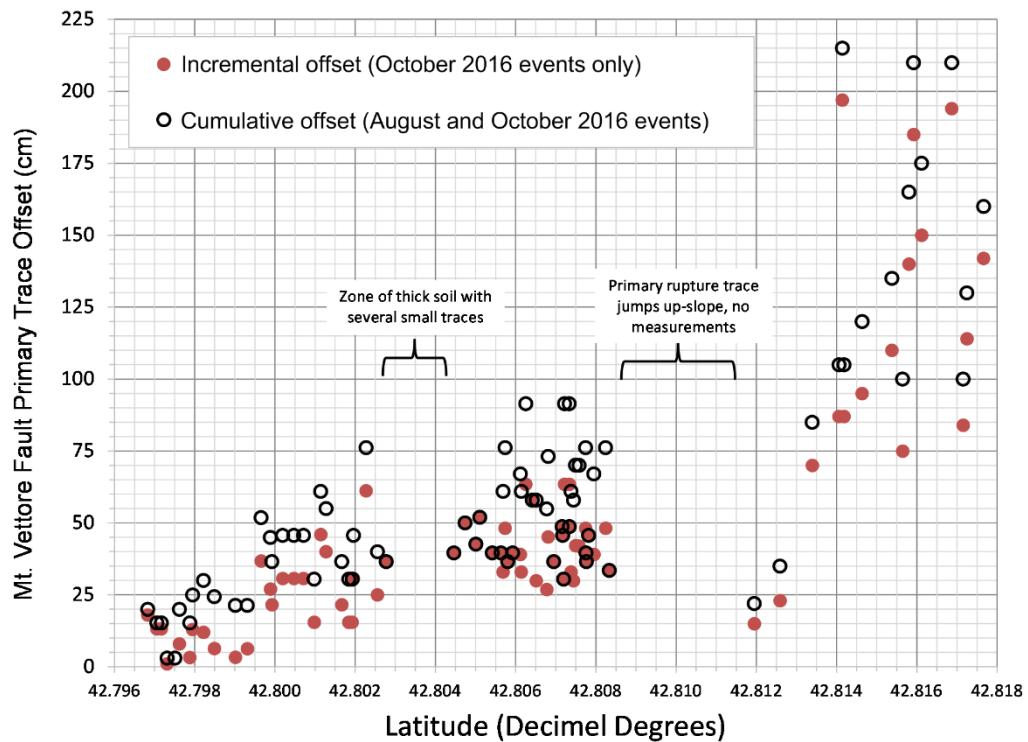
Figure 2.6. Distribution of incremental and cumulative fault offsets for the southern half of the Mt. Vettore fault. All data in this Figure from hand measurements.

In the southern portion of Mt Vettore fault, slip occurred on three segments. The primary segment is on the ridge of Monte Vettore at the contact between bedrock and thin overburden talus and alpine deposits. An apparently secondary segment occurs lower on the ridge, which ruptured in the 30 October event but not in the earlier events. Another secondary segment is in the lower-lying basin, Piano Grande, in lacustrine and alluvial deposits that have infilled the basin. Rupture on this segment was only observed following the 30 October event.

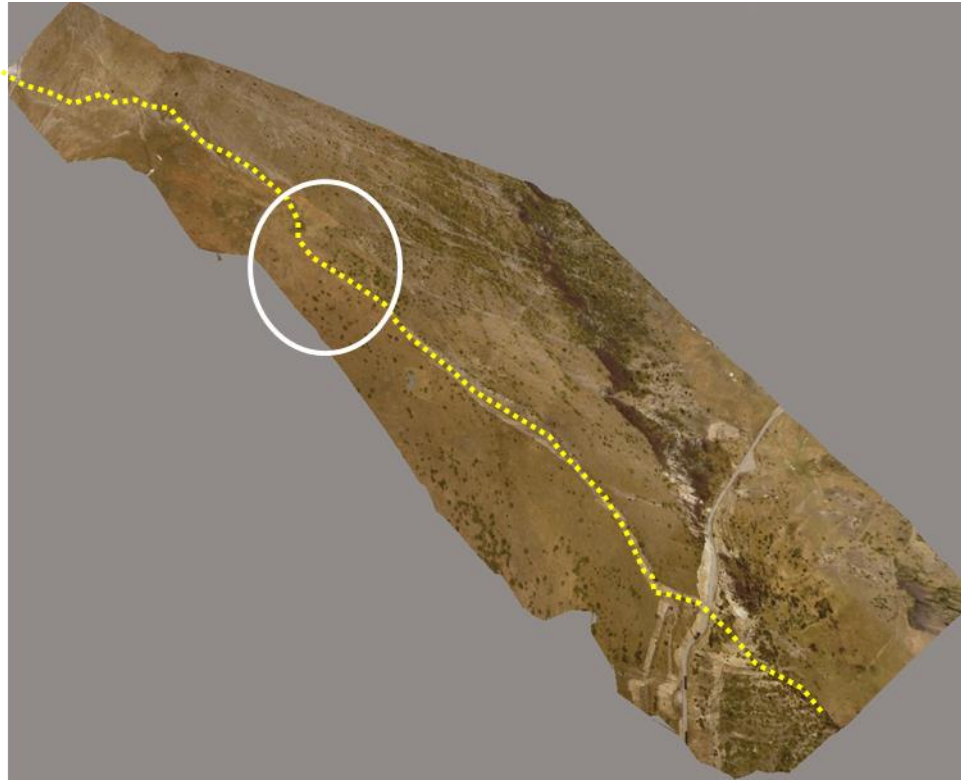
The 3D point cloud model, generated using both UAV SfM and LiDAR point cloud modeling, for the south face of Mt. Vettore is shown in Figure 2.9. Due to the large area and low color contrast of fault scarps compared to the native ground surface, lines have been added to this image to show approximate surface fault rupture traces. Figure 2.9 shows that the fault rupture alignment climbs the slope from south to north. In general, larger fault offsets were measured to the north. The southern terminus of observed fault rupture is down slope of road SP477 which is at bottom of Figure 2.9. Most of the mapping effort was performed north of SP477, as the fault dip offsets observed south of SP477 were minimal.

An interesting observation from both 3D point cloud and conventional mapping is that there is a zone of apparently thick and soft (ductile) soil sediment overburden on the slope where the distinct single fault rupture surface is defrayed into several smaller scarps. This area is shown in Figure 2.9. Above and below this area, the fault trace is singular and well defined. Within the

area, the fault splinters into 4 to 6 distinct, short, small displacement traces roughly parallel to one another.

Figure 2.9. 3D digital terrain model from merged SfM and LiDAR data of the Mt Vettore fault on the southern flank of the Mt Vettore Massif. Approximate main fault trace indicated in yellow. Looking from the west to the east. The upper left of the image is the top of the slope. Area of soft sediments where the fault trace breaks into several (4 – 6) small scarps is indicated in white.

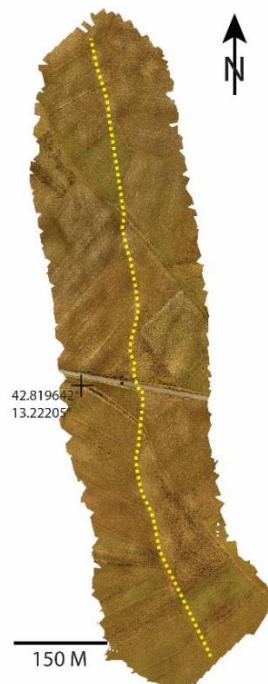
The final 3D point cloud model is from LiDAR imaging of the Piano Grande fault at the western foot of the Mt. Vettore Massif (location shown by the orange rectangle on left side of Figure 2.8). The Piano Grande fault has been interpreted as a secondary rupture surface. This fault was not observed after the August 2016 event. Figure 2.11 presents an image of this 3D model.

Figure 2.11. 3D digital terrain model from merged SfM and LiDAR data of the Piano Grande fault on the western toe of the Mt Vettore Massif. Approximate fault trace(s) indicated in yellow. Looking from the west. The left of the image is to the north. Mt. Vettore on the top of the image

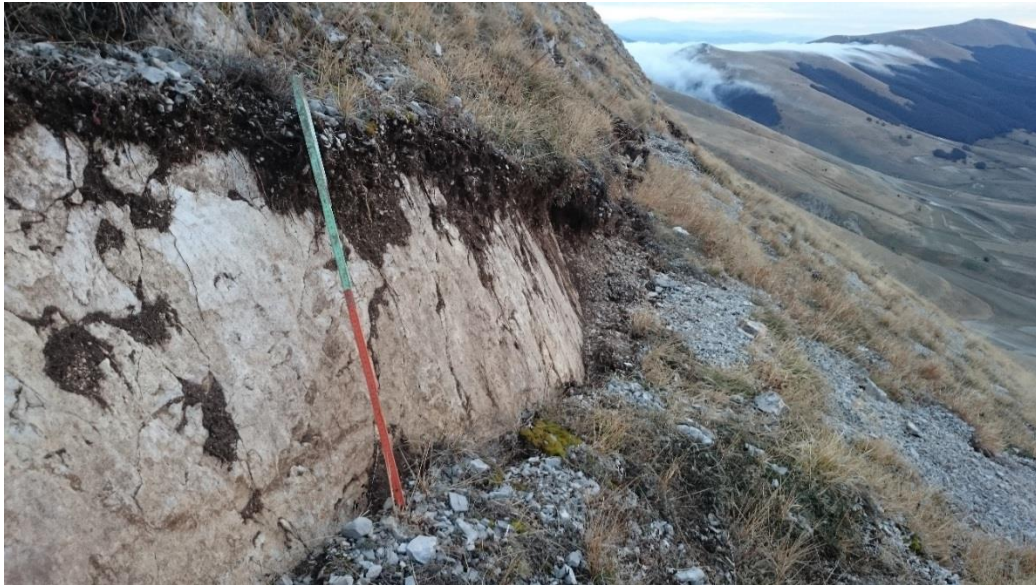
Figure 2.12. Fault offset measurements showing relative offset of August 2016 (0 cm) and October 2016 (70 cm) events on the lower or “western” fault trace in Figure 2.10 (shown in white). Lat = 42.812901, Long = 13.24626.

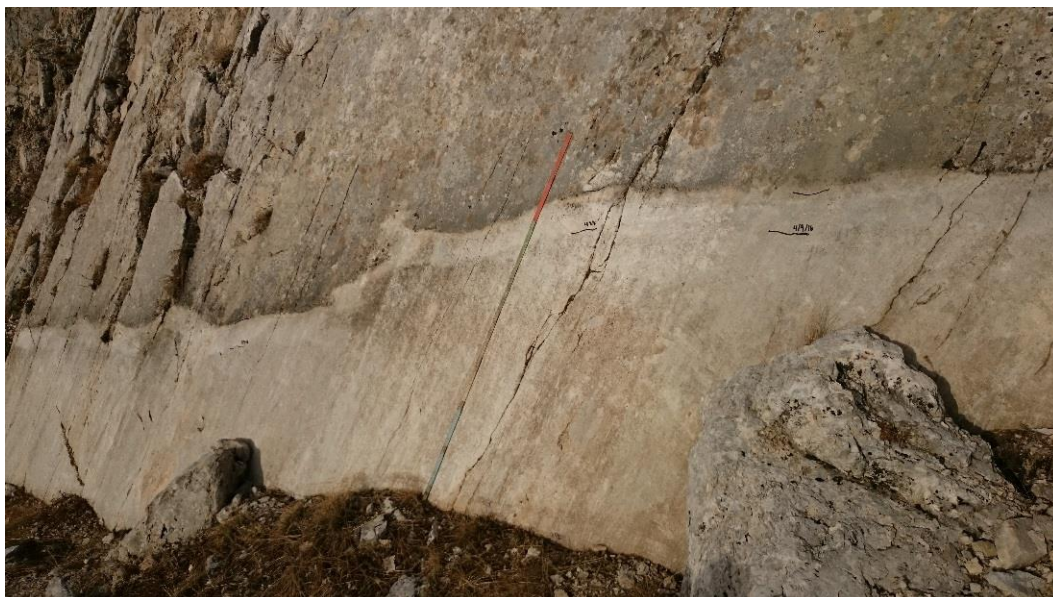
Figure 2.13. Fault slip measurements showing multi-epoch offsets from August 2016 (upper white band, 16 cm) and October 2016 (130 cm) events. Lat = 42.81724, Long = 13.25449.

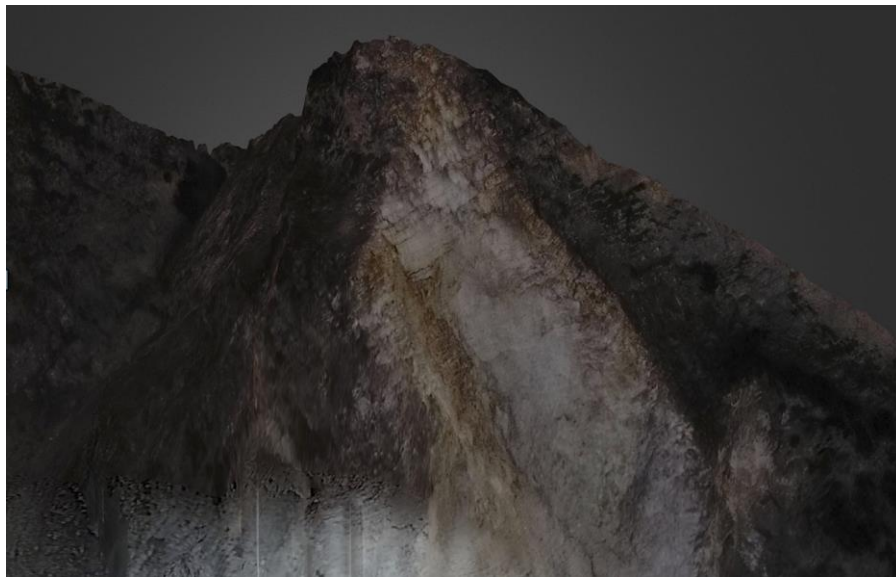
During the 30 October 2016 earthquake, the rock avalanche at Nera separated from the steep rock-face in a brittle detachment. The fall was fast-moving and disintegrative. Quantitative measurements from the rockfall were made from photogrammetric reconstruction of imagery captured from the UCA DJI Phantom drone quad copter. Reconstruction was performed using the Structure-from Motion method. The crest of the valley wall at the top of the detachment is approximately 330 meters above SS209. The slope at the detachment area is between 75° and 80°. The slope of the debris apron SS209 is about 27°. The entire talus field covers about 20,000 m².

The upper detachment zone can be seen in the SFM imagery of Figure 4.6-4.7. In these images, the bedding is seen with an apparent dip towards the east of 20°-30°, and the wedge is apparently a double joint set orthogonal to the bedding. The failure occurred along the joint sets. Further analysis of the SFM data may resolve the strike and dip of the bedding and the joint sets that resulted in the detachment.

Figure 4.6. Headscarp of Nera rockfall.

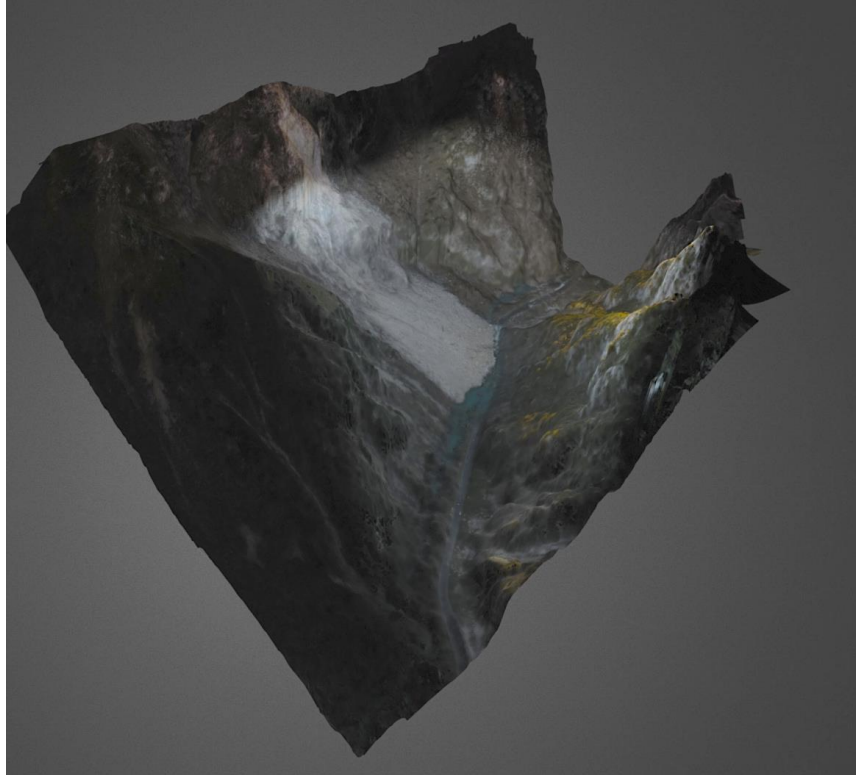
Figure 4.7. 3D Structure-from Motion (SfM) model of the Nera river valley at the rockfall. The Nera rock avalanche is seen here from the east (Visso) side of the rockfall. The light color on the midslope is from the setting sunlight on the SfM UAV imagery. Elevation difference from the crest of the headscarp to the river is 330m.

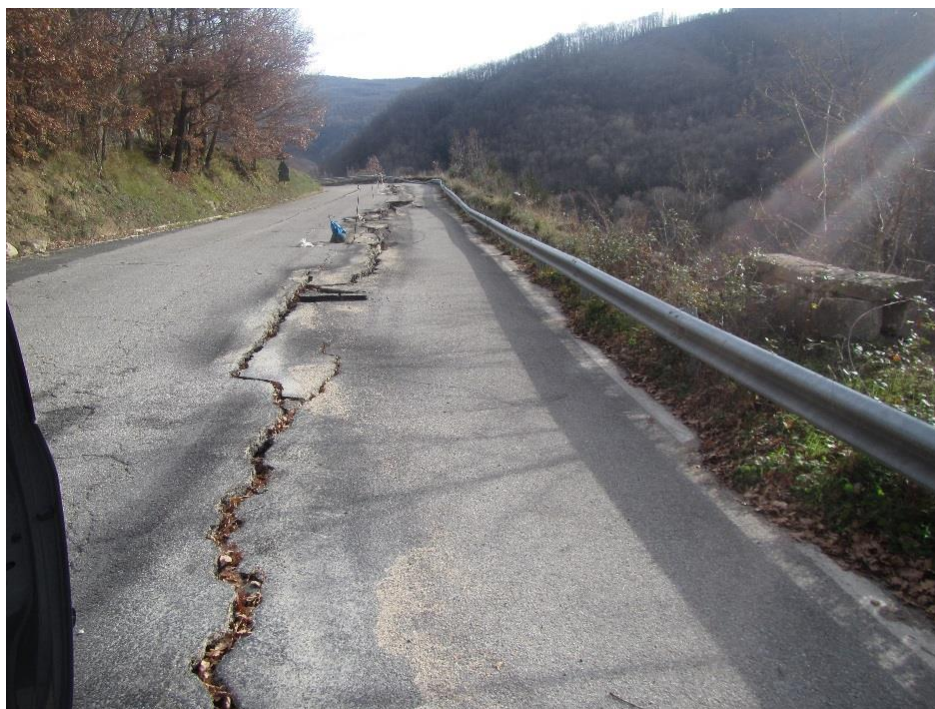
Moderate to severe damage was observed in most of the roads located adjacent to slopes and/or above retaining walls throughout Pescara del Tronto. An example of the typical damage that was observed is presented in Figures 4.16 and 4.17. Most of the damaged observed in the roads appears to be due to horizontal deformations in the fill material placed on the slopes (Figure 4.16) or behind the retaining walls (Figure 4.17). Observed damage typically consisted of long cracks in the pavement running parallel with the face of the slope or retaining wall, often with variable amounts of vertical offsets due to rotation of the retaining wall and/or settlement of the underlying fill.

Figure 4.17. Road damage induced by slight rotation of the underlying retaining wall and/or settlement of the retaining wall backfill.

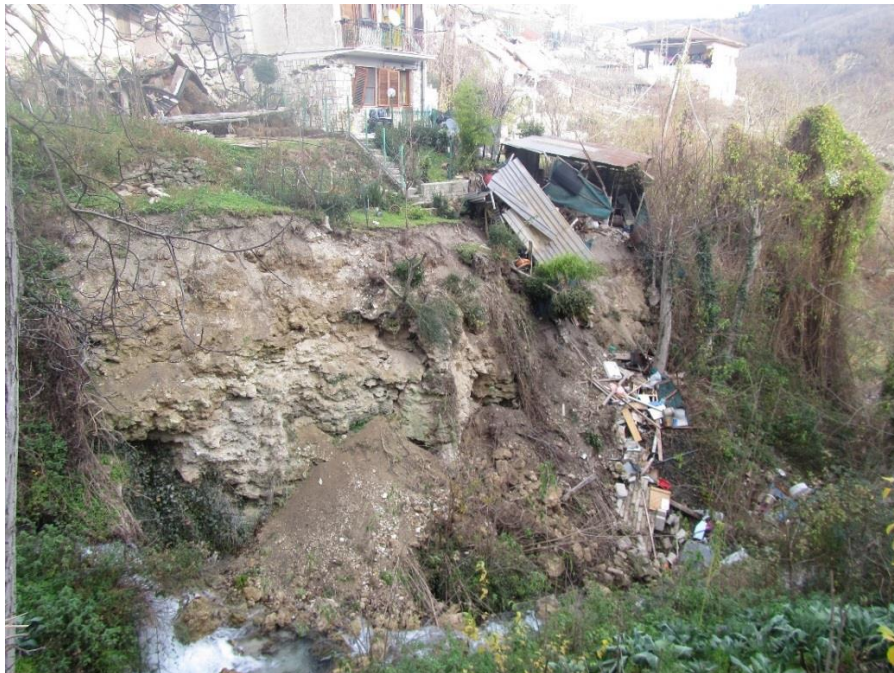
Within the village of Pescara del Tronto, there exists a natural creek that flows down a gulley located in the middle of the village. The presence of the gulley gives Pescara del Tronto the appearance of an inverted horseshoe shape or upside-down “U” when observed from the air (see Figure 4.12). During the December reconnaissance mission, GEER team members observed that portions of the gulley wall had failed in localized landslides, causing any overlying structures to fall into the gulley (Figure 4.20). The exposed scarps revealed talus comprised of heavily weathered limestone.

Figure 4.20. Failure of steepened talus gully wall material and crest area above (Location 3e).

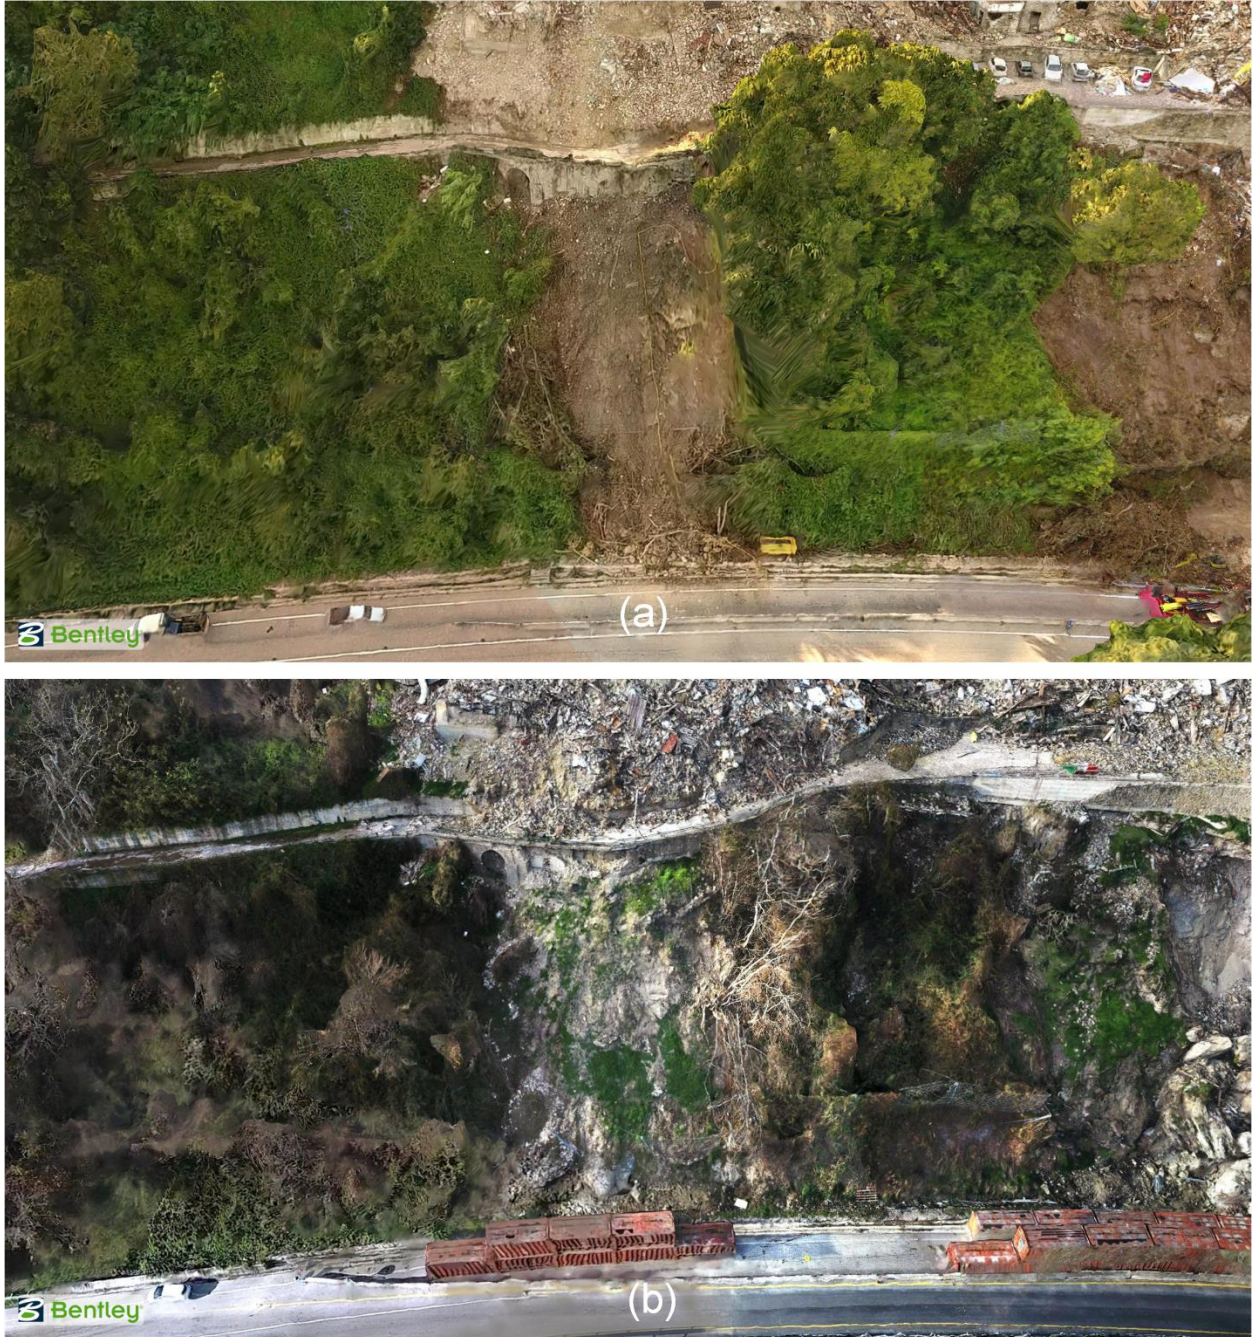
Area 2: Smaller landslide above Strada Statale No. 4: The smaller landslide just to the south of the landslide described as Area 1 was not observed to change significantly between September (Figure 4.23a) and December (Figure 4.23b). In this section, even the retaining wall supporting the road appeared to maintain its stability. However, significantly more structural debris from collapsed residences was observed at this location in December.

Figure 4.23. 3D model comparison of the smaller landslide below Pescara del Tronto between September 2016 (a) and December 2016 (b).

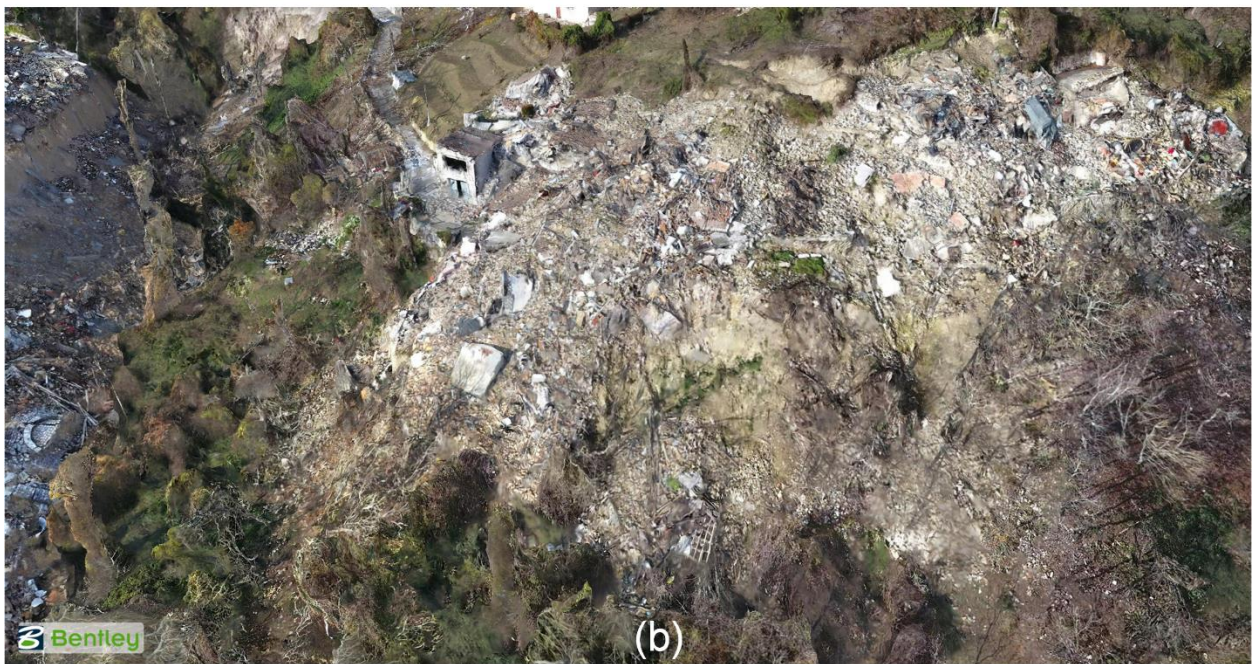
Area 6: Landslide on the Northern Slope of the Village: A shallow landslide was observed on the northern slope of the city following the 24 August event (Figure 4.27a). This landslide was observed to have exposed some tree roots and undermined a few residential structures. Investigation of the same slope in December following the October events revealed that the depth of the landslide remained relatively unchanged, but the width of the landslide appears to have expanded from 17 m in September to more than 36 m in December (Figure 4.27b). However, it is difficult to discern from the UAV images and 3D model whether the flattened trees along the slope are due to an expansion of the shallow landslide or due to structural debris from above the slope.

Figure 4.27. 3D model comparison of the landslide beneath the northern slope of Pescara del Tronto between September 2016 (a) and December 2016 (b).

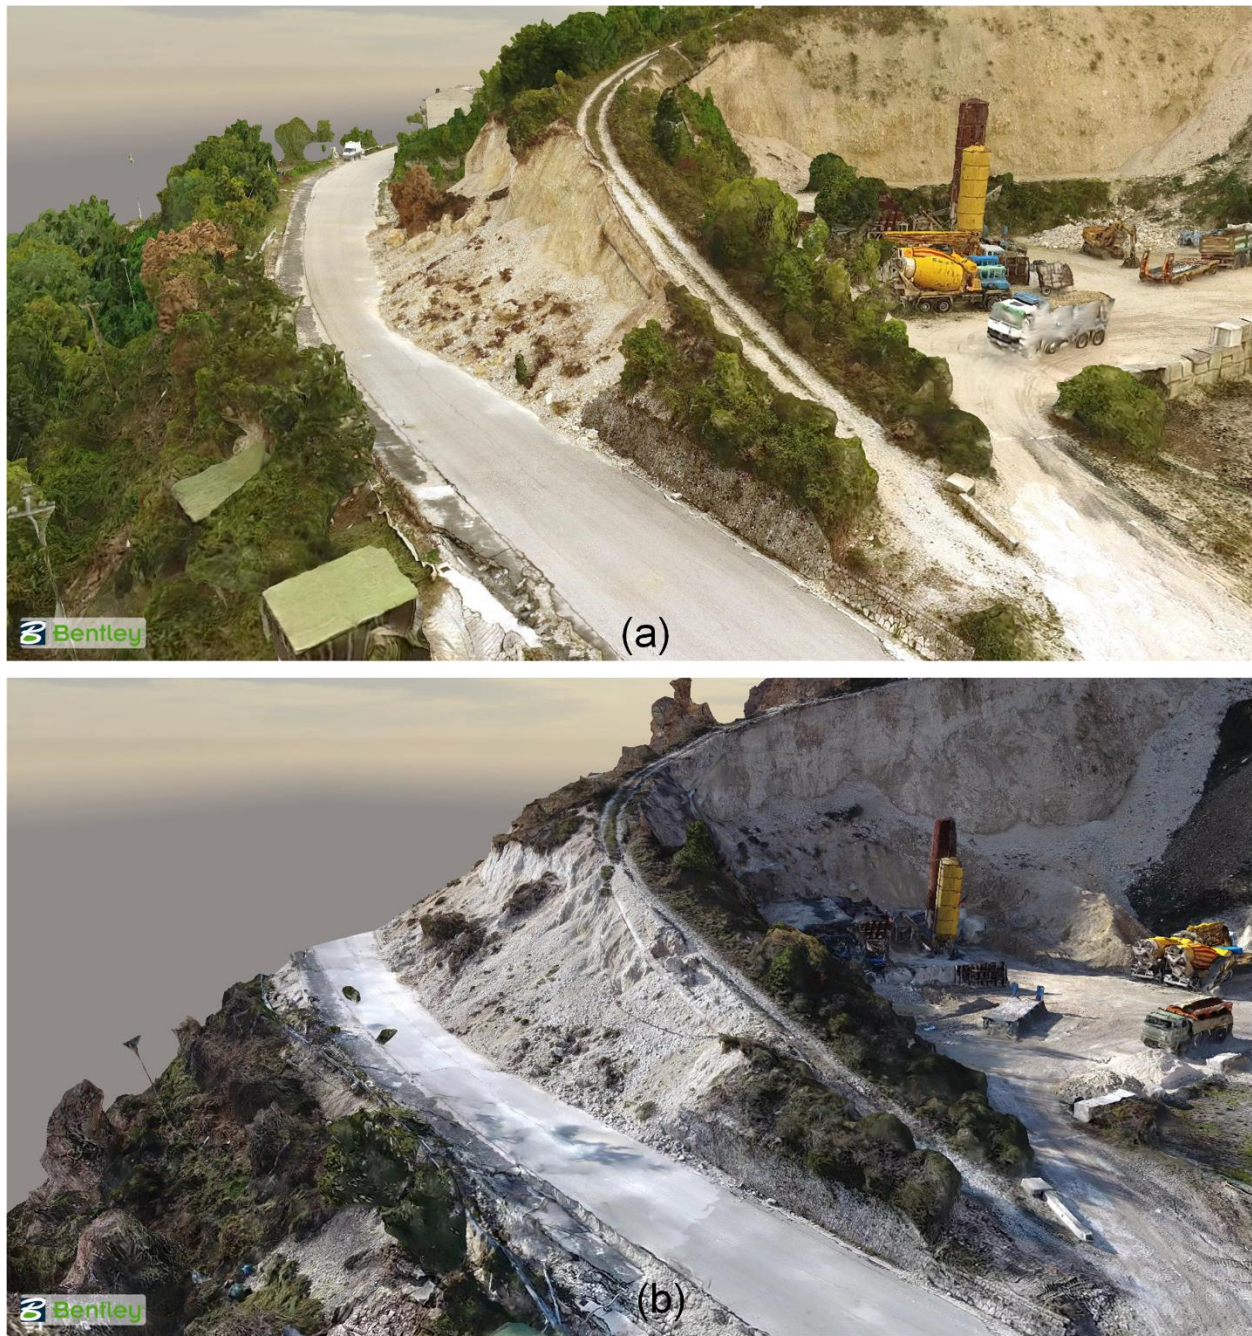
Area 7: Haul Road and Exposed Pipeline near the Gravel Pit: A small landslide was observed on the slope bounding the gravel pit on the southern portion of the village of Pescara del Tronto, adjacent to SP129, following the 24 August event (Figure 4.28a). This landslide was caused by the unraveling of weathered limestone and calcareous soils that were underlying a dirt haul road for the gravel pit. The landslide exposed approximately 15 m of a 50 cm-diameter pipeline. The

condition of the landslide remained largely unchanged following the October earthquake events (Figure 4.28b). The slope beneath the haul road degraded slightly more, causing nearly half of the haul road above the landslide to disappear. Additionally, approximately 8 more meters of the pipeline became exposed from the additional slope movements, causing the pipeline to apparently sag and bow slightly. Another smaller pipe of a few centimeters' diameter was also exposed and sagging substantially along the scarp.

Figure 4.28. 3D model comparison of the landslide near the gravel pit in Pescara del Tronto between September 2016 (a) and December 2016 (b).

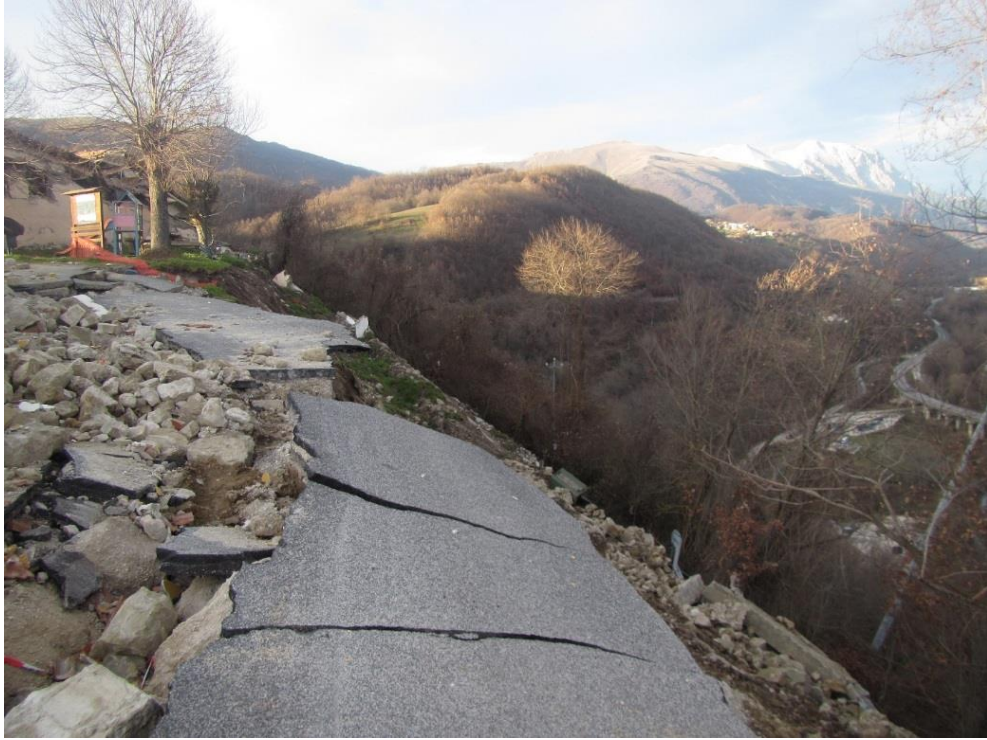
During the December GEER deployment, much more damage was observed. It appeared that a shallow landslide developed beneath the retaining wall and caused the entire structure to slide several meters down the slope. Figures 4.30 and 4.31 present photographs of the head of the shallow landslide showing the retaining wall's former location. Figure 4.32 presents an aerial screenshot of the 3D model developed from Phantom 4 UAV imagery of the site. Several features of interest are identified in Figure 4.32, and will be discussed below.

Figure 4.30. Failure of retaining wall due to shallow landslide (Point 4a, looking towards north).

The shallow landslide appeared to be limited to the upper corner of the slope, near the crown. The slide therefore likely occurred in the non-native fill slopes placed during the construction of the village. The scarp of the landslide appeared to follow the scarp of the soil graben observed behind the wall in September, suggesting that the graben may have been caused by more than just the rotation of the retaining wall. The landslide displaced the top of the wall between 5 to 6 m horizontally and between 3 to 4 m vertically downward. In total, approximately 50 m of the retaining wall below Accumoli failed and slid 5 to 6 m downslope. This loss of confinement resulted in significant horizontal and vertical deformations in the overlying roadway Frazione Fonte del Campo (SP18), as shown in Figure 4.33. The road was measured to have displaced horizontally between 0.1–1.6 m, and vertically downward 9–50 cm. Vegetation remained intact below the collapsed retaining wall, again suggesting that the landslide was likely shallow and limited to the upper limits of the slope. However, the rotated telephone pole located further down the slope, which was observed to have rotated 13 degrees in September, was observed to have rotated a total of 27 degrees in December. However, it is not clear whether this rotation was due to displacements of the heavily-vegetated soil slope or due to inertial effects on the pole from the earthquake.

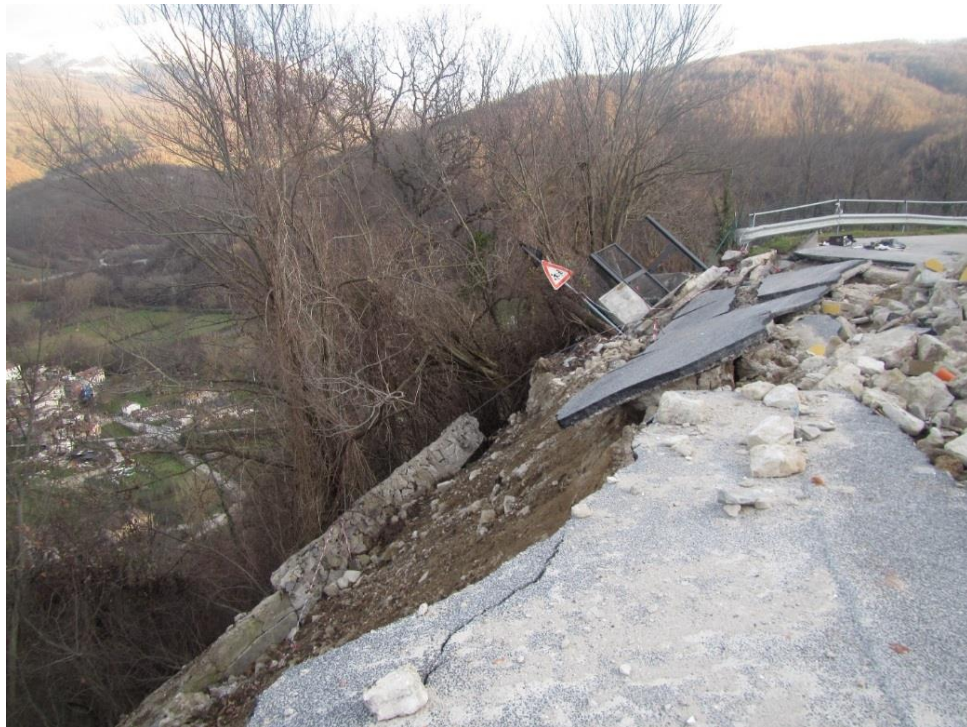
Figure 4.31. Failure of retaining wall due to shallow landslide (Point 4a, looking towards south).

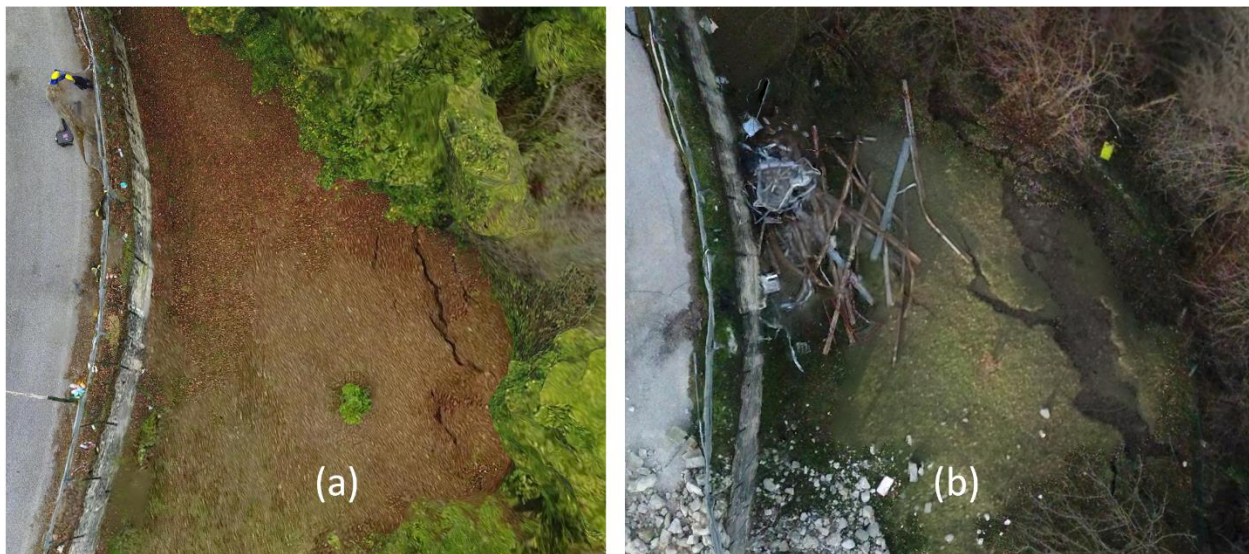
During the September 2016 reconnaissance, the GEER team observed a series of shallow cracks approximately 5–14 cm in width in the soil below the southeastern slope of the village (42.69406 N 13.25019 E). These cracks were believed to have been caused by shallow landslide displacements in the soft silty-sand located near the surface of the fillslope.

Much more deformation was observed by the GEER team in December 2016. Figure 4.35 presents 3D model images of the headscarp cracks in both September (Figure 4.35a) and December (Figure 4.35b). In general, the GEER team observed that the cracks developed in the 24 August event opened further from 5-14 cm to 0.8-1.9 m. The depth of the crack was measured from the 3D model as approximately 55 cm. However, beyond the widening of the cracks from the shallow landslide, no other significant damage was observed at this point.

Figure 4.35. 3D model screenshots showing cracking from a shallow landslide (a) during the September GEER reconnaissance, and (b) during the December GEER reconnaissance.

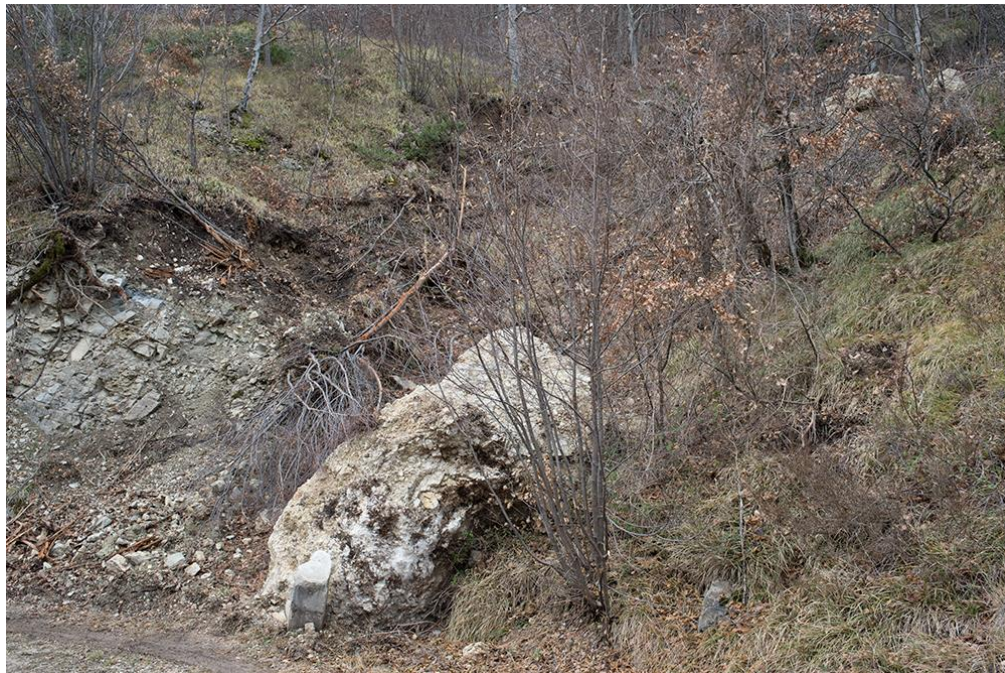
Figure 4.41. Photograph of the largest observed boulder fragment in the Valle di Panico rockfall. The boulder measured approximately 3.0 meters in diameter.

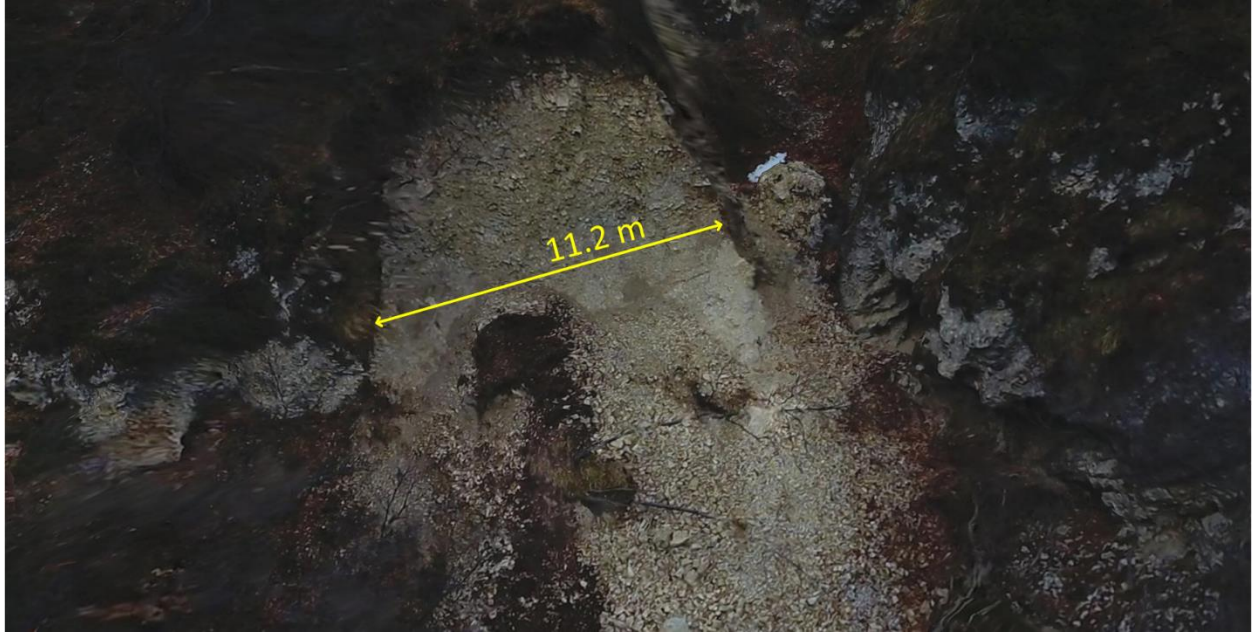
Figure 4.42. 3D model of the source of the Valle di Panico rockfall, located 90 meters above the mountain road.

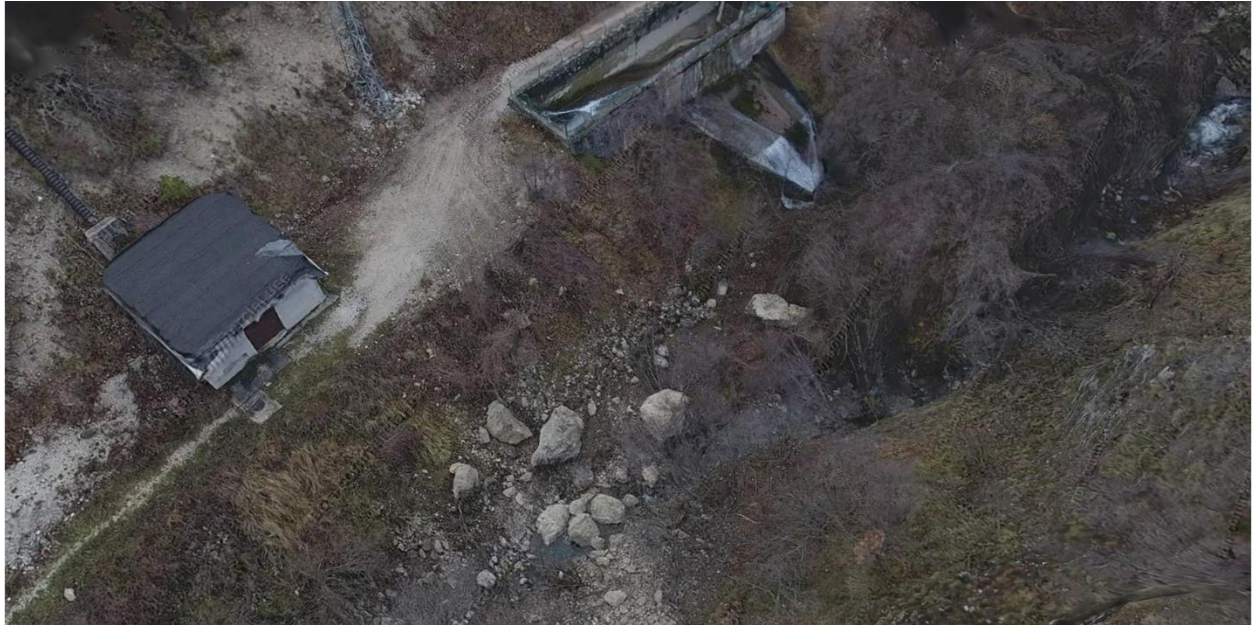
Figure 4.43. 3D model of the boulders and small power or pump house at the toe of the Valle di Panico rockfall.

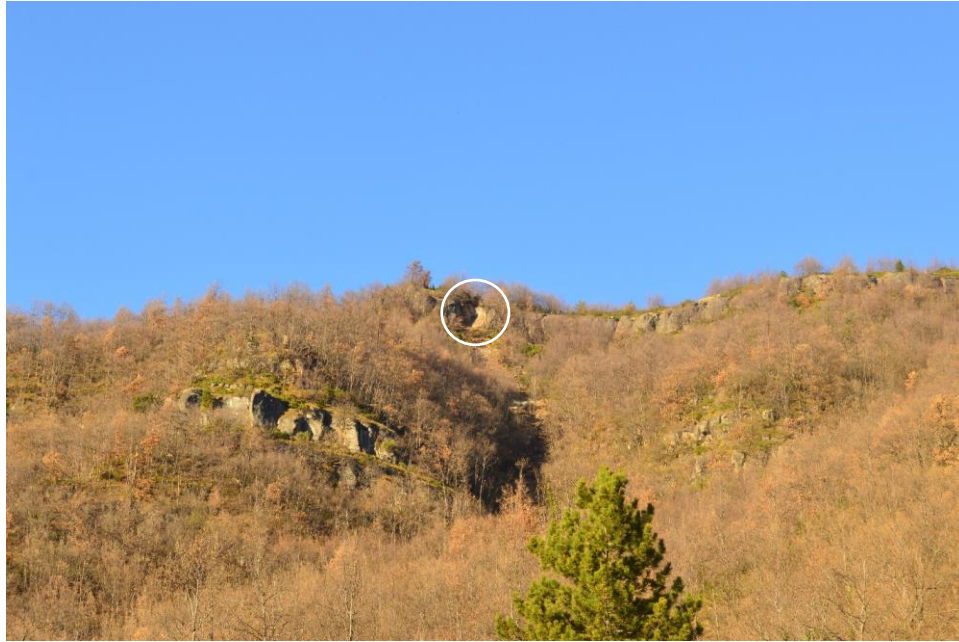
the mid-slope rock face. However, our data indicates that most of the boulders that reached near to the road came from the primary source area at the top of the slope. From the perspective of the Via Trieste, the photo in Figure 4.46 shows the mid-slope rock face and the source at the top of the slope from the rim-rock limestone exposure.

Figure 4.46. Source and runout chute of rockfall site near Cervaro village (Crognaleto) as seen from road at base of slope. Primary rock source circled in white.

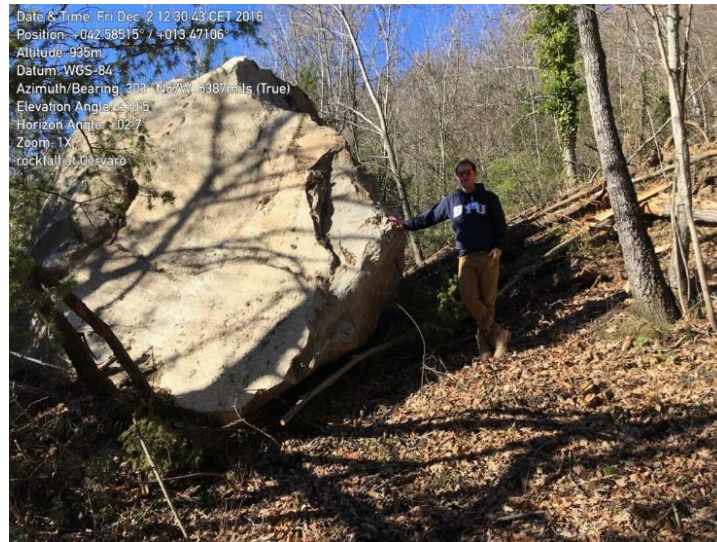
Figure 4.48. Last boulder fragment (4 meter) from rockfall near road at base of slope. Also pictured are freshly toppled trees from the boulder’s roll to its final position.

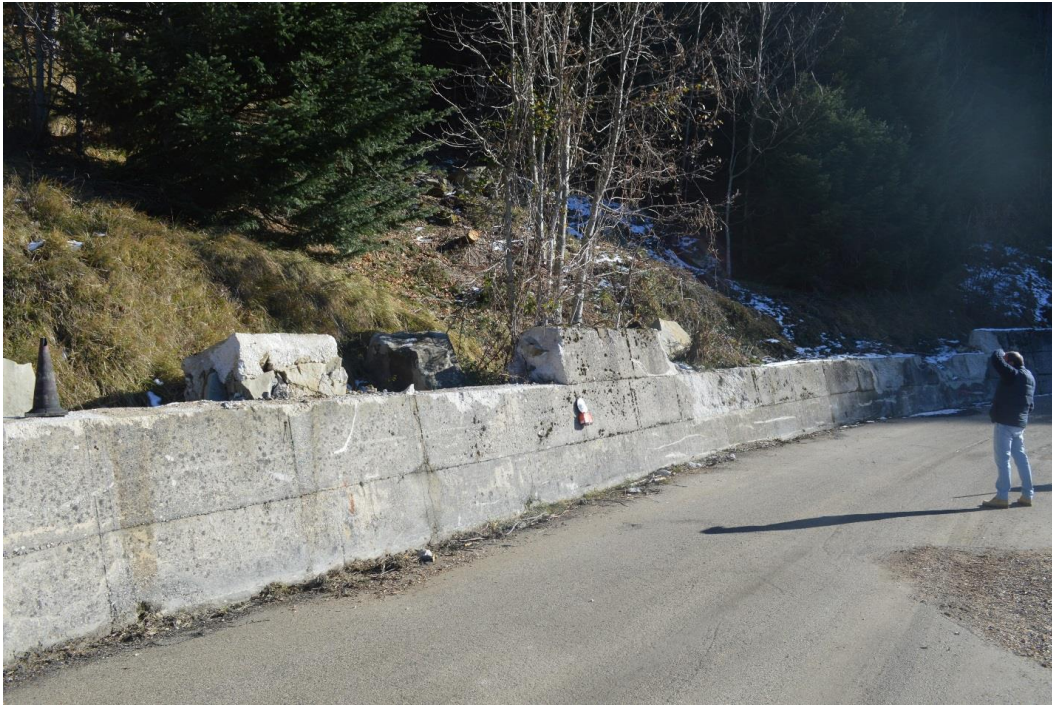
The local highway officials also cleared 9 pre-cast concrete retaining wall blocks off of the road after the earthquake. These large pre-cast concrete retaining wall blocks can be seen in Figure 4.52. Each block is 75cmx100cmx200cm and has some small amount of internal steel reinforcement. Two small steel bars connect the blocks in the wall as shear pins. Concrete blocks not damaged appeared to be in good condition, with minor surface weathering but no cracking. The wall is formed by stacking the blocks with shear pins in place and a thin mortar. The retaining wall runs along SP45a for several hundred meters with no damage from strong ground shaking or dynamic lateral earth pressures. Only at the location of the rockfall and boulder run-out does that wall have any damage. At the location of the boulder runout, it is clear that the boulders impacted the back of the retaining wall, dislodged or shattered the top blocks, and then fell onto or over the road. Figure 4.53 is a photo taken from SP45a looking up the runout chute towards the top of the slope over the damaged wall. A number of boulders are seen in this photo, two of which are the remains of a larger boulder blasted by local officials due to an unsafe resting position. Other, older rockfall boulders can be seen in Figure 4.53 covered in vegetation. This

Figure 4.52. Damaged segmented concrete block retaining wall at roadway. Blocks that fell on road have been removed by local officials prior to visit from GEER team.

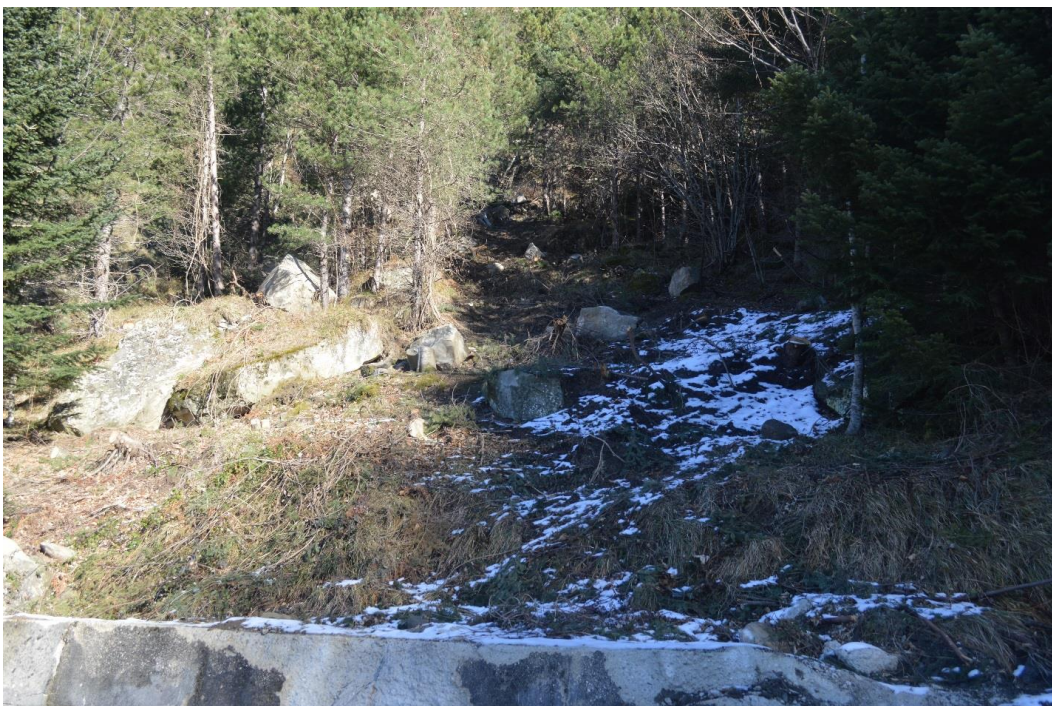
shows that the area has regular rockfall, and that strong ground shaking from the October 30, 2016 earthquake has merely accelerated the rate of rockfall at the site.

Figure 4.53. View upslope of damaged retaining wall, boulder fragments and runout chute from road at rockfall site near Crognaleto village.

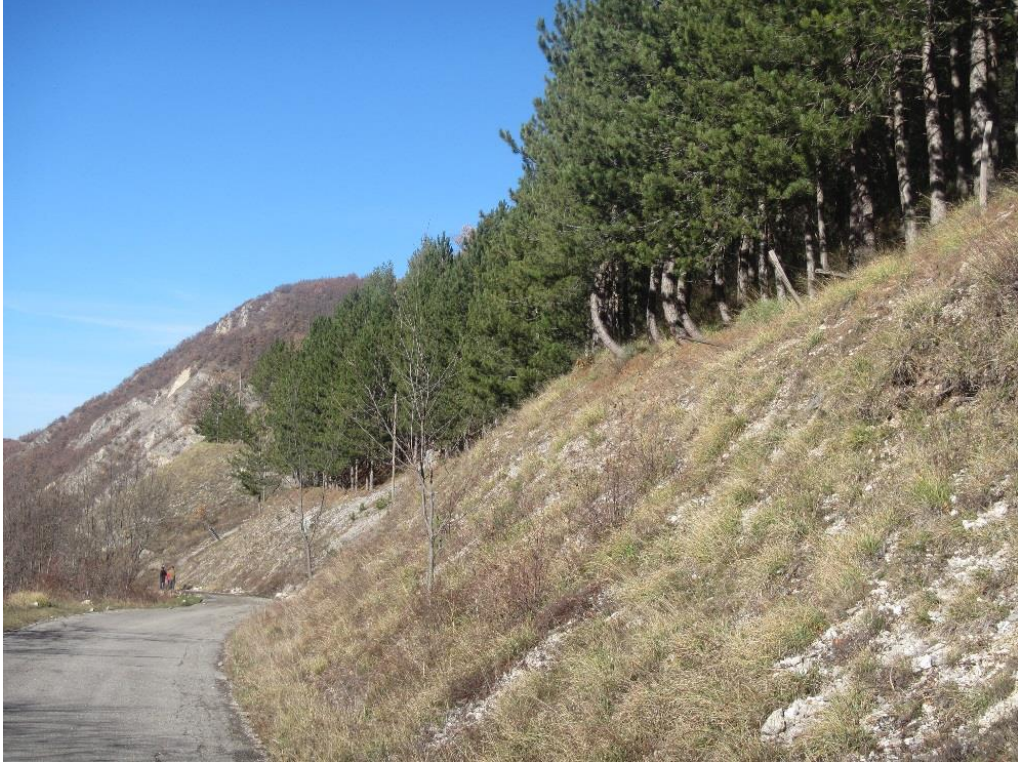
Figure 4.55. Pescia rockfall. Possible soil slope creep shown by tree trunks. (site 9a).

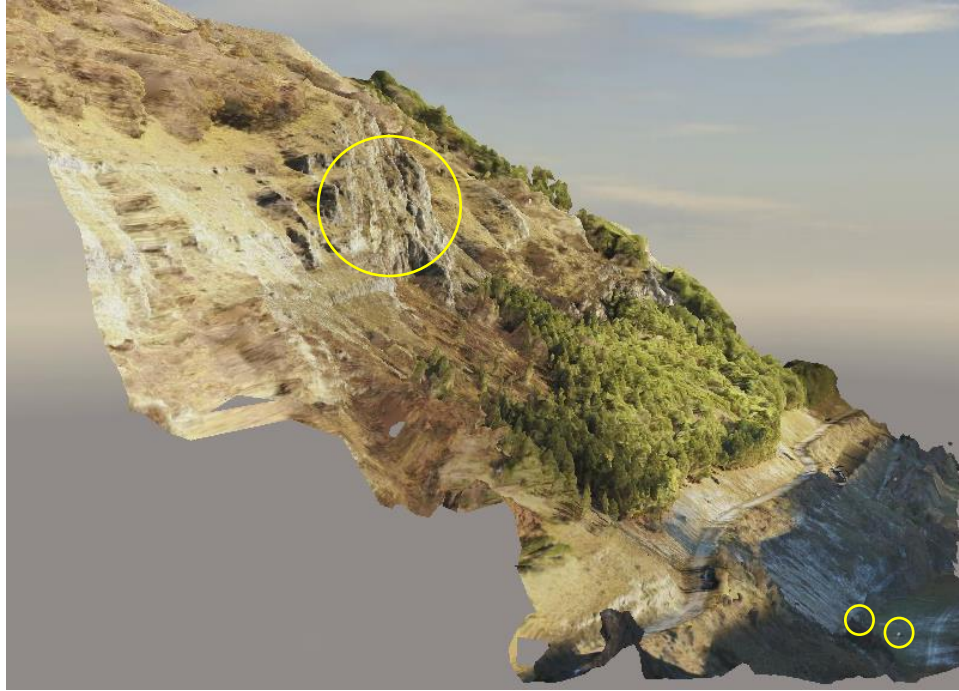
The 3D SfM model for site 9a is shown in Figure 4.56, while an orthophoto of the rock face and source of the rockfall are shown in greater detail in Figure 4.57. The rock face is approximately 90 m wide and 60 m high. The rock material that composes the face is a combination of limestone, argillaceous limestone, and Marlstone. The GEER team climbed the slope above Via del Passero and examined the intact rock at the rock face. The GEER team determined that the rock was at times laminated and at times massive. The limestone tended to be massive (and produce large boulders), while the Marlstone and argillaceous limestone was laminated to thinly bedded. All of the rock species were moderately weathered. The limestone was strong and resisted a geologist's hammer, while the other species of rock crumbled under a blow from a geologic hammer, but could not be peeled via a pocketknife. The limestone was hard, while the other species were moderately hard. Discontinuities were narrow joints with little infilling and spaced widely. Our assessment of the intact rock are that the conditions are ideal for rockfall with boulders up to 2.5 m. Boulders of this size were indeed observed on the slope, on Via del Passero itself, and at the bottom of the slope. Indicated on Figure 4.56 are two boulders of at least 2.5 m that reached the valley floor below Via del Passero. Boulder diameters were measured by hand, and compare well with the measurements performed via 3D SfM models. The boulders encountered below the tree line, on the road, and on the valley floor were all limestone. Boulders above the tree line were mostly the argillaceous limestone and marlstone.

Figure 4.56. Pescia rockfall site 9a 3D SfM model from UAV data. Rock source and 2.5 meter boulders circled in yellow.
