Engineering Reconnaissance Following the October 2016 Central Italy Earthquakes *Version 2*

GEER Team Leaders: Jonathan P. Stewart and Giuseppe Lanzo

Geotechnical Extreme Events Reconnaissance Association
Report No. GEER-050D
8 May 2017

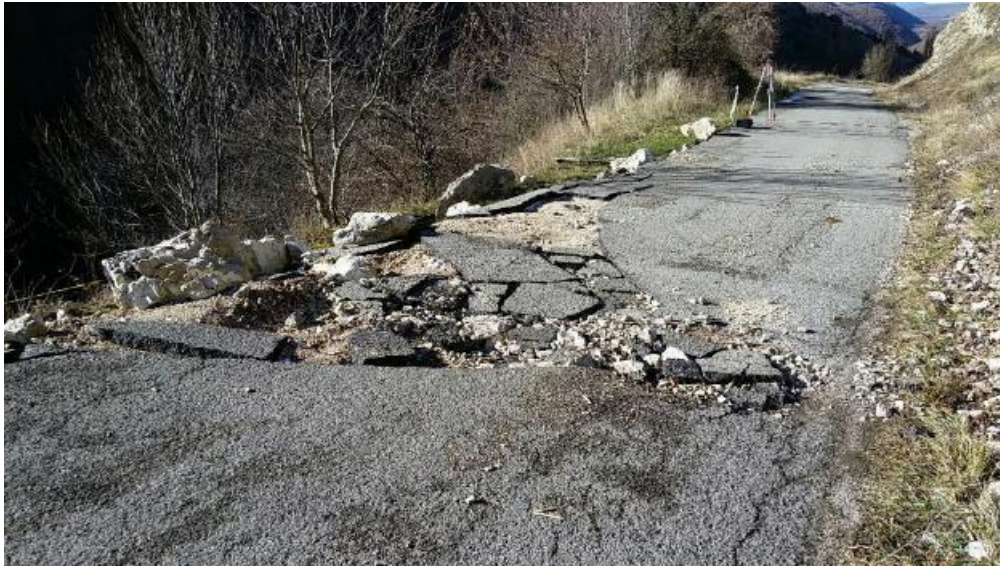
Damage to the pavements occurred between Sites 9a and 9b from boulder impacts. Figure 4.58 shows one such example. This photo was taken directly up-slope of the large 2.5 m boulders

shown in Figure 4.56. Still visible in Figure 4.58 is a smaller 1 m limestone boulder and several smaller 150-250cm boulders. The pavement was heavily damaged from multiple boulder impacts at this and several other locations.

Figure 4.58. Damage to road from 1-2.5 m boulder impacts from rockfall between sites 9a and 9b.

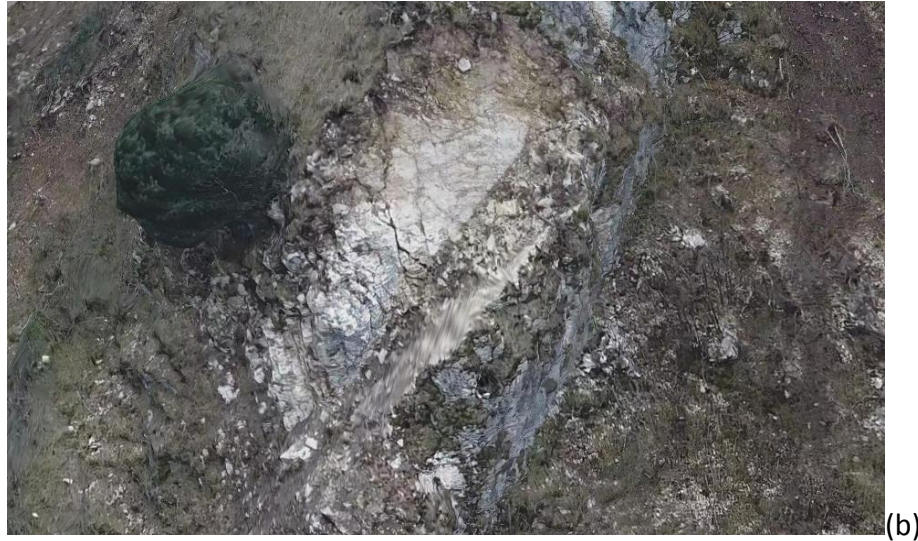
On the opposite valley flank a rock slide occurred at a height of about 100 m above the valley bottom and evolved into a small rock avalanche that fell into the Nera River (some blocks reached the opposite riverside). UAV drone surveys were instrumental in understanding landslide geometry, rock mass quality and failure mechanism. The oblique view in Figure 4.63a shows that the failed mass suffered intense fragmentation and eroded the slope with significant entraining of debris overlying the bedrock. Figure 4.63b indicates that sliding involved an intensely fractured wedge of Maiolica limestone delimited by two persistent joints.

Figure 4.63. General oblique view of the rock slide and subsequent rock avalanche on the left flank of the Nera valley (km 3 of SP134 motorway) (a); detail of the detachment area (b). Images taken from the 3D model generated by BYU on the basis of drone surveys.

The left joint (observing the slide from the opposite flank) was a sub-vertical, persistent, relatively smooth and striated fault plane, whilst the right joint seems a relatively planar joint dipping at low angle toward the valley. It is not clear if the mechanism was planar or three-dimensional. The wedge is sector-shaped with a height of 19 m and maximum transversal dimensions of 8m and 4 m respectively.

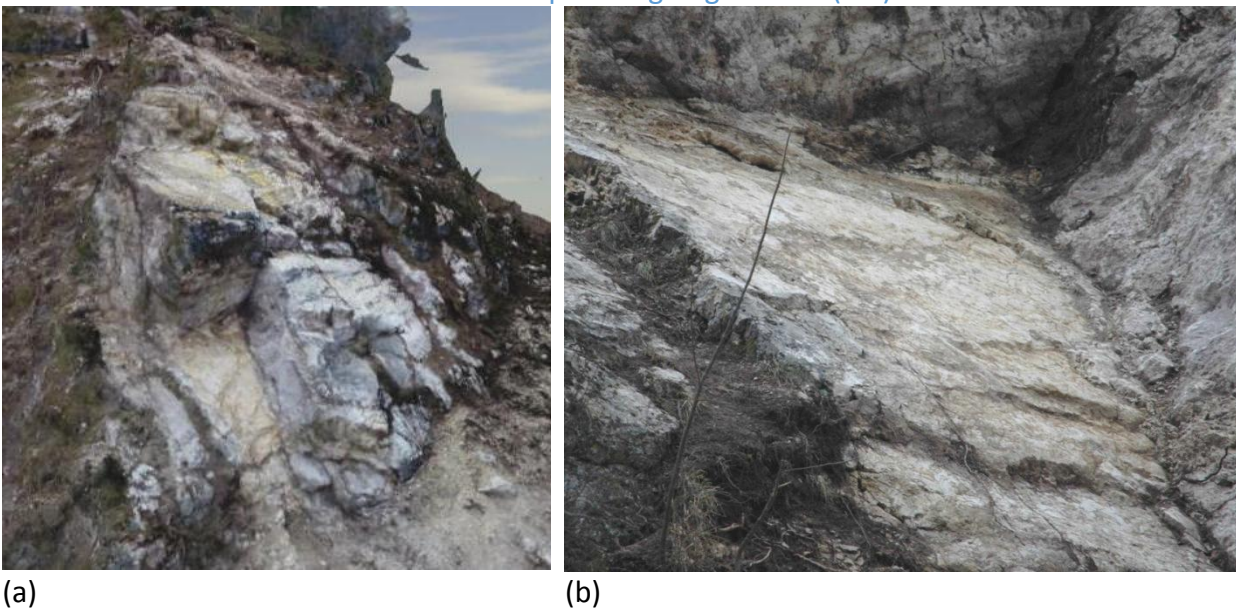
A major failure occurred on the northeast flank of the valley at km 4 of SP 134 within the Maiolica limestone formation (Figure 4.64a). The subsequent rock avalanche invaded the motorway and the valley bottom below for a stretch of about 70 m with large blocks (Figure 4.64b and Figure 4.64c). The main slide scar, located on a rock spur, suggests that the slide was planar and occurred along a surface composed of a number of bedding joints dipping parallel to the slope. Bedding dip progressively increases from top to bottom of the slide scar (about 15°). The sliding surface is stepped both longitudinally and transversally (Figure 4.65a) due to well-spaced joints of two sets roughly striking parallel and normal to the slope. On the left side (viewing from the opposite, southwest, valley flank) the slide had no confinement. Bedding joints are relatively planar and smooth with apparent signs of weathering and oxidation (Figure 4.65b). Weathering seems to affect also the sub-vertical joints. The rock mass appears to be loosened and the rock material intensely fractured.

Figure 4.65. Close-range drone image of the detachment area (a) and detail of a bedding joint forming the sliding surface taken from the slide foot (b).

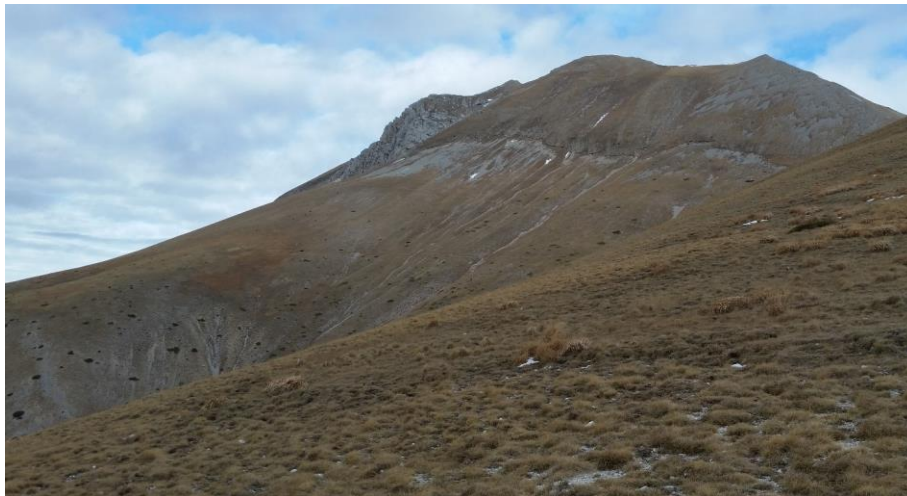
Figure 4.69 shows an image of the west flank of Mt. Vettore from the footpath. The fault can be seen as the linear feature that runs along the slope towards the large rock outcropping of Cima del Lago at the top left of the Massif in the image. Also seen are thick talus slopes below the fault. One of the key features that enables the distinction between faulting versus slope instability or talus compaction as the cause of the linear feature is the large fault offsets recorded at Cima del Lago. At Cima del Lago, limestone bedrock rises steeply to exposure at the surface. Below the limestone exposure is thick sediments without thick talus. At this location very few fissures, cracks, or scarps were identified aside from the fault trace. The only scarp lower on the slope at this location is the western trace of the Mt. Vettore fault, approximately half way down the face of the Massif to the Piano Grande plain below. No indications of slope instability, landsliding, or talus compaction were observed at Cima del Lago.

Figure 4.69. View of the east slope of Mt. Vettore showing talus slopes and fault rupture trace. Fault rupture displacements and strong ground shaking have caused densification and sliding of talus.

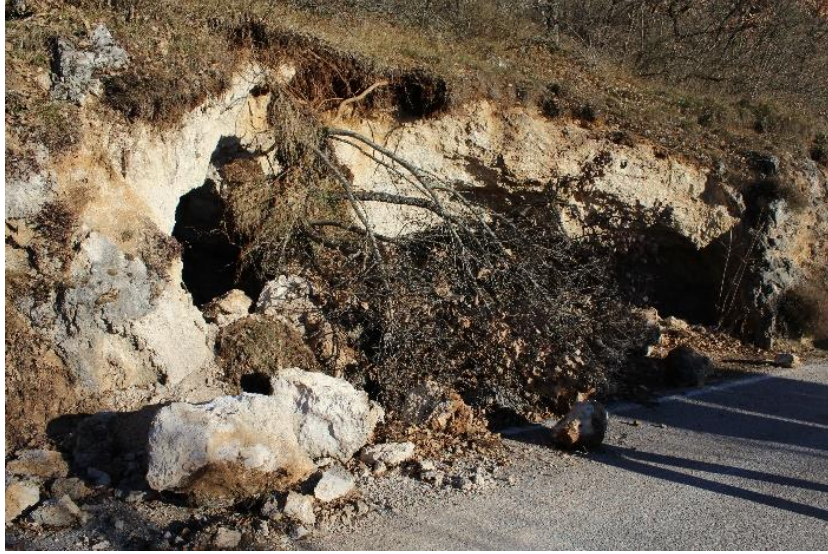
Figure 4.75. Rockfalls with boulders on the road.

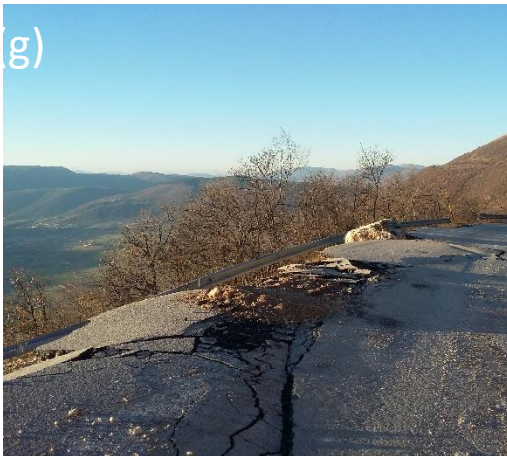
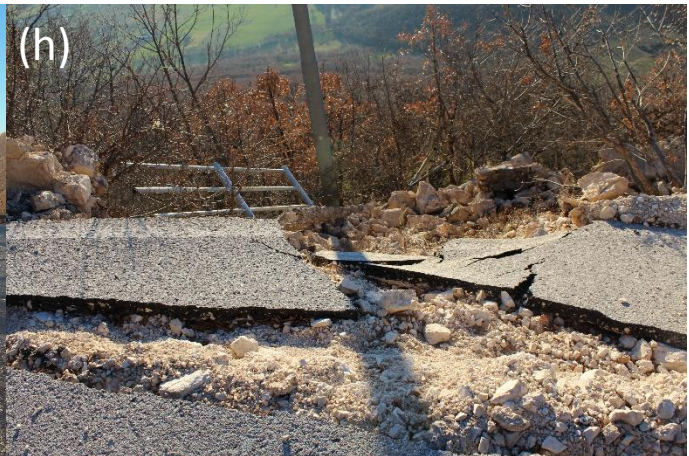
Figure 4.79. Fracture along the road, large vertical offset due to fracture and ultimate movement, damaged edge barriers and debris and boulders on the road surface.

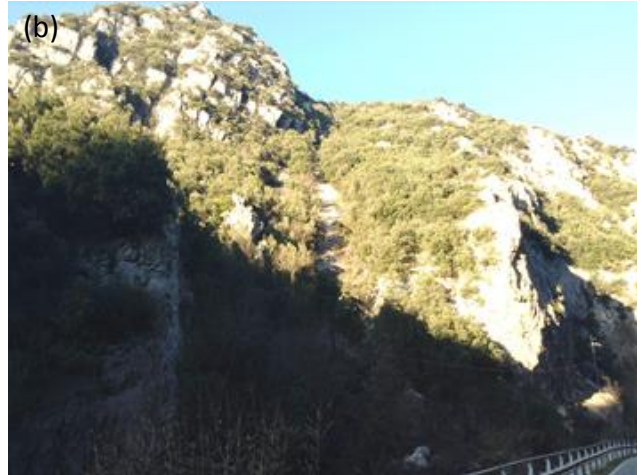
Figure 4.84. Debris occurred on the right bank of the Nera river along SP209 (lat 42.9157N, lon 13.0456E).

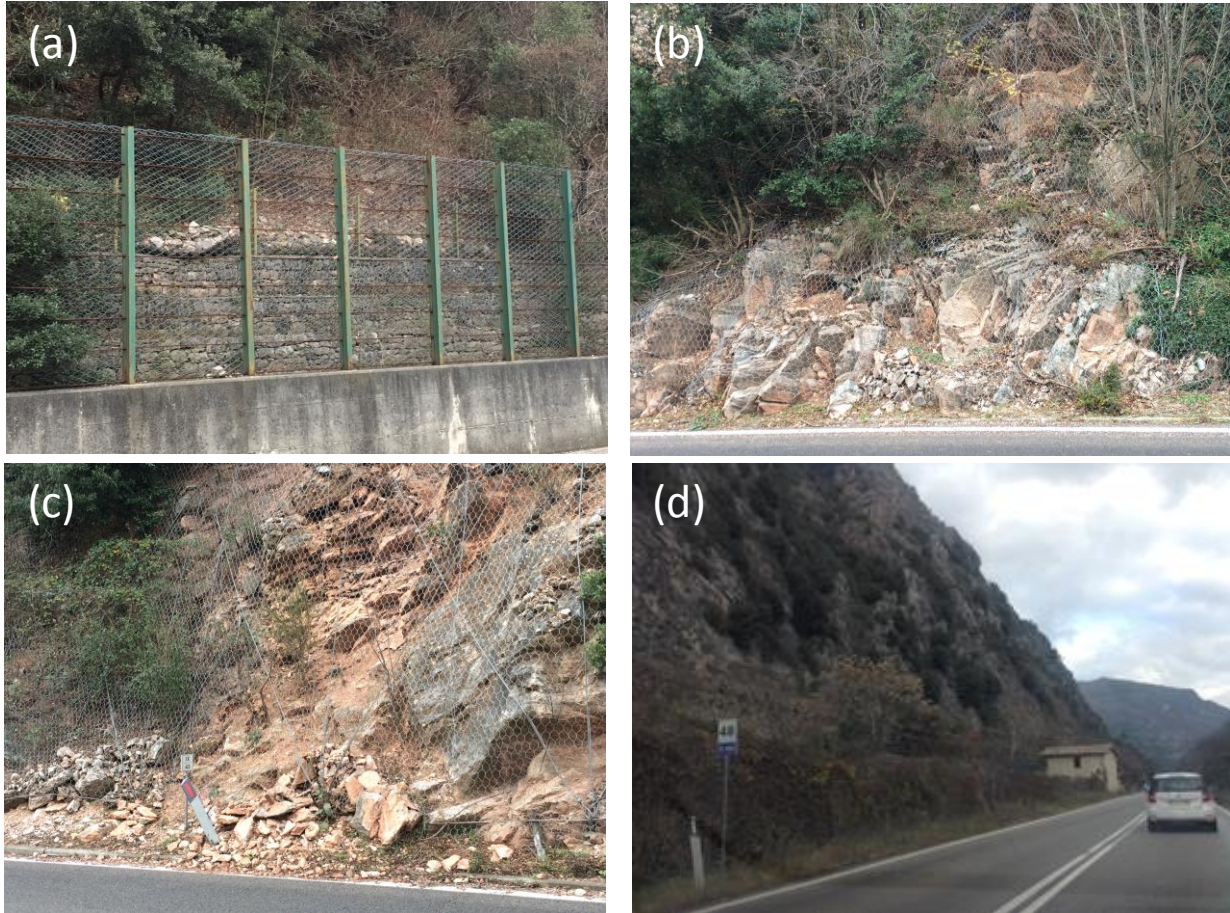
We observed several rock failures along the highway SS685 (also known as Tre Valli Umbre) between the villages of Piedipaterno and Borgo Cerreto (Figure 4.85). These features, shown in Figure 4.86, are mainly isolated rock falls having a volume ranging from a dozen of cubic centimeters to a few of cubic meters. The geology of the site is characterized by the presence of calcareous rock formations known as red flakes (*scaglia rossa*), and screes constituted by broken rock fragments variously sized. The IFFI landslide inventory (Figure 4.1b) classifies this area as subjected to widespread rock falls and slumps. We did not observe damages on the slope protections (i.e. rockfall nets, dynamic rockfall barriers or catch fences) present along the road.

Figure 4.86. Rockfalls between Piedipaterno and Cerreto along highway SS685.

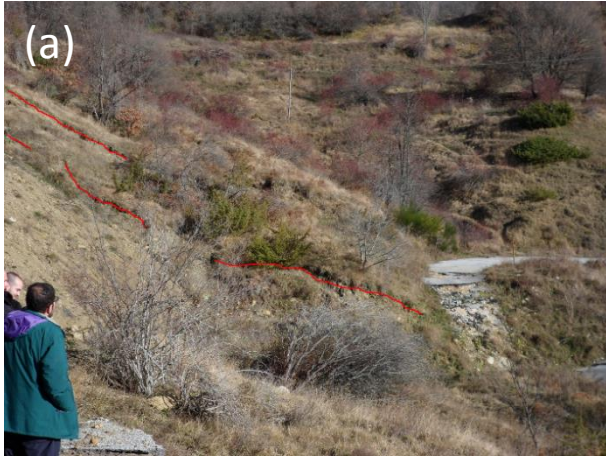
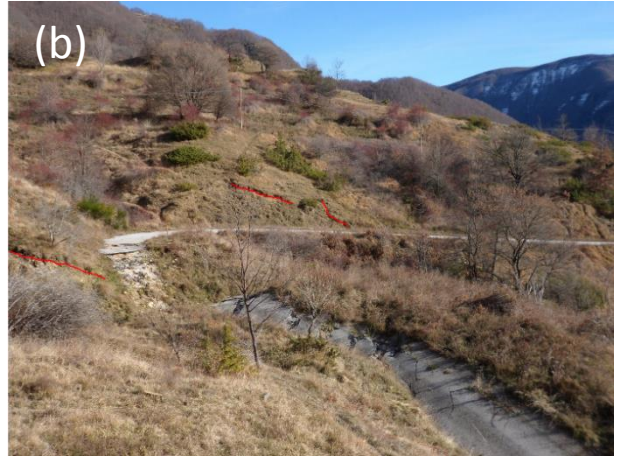
Figure 4.94. Fractures on the cut slope.

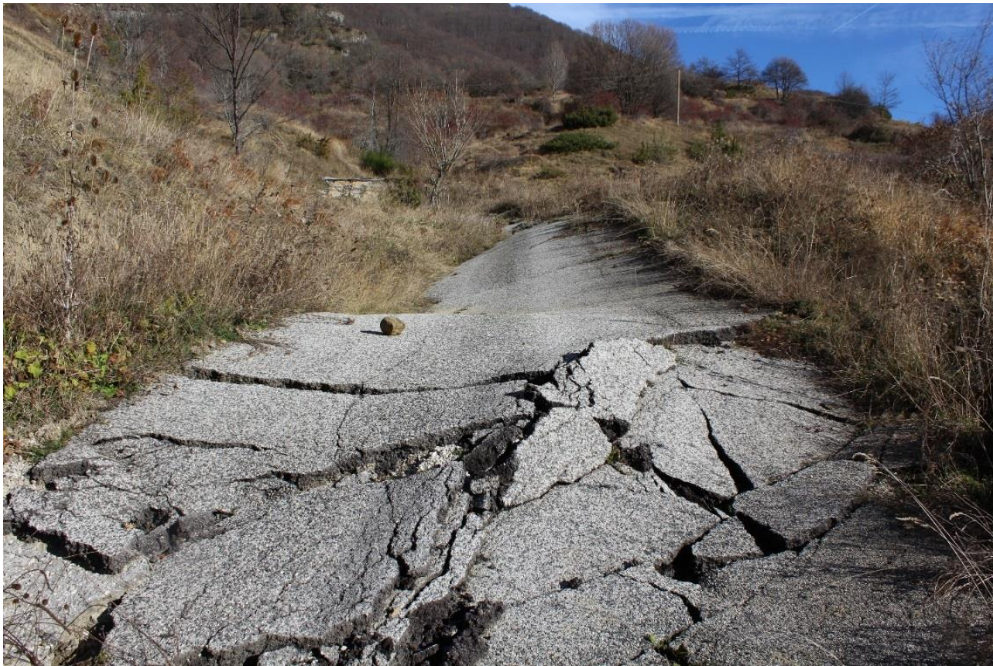
Figure 4.95. Damages along the road.

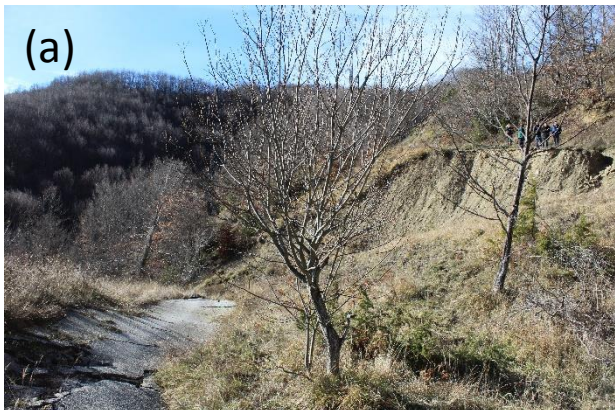
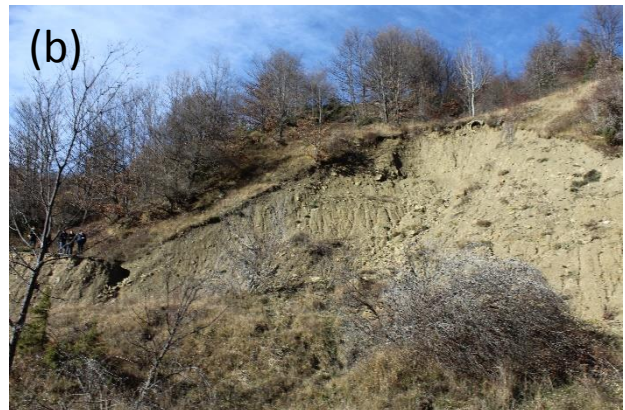
Figure 4.96. Minor scarps observed on the cut slope side of the road.

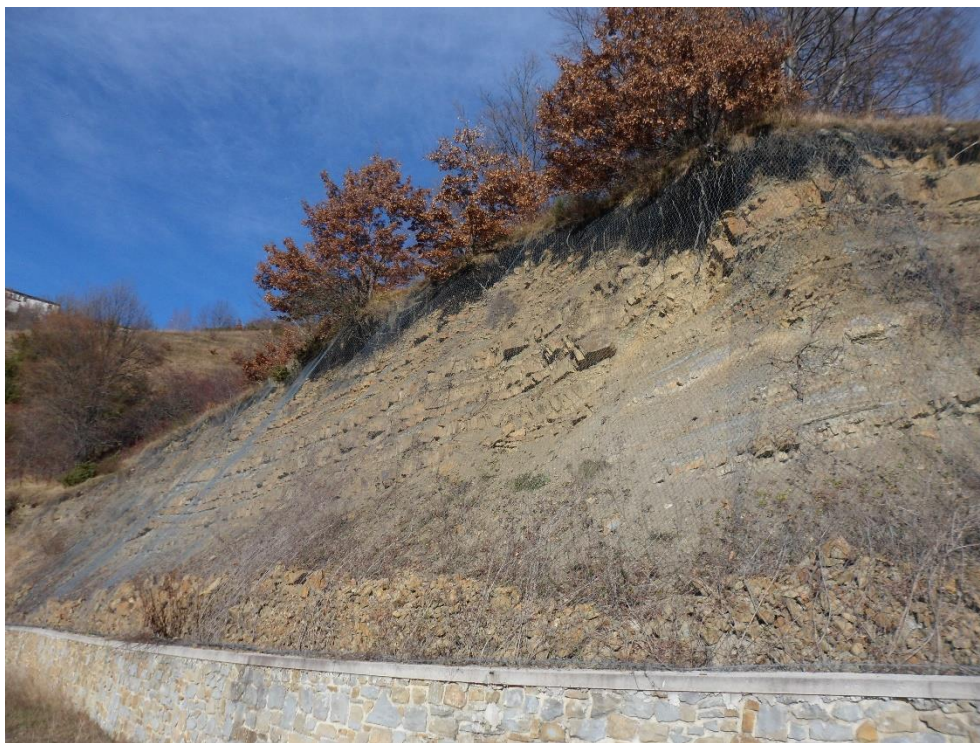
Figure 4.97. Rock-net protection with captured debris.

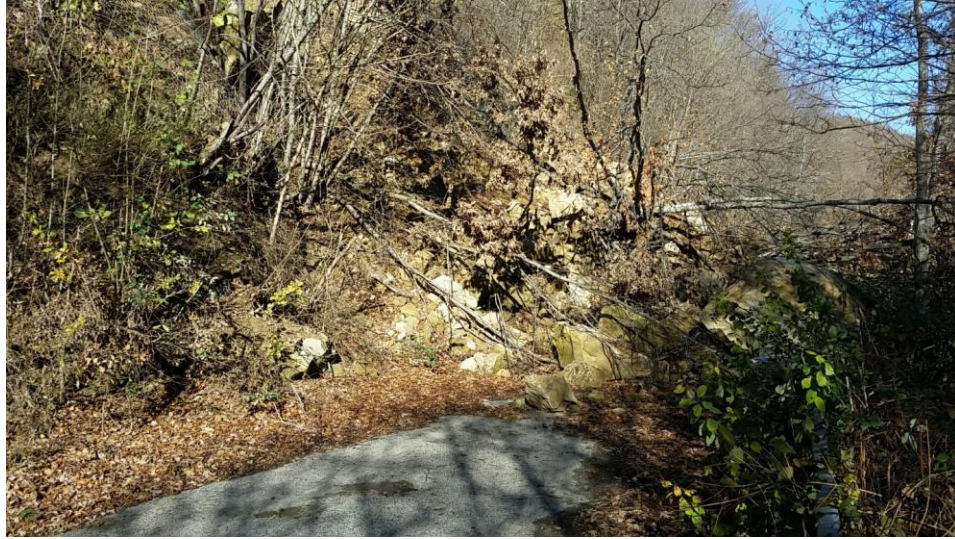
Figures 4.101 and 4.102 show the landslide. Several of the boulders from the landslide measured 2 m and appeared to be heavily weathered. Rock was limestone or dolomite (limited time at the site to assess rock type did not allow for more precise identification). Soil cover over the rock was thin (less than 30cm). The slide debris consisted of large amounts of vegetation, as would be expected given the heavy forestation of the slope. No seepage was observed at the bottom of the slide or within the slide mass. To the south and the north of the landslide the slopes are flatter (15° to 20°), while at the location of the slide, the inclination is approximately 34° as measured via a clinometer. Landslide width was estimated at 11 m.

Figure 4.101. Landslide debris covering the roadway. Boulders range in size up to 2 meters. Also pictured is rockfall netting used by local officials for minor rockfall control on the slope.

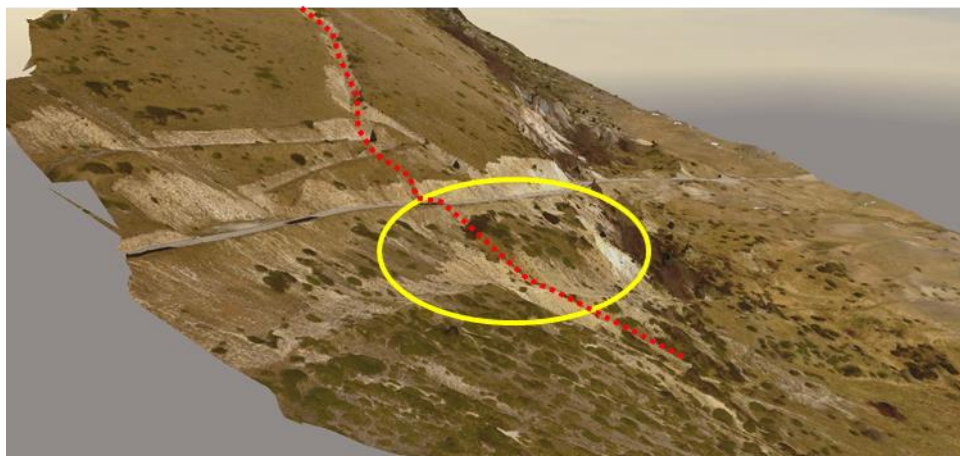
The fill embankment for Road SP477 running across the south face of Mt. Vettore was damaged in the 30 October event, occurring at the same location as the Mt. Vettore fault surface rupture (Figures 4.103 and 4.104). No reports of slope instability at this location were made following the 24 August event nor the 26 October event. Road embankment damage was parallel to the roadway, in the direction of the slope.

Figure 4.104. 3D SfM model of embankment fill damage area next to fault trace zone along SP477 road, Mt Vettore. Fill that has experienced 15 to 20cm lateral displacement circled in yellow. Observed fault rupture trace shown in red.

We visited the fault rupture and observed the embankment slope damage after documenting surface fault rupture offset. At the location of the SP477 road, strike displacements on the Mt. Vettore fault (in the direction of the embankment displacement down slope) were observed to be zero. Therefore, the GEER team concluded that the roadway embankment damage was from slope displacements rather than lateral fault rupture. Lateral displacement of the slope was estimated at 15cm to 20cm. Cracking parallel to the road along the top of the embankment is seen in Figures 4.105 and 4.106. The total height of the embankment slope was measured at 25-35 m from 3D SfM model (Chapter 2) for the south face of Mt. Vettore. The embankment fill

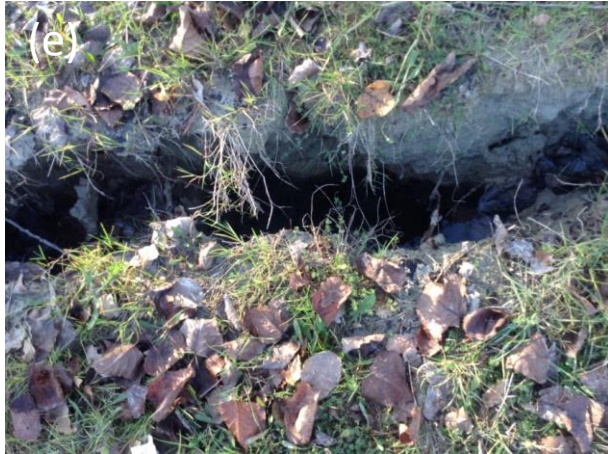
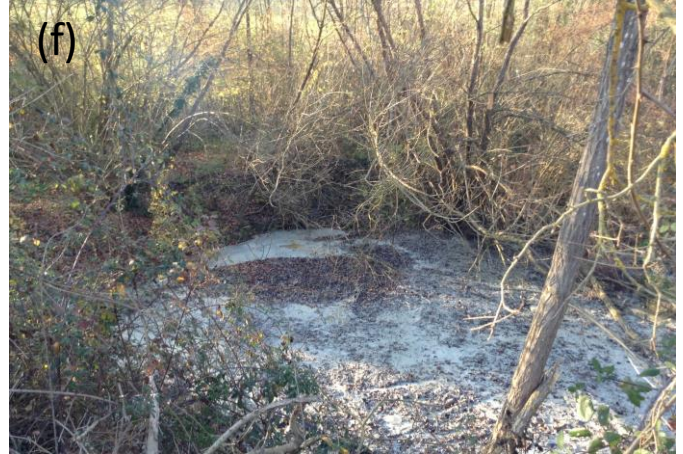
We inspected two mud volcanoes that erupted within one day from the **M6.5** 30 October earthquake event (Figure 5.3): (1) Santa Maria in Paganico (Figures 5.4a-b) and (2) Valle Corvone (Figures 5.4c-d-e-f). In both cases, we observed fresh deposits of ejected material. Both eruptions, are located within 45 km from the epicenter. . During our reconnaissance activities, both mud volcanoes showed a reduced activity, with a small emission of water. We inspected the sites about one month after the INGV reconnaissance mission. We did not detect any new activity or variations in the soil surface conditions in the inspected area as shown in Figure 5.5. As shown in Figure 5.4c-d-e-f, the material erupted by the mud volcano located in Valle Corvone covered a wide area involving both the river and the pavement of the road. This mud volcano is characterized by radial fractures 140 cm long, 38 cm wide and 80 cm deep. This eruption partially blocked the Ete river's course (Figure 5.4f).

Figure 5.4. (a) overview of the mud volcano in Santa Maria in Paganico; (b) sampling activities in in Santa Maria in Paganico; (c) crack originated by the mud volcano in Valle Corvone, (d) mud volcano in Valle Corvone, (e) details of a crack in Valle Corvone, (f) close-up view of the material ejected in the Ete Vivo river (Valle Corvone).

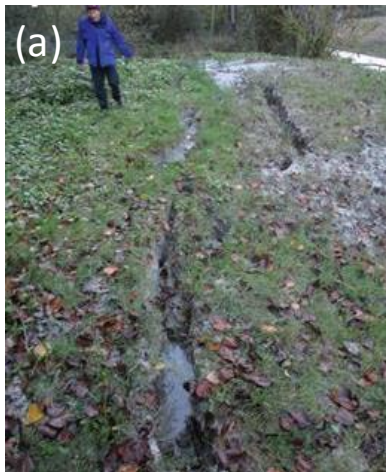
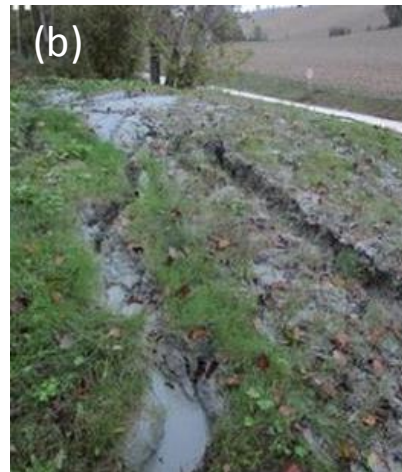
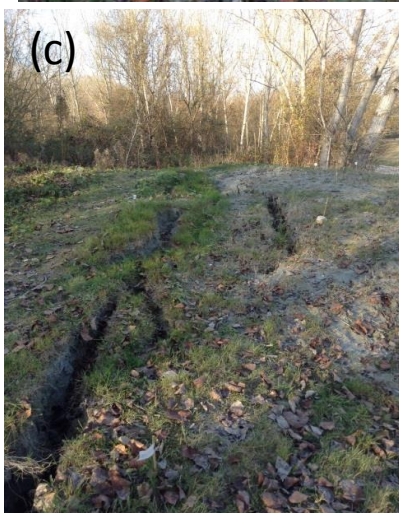
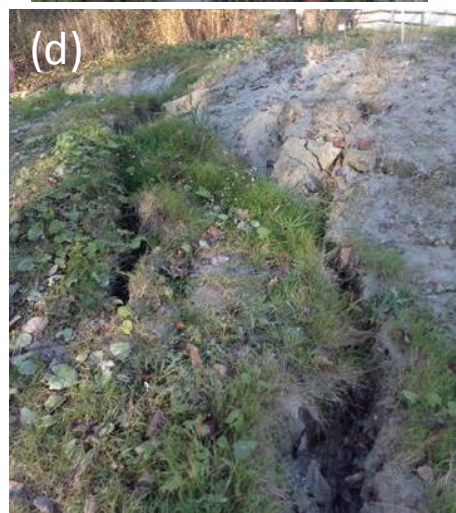
Figure 5.5. (a) and (b) photos of the mud volcano in Valle Corvone taken by INGV in November 2016 (INGV, 2016); (c) and (d) photos of the mud volcano in Valle Corvone taken from a common perspective by GEER in December 2016.

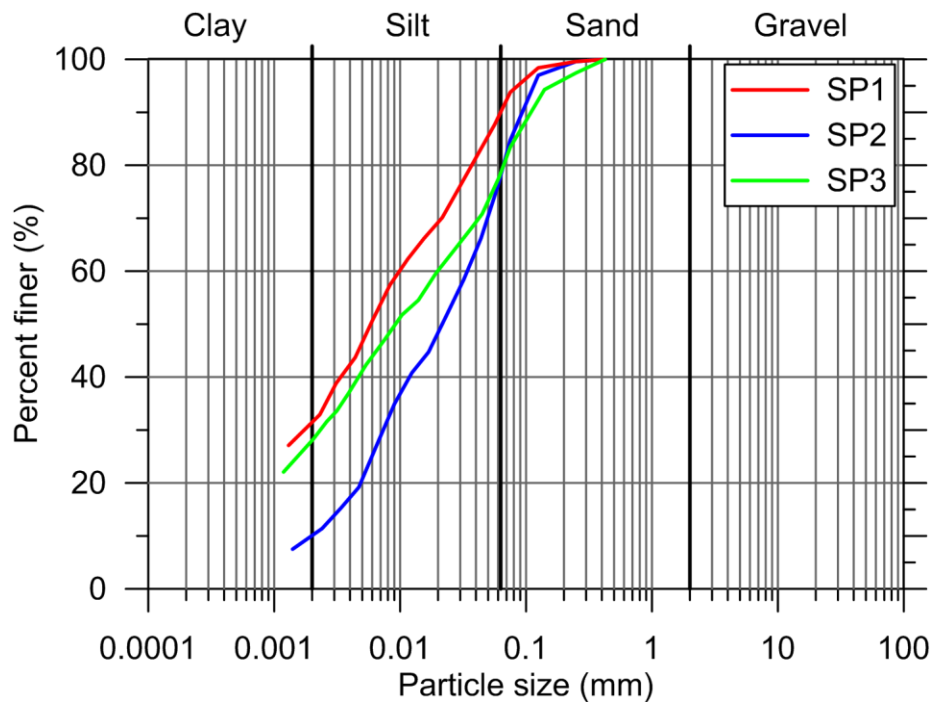
Figure 5.6 shows the particle size distribution for samples SP1 (Santa Maria in Paganico) and SP2 (Valle Corvone). The soil in sample SP1 is constituted of 57.4% brown silt, 31.6% clay and 11.0% sand. The fine-grained soil exhibits a liquid limit $LL = 47.5\%$, a plastic limit $PL = 17.8\%$, and a plasticity index $PI = 29.7\%$. The plasticity chart (Figure 5.7a), shows that the soil of sample SP1 can be classified as inorganic clay (CL) or organic silts and clays of low plasticity (OL). For SP1, the activity of clay is 0.94 and is therefore defined as normal (Figure 5.7b). The values of the Atterberg limits are representative of clayey soils for SP1. For SP2, the silt fraction is 66.2%, the sand fraction is 23.7%, and the clay fraction is 10.1%. The Atterberg limits for SP2 are $LL = 30.7\%$, $PL = 18.7\%$, the plasticity index is equal to 11.9% and the fine-grained soil can be classified as inorganic clay (CL) or organic silts and clays of low plasticity (OL). The activity of clay for SP2 is normal (Fig. 5.7b). The Atterberg limits for SP2 are typical of silty soils

Figure 5.6. Particle size distributions of the mud volcano soils in Monteleone di Fermo and Santa Vittoria in Matenano.

We sampled soil erupted from the volcano in Santa Vittoria in Matenano (SP3). This sample was taken on 16 November, 2016. On this sample, we performed sieve analysis, along with Atterberg limits. Figure 5.6 shows the particle size distribution for samples SP3. It is consistent with those observed for the mud volcanoes in Monteleone di Fermo. The fine-grained soil exhibits a liquid limit $LL = 33.0\%$, a plastic limit $PL = 16.0\%$, and a plasticity index $PI = 17.0\%$. The plasticity chart (Figure 5.7a), shows that the soil of sample SP3 can be classified as inorganic clay (CL). The clay can be classified as inactive (Figure 5.7b).

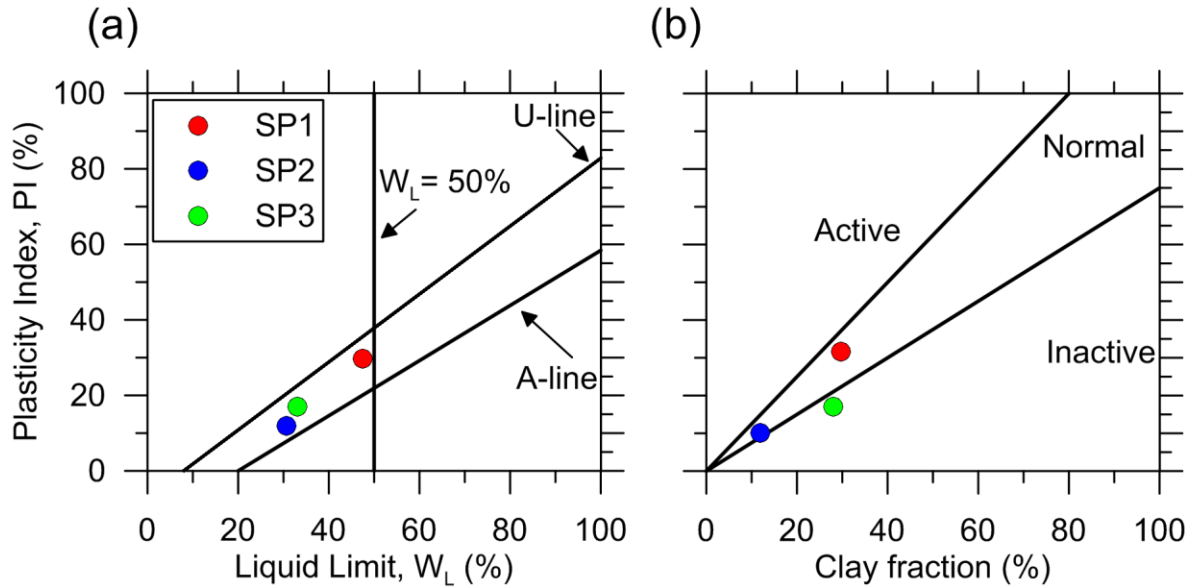
Figure 5.7. (a) Plasticity chart and (b) activity chart of the mud volcano soils in Monteleone di Fermo and Santa Vittoria in Matenano.

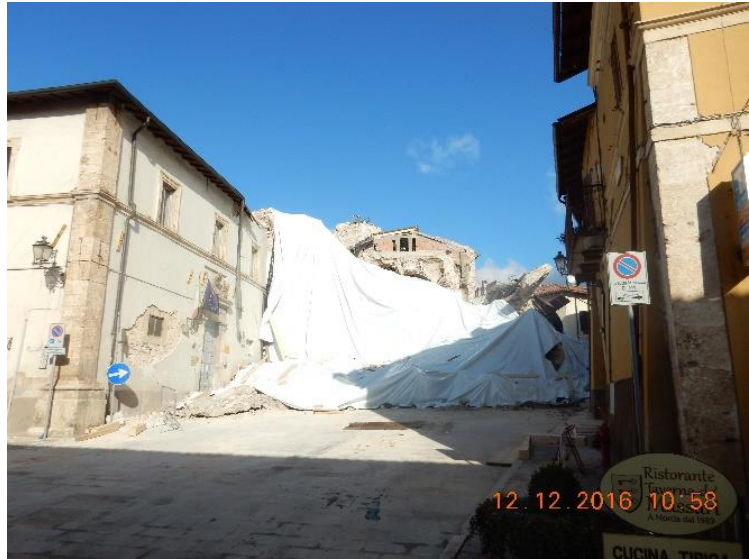
Figure 6.4. Building M1.

Apart from the wider assessment, a side-by-side comparison of significant structures with multi-epoch surveys is made. Figure 6.3 depicts the locations of the buildings presented. Figure 6.4 illustrates one of the churches that were slightly damaged by the first seismic event, but completely collapsed subsequently. Many historical churches in Norcia experienced the same kind of damage evolution. Figure 6.5 shows one exceptional case of a typical residential masonry building where the evolution of damage was rather moderate (damage state shifting from DS2 to DS3). Conversely, Figure 6.6 shows a residential building with irregular masonry construction. This group of buildings experienced an abrupt damage evolution, with an out-of-plane mechanism and increased in-plane damage. Finally, Figure 6.7 depicts the out-of-plane failure of an historical monastery leading to partial loss of support of the roof. Notably, the wall failure was concentrated at a level higher to that of the seismic retrofit, thus highlighting that local interventions should not be only localized on the ground level but also take into consideration the reduced axial load and weak diaphragm action of the masonry walls at higher levels.

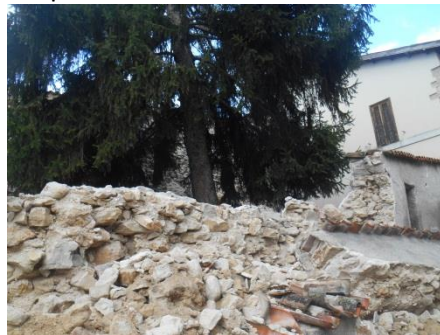
N. 8 Collapsed wall

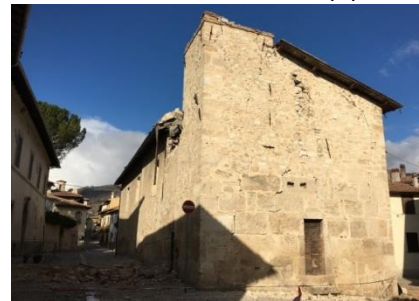
N. 21 Collapsed church (1)

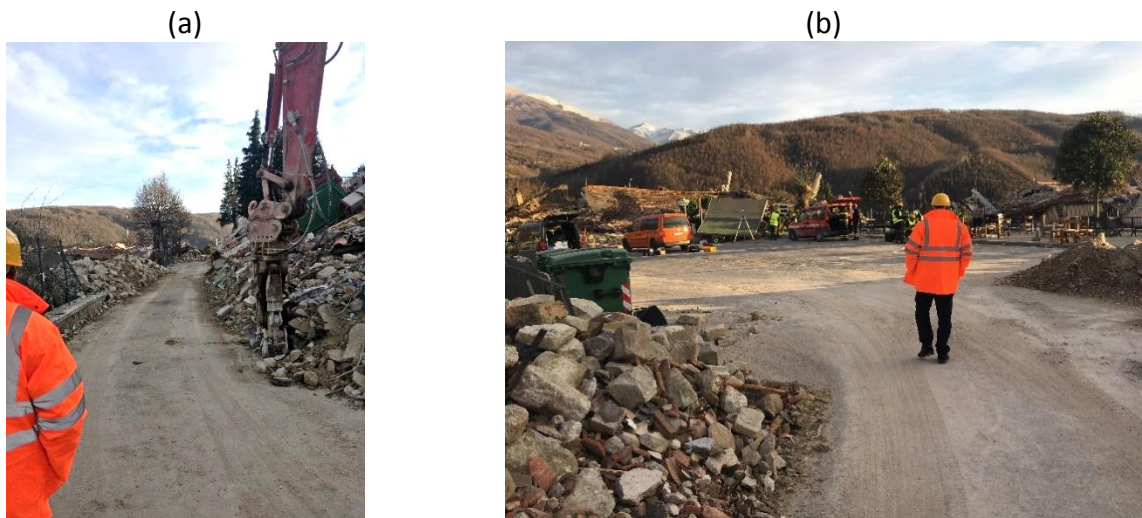
At the time of the visual inspection by the GEER team, the only accessible walking route was the one connecting the village entrance to the main square, because of the major building damage and collapse in the surrounding areas (Figure 6.20). As a result, a detailed inspection was feasible only within the eastern part of the village, the western part being inspected by means of UAVs. Figure 6.21, Figure 6.22, and Figure 6.23 illustrate the upper part of the village with a colored scale distinguishing three main zones of distinct level of damage.

Figure 6.20. (a) Access route to the lowest (easternmost) portion village (V1). (b) Piazza San Francesco (V2).

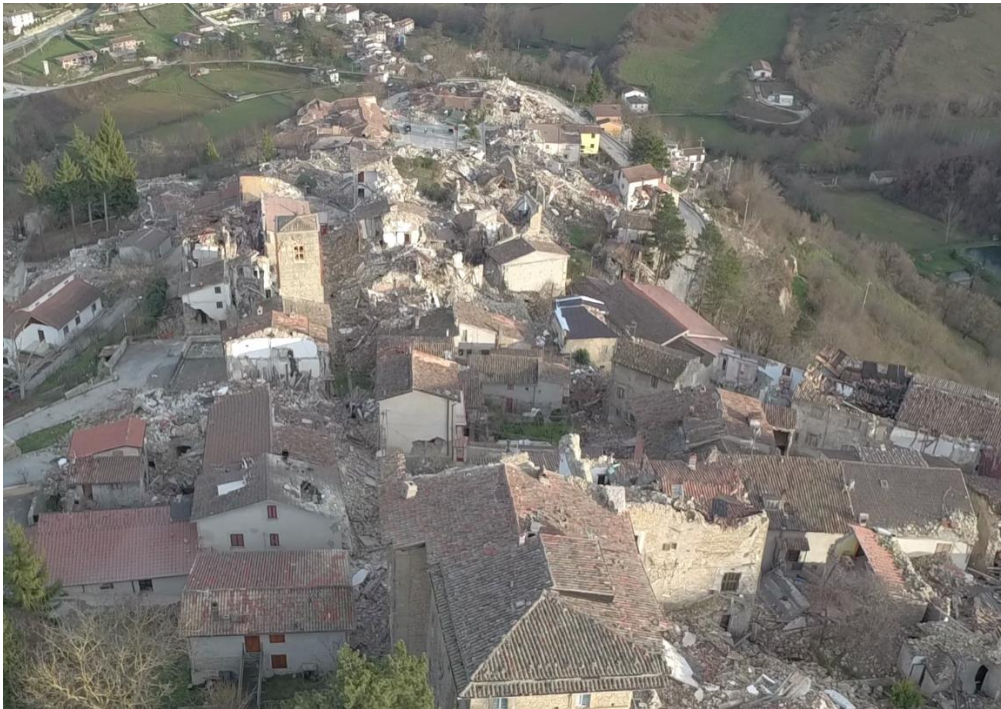
Figure 6.22. Aerial view, west-east direction (V4).

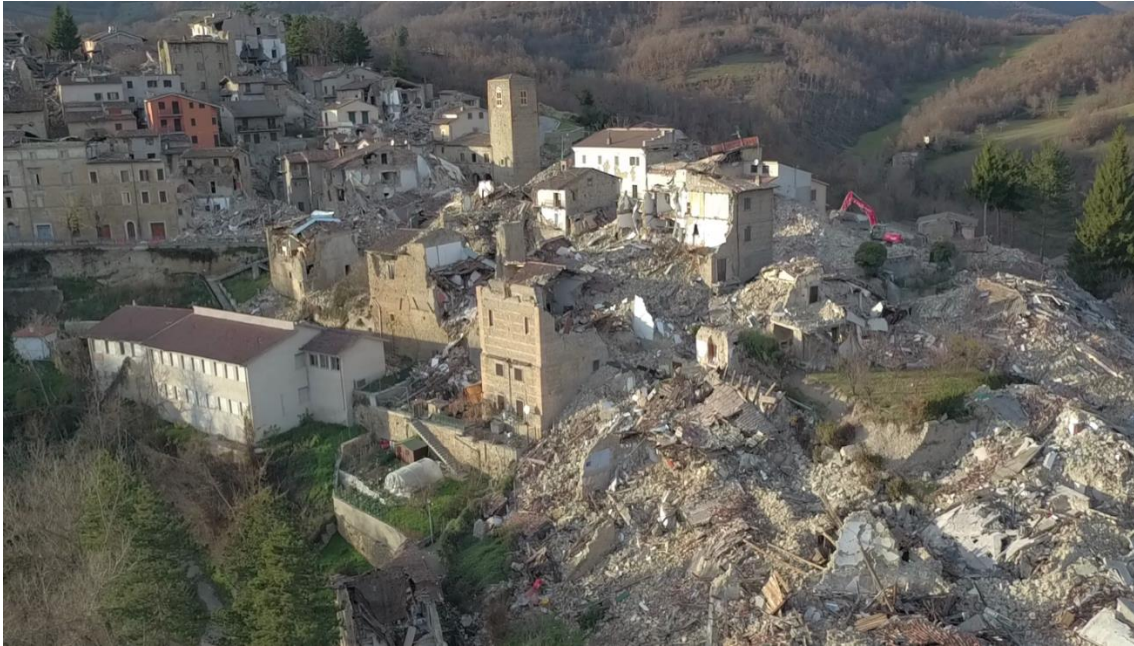
Figure 6.23. Aerial view, south-north direction (V5).

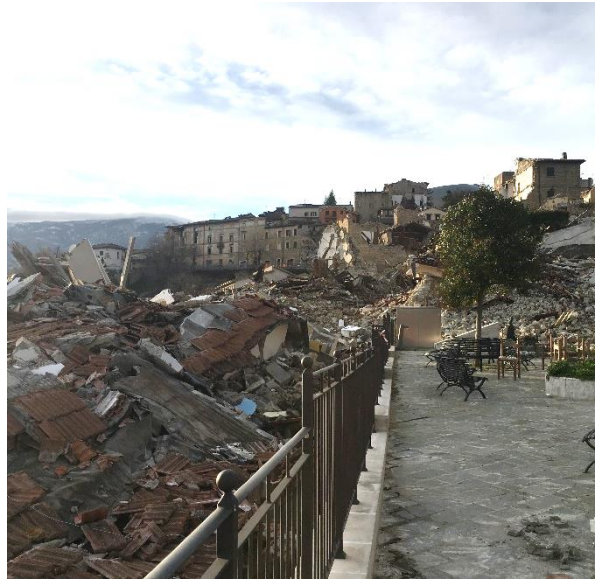
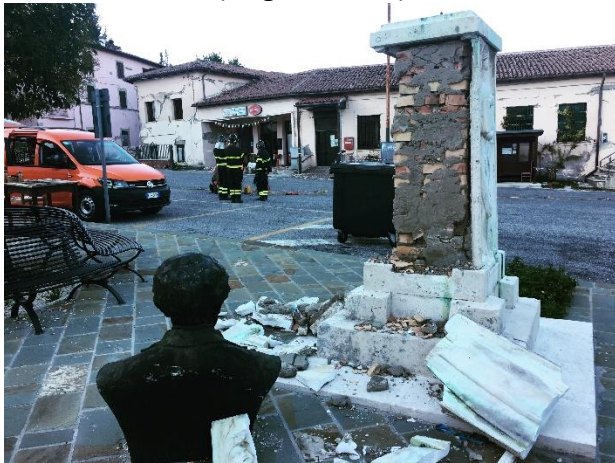
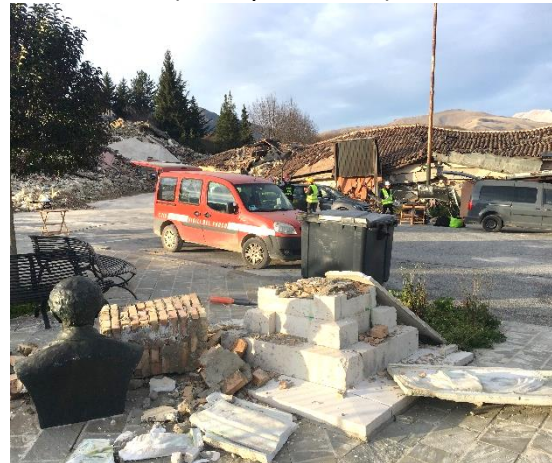
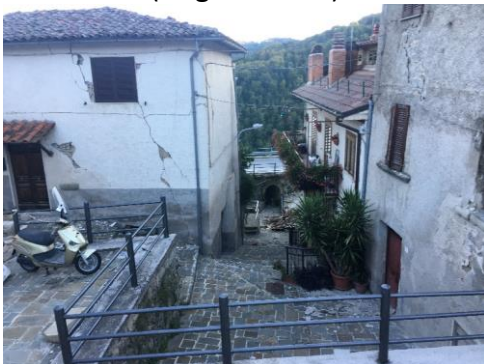
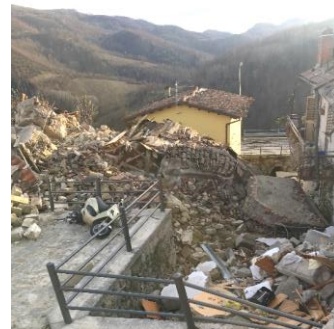
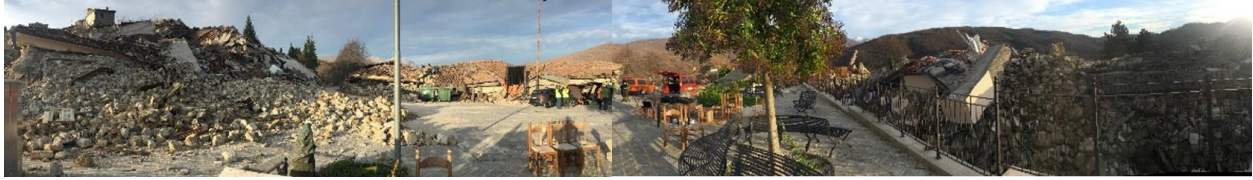
The current orthophoto of the village is presented in Figure 6.24 with the location and orientation of pictures depicting multi-epoch damage states for individual structures. Further details are summarized in Table 6.2 to document the photographed structures and to compare the damage levels detected after the September and December visual inspections. Figure 6.25 shows photos presented in Table 6.2.

Figure 6.25. Representative pictures taken in Accumoli during the GEER survey (see Table 6.2).

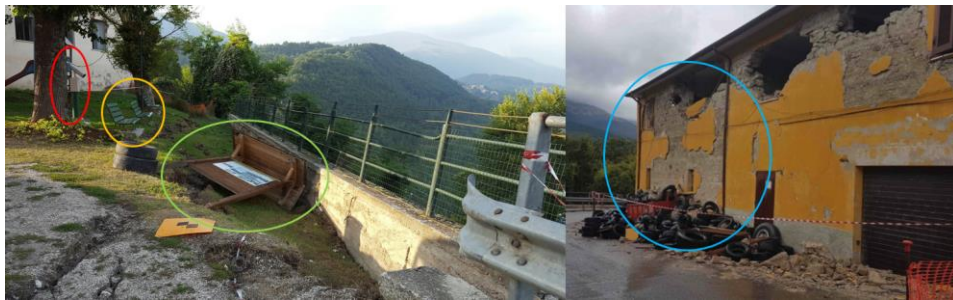
The accumulation of damage across seismic events is also evident by comparing the panoramic view of the village after the September and December field missions (Figure 6.26 and Figure 6.27). More precisely, it is seen that the retaining wall completely overturned, causing disruption of the adjacent road. It is noted that it was not possible to take the pictures from the same position, hence, colored circles are used to indicate the corresponding spots.

Figure 6.26. Representative pictures of landslide in eastern part of village (September 2016).

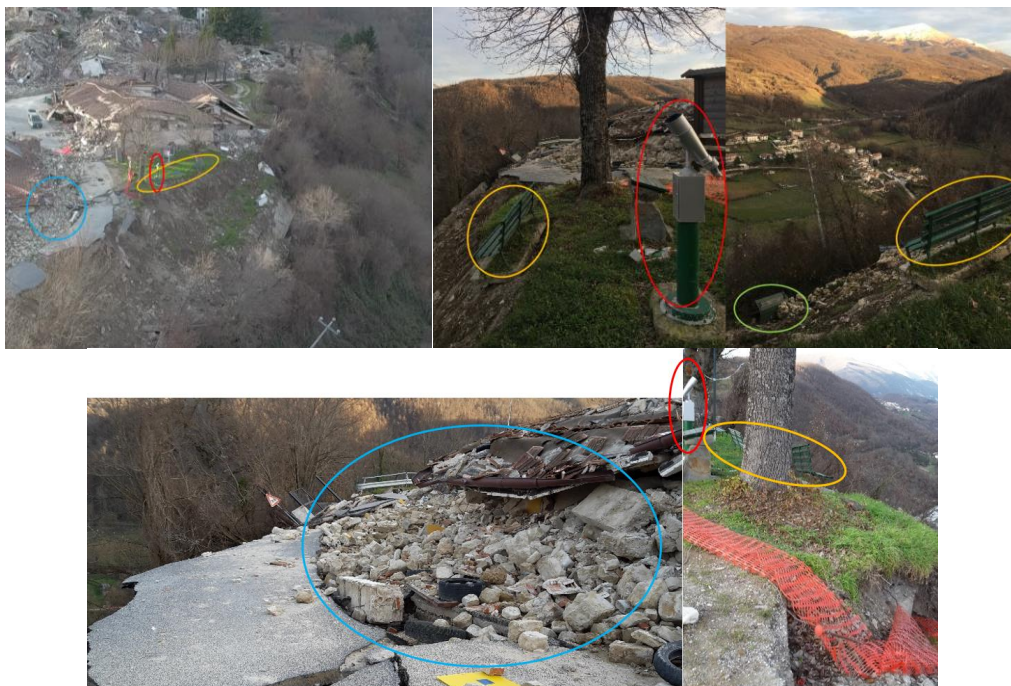
Figure 6.27. Representative pictures of landslide in the eastern part of village (December 2016).

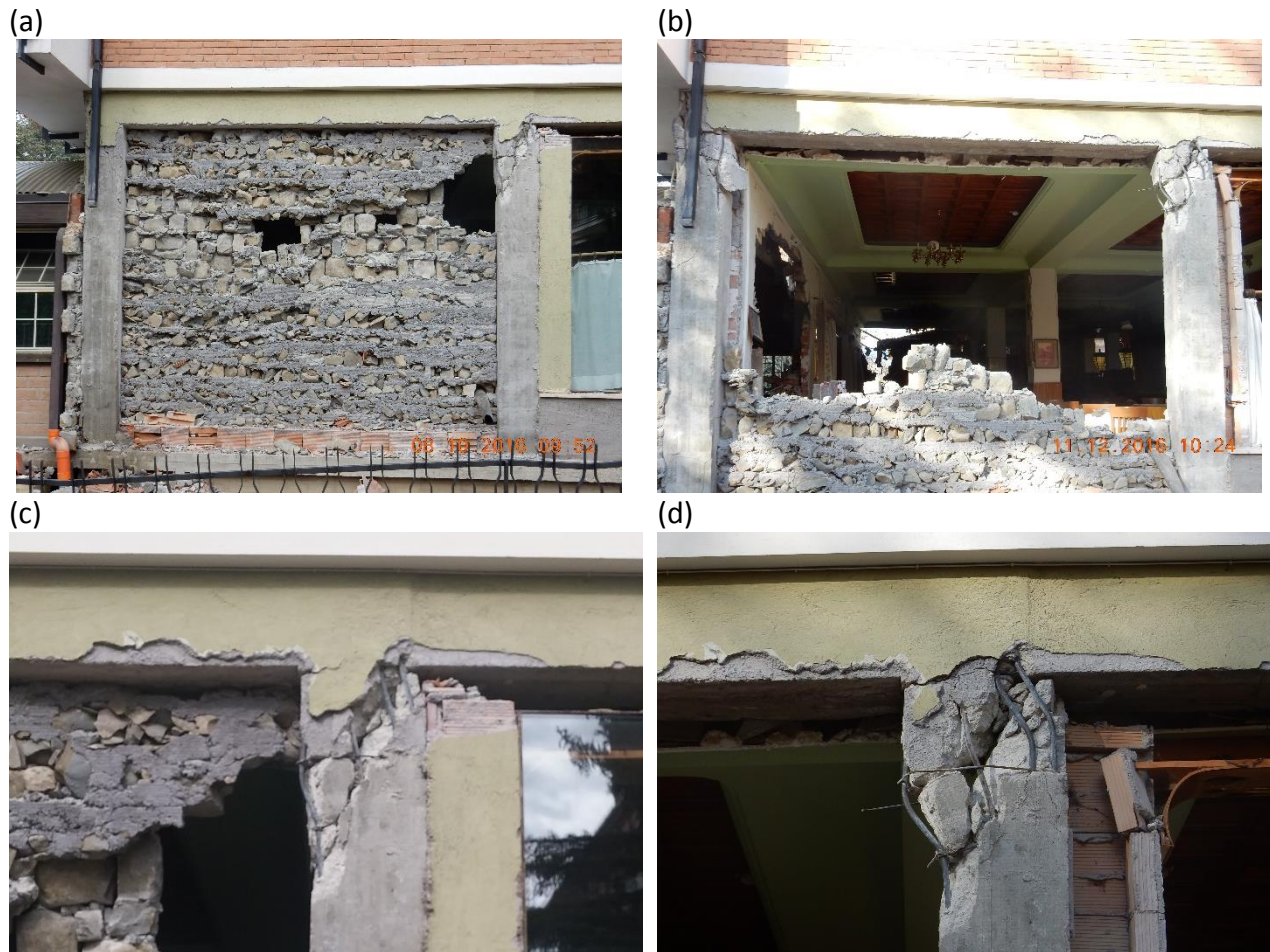
Figure 6.37. Building RC1.

Figure 6.37 illustrates building RC1 in the aftermath of the first event (a,c) and after the October sequence (b,d). It is evident that the infill panel has failed out-of-plane after the seismic sequence (but not after the first main shock), whereas the shear failure at the top of the right column has been clearly pronounced. Figure 6.38 depicts building RC2, a dual shear wall – moment resisting frame built with the older Italian seismic code (The Italian National Annex DM 1996, Norme Tecniche per le Costruzioni, 1996; NTC96). Similar out of plane failure of the,

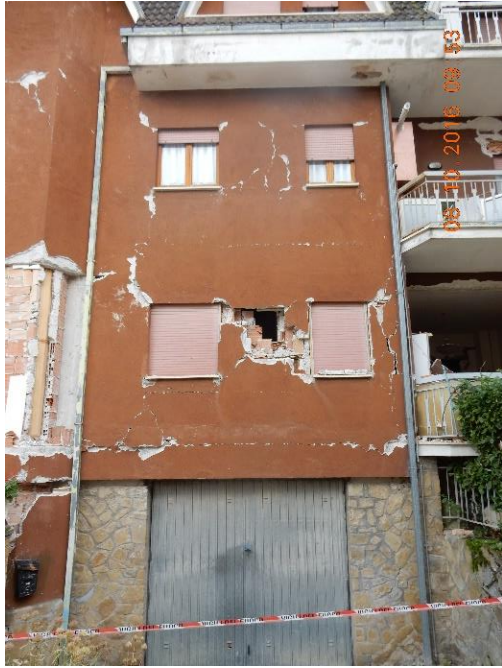
Figure 6.38. Building RC2.

initially diagonally cracked, infill panel is again observed as a result of shaking from multiple events. A detail of beam-column joint damage is illustrated in Figure 6.39 for building RC3. We observe cyclic degradation of column top, spalling of concrete, and minor longitudinal rebar buckling in the absence of adequate transverse reinforcement. Finally, building RC4 in Figure 6.40 experienced only minor damage after the August event but suffered out-of-plane failure of the majority of its infill panels subsequently, thus exposing the structure to a potential soft story mechanism. Performance of this type was characteristic of the area.

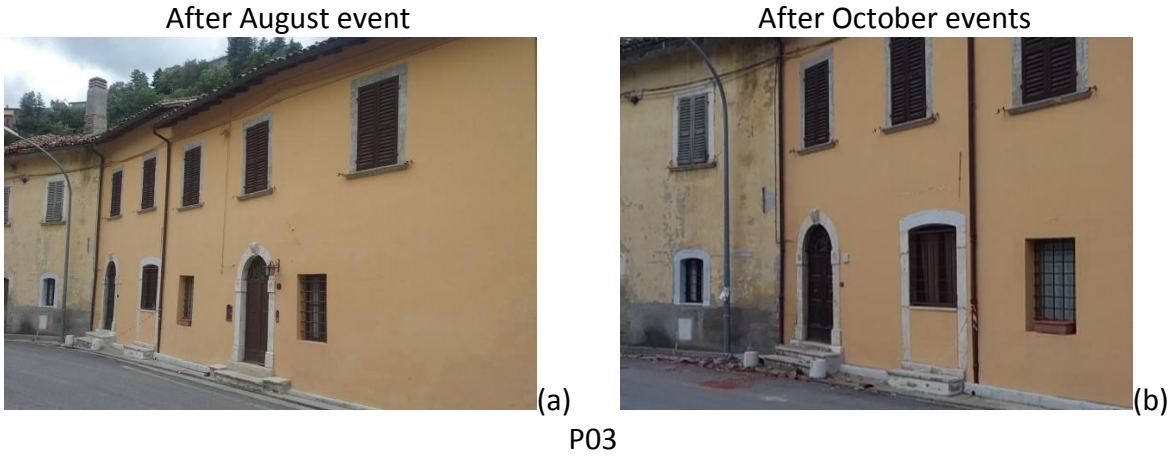
The photographs in Figure 6.48 show Arquata del Tronto after the August and October events, from which a substantial damage increase is evident following the 26 and 30 October earthquakes. Conversely, Borgo did not suffer appreciable cumulated damage, as shown in Figure 6.49 and Figure 6.50. Figure 6.51 shows the collapse of a structure onto the access road for Arquata village. At the time of our November reconnaissance, the village was not accessible and much of the village center was destroyed. The damage level assigned to Arquata del Tronto

Figure 6.49. A reinforced masonry building in Borgo (a) after the 24 August earthquake, and (b) after the October events.
