Engineering Reconnaissance Following the October 2016 Central Italy Earthquakes *Version 2*

GEER Team Leaders: Jonathan P. Stewart and Giuseppe Lanzo

Geotechnical Extreme Events Reconnaissance Association
Report No. GEER-050D
8 May 2017

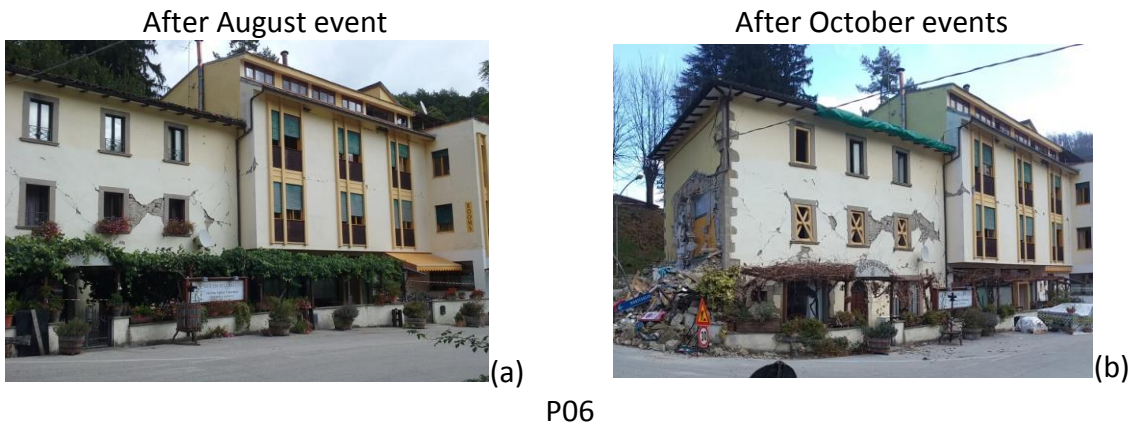
The photographs in Figure 6.48 show Arquata del Tronto after the August and October events, from which a substantial damage increase is evident following the 26 and 30 October earthquakes. Conversely, Borgo did not suffer appreciable cumulated damage, as shown in Figure 6.49 and Figure 6.50. Figure 6.51 shows the collapse of a structure onto the access road for Arquata village. At the time of our November reconnaissance, the village was not accessible and much of the village center was destroyed. The damage level assigned to Arquata del Tronto

Figure 6.50. A building in Borgo (a) after the 24 August earthquake, and (b) after the October events.

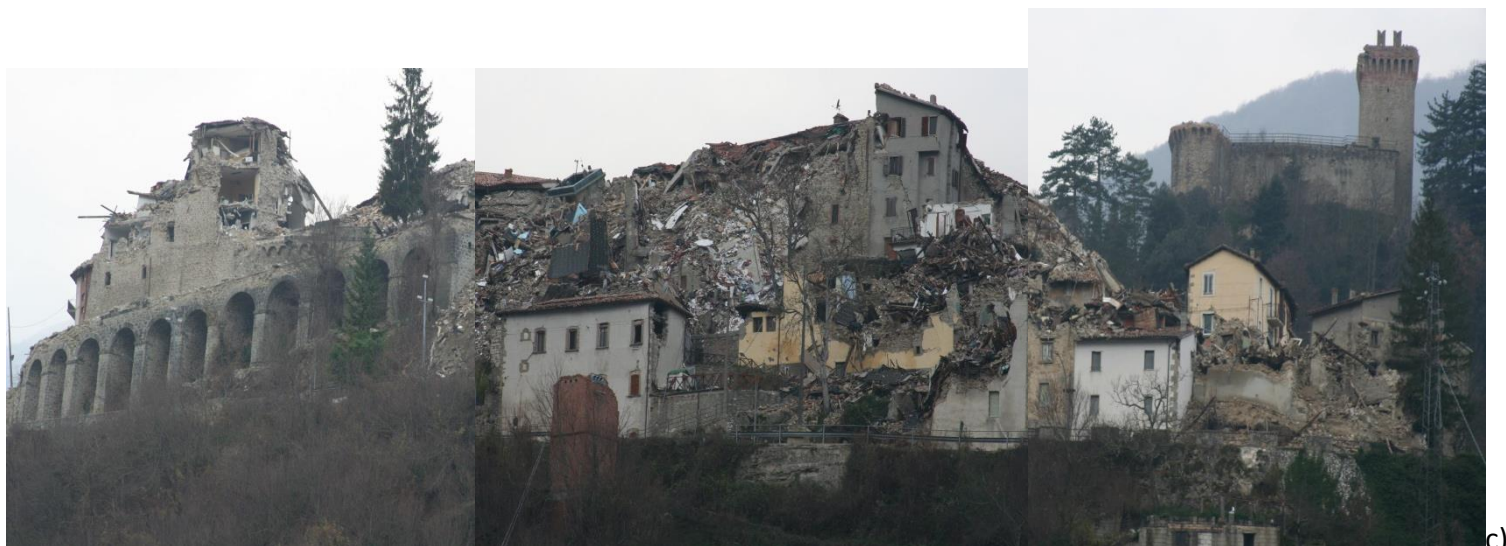
(D5) is documented in Figure 6.52. Table 6.3 shows the locations and damage levels for all selected representative structures.

Figure 6.52. Overview of the damage level in Arquata del Tronto after October events.

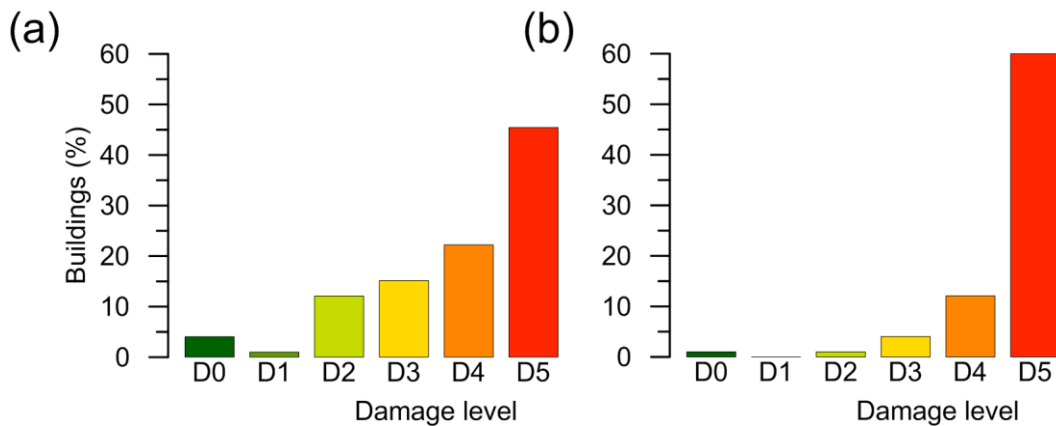
Figure 6.53. Mapped damage levels in Pescara del Tronto: (a) after the 24 August, and (b) the October events.

Pescara del Tronto was devastated by the 24 August earthquake (GEER 2016), with nearly half of the structures having collapsed. Figure 6.53 and Figure 6.54 show the evolution of damage from the August (Figure 6.53a and Figure 6.54a) to the October events (Figure 6.53b

and Figure 6.54b). Damage levels in Pescara del Tronto increased as a result of the October events, with approximately 70% of the structures having damage levels D4 or D5 (was 65% following August events).

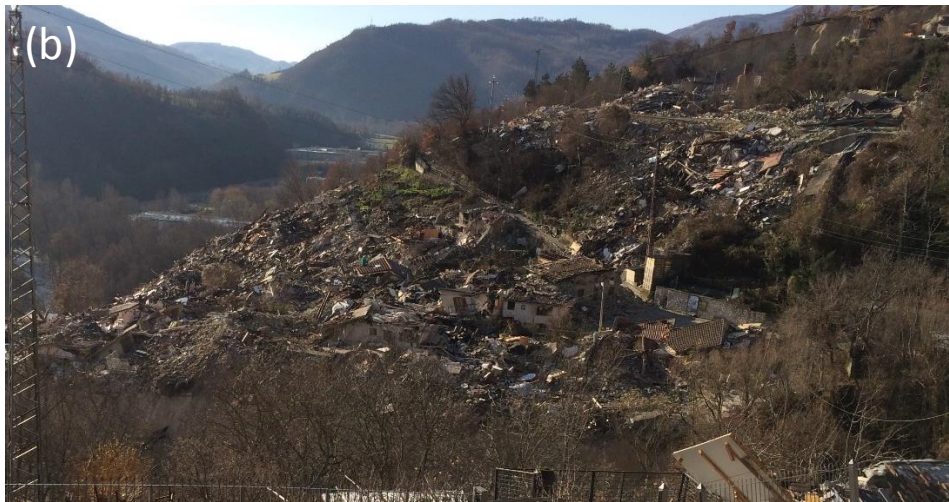
Figure 6.55 shows locations of selected buildings for which we show photos taken after the August and October events. The cumulative damage is also evident from Figure 6.56. Figure 6.57 shows a photographic overview of the hamlet taken from a common perspective after the August and October events. Figure 6.58 shows screenshots captured from 3D models created from images taken by UAVs. Table 6.4 summarizes locations and damage levels for all selected representative structures.

Figure 6.57. Overview of Pescara del Tronto from a common perspective (a) after the 24 August earthquake, and (b) after the October events.

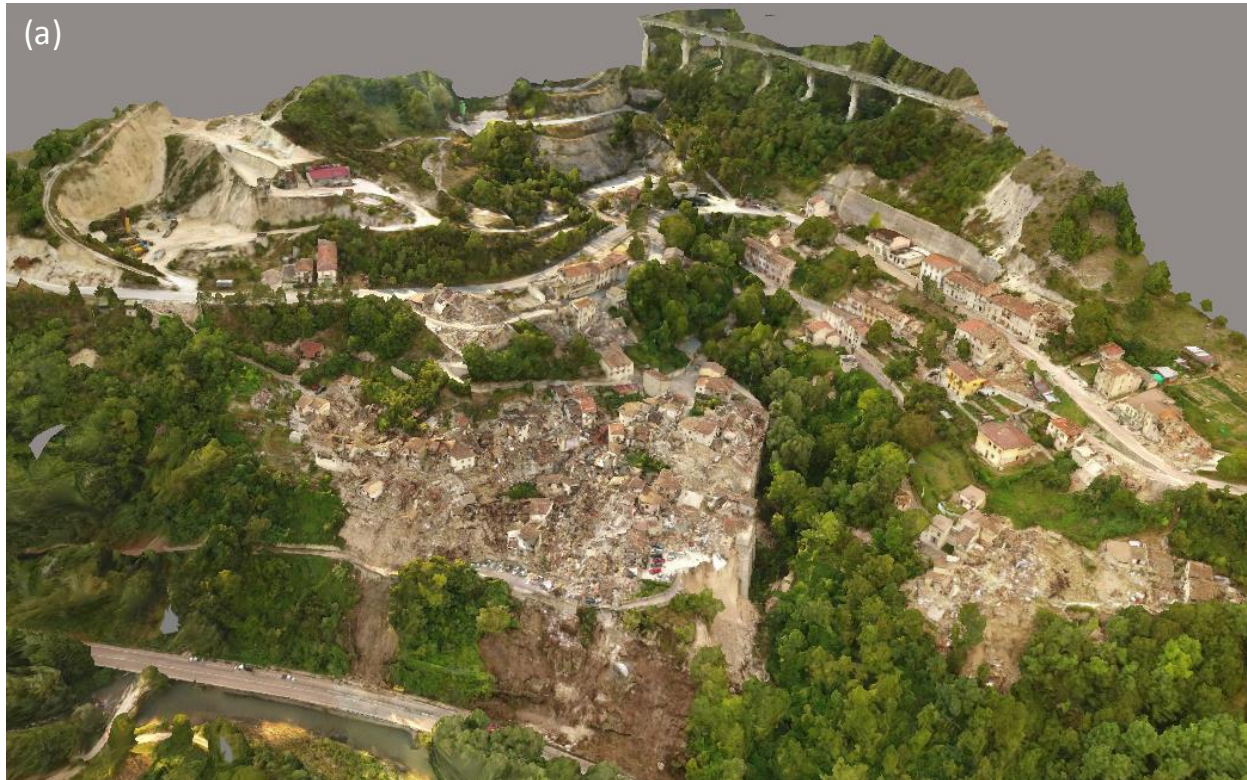
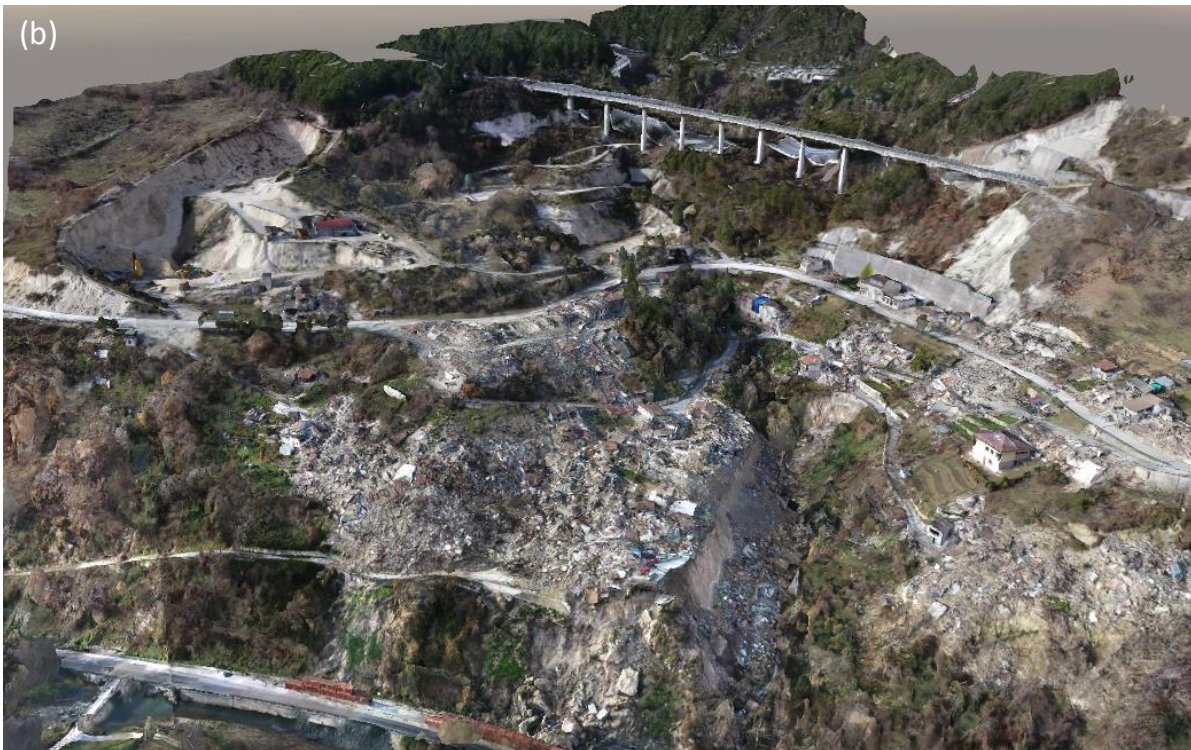
Figure 6.58. 3D-model overview of Pescara del Tronto from a common perspective (a) after the 24 August earthquake, and (b) after the October events.

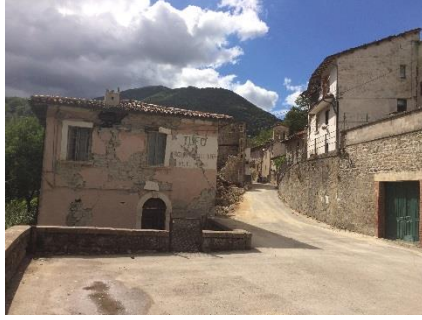
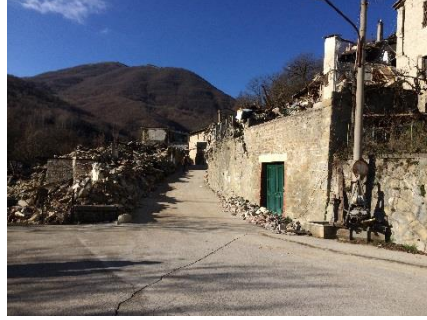
Picture	DATUM	Description	Location		September Damage Level	December Damage Level
			Lat.	Long.		
P1	WGS-84	Entrance of the historical center (M2-M3)	42.7353°	13.2532°	D3	D5
P2	WGS-84	Masonry buildings (M4)	42.7354°	13.2528°	D1	D5
P3	WGS-84	Reinforced concrete building (RC1)	42.7351°	13.2519°	D0	D2
P4	WGS-84	Santissima Maria Annunziata Church (M1)	42.7351°	13.2522°	D0	D3
P5	WGS-84	Santissima Maria Annunziata Church (M1)	42.7351°	13.2522°	D0	D3
P6	WGS-84	Santissima Maria Annunziata Church (M1)	42.7351°	13.2522°	D0	D3

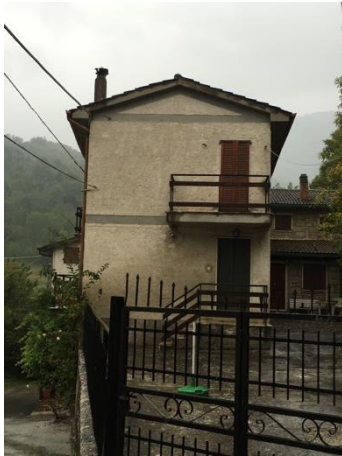
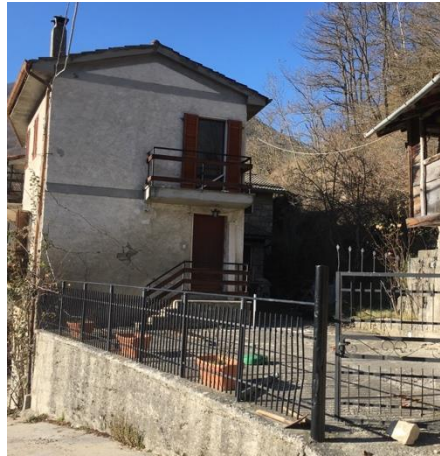
P3

Figure 6.61 shows locations of selected buildings for which we show photos taken after the August and October events. Figure 6.62 shows these pictures, which were taken from a common perspective. Table 6.5 summarizes locations and damage levels for each of the representative structures. Structures M2, M3, and M4 (P1 and P2 in Figure 6.62) are unreinforced masonry buildings. They had damage levels ranging from D1-D3 after the August events and D5 (complete collapse) following the October events. We documented the performance of one reinforced concrete structure (RC1). It had no apparent damage from the August events and damage level D2 after the October events (P3 in Figure 6.62).

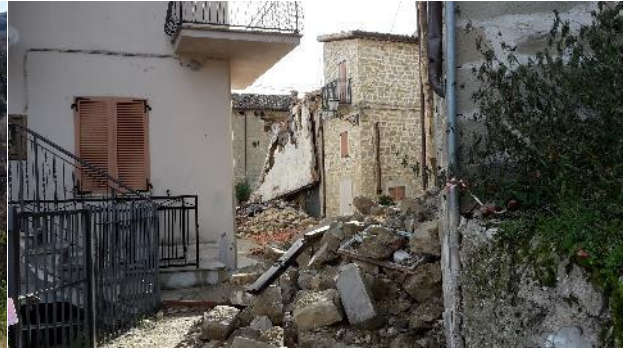
P06 (Castro)

Table 6.6 summarizes observed damage patterns for each hamlet. Most of these hamlets were visited (Astorara, Collefratte, Colleluce, Colle, Piano and Pistrino), although Balzo and Castro were assessed from afar due to limited access. In particular, the main access road to Castro was blocked by debris (see Picture P06 below).

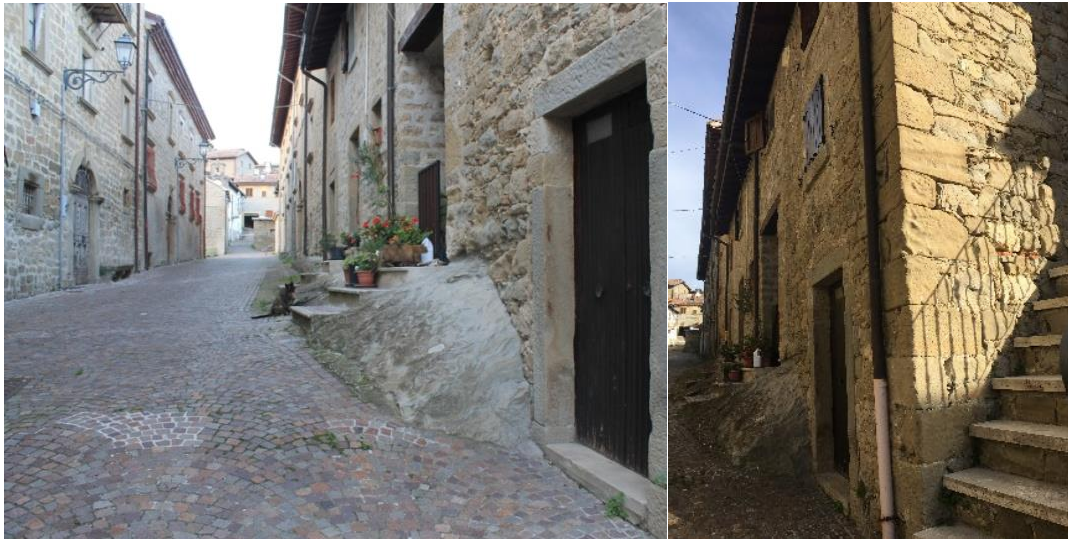
P14 (Piano)

Damage levels were variable across Montegallo, which is likely a result of variable ground motion levels (mostly as a result of different site effects) and variable construction types and quality. In general, we encountered significant increased damage levels (approximately one class, e.g., D2 to D3) following the October events. A notable exception is Piano, which showed no evidence of damage following either event sequence, despite some examples of apparently poor construction (P14 in Figure 6.63).

Colleluce	P13	Totally D4/5.
Piano	P14*	Generally D0/D1.
Pistrino	P15*-P16*-P17*	The initial part of the village (Pistrino di Sopra) was seriously damaged (D3/D4), whereas the other part (Pitrino di sotto, 1 km from Piano) showed minor problems (D0/D2) except for a collapsed small stones wall.

Picture	Hamlet	DATUM	Position		September damage Level	December damage Level
			Lat.	Long.		
P13	Colleluce	WGS-84	42.83805°	13.30722°	-	D4-D5
P14*	Piano	WGS-84	42.854116°	13.339129°	D0	D0
P15*	Pistrino	WGS-84	42.855579°	13.332649°	D0-D1	D0-D1
P16*	Pistrino	WGS-84	42.855579°	13.332642°	D0-D1	D0-D1
P17*	Pistrino	WGS-84	42.855579°	13.332649°	D0-D1	D0-D1

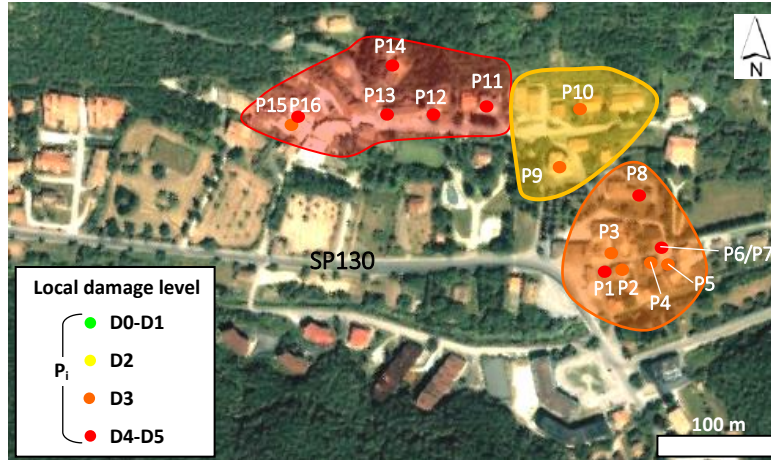
Figure 6.69. Locations of representative structures inspected in Ussita, and damage zonation within the village.

Figure 6.69 shows locations of representative structures inspected in Ussita and maps damage zones within the village. Damage levels were generally between D3 and D4. Figure 6.70 shows pictures of selected structures in the area of Ussita that experienced the higher level of damage.

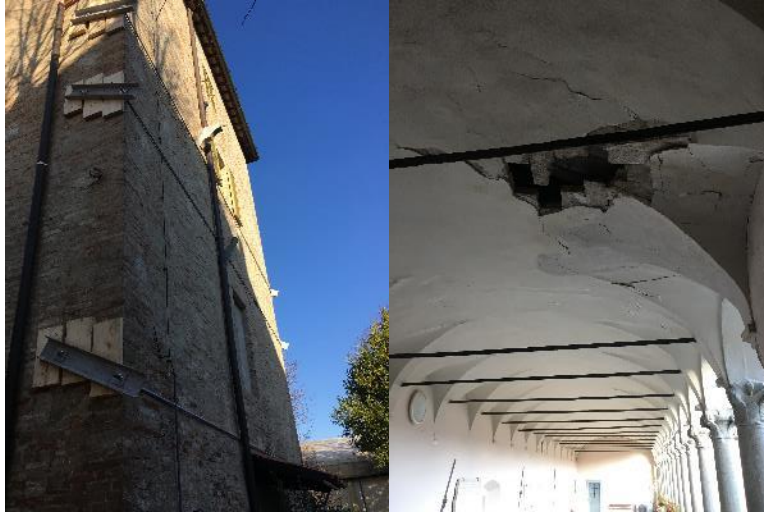
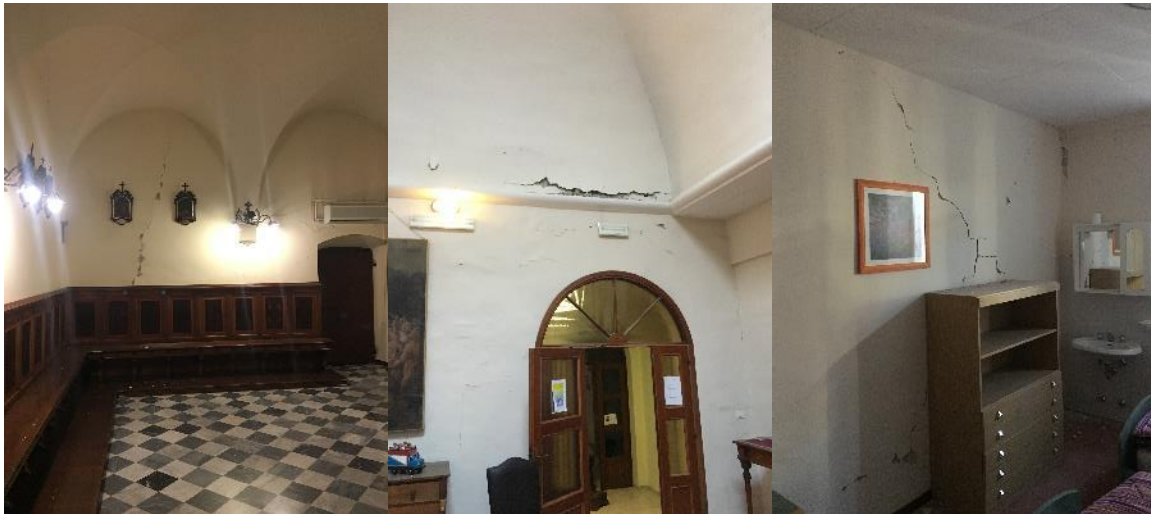
P03c-d-e Monastery of the Basilica di San Nicola (Saint Nicholas Church)

The San Nicola church is out of service and not accessible to the public as a result of diffused damage to the façade and the unstable wood decorated roof. The adjacent convent is a complex and heterogeneous building made by different and subsequent enlargements. For this reason, there are different states of damage inside the huge complex, depending on the structural type (masonry or reinforced concrete).

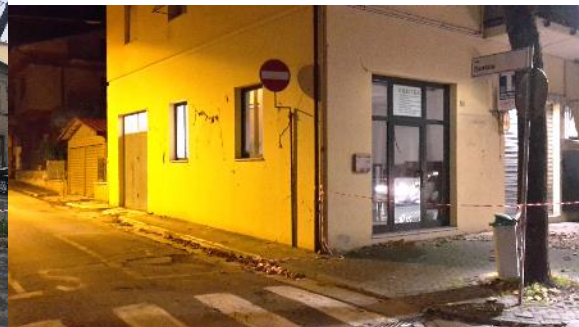
P06-P07 (Viale Vittorio Veneto)

Very interesting is the Viale Vittorio Veneto-Viale Martin Luther King-Via Kennedy area. In this neighborhood, an evident site effect was observed, since diffused building damages are observed much more prominently than in the other parts of the town. In particular, the buildings along the eastern side of Martin Luther King road are recent reinforced concrete frames 5-to-8 floors above ground from the 1980s. Most of these buildings were seriously damaged and abandoned at the time of the reconnaissance. On the other side of the road, smaller buildings (most of them 3 floors above ground) suffered much less damage and were apparently in use at the time of the reconnaissance.

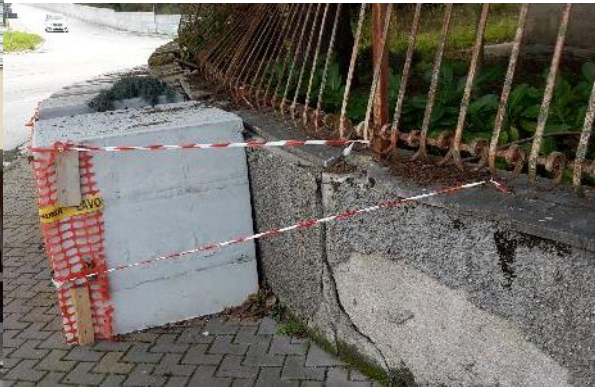
P11 (Retaining wall)

At the roundabout connecting Viale Vittorio Veneto e Viale Martin Luther King a retaining wall next to a rail bridge was seriously damaged. In particular, the wall was secured by huge concrete blocks in order to maintain the stability of the back private garden.

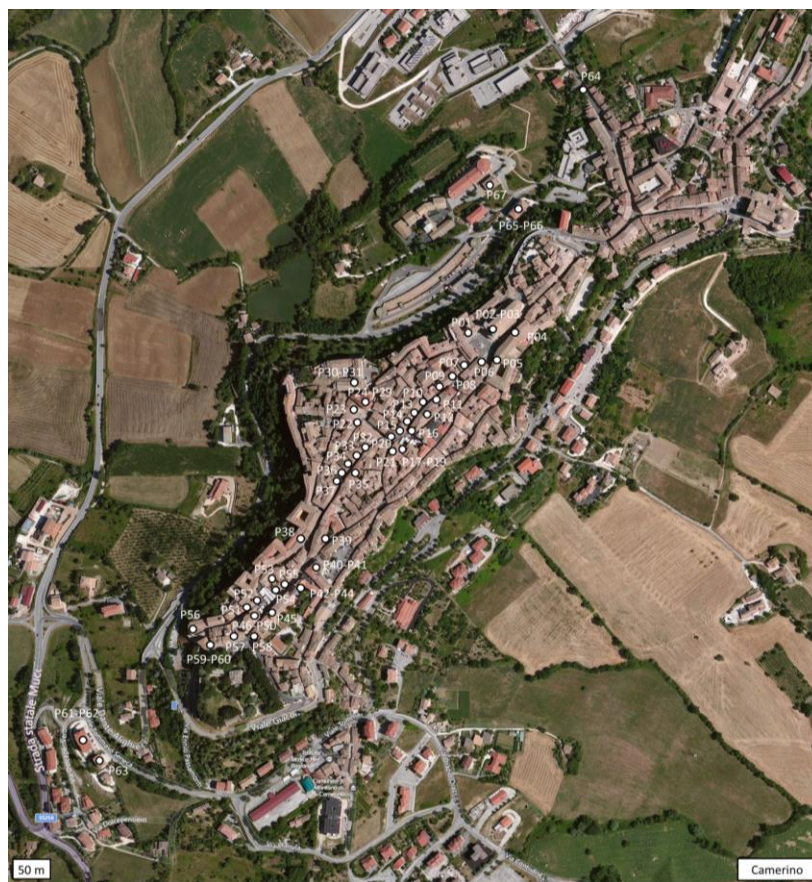
Figure 6.83. Locations of the representative structures inspected in Camerino (including red zone) (see Table 6.11 for details).

Figure 6.83 and Table 6.11 show locations of representative buildings inspected in the historic center of Camerino, including the red zone. Figure 6.84 shows photographs of these representative structures, which include both masonry and reinforced concrete dwellings two to four stories in height. The average damage level in the inspected zone was D2.

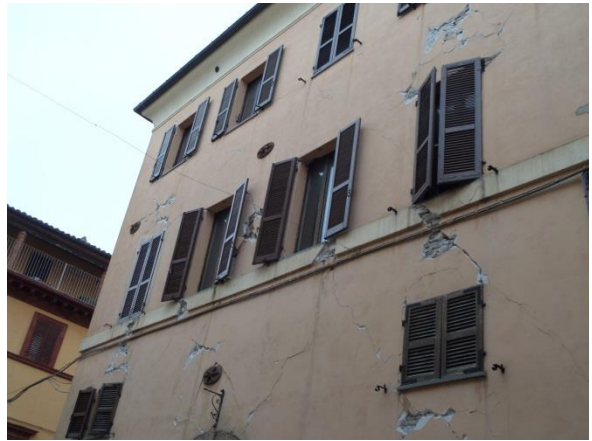
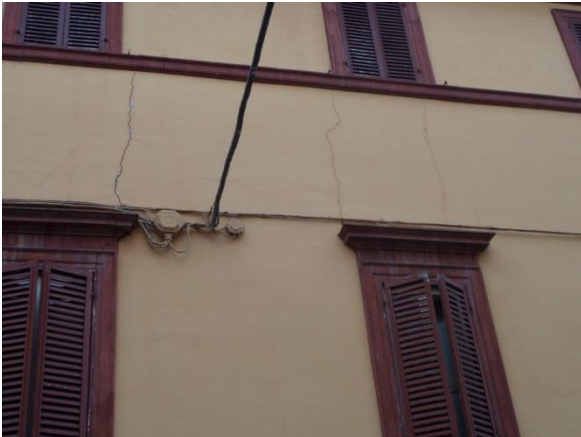
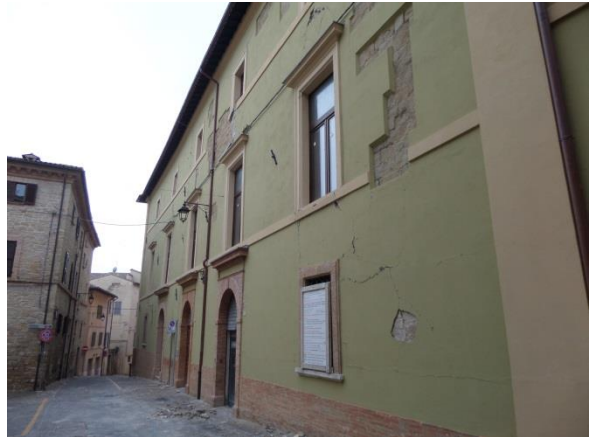
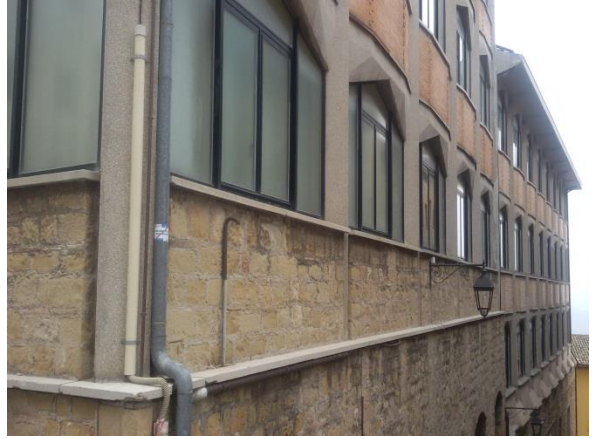
Figure 6.84. Representative pictures taken in Camerino (see Table 6.11 for details).

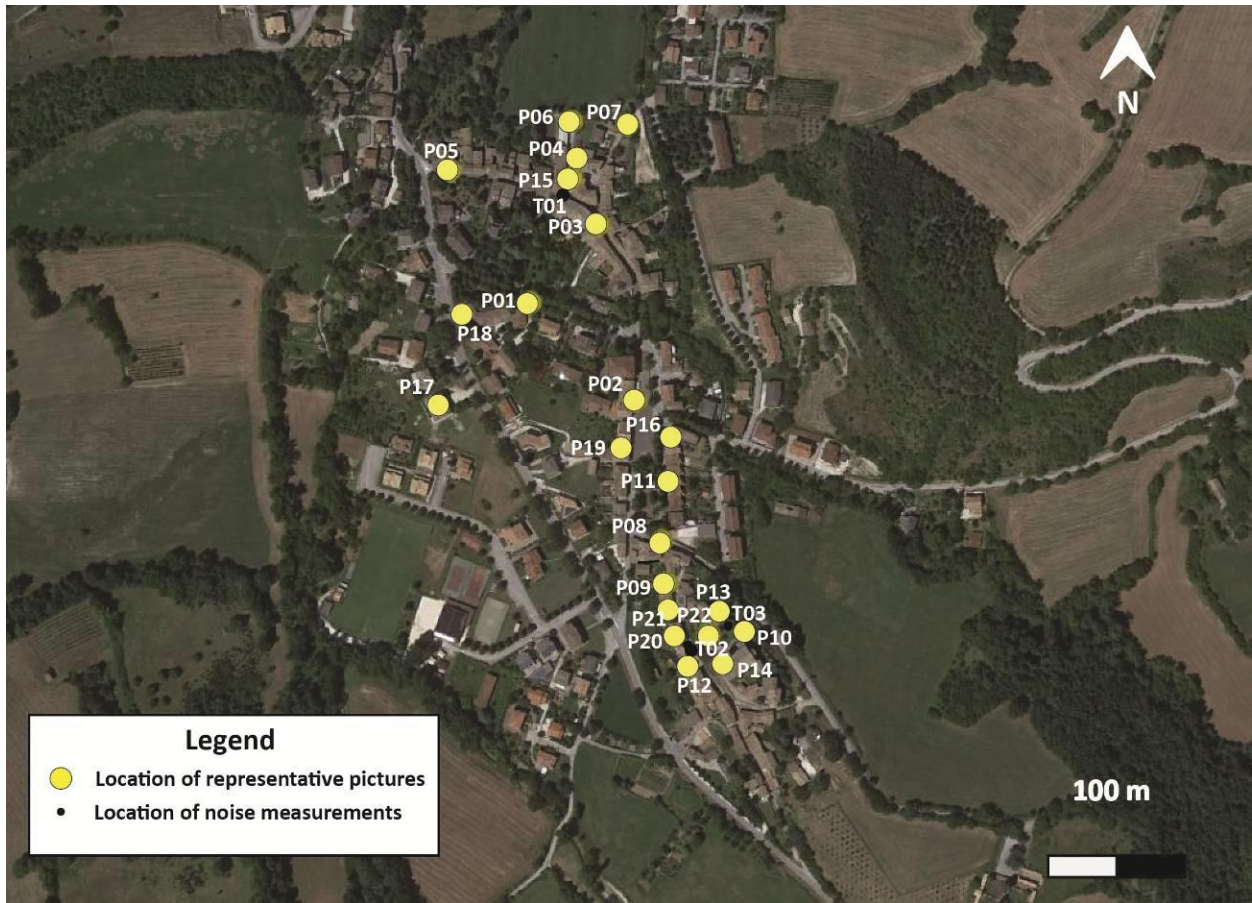
Figure 6.86. Locations of representative structures inspected in Pievebovigliana (see Table 6.12 for details).

Locations of representative photos taken in Pievebovigliana by the GEER team are reported in Figure 6.86. The pictures are presented in Figure 6.87. The historical center consists mainly of un-reinforced old masonry structures, 2-3 stories in height. Some of these structures have retrofitted. Outside of the historical center, isolated modern masonry and reinforced concrete structures were found (see P17-P18). Table 6.12 shows details and damage levels for the inspected structures.

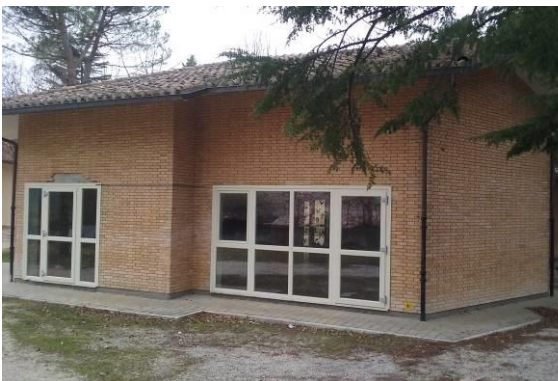
P17

Pievebovigliana was significantly damaged by the October events. However, the degree of damage to buildings is quite variable across the village. A preliminary damage zonation is reported in Figure 6.88. Damage levels as high as D3-D4 are concentrated in the southern portion (area of Castello or S. Maria Assunta church) built on a slight ridge oriented NNW-SSE that is comprised of Scaglia-Cinerea bedrock. Topographic site effects may have impacted structural performance in this area. The northern and central portions of the village generally have damage levels D2 to D2-D3. These areas are mainly located on alluvial terraced deposits. Minor damage was observed along the western portion of the village; the northern part of this area, located on alluvium, has relatively modern buildings (see P17) while the southern area is on bedrock at the toe of the Scaglia-Cinerea ridge.

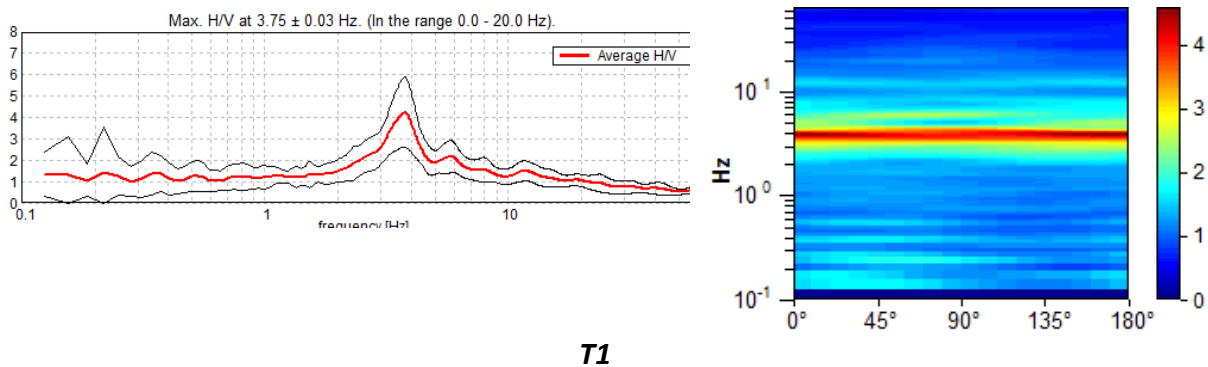
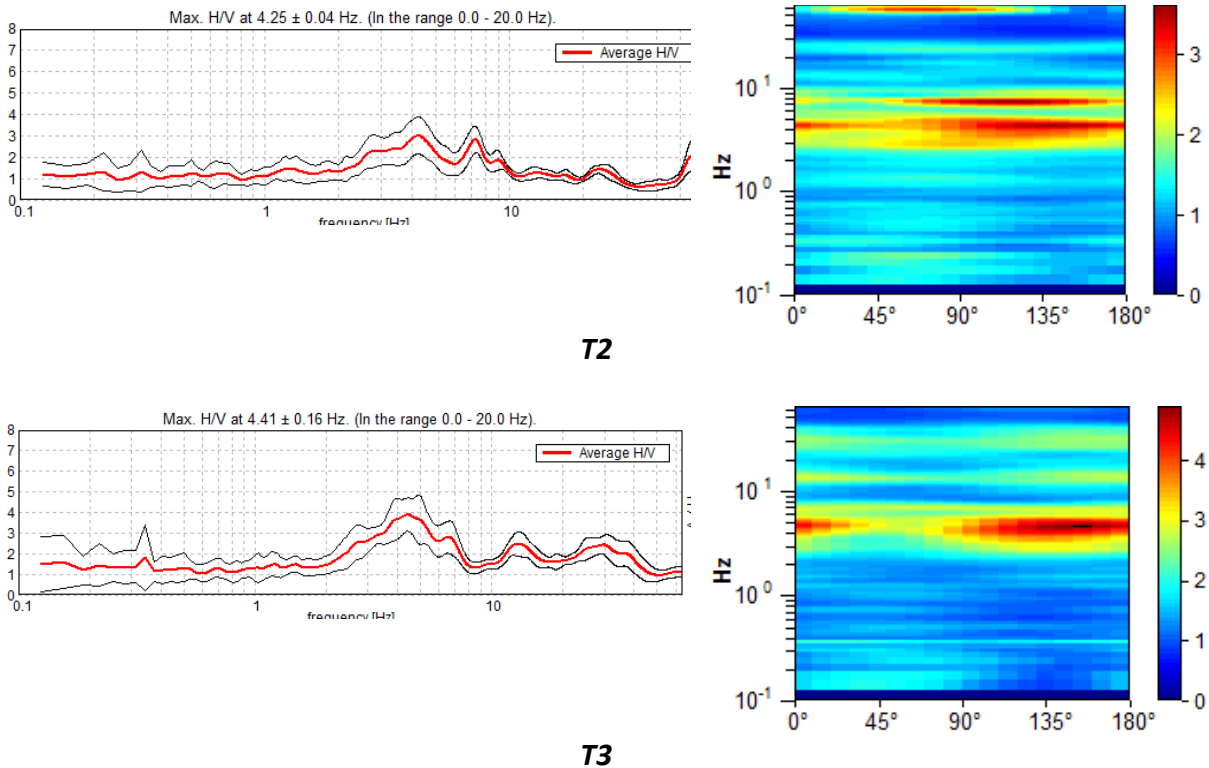
Figure 6.89. Noise measurements results in terms of H/V spectral ratio (on the left column) and H/V polar plots (on the right).

Three microtremor noise measurements (T01-T02-T03 in Figure 6.88) were carried out during the survey in the most damaged zone of the historical center. The same instrument and data acquisition procedures described for Visso were employed here. Average horizontal-to-vertical (H/V) spectral ratios and polar H/V are reported in Figure 6.89. The data indicate relevant H/V peaks in the 3-5 Hz range. The highest peak in T01 can be related to the resonance of alluvial soils on bedrock while peaks in T02 and T03, slightly lower in amplitude and strongly polarized, are probably influenced by the topographic feature present in southern portion of village.

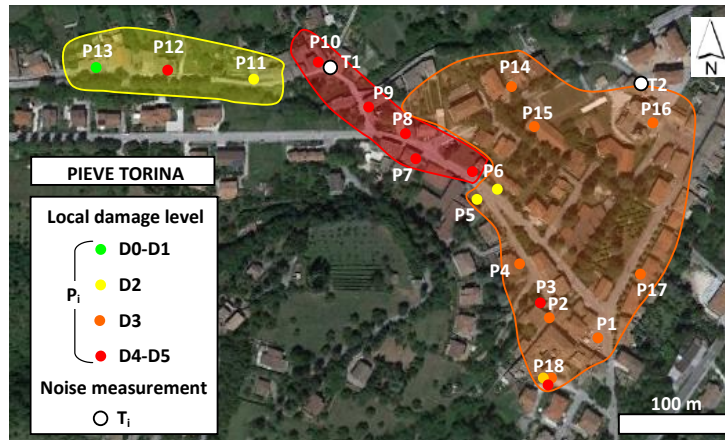
Figure 6.90. Locations of representative structures inspected in Pieve Torina, and damage zonation within the village.

Pieve Torina is crossed by the Sant'Angelo creek. Most of the buildings are masonry structures. Figure 6.90 shows the locations of representative structures inspected and a preliminary damage zonation. Figure 6.91 shows details of a building complex, and a damaged structure located in the center of the village. Two microtremor noise measurements (T01-T02 in Figure 6.90) were carried out during the survey in the most damaged zone of the town. Figure 6.92 shows noise measurements results in terms of H/V spectral ratio and H/V polar plots. Both measurements show a peak at about 10 Hz. This value is compatible with the high level of damage observed for one-two stories buildings (usually characterized by similar values of fundamental frequency), indicating possible double resonance phenomena.

- D1-D2 - With the exception of complete collapse of pre-existing ruins, the area seems to be characterized by limited damages to non structural elements.
- D3 - Heterogeneous area, in terms of structural typology and damage extent; overall, major damage to non structural elements and limited to significant damage to load bearing elements (with local collapse in some points) can be identified.
- D4-D5 - Strip characterized by structures interested by huge damage to load bearing elements and local collapse.

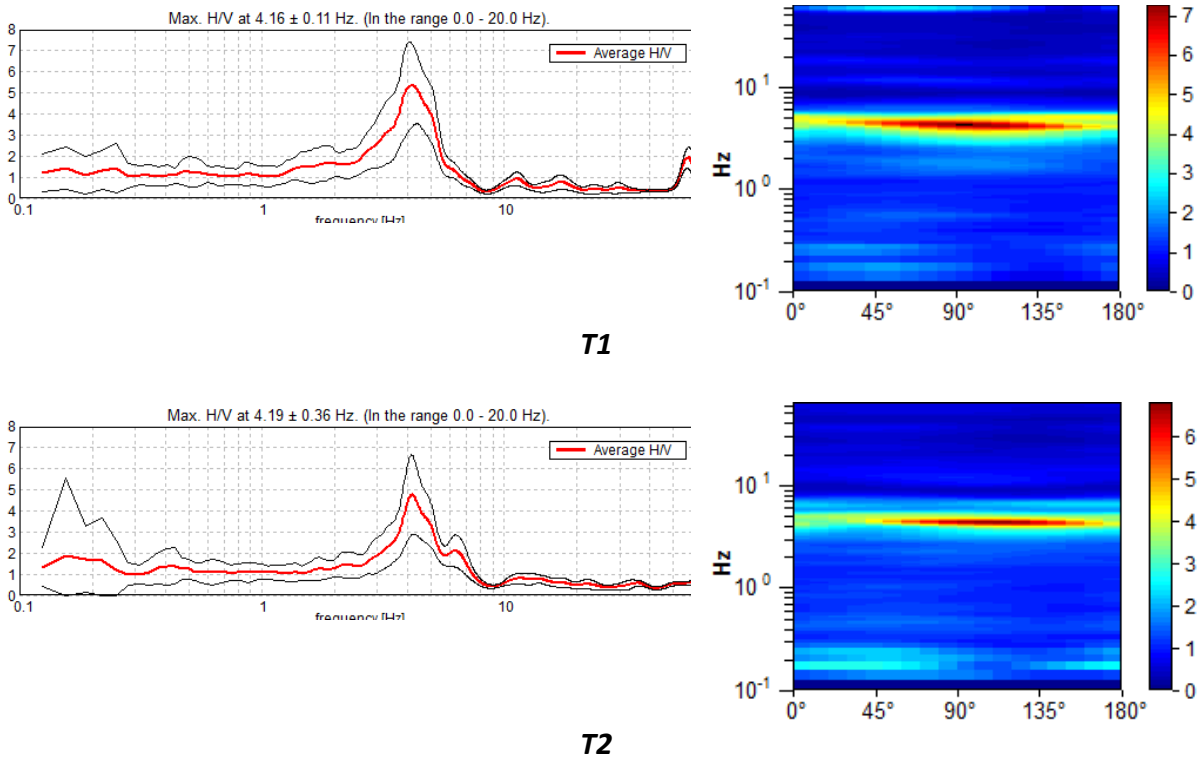
Figure 6.96. Noise measurements results in terms of H/V spectral ratio (on the left column) and H/V polar plots (on the right).

Two microtremor noise measurements (T01-T02 in Figure 6.94) were carried out during the survey in the damage zone. The same instrument and data acquisition procedures described for Visso were employed. Average horizontal-to-vertical (H/V) spectral ratios and polar H/V are reported in Figure 6.96. Both measurements show a large H/V peak around 4 Hz that is likely related to stiffness contrast between soil cover and underlying bedrock.

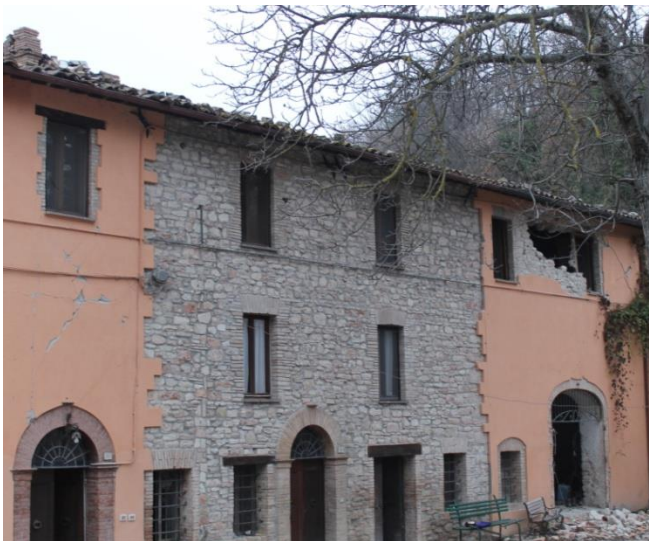
P01

the upper part (Casavecchia Alta) where several partial and full collapses took place (see P03-P04) with respect to Piè Casavecchia (P01-P02).

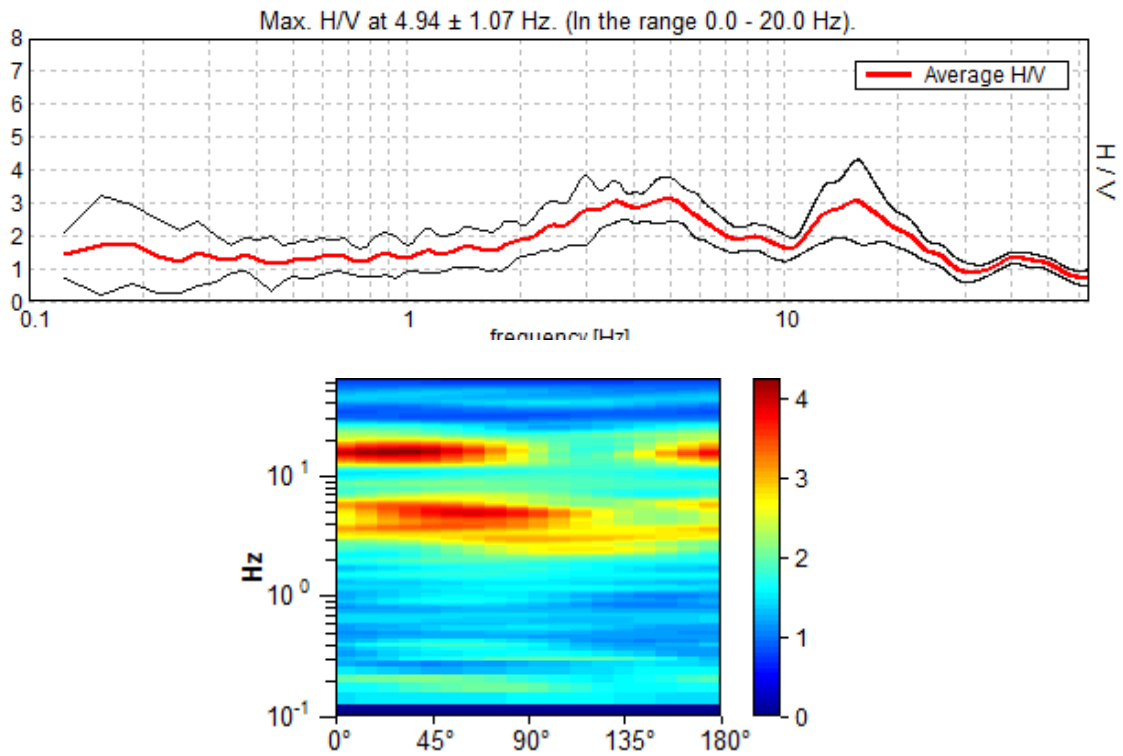
A noise measurements (T01 in Figure 6.98) was carried out during the survey in the upper part. The same instrument and data acquisition procedures described for Visso survey were employed. Average horizontal-to-vertical (H/V) spectral ratios and polar H/V plot are reported in Figure 6.100. A broad band H/V peak appears at 2-6 Hz polarized in the direction of about 60°, i.e. perpendicular to the axis of the ridge, thus indicating possible topographic site effects (Pagliaroli et al., 2015).

Figure 6.100. Noise measurement T01 results in terms of H/V spectral ratio (up) and H/V polar plots (bottom).

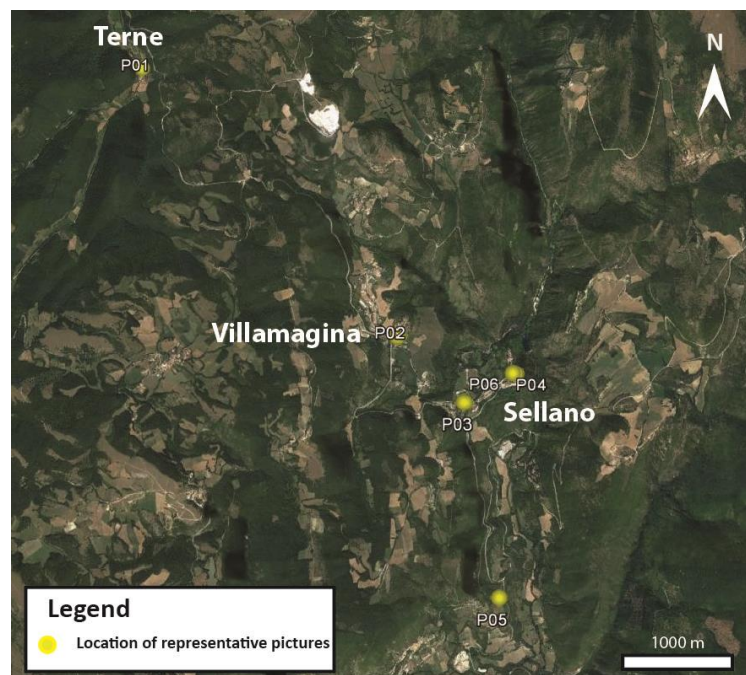
No or negligible damage was observed in the hamlets of Terne and Villamagina (on average D0-D1). Slightly higher damage (D1-D2) was reported in the upper part of Sellano (area of Santa Maria Assunta and Municipio, see P04 and P06).

Figure 6.101. Locations of representative structures inspected in Sellano and surrounding hamlets (see Table 6.15 for details).

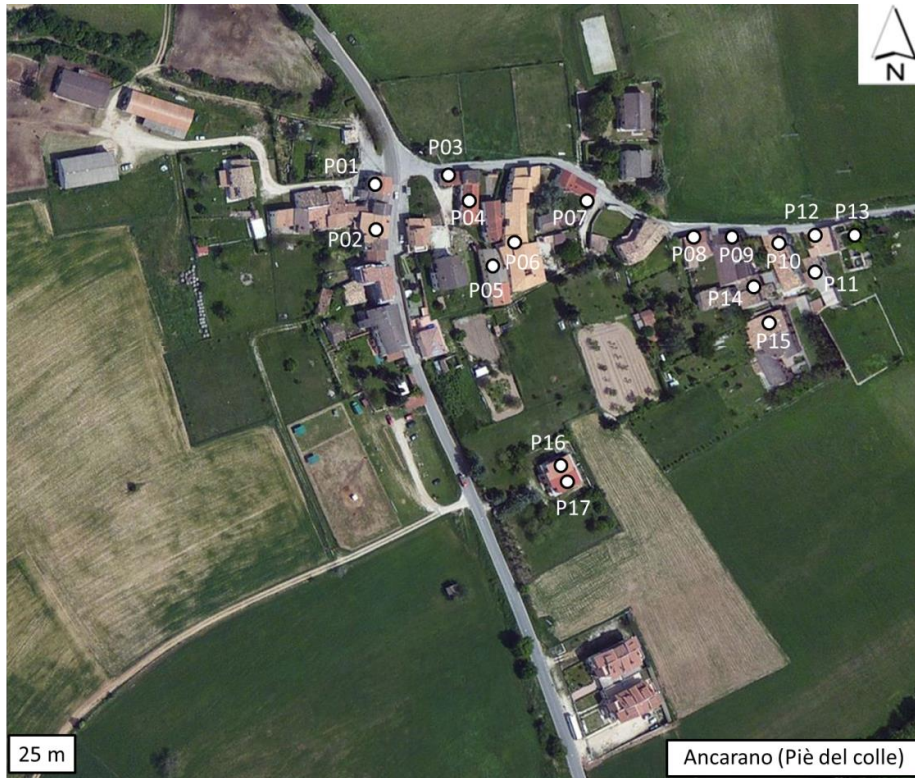
Figure 6.104 and Table 6.16 show locations and details of representative buildings inspected in Pié del Colle. Figure 6.105 shows representative structures, which include unreinforced masonry and reinforced concrete buildings. Damage was observed to both types of structures, although among reinforced concrete structures the principal damage was collapse of interior tiles from frames. Typical damage levels were between D2 and D3.

Figure 6.104. Locations of the representative structures inspected in Ancarano piè del colle (see Table 6.16 for details).

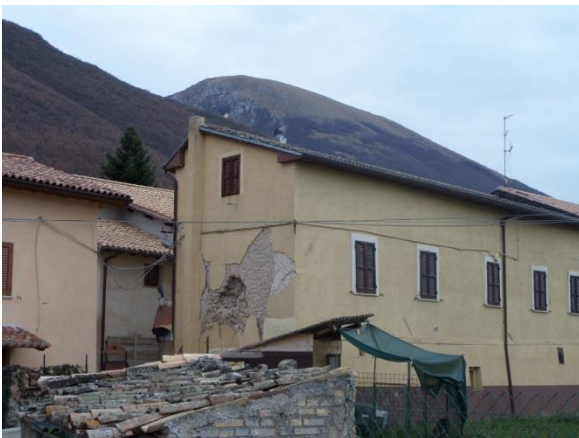
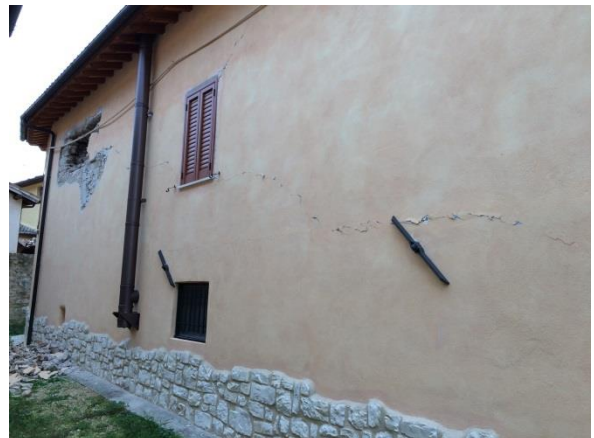
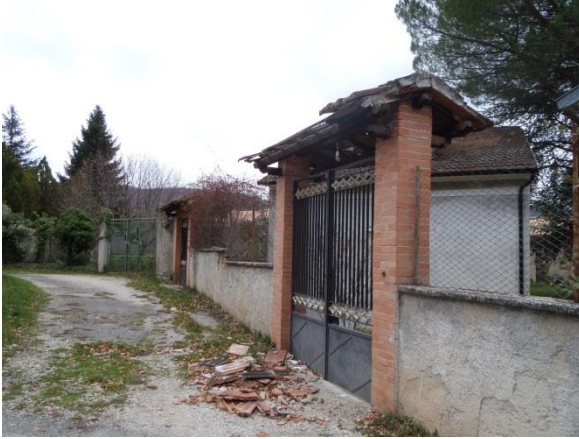
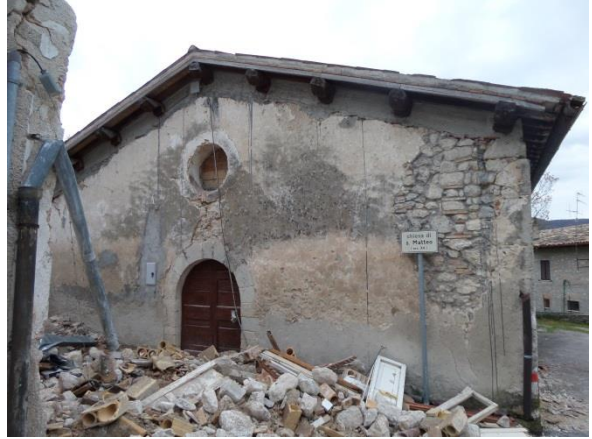
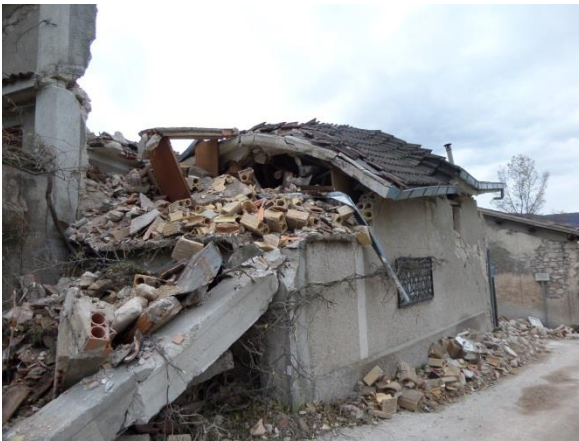
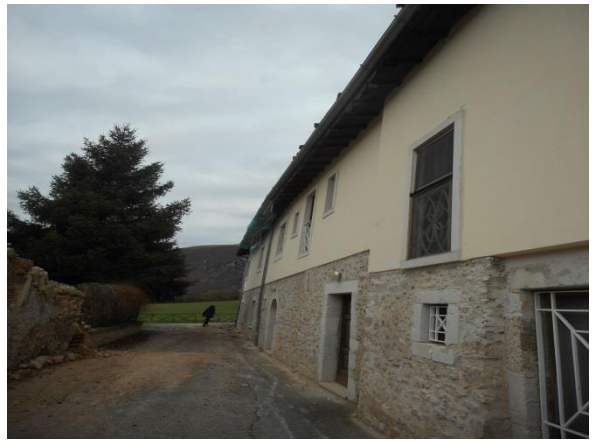
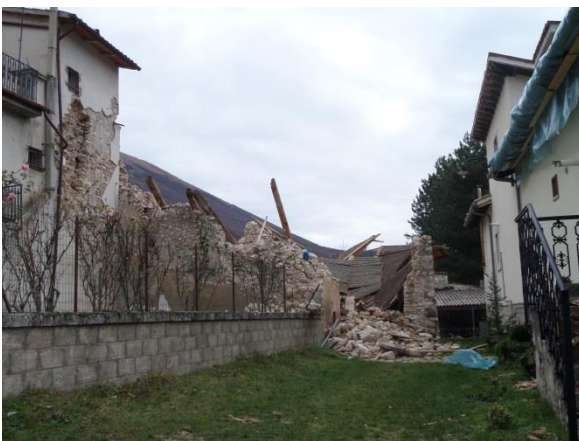
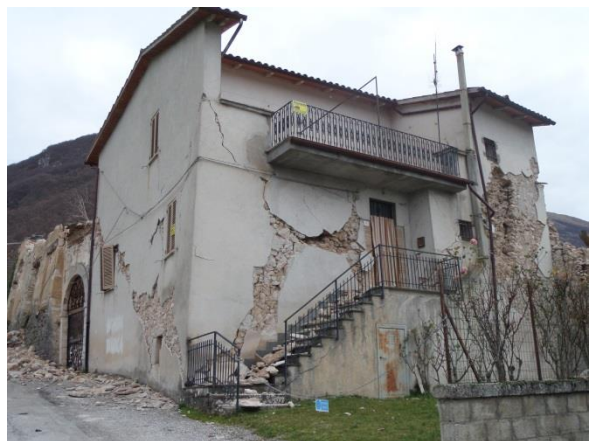
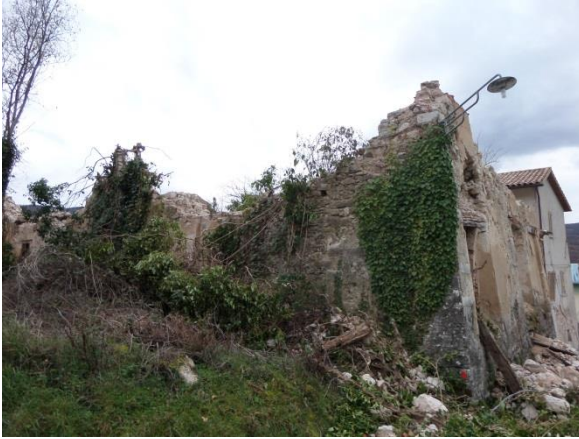
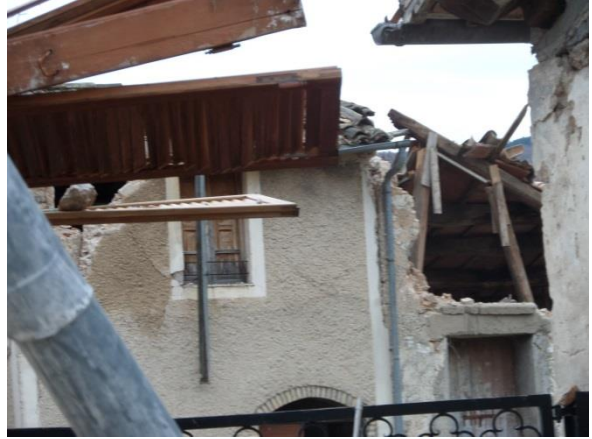
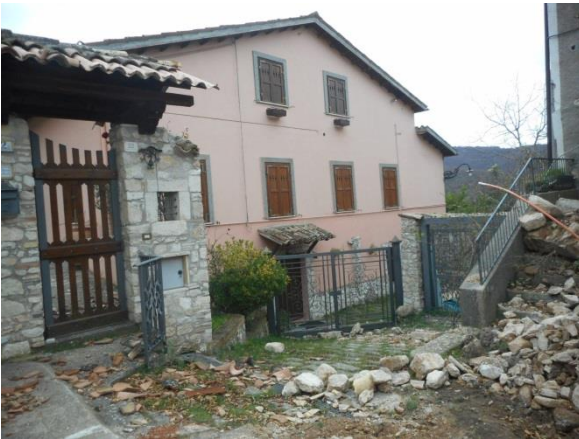
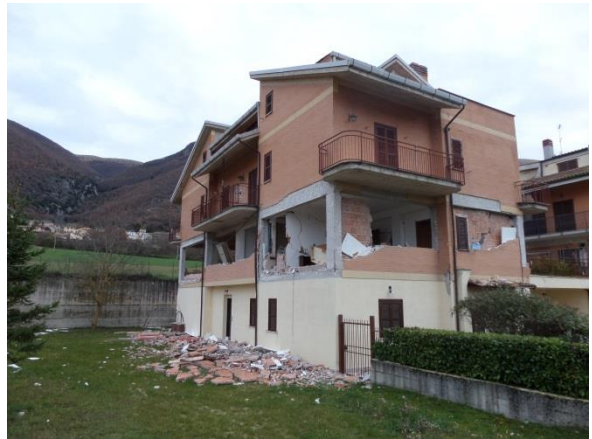
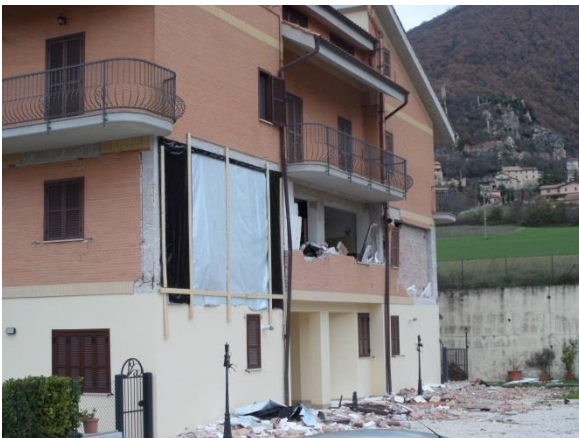
Figure 6.105. Representative pictures taken at Ancarani pié del Colle (see Table 6.16 for details).
