Engineering Reconnaissance Following the October 2016 Central Italy Earthquakes *Version 2*

GEER Team Leaders: Jonathan P. Stewart and Giuseppe Lanzo

Geotechnical Extreme Events Reconnaissance Association
Report No. GEER-050D
8 May 2017

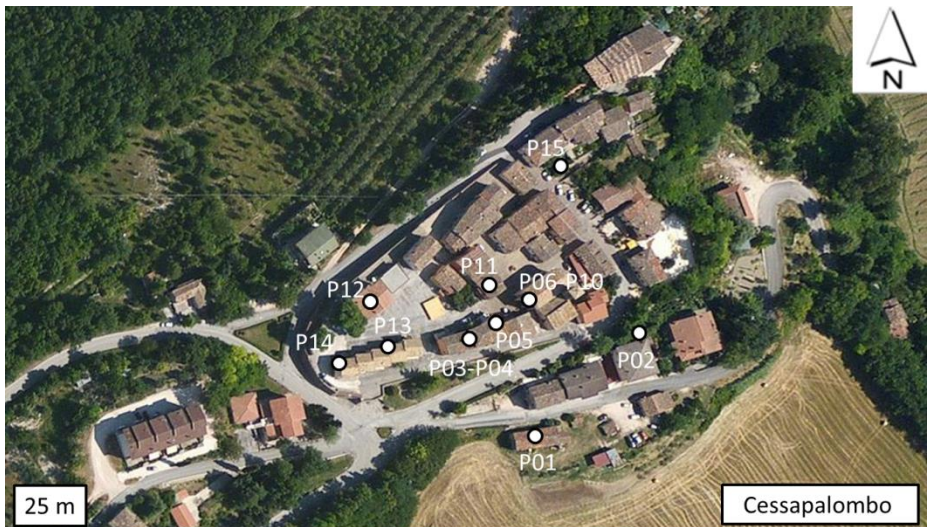
Table 6.17 summarizes locations and details of the representative inspected buildings, while Figure 6.108 shows locations of these buildings. Figure 6.109 shows pictures of representative structures in the village. The average damage level in the main village is approximately D1 to D2.

Figure 6.108. Locations of the representative structures inspected in Cessapalombo (see Table 6.17 for details).

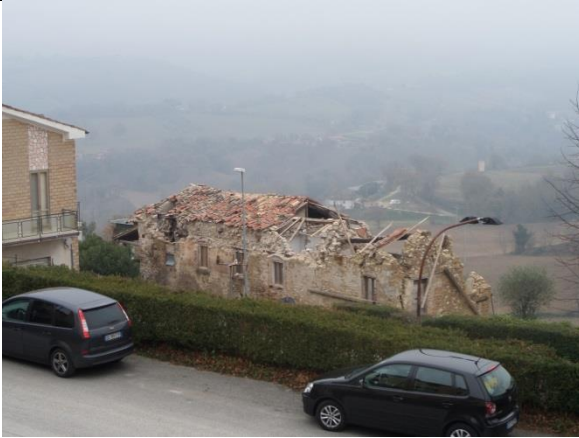
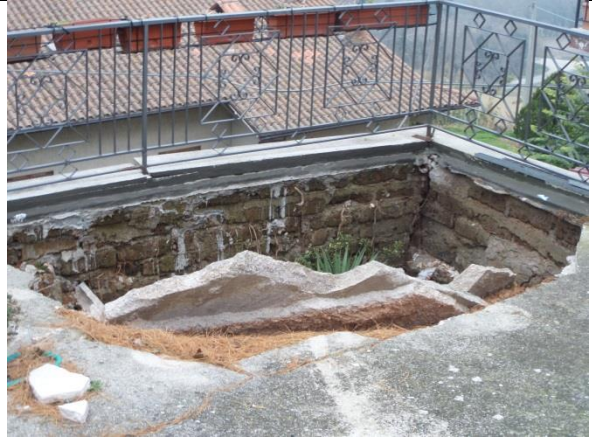
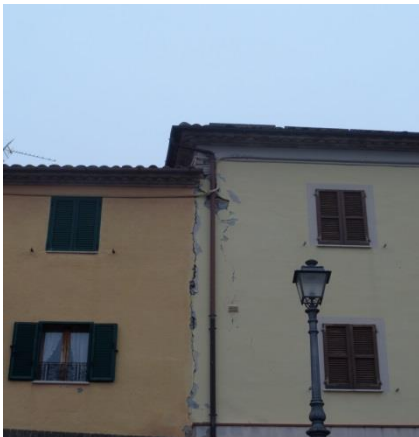
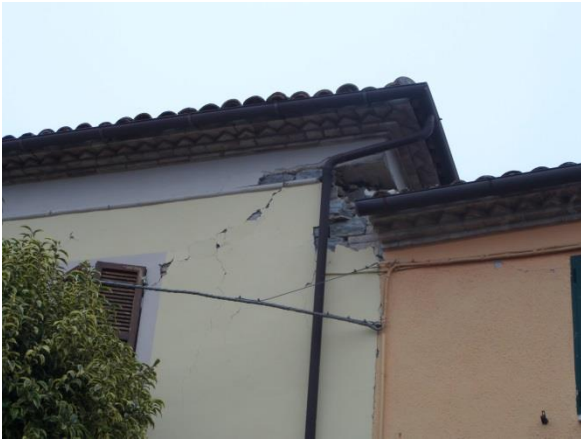
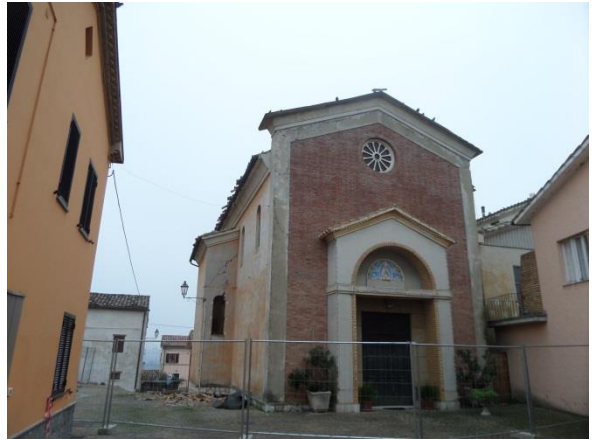
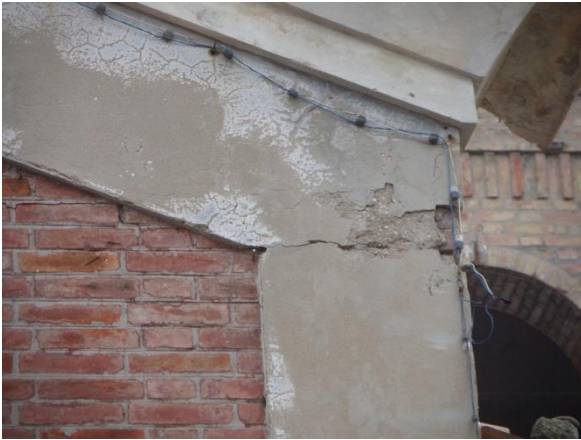
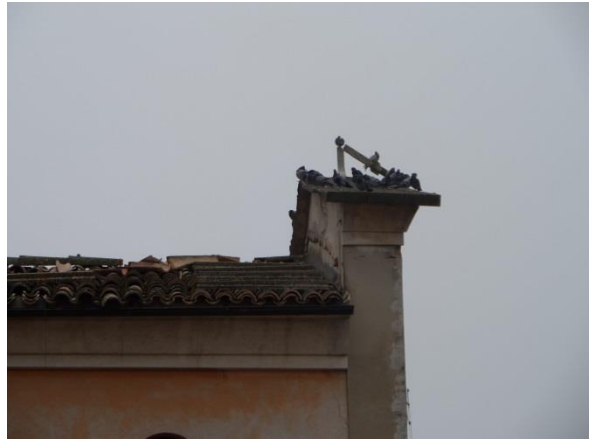
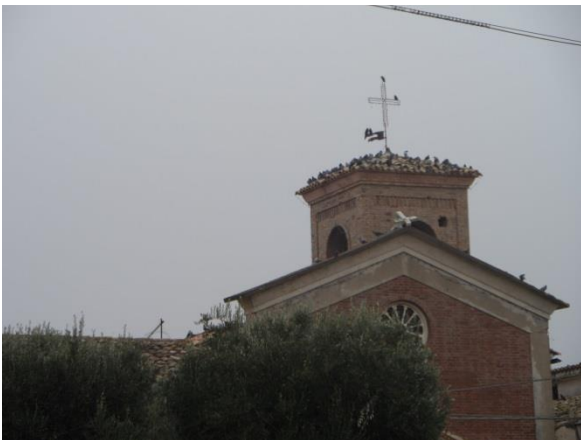
Figure 6.109. Representative pictures taken at Cessapalombo (see Table 6.17 for details).

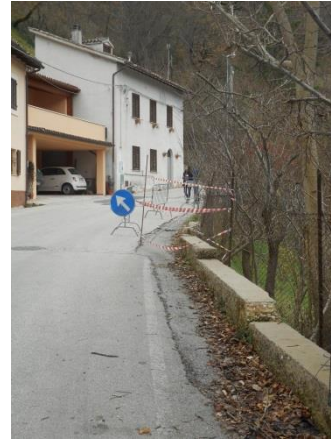
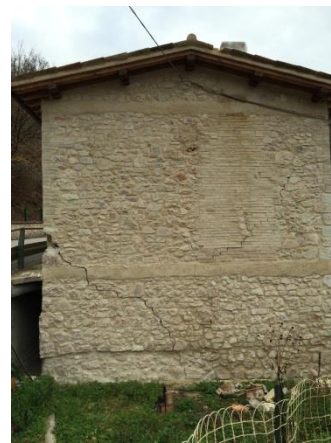
The hamlet of Piedivalle (42.866786, 13.060767) belongs to the municipality of Preci and is about 2.5 km from the Preci center. Its elevation is 611 m a.s.l. and it has 35 inhabitants. Estimated ground motions are given in Table 6.1. We inspected three structures at the location shown in Figure 6.112. The building photographs are shown in Figure 6.113. The masonry structures have damage level D1.

Figure 6.113. Representative pictures taken at Piedivalle.

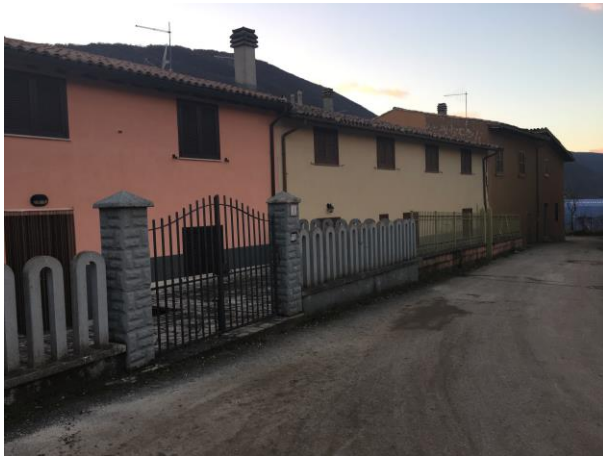
Picture	DATUM	Location		Damage Level
		Lat.	Long.	
P01	WGS-84	42.751381	13.106139	D1
P02	WGS-84	42.751381	13.106139	D1
P03	WGS-84	42.751800	13.105000	D3
P04	WGS-84	42.751700	13.105700	D2/D3
P05	WGS-84	42.751572	13.106256	D4/D5
P06	WGS-84	42.751300	13.106075	D0

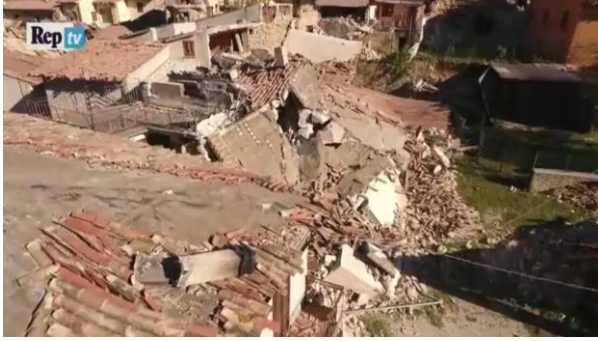
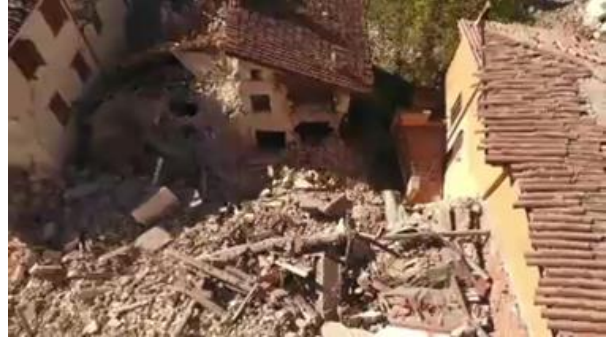
During our reconnaissance following the 30 October event, we observed extensive damages in almost all the masonry structures (classified as D3-D5) located mainly in the historical center of the town, which was in part not accessible. Some pictures of the damaged buildings in the historical center are shown in Figure 6.127 (source Repubblica.it, last accessed 21 April, 2017). In the new part of the town damages were concentrated on non-structural components of some of the reinforced concrete buildings recently constructed (classified as D2). Figure 6.128 shows multi-epoch pictures (before August and after 30 October, 2017) of selected locations. Table 6.24 summarizes the overall damage level observed in these locations.

Figure 6.127. Damaged constructions in the oldest part of San Pellegrino (<http://video.repubblica.it/dossier/terremoto-30-ottobre/terremoto-centro-italia-la-distruzione-a-san-pellegrino-di-norcia-dal-drone/257495/257761>).

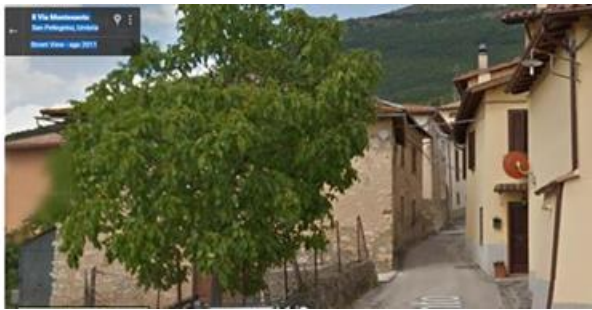
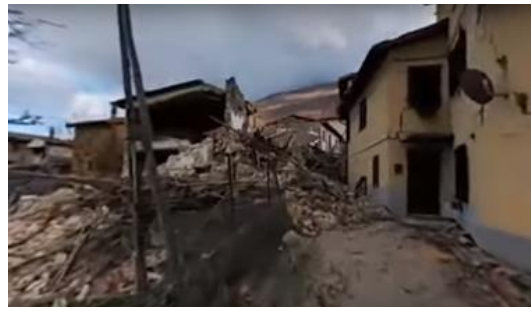
P01. Montesanto street

<i>Picture</i>	<i>Damage Level</i>
<i>P01</i>	<i>D4</i>
<i>P02</i>	<i>D4</i>
<i>P03</i>	<i>D5</i>
<i>P04</i>	<i>D3/D4</i>
<i>P05</i>	<i>D4/D5</i>

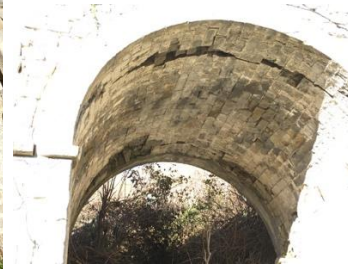
(c)

width of the crack in the longitudinal direction (Figure 7.3d) has increased with respect to that observed in the first reconnaissance (Figure 7.3c). However, there was no additional spalling of masonry elements as had been observed following the first event.

Figure 7.3. Roman-era bridge along the Trisungo route (1 span bridge - Tufo area – Arquata del Tronto - N42.735981, E13.254862): view of the arch (a, b) and the road cracks (c, d) after the 24 August event (photo on September 7 2016 (a, c)) and after the 30 October event (photo on December 13 2016 (b, d)).

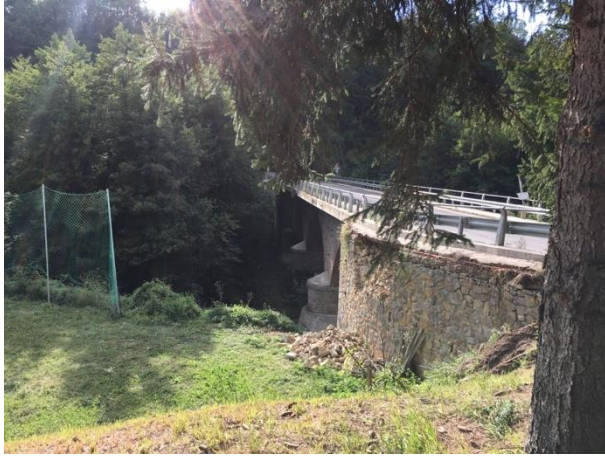
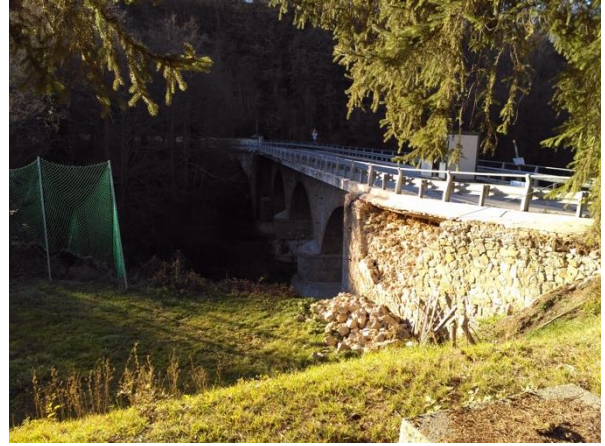
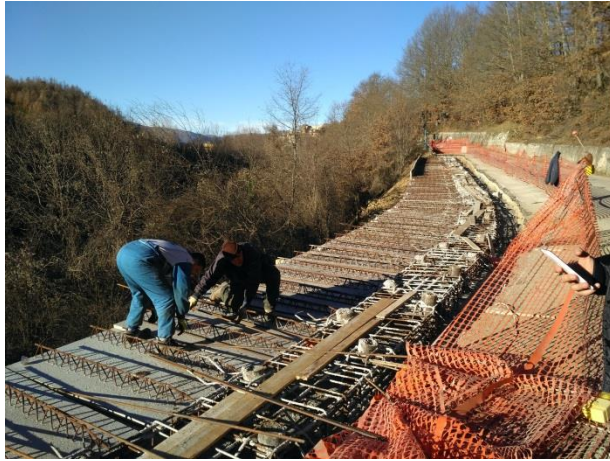
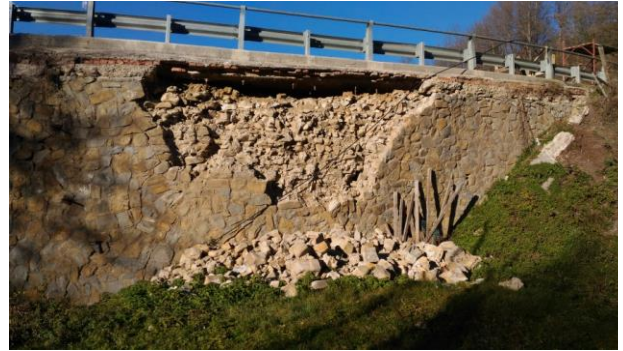
Figure 7.4 shows the response of the second arch along the Trisungo route (3 spans bridge) after the different events (24 August and October 2016). The incremental damage was significant: part of central arch, already damaged after the first event (Figures 7.4a and 7.4c), collapsed as a result of the October earthquakes (Figures 7.4b and 7.4d).

Figure 7.4. Roman-era bridge along the Trisungo route (3 spans bridge - Tufo area – Arquata del Tronto - N42.73538, E13.25365): (c) after the 24 August event (photo on September 7 2016) and (d) after the 30 October event (photo on December 13 2016).
