Engineering Reconnaissance Following the October 2016 Central Italy Earthquakes - Version 2

Engineering Reconnaissance Following the October 2016 Central Italy Earthquakes *Version 2*

Geotechnical Extreme Events Reconnaissance Association
Report No. GEER-050D
8 May 2017

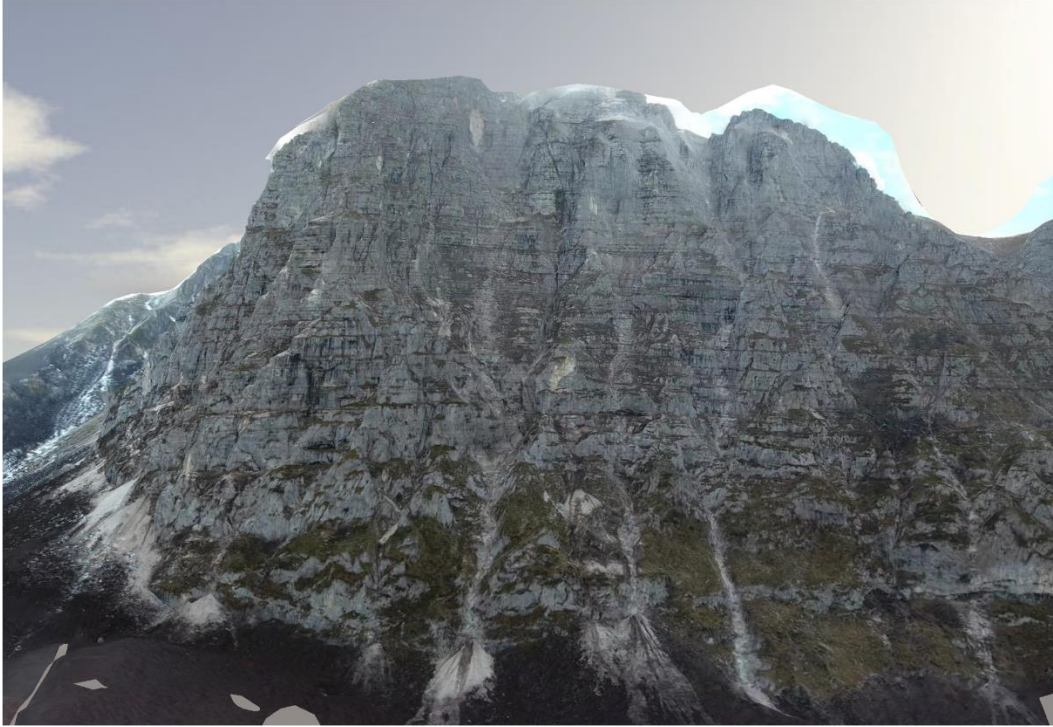
Figure 4.11. Screenshot of Monte Bove SfM meshed 3D model. Note the missing summit of the mountain in the model due to insufficient UAV imagery

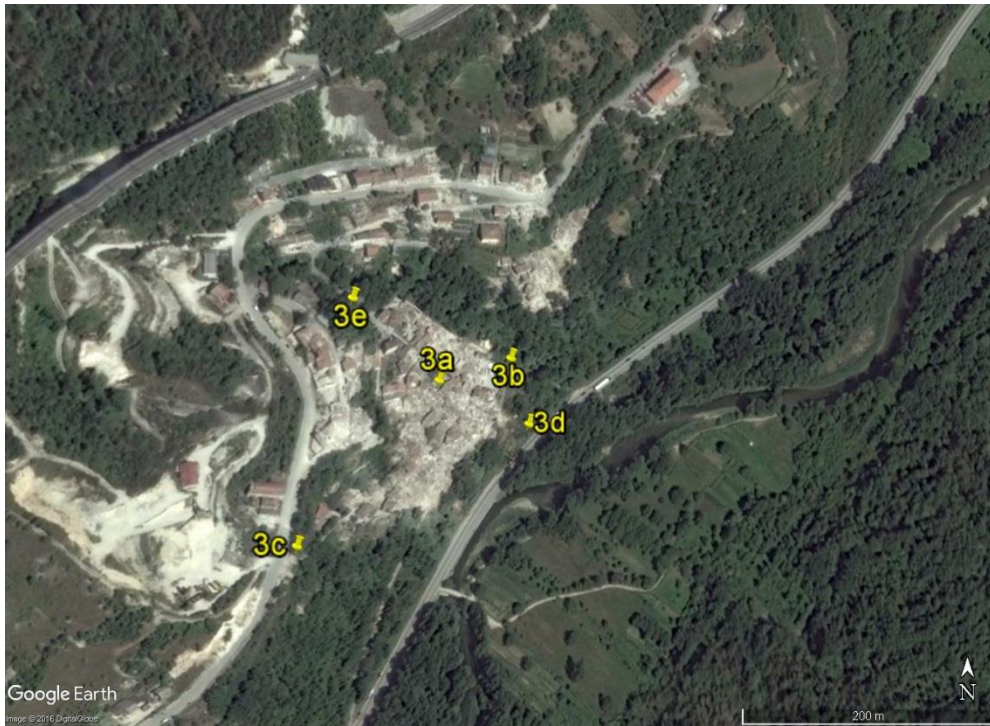
Figure 4.12. Pescara del Tronto locality map. Specific locations referred to in the text shown.

Area 3(a) shown in Figure 4.12 identifies the region of Pescara del Tronto characterized by completely collapsed residential structures built upon talus deposits (Figure 4.14). Structural damage in this area is described in Section 6.1.5. Structural debris was so complete and widespread that it was difficult (if not impossible) to investigate ground deformations in this zone from the UAV. Any attempt to manually investigate this zone was infeasible due to the dangerous and unstable nature of the debris field.

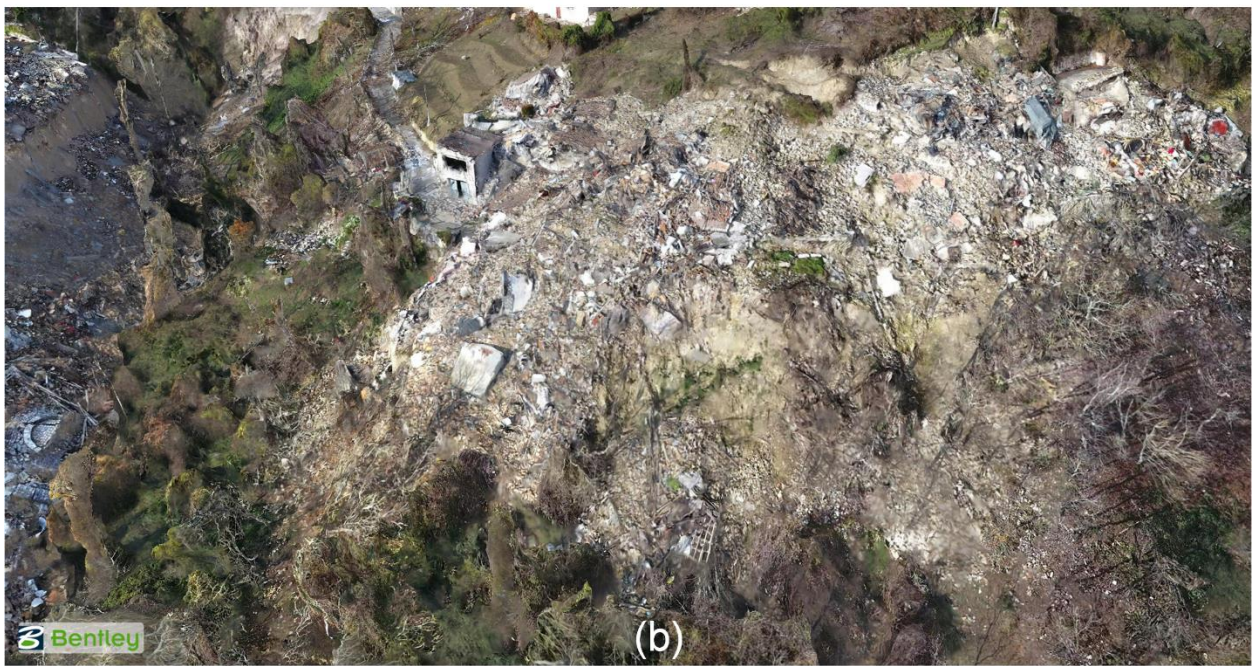
Area 6: Landslide on the Northern Slope of the Village: A shallow landslide was observed on the northern slope of the city following the 24 August event (Figure 4.27a). This landslide was observed to have exposed some tree roots and undermined a few residential structures. Investigation of the same slope in December following the October events revealed that the depth of the landslide remained relatively unchanged, but the width of the landslide appears to have expanded from 17 m in September to more than 36 m in December (Figure 4.27b). However, it is difficult to discern from the UAV images and 3D model whether the flattened trees along the slope are due to an expansion of the shallow landslide or due to structural debris from above the slope.

Figure 4.27. 3D model comparison of the landslide beneath the northern slope of Pescara del Tronto between September 2016 (a) and December 2016 (b).

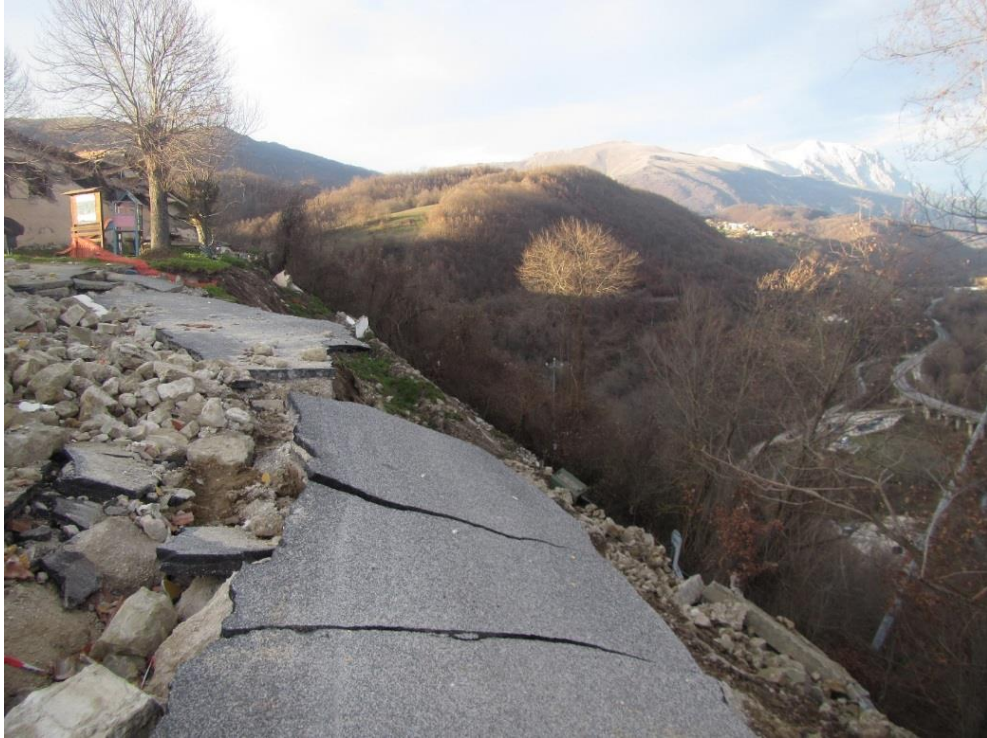
During the December GEER deployment, much more damage was observed. It appeared that a shallow landslide developed beneath the retaining wall and caused the entire structure to slide several meters down the slope. Figures 4.30 and 4.31 present photographs of the head of the shallow landslide showing the retaining wall's former location. Figure 4.32 presents an aerial screenshot of the 3D model developed from Phantom 4 UAV imagery of the site. Several features of interest are identified in Figure 4.32, and will be discussed below.

Figure 4.30. Failure of retaining wall due to shallow landslide (Point 4a, looking towards north).

The shallow landslide appeared to be limited to the upper corner of the slope, near the crown. The slide therefore likely occurred in the non-native fill slopes placed during the construction of the village. The scarp of the landslide appeared to follow the scarp of the soil graben observed behind the wall in September, suggesting that the graben may have been caused by more than just the rotation of the retaining wall. The landslide displaced the top of the wall between 5 to 6 m horizontally and between 3 to 4 m vertically downward. In total, approximately 50 m of the retaining wall below Accumoli failed and slid 5 to 6 m downslope. This loss of confinement resulted in significant horizontal and vertical deformations in the overlying roadway Frazione Fonte del Campo (SP18), as shown in Figure 4.33. The road was measured to have displaced horizontally between 0.1–1.6 m, and vertically downward 9–50 cm. Vegetation remained intact below the collapsed retaining wall, again suggesting that the landslide was likely shallow and limited to the upper limits of the slope. However, the rotated telephone pole located further down the slope, which was observed to have rotated 13 degrees in September, was observed to have rotated a total of 27 degrees in December. However, it is not clear whether this rotation was due to displacements of the heavily-vegetated soil slope or due to inertial effects on the pole from the earthquake.

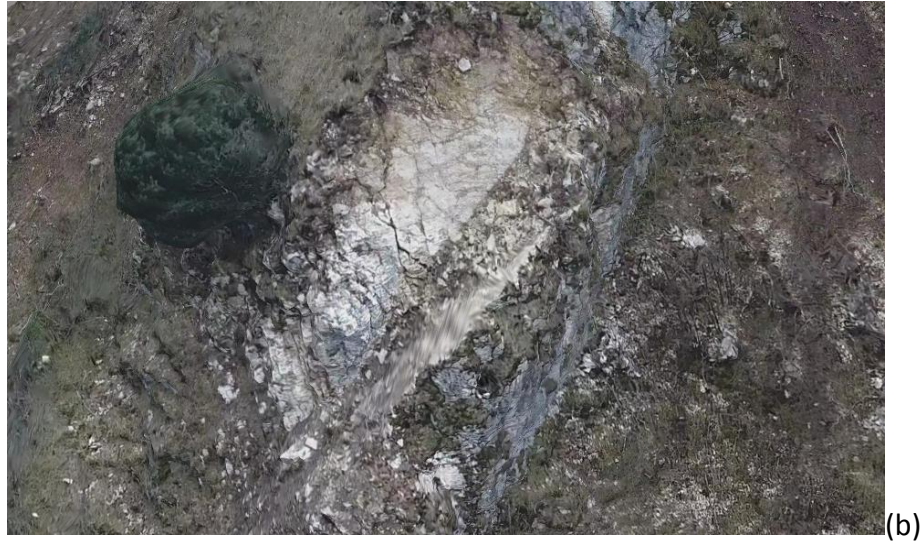
On the opposite valley flank a rock slide occurred at a height of about 100 m above the valley bottom and evolved into a small rock avalanche that fell into the Nera River (some blocks reached the opposite riverside). UAV drone surveys were instrumental in understanding landslide geometry, rock mass quality and failure mechanism. The oblique view in Figure 4.63a shows that the failed mass suffered intense fragmentation and eroded the slope with significant entraining of debris overlying the bedrock. Figure 4.63b indicates that sliding involved an intensely fractured wedge of Maiolica limestone delimited by two persistent joints.

Figure 4.63. General oblique view of the rock slide and subsequent rock avalanche on the left flank of the Nera valley (km 3 of SP134 motorway) (a); detail of the detachment area (b). Images taken from the 3D model generated by BYU on the basis of drone surveys.

The left joint (observing the slide from the opposite flank) was a sub-vertical, persistent, relatively smooth and striated fault plane, whilst the right joint seems a relatively planar joint dipping at low angle toward the valley. It is not clear if the mechanism was planar or three-dimensional. The wedge is sector-shaped with a height of 19 m and maximum transversal dimensions of 8m and 4 m respectively.

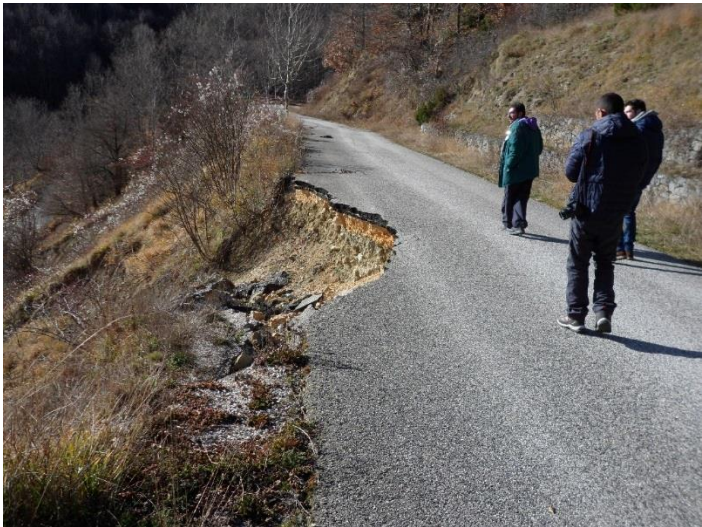
Figure 4.93. A slide observed on the fill slope.

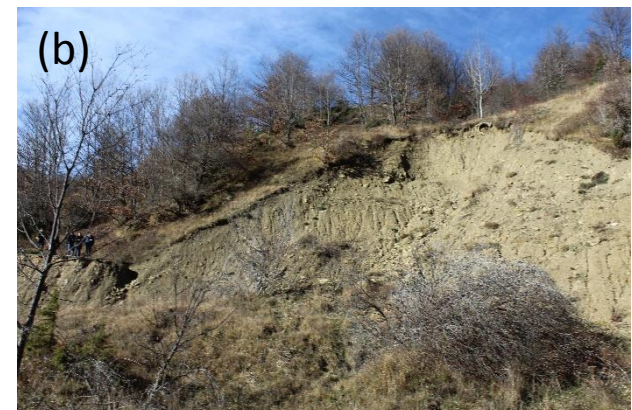
Figure 4.96. Minor scarps observed on the cut slope side of the road.

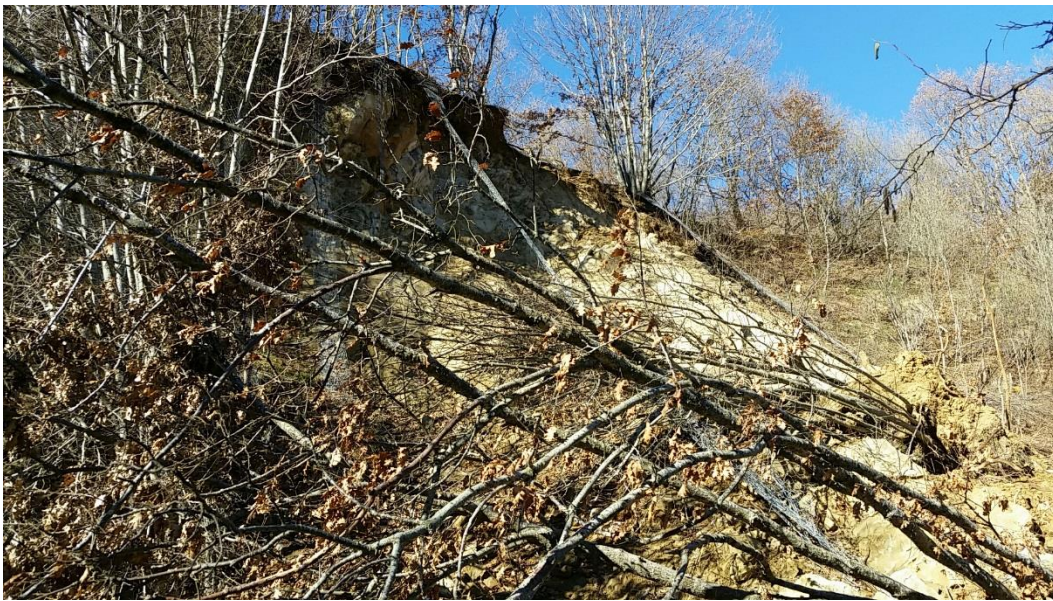
Figure 4.102. Landslide debris and head scarp. Also pictured is rockfall netting.

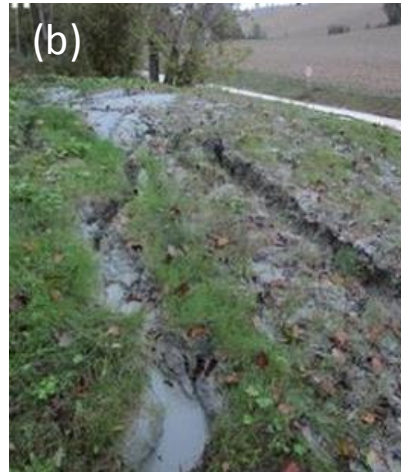
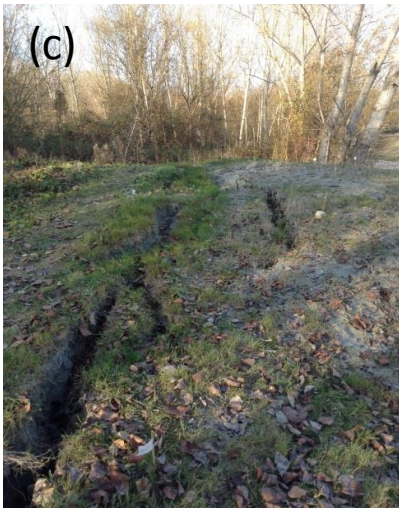
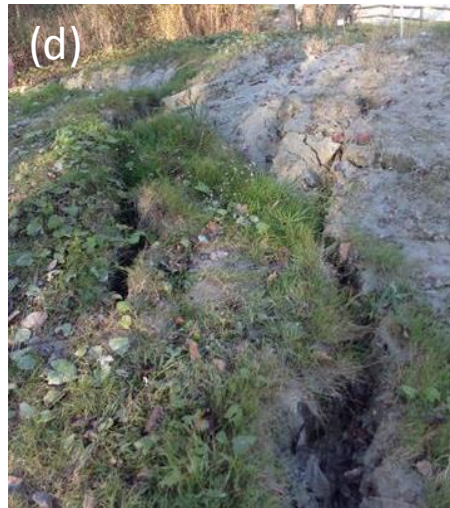
Figure 5.5. (a) and (b) photos of the mud volcano in Valle Corvone taken by INGV in November 2016 (INGV, 2016); (c) and (d) photos of the mud volcano in Valle Corvone taken from a common perspective by GEER in December 2016.

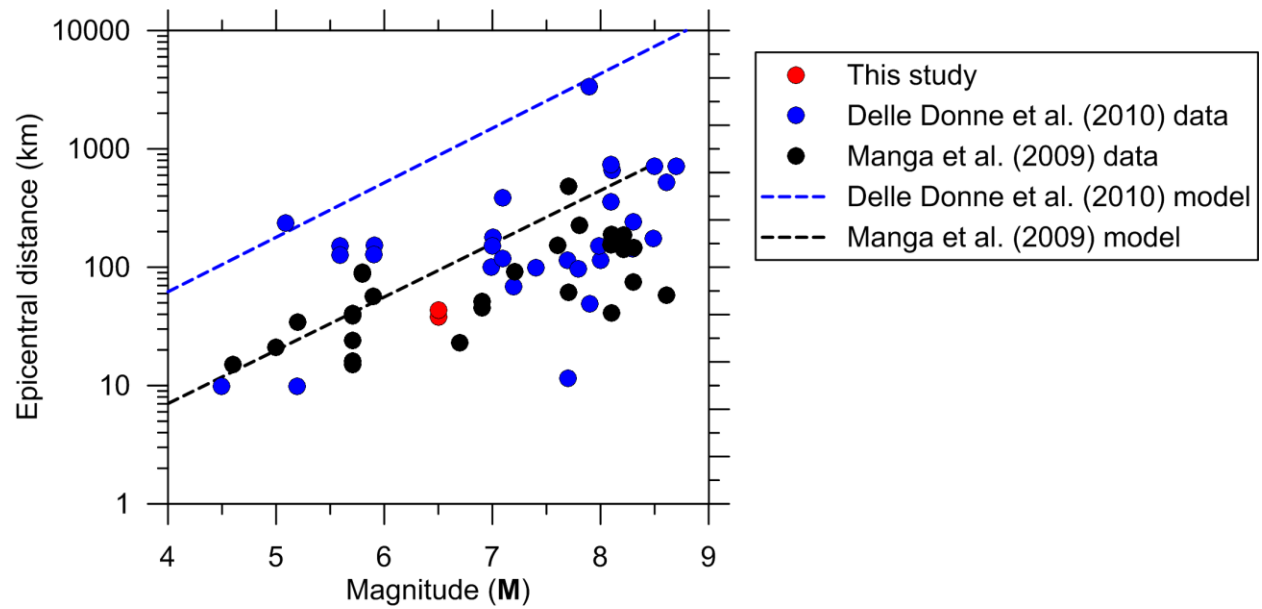
Manga et al. (2009) and Delle Donne et al. (2010) proposed empirical relationships for earthquake-induced eruptions, based on earthquake magnitude and distance (Figure 5.10). The limit curve of Manga et al. (2009) is based on an empirical database of 29 mud volcano eruptions that occurred following earthquakes with magnitudes $M=4.5-9.3$ at epicentral distances of $R_{epi}=4-900\text{km}$. Delle Donne et al (2010) based their relationship on a larger dataset of 68 data points derived for $M=4.5-9.5$ events and $R_{epi}=10-10000\text{km}$. The two limiting curves have similar shapes. Mazzini and Etiope (2017) argue that for large magnitude events, eruptions can be triggered at very long distances. Furthermore, Mazzini and Etiope (2017) point out that many data points lie above the threshold curve developed by Manga et al. (2009), also for relatively small magnitude events. As a result, they believe that the model by Delle Donne et al. (2010) should be generally preferred. Figure 5.10 shows all data points used by Manga et al. (2009) and Delle Donne et al. (2010), along with their limiting curves. Also shown in Figure 5.10 are the earthquake-triggered eruptions observed in this study. The data points related to the Central Italy earthquake are consistent with the general trend, and they lie below both limiting curves.

Figure 5.10. Earthquake magnitude versus epicentral distance for earthquake-triggered mud volcanoes, along with limiting curves from Delle Donne et al (2010, blue dashed curve), and Manga et al. (2009, black dashed curve). Red dots represent data collected in this study, blue dots are data points from Delle Donne et al. (2010), black dots are data points from Manga et al. (2009).

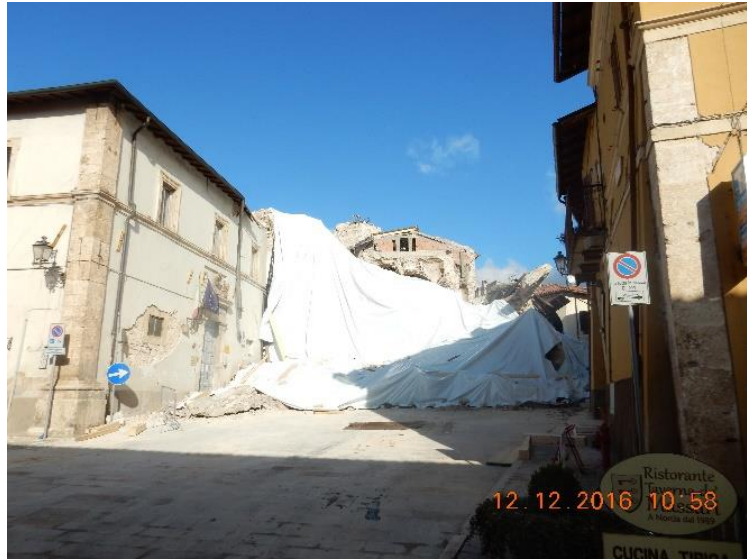
Figure 6.4. Building M1.

Apart from the wider assessment, a side-by-side comparison of significant structures with multi-epoch surveys is made. Figure 6.3 depicts the locations of the buildings presented. Figure 6.4 illustrates one of the churches that were slightly damaged by the first seismic event, but completely collapsed subsequently. Many historical churches in Norcia experienced the same kind of damage evolution. Figure 6.5 shows one exceptional case of a typical residential masonry building where the evolution of damage was rather moderate (damage state shifting from DS2 to DS3). Conversely, Figure 6.6 shows a residential building with irregular masonry construction. This group of buildings experienced an abrupt damage evolution, with an out-of-plane mechanism and increased in-plane damage. Finally, Figure 6.7 depicts the out-of-plane failure of an historical monastery leading to partial loss of support of the roof. Notably, the wall failure was concentrated at a level higher to that of the seismic retrofit, thus highlighting that local interventions should not be only localized on the ground level but also take into consideration the reduced axial load and weak diaphragm action of the masonry walls at higher levels.

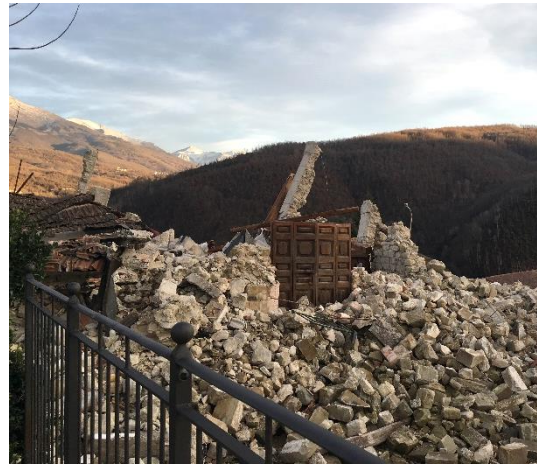
P01 (Church)

Figure 6.25. Representative pictures taken in Accumoli during the GEER survey (see Table 6.2).

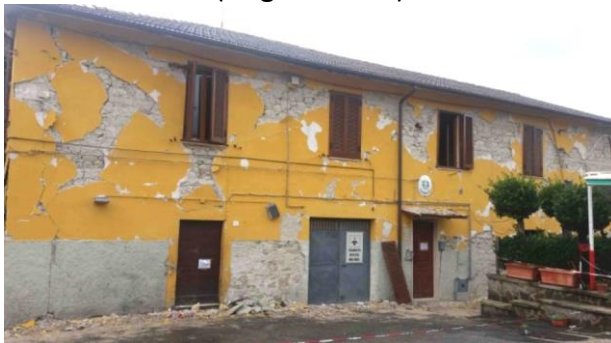
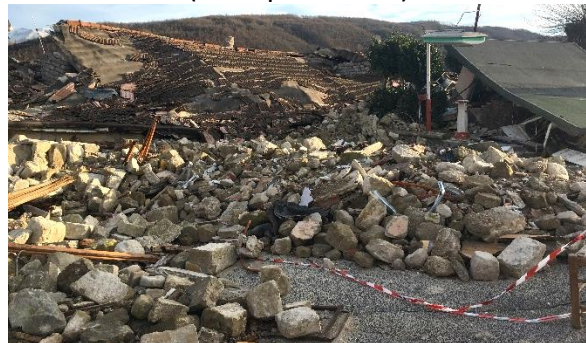
P03 (Police station, square side)

of the police station and the small church. Moreover, the retaining wall along the eastern side of the village experienced significant relative movements, most likely associated to the instability of the slope below.

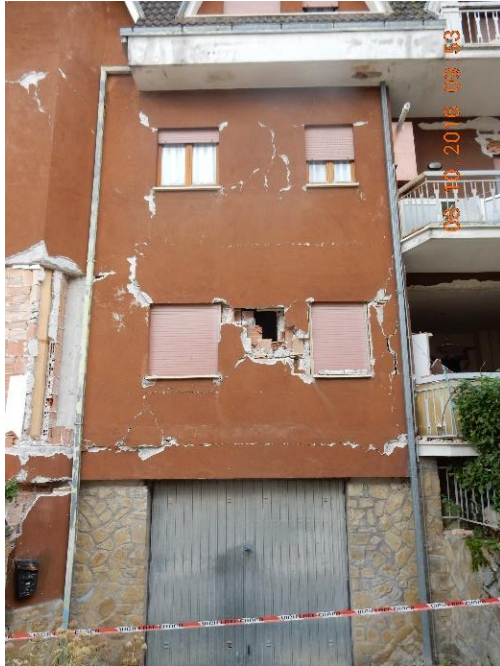
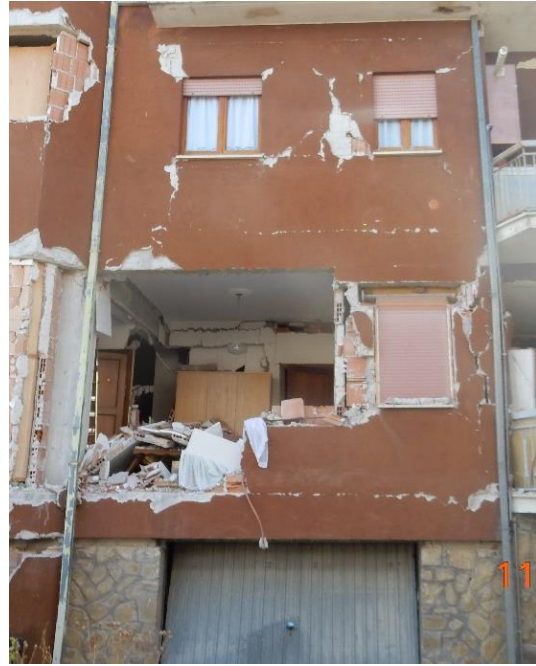
Figure 6.37. Building RC1.

Figure 6.37 illustrates building RC1 in the aftermath of the first event (a,c) and after the October sequence (b,d). It evident that the infill panel has failed out-of-plane after the seismic sequence (but not after the first main shock), whereas the shear failure at the top of the right column has been clearly pronounced. Figure 6.38 depicts building RC2, a dual shear wall – moment resisting frame built with the older Italian seismic code (The Italian National Annex DM 1996, Norme Tecniche per le Costruzioni, 1996; NTC96). Similar out of plane failure of the,

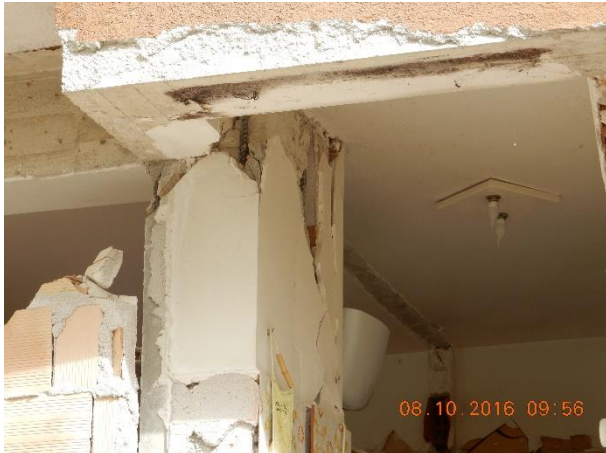
Figure 6.38. Building RC2.

initially diagonally cracked, infill panel is again observed as a result of shaking from multiple events. A detail of beam-column joint damage is illustrated in Figure 6.39 for building RC3. We observe cyclic degradation of column top, spalling of concrete, and minor longitudinal rebar buckling in the absence of adequate transverse reinforcement. Finally, building RC4 in Figure 6.40 experienced only minor damage after the August event but suffered out-of-plane failure of the majority of its infill panels subsequently, thus exposing the structure to a potential soft story mechanism. Performance of this type was characteristic of the area.

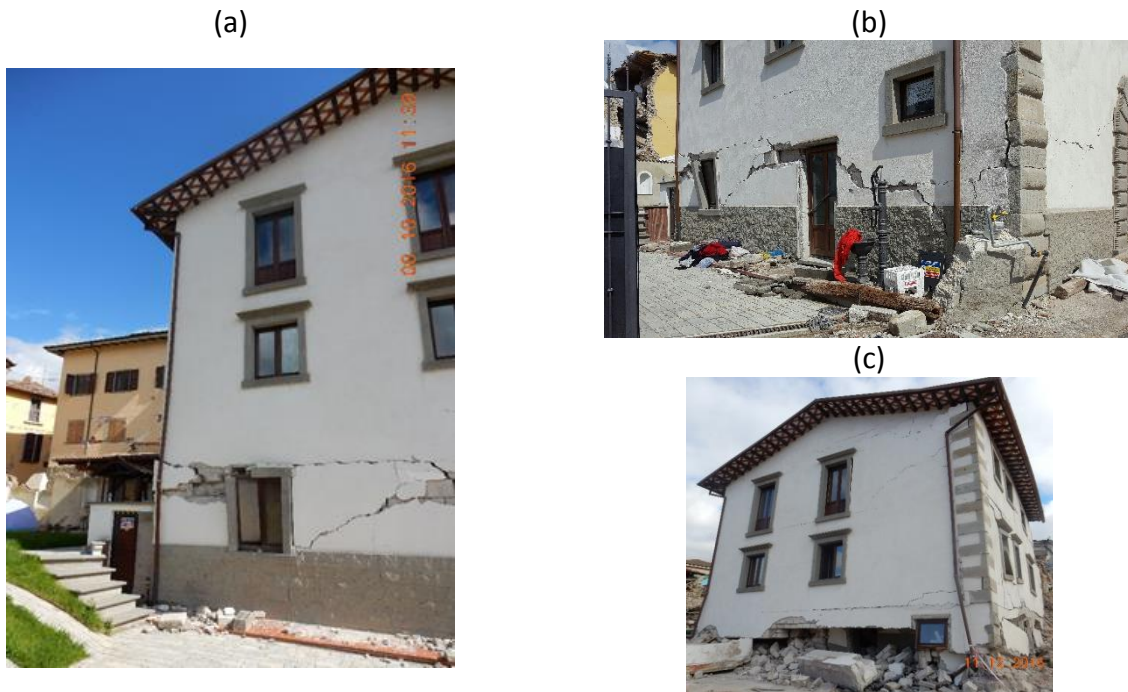
Figure 6.45. Building M4.

Figure 6.44 and Figure 6.45 present two buildings within the Amatrice red-zone, where initial damage of the outer masonry due to the first event evolved to partial collapse after the event sequence. This is also an interesting case in that such partial collapse is not always visible by satellite, thus highlighting the importance of careful on-site ground inspection. The soft-story of another masonry building is illustrated in Figure 6.45. Such a mechanism is presumably due to the higher stiffness of the upper part with respect to the ground floor, and due to the previous shear failures observed at the ground level in the aftermath of the first event. It is also a characteristic case where the evolution of damage in masonry structures under multiple seismic events, as well as the increase of the corresponding damage indeed, is strongly nonlinear. Figure 6.46 shows the complete collapse of a building that was heavily damaged from the first event.

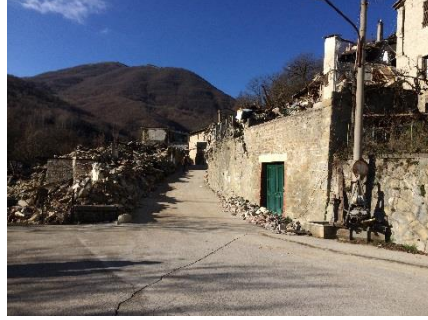
Figure 6.61 shows locations of selected buildings for which we show photos taken after the August and October events. Figure 6.62 shows these pictures, which were taken from a common perspective. Table 6.5 summarizes locations and damage levels for each of the representative structures. Structures M2, M3, and M4 (P1 and P2 in Figure 6.62) are unreinforced masonry buildings. They had damage levels ranging from D1-D3 after the August events and D5 (complete collapse) following the October events. We documented the performance of one reinforced concrete structure (RC1). It had no apparent damage from the August events and damage level D2 after the October events (P3 in Figure 6.62).

Picture	DATUM	Description	Location		September Damage Level	December Damage Level
			Lat.	Long.		
P1	WGS-84	Entrance of the historical center (M2-M3)	42.7353°	13.2532°	D3	D5
P2	WGS-84	Masonry buildings (M4)	42.7354°	13.2528°	D1	D5
P3	WGS-84	Reinforced concrete building (RC1)	42.7351°	13.2519°	D0	D2
P4	WGS-84	Santissima Maria Annunziata Church (M1)	42.7351°	13.2522°	D0	D3
P5	WGS-84	Santissima Maria Annunziata Church (M1)	42.7351°	13.2522°	D0	D3
P6	WGS-84	Santissima Maria Annunziata Church (M1)	42.7351°	13.2522°	D0	D3

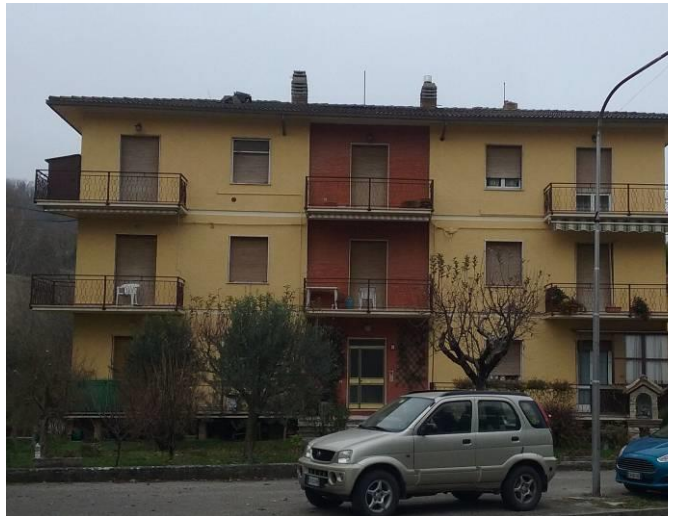
P17

Locations of representative photos taken in Pievebovigliana by the GEER team are reported in Figure 6.86. The pictures are presented in Figure 6.87. The historical center consists mainly of un-reinforced old masonry structures, 2-3 stories in height. Some of these structures have retrofitted. Outside of the historical center, isolated modern masonry and reinforced concrete structures were found (see P17-P18). Table 6.12 shows details and damage levels for the inspected structures.

Pievebovigliana was significantly damaged by the October events. However, the degree of damage to buildings is quite variable across the village. A preliminary damage zonation is reported in Figure 6.88. Damage levels as high as D3-D4 are concentrated in the southern portion (area of Castello or S. Maria Assunta church) built on a slight ridge oriented NNW-SSE that is comprised of Scaglia-Cinerea bedrock. Topographic site effects may have impacted structural performance in this area. The northern and central portions of the village generally have damage levels D2 to D2-D3. These areas are mainly located on alluvial terraced deposits. Minor damage was observed along the western portion of the village; the northern part of this area, located on alluvium, has relatively modern buildings (see P17) while the southern area is on bedrock at the toe of the Scaglia-Cinerea ridge.

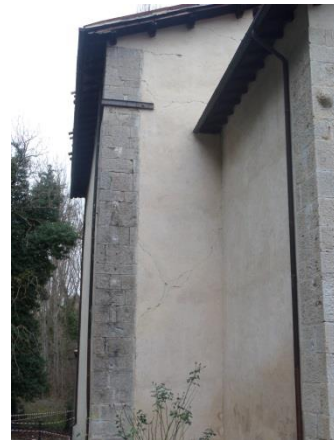
Figure 6.111. Representative pictures of church in Preci (Lat = 42.881418, Lon = 13.036290).

Guado. Ground motion levels are reported in Table 6.1. The main village was lightly damaged. Figure 6.110 shows the location of representative pictures taken in Preci, while Figure 6.111 shows a church with damage level D1.

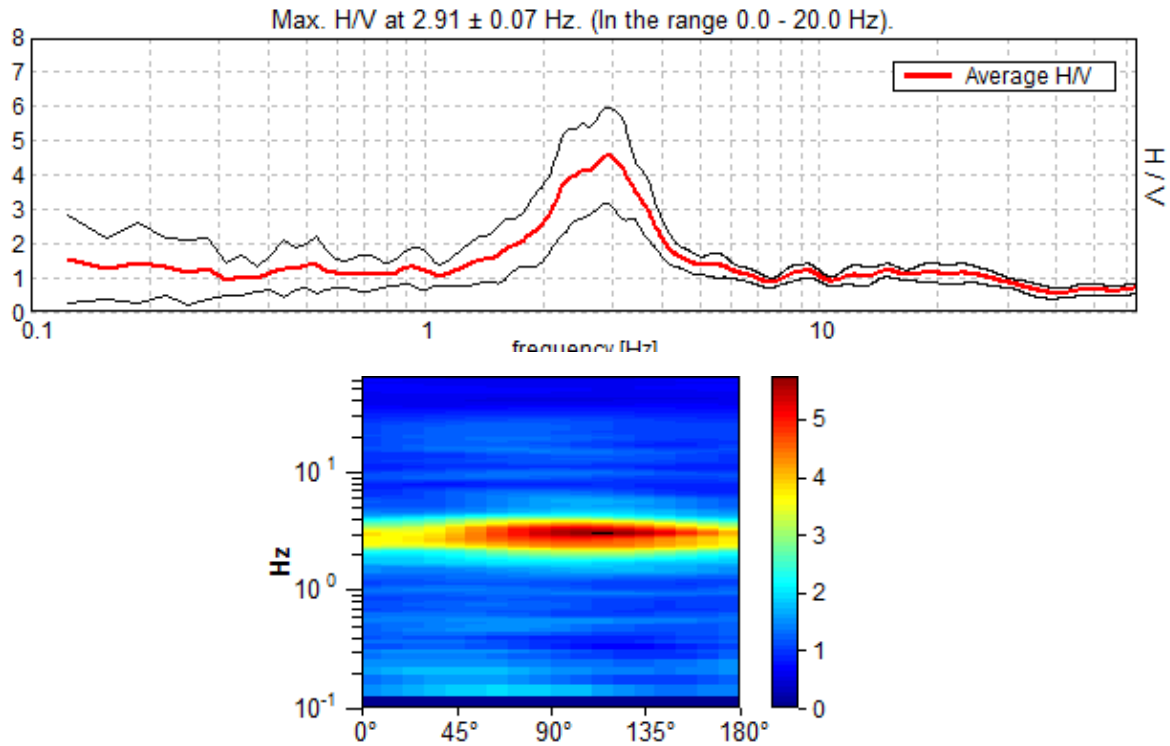
Figure 6.122. Noise measurements results in terms of H/V spectral ratio (top) and H/V polar plots (bottom).

A noise measurements (T01 in Figure 6.120) was carried out during the survey on the ridge on to which San Lorenzo is founded. The same instrument and data acquisition procedure described for Visso survey were employed. Average horizontal-to-vertical (H/V) spectral ratios and polar H/V plot are reported in Figure 6.122. A peak can be identified at about 3 Hz polarized in the direction of about 100°, i.e. perpendicular to the axis of the ridge, thus indicating possible topographic site effects (Pagliaroli et al., 2015).

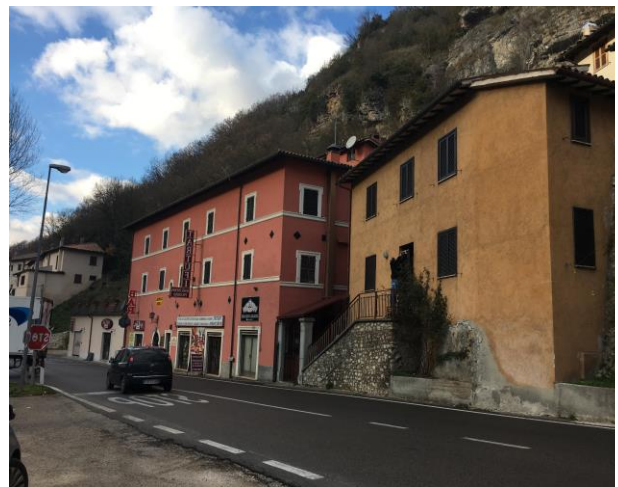
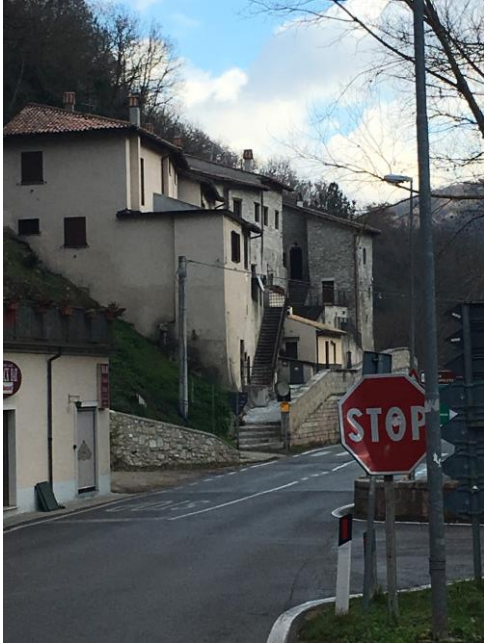
Serravalle is a hamlet part of the municipality of Norcia, in the province of Perugia, Umbria region. Serravalle is located about 6 kilometers from Norcia and it has a population of 25 people. Ground motion levels are reported in Table 6.1 The hamlet was not damaged by the earthquake and the generalized damage level was D0 (Figure 6.123, Table 6.22).

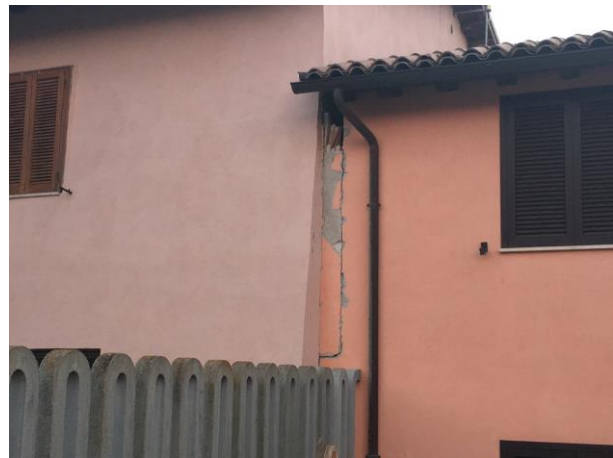
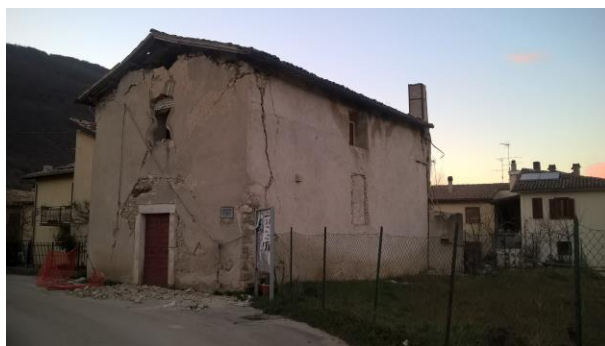
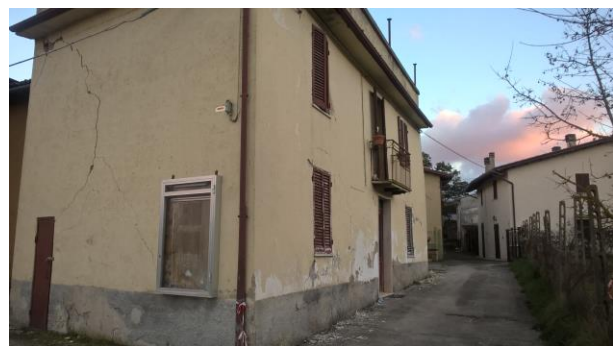
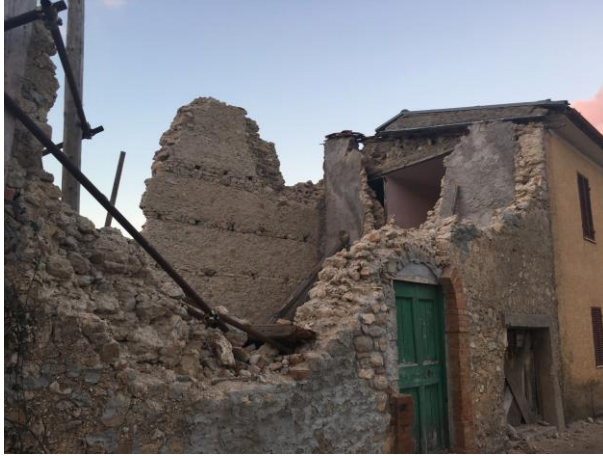
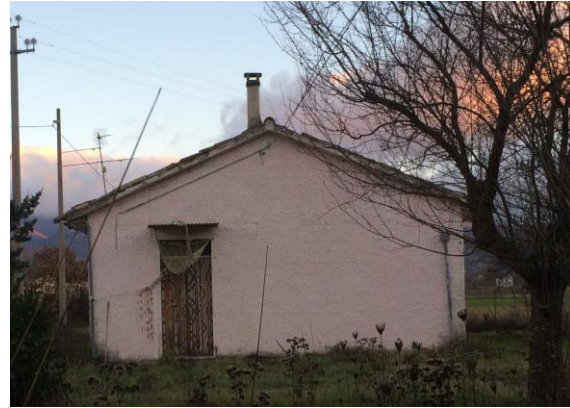
level damage ranging from D0 to D5. Only poorly constructed masonry buildings experienced major damage.
