Engineering Reconnaissance Following the October 2016 Central Italy Earthquakes - Version 2

GEER Team Leaders: Jonathan P. Stewart and Giuseppe Lanzo

Geotechnical Extreme Events Reconnaissance Association
Report No. GEER-050D
8 May 2017

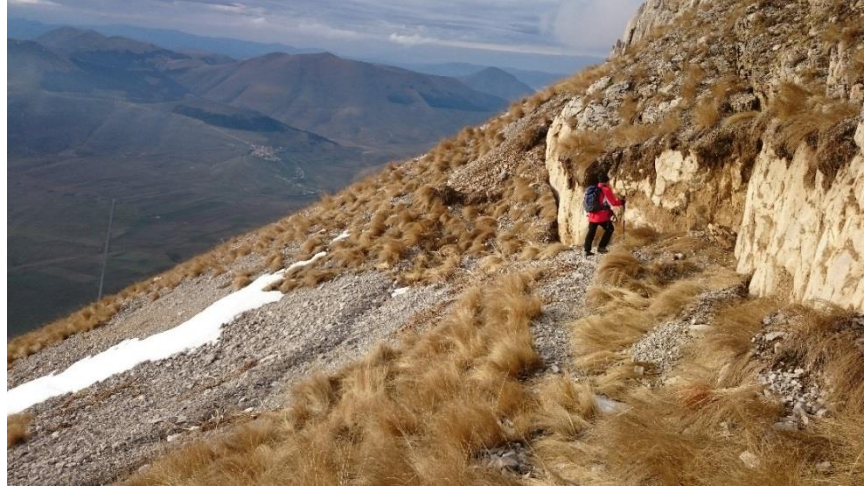
Figure 2.14. Location of maximum fault offset of 210 cm following October 2016 events. The August event offset at this location is estimated as 20 cm, based on nearby data points. Lat = 42.81687, Long = 13.25503.

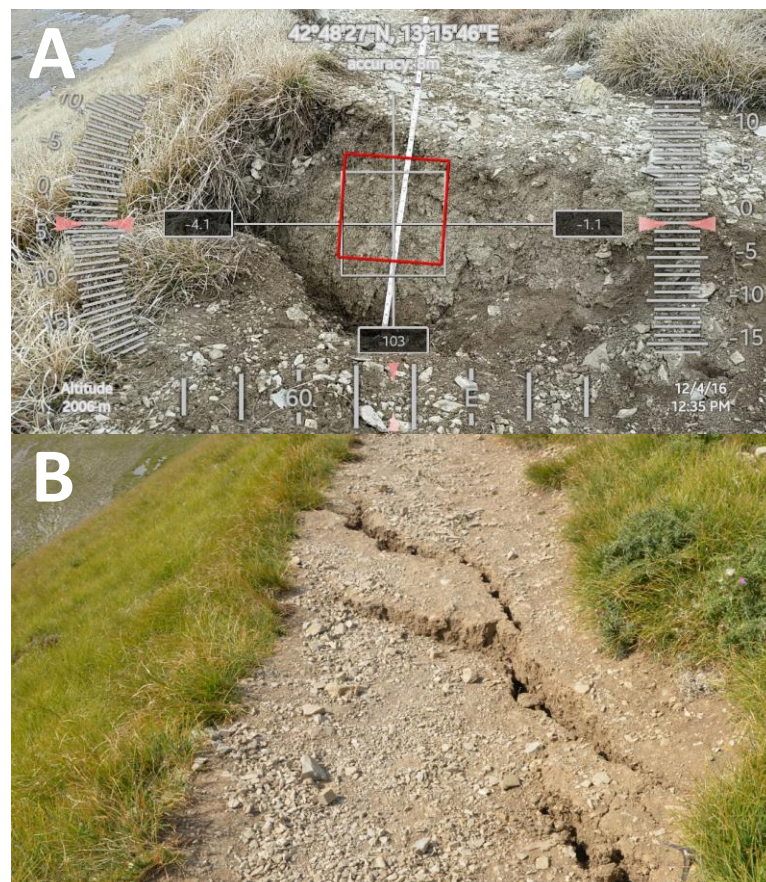
Figure 2.15. Fault offset measurement across the footpath on the west face of Mt. Vettore. Offset measured as 80 cm following October events (a). This offset was 30 cm following August events (b). Lat = 42.807379, Long = 13.262966.

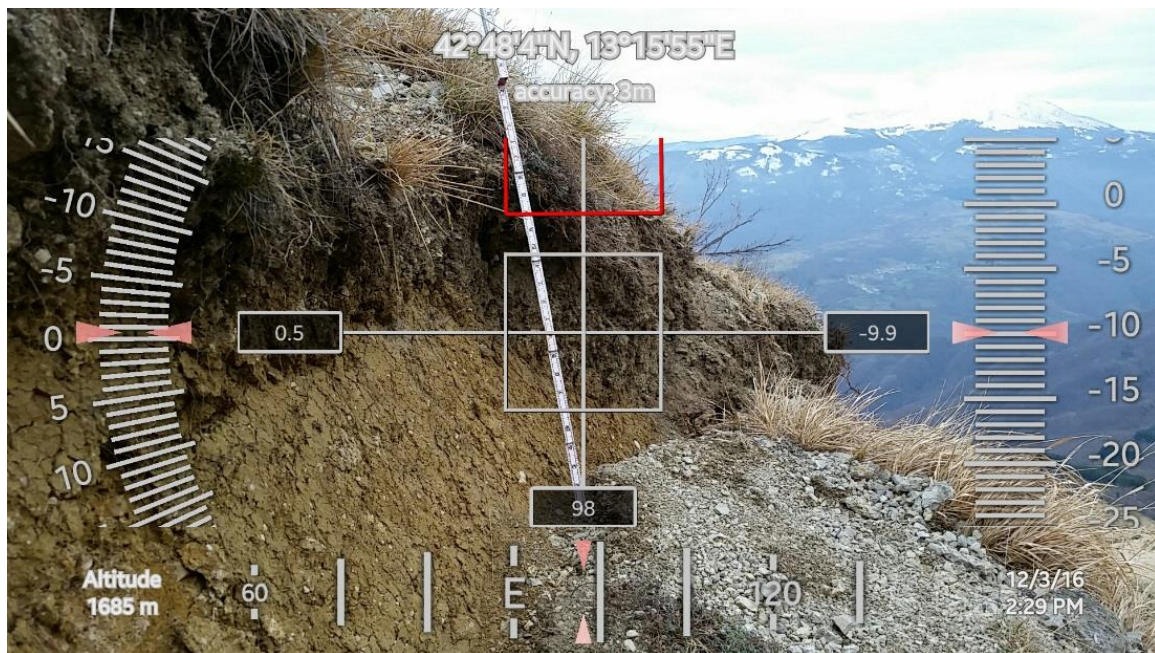
Figure 2.18. Fault offset measurement in gulley on south face of Mt. Vettore. Offset measured at 80cm. August offset data nearby is 15cm, indicating October 2016 offset of 65cm.

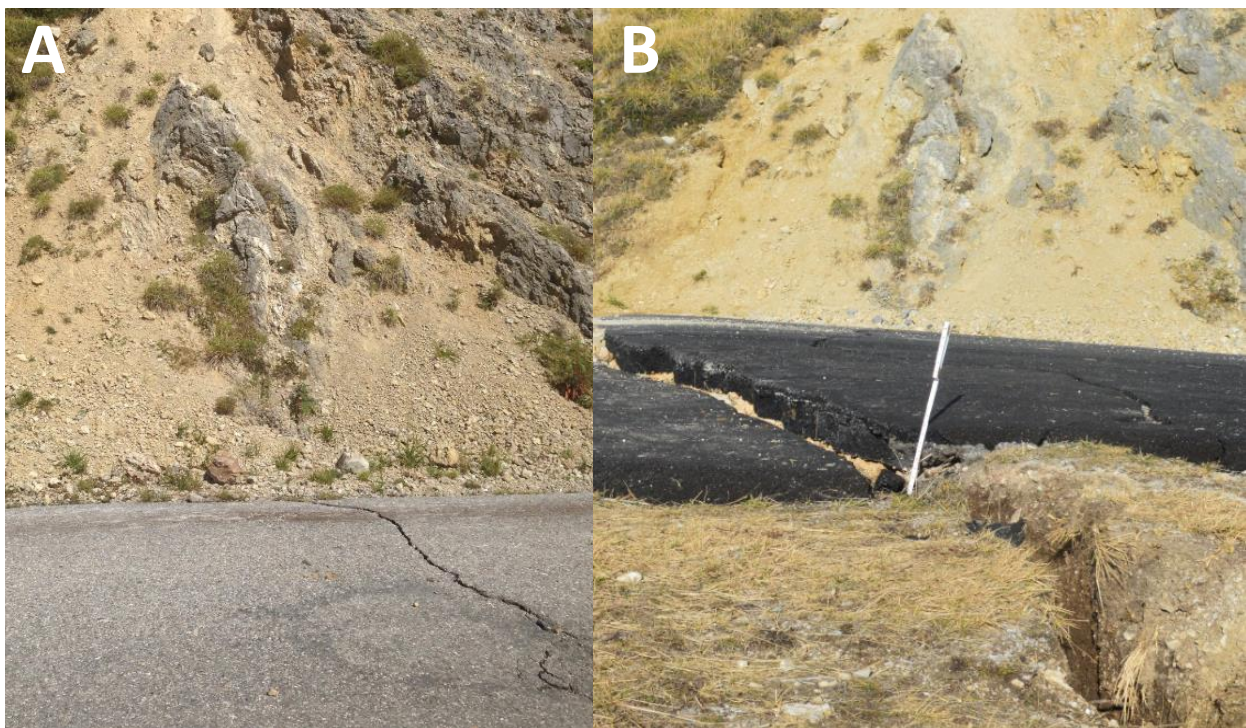
Figure 2.19. Fault offset measurement across SR477 on south face of Mt. Vettore. August offset data nearby is 2cm (a). Offset measured at 18cm to 20cm after October (b). Lat = 42.796829, Long = 13.265899.

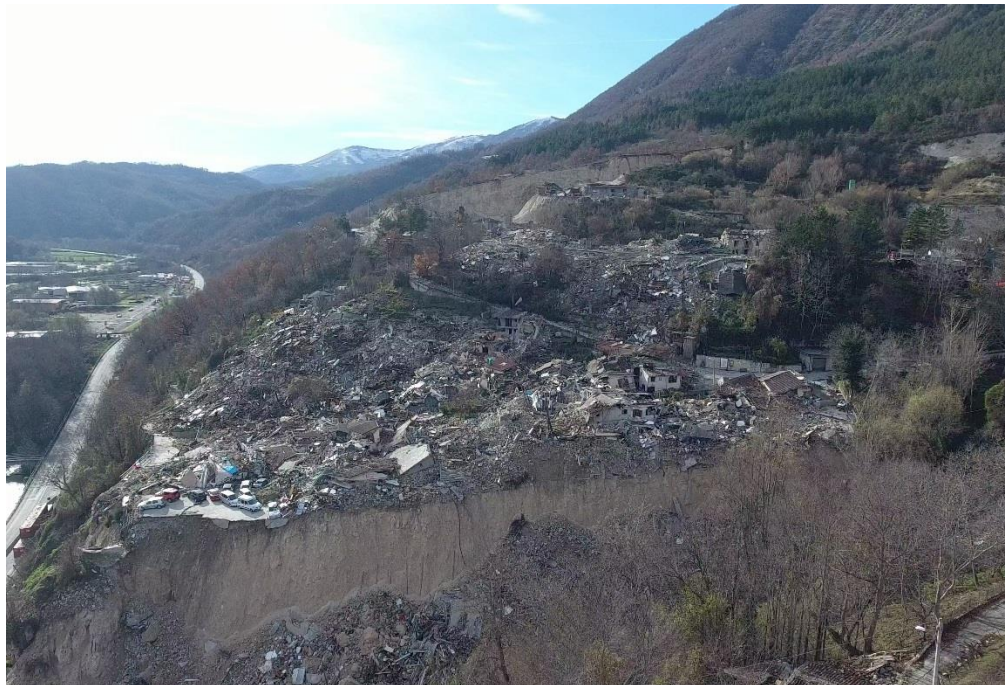
Figure 4.13. Pescara del Tronto aerial photograph taken from the Phantom 4 UAV.

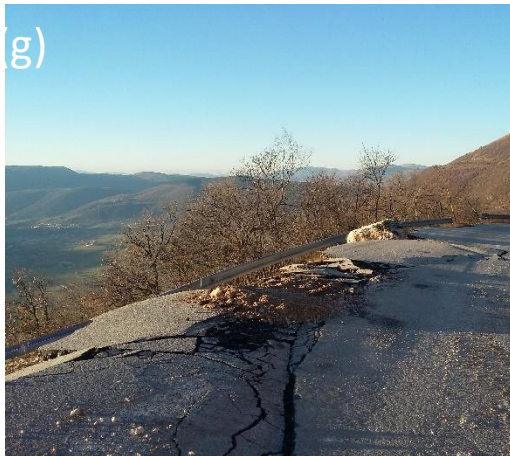
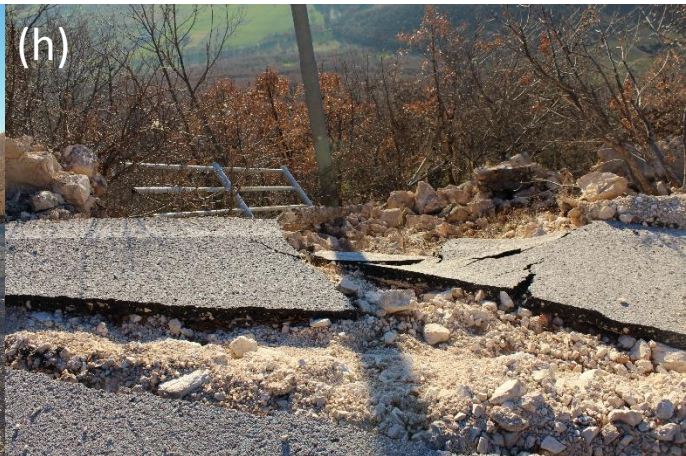
We performed a field reconnaissance along the SP 477 (indicated in Figure 4.71). During our visit (December 10, 2016), public vehicular movement along the road was not possible because of pavement fissures, embankment failures and rock obstructions. Indeed, several rock fall sites and mass movements along SP477 were observed between 42.776881N 13.143958E and 42.770243N 13.151854E. Roadway damage mainly consisted of cracks along the road, uneven track trails, edge barriers destroyed by rock falls, and damaged rock protection nets. Several boulders were unstably supported by vegetation on the steep mountain slopes. Due to steep slopes, most of the falls should have run down, however countable debris was still present on road pavement during our visit. Generally, boulder sized rocks were present in debris and the same sized were found in the unstably supported condition. A systematic overview of the various damage features is presented in Figures 4.74-4.79. Minor damage in culvert was observed across the road section. A telecommunication facility near the road pavement was found to be not damaged due to rockfall (see Figure 4.80).

Figure 4.79. Fracture along the road, large vertical offset due to fracture and ultimate movement, damaged edge barriers and debris and boulders on the road surface.

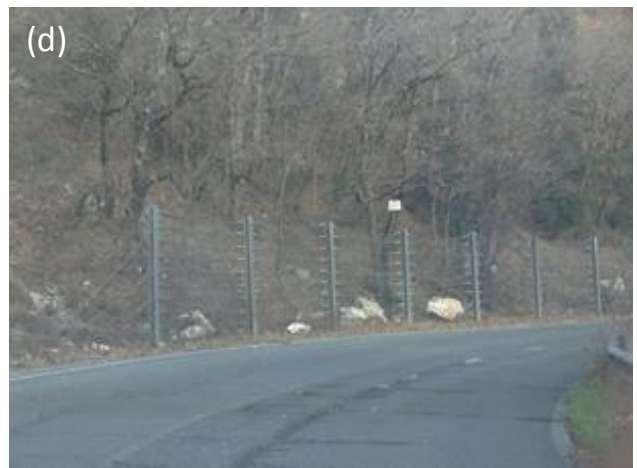
The area has been subjected to slump failures in the past. As a result, slope protections (i.e. rockfall nets, dynamic rockfall barriers or catch fences) are present along the road. Figure 4.83 shows many cases in which rock-nets have been passed over or damaged by boulders and rock-blocks. The slope located on the right bank of the Nera river has been interested by various slope instability events. They consisted of gravel debris. These features (Figure 4.84) are similar to those observed for the Nera landslide (Section 4.2.1) but very limited spatially and in volume.

Figure 4.83. Slope protection damaged by boulders and rock-blocks.

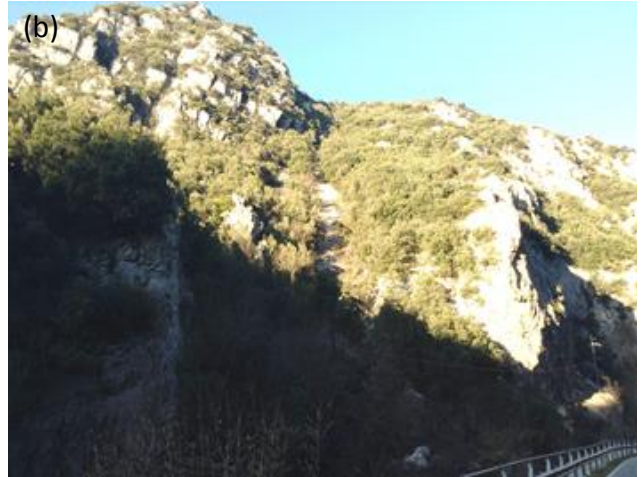
Figure 4.84. Debris occurred on the right bank of the Nera river along SP209 (lat 42.9157N, lon 13.0456E).

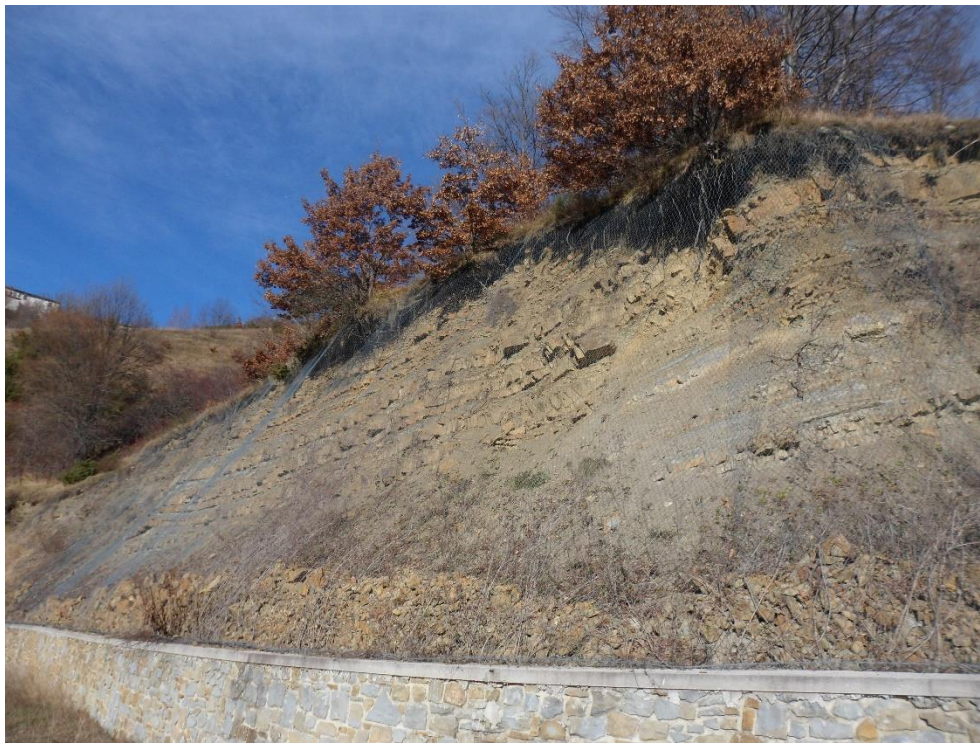
Figure 4.97. Rock-net protection with captured debris.

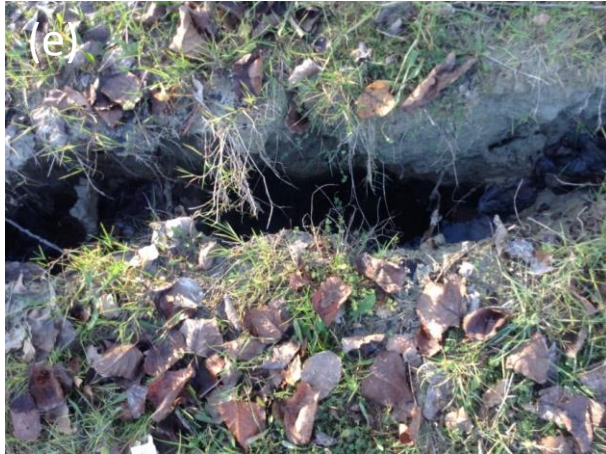
We inspected two mud volcanoes that erupted within one day from the **M6.5** 30 October earthquake event (Figure 5.3): (1) Santa Maria in Paganico (Figures 5.4a-b) and (2) Valle Corvone (Figures 5.4c-d-e-f). In both cases, we observed fresh deposits of ejected material. Both eruptions, are located within 45 km from the epicenter. . During our reconnaissance activities, both mud volcanoes showed a reduced activity, with a small emission of water. We inspected the sites about one month after the INGV reconnaissance mission. We did not detect any new activity or variations in the soil surface conditions in the inspected area as shown in Figure 5.5. As shown in Figure 5.4c-d-e-f, the material erupted by the mud volcano located in Valle Corvone covered a wide area involving both the river and the pavement of the road. This mud volcano is characterized by radial fractures 140 cm long, 38 cm wide and 80 cm deep. This eruption partially blocked the Ete river's course (Figure 5.4f).

Figure 5.4. (a) overview of the mud volcano in Santa Maria in Paganico; (b) sampling activities in in Santa Maria in Paganico; (c) crack originated by the mud volcano in Valle Corvone, (d) mud volcano in Valle Corvone, (e) details of a crack in Valle Corvone, (f) close-up view of the material ejected in the Ete Vivo river (Valle Corvone).

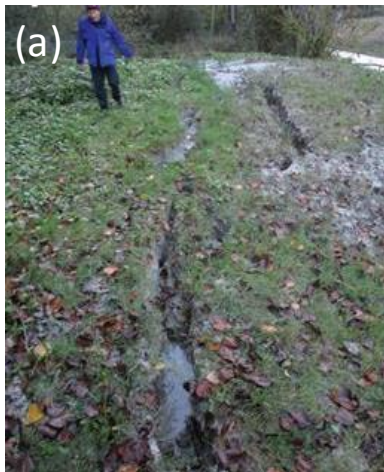
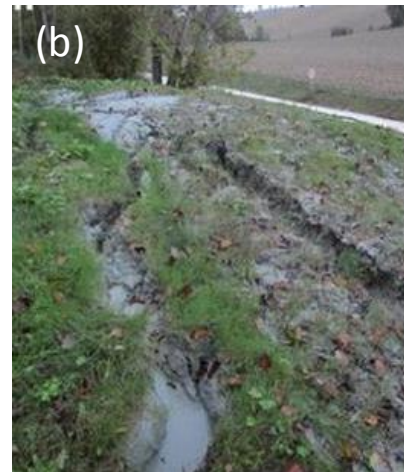
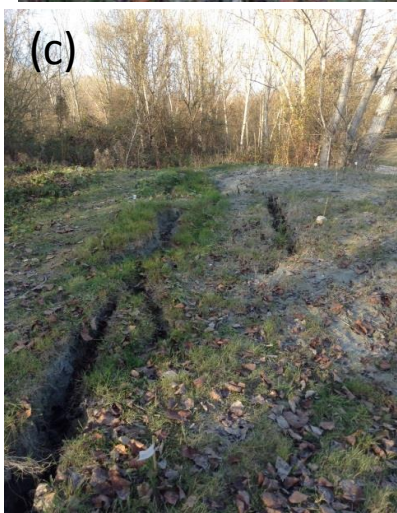
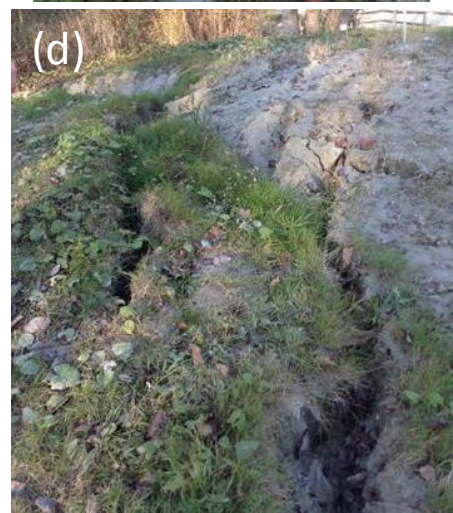
Figure 5.5. (a) and (b) photos of the mud volcano in Valle Corvone taken by INGV in November 2016 (INGV, 2016); (c) and (d) photos of the mud volcano in Valle Corvone taken from a common perspective by GEER in December 2016.

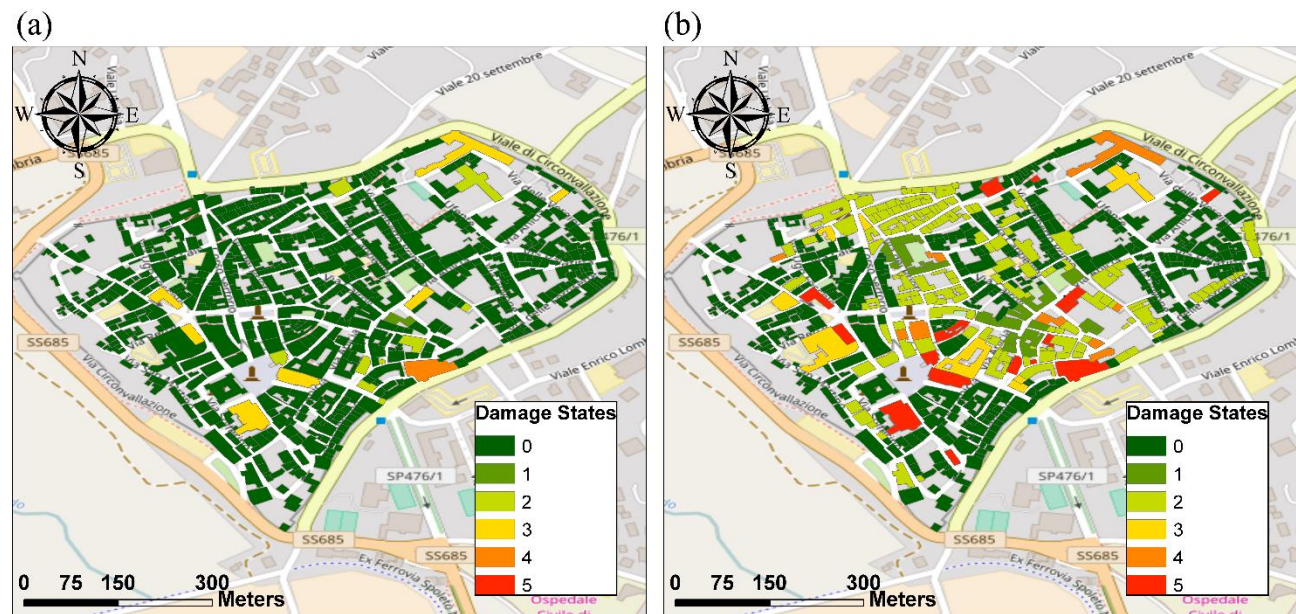
Norcia's buildings were not severely affected by the first event in August 2016. After the multiple October events, several structures suffered moderate-to-significant of damage or collapse. Figure 6.1 shows the evolution of damage between the two inspections. The distribution of Damage States among the buildings inspected in the red-zone of Norcia is shown in Figure 6.2. These figures show that the structural damage in Norcia was much more severe in the October events than in the earlier August events.

Even though the majority of the building stock is masonry, there is no disproportional damage observed between the first and the sequence of seismic events (Figure 6.1). This is because, unlike Amatrice (Section 6.1.3), the initial damage state of most buildings after the August earthquake was D0, hence the structures had adequate strength to resist the subsequent earthquakes. By focusing more carefully on Figure 6.2, it is also evident that the few structures that suffered damage during the first event, indeed presented a disproportional level of damage increase shifting from DS3 to DS5. Based on the above comparative assessment it can be concluded that masonry structures are particularly prone to failure under cascading seismic events provided that one event in the sequence initiates non-catastrophic damage, a fact that highlights the importance of quick visual inspection and reliable retrofit.

Figure 6.1. Evolution of damage after (a) the 24 August earthquake, and (b) the October events.

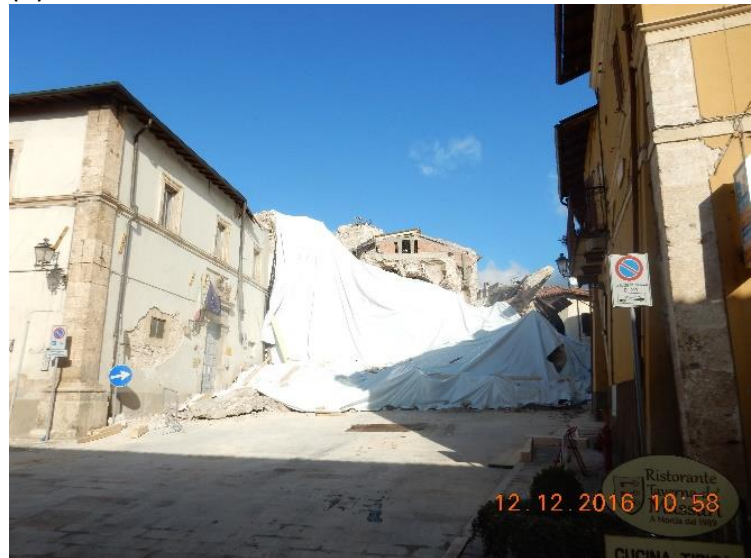
Figure 6.4. Building M1.

Apart from the wider assessment, a side-by-side comparison of significant structures with multi-epoch surveys is made. Figure 6.3 depicts the locations of the buildings presented. Figure 6.4 illustrates one of the churches that were slightly damaged by the first seismic event, but completely collapsed subsequently. Many historical churches in Norcia experienced the same kind of damage evolution. Figure 6.5 shows one exceptional case of a typical residential masonry building where the evolution of damage was rather moderate (damage state shifting from DS2 to DS3). Conversely, Figure 6.6 shows a residential building with irregular masonry construction. This group of buildings experienced an abrupt damage evolution, with an out-of-plane mechanism and increased in-plane damage. Finally, Figure 6.7 depicts the out-of-plane failure of an historical monastery leading to partial loss of support of the roof. Notably, the wall failure was concentrated at a level higher to that of the seismic retrofit, thus highlighting that local interventions should not be only localized on the ground level but also take into consideration the reduced axial load and weak diaphragm action of the masonry walls at higher levels.

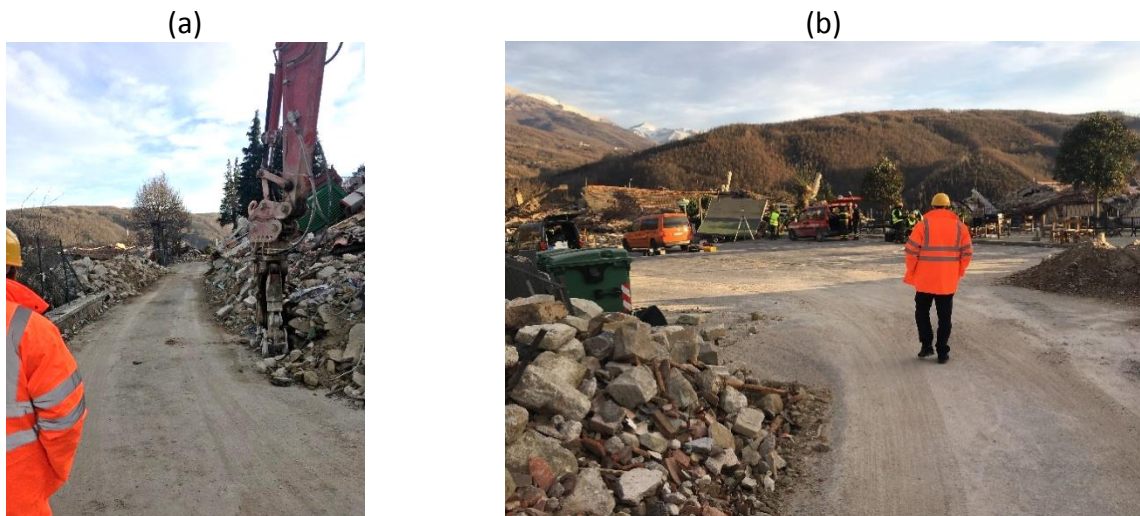
Figure 6.20. (a) Access route to the lowest (easternmost) portion village (V1). (b) Piazza San Francesco (V2).

At the time of the visual inspection by the GEER team, the only accessible walking route was the one connecting the village entrance to the main square, because of the major building damage and collapse in the surrounding areas (Figure 6.20). As a result, a detailed inspection was feasible only within the eastern part of the village, the western part being inspected by means of UAVs. Figure 6.21, Figure 6.22, and Figure 6.23 illustrate the upper part of the village with a colored scale distinguishing three main zones of distinct level of damage.

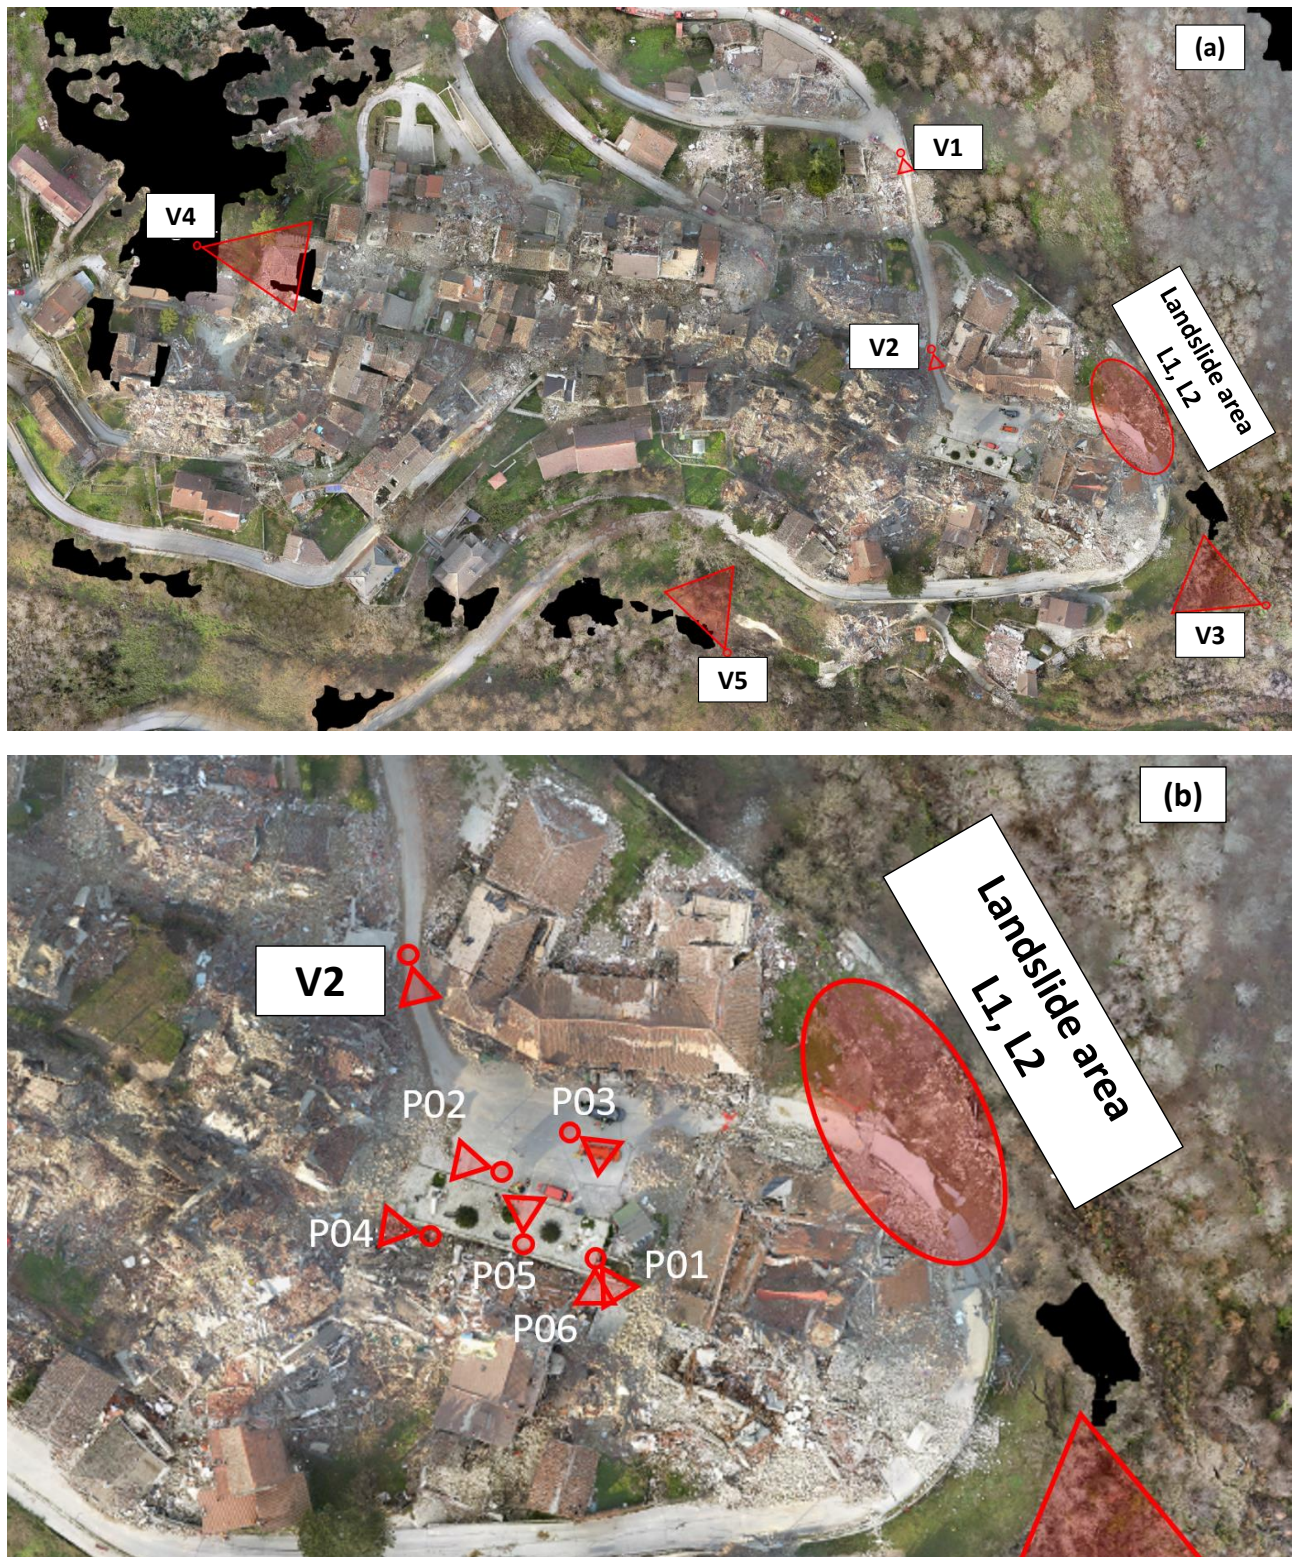
Figure 6.24. Ortho-images captured on December: (a) overview; (b) zoom on Piazza San Francesco.

The current orthophoto of the village is presented in Figure 6.24 with the location and orientation of pictures depicting multi-epoch damage states for individual structures. Further details are summarized in Table 6.2 to document the photographed structures and to compare the damage levels detected after the September and December visual inspections. Figure 6.25 shows photos presented in Table 6.2.

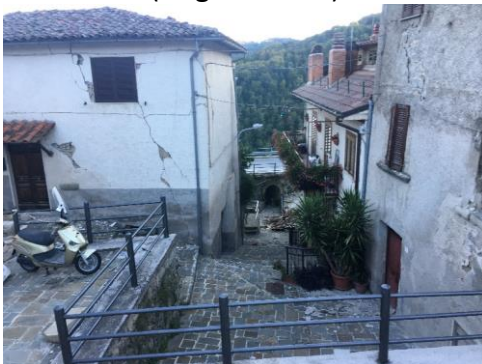
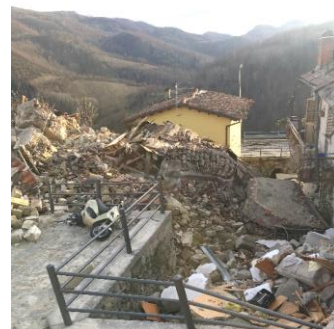
P05 (Northern view from square, bar on the background)

Picture	DATUM	Description	Position		September Damage Level	December Damage Level
			Lat.	Long.		
V1	WGS-84	Pedestrian route crossing the village	42.694972°	13.248886°	D3	D5
V2	WGS-84	Piazza San Francesco entrance	42.694601°	13.248556°	D3	D5
V3	-	Air view east-west direction	-	-	D1-2	D5
V4	-	Air view west-east direction	-	-	D1-2	D4
V5	-	Air view south-north direction	-	-	D1-2	D3/4
P01*	WGS-84	Church	42.694073°	13.249509°	D4	D5
P02*	WGS-84	Town hall	42.694304°	13.249263°	D3	D5
P03*	WGS-84	Police Station (view from the square)	42.694325°	13.249507°	D3	D5
P04*	WGS-84	Western (view from the square)	42.694215°	13.248842°	D2	D5
P05*	WGS-84	Northern view from the square (bar)	42.694428°	13.249379°	D3	D5
P06*	WGS-84	Small square in front of the church	42.694073°	13.249509°	D2	D5
P07	WGS-84	Panoramic view of the square	42.694215°	13.248842°	D2	D5

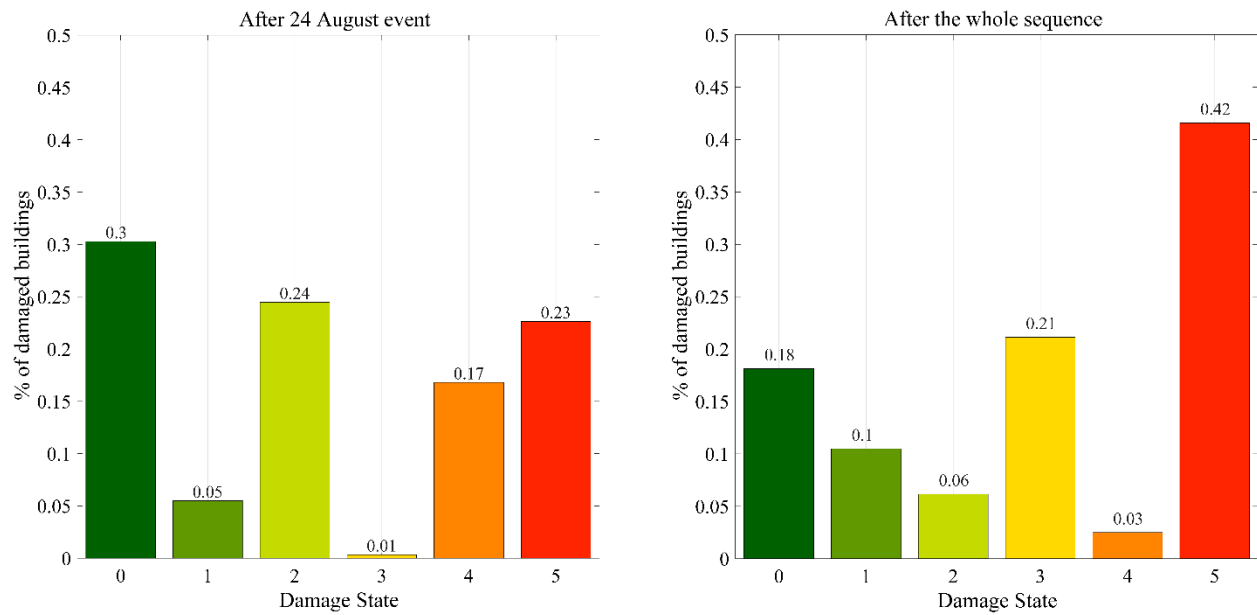
Figure 6.29. Percentage of damaged structures (a) in the aftermath of first event and (b) after the whole sequence.

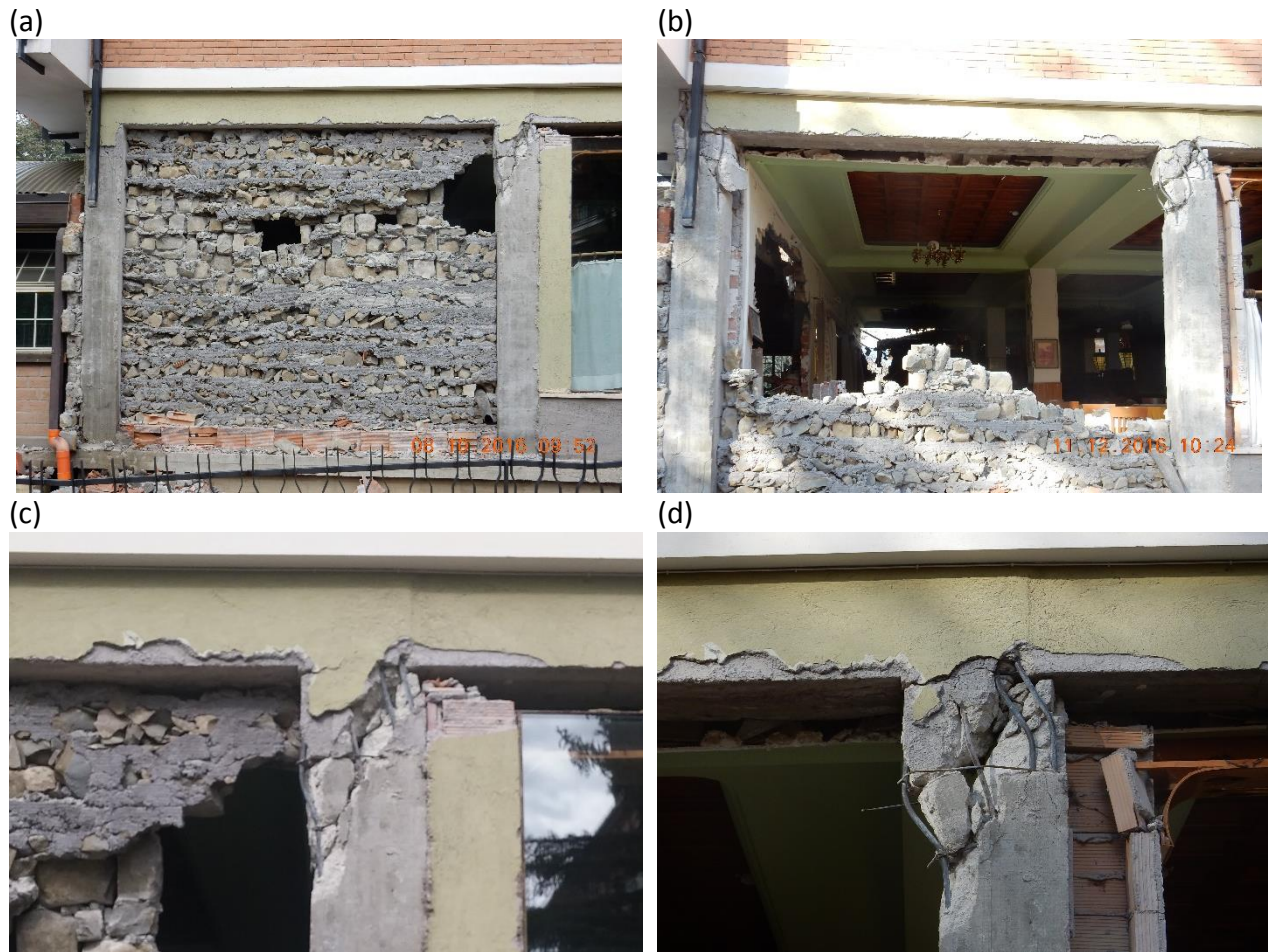
Figure 6.37. Building RC1.

Figure 6.37 illustrates building RC1 in the aftermath of the first event (a,c) and after the October sequence (b,d). It evident that the infill panel has failed out-of-plane after the seismic sequence (but not after the first main shock), whereas the shear failure at the top of the right column has been clearly pronounced. Figure 6.38 depicts building RC2, a dual shear wall – moment resisting frame built with the older Italian seismic code (The Italian National Annex DM 1996, Norme Tecniche per le Costruzioni, 1996; NTC96). Similar out of plane failure of the,

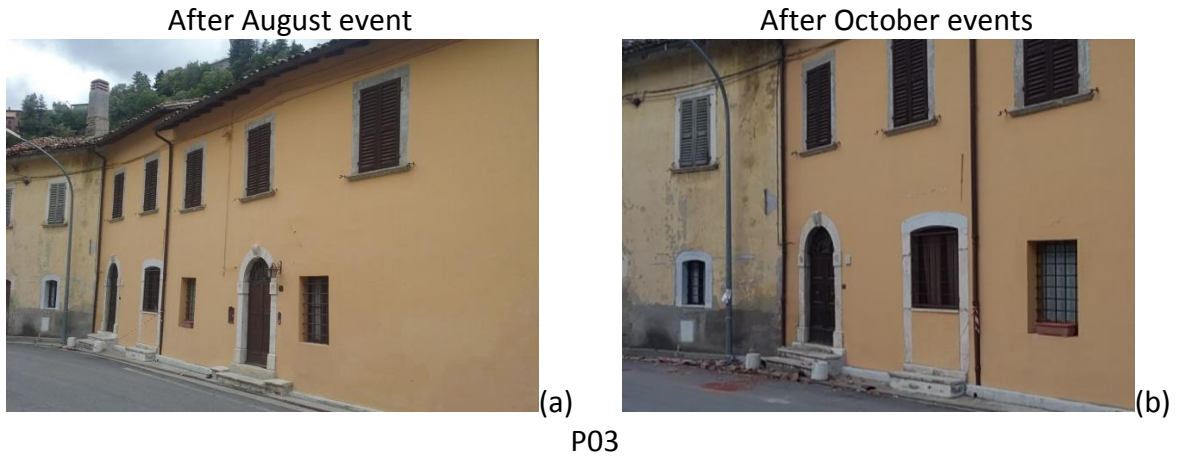
The photographs in Figure 6.48 show Arquata del Tronto after the August and October events, from which a substantial damage increase is evident following the 26 and 30 October earthquakes. Conversely, Borgo did not suffer appreciable cumulated damage, as shown in Figure 6.49 and Figure 6.50. Figure 6.51 shows the collapse of a structure onto the access road for Arquata village. At the time of our November reconnaissance, the village was not accessible and much of the village center was destroyed. The damage level assigned to Arquata del Tronto

Figure 6.49. A reinforced masonry building in Borgo (a) after the 24 August earthquake, and (b) after the October events.

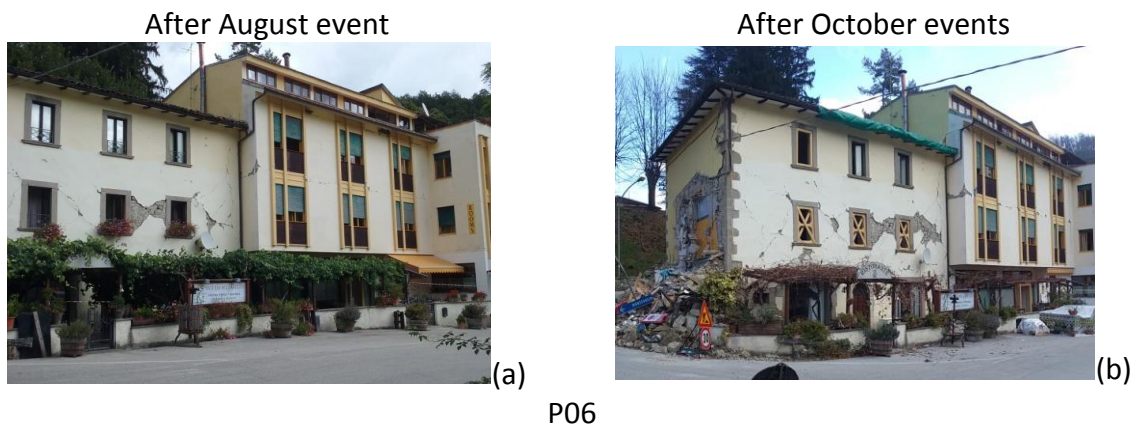
Figure 6.50. A building in Borgo (a) after the 24 August earthquake, and (b) after the October events.

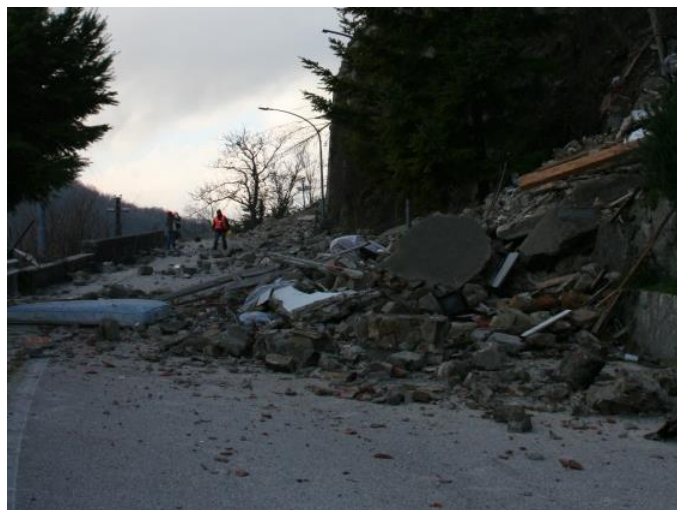
Figure 6.51. Access road to Arquata del Tronto after the October events.

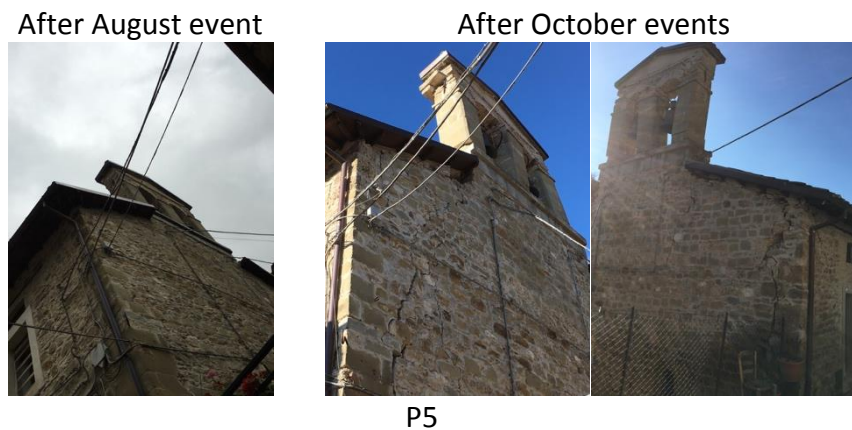
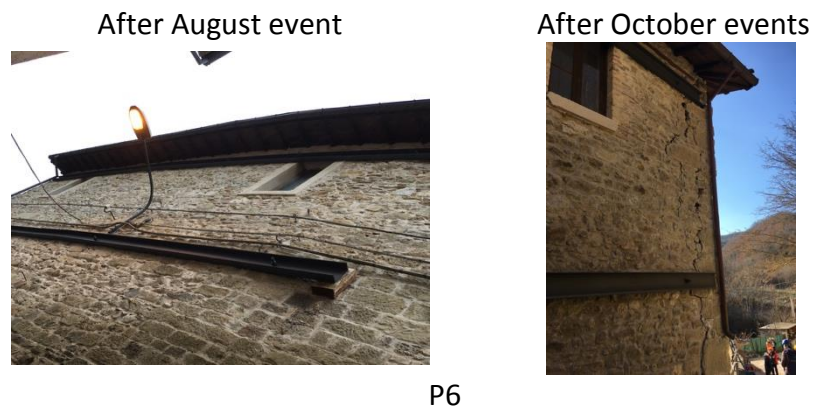
Figure 6.62. Comparative pictures of selected structures in Tufo after the 24 August event, and after the October events.

An important monument in Tufo is the *Santissima Maria Annunziata Church*. It is a church built in the XVII century that appears to have been recently retrofitted. The church had no apparent damage (D0) from the August events (P4, P5, and P6 in Figure 6.62) and damage level D3 (partial collapse of façade around the rose window; P4 in Figure 6.62) following the October events. Figure 6.62 also shows multiple layers of untied bricks and significant new cracks at corners (P5 and P6), possibly from lack of lateral reinforcement at the corner.

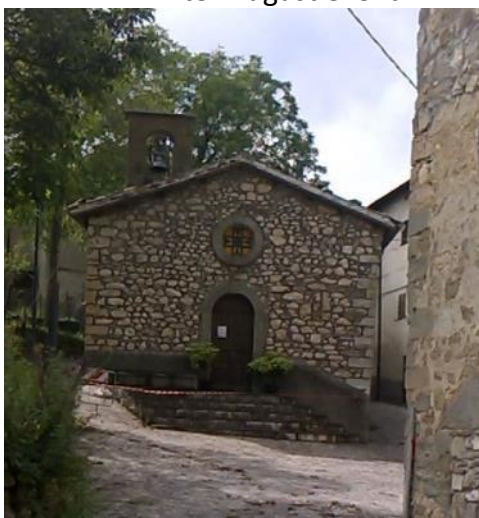
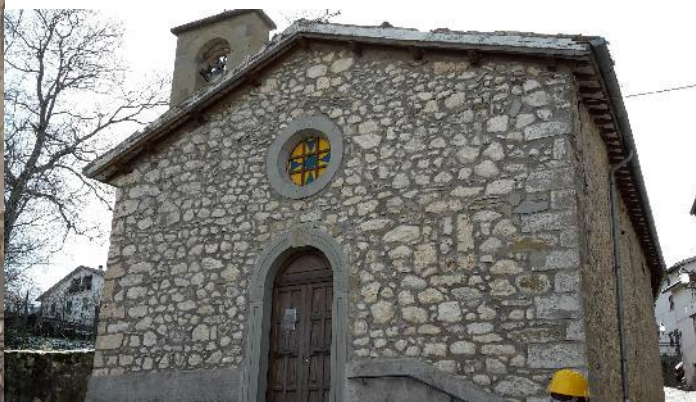
P01 (Astorara)

Hamlet	Structures	Damage description
Astorara	P01*-P02-P03	At the entrance, there are recent buildings with evidence of recent structural retrofitting (D0 level). Many older structures at the back of the village show a D4/5 damage level. At the highest portion of the village a full collapse occurred.
Balzo	P04	General D2/D3 damage level. The village is completely abandoned, while in September after the August main shock it was still populated and with shops and restaurants still in operation.
Castro	P05-P06	Church with a full collapsed apse and the rest of the hamlet with diffused D4/5 damage level. A recent house on the main road with no damage (D0) and still inhabited.
Colle	P07-P08-P09	Similar to Astorara with various levels of structures vulnerability. Recently restored buildings with D0; old masonry buildings with partial or full collapses (D4/D5).
Collefratte	P10-P11*-P12	Very damaged hamlets D3/D3 and a full collapse D5.

Picture	Hamlet	DATUM	Position		September damage Level	December damage Level
			Lat.	Long.		
P01*	Astorara	WGS-84	42.837436°	13.31119°	D0-D1	D0-D1
P02	Astorara	WGS-84	42.837222°	13.31055°	-	D0-D1
P03	Astorara	WGS-84	42.837222°	13.31055°	-	D4-D5
P04	Balzo	WGS-84	42.8425°	13.33222°	-	D2-D3
P05	Castro	WGS-84	42.84583°	13.32527°	-	D4-D5
P06	Castro	WGS-84	42.84722°	13.32638°	-	D4-D5
P07	Colle	WGS-84	42.84416°	13.30583°	-	D4-D5
P08	Colle	WGS-84	42.84416°	13.30583°	-	D4-D5
P09	Colle	WGS-84	42.84416°	13.30583°	-	D4-D5
P10	Collefratte	WGS-84	42.83952°	13.31907°	-	D5
P11*	Collefratte	WGS-84	42.83934°	13.31907°	D3	D3
P12	Collefratte	WGS-84	42.83952°	13.31907°	-	D3-D4

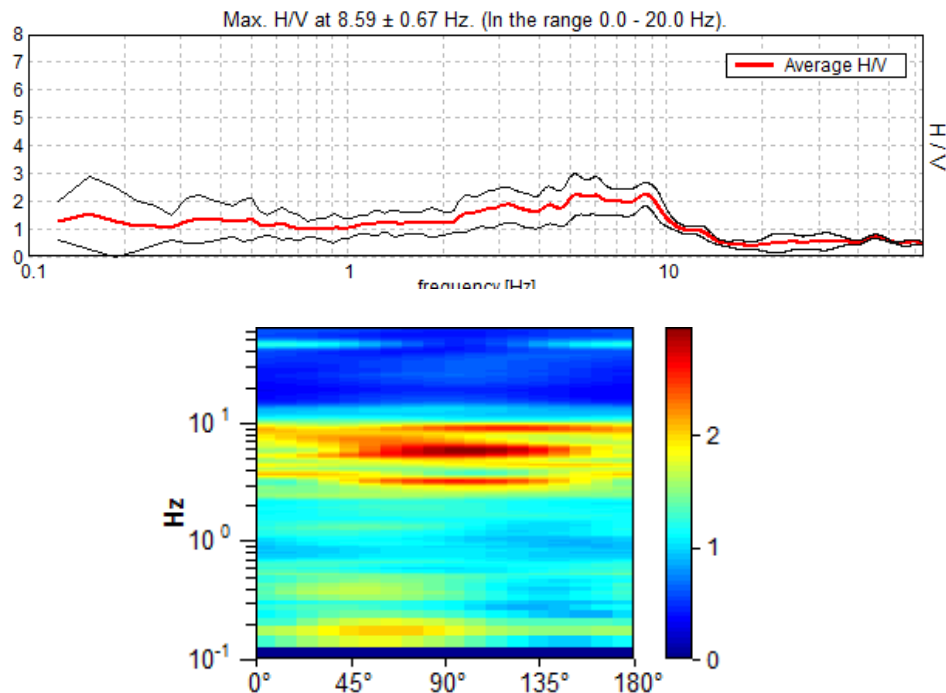
Figure 6.68. Noise measurement T01 results in terms of H/V spectral ratio (up) and H/V polar plots (bottom).

Microtremor noise measurements (location T01 in Figure 6.67) were carried out during the survey in the most damage zone of the historical center. A portable Tromino tomograph was employed and the total duration of each measurement was approximately 15 minutes. Horizontal-to-vertical (H/V) spectral ratios were computed by using the geometrical mean of horizontal components. Moreover, in order to investigate preferential directions of the amplification (i.e., polarization of ground motion), H/V ratios were computed by rotating the horizontal component between 0° and 180° (directional or polar HVSR). Both H/V and polar H/V

are reported in Figure 6.68. We observe no large H/V peaks at T1, suggesting the lack of a site condition producing a strong resonant site response.

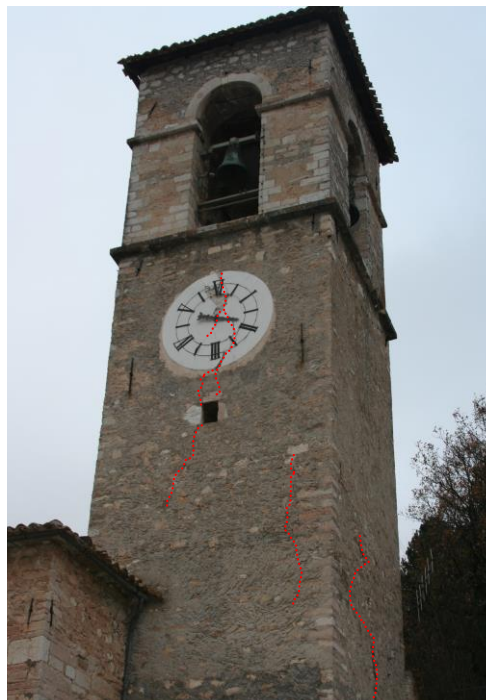
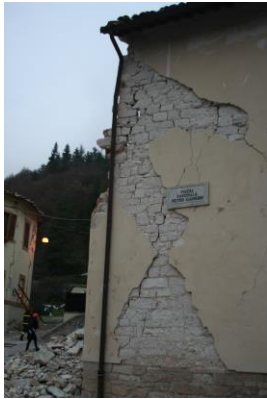
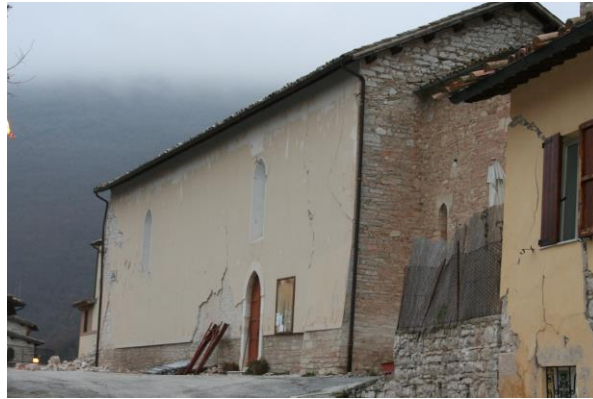
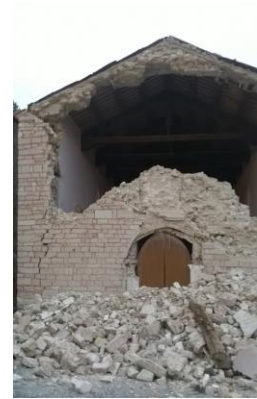
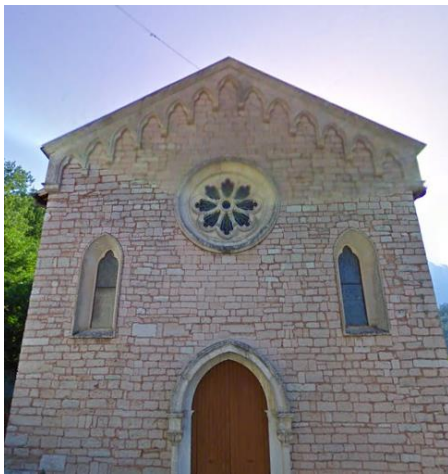
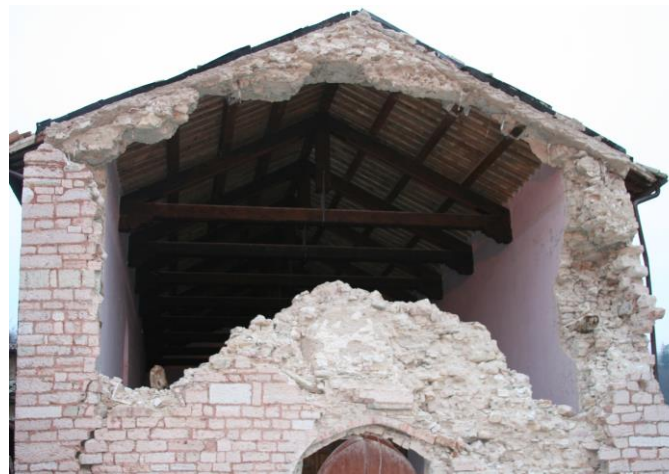
Figure 6.69 shows locations of representative structures inspected in Ussita and maps damage zones within the village. Damage levels were generally between D3 and D4. Figure 6.70 shows pictures of selected structures in the area of Ussita that experienced the higher level of damage.

Figure 6.70. Representative pictures taken in Ussita (P13)

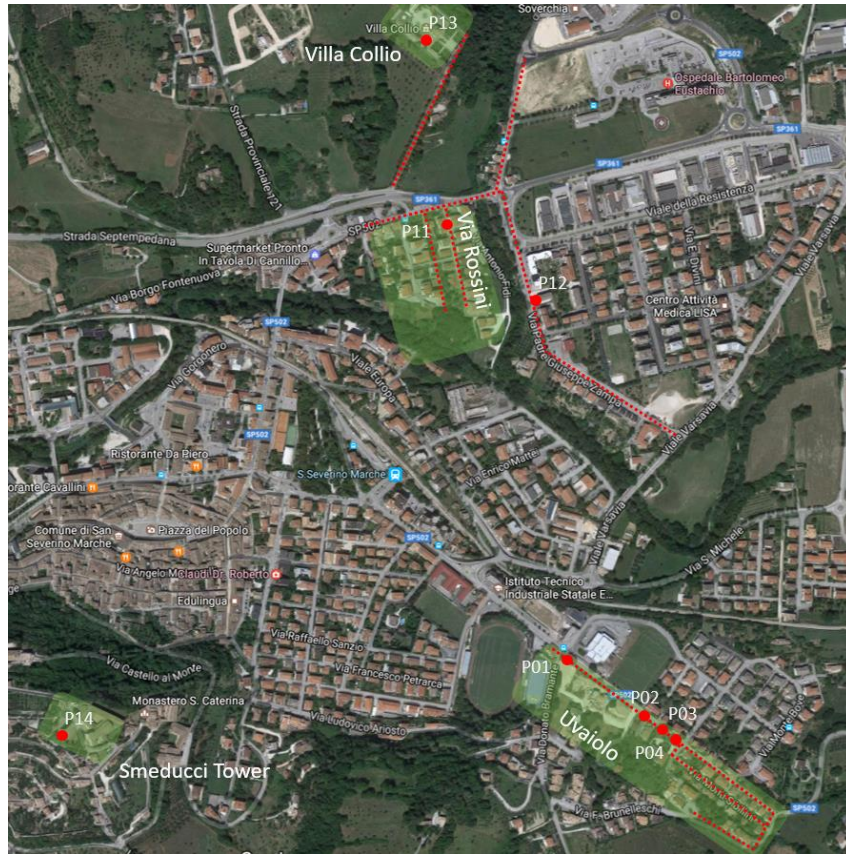
Major attention during the reconnaissance was paid to Via Mazzini and Via Rossini neighborhoods, since evident site effects were detected. The first is located on a rise and is parallel to another very damaged road (Via Monti Sibillini). The latter is very close to the Potenza River and the structures were likely built up on the ancient riverbed. Close to Via Rossini there is Villa Collio, a restaurant-villa that was severely damaged. Furthermore, a quick inspection of two towers located on the village hill was carried out (Torre Smeducci and the old Cathedral Tower), as there are plans for the installations of a permanent monitoring system by Politecnico di Torino and Nagoya City University.

Figure 6.78. Summary reconnaissance map for San Severino Marche.

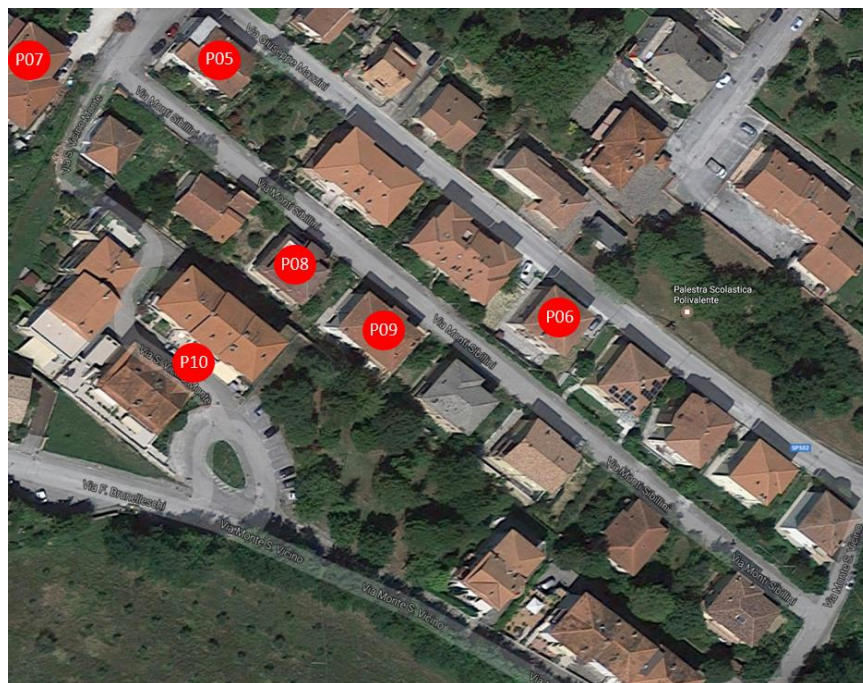
Figure 6.79. Summary reconnaissance map for San Severino Marche (zoom on the Uvaiolo neighborhood).
