Engineering Reconnaissance Following the October 2016 Central Italy Earthquakes - Version 2

GEER Team Leaders: Jonathan P. Stewart and Giuseppe Lanzo

Geotechnical Extreme Events Reconnaissance Association
Report No. GEER-050D
8 May 2017

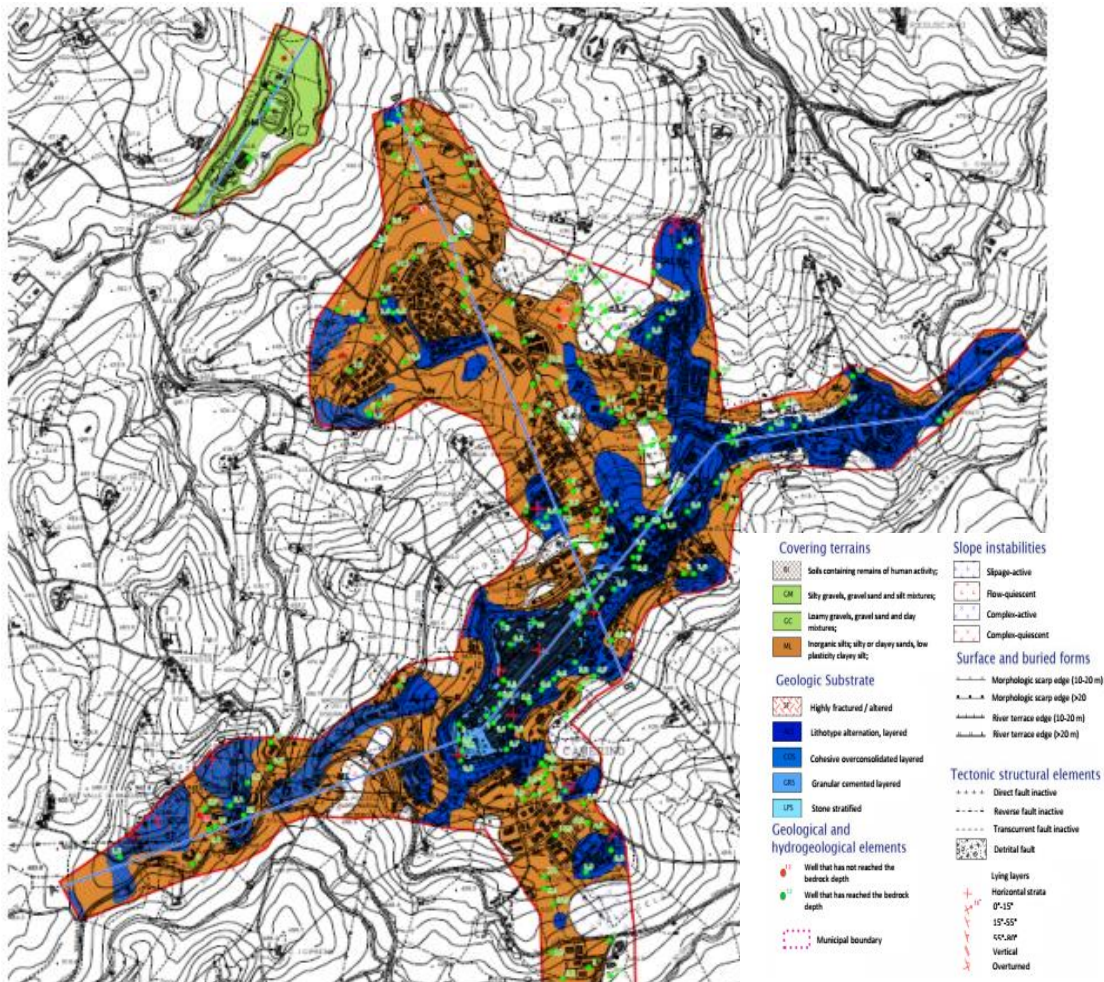
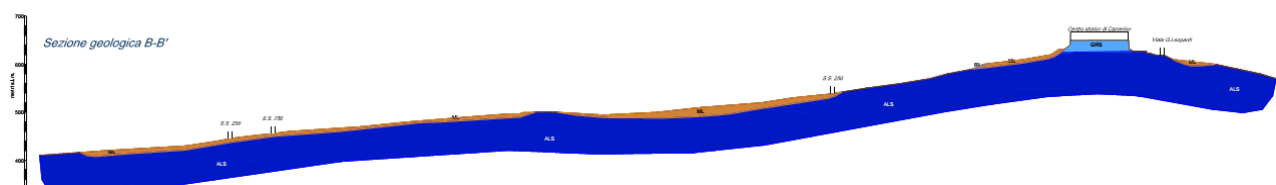
Figure 6.81. Geological map of Camerino (a) and cross section BB' (b) (Regione Marche, 2012).

on the arenaceous formation referred to as “Formazione delle Arenarie di Camerino” (Figure 6.81).

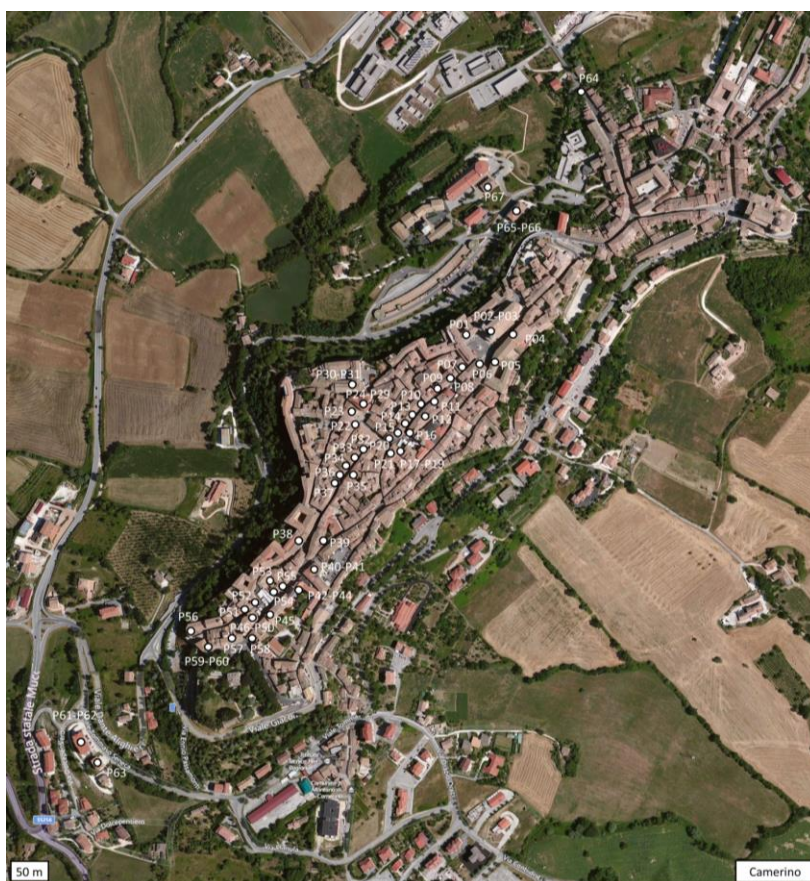
Figure 6.83. Locations of the representative structures inspected in Camerino (including red zone) (see Table 6.11 for details).

Figure 6.83 and Table 6.11 show locations of representative buildings inspected in the historic center of Camerino, including the red zone. Figure 6.84 shows photographs of these representative structures, which include both masonry and reinforced concrete dwellings two to four stories in height. The average damage level in the inspected zone was D2.

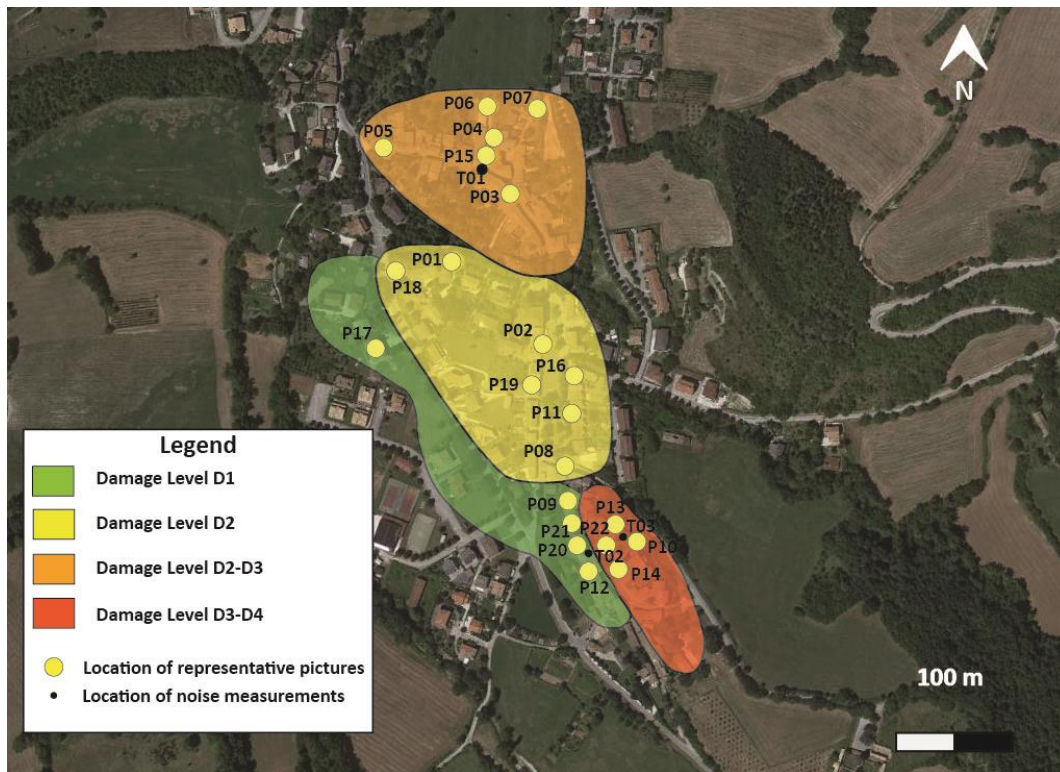
Figure 6.88. Damage zonation within the villages of Pievebovigliana village.

Pievebovigliana was significantly damaged by the October events. However, the degree of damage to buildings is quite variable across the village. A preliminary damage zonation is reported in Figure 6.88. Damage levels as high as D3-D4 are concentrated in the southern portion (area of Castello or S. Maria Assunta church) built on a slight ridge oriented NNW-SSE that is comprised of Scaglia-Cinerea bedrock. Topographic site effects may have impacted structural performance in this area. The northern and central portions of the village generally have damage levels D2 to D2-D3. These areas are mainly located on alluvial terraced deposits. Minor damage was observed along the western portion of the village; the northern part of this area, located on alluvium, has relatively modern buildings (see P17) while the southern area is on bedrock at the toe of the Scaglia-Cinerea ridge.

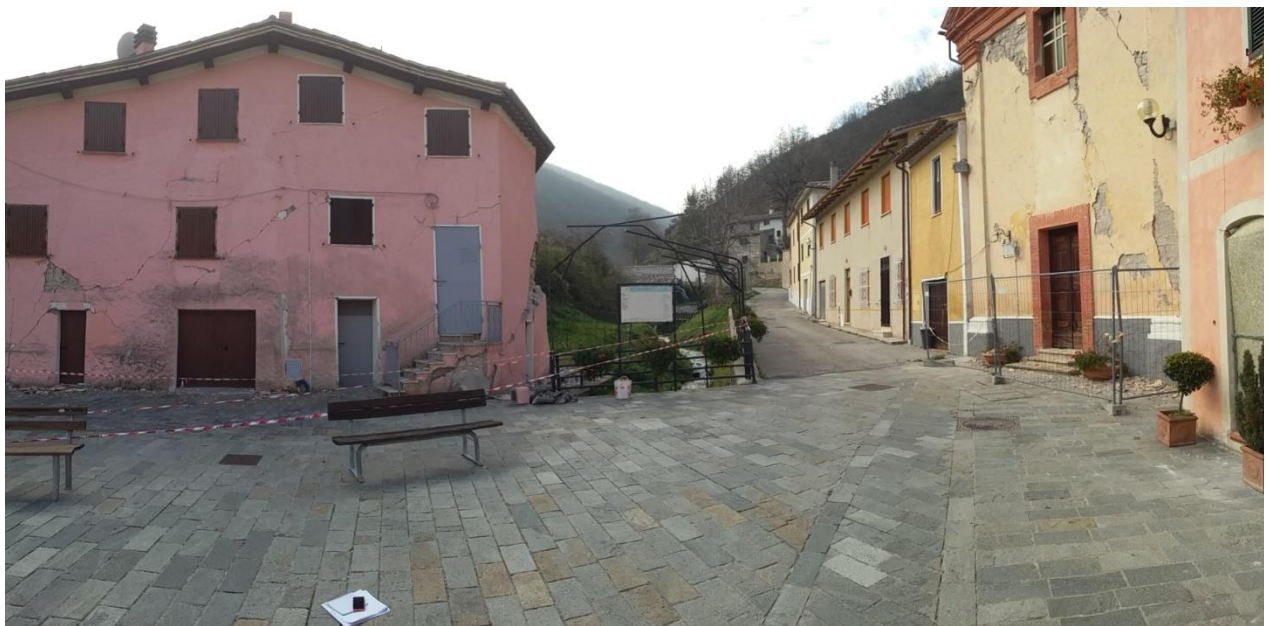
Fiume was significantly damaged by the October events. However, the degree of damage to buildings is strongly variable across the village (Figure 6.94). In particular, the eastern portion, founded on colluvial and alluvial deposits resting on bedrock, experienced high levels of damage (D3, see pictures P01-P02) whereas the western portion located on travertine rock had negligible damage (see P03).

Fiume (Pieve Torina)				
Picture	Datum	Location		Damage Level
		Lat	Long	
P01a,b	WGS-84	43.042201°	13.001130°	D3
P02	WGS-84	43.042146°	13.001298°	D3
P03	WGS-84	43.042172°	13.000544°	D0/D1
P04	WGS-84	43.041870°	13.001228°	D3

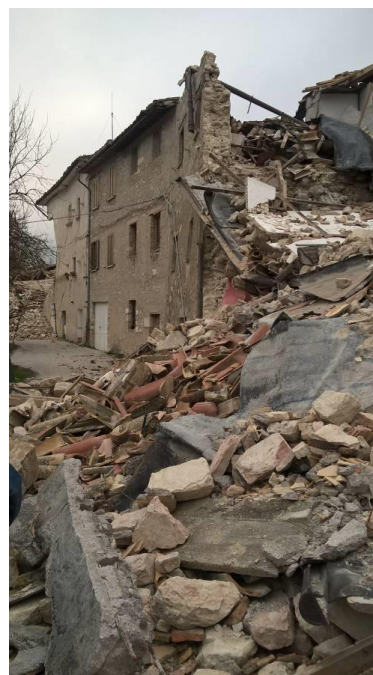
Casavecchia Alta / Piè Casavecchia				
Picture	Datum	Location		Damage Level
		Lat	Long	
P01	WGS-84	42.996714°	13.060456°	D3-D4
P02	WGS-84	42.997693°	13.064266°	D2-D3
P03	WGS-84	42.998803°	13.062181°	D4-D5
P04	WGS-84	42.998500°	13.061722°	D4-D5

Figure 6.99. Representative pictures taken in Casavecchia during the survey (see Table 6.14).

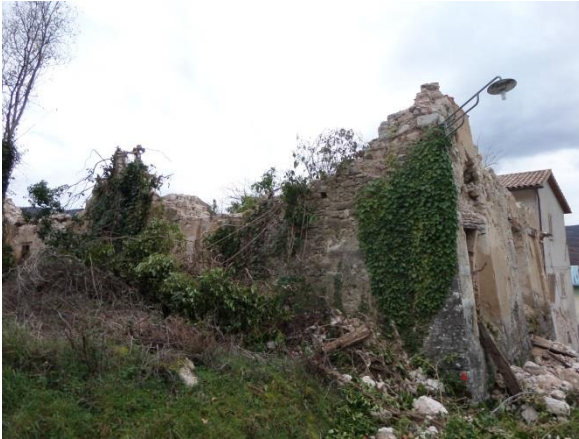
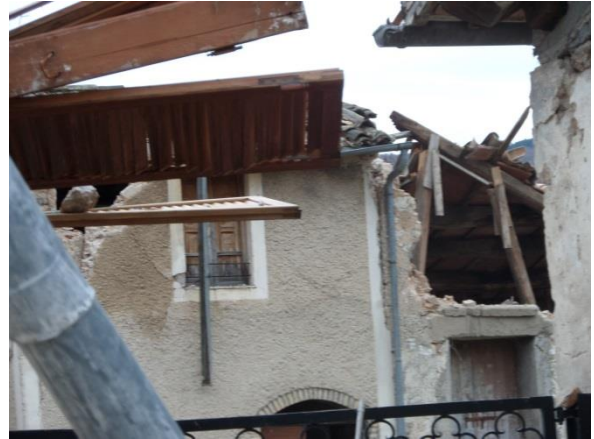
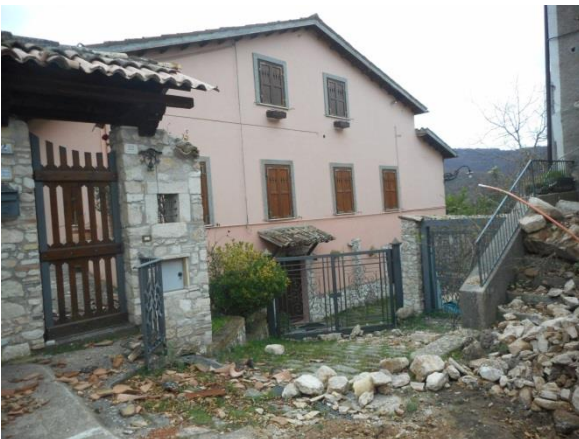
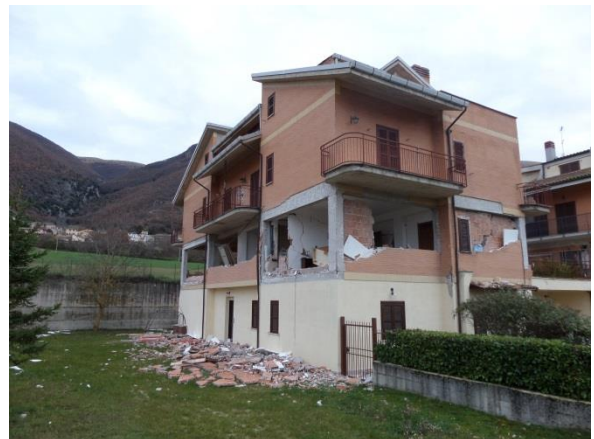
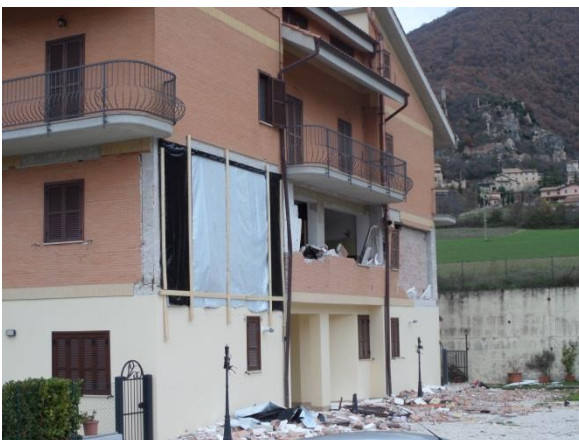
Figure 6.104 and Table 6.16 show locations and details of representative buildings inspected in Pié del Colle. Figure 6.105 shows representative structures, which include unreinforced masonry and reinforced concrete buildings. Damage was observed to both types of structures, although among reinforced concrete structures the principal damage was collapse of interior tiles from frames. Typical damage levels were between D2 and D3.

Picture	DATUM	Location		Damage Level	Notes
		Lat.	Long.		
P01	WGS-84	42.844373	13.101296	D2	
P02	WGS-84	42.844211	13.101267	D2	
P03	WGS-84	42.844400	13.101682	D1	
P04	WGS-84	42.844270	13.101787	D1	
P05	WGS-84	42.844039	13.101900	D1	
P06	WGS-84	42.844130	13.102034	D1	
P07	WGS-84	42.844310	13.102489	D1	
P08	WGS-84	42.844148	13.103076	D1	
P09	WGS-84	42.844152	13.103284	D4	
P10	WGS-84	42.844152	13.103527	D0	
P11	WGS-84	42.844028	13.103713	D5	
P12	WGS-84	42.844166	13.103785	D2	
P13	WGS-84	42.844177	13.103916	D5	
P14	WGS-84	42.843939	13.103436	D3	
P15	WGS-84	42.843826	13.103548	D0	
P16	WGS-84	42.843215	13.102244	D2	
P17	WGS-84	42.843167	13.102265	D2

Figure 6.105. Representative pictures taken at Ancarano pié del Colle (see Table 6.16 for details).

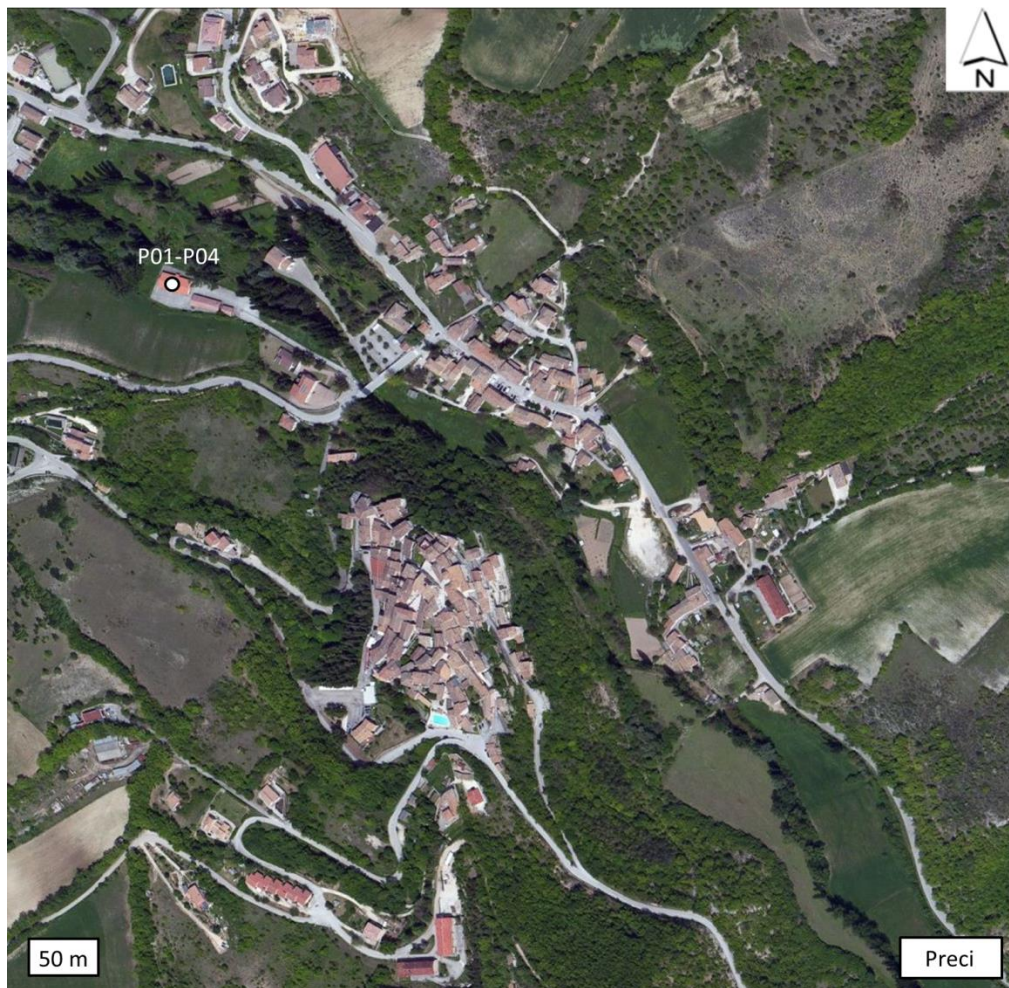
Figure 6.110. Locations of the representative structures inspected in Preci.

Guado. Ground motion levels are reported in Table 6.1. The main village was lightly damaged. Figure 6.110 shows the location of representative pictures taken in Preci, while Figure 6.111 shows a church with damage level D1.

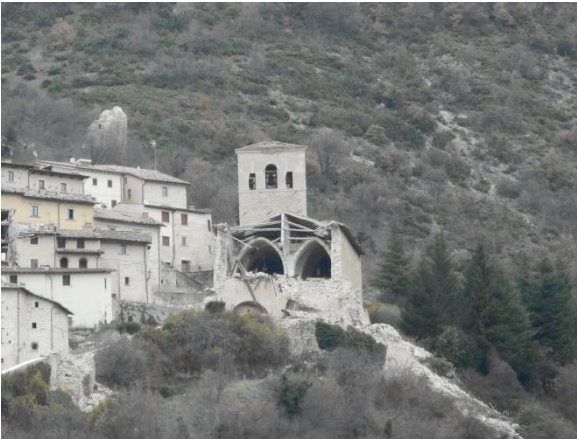
Picture	DATUM	Location		Damage Level	Notes
		Lat.	Long.		
P01	WGS-84	42.853422	13.101411	D4	
P02	WGS-84	42.853480	13.100616	D2-D5	
P03	WGS-84	42.853819	13.100276	D2-D5

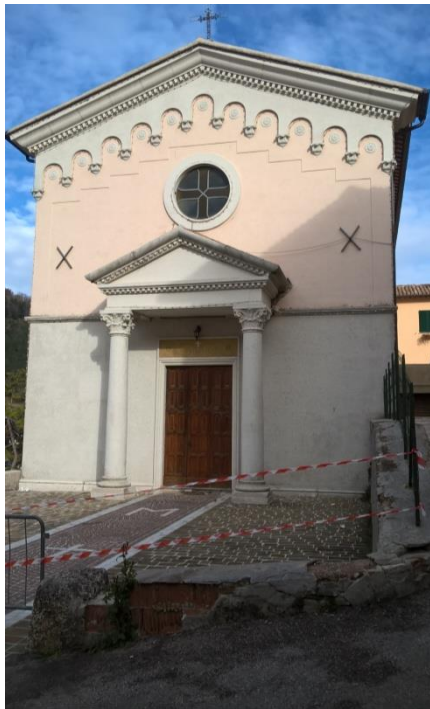
Colfiorito				
Picture	Datum	Location		Damage Level
		Lat	Long	
P01	WGS-84	43.026700°	12.890759°	D1
P02	WGS-84	43.028375°	12.891436°	D0
P03	WGS-84	43.026766°	12.890206°	D0

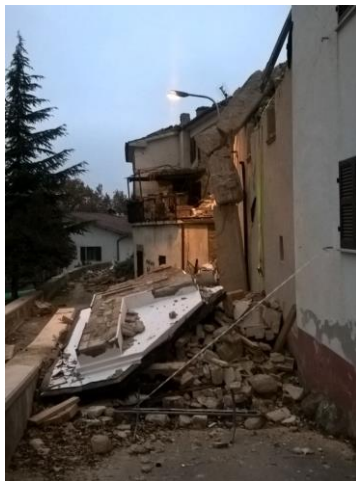
P01

The village consists essentially of un-reinforced masonry structures, 2-3 stories in height. Some structures are retrofitted. The damage at the top of the ridge was quite high (D3-D4 on average) with several partial collapses (see P01- P03-P04).

Figure 6.121. Representative pictures taken in San Lorenzo in Colpolina during the survey (see Table 6.21).

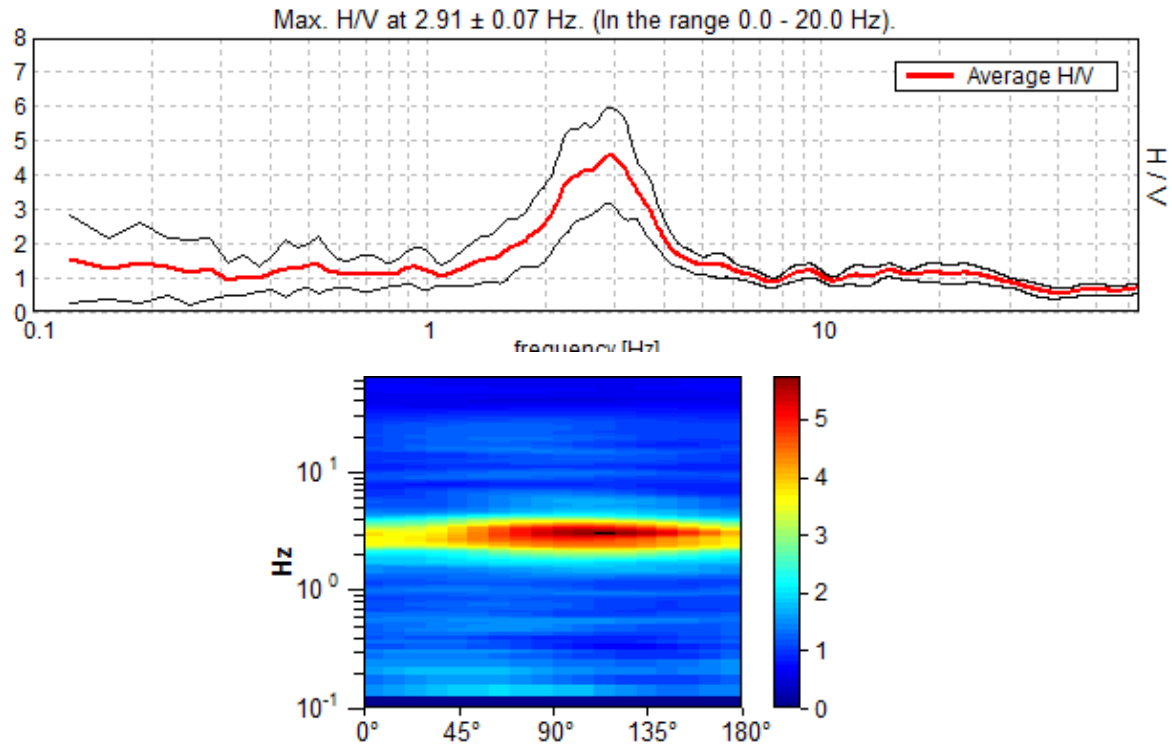
A noise measurements (T01 in Figure 6.120) was carried out during the survey on the ridge on to which San Lorenzo is founded. The same instrument and data acquisition procedure described for Visso survey were employed. Average horizontal-to-vertical (H/V) spectral ratios and polar H/V plot are reported in Figure 6.122. A peak can be identified at about 3 Hz polarized in the direction of about 100° , i.e. perpendicular to the axis of the ridge, thus indicating possible topographic site effects (Pagliaroli et al., 2015).

Figure 6.122. Noise measurements results in terms of H/V spectral ratio (top) and H/V polar plots (bottom).

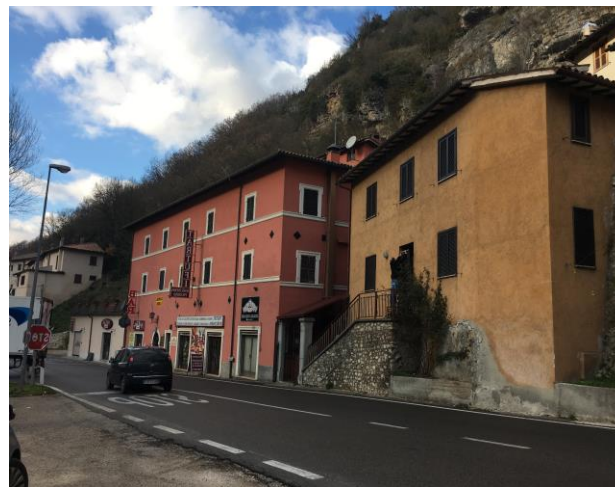
Serravalle is a hamlet part of the municipality of Norcia, in the province of Perugia, Umbria region. Serravalle is located about 6 kilometers from Norcia and it has a population of 25 people. Ground motion levels are reported in Table 6.1 The hamlet was not damaged by the earthquake and the generalized damage level was D0 (Figure 6.123, Table 6.22).

Figure 6.123. Representative pictures taken in Serravalle during the GEER reconnaissance (see Table 6.22).

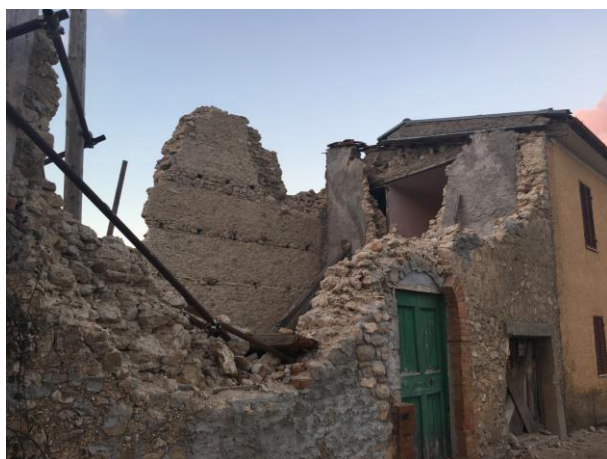
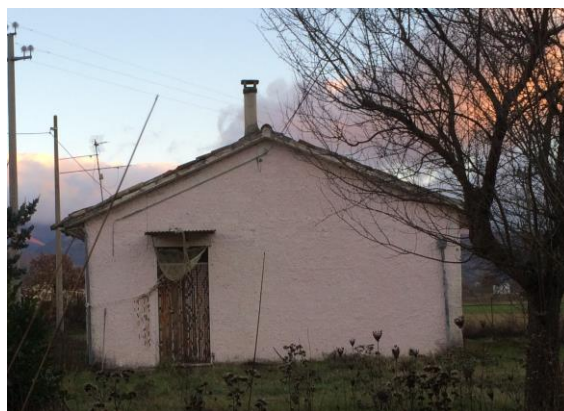
level damage ranging from D0 to D5. Only poorly constructed masonry buildings experienced major damage.

Figure 6.125. Representative pictures taken in Popoli during the GEER reconnaissance (see Table 6.23).

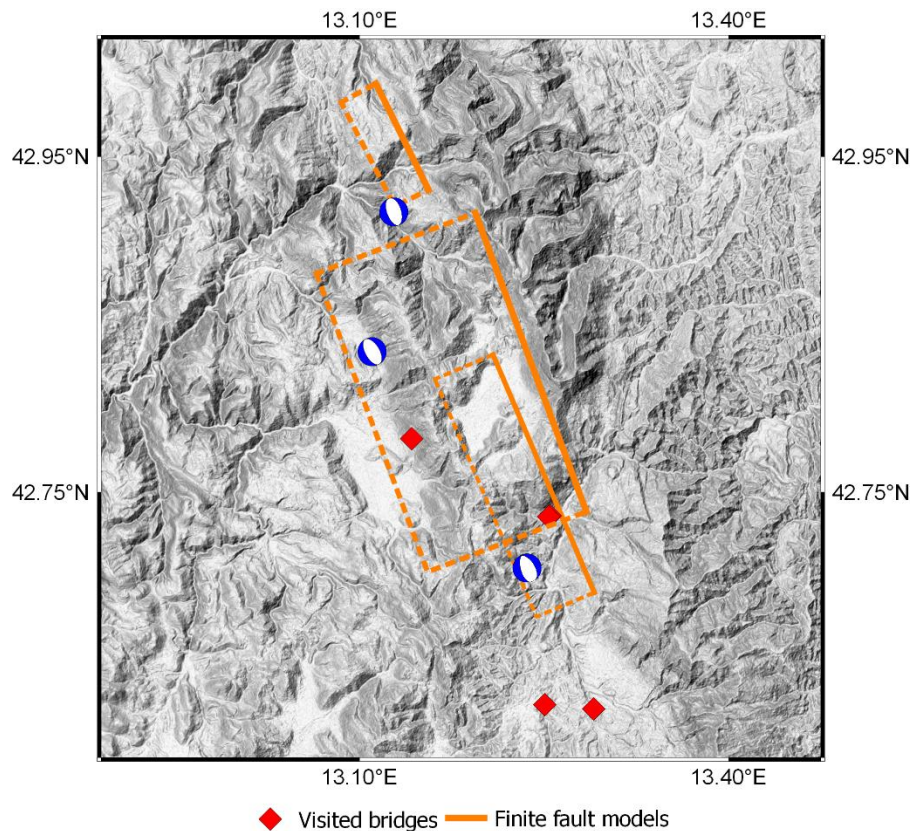
Figure 7.1. Map of epicentral region showing locations of bridge sites visited by the GEER team following the October 2016 seismic sequence.

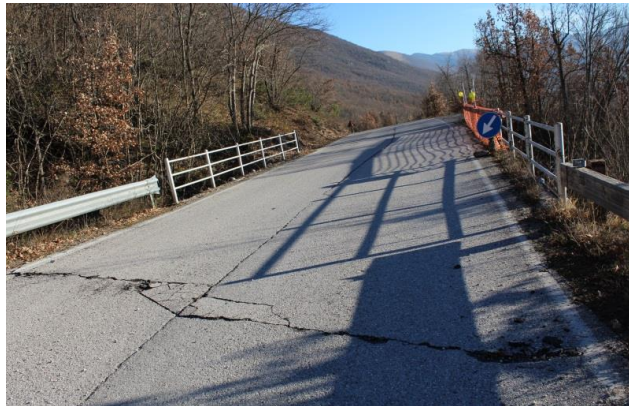
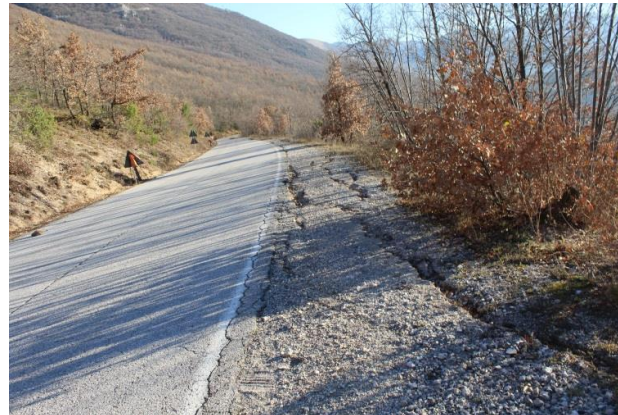
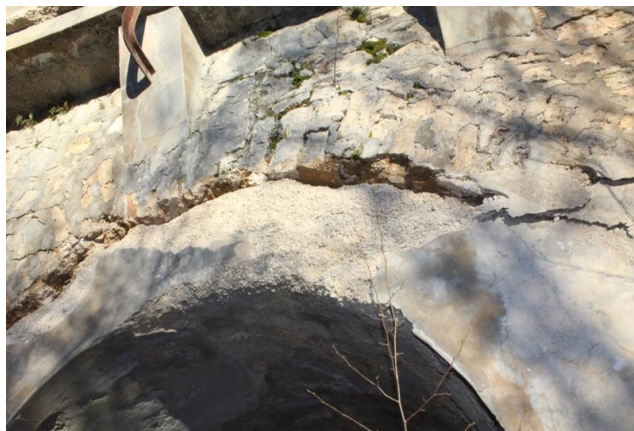
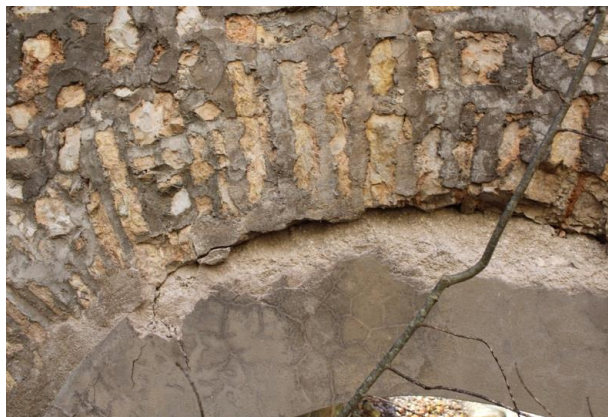
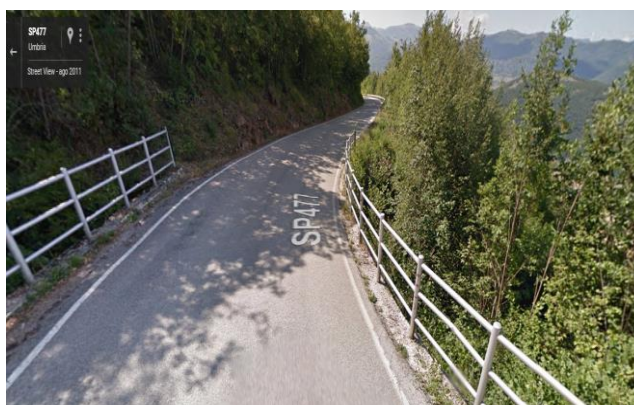
Figure 7.2 shows damage observed on the single arch masonry bridge along road SP477. The bridge did not appear seriously damaged, but several cracks were observed, especially in the road carriage. Transversal and longitudinal cracks along the road surface were documented (Figure 7.2a), with a measured maximum opening in the longitudinal direction of about 6 cm. From the visual inspection, the transversal cracks close to the road-bridge connection appear more recent when compared to those in the longitudinal direction. Longitudinal cracks also formed in road fill adjacent to the bridge (Figure 7.2b). Minor additional cracking was observed within the bridge arch (Figures 7.2c and 7.2d). Figure 7.2e (from Google earth) shows a photo of the bridge in December 2011, when no roadway cracks are evident. Because this bridge was not inspected in the reconnaissance performed following the August 2016 sequence, we cannot identify which events produced the observed effects.

Figure 7.2. Bridge along SP477 (42.782073 deg, 13.142383 deg): road surface cracks (a); longitudinal cracks along the road side (b); cracks between the bridge arch and the main structure (c-d); view of the bridge on December 2011 (e).

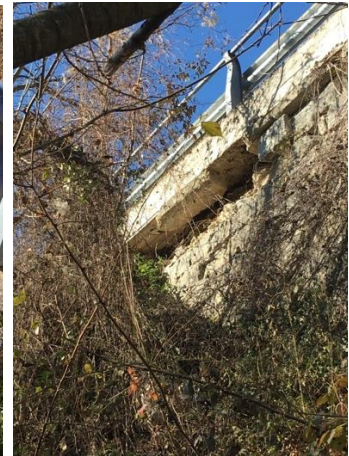
Figure 7.3 shows comparative pictures (taken after the 24 August and the October events) of the 1-span masonry bridge along the Trisungo route (along road SP129). The bridge presents additional cracks following the October events in the interior part of the arch (Figure 7.3b). The

width of the crack in the longitudinal direction (Figure 7.3d) has increased with respect to that observed in the first reconnaissance (Figure 7.3c). However, there was no additional spalling of masonry elements as had been observed following the first event.

Figure 7.3. Roman-era bridge along the Trisungo route (1 span bridge - Tufo area – Arquata del Tronto - N42.735981, E13.254862): view of the arch (a, b) and the road cracks (c, d) after the 24 August event (photo on September 7 2016 (a, c)) and after the 30 October event (photo on December 13 2016 (b, d)).
