Considerations over the Italian road bridge infrastructure safety after the Polcevera viaduct collapse:
past errors and future perspectives

Fabio Bazzucchi, Luciana Restuccia, Giuseppe Andrea Ferro

Politecnico di Torino, Turin, Italy

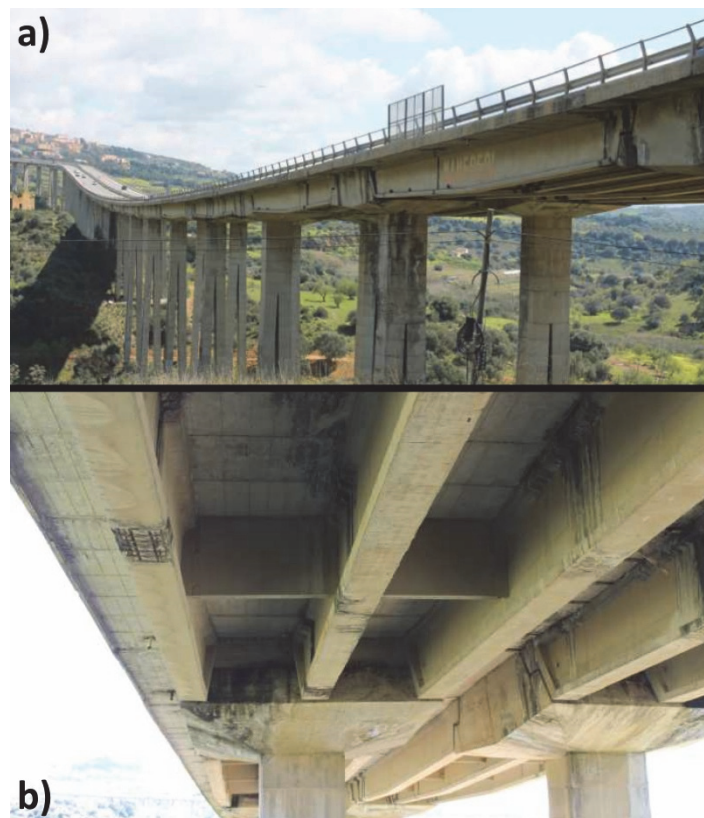
Figure 13: Overall view of the Akragas viaduct (a); deck detail (b) [23].

Throughout the same years, the Akragas Viaduct (S.S. 115-AG, Agrigento, 1970) was erected in Sicily. The design, by Morandi, considered a total length of 1400 m skewed viaduct with 31 spans, each 44 m long (Fig. 13(a)). The deck, 10 m wide, was realized by a grillage of 3 unbonded prestressed I-beams, 5 transverse beams, and a precast pavement (Fig. 13(b)) [23]. Support for each beam consisted in a couple of reinforced concrete A columns, with a maximum height of 60 m. To date, these latter elements represent the key vulnerability of the structure. Each column was erected through a concrete concave precast box that works both as scaffolding (in the pouring phase) and as shear resisting element (Fig. 14(a)). It is reasonable to think that visible damage is due to the concave shape of the external box. When shear forces required confinement, the bars pushed against the box bulged the internal part as visible in Fig. 14(b). Together with the static problems, the retrofitting intervention has the aim of improving the seismic behavior by providing sufficient shear strength and ductility: a new element and the recovering of a confined state for the concrete of the core.

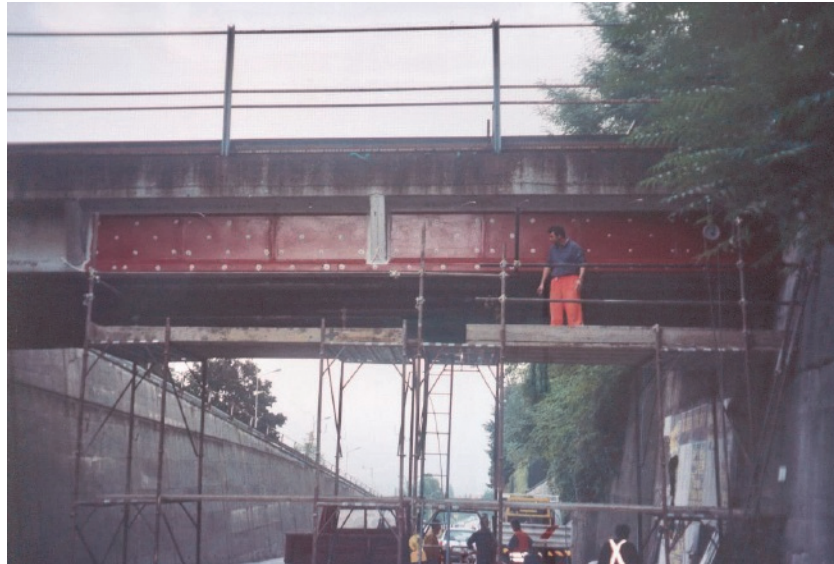
Figure 19: Steel resurfacing for I-beams of an overpass [Copyright: RELUIS].

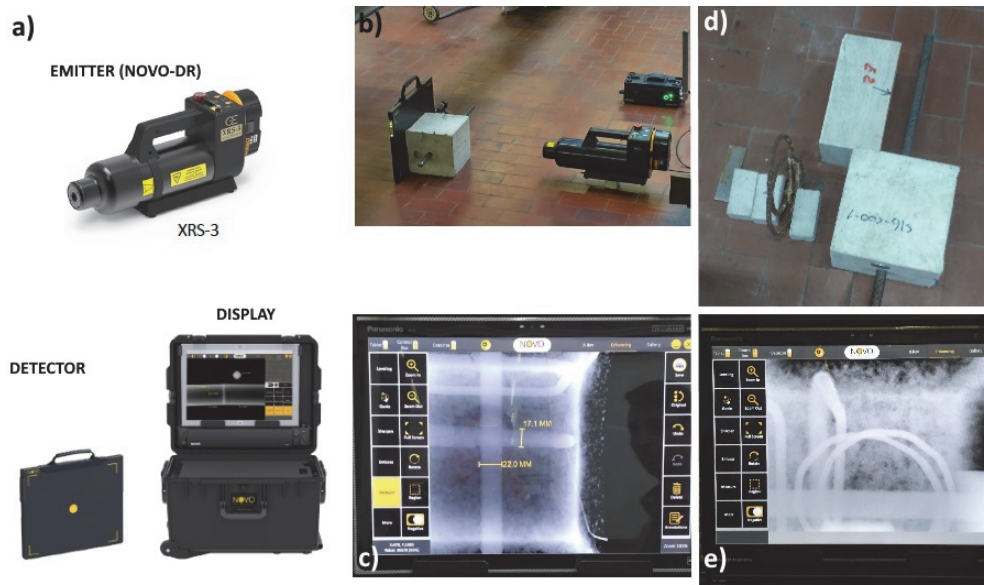
Figure 20: X-Ray device (a) [Copyright: <https://www.novo-dr.com/>]; scanned image (b) of specimen (c); scanned image (d) of specimen (e).

The system is usually composed by an emitter, a real time display and a shielded detector (Fig. 20(a)). This technology enables to generate immediate and high-quality X-ray images while keeping radiation levels to the minimum. Fig. 20(b) shows the results of an X-Ray test conducted in Politecnico di Torino laboratory Fig. 20(c). The system exhibited a significant power of penetration, completely scanning the 150x150x150 mm concrete cube. Furthermore, the system was able to detect additional reinforcement positioned beyond the cube, then has a great potential also for the inaccessible portion of a structure (Fig. 20(d), Fig. 20(e)). The all system weight less than 200 kg (the heavier component is the detector, 150 kg in its largest dimension) and can be easily carried by a robotic-arm installed on a vehicle (Fig. 21). Inspection of I-beams could be carried by a scraped scanning. Of course, this method represents a screening procedure but could be extremely reliable and effective for a preliminary census or fast track assessment.
