Considerations over the Italian road bridge infrastructure safety after the Polcevera viaduct collapse: past errors and future perspectives

Fabio Bazzucchi, Luciana Restuccia, Giuseppe Andrea Ferro

ABSTRACT. In the last four years, Italy experienced the collapse of five road bridge: Petrulla viaduct (2014), Annone (2016) and Ancona (2017) overpasses, Fossano viaduct (2017) and Polcevera (2018) bridge.

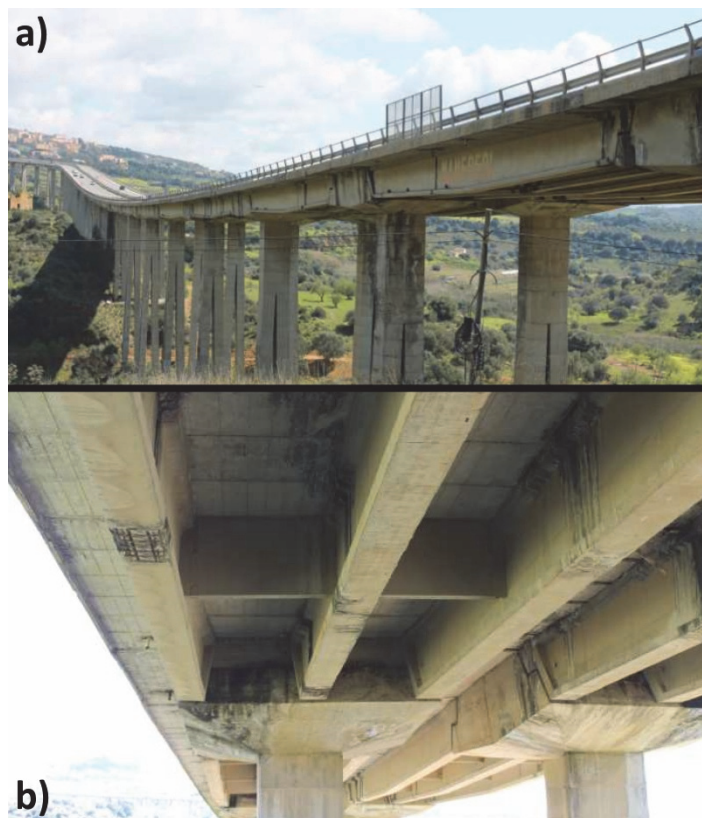
Figure 13: Overall view of the Akragas viaduct (a); deck detail (b) [23].

Throughout the same years, the Akragas Viaduct (S.S. 115-AG, Agrigento, 1970) was erected in Sicily. The design, by Morandi, considered a total length of 1400 m skewed viaduct with 31 spans, each 44 m long (Fig. 13(a)). The deck, 10 m wide, was realized by a grillage of 3 unbonded prestressed I-beams, 5 transverse beams, and a precasted pavement (Fig. 13(b)) [23]. Support for each beam consisted in a couple of reinforced concrete A columns, with a maximum height of 60 m. To date, these latter elements represent the key vulnerability of the structure. Each column was erected through a concrete concave precast box that works both as scaffolding (in the pouring phase) and as shear resisting element (Fig. 14(a)). It is reasonable to think that visible damage is due to the concave shape of the external box. When shear forces required confinement, the bars pushed against the box bulged the internal part as visible in Fig. 14(b). Together with the static problems, the retrofitting intervention has the aim of improving the seismic behavior by providing sufficient shear strength and ductility: a new element and the recovering of a confined state for the concrete of the core.

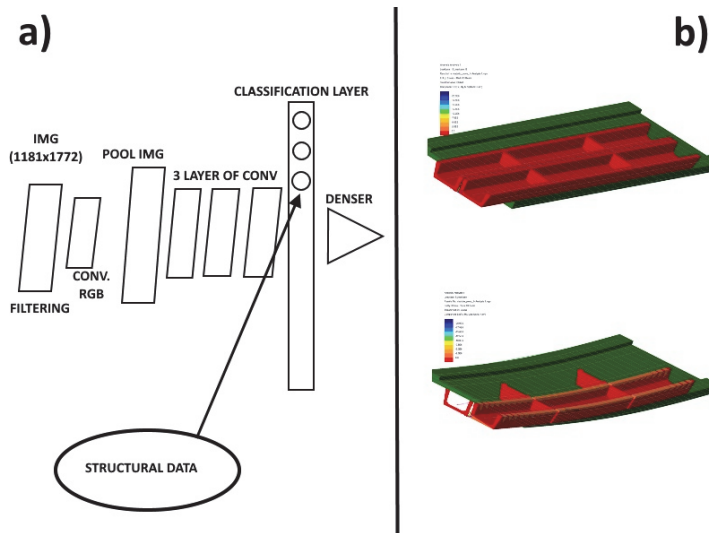
Figure 23: DCNN scheme (a); FEM tuned model (b).
