Considerations over the Italian road bridge infrastructure safety after the Polcevera viaduct collapse:
past errors and future perspectives

Fabio Bazzucchi, Luciana Restuccia, Giuseppe Andrea Ferro

Politecnico di Torino, Turin, Italy

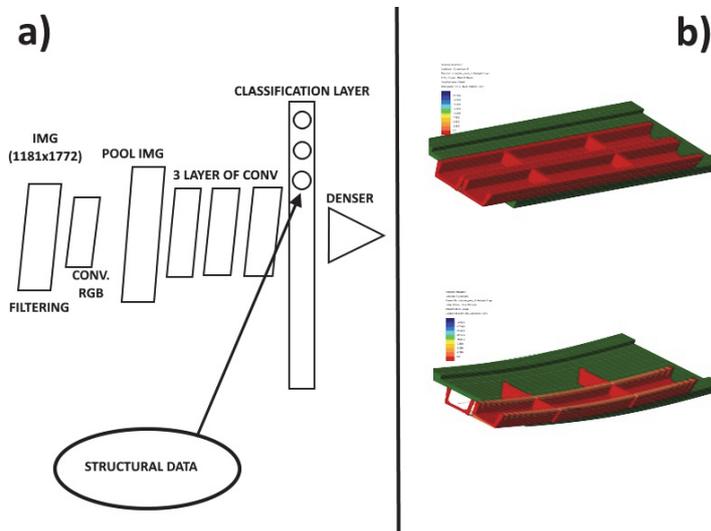
Figure 23: DCNN scheme (a); FEM tuned model (b).
