# Engineering Reconnaissance of the 24 August 2016 Central Italy Earthquake. Version 2

Geotechnical Extreme Events Reconnaissance Association

Report No. GEER-050B

22 November 2016

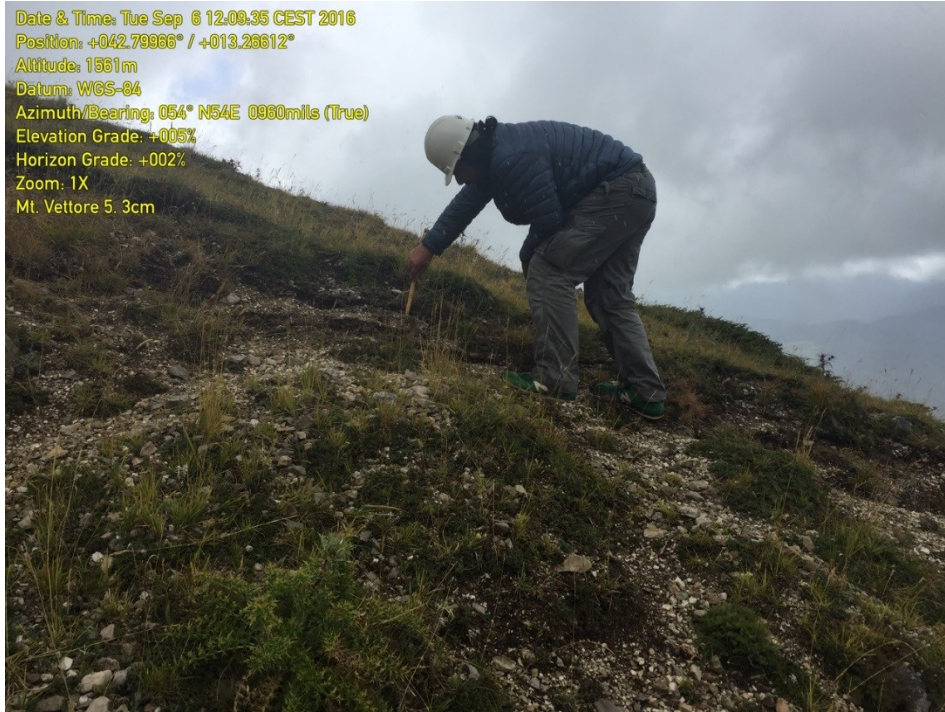
**Figure 2.19g.** Mt. Vettore fault Site 5 at a WGS84 ellipsoid elevation of 1561 m. The normal fault displacement at this site was 3 cm down toward the west (Latitude and Longitude are annotated on the image).

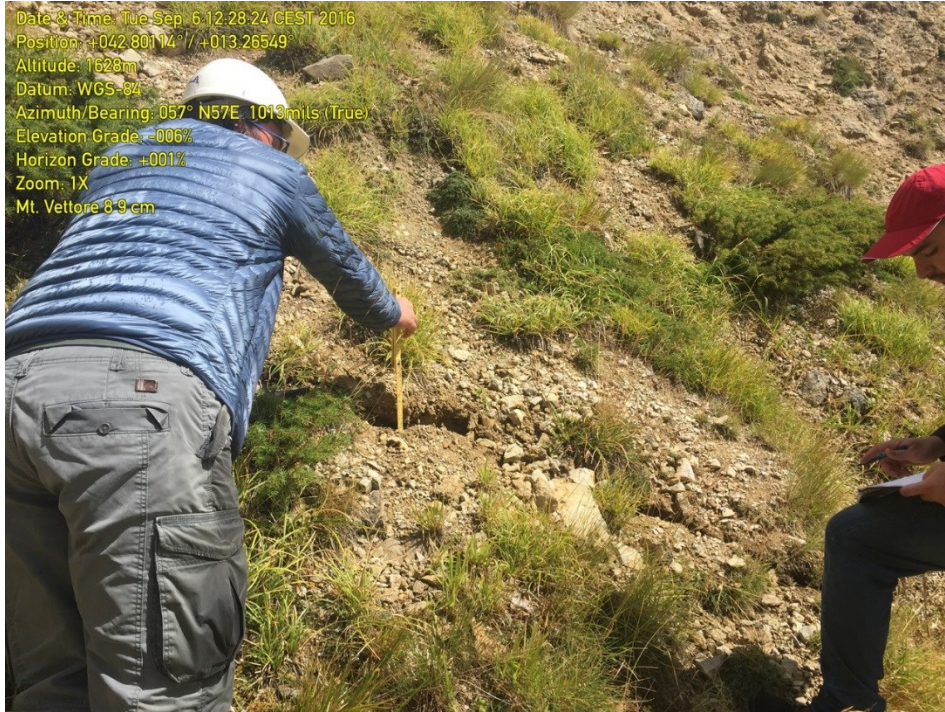
**Figure 2.19k.** Mt. Vettore fault Site 8 at a WGS84 ellipsoid elevation of 1628 m. The normal fault displacement at this site was 9 cm down toward the west (Latitude and Longitude are annotated on the image).

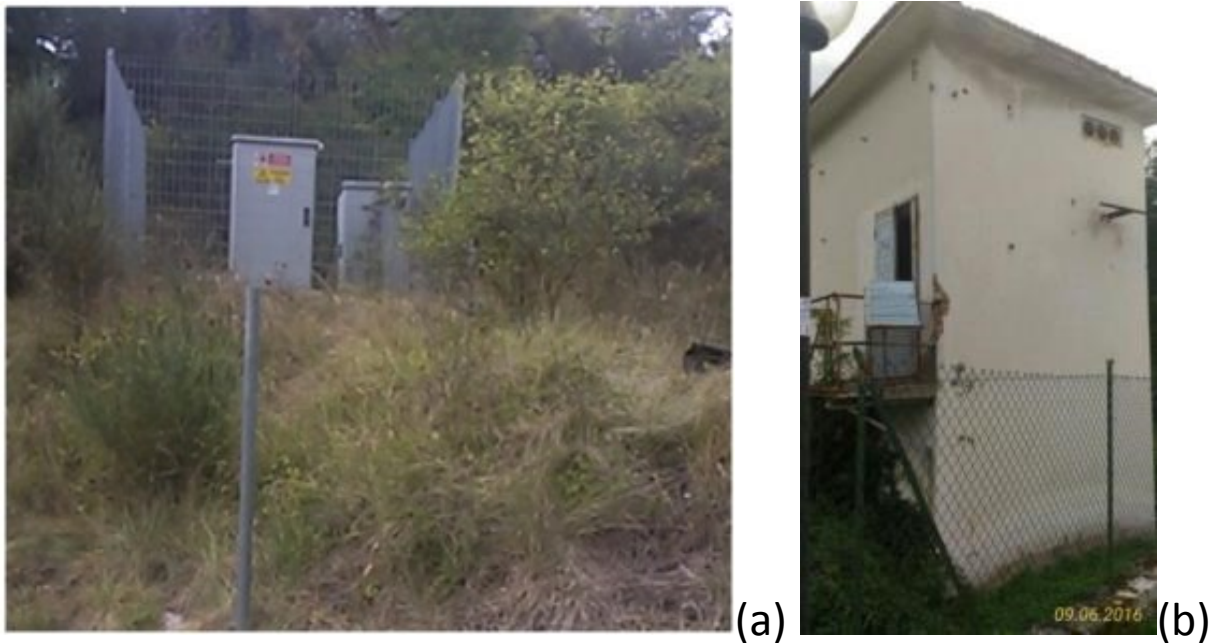
The GEER team inspected two recording station sites: (1) AMT in the town of Amatrice (Figure 3.2a; Lat: 42.632460 – Long: 13.286176), and (2) NRC in the town of Norcia (Figure 3.2b; Lat: 42.792543 – Long: 13.096475). Both stations are part of the RAN network, owned and operated by the Italian department of civil protection. AMT is a free-field station with a digital sensor protected by a fiberglass box, while the accelerometers at NRT are installed inside an ENEL electric transformer cabin. The AMT and NRC stations recorded the highest acceleration values during the M6.1 mainshock (0.43g and 0.36g, respectively) but the level of damage in Amatrice and Norcia was quite different as discussed in Chapter 5. As shown in Figure 3.2, we did not find ground failure features or earthquake-induced damage traces at these locations.

Figure 3.2. (a) AMT station; (b) NRC station.

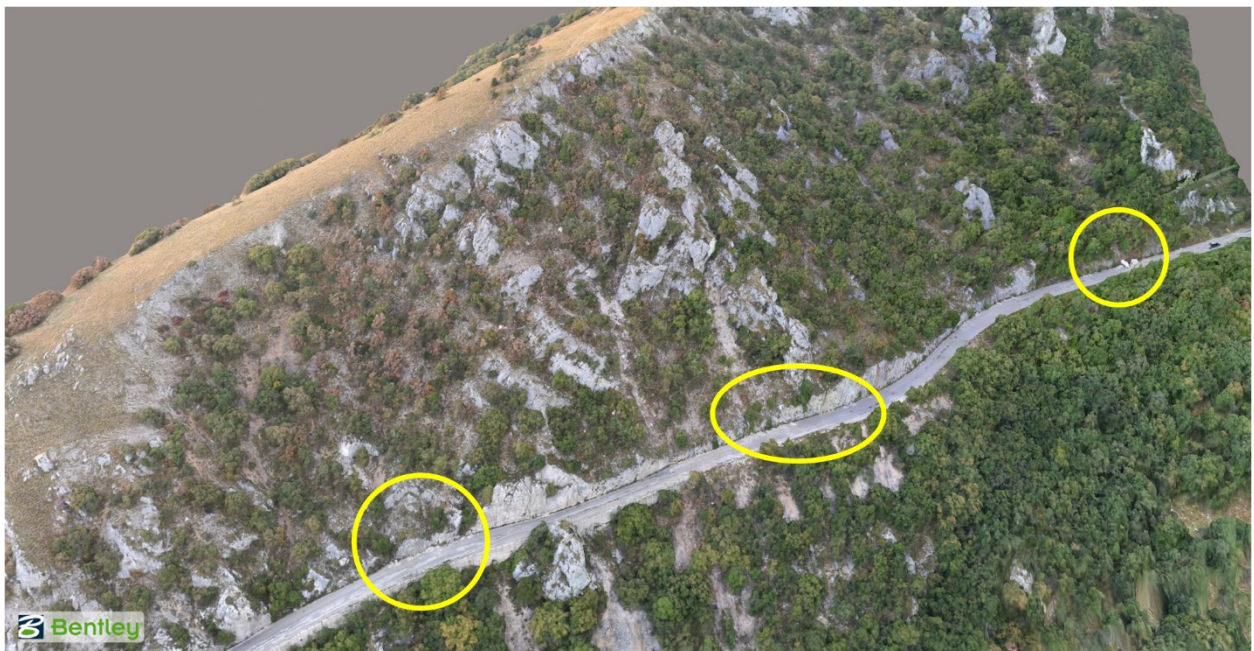
**Figure 4.19.** 3D model image of the SP 477 rockfall. Visible rocks and debris on the road are circled in yellow (42.7661 N 13.1669 E).

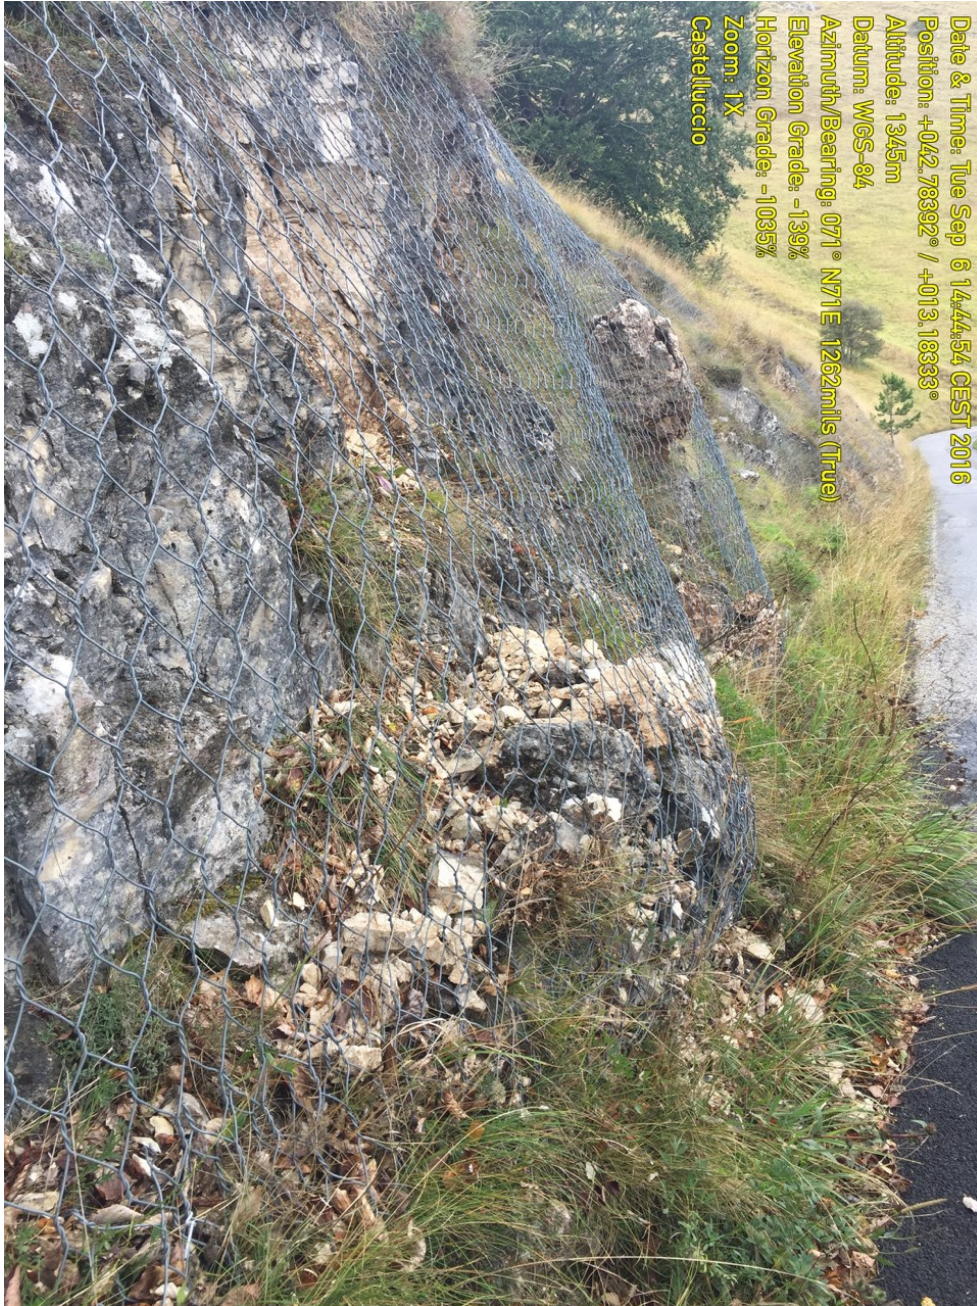
Slope protection in the form of rock bolts, tiebacks, retaining walls, and rockfall nets and fences were deployed in the epicentral region, and seemed to be effective at protecting roads and structures below. Figure 4.20 shows an example of falling debris caught behind rock-nets on the road to Plano Grande and Casteluccio. These successful applications of rock-net protection allowed roads to remain functional after the earthquake and provided critical access to the severely damaged town of Castelluccio immediately after the earthquake.

**Figure 4.20.** Rock-net protection with captured debris from the earthquake, including minor small debris in the foreground and a large ~0.5-m block in the background (42.78392 N 13.18333 E).

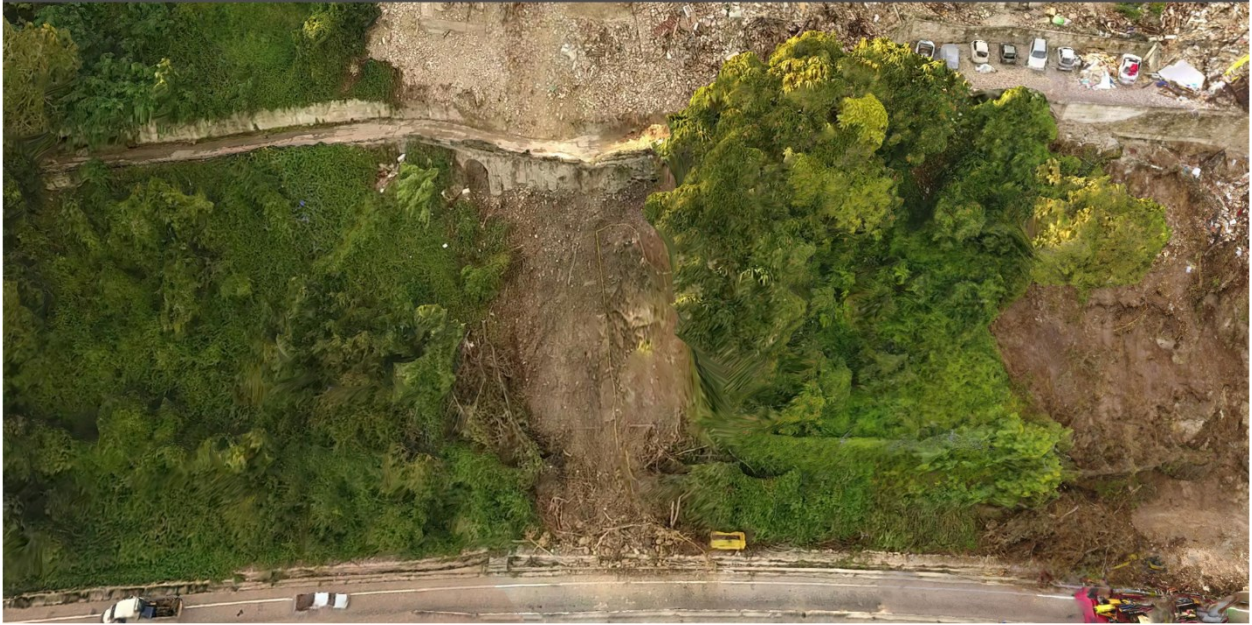
A second, smaller shallow landslide was located above Highway SS4 (marked as #2 in Figure 4.24), just south of the larger landslide discussed above (42.7501 N 13.2719 E). This landslide was approximately 16 meters wide and occurred on a slope 26 meters high. A model image of this landslide is presented in Figure 4.29.

**Figure 4.29.** 3D model of smaller landslide adjacent to Highway SS4 (42.7501 N 13.2719 E).

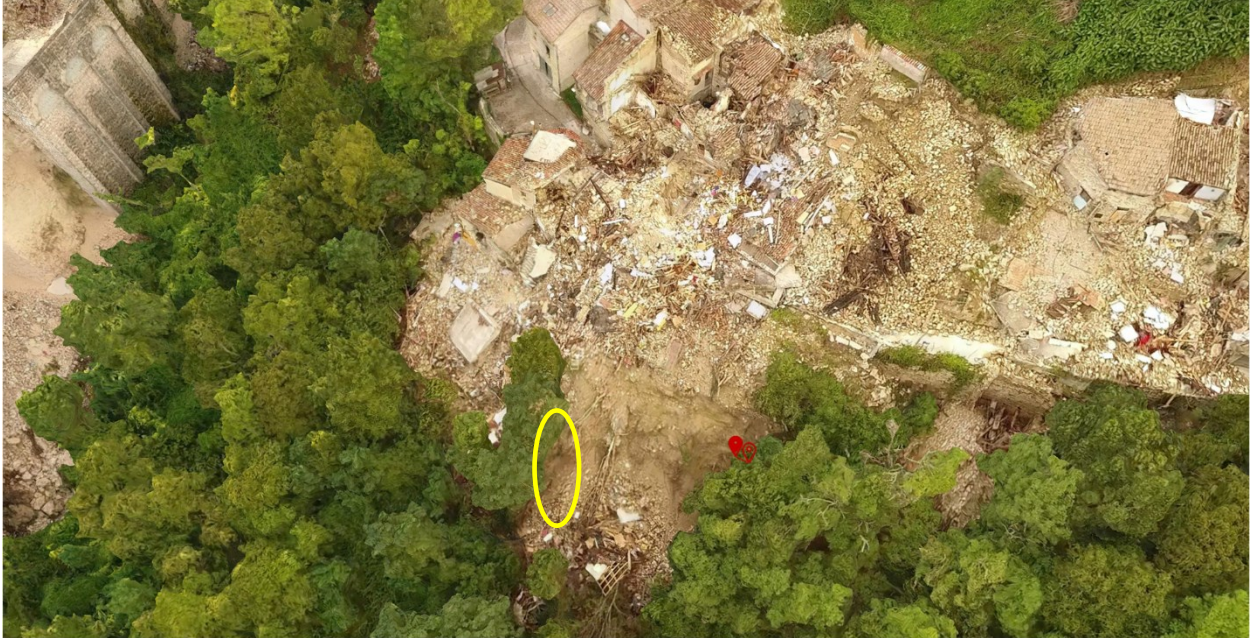
Another shallow landslide occurred on the northern side of Pescara del Tronto (marked as #6 in Figure 4.24; 42.75171 N 13.27261 E). Low-resolution pre-earthquake satellite imagery from Google Earth suggests that this area was already partially barren of vegetation, perhaps due to an existing localized landslide. However, the aerial imagery from the UAV and resulting

3D model, presented in Figure 4.34, show exposed tree roots (circled in yellow) and scarps that appear to be less than one meter-deep into the hillside. The landslide is approximately 17 meters wide by 20 meters high. Significant amount of structural rubble from collapsed residences is also visible in the landslide debris.

**Figure 4.34.** Model of shallow landslide below a northern portion of Pescara del Tronto (42.75171 N 13.27261 E).

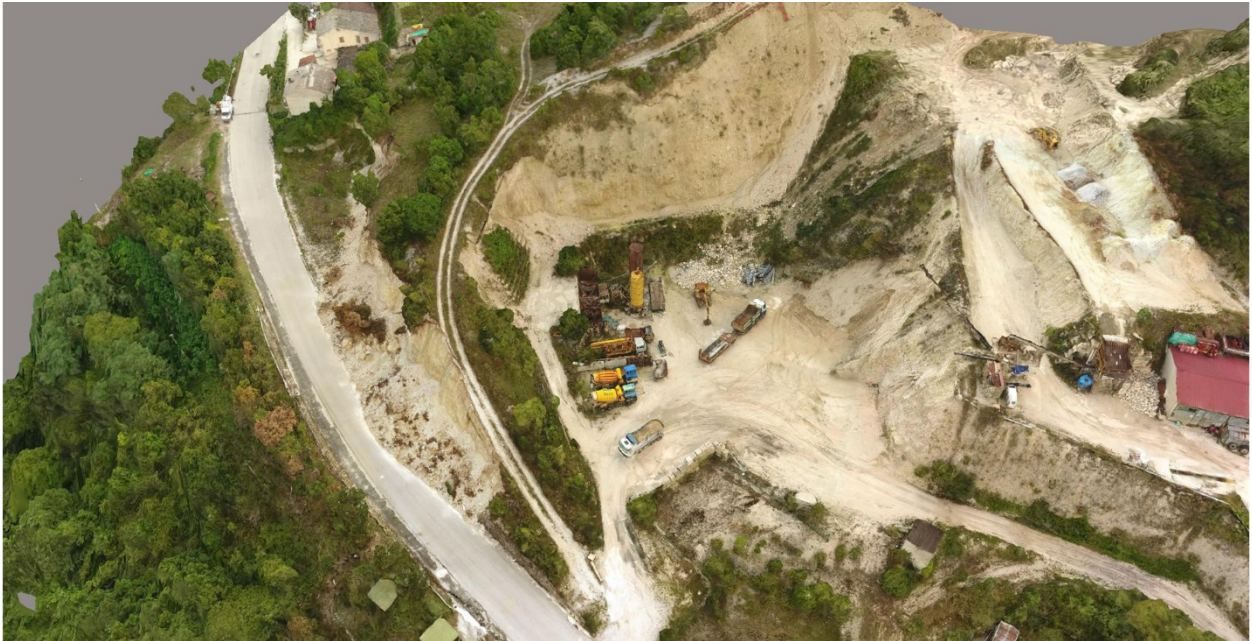
Figure 4.35. Overview model image of the gravel pit in Pescara del Tronto (42.74985 N 13.26893 E).

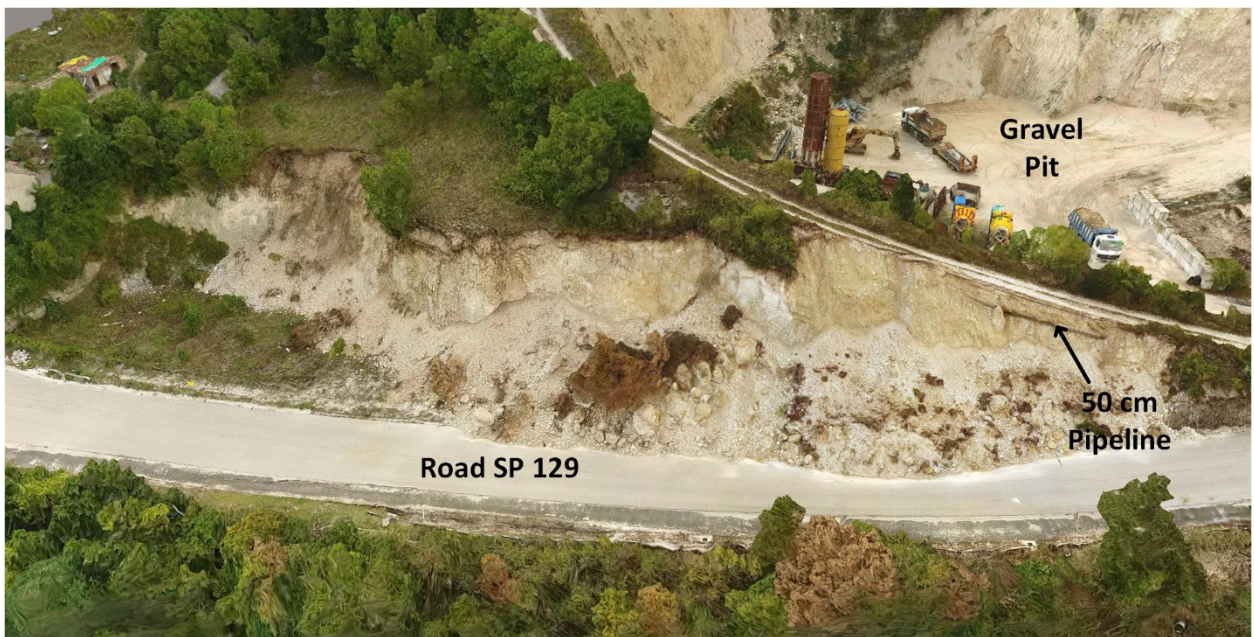
Figure 4.36. Model image of landslide near gravel pit and Road SP 129 that exposed a 50 cm-diameter pipeline (42.74950 N 13.26958 E).

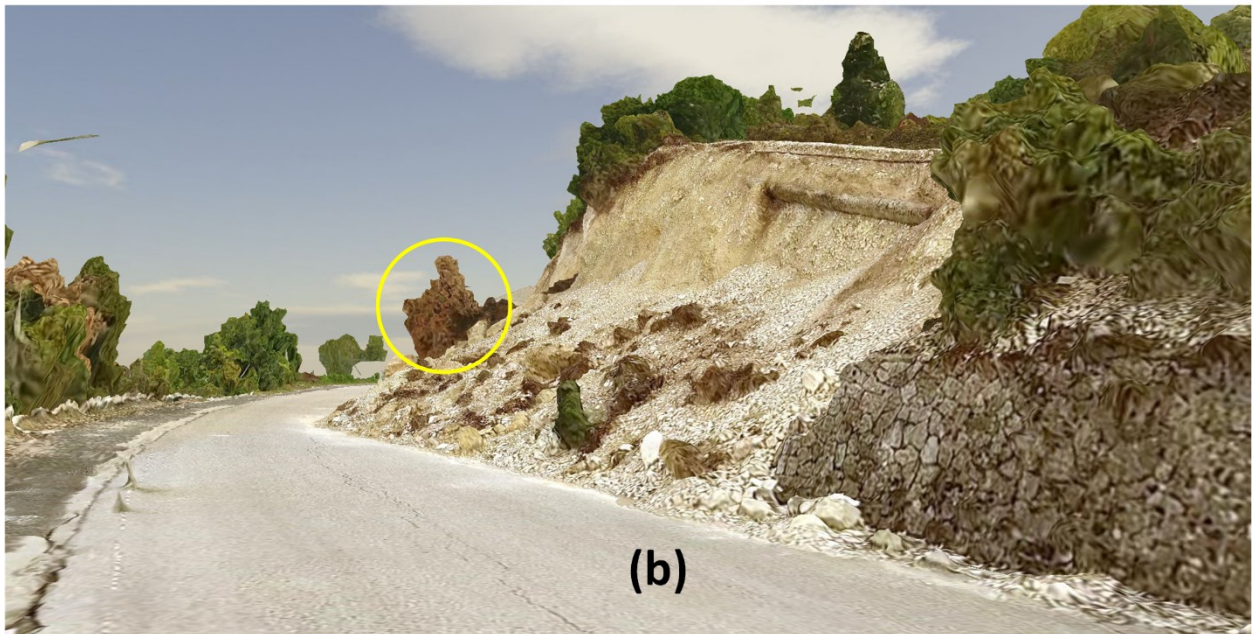
**Figure 4.37.** Both pre-earthquake (a) and post-earthquake (b) images of the slope near the gravel pit where a landslide exposed a pipeline. Pre-earthquake imagery courtesy of Google.

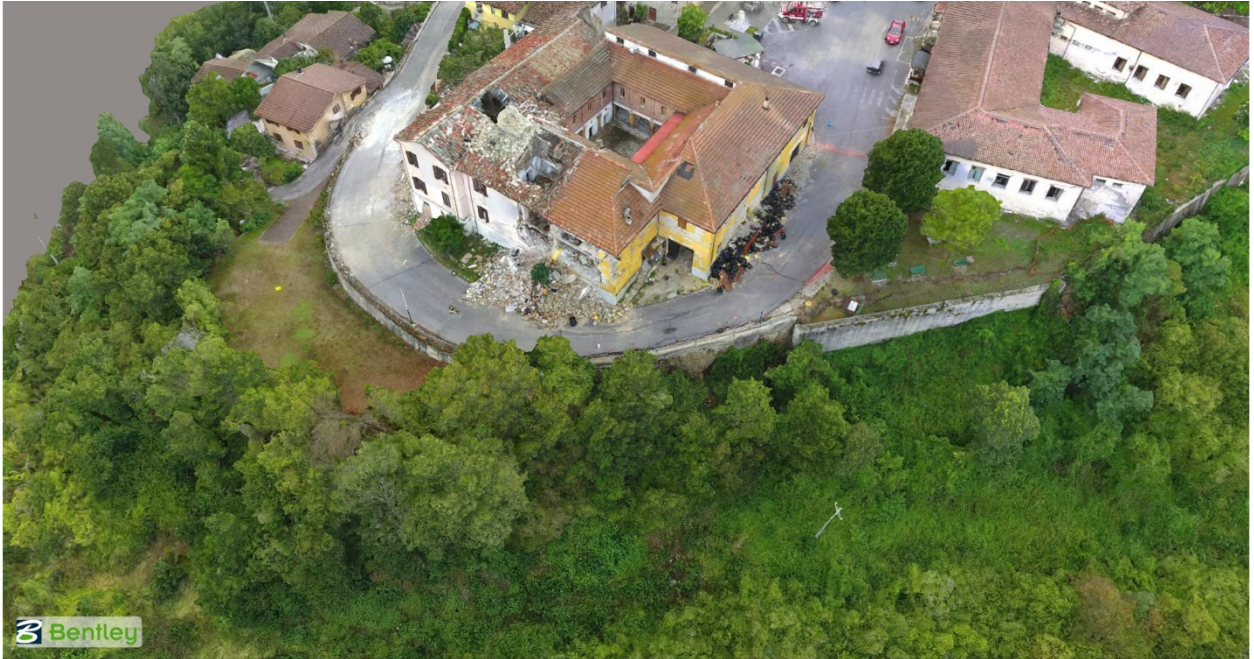
Figure 4.41. 3D Model overview image of the eastern portion of Accumoli

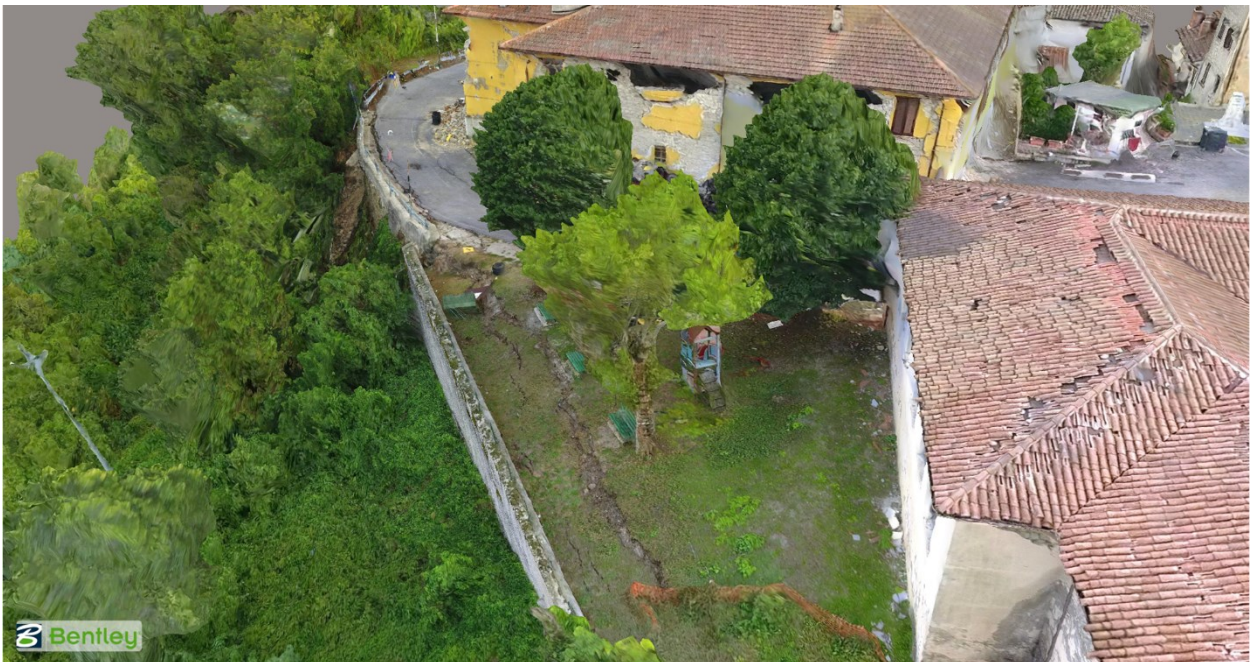
Figure 4.42. Model image of a rotated retaining wall (3.5-degrees) and the subsequent soil graben behind the wall (42.69446 N 13.24980 E).

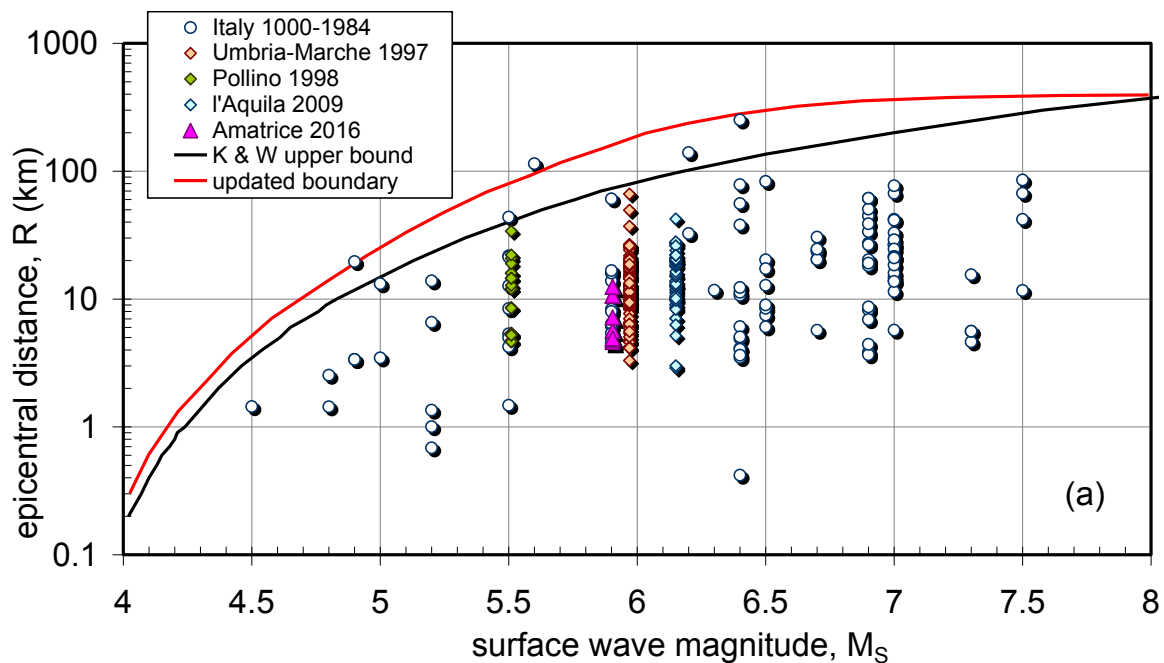
**Figure 4.47.** Data points showing surface wave magnitude and epicentral distance (km) for (a) Category I (rock falls and topples) and (b) Category II (rigid body landslides) inventoried in Italy together with those surveyed by GEER team after the 24 August 2016 earthquake (labelled as 'Amatrice 2016'). The data are compared to upper bound relationships for Category I and II instability mechanisms proposed by Keefer and Wilson (1989) (lower curves) and those updated by Silvestri et al. (2006) (upper curves).

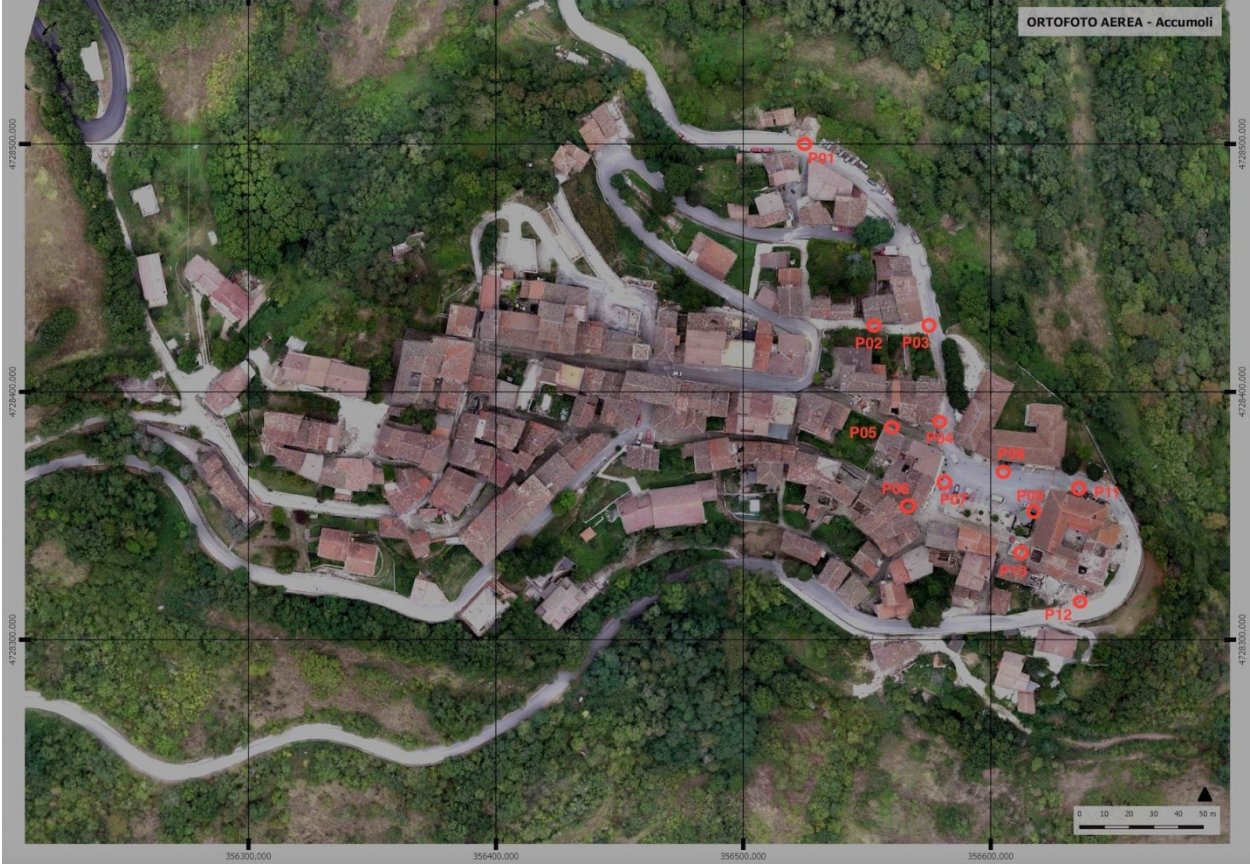
Figure 5.2. Locations of representative structures inspected in the village (see Table 5.2 for details).

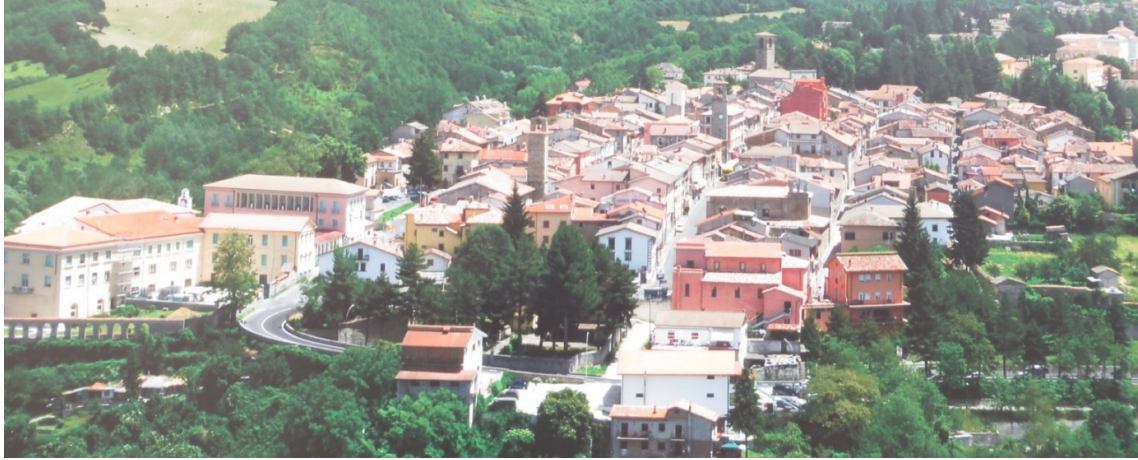
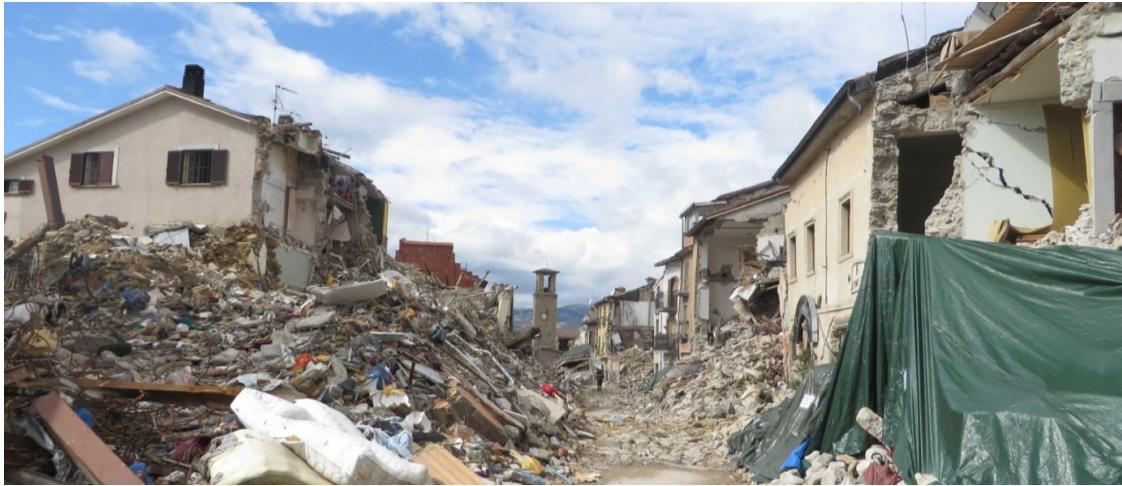
Figure 5.11. Overview of Amatrice Red Zone before and after the 24 August event.

During the second phase of the reconnaissance field mission detailed building-by-building inspections were performed within the Amatrice Red Zone (as shown in Figure 5.11 along with a pre-event aerial photo). It is noted that for safety purposes, access to the Red Zone was permitted to specific streets only, e.g., the main Amatrice market street, a number of perpendicular streets, as well as streets around the inner perimeter of the Red Zone. The steps of the detailed visual inspection of Amatrice were also followed in all other areas inspected by the group and are briefly summarized as follows: (a) Initialization of the field mission based on Copernicus aerial imaging, (b) geo-localization of the photoshoots, (c) identification of the structural typologies and translation of the Italian quick inspection sheet as described in the Field Manual for the Post-earthquake damage and short-term counter measures (AeDES form), (d) transformation of the AeDes form into an Access database for archiving and statistical post-processing, (e) completion of hardcopy AeDes forms in the field for reliability purposes, (f) correlation of the damage observed for each building with pre-event Google Street View photos, (g) definition of a quantitative weighting procedure to derive the global building damage at a scale of D0 to D5 based on the local damage identified according to the Italian quick inspection sheet, (h) generation of the spatial distribution of damage in the form of shape and KMZ files.

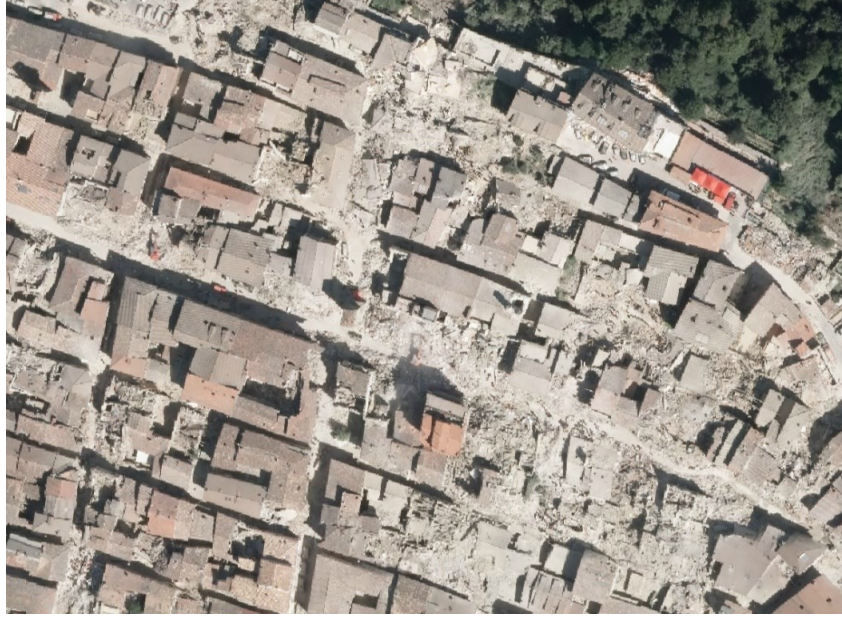
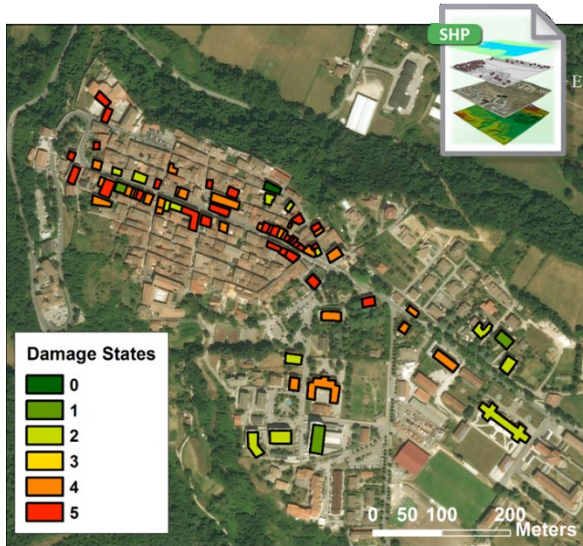
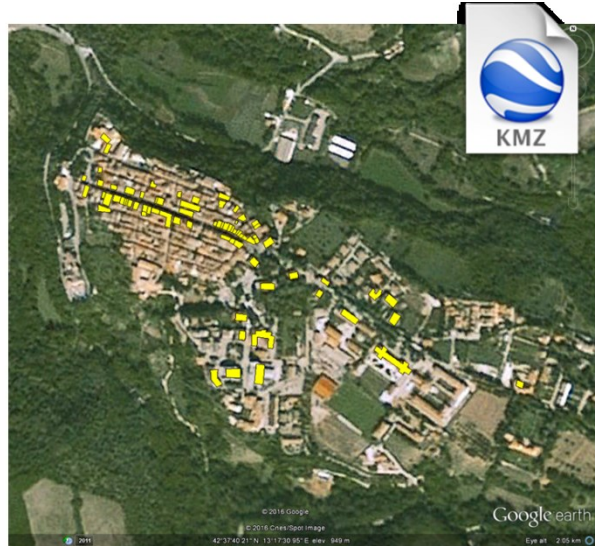
Figure 5.12. Overview of structural damage within the Amatrice Red Zone as seen by aerial image and after visual inspection (note that access to some streets within the Red Zone was not permitted and that additional inspection data are still under post-processing).

Figure 5.12 (top photograph) illustrates the extent of structural damage while the distribution of global damage is portrayed in lower figures (it is noted that the building sample is still being processed). Characteristic images of building collapses are shown in Figure 5.13 and Figure 5.14 (P21-P28) while corresponding coordinates are reported in Table 5.5. Of particular interest was the five story R/C building of P29-P30 in Figure 5.14 along the main market street, which exhibited major damage but did not collapse during the **M6.1** main shock nor subsequent aftershocks. Unfortunately, it subsequently collapsed during the 26 October 2016 **M6.1** event. A few buildings, recently restored, remained undamaged or suffered only minor damage, two of which are depicted in P31-P32. The same applies to the three-story steel building of P33-P34 (Figure 5.15) that experienced minor damage (i.e., shear failure of the infill panels and only minor buckling to one of its columns). The latter building was located very close to the R/C building of Hotel Roma, the town's main hotel, which collapsed (P35-P36 in Figure 5.15).

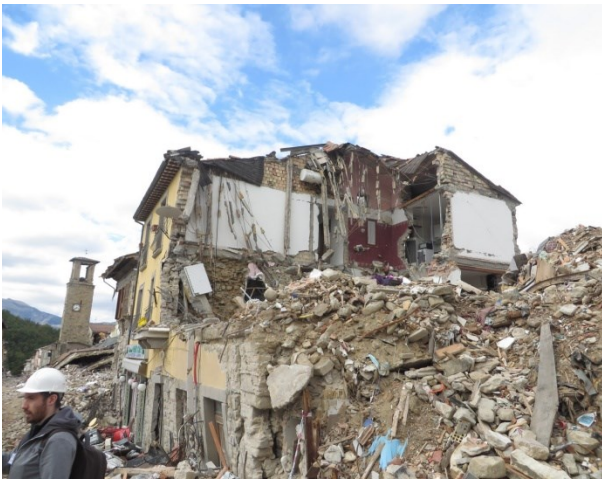
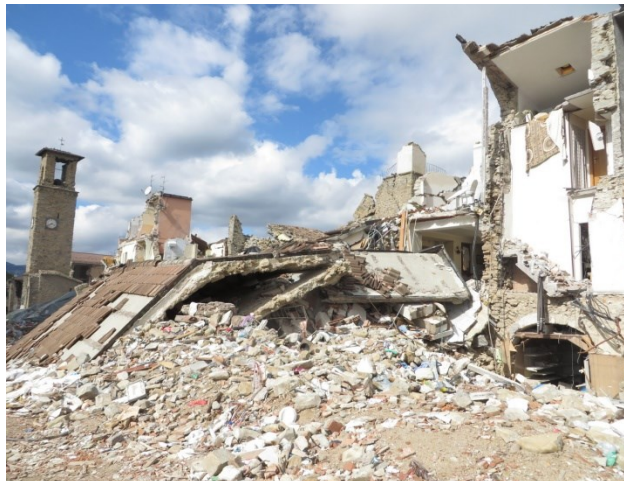
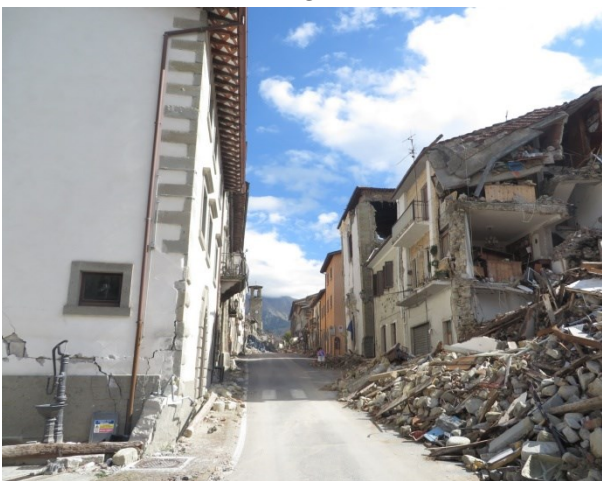
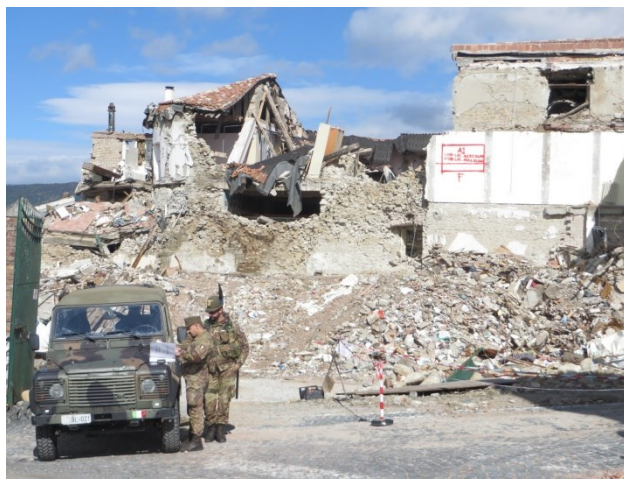
**Figure 5.13.** Photos of extensive building collapse within Amatrice Red Zone after the 24 August event.

Picture	DATUM	longitude	latitude	Damage level	Note
P21	WGS- 84	13.291061	42.62863	D4	
P22	WGS- 84	13.29059	42.62862	D5	
P23	WGS- 84	13.29043	42.62889	D5	
P24	WGS- 84	13.29016	42.62894	D5	
P25	WGS- 84	13.28724	42.62971	D5	
P26	WGS- 84	13.28732	42.63057	D5	
P27	WGS- 84	13.28937	42.62907	D5	
P28	WGS- 84	13.29051	42.62929	D5	
P29	WGS- 84	13.28952	42.62892	D5	
P30	WGS- 84	13.28952	42.62892	D5	
P31	WGS- 84	13.28840	42.62923	D2	
P32	WGS- 84	13.28801	42.62955	D2	
P33	WGS- 84	13.29037	42.62945	D2	
P34	WGS- 84	13.29037	42.62945	D2	
P35	WGS- 84	13.28799	42.62977	D5	
P36	WGS- 84	13.28799	42.62977	D4

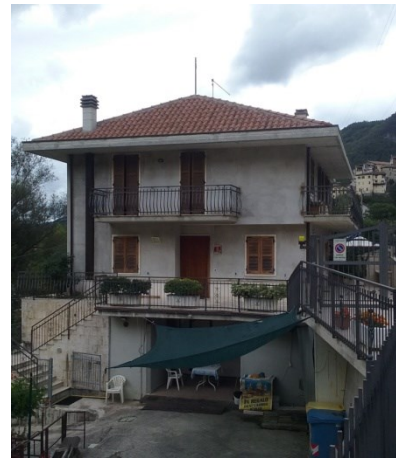
**P08**

Locations of representative structures inspected in Arquata and Borgo by the GEER team are reported in Figure 5.17, while details (WGS-84 coordinates, damage level of buildings, other notes) are given in Table 5.6. The pictures are presented in Figure 5.18. The area around P15 (especially the zone NE of this point) had limited access on the date of the survey. The village consisted mainly of un-reinforced masonry structures, 2-3 stories in height. Very few of the structures were retrofitted with through-going iron bars (for instance P4). Isolated relatively modern reinforced concrete structures were found (see P08) showing negligible or low damage.

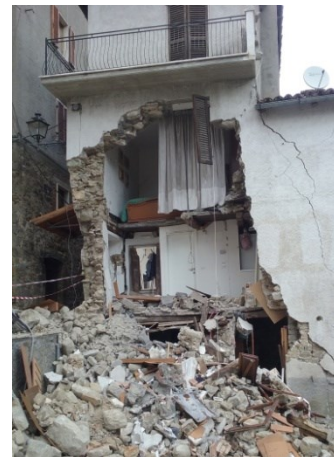
**P11**

Damage patterns evaluated from aerial image analysis of Arquata are presented in Figure 5.20. No information is provided for Borgo. The higher degree of damage in Arquata, located near the top of the ridge, relative to Borgo was captured on average. Again, a decreasing degree of damage was observed away from the edge. The cases of full collapse were generally captured by the aerial image analysis (P13 and P14 were reproduced, while P12 was reported as highly damaged). The degree of damage to highly damaged and partially collapsed buildings was sometimes underestimated and identified as “negligible to slight damage” (e.g., P11).

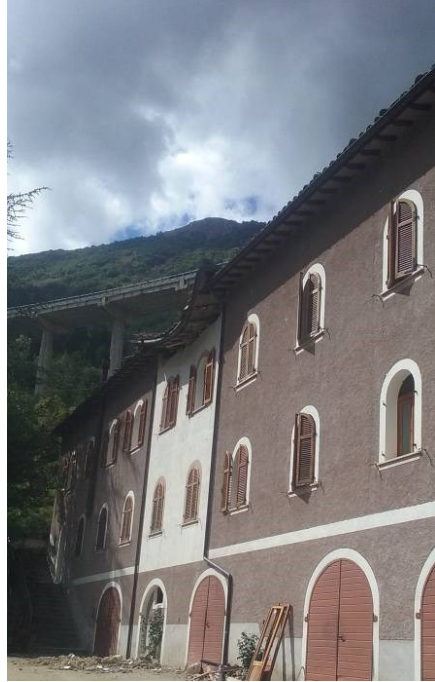
**P03**

Damage patterns from aerial image analysis of Pescara are reported in Figure 5.29. The major damage in the southern portion of the village was well captured. As observed for Arquata del Tronto, the buildings with minor damage were not always correctly identified (e.g., P03 not captured by aerial analysis while P04 was identified as highly damaged).

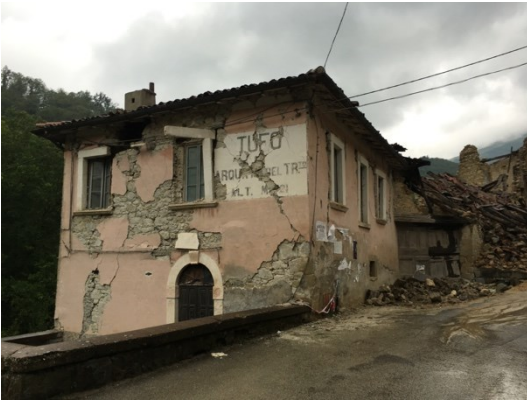
**P1**

TAG	DATUM	Location		Damage level	Notes
		Lat.	Long.		
P1	WGS-84	42.7353°	13.2532°	D3	Diffused cracks
P2	WGS-84	42.7353°	13.2530°	D5	Collapse of the entire structure
P3	WGS-84	42.7354°	13.2528°	D2	Crack starting from the window corner
P4	WGS-84	42.7351°	13.2519°	D0	No damage
P5	WGS-84	42.7351°	13.2522°	D0	No damage
P6	WGS-84	42.735°	13.2522°	D4	Partial collapse of the structure

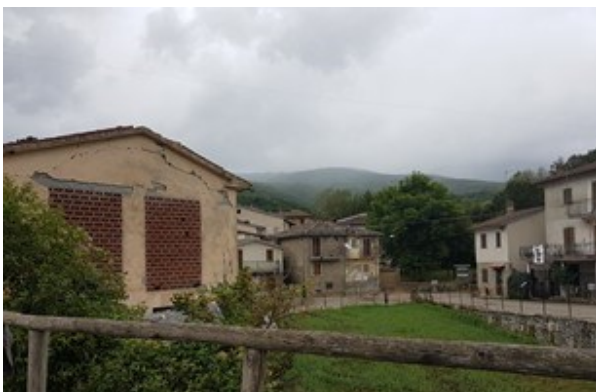
**P03**

Picture	DATUM	longitude	latitude	Damage level	Note
P01.jpg	WGS- 84	13.255	42.69528	D3	
P02.jpg	WGS- 84	13.255	42.69417	D4	View of several buildings
P03.jpg	WGS- 84	13.255	42.69528	D3	View of several buildings
P04.jpg	WGS- 84	13.255	42.69528	D3	
P05.jpg				D3	Downloaded from <a href="http://www.fontedelcampo.it/foto/foto-terremoto/">http://www.fontedelcampo.it/foto/foto-terremoto/</a>
P06.jpg				D5	Downloaded from <a href="http://www.fontedelcampo.it/foto/foto-terremoto/">http://www.fontedelcampo.it/foto/foto-terremoto/</a>
P07.jpg				D3	Downloaded from <a href="http://www.fontedelcampo.it/foto/foto-terremoto/">http://www.fontedelcampo.it/foto/foto-terremoto/</a>

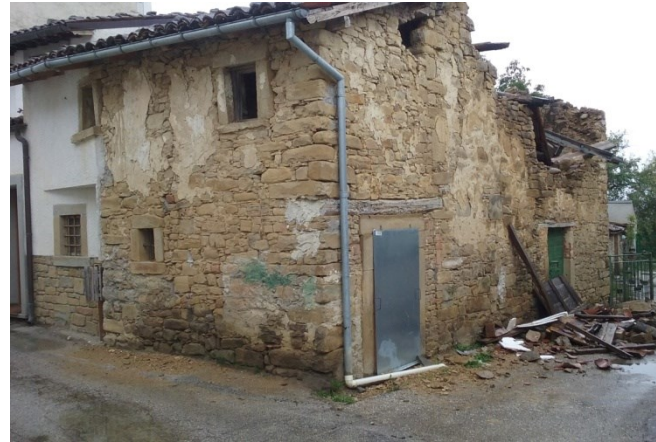
**P04**

Photos of representative structures inspected in Mosicchio are shown in Figure 5.60, with further details provided in Table 5.15 (WGS-84 coordinates, damage level of buildings, other notes). The hamlet consists mainly of unreinforced masonry structures, 2-3 stories in height. The damage was quite low, on average classified as D2. Only one case of partial collapse (D4) was observed in a poorly constructed, unreinforced masonry building (see P4).

Picture	DATUM	Location		Damage Level	Notes
		Lat.	Long.		
P01	WGS-84	42.622807°	13.279402°	D0-D1	
P02	WGS-84	42.623130°	13.279552°	D1-D2	
P03	WGS-84	42.623654°	13.279299°	D2-D3	
P04	WGS-84	42.623777°	13.279313°	D4	<i>Partial collapse of the roof</i>

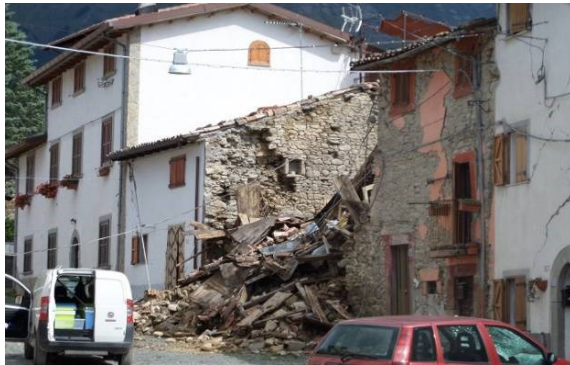
**P02**

Only a small part of the village was accessible in the days of the reconnaissance, which was surveyed as shown in Figure 5.69 and Table 5.18. The few buildings inspected (Figure 5.70) in some cases were partially or totally collapsed (P02, P03, P07), but most frequently had diffuse cracking (P04, P05, P06). Sommati had an average damage level in the order of D3-D4 with a local IMCS = 9 (Galli et al. 2016).

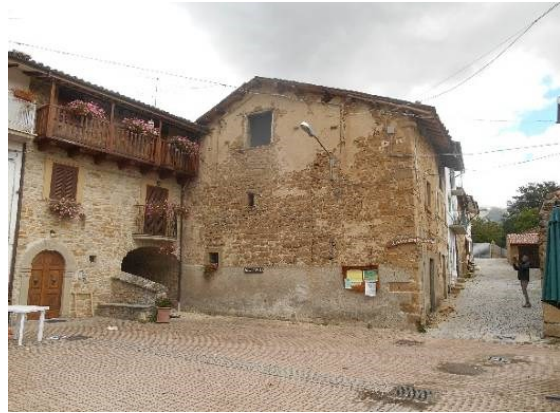
**P01**

Picture	DATUM	longitude	latitude	Damage level	Note
P01	WGS- 84	13.324494	42.630019	D0	Traditional buildings facing the small square, all undamaged
P02	WGS- 84	13.324644	42.629939	D1	Only slight cracking visible
P03	WGS- 84	13.324978	42.629897	D1	Maybe the most ‘damaged’ building
P04	WGS- 84	13.323975	42.630127	D0	New houses close to the main road, totally undamaged
P05	WGS- 84	13.323884	42.629816	D0	
P06	WGS- 84	13.323549	42.630106	D0

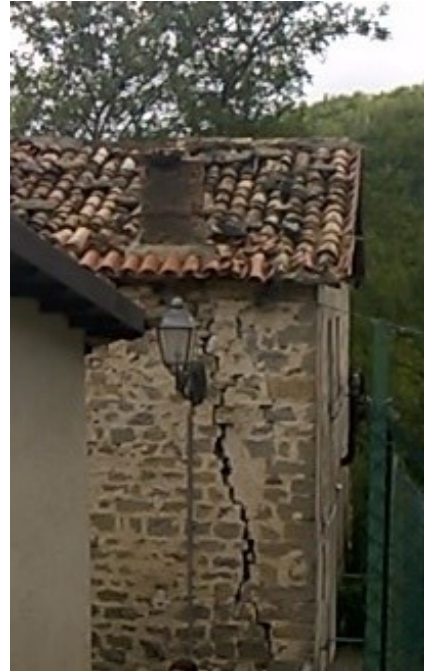
**P20 (Collefratte)**

**Figure 5.82.** Representative pictures in Montegallo (location listed in Table 5.22).

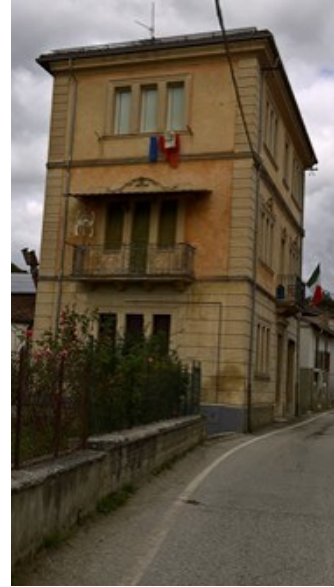
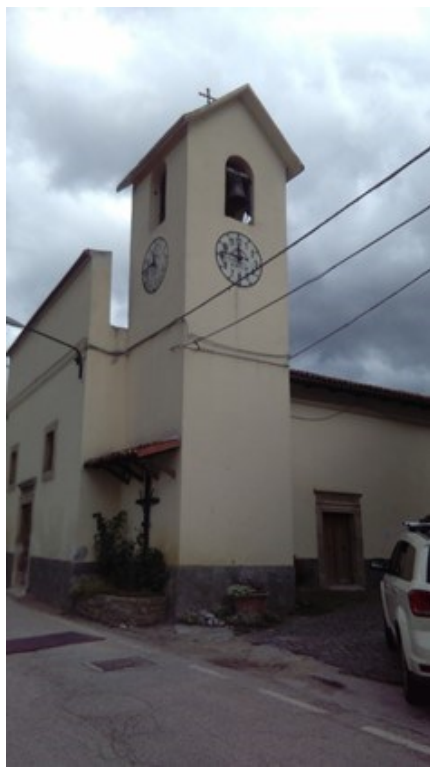
Picture	DATUM	longitude	latitude	Damage level
P01	WGS- 84	13.26763	42.55525	D0
P02	WGS- 84	13.26752	42.55489	D0
P03	WGS- 84	13.26760	42.55502	D0

**Figure 5.87.** Representative structures in Aringo (Montereale).

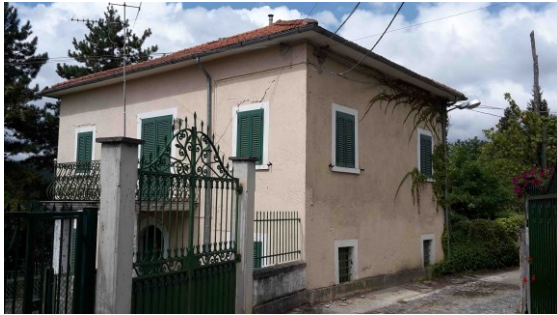
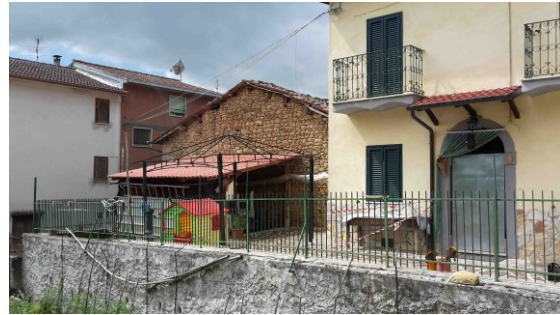
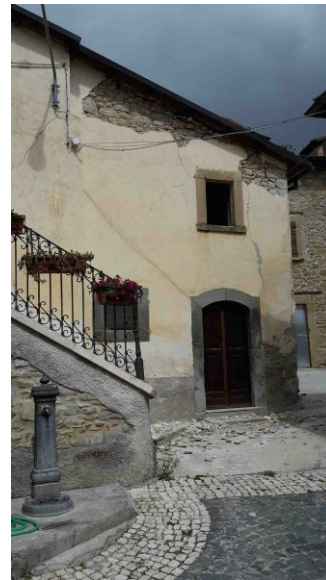
Picture	DATUM	Location		Damage Level
		Lat.	Long.	
P01	WGS-84	42° 34' 18" N	13° 15' 42" E	D1
P02	WGS-85	42° 34' 18" N	13° 15' 43,998" E	D0
P03	WGS-86	42° 34' 18" N	13° 15' 43,998" E	D1
P04	WGS-87	42° 34' 18" N	13° 15' 42" E	D1
P05	WGS-88	42° 34' 16,998" N	13° 15' 43,002" E	D5
P06	WGS-89	42° 34' 16,998" N	13° 15' 43,002" E	D2
P07	WGS-90	42° 34' 15" N	13° 15' 46,002" E	D3
P08	WGS-91	42° 34' 16,002" N	13° 15' 43,002" E	D2

**Figure 5.89.** Representative pictures in Santa Lucia (Montereale) (see Table 5.24 for details).
