# Engineering Reconnaissance of the 24 August 2016 Central Italy Earthquake. Version 2

Geotechnical Extreme Events Reconnaissance Association

Report No. GEER-050B

22 November 2016

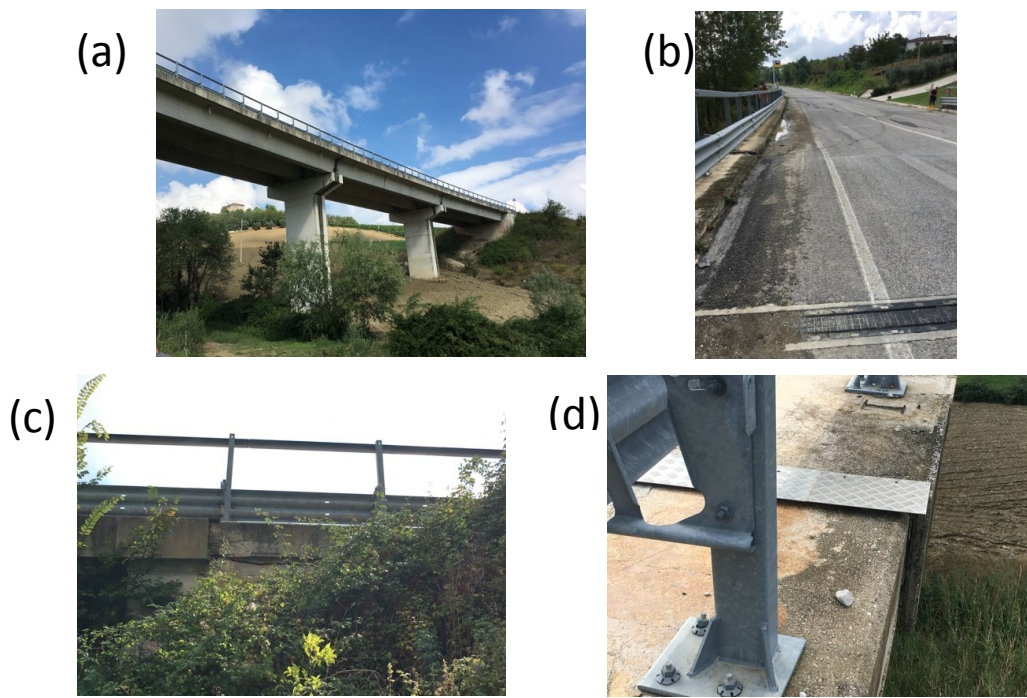
Figure 6.6 shows the RC bridge along the SP173 in Offida. This bridge presents significant settlements on the road close to the abutments (Figure 6.6b), that caused damage at the structural elements, as shown in Figure 6.6c. These settlements, which existed before the earthquake, have been amplified by seismic compression of backfill as a result of strong ground motion from the 24 August 2016 mainshock. Thus, it was suggested to limit the maximum load to be carried by the bridge, until specific geotechnical improvements to stabilize the area can be performed.

Figure 6.6. RC bridge along the SP173 in Offida (42.941687 deg, 13.702294 deg): overview of the bridge (a), settlement of the road (b) crack (c) and relative displacement of the abutment (d).

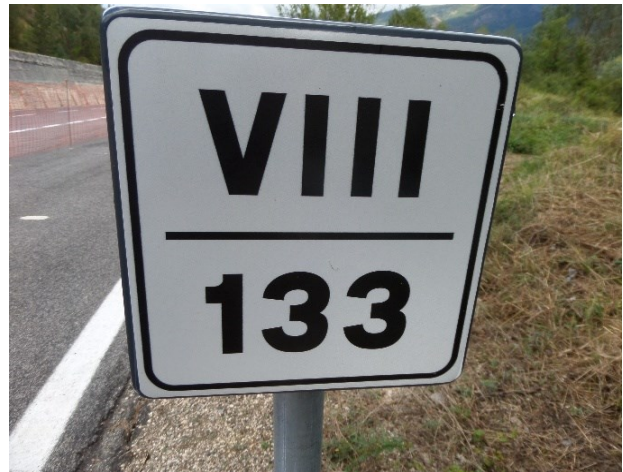
We observed longitudinal cracks (Figure 7.8a-b) at km 133 of main road SS4 (Salaria). Maximum crack widths in the asphalt surface are around 3 cm (Figure 7.8c) and cracking was also observed at the edge of the road pavement (Figure 7.8d). Adjacent to this section of road is a nearly vertical cut. Nearby areas with gentler slopes had no pavement cracking.

**Figure 7.8.** Embankment instability along the SS4 road at km 133 (42.650533N - 13.270442E): (a) longitudinal cracks along the whole rest area, (b) identification of the site location by road sign, (c) maximum horizontal opening of the longitudinal crack, (d) disconnection between the lateral slope and the road surface.

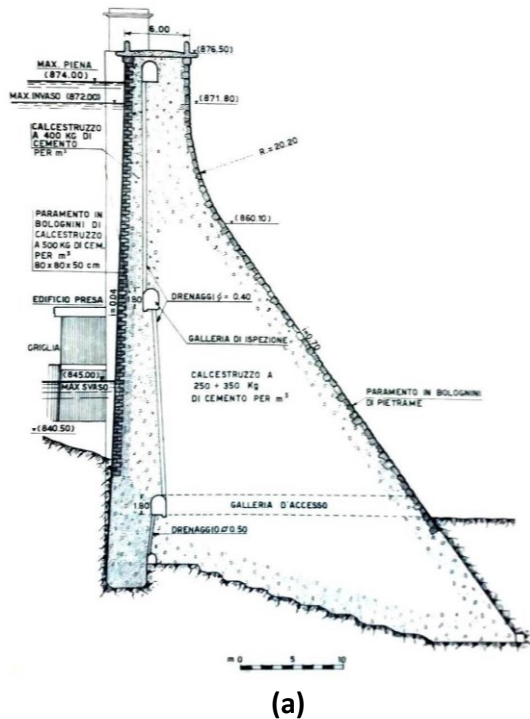
Inspections carried out by ENEL staff after the earthquake revealed no damage to Scandarello dam, which we confirmed on October 19, 2016 (Figure 7.12). Furthermore, ENEL staff stated that

Figure 7.13. Scandarello dam: (a) cross-section (ANIDEL, 1951); (b) photo of the upstream face taken on October 19, 2016 (42.641560°N, 13.269000°E).

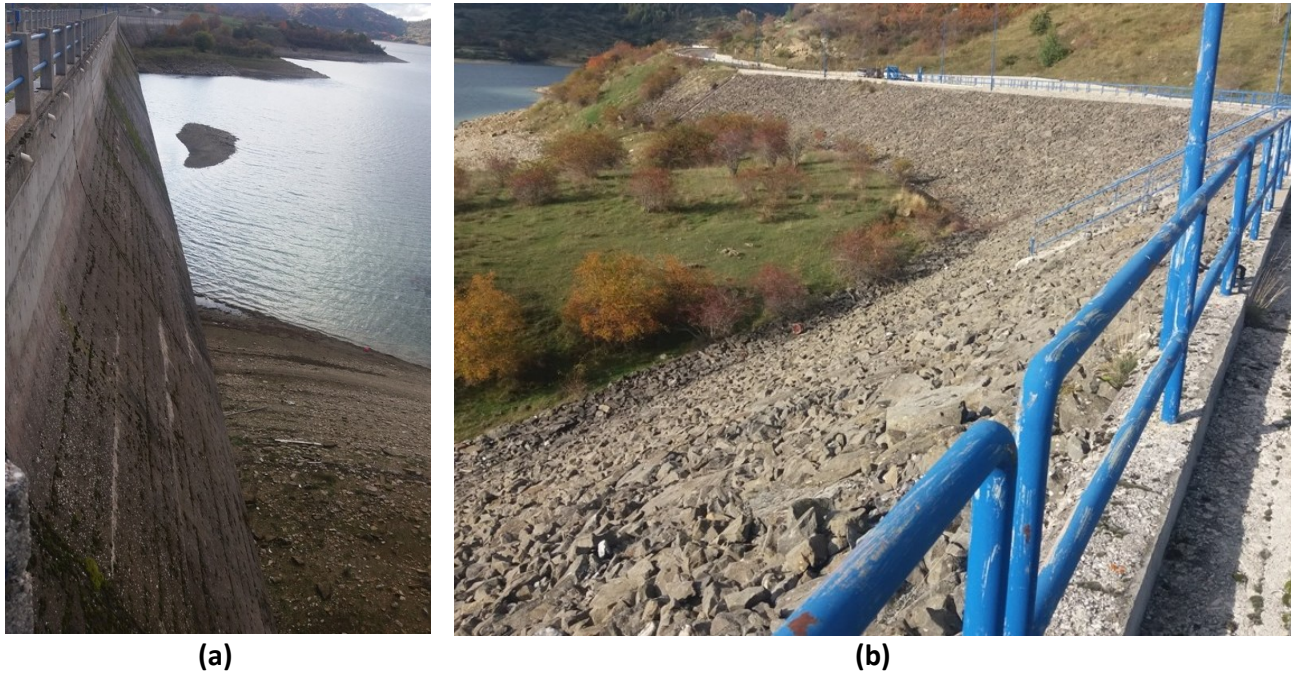
It is important to highlight that the SPD seismic station was located within the surveillance station of the dam since April 15, 2009 (after L'Aquila earthquake). During the August 24 earthquake, the SPD station recorded a peak ground acceleration of about 0.11 g. After the mainshock, no damage was observed to Sella Pedicate dam, which is located 23.7 km from the epicenter.

**Figure 7.18.** Photos taken on October 19, 2016 of the upstream face of Sella Pedicate concrete dam (a) and of one of its extremities (b), which is an embankment dam (42.514468°N, 13.370155°E).
