Path of Knowledge for the Assessment of Structural Safety of the Pisan Tower of the Royal Palace of Palermo in Italy

Path of Knowledge for the Assessment of Structural Safety of the Pisan Tower of the Royal Palace of Palermo in Italy / La Mendola, L.; Accardi, M.; Agnello, F.; Monaco, A.. - In: HERITAGE. - ISSN 2571-9408. - 6:8(2023), pp. 5818-5847. [10.3390/heritage6080306]

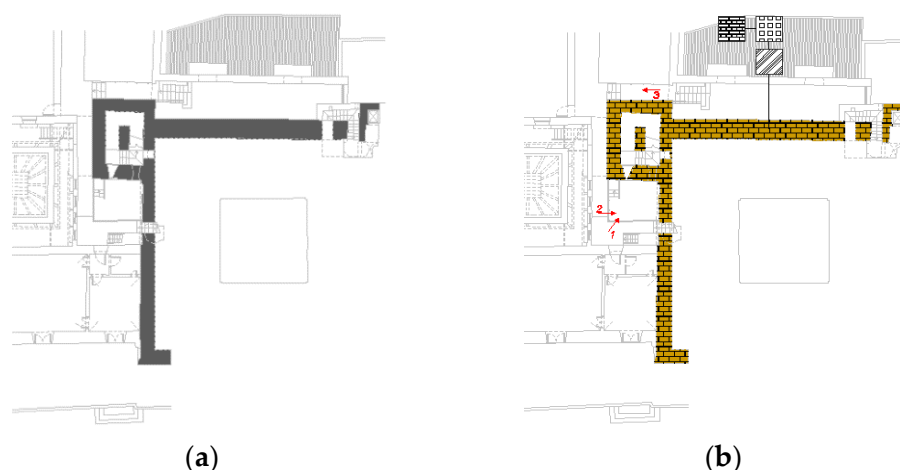
Figure 20. Identification of the structure of the Tower on level G (height 27.00 m): (a) hypothesized vertical load-bearing structure; (b) hypothesized materials.

Level G includes the rooms of the Astronomical Observatory adjacent to the south and west sides of the Tower. As has been mentioned, these were involved in the restoration intervention in the 1990s by Boscarino and Cottone. The intervention exposed the load-bearing structure on this level, allowing us to observe that it can be substantially associated with the original Norman construction (Figure 20a) and that it consists of large calcarenite ashlars and lime mortar (Figure 20b).
