Path of Knowledge for the Assessment of Structural Safety of the Pisan Tower of the Royal Palace of Palermo in Italy

Path of Knowledge for the Assessment of Structural Safety of the Pisan Tower of the Royal Palace of Palermo in Italy / La Mendola, L.; Accardi, M.; Agnello, F.; Monaco, A.. - In: HERITAGE. - ISSN 2571-9408. - 6:8(2023), pp. 5818-5847. [10.3390/heritage6080306]

Abstract: This paper presents the path of knowledge developed for assessing the structural safety of the Norman-age Pisan Tower, which is mostly incorporated into the Royal Palace in Palermo, Italy. Historical, geomatic, and mechanical investigations were conducted and the most relevant results are herein collected and presented. The research path was addressed to specific tasks: identification of the building, geometric surveys, recognition of the sequence of phases of building transformation, detection of the components of the load-bearing structure, structural diagnostic surveys, and investigation of the subsoil and foundations. The explicit vulnerabilities found were mostly confined to the Piazza library floor, while implicit vulnerabilities were identified in the presence of false walls and in high loads

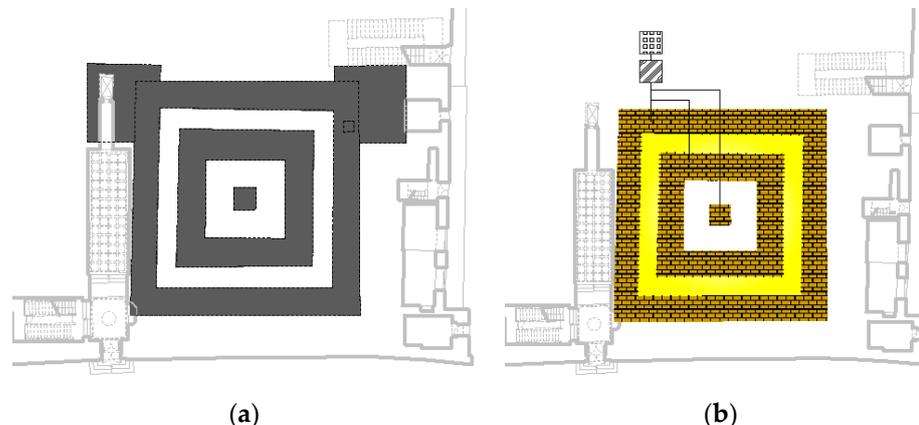
The surveys performed and the information collected showed that the vertical load-bearing structure of the Tower consists, on level A, of two concentric quadrilaterals in the planimetry, with walls wider than 2 m, and two turrets at the vertices of the west side of the Tower, as represented in Figure 15a. These walls have been realized with a wall in large (70–100 cm) calcarenite ashlar, dry-placed and/or with low-width mortar joints. The wall was considered to show good workmanship and the ashlar have excellent mechanical properties, as shown by the high value of the compression strength of the extracted core samples. The material between the two squares of the Tower can be associated with an infill, mainly constituted by crushed ashlar, masonry with scarce mechanical properties, and incoherent materials (Figure 15b).

Figure 15. Identification of the structure of the Tower on level A (height 2.90 m); (a) hypothesized vertical load-bearing structure; (b) hypothesized materials.

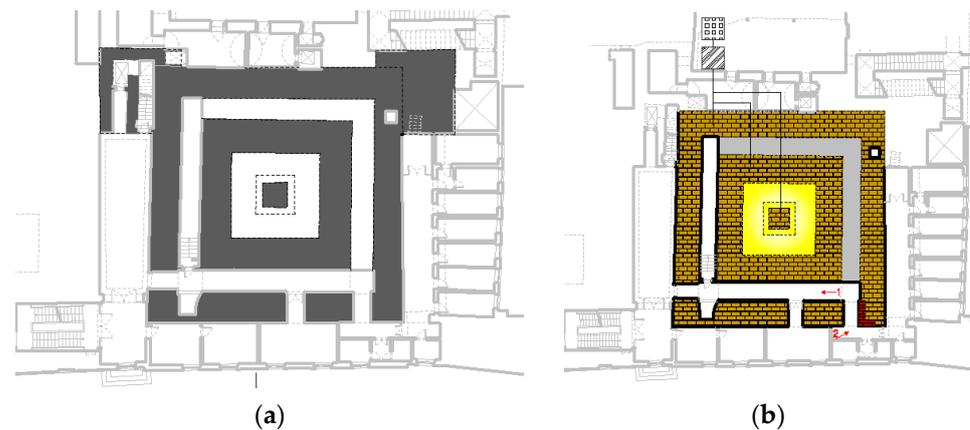
The surveys performed and the information collected at level B repeated and confirmed the same structural layout as the lower level, consisting of two homothetic quadrilaterals with wall widths above 2 m, in calcarenite ashlar, dry-placed and/or with mortar (Figure 16a). Today, as in the Norman layout, the south turret is mainly used for vertical connections. The structural layout of the Tower has been presumably subjected to modifications during the complex and intricate evolution of the Norman Palace. At this level, the wall, which is partly visible, consists of calcarenite ashlar and variable-width lime mortar joints. The performed tests showed that the ashlar have good mechanical properties; however, these were lower than the values found at the lower level. The infill of the core between the two masonry squares is heterogeneous and incoherent, while in the internal core it is constituted by crushed ashlar with variable size and resistance (Figure 16b).

Figure 16. Identification of the structure of the Tower on level B (height 8.40 m): (a) hypothesized vertical load-bearing structure; (b) hypothesized materials.

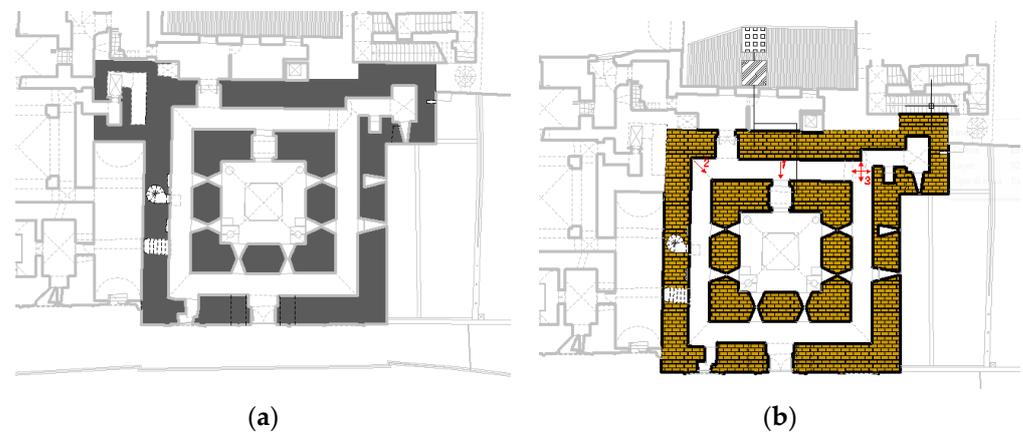
Level C has a completely exposed structural layout, consisting of two concentric quadrilaterals, divided by an ambulatory with a barrel vault covering and two side turrets (Figure 17a). The masonry walls are in large calcarenite ashlar and lime mortar. The mechanical parameters of the ashlars were only available for the exterior of the east wall, and the resistance values were aligned with those of the lower level. The values for the operating tension of the masonry wall of the external square were very high; this is probably incompatible with the resistance of the masonry (Figure 17b).

Figure 17. Identification of the structure of the Tower on level C (height 13.00 m): (a) hypothesized vertical load-bearing structure; (b) hypothesized materials.

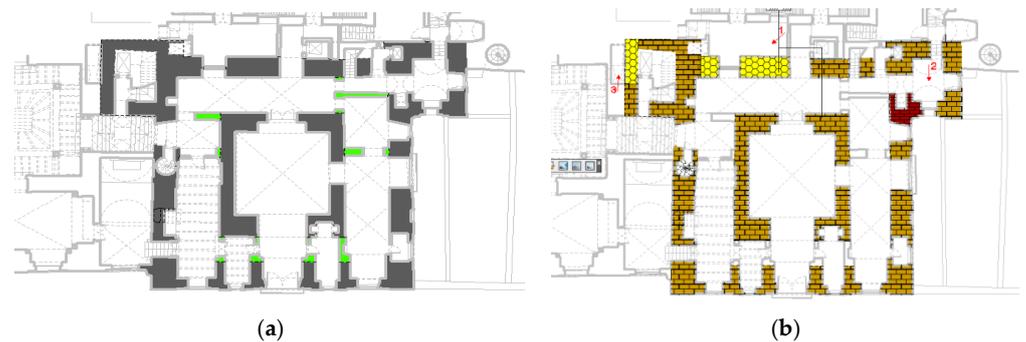
On levels D-E, the structural layout of the concentric quadrilaterals can be detected even if the walls are significantly set back from the lower level (Figure 18a). Moreover, the walls of the external square are intermitted by wide and numerous openings (doors, windows, rooms, and staircases). The President's Room has two different heights, while the other rooms are mainly double-height or have timber roofs. Superintendent Valenti, during the 1929 restoration intervention, performed several modifications to the structural layout. He demolished many mezzanine rooms, which had presumably been realized in the period of the Spanish Viceroyalty, and relocated some masonry walls to restore the Norman layout. The numerous performed interventions and the finishing with exposed faux masonry plaster were an obstacle to the precise definition of the wall typologies. Figure 18b shows a possible hypothesis, reconstructed solely on the basis of the historical documentation found.

Figure 18. Identification of the structure of the Tower on levels D-E (height 19.60 m): (a) hypothesized vertical load-bearing structure; (b) hypothesized materials.

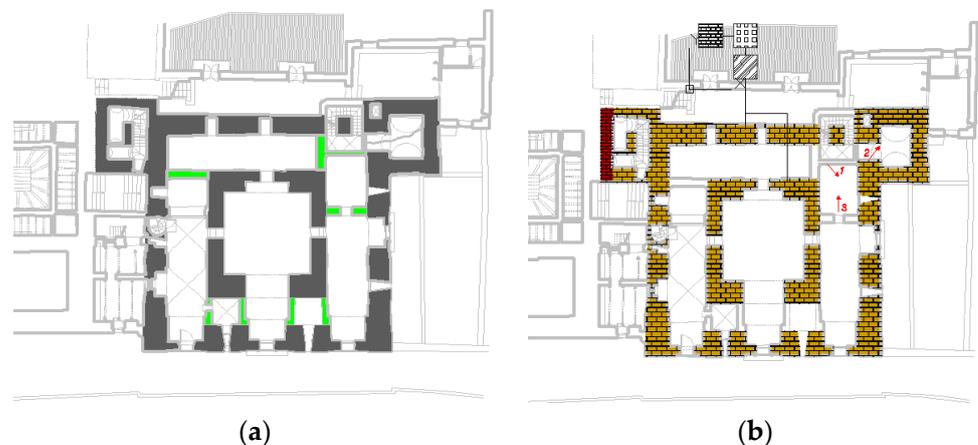
At level F, the two mezzanine rooms used as offices were examined. The structural layout and related considerations (Figure 19a) were the same as for the lower level (19.60 m). During the 1929 restoration intervention, Superintendent Valenti performed several modifications to the structural layout. He demolished many mezzanine floors on this level and only left the ones that are currently being examined. Several extensive reinforcement interventions were performed on the vertical load-bearing structure through local rebuilding and, sometimes, demolition and reconstruction. The masonry walls used in these interventions were both in aerated bricks and calcarenite blocks (Figure 19b); however, the large number of interventions and the use of an exposed faux masonry plaster finishing complicate the precise definition of the wall typologies.

Figure 19. Identification of the structure of the Tower on level F (height 23.60 m): (a) hypothesized vertical load-bearing structure; (b) hypothesized materials.

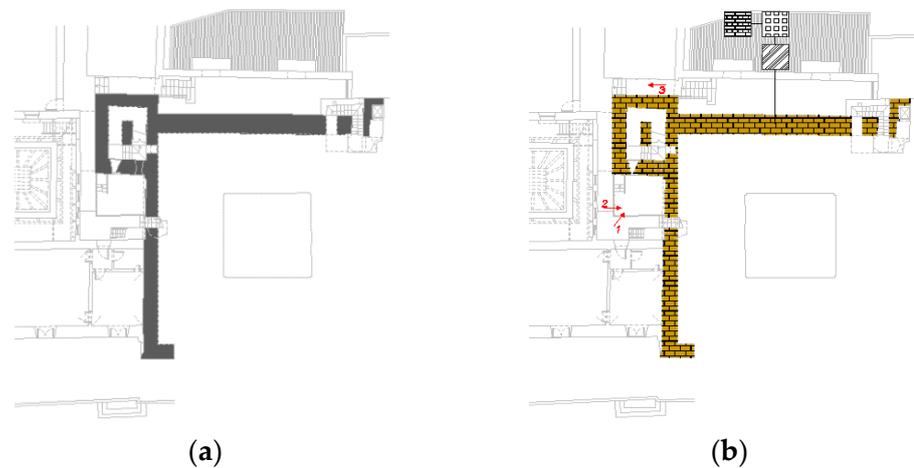
Level G includes the rooms of the Astronomical Observatory adjacent to the south and west sides of the Tower. As has been mentioned, these were involved in the restoration intervention in the 1990s by Boscarino and Cottone. The intervention exposed the load-bearing structure on this level, allowing us to observe that it can be substantially associated with the original Norman construction (Figure 20a) and that it consists of large calcarenite ashlars and lime mortar (Figure 20b).

Figure 20. Identification of the structure of the Tower on level G (height 27.00 m): (a) hypothesized vertical load-bearing structure; (b) hypothesized materials.

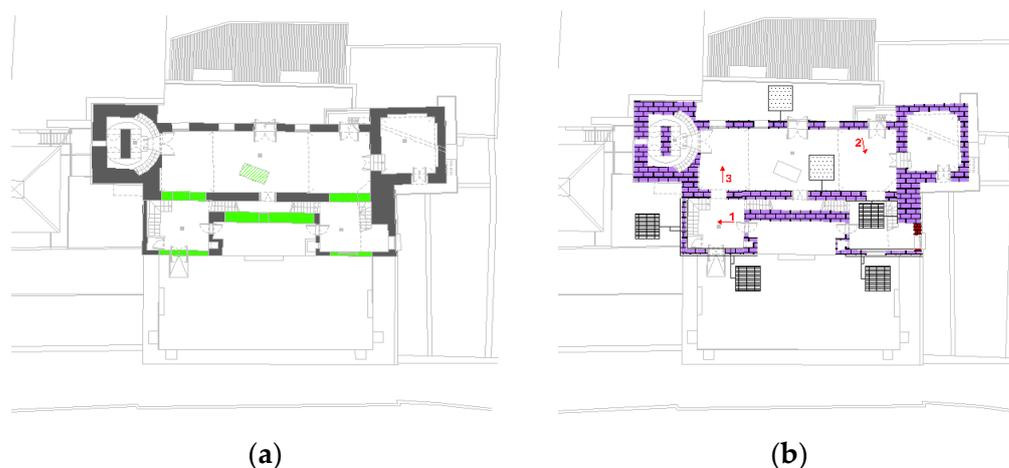
it was subjected to several integrations, modifications, adaptations, and an extended and complete restoration intervention by Boscarino and Cottone, who restored the layout of the original Observatory. At this level, the structural layout no longer has a rigid system with two concentric quadrilaterals; instead, a single hall connects the south and the north turrets (Figure 22a). Boscarino and Cottone's intervention included the demolition of the partition walls in the main room, and the substitution and/or the reconstruction of all the floors of this and the upper level, in addition to the construction of a new dome based on an octagonal steel drum. Since the original construction, the walls had been almost entirely in masonry, with calcarenite ashlar and mortar joints (Figure 22b). They were then subjected to repeated reinforcement interventions, using the techniques common at the times of the interventions, including local rebuilding with aerated bricks, reinforced plaster with an electro-welded mesh on the two sides, re-pointing of mortar joints, substitution and/or realization of new steel lintels, and construction of new steel tie-rods. These interventions improved the masonry resistance, but they did not cure the vulnerabilities of the vertical load-bearing structural components at this level, which are mainly related to the presence of some transfer walls. Among these, the wall on the east side—which provides a basement for the drum of the central dome—must certainly be investigated. At the walking level of the museum (36.18 m), Cottone and Boscarino's intervention removed the infill and realized new floors in I-beams and hollow flooring blocks detached from the vaults, which then lost their load-bearing structural role. Instead, the vault of the central room was reinforced so as to support the equatorial telescope. At the upper level, that is, the roof covering of the museum of the Observatory, the pre-existing timber roofs were substituted with new slabs, steel I-beams, and hollow flooring blocks.

Figure 22. Identification of the structure of the Tower on level L (height 37.70 m): (a) hypothesized vertical load-bearing structure; (b) hypothesized materials.

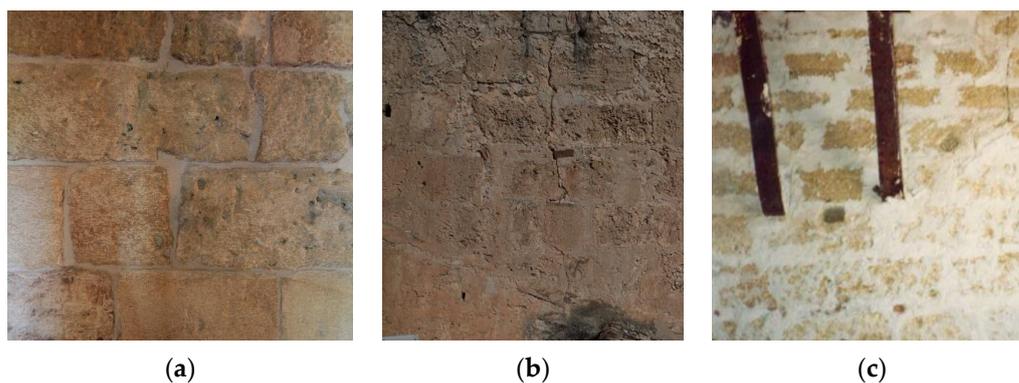
- Masonry in soft stone ashlar (tuff, calcarenite, etc.) of the Norman period (Figure 23a);
- Masonry in soft stone ashlar (tuff, calcarenite, etc.) of the period of the Spanish Viceroyalty (Figure 23b);
- Masonry in soft stone ashlar (tuff, calcarenite, etc.)—19th century—Astronomical Observatory (Figure 23c).

Figure 23. Masonry typologies: (a) Norman era; (b) Spanish era; (c) 19th century.

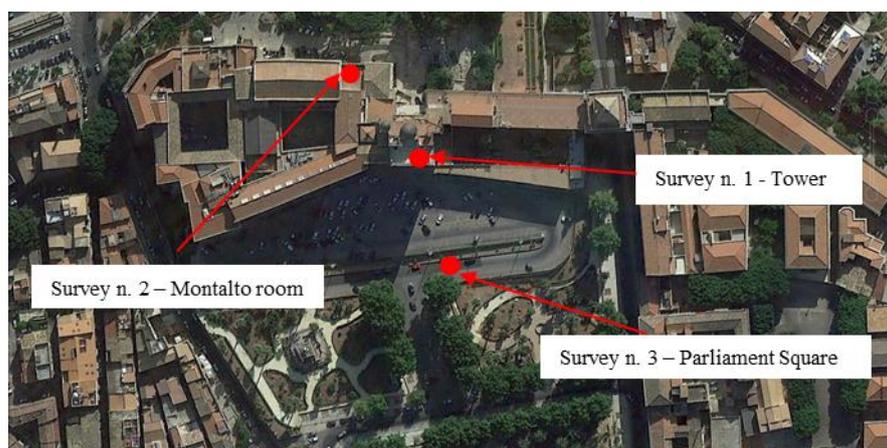
The surveys were performed at the points shown on the planimetry in Figure 27; the first one was inside the Tower at the lowest height (n. 1), the second one was outside the Tower, but at a lower height corresponding to the Montalto Room (n. 2), and the third one was in Parliament Square (n. 3), just beyond the caretaker's office at the entrance. Survey n. 1, named "Tower", obtained a value of $V_{S,30} = 342 \text{ m/s}$ and a width of 8 m for landfill on the sandy–calcarenite complex. Survey n. 2, named "Montalto room", obtained a value of $V_{S,30} = 345 \text{ m/s}$ and a width of 5 m for landfill on the sandy–calcarenite complex. Survey n. 3, named "Parliament Square", obtained a value of $V_{S,30} = 352 \text{ m/s}$ and a width of 5 m for landfill on the sandy–calcarenite complex.

Figure 27. Planimetry with the location of the surveys.

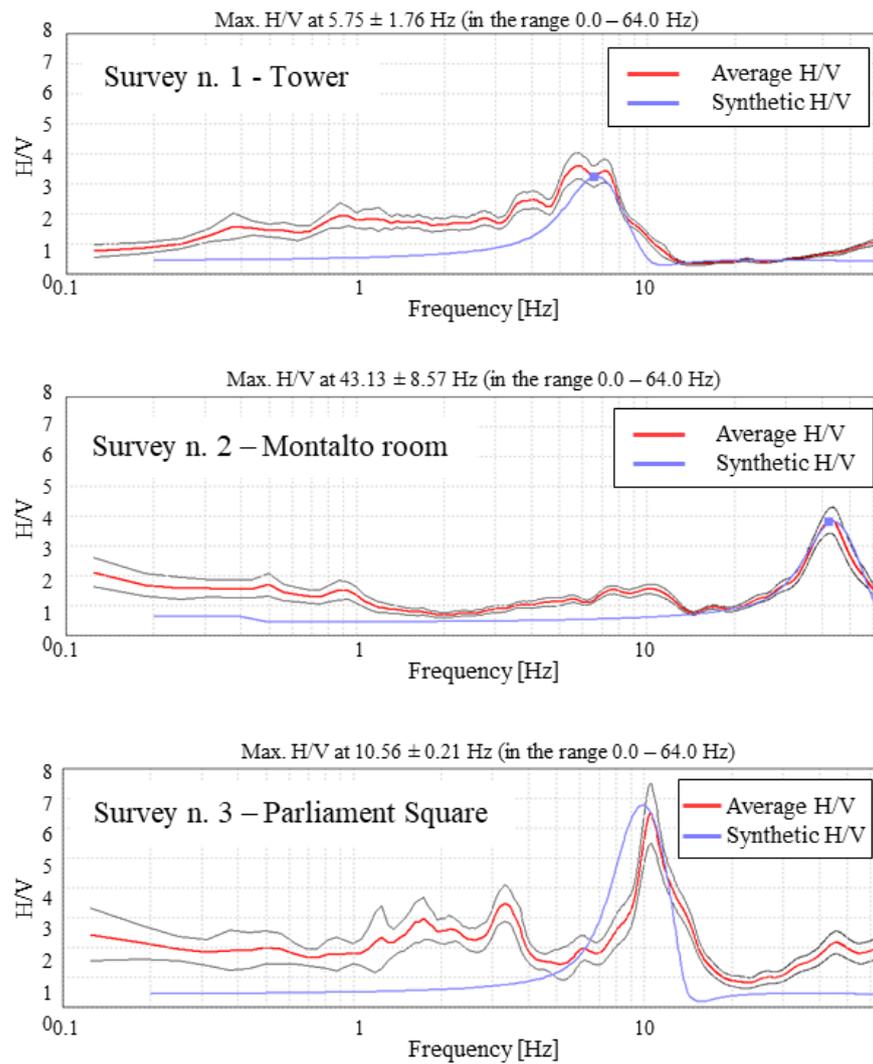
In accordance with chapter 3 of *Guidelines*, which defines seismic action with reference to Section 3.2.2 of NTC2018, and hence according to the value of $V_{S,30}$ obtained in the three tests, the soil class to be assumed for the definition of the response spectra was Class C—coarse-grained, medium-dense soil deposits or fine-grained soils with a medium consistency, thicker than 30 m, characterized by a gradual improvement of mechanical properties along with the depth, and by values for $V_{S,30}$ between 180 m/s and 360 m/s (that is, $15 < N_{SPT,30} < 50$ in coarse-grained soils and $70 < c_{u,30} < 250 \text{ kPa}$ in fine-grained soils). Figure 28 shows the details of the interpretations of the experimental data obtained.

Depth [m]	Thickness [m]	V_s [m/s]	Poisson's Ratio
Survey n. 1 – Tower			
8.00	8.00	209	0.40
inf.	inf.	445	0.35
Survey n. 2 – Montalto room			
1.00	1.00	168	0.40
inf.	inf.	358	0.35
Survey n. 3 – Parliament Square			
5.00	5.00	180	0.42
inf.	inf.	436	0.35

Figure 28. Results of single-station passive seismic tests.
